# **I-5 Blakeslee to Grand Mound (TDA 12) Mitigation Site**

## **USACE IP NWS-2008-744-SOD**

#### **2015 MONITORING REPORT**

# I-5 Blakeslee to Grand Mound (TDA 12) Mitigation Site

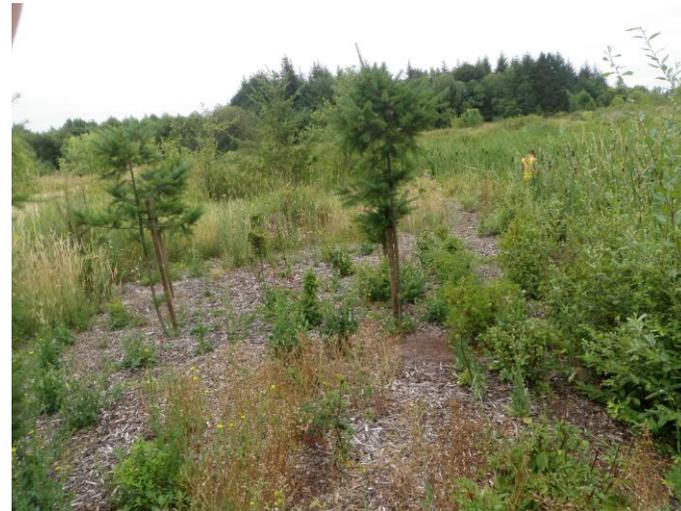
**Photo 1**  
**Trees in the Riparian Buffer (July 2015)**

The density of trees in the scrub-shrub area and the riparian buffer combined is 328 plants/acre (CI<sub>80%</sub> = 264-391). Tree species present include bigleaf maple (*Acer macrophyllum*), western red cedar (*Thuja plicata*), Douglas-fir (*Pseudotsuga menziesii*), and Oregon ash (*Fraxinus latifolia*). The red cedar appeared to be suffering some mortality but the Douglas fir plantings were thriving in the sun (Photo 1)

The region has plans to continue weed control and replant areas that experienced die off during the last year.

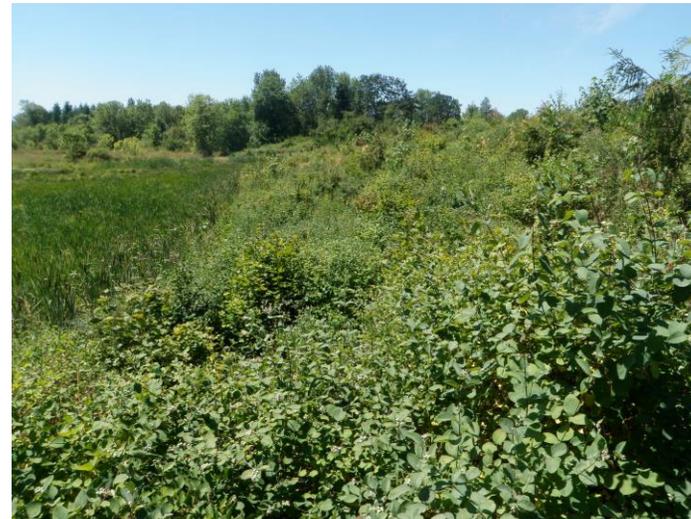
**Photo 2**  
**Woody cover in the Riparian Buffer (July 2015)**

The density of shrubs in the scrub-shrub area and riparian buffer is 3983 plants/acre (CI<sub>80%</sub> = 3642-4323). Shrub species present include snowberry (*Symphoricarpos albus*), beaked hazelnut (*Corylus cornuta*), vine maple (*Acer circinatum*), and western serviceberry (*Amelanchier alnifolia*) (Photo 2).

While no one species makes up more than 60 percent cover across the site, snowberry is definitely a dominant species. The scrub-shrub community on this site is so small and so similar in composition to the riparian buffer; it was included in the riparian buffer sample.

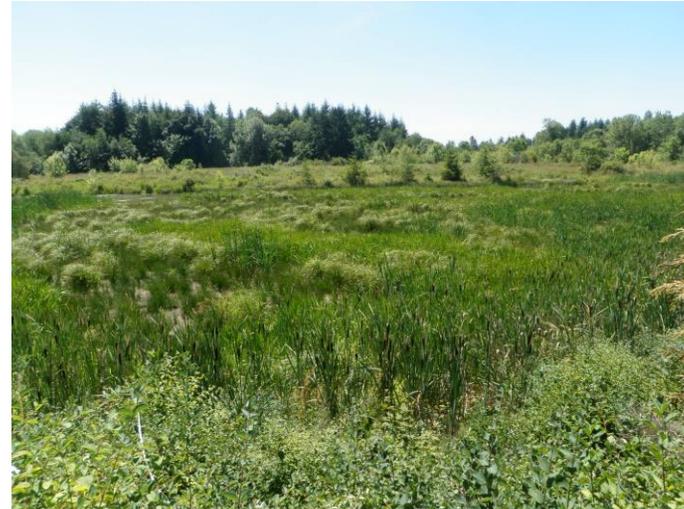
**Photo 3**  
**Overview of Emergent cover in Wetland (July 2015)**

The emergent zone has 89% cover ( $CI_{90\%} = 85-94\%$ ) and is made up of a diverse community of herbaceous species. Common spikerush (*Eleocharis palustris*) provides a large amount of cover in this zone but is interspersed with simplestem bur-reed (*Sparganium emersum*), slough sedge (*Carex obnupta*), marsh seedbox (*Ludwigia palustris*), and broadleaf cattail (*Typha latifolia*) (Photos 3 and 4).
