Washington State Department of Transportation North Fork Newaukum Mitigation Bank

2010 MONITORING REPORT

Wetland Assessment and Monitoring Program

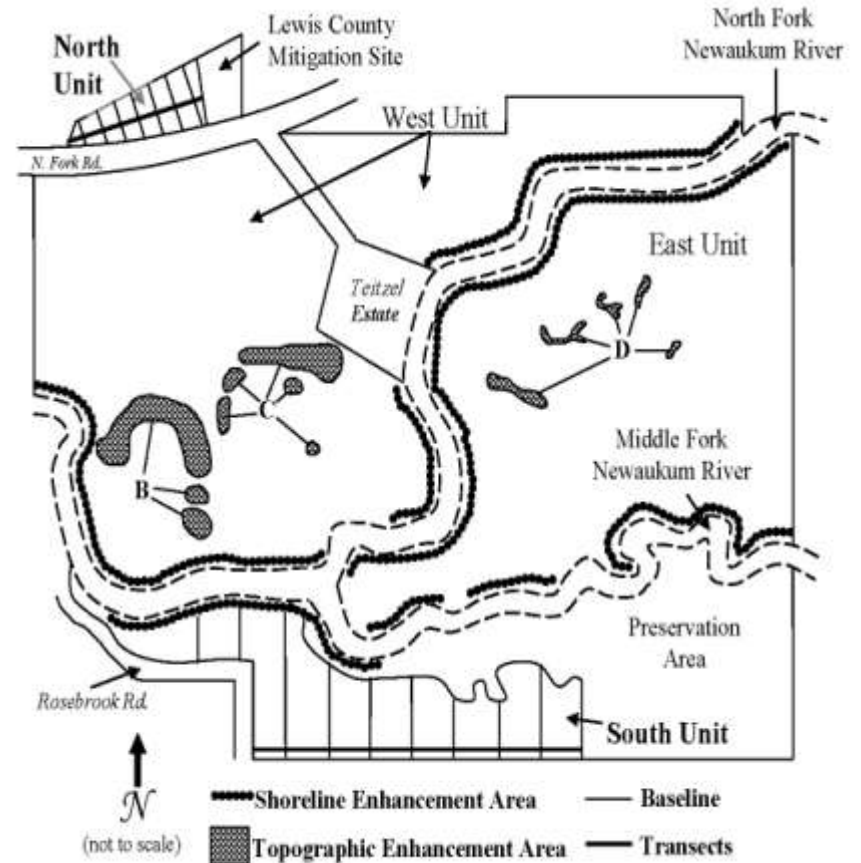
Figure 2 Site Sampling Design (2010)

Unequal-area belt transects were used to estimate the density of living trees per acre in the North, and South Units (Performance Standards 5D and 5H). A baseline was placed perpendicular to the primary environmental gradient in each of the two units (Figure 2). In the South Unit, 17 four-meter wide unequal-area belt transects were placed along the baseline using a restricted random sampling method. In the North Unit, 10 two-meter wide unequal-area belt transects were placed at set intervals along each baseline using a systematic random sampling method. Living and dead stems were counted in each belt transect. Species richness is also addressed by performance standards 5D and 5H by requiring four of the native tree species to be present at over 10% of the survival threshold standards for each native tree species in Table 1, section 5.14 of the Monitoring Plan (see Appendix 3)

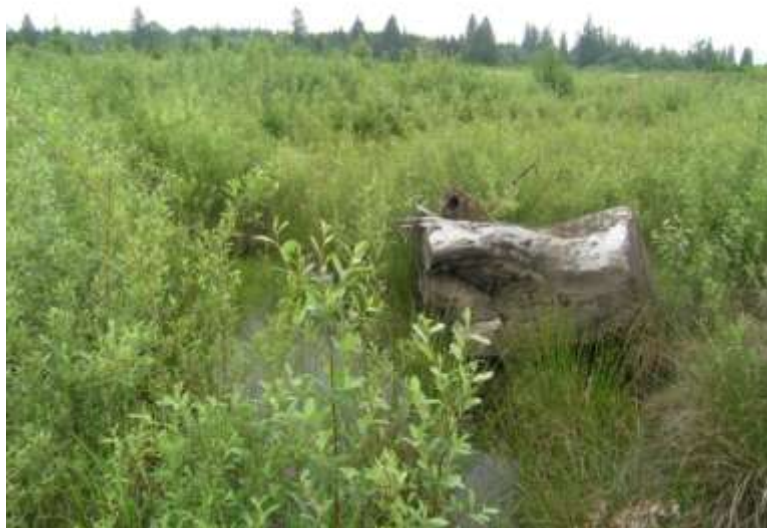
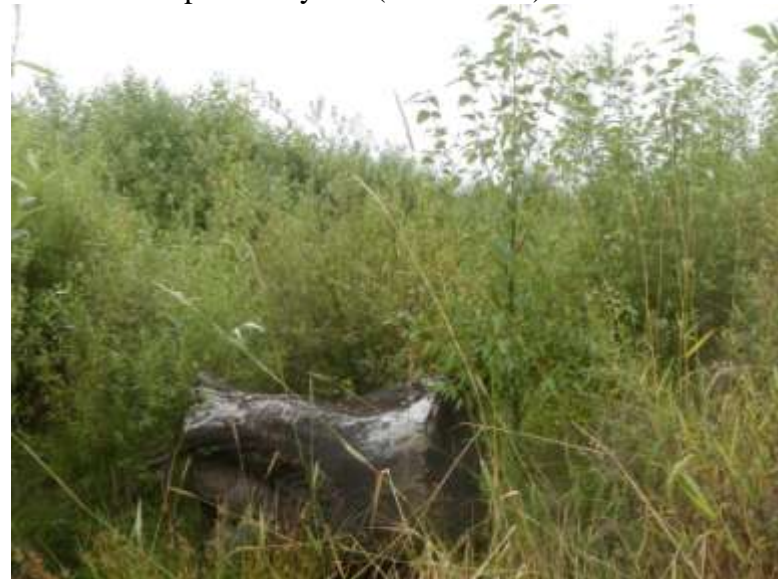
Ponds dominated by willows (*Salix* sp.) significantly increased in cover over the past two years (2008 -2010).

Pond C2 in 2008

Pond C2 in 2010

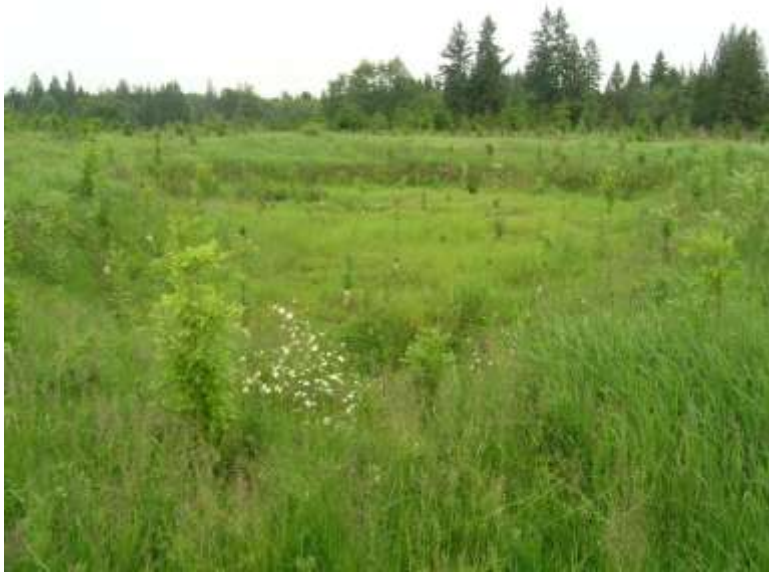
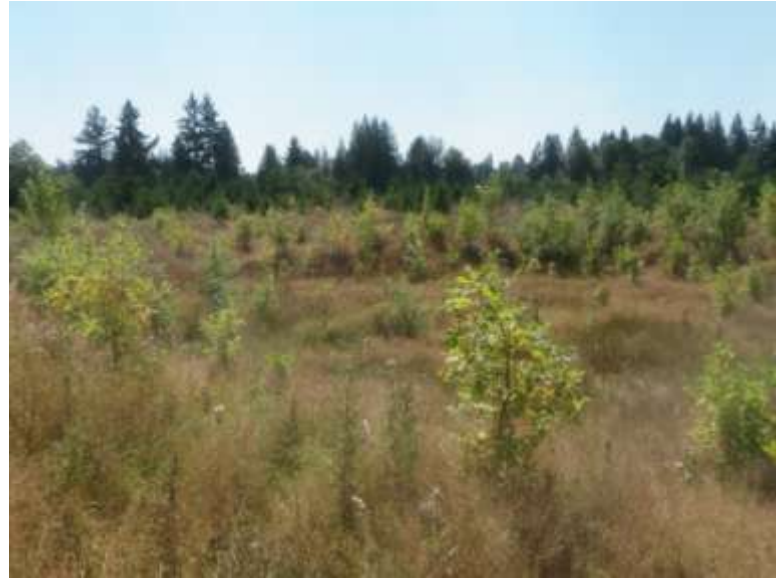
Ponds dominated by Oregon ash (*Fraxinus latifolia*) and sub-dominated by quaking aspen (*Populus tremuloides*) seemed to remain similar in cover.

Pond C3 in 2008

Pond C3 in 2010

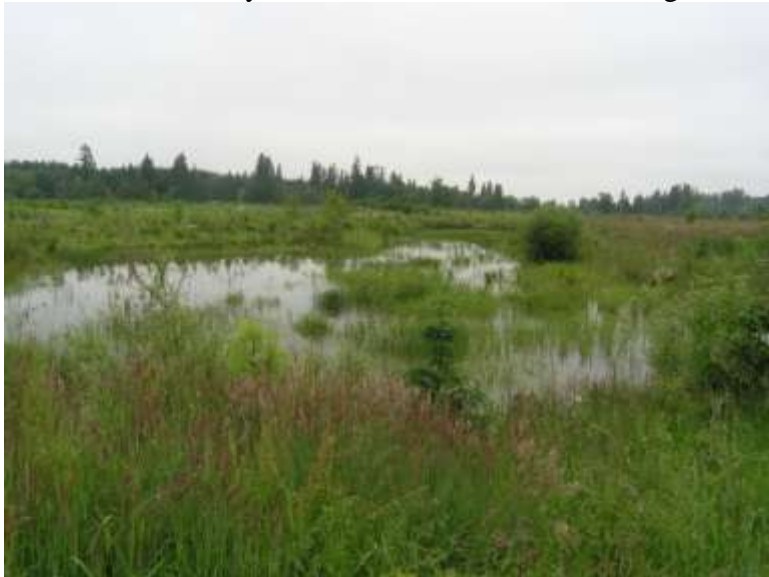
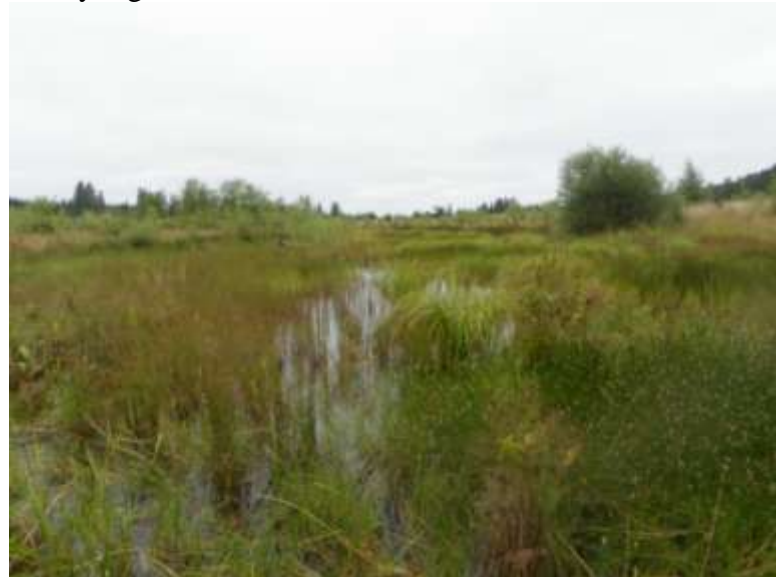
Ponds dominated by herbaceous FAC and wetter vegetation had relatively high cover in 2008 and remain in a similar state.

Pond C1 in 2008

Pond C1 in 2010

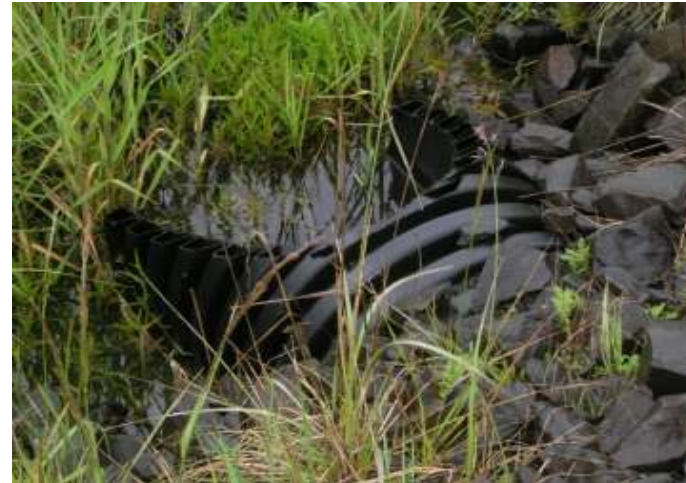
The culvert underneath North Fork Road is functioning as intended (Photo 1). Evidence of erosion or flow impedance has not been observed. Additional photos are included in Appendix 7.

Photo 1
Flow observed in the culvert under North Fork Road (June 2010)

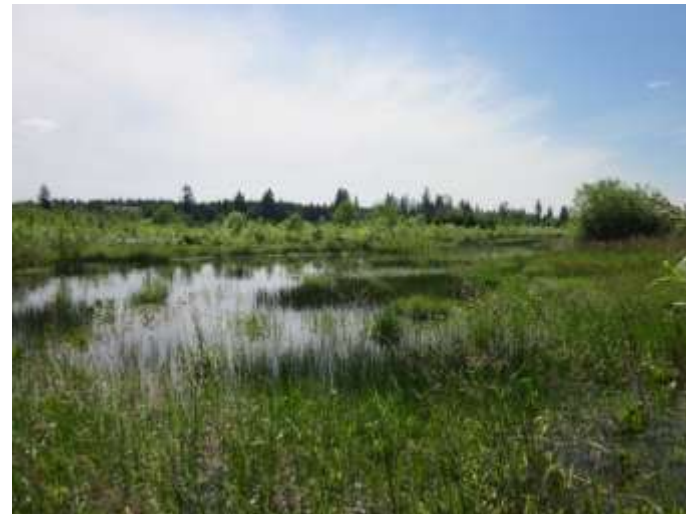
In 2010 inundation was observed in all the seasonal pond habitats (Topographic Enhancement Area B, C, and D) during a site visit June 22, 2010 (Photo 2). Additional photos documenting 2010 inundation are included in Appendix 10.

Photo 2
Inundation observed in pond C1 (June 2010)

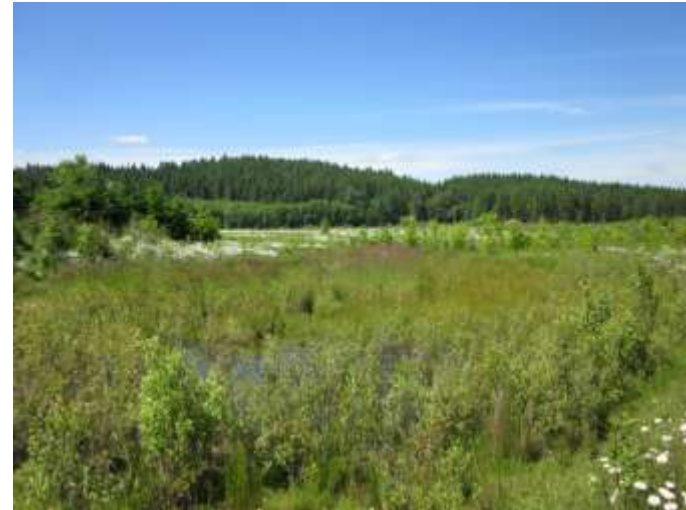
A list and cover of dominate plant species in the seasonal pond habitat (Topographic Enhancement Areas B, C, and D) is included in Appendix 9 (Photos 3 and 4). Cover of the bare ground in the seasonal pond habitat is included in Table 1.

Photo 3
Vegetation establishing in Pond C5 (June 2010)

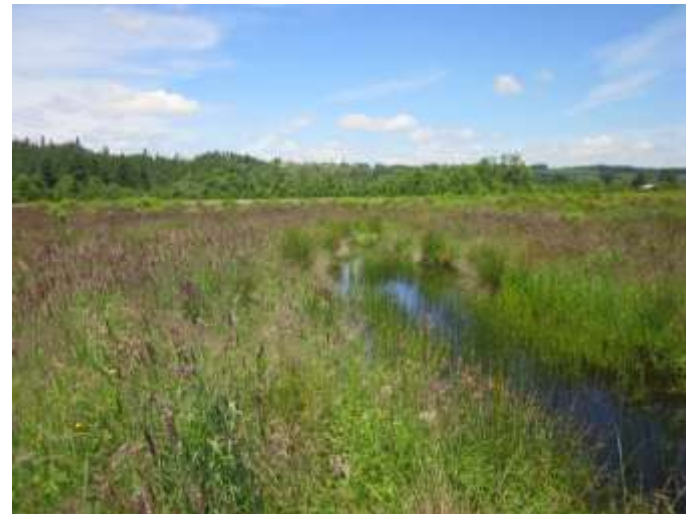
Photo 4
Vegetation establishing in Pond D3 (June 2010)

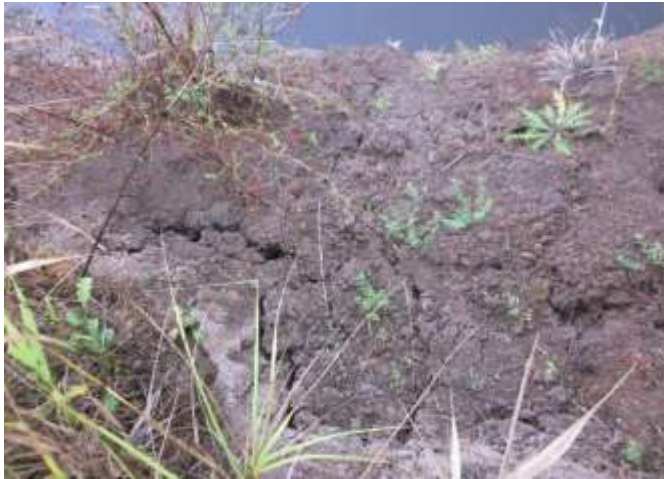
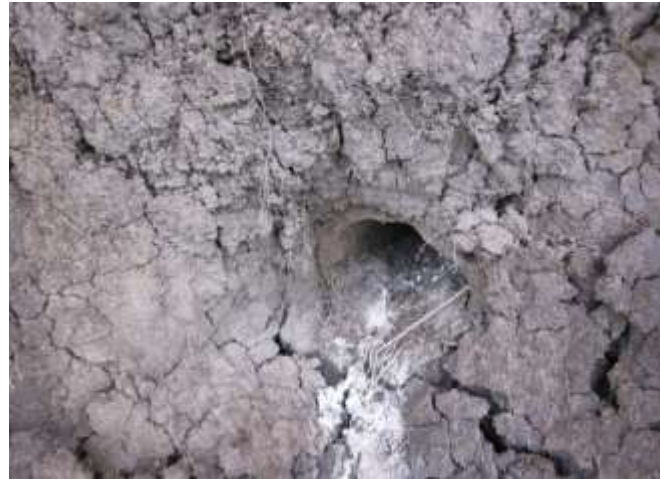
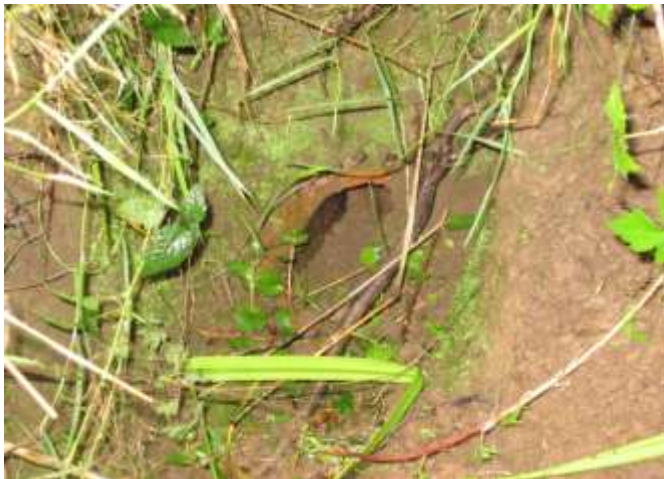
Appendix 8 – Outfall Photos

Water does not appear to be discharging into the drain tile system. Additional photos are included in Appendix 8.

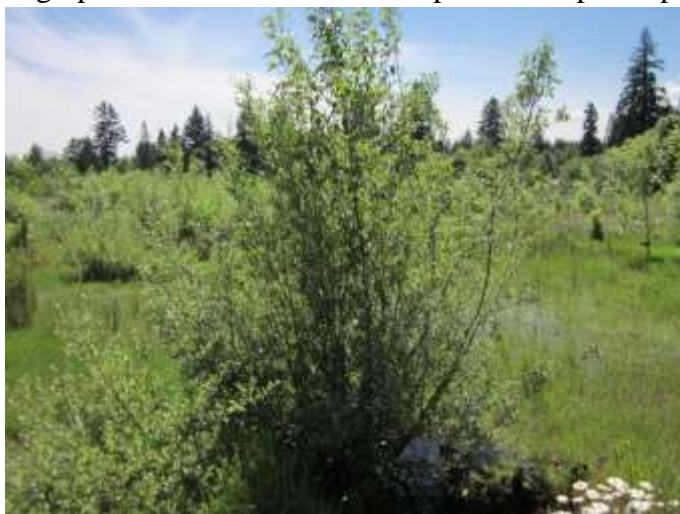
Photo Point B1A

The photographs below were taken from permanent photo-points on June 22, 2010 and document current site development.
