SR 20: Quiet Cove to SR 20 Spur Safety Mitigation Site
SR 11: Chuckanut Park and Ride
WIN # A02027C

2010 MONITORING REPORT

Wetland Assessment and Monitoring Program

Issued March 2011

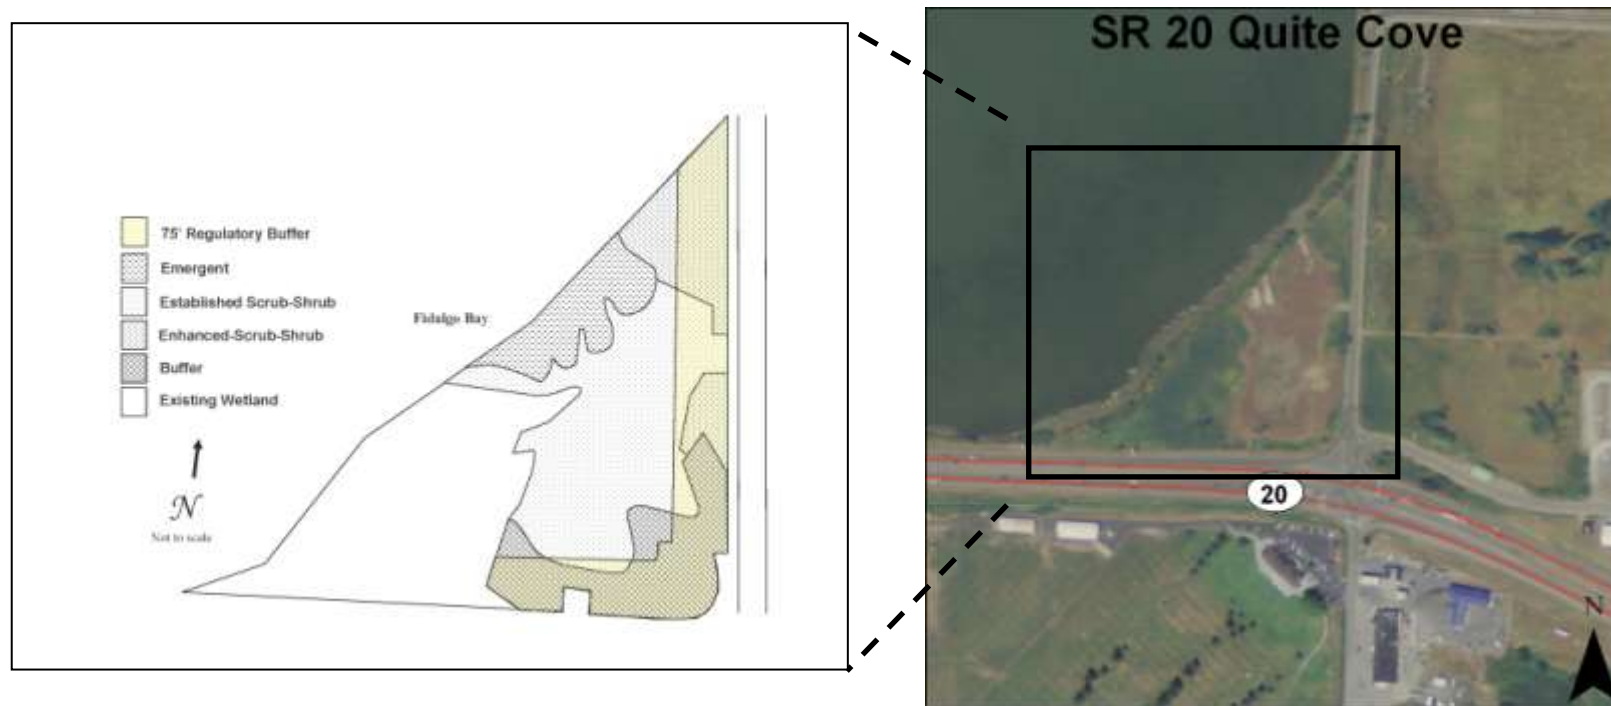
Figure 1 Site Sketch

The SR 20 Quiet Cove Mitigation Site contains three established emergent finger-like depressions that are tidally influenced from Fidalgo Bay. Scrub-shrub areas flank the finger-like depressions and buffer enhancement borders the site to the east and south.

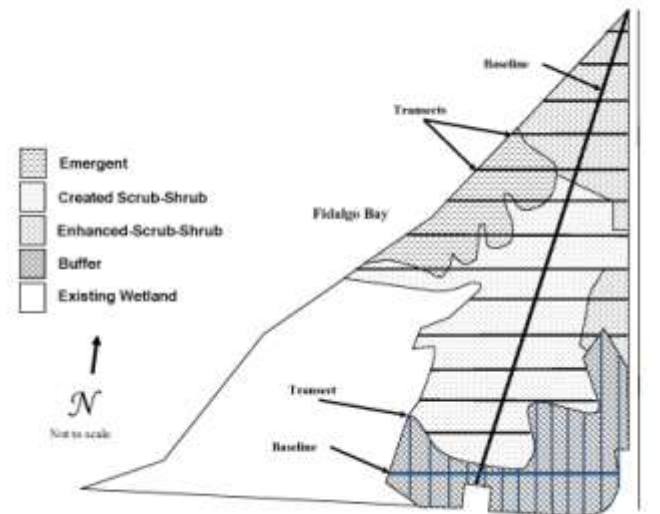
Figure 2 Site Sampling Design (2010)

To evaluate standards for vegetative cover in the wetland, a baseline was established diagonally across the center of the wetland (Figure 2). Twenty sampling transects were randomly placed perpendicular to the baseline. The unequal-area belt transect method was used to determine survival of planted woody species (Performance Standard 2). One-meter wide belt transects were placed along the length of each transect. A second baseline was placed parallel to the southern border of the site to sample for vegetative cover in the buffer. Twenty sampling transects were randomly placed perpendicular to the baseline. The unequal-area belt transect method was used to determine survival of planted woody species (Performance Standard 4). One-meter wide belt transects were placed along the length of each transect. Only the areas with an upland buffer community were sampled, this excluded the enhanced wetlands on the eastern border within the regulated buffer. These areas were sampled as wetland vegetative cover. Cover of non-native invasive species was qualitatively estimated (Performance Standards 3 and 6). Survival of woody plantings along the streambanks was assessed by conducting a total count. Survival percentage is based on numbers established in the field, comparing the ratio of visibly live to dead native woody species (Permit Requirement 1 and Performance Standard 5). Photographs were taken to evaluate tree and shrub growth (Appendix 3).

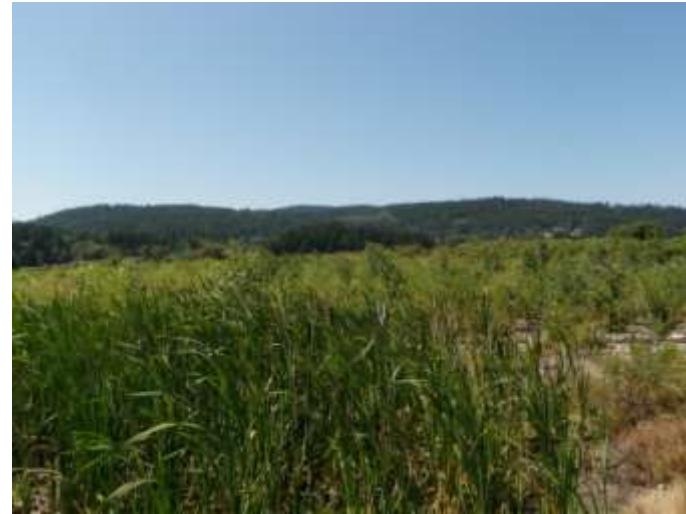
Survival of planted woody species is 91% survival ($CI_{80\%} = 89-94\%$) (Photo 1). The wetland woody species were replanted to 100 percent in the winter of 2009. The performance standard has been met. The site is on a trajectory to meet Year-3 density performance standards. There is moderate mortality of willow (*Salix* spp.) stakes around the three lobes of emergent plantings.

Photo 1
Woody cover in the scrub-shrub wetland (July 2010)

Replacement plant material is scheduled to be installed in the mitigation site upland buffer during the 2011/2012 planting window. Weed control shall continue in 2011 as necessary.

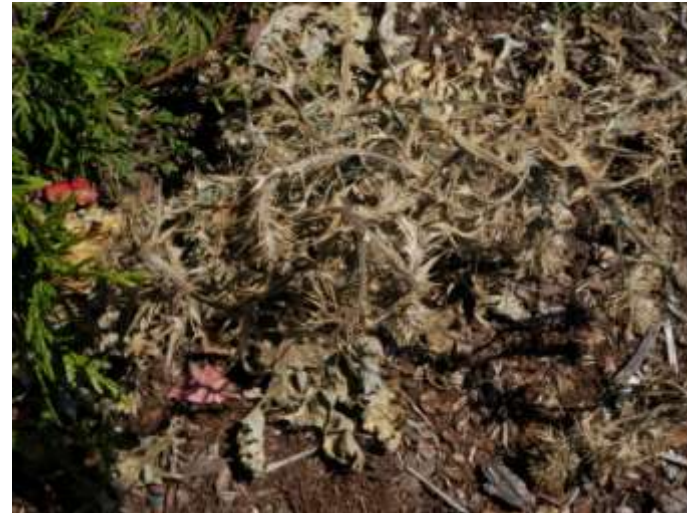
jacobaea). Active weed management was observed on site (Photo 2 – next page).

Photo 2
Treated Canada thistle (*Cirsium arvense*) (July 2010)

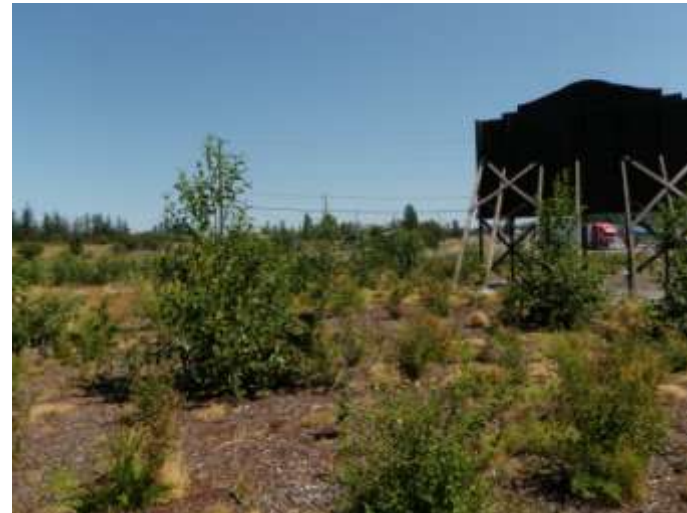
Survival of planted woody species is 93% survival (CI_{80%} = 92-95%) (Photo 3). Garden vetch (*Vicia sativa*) was observed growing in dense mats over a number of woody species in the buffer; its removal may benefit the establishment of plantings. The majority of the western serviceberry (*Amelanchier alnifolia*) on site exhibited signs of severe herbivory. The upland woody species were replanted to 100 percent in the winter of 2009. The performance standard has been met. The site is on a trajectory to meet Year-3 density performance standards.

Photo 3
Woody cover in buffer (July 2010)

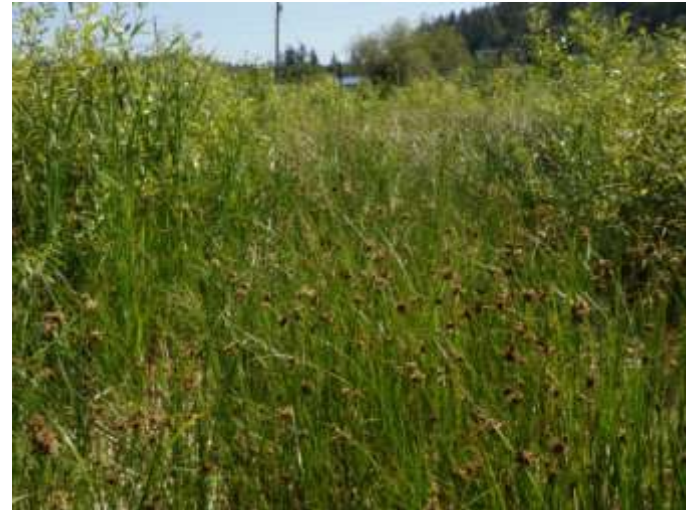
The three emergent “fingers” are beginning to be colonized by Seacoast bulrush (*Schoenoplectus maritimus*) and there has been a considerable increase in cover (Photo 4 – p. 9).

**Photo 4
Emergent cover in finger-like depressions (July 2010)**

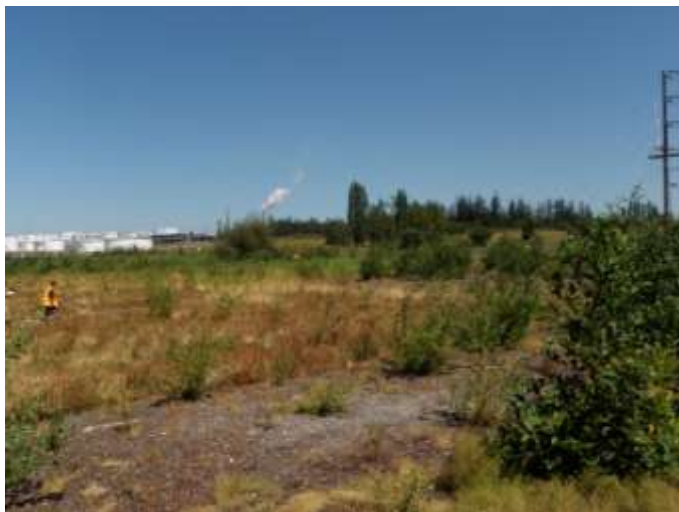
Photo Point 1

The photographs below were taken from permanent photo-points on July 27, 2010 and document current site development.

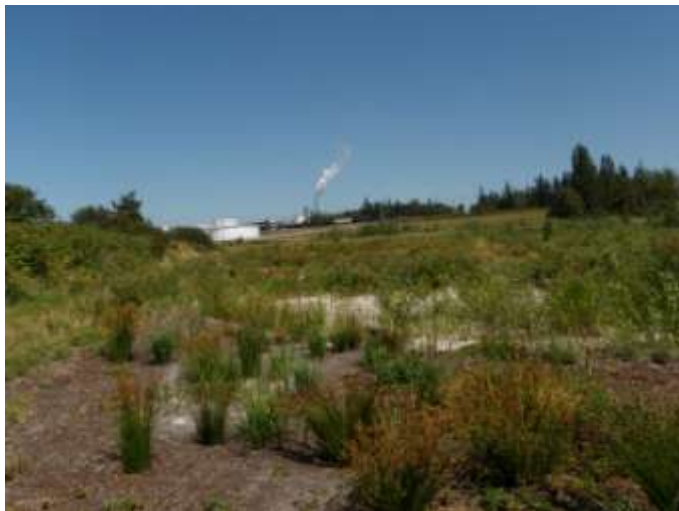
Photo Point 5

The photographs below were taken from permanent photo-points on July 27, 2010 and document current site development.
