**NACHES RIVER REACH ANALYSIS AND MANAGEMENT PLAN
LOWER NACHES RIVER
RIVER MILE 0 – 3.75**

Final Report

**Prepared for the
Washington State Department of Transportation**

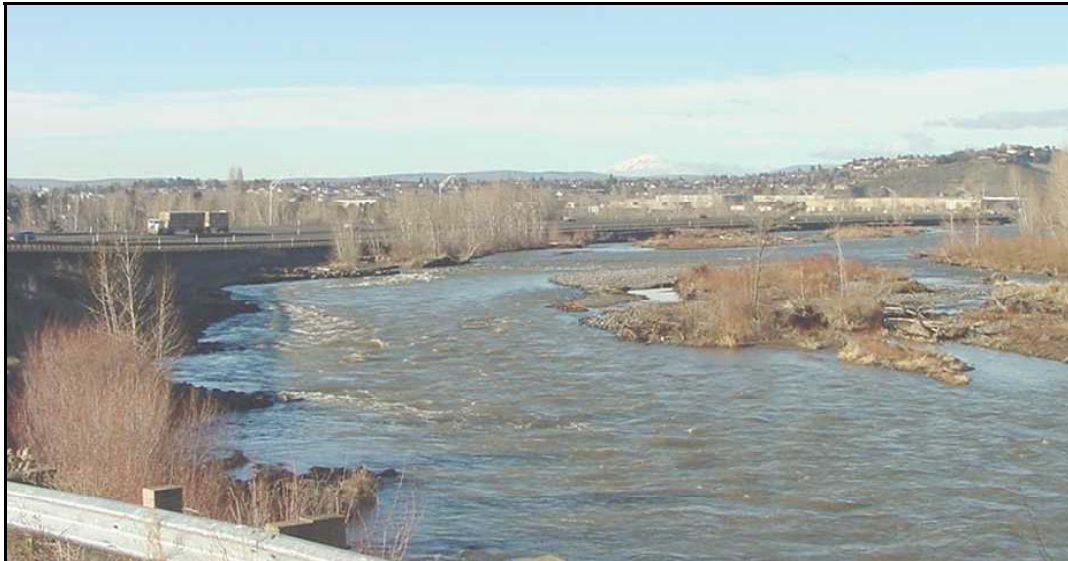
Figure 1: Photograph taken from the parking area at 16th Avenue interchange. Note the westbound lane of US 12 running along the right bank of the river.

The Naches River within the project area is very dynamic, frequently changing channel configuration and location over time. Channel migration and reach-scale fluvial processes have led to the loss of riparian buffers between US 12 and the river, and US 12 has periodically experienced erosion of portions of the highway prism. Most recently, the primary problems have been experienced from the 16th Avenue parking area upstream to the 40th Avenue interchange (Figure 1).

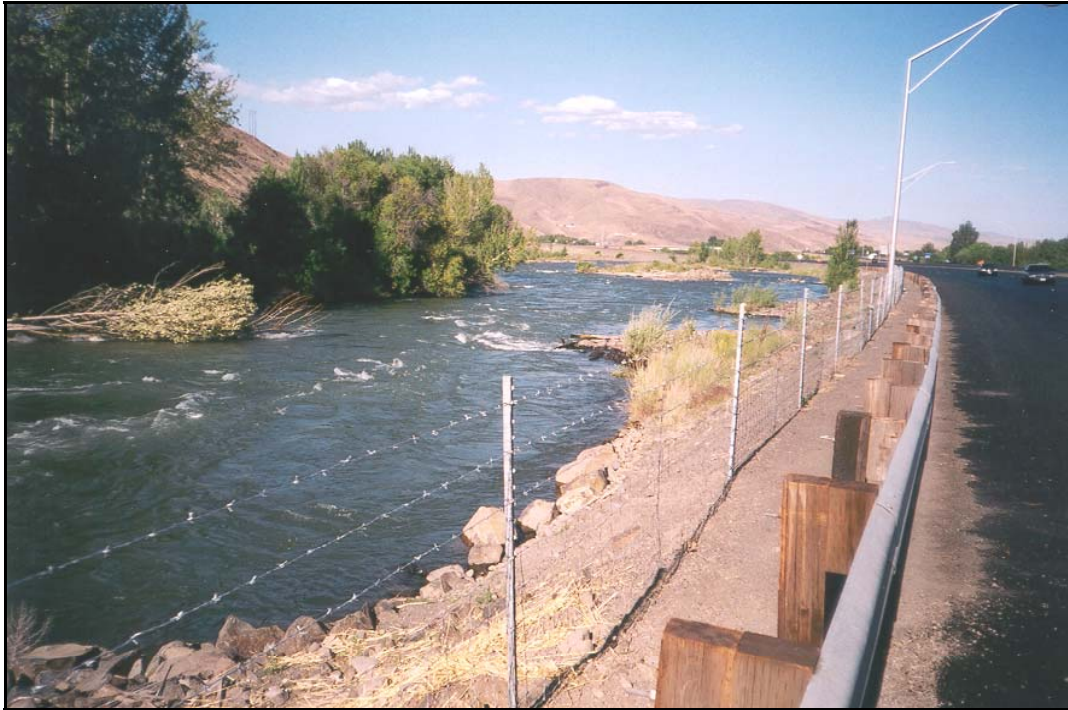
Figure 2: Photograph taken from westbound side of US 12, approximately 3,000 feet upstream of 16th Avenue. Note rock at toe of highway prism and groins and barbs extending into channel.

From Station 8000 to 5000, the river flows very near US 12 and the roadway is protected by riprap installations and numerous rock barbs (Figures 2 and 7). The current channel configuration is related to the upstream channel location and its association with the left valley wall (Figure A-2). Specifically, from Station 11000 to 9000 the river flows at the toe of the left valley wall where it is directed south toward the highway by a bedrock knob extending into the floodplain near Station 8500. Former channel locations can be found through the floodplain toward the left valley margin and this area also experienced overbank flow and riparian root saturation during the flip flop.

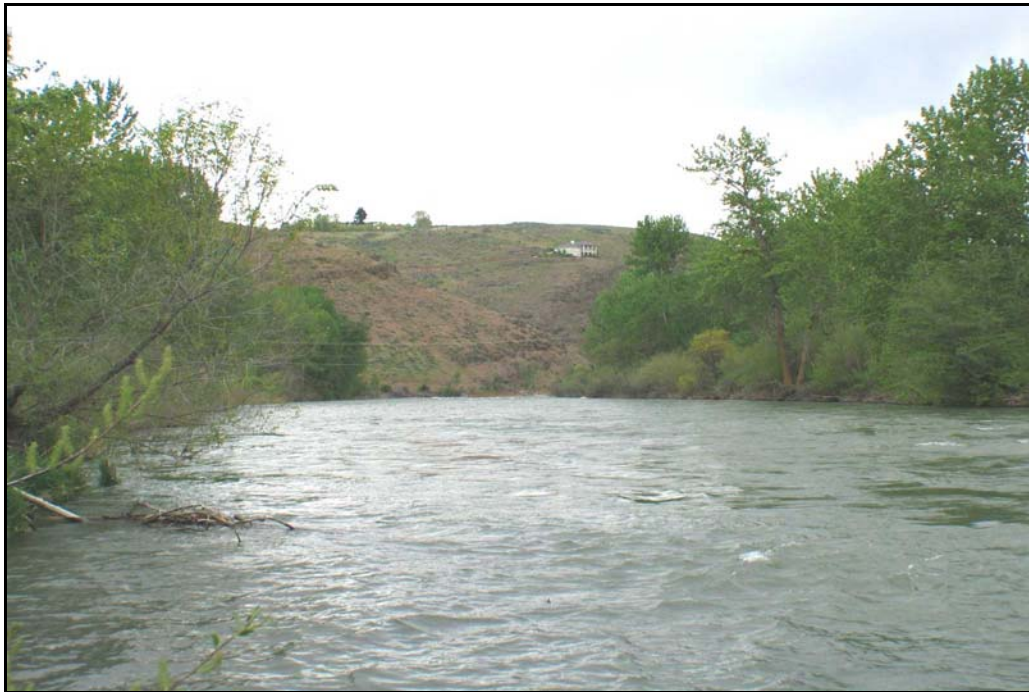
Figure 3: Looking downstream from Station 19900 toward bedrock along left bank at Station 18300. Discharge is approximately 2,500 cfs.

The upper extent of the project area begins at Station 20000 near the Naches Gap. From this location to Station 18000, the channel is a simple planebed channel that is confined along the right bank by an extensive levee placed to isolate an orchard in the floodplain. Floodplain encroachment and perhaps some floodplain filling have occurred on the left bank near Station 18300 where the river contacts the bedrock hillside that comprises the left valley wall (Figure 3) (left and right banks, floodplains, and valley walls are defined as one would stand in the middle of the channel and face downstream). This section of the river is narrow and displays planebed channel characteristics. Indications of channel incision are evident and it is clear that this is a transport reach where little if any sediment is stored. No side channels exist in this area, and aquatic habitat is limited to a riffle/run channel units. Because of high velocities and limited floodplain access, there is little opportunity for juvenile refuge in this area during higher discharges.

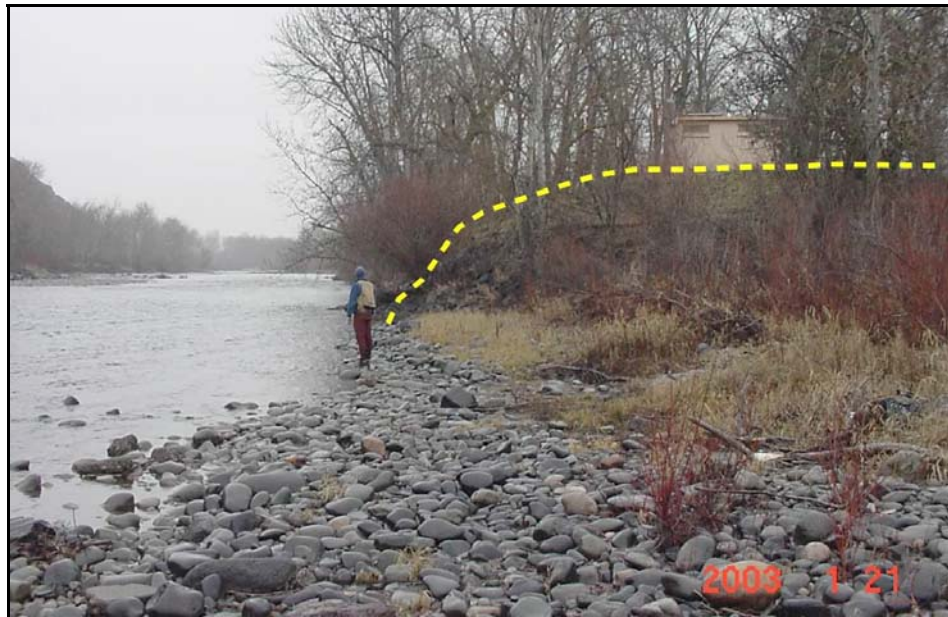
Figure 4: Floodplain and perhaps a portion of the active channel have been filled for the City of Yakima's Ranney-type diversion structure and pump located near Station 16000. Yellow line in figure highlights the extent of fill, which is over 20 feet above the riverbed.

Downstream of this constriction point (Figure 4), flow is accelerated and incision has occurred at least through Station 14500. The river continues to be channelized through Station 12000 because of the additional influence of grade control activities associated with diversion channels, placed rock, and the filling of the right floodplain. This segment of the river is a narrow, straight, plane-bed channel with little bedform complexity, hence we characterize this segment as a transport reach. Early aerial photographs of this area depicting side channels and floodplain areas clearly connected to the river sharply contrast with conditions seen in more recent aerial photographs and viewed during our field observations. Numerous former side

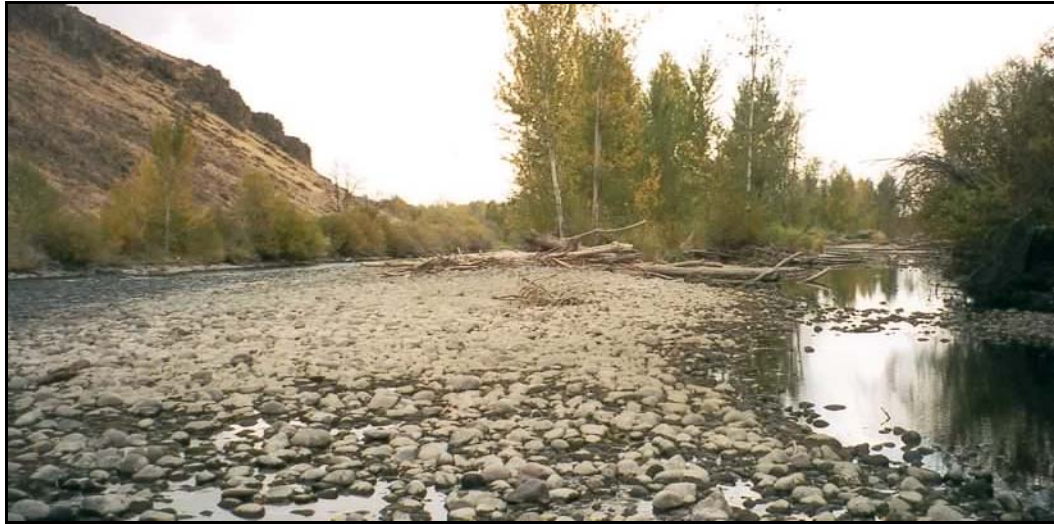
Figure 5: Station 10200 looking downstream at the mainstem channel (left) and a secondary flow channel (right). Photograph taken October 22, 2002, discharge approximately 250 cfs.

Below Station 12000, the channel widens, is more connected to its floodplain, and high flow channels through the floodplain are present. From Station 10500 to 9000, the river is located adjacent to the bedrock wall along the left valley margin, although evidence of recent channel occupation can be found throughout the right floodplain. This segment of the river is highly connected to its floodplain (Figure 5).

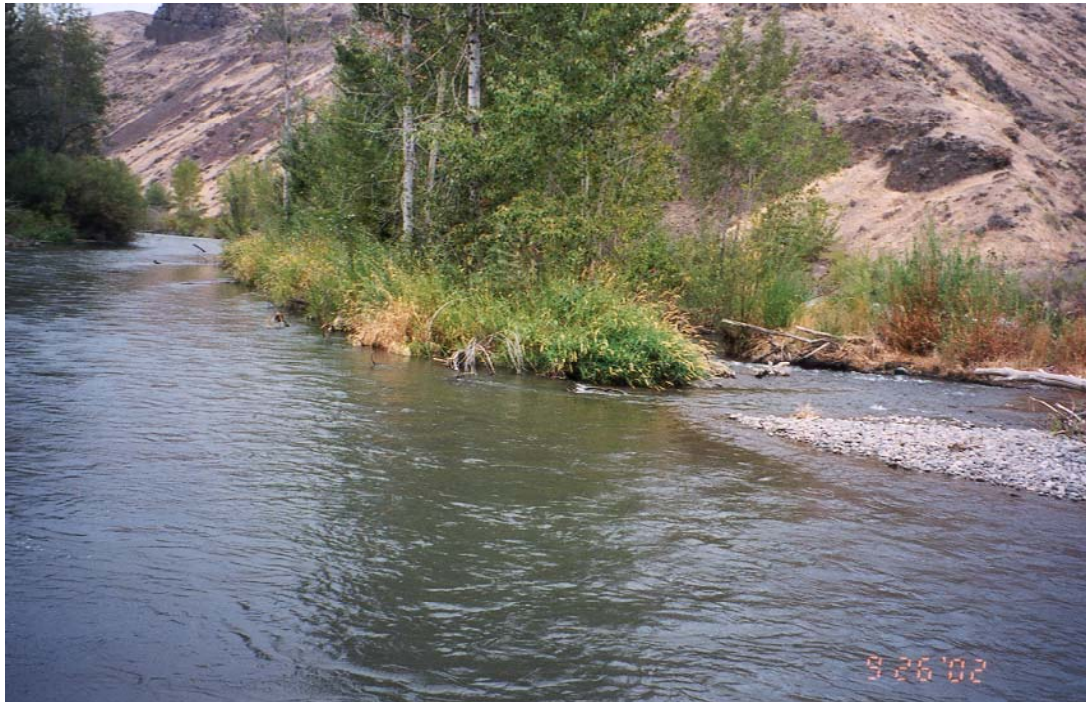
Figure 6: Secondary channel through floodplain during the flip flop. (Note: looking upstream at same channel as shown in Figure 5) Mainstem channel is flowing along the base of the hillside seen in the background. Discharge approximately 2200 cfs.

We visited the site during the flip flop and found numerous secondary channels flowing through the floodplain (Figure 6).

Notice the relationship between the riparian vegetation and the water surface elevation during the flip flop (Figure 6). This was typical for conditions through much of the floodplain in this area. Based upon the elevation of these discharges, it is reasonable to surmise that saturation of the root structure of the riparian zone was occurring extensively across the floodplain. This segment of the river is a depositional environment where sediment transported through the upstream reach is deposited. Sediment deposition through this area is likely influenced by downstream conditions as well. While instream aquatic habitat conditions during low discharges are of a similar, poor quality to the section of river just upstream, conditions in this section likely improve as river stage increases. Access to the floodplain and multiple flow paths add hydraulic complexity and refugia for both juvenile and adult salmonids.

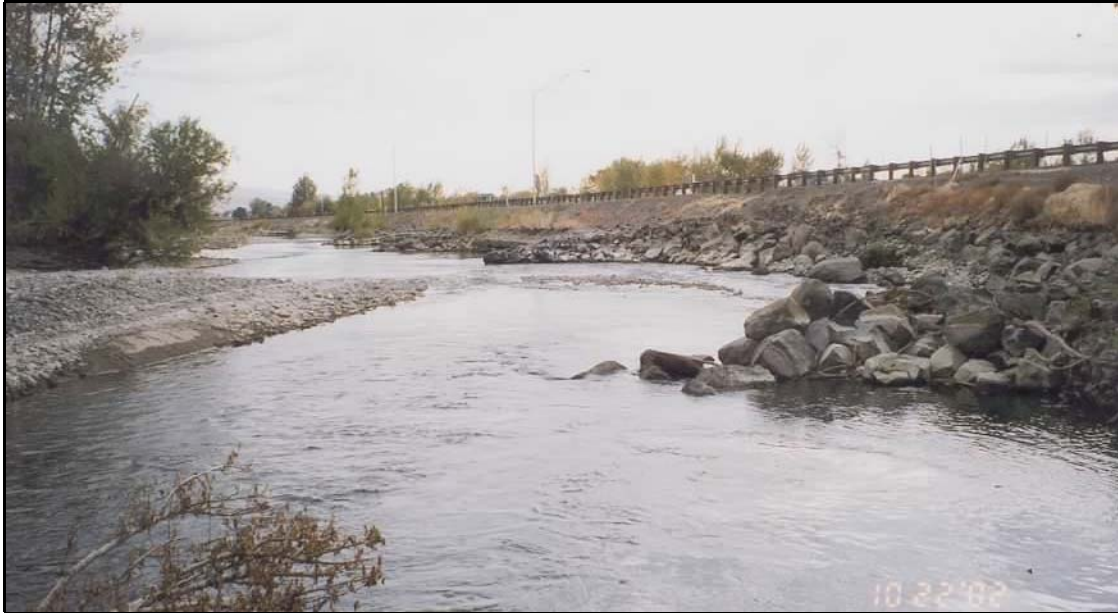
Figure 7: Photograph taken from Station 7800 looking downstream at recent efforts to protect the road prism of US 12. Note railing along edge of eastbound lane of US 12

From Station 9000 to 8000 the river moves from the left valley wall across the floodplain and impacts the base of US 12 (Figure 7). This segment is steep relative to adjacent river sections and is one of the critical areas of management concern at the time of this report.

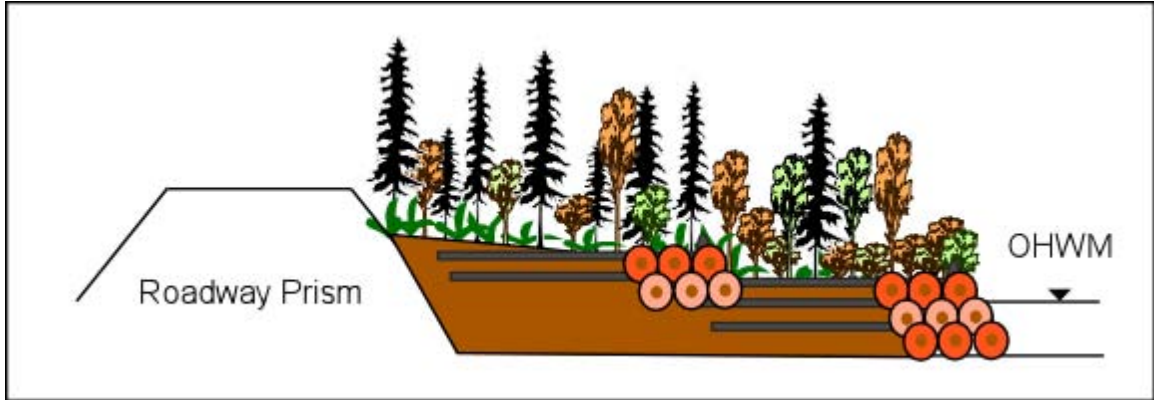
Figure 13: Potential longterm conditions for floodplain reclamation using a terrace approach.

With this type of configuration, a terraced floodplain could be developed that provides additional protection against erosion and also establishes a higher elevation terrace that would enhance the successful recruitment and growth of inundation intolerant riparian species. This could result in a coniferous dominated upper terrace and a deciduous dominated lower terrace as shown in Figure 13.
