**SR 305 Vicinity Poulsbo South City Limits to Bond Road
(SR 305 Poulsbo and Wall 10) Mitigation Site**

USACE NWP 200500967

2014 MONITORING REPORT

Issued March 2015

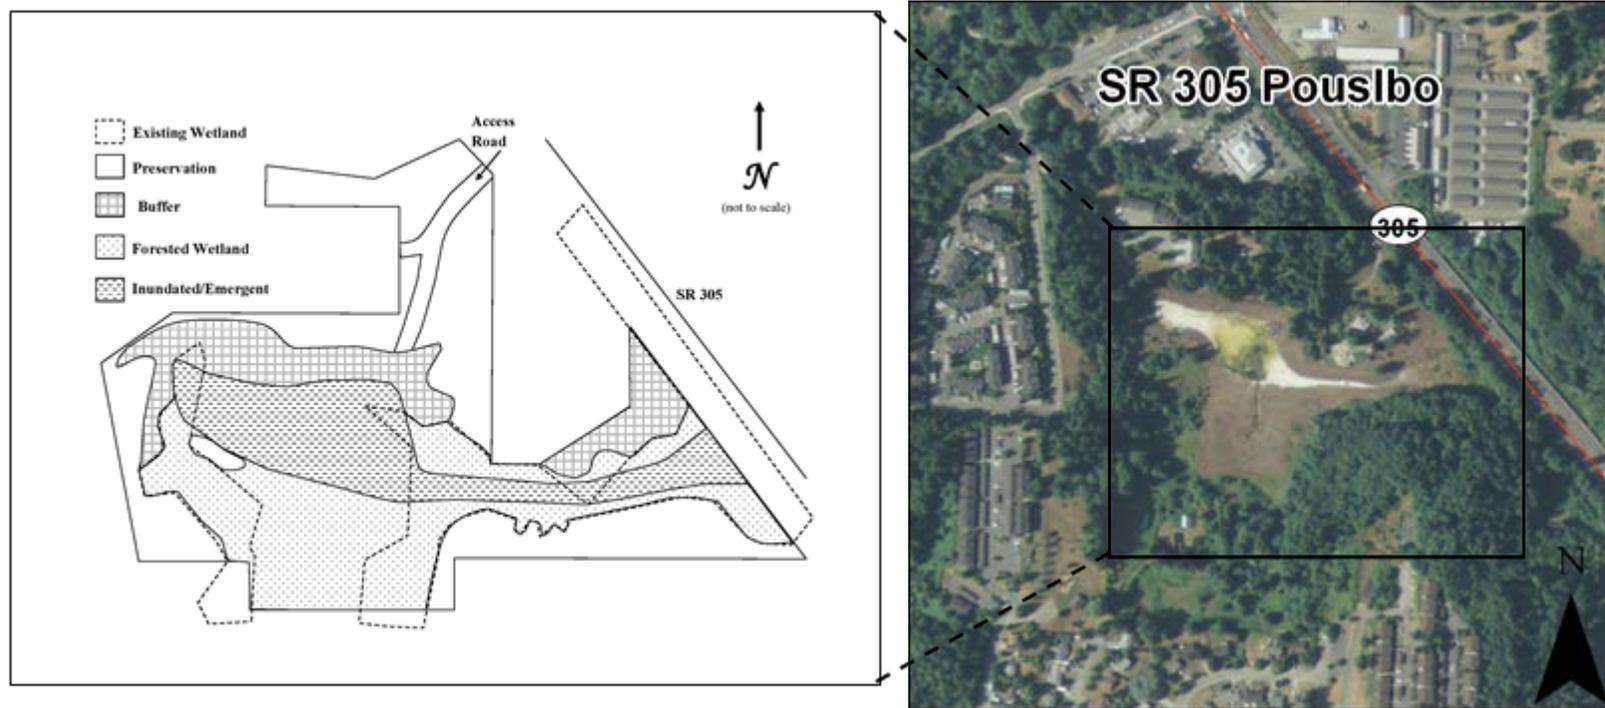
Figure 1 Site Sketch

The SR 305 Poulsbo Mitigation Site includes wetland establishment, wetland enhancement, buffer enhancement, and riparian enhancement adjacent to South Fork Dogfish Creek. Wall 10 is a replanted retaining wall located off site. Appendix 2 includes site directions.

This 13.6-acre mitigation site (Figure 1) located west of SR 305 focuses on establishing a scrub-shrub and forested wetland and enhancing the existing wetland with woody vegetation to provide structural diversity. This site was created to compensate for the loss of 2.05 acres of wetlands due to road improvements along SR 305. The large seasonally ponded depression and surrounding scrub-shrub and forested areas are designed to provide mitigation for lost wetland functions including flood flow alteration, sediment removal, nutrient and toxicant removal, erosion control and shoreline stabilization, production of organic matter and its export, general habitat suitability, habitat for wetland-associated birds, and general fish habitat.

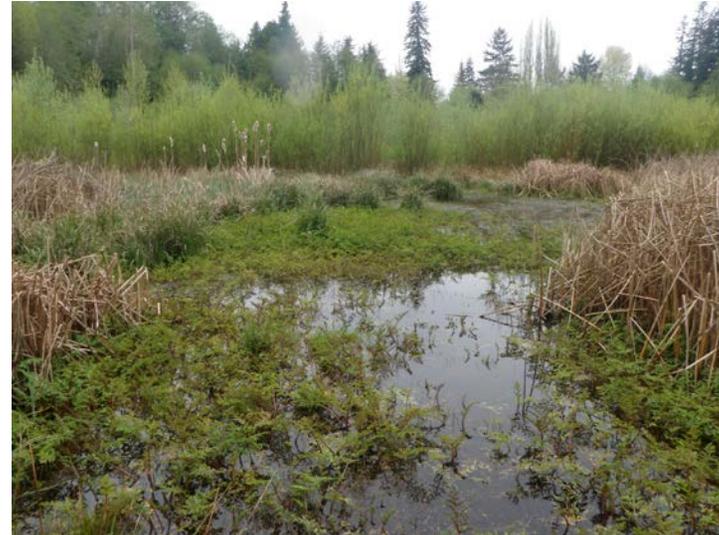
Water was observed in various depths across the site (Photo 1) during each of the three visits, with the PEM being inundated throughout spring into the summer monitoring visit in July.

Photo 1
Inundation in the wetland (April 2014)

Based on three hydrology visits in the months of March and April 2014, the hydrology standard was not fully achieved. Water was not observed in the top twelve inches of the soil surface on the third visit in well number two. Well number two is located within the narrow constriction between the western and eastern portion of the site at the upper edge of the transition between wetland and buffer (See Appendix 1 for a map of well locations and Appendix 3 for results).

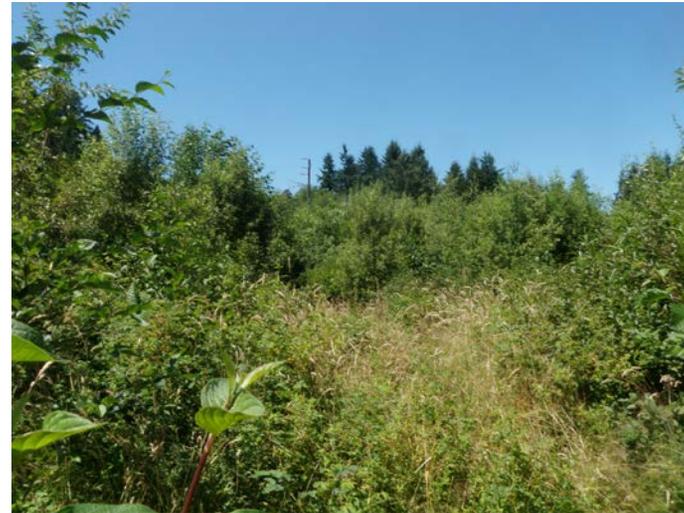
Woody cover in the forested wetland is 71 percent cover ($CI_{80\%} = 58-84\%$) (Photo 2). This exceeds year-7 standards for the third year in a row and is just shy of the year 10 success standard. The dominant species include twinberry honeysuckle (*Lonicera involucrata*), Nootka rose (*Rosa nutkana*), redosier dogwood (*Cornus alba*), Sitka willow (*Salix sitchensis*), and red alder (*Alnus rubra*).

Photo 2
Woody cover in the Wetland (July 2014)

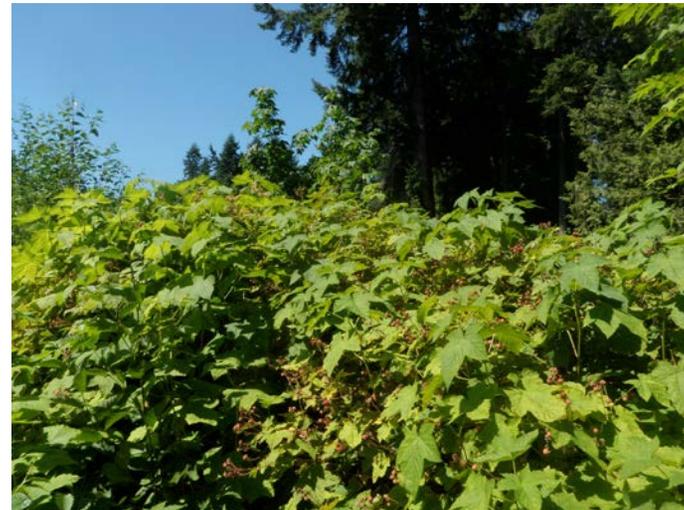
Native woody cover in the buffer is 96 percent cover ($CI_{80\%} = 94-98\%$) (Photo 3). This exceeds the year 10 success standard of 75 percent cover. The dominant species in this zone include thimbleberry (*Rubus parviflorus*), red alder (*Alnus rubra*), snowberry (*Symphoricarpos albus*), and oceanspray (*Holodiscus discolor*).

Photo 3
Woody cover in the buffer (July 2014)

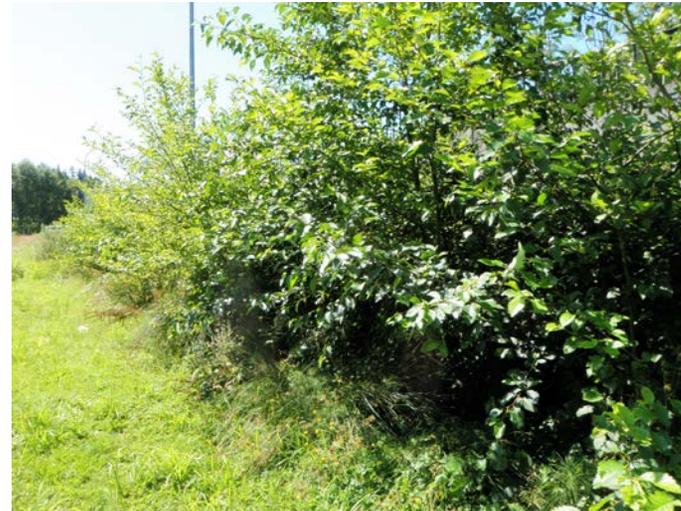
Cover of woody species in the Wall 10 retaining wall area is 92 percent (CI_{80%} = 87-97%) (Photo 4). Red alder (*Alnus rubra*) is dominant in this area with redosier dogwood (*Cornus alba*), and Pacific willow (*Salix lasiandra*) as sub-dominants.

Photo 4
Woody cover in the Wall 10 re-vegetation area (July 2014)

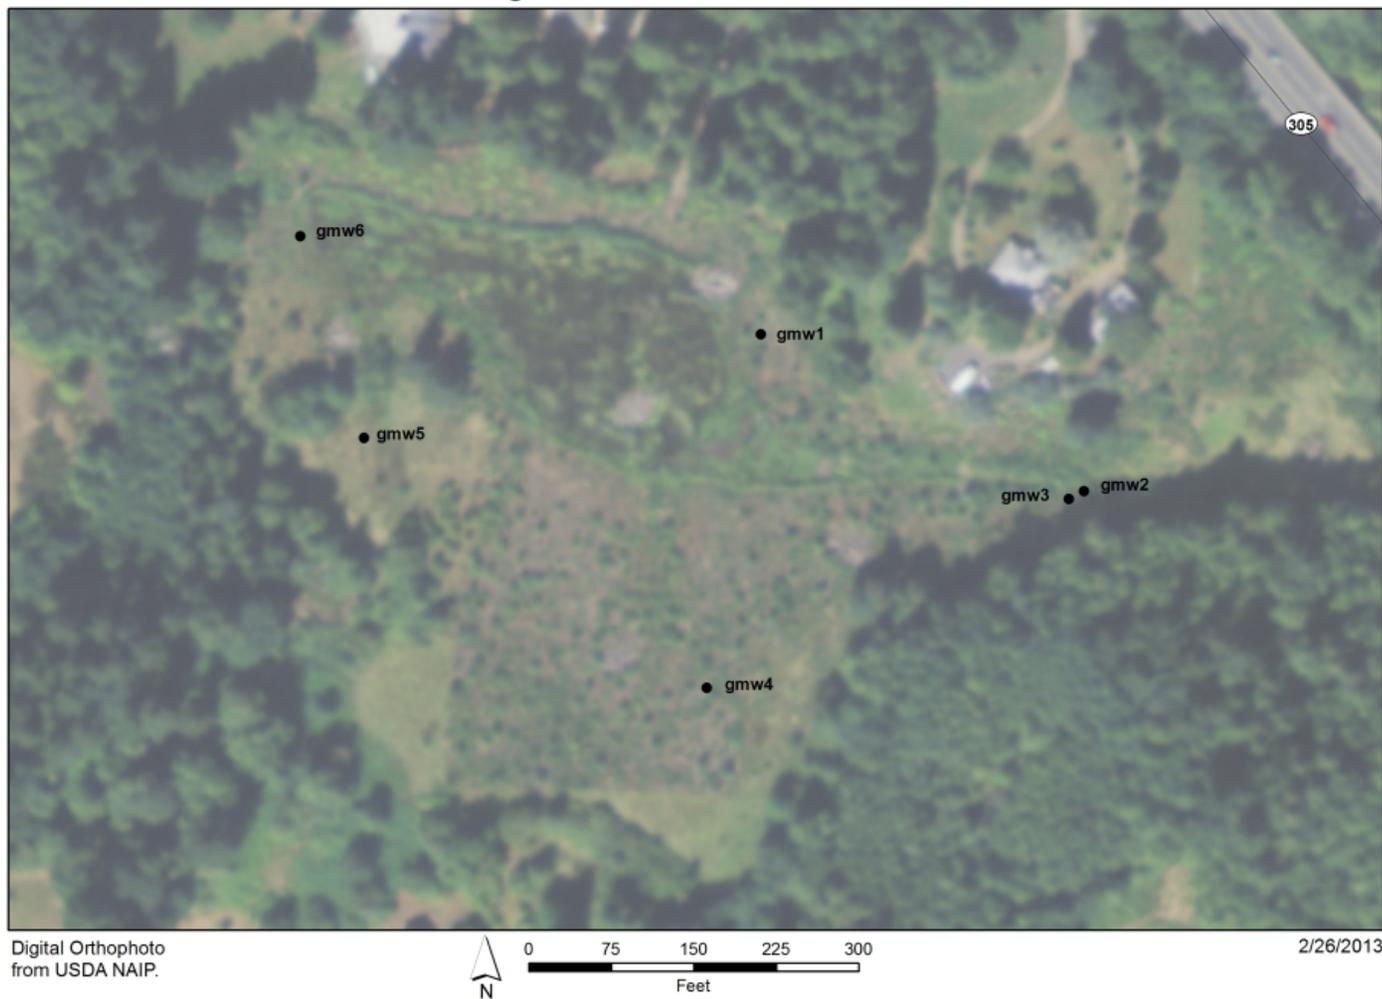
Ground Monitoring Well Locations

GPS Data - SR 305 Poulsbo Mitigation Site, 2/21/2013
