**SR 18 Maple Valley to Issaquah-Hobart Road
(MP 16.6 to 19.3) (SR 18 Cedar River Tributary SE 216th
Place) Restoration Site
WIN A01820C**

2010 MONITORING REPORT

Wetland Assessment and Monitoring Program

Issued March 2011

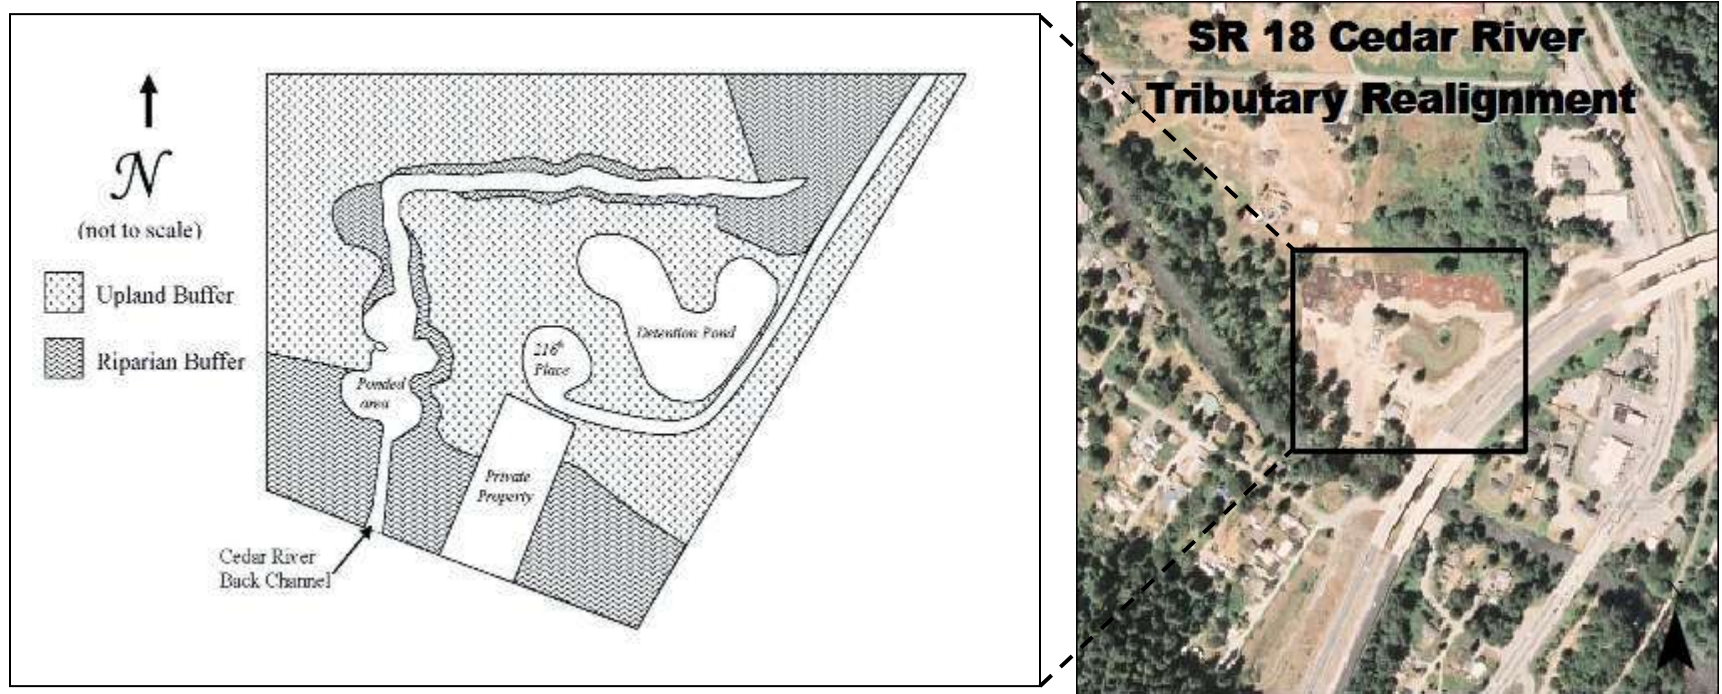
Figure 1 Site Sketch

The SR 18 Cedar River Tributary SE 216th Place Restoration Site includes a large upland buffer area that extends east across a private drive and up a steep slope to SR 18. The riparian buffer runs northeast, along the steeply banked backwater channel and ponded areas. A detention pond and a preservation area occupy the center of the site.

This 6.83-acre site (Figure 1) is a riparian re-vegetation and stream restoration site. The site compensates for impacts to 1.65 acres of riparian buffer and 620 linear feet of stream channel due to stream channel realignment and bridge construction associated with road improvements along SR 18.

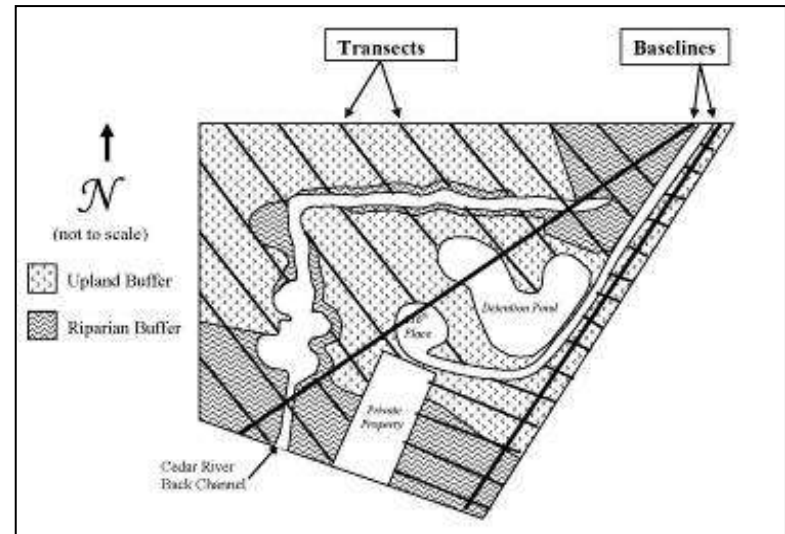
Figure 2 Site Sampling Design (2010)

To evaluate permit requirements for vegetative survival, a baseline consisting of two segments was established. Segment A was placed across the center of the site (Figure 2). Segment B was placed parallel to the retaining wall. Twenty-eight transects were randomly placed perpendicular to the baseline segments. One meter unequal-area belt transects were used to estimate survival (Permit Requirement 1).

To conduct stream depth monitoring, a baseline was placed between the lower pool and the Cedar River. Three transects were randomly placed perpendicular to the baseline. Four points were randomly selected from each transect. Water depth was measured at each point (Permit Requirement 2). This was repeated a total of three times as the permit dictates.

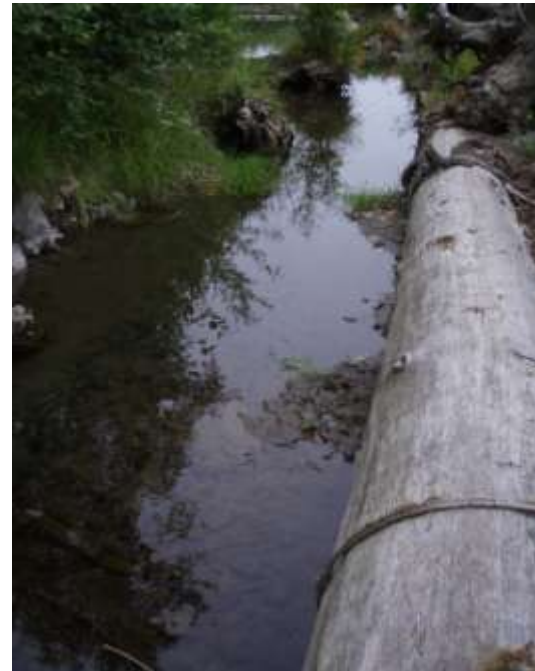
Photo 1
Sediment accumulation (July 2010)

The permit requirement is achieved. Although the stream depth was not greater than four inches during every monitoring event at each sampling location, at no point did we cross the threshold of “consistent” measurements below the four inch requirement (Appendices 1 and 2). Some minor gravel build up was observed in mouth of the realignment but not an amount sufficient enough to reduce flows. A sketch of the stream channel is available on the following page (Figure 3).

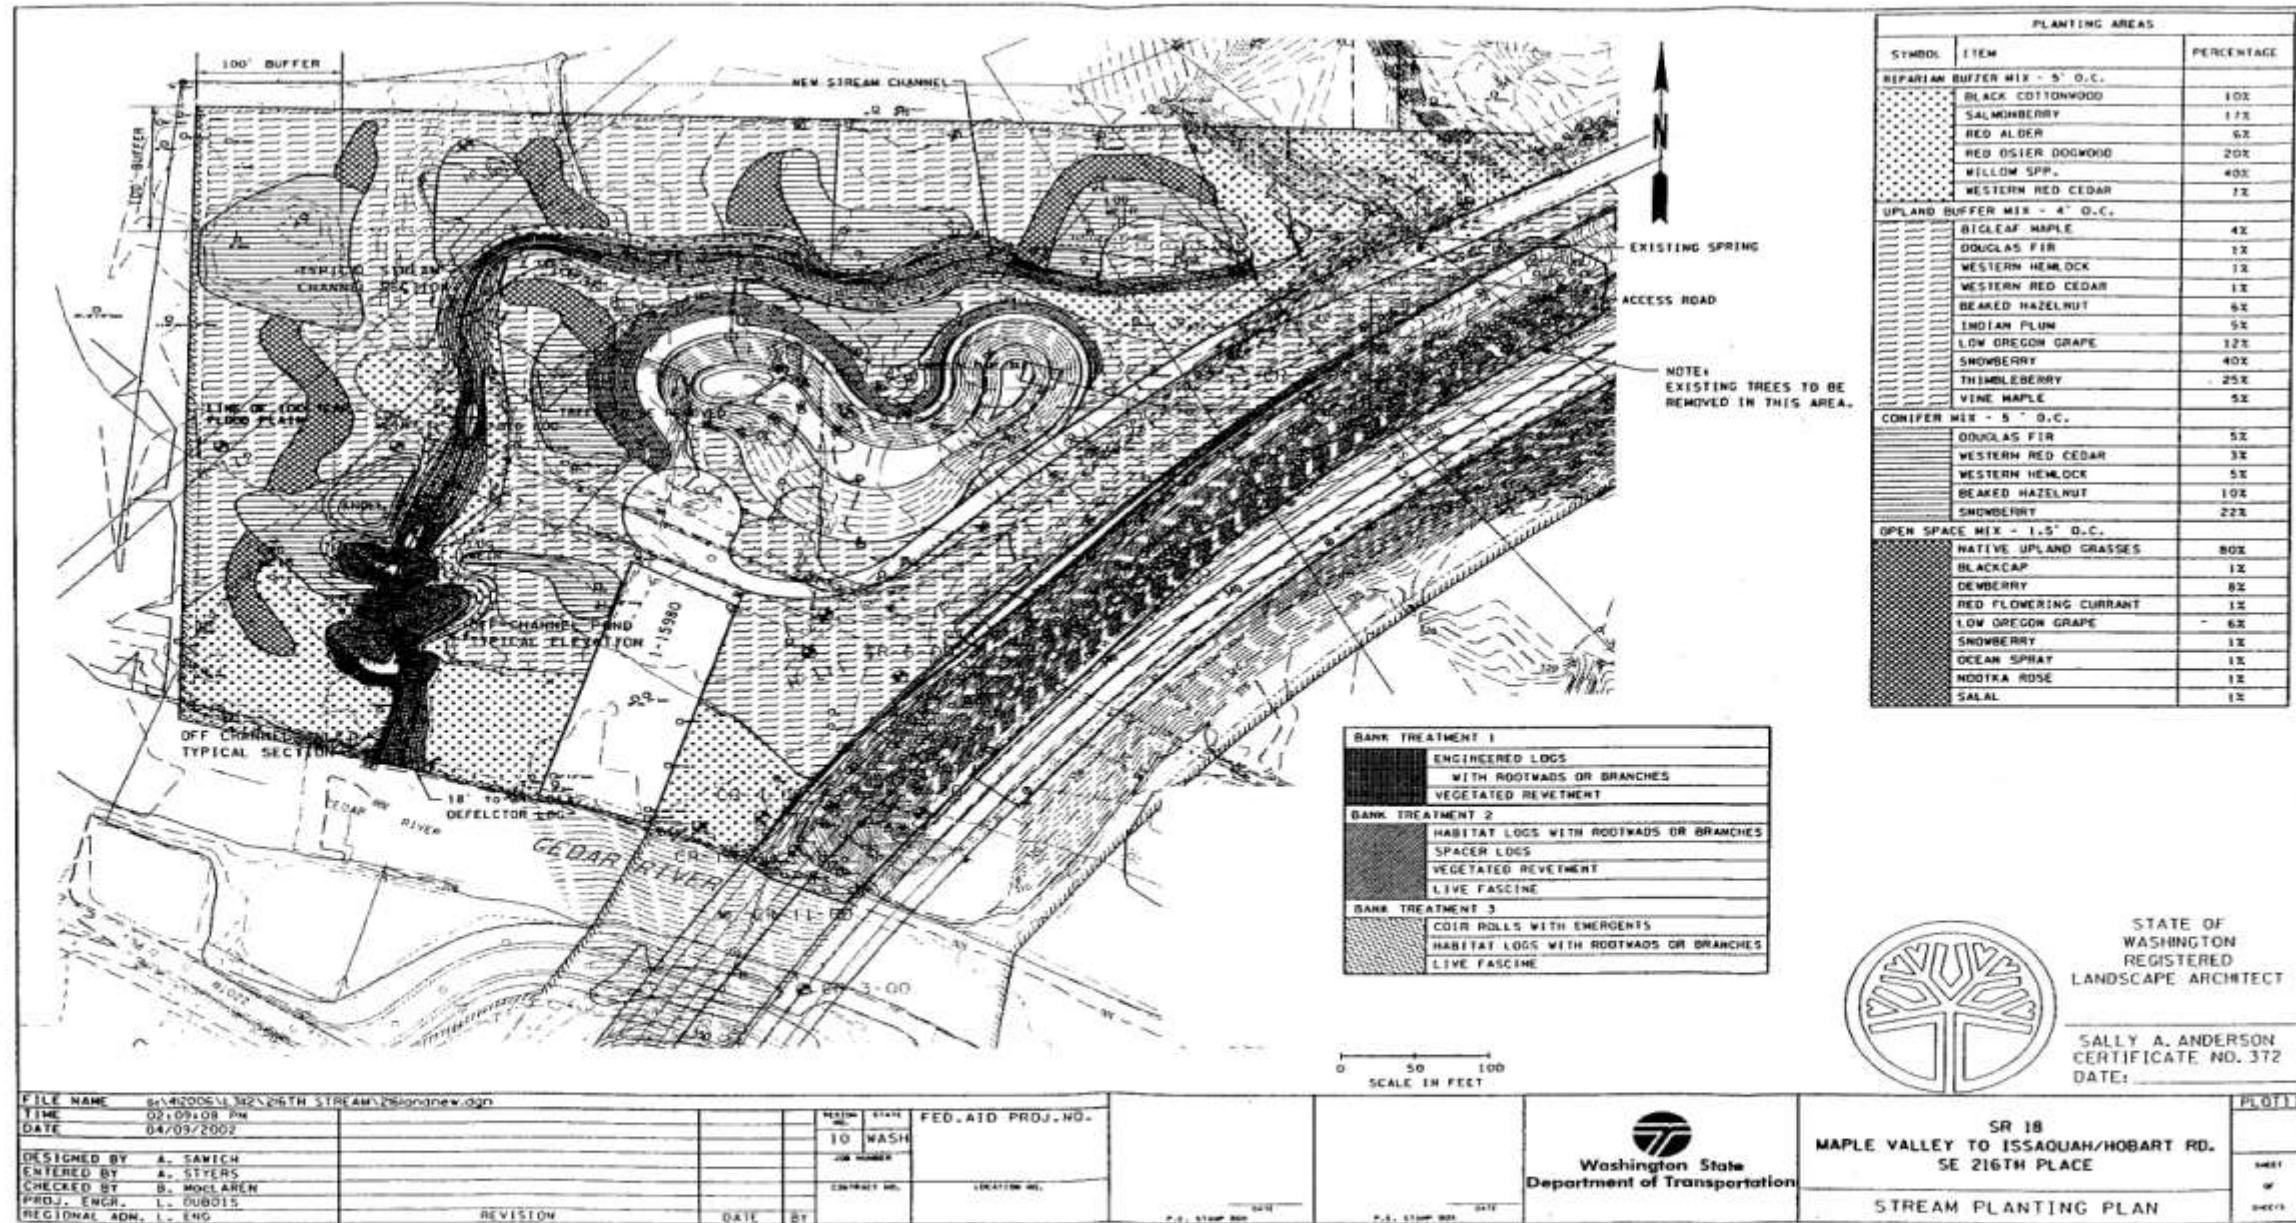
Appendix 3 – Planting Plan

Appendix 1 provides the complete text of the permit requirements for this project, and Appendix 3 shows the planting plan (Sawich 2003).
