**RE: SR 522 Paradise Lake Road to Snohomish River Stage 2 and 4 - Northeast
Mitigation Site**
USACE 200201342
NMSF Tracking No. WHB-02-143

The Washington State Department of Transportation completed qualitative monitoring of the SR 522 Paradise Lake Road mitigation site on August 10, 2010, to address Year-7 (2011) and Year-10 (2014) performance standards. Monitoring activities included an assessment of wetland hydrology, vegetation observations, and photo documentation. This Year-6 report is being issued for compliance with the terms and conditions of the Biological Assessment WHB-02-143, and to confirm the second year in a row of achieving final year performance standards.

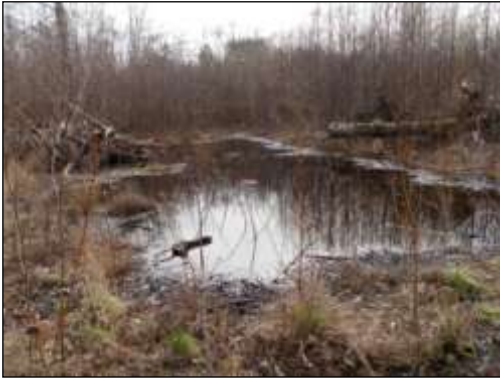
Monitoring records from March and April 2010 indicate wetland hydrology was not present in all of the intended areas. Observations of saturation to the soil surface and inundation were made

throughout most of the site, however on two out of three visits the sample point in the southwest corner of the site failed to meet the performance standard for wetland hydrology. Multiple site visits, indicate wetland hydrology is present in most intended areas.

Photo 1 – Inundated topographical depression (March 2010)

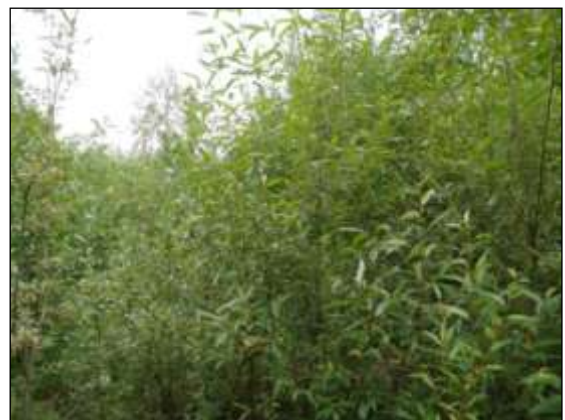
The forested and scrub shrub wetland zones are qualitatively estimated to have 85 percent cover (Photo 2). This value exceeds the performance standard requirement. Over eight woody species were observed in the wetland creating potential for future varied canopy structure and diverse habitat for wildlife.

The aerial cover of native woody species in the buffer is qualitatively estimated 95 percent. This greatly exceeds the performance standard requirement (Photo 2). Species observed in this zone include snowberry (*Symphoricarpos albus*), red elderberry (*Sambucus racemosa*), thimbleberry (*Rubus parviflorus*), Douglas-fir (*Pseudotsuga menziesii*), and western red cedar (*Thuja plicata*).

Photo 2 – Woody cover in the wetland (August 2010)
