Seal System Gaps on the Tunneling Machine

Seattle Tunnel Partners will make repairs to the seal system and main bearing of the SR 99 tunneling machine.

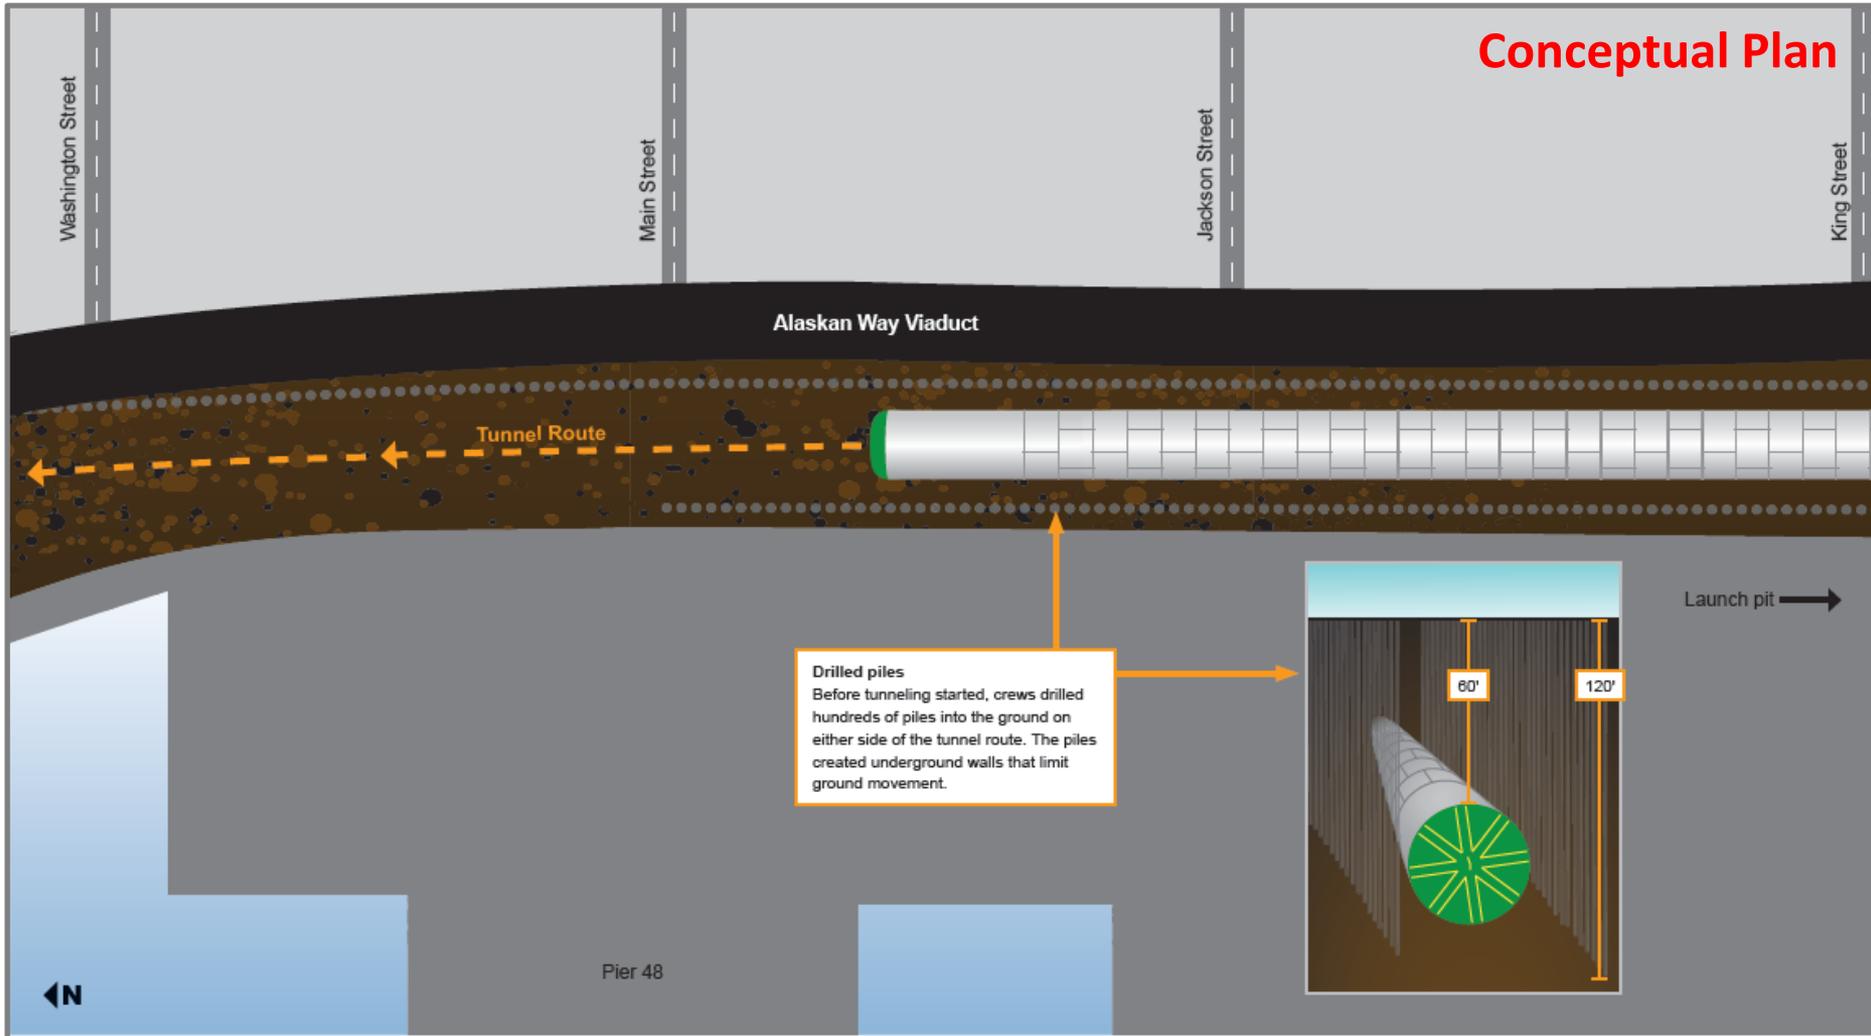
SR 99 Tunneling Machine's Current Location

Seattle Tunnel Partners conceptual plan for repairing the SR 99 tunneling machine as of March, 20 – not to scale

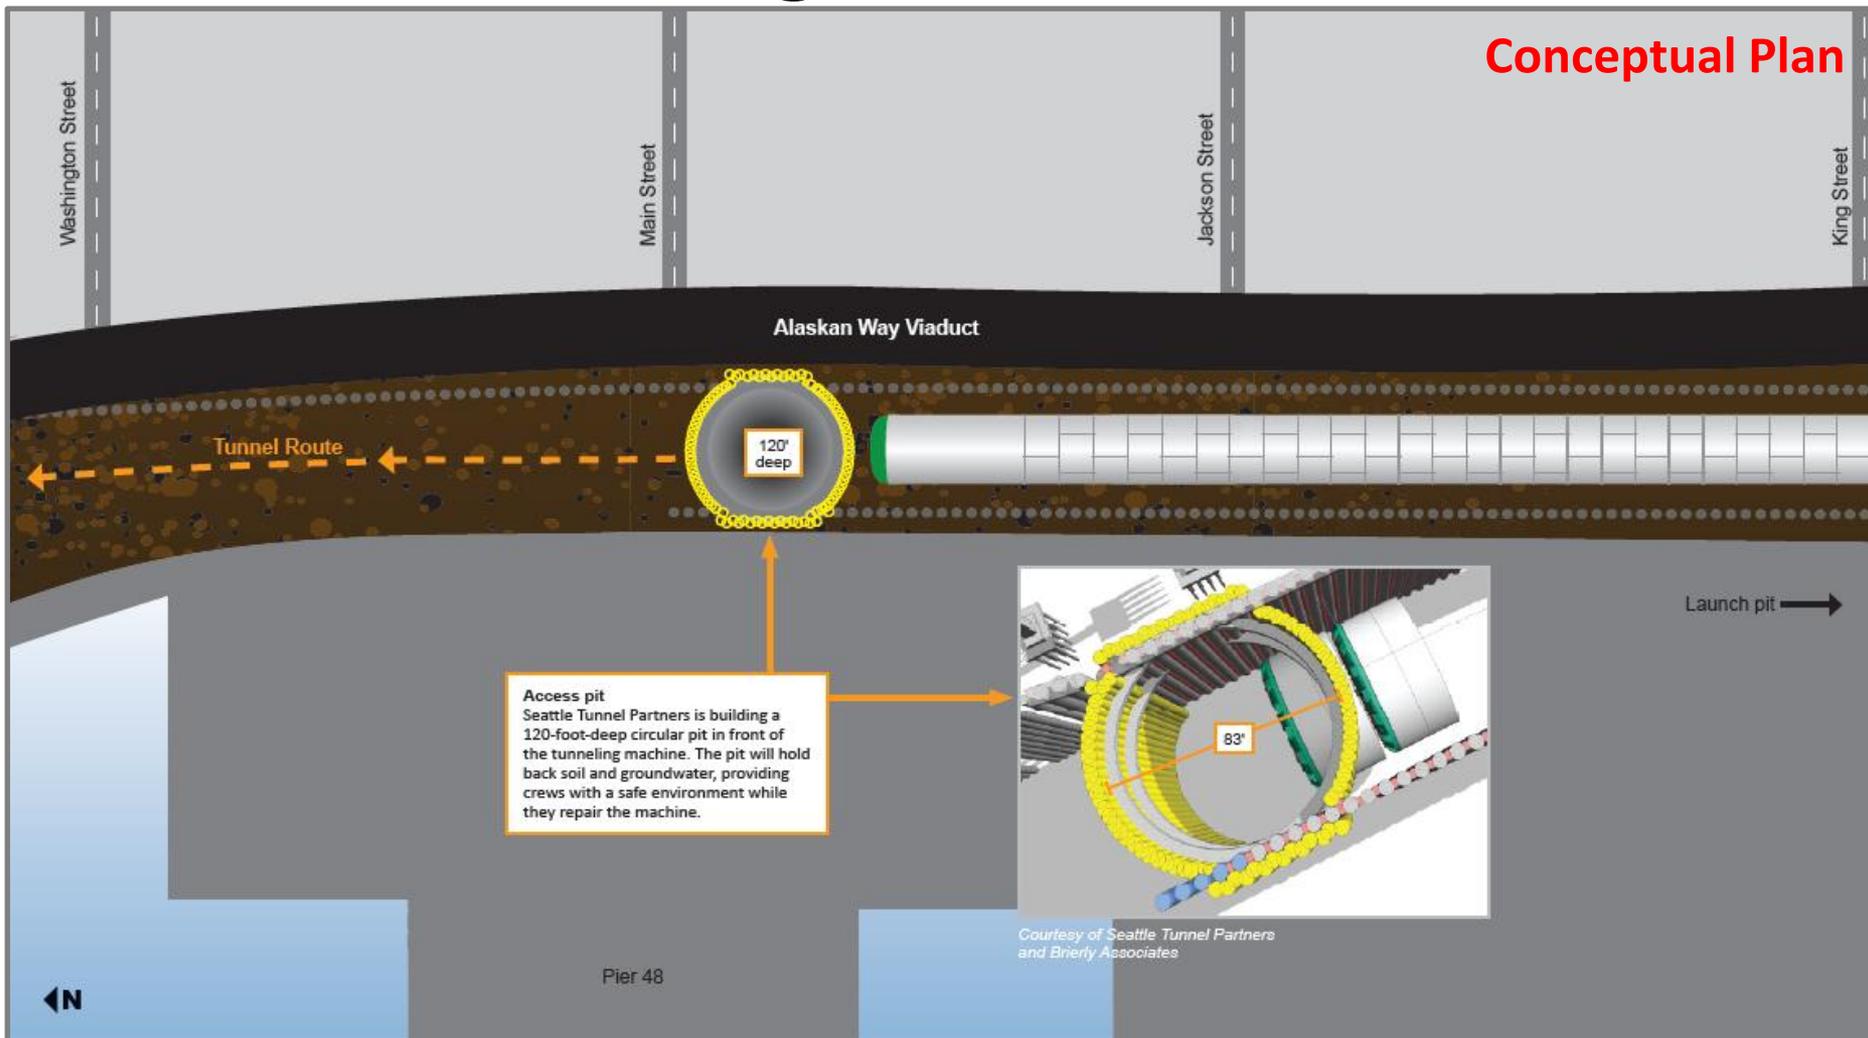
Building the Access Pit

Seattle Tunnel Partners conceptual plan for repairing the SR 99 tunneling machine as of March, 20 – not to scale

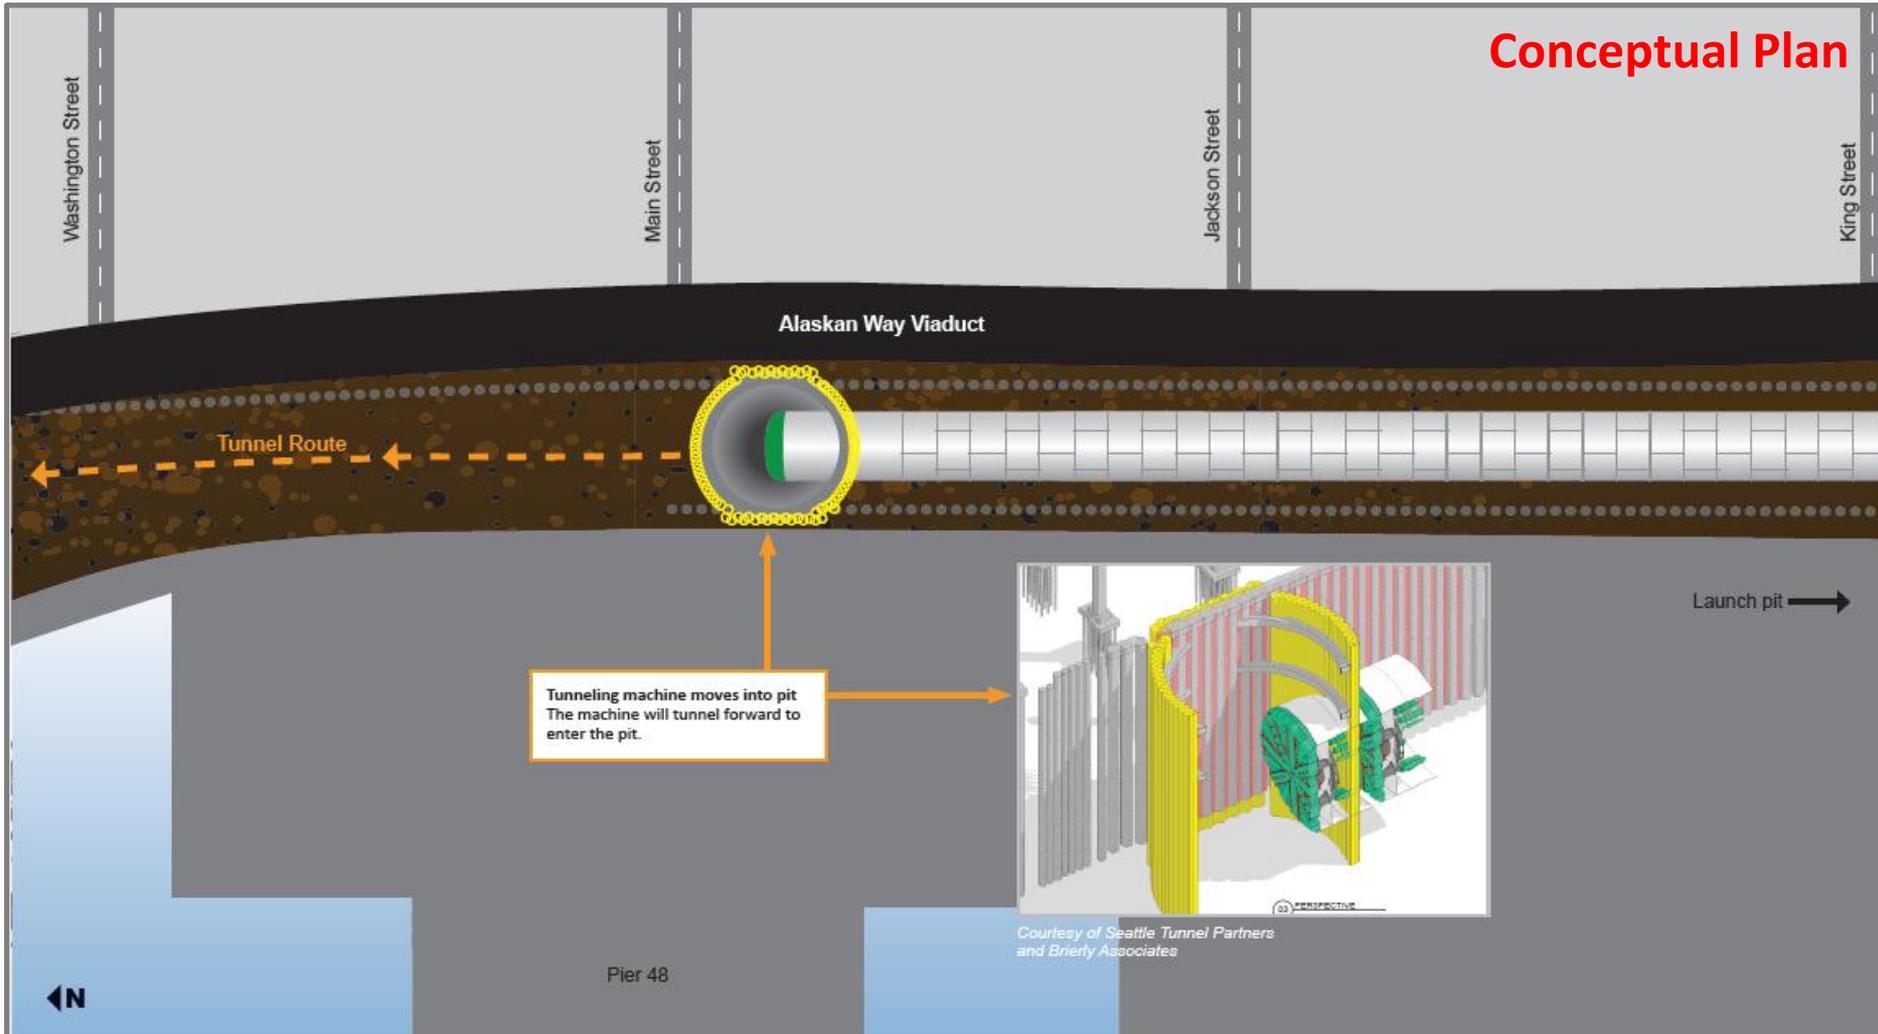
Tunneling into the Access Pit

Seattle Tunnel Partners conceptual plan for repairing the SR 99 tunneling machine as of March, 20 – not to scale

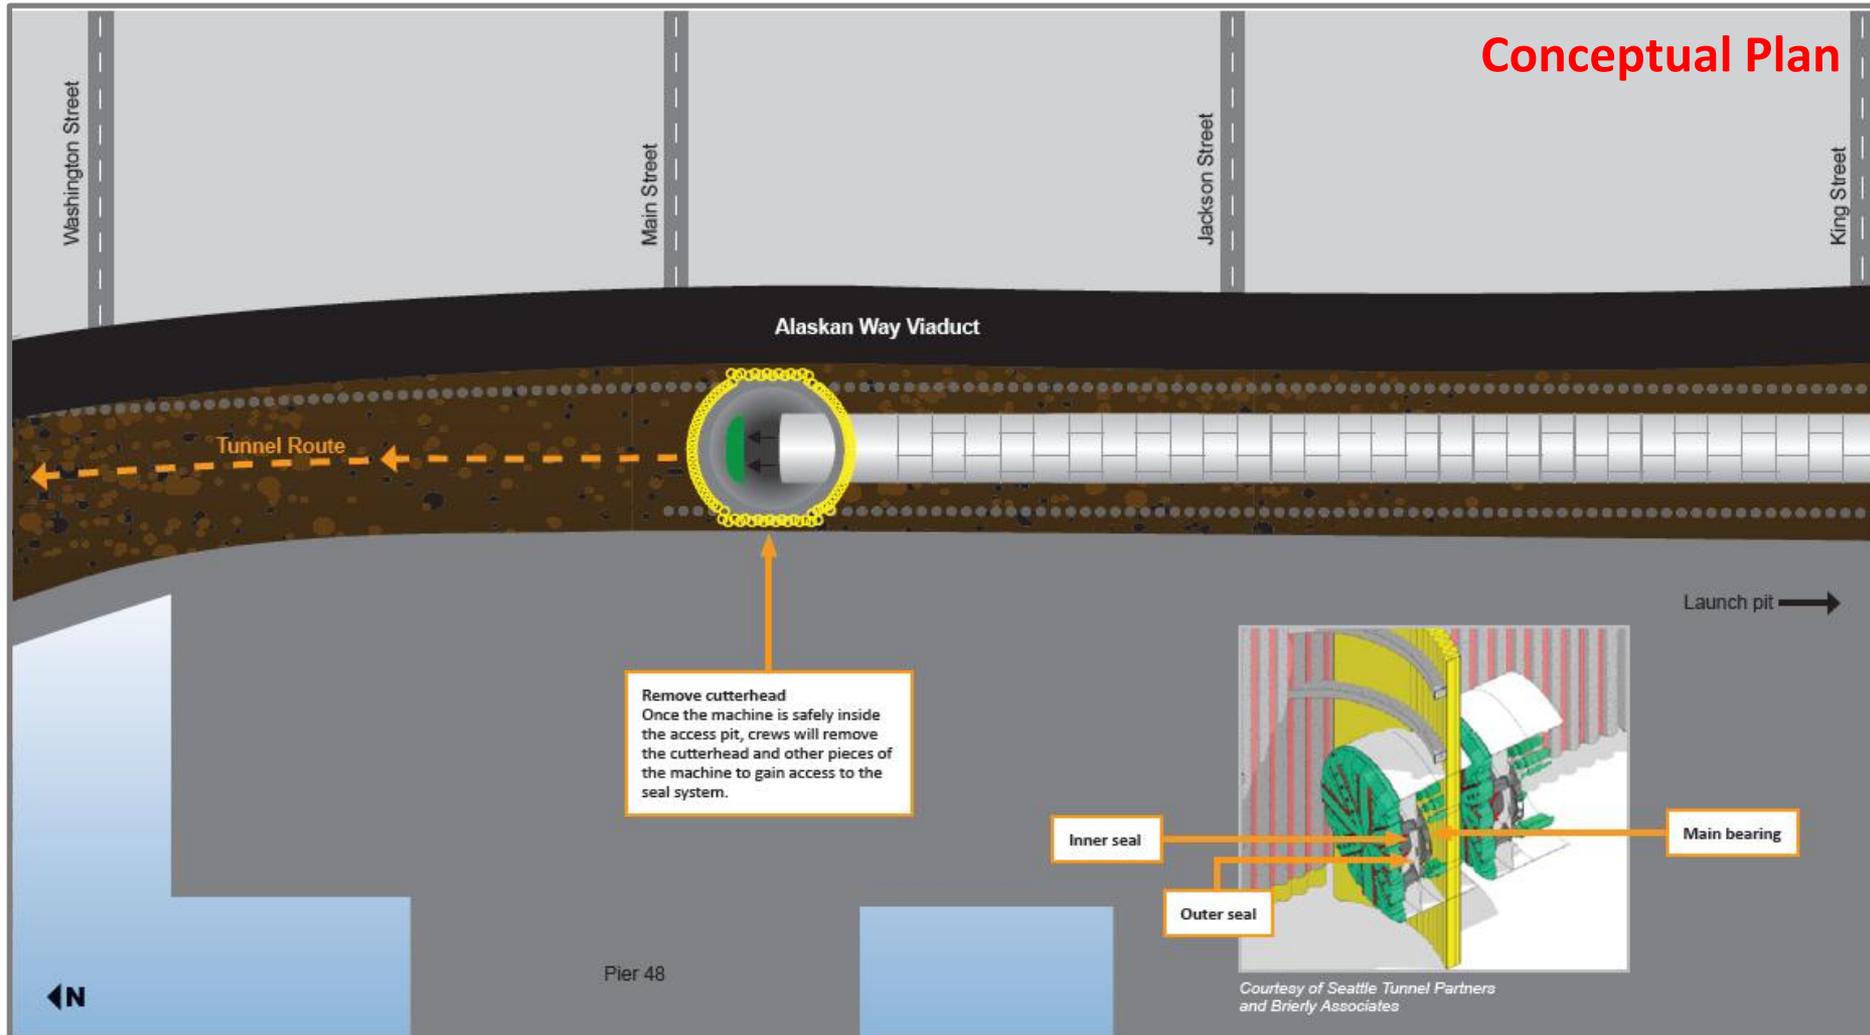
Repairing the Seal System

Seattle Tunnel Partners concept plan for repairing the SR 99 tunneling machine as of March, 20 – not to scale
