Combined Aggregate Gradation As A Method for Mitigating Studded Tire Wear On PCCP

Contract 5947

I-90

Sprague Avenue Interchange Phase 3

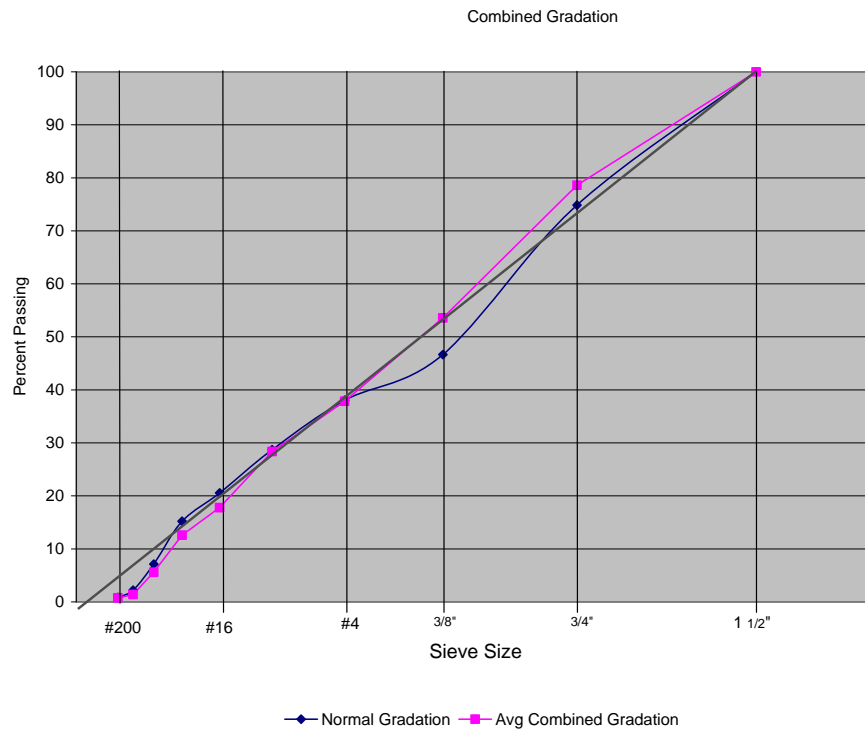
The aggregate gradations for the two projects are plotted on a 45-power curve chart in Figure 1. The closer fit of the combined gradation to the 45-power curve is evident from this chart.

Figure 1. Normal and combined aggregate gradations for the Sprague Avenue Interchange Phase 3.

The portland cement concrete pavement for Sprague Avenue Interchange Phase 2 (Eastbound Milepost 284.36 to 286.65) that was constructed during the summers of 1999 and 2000 used the standard aggregate specification, while the project that constructed the westbound lanes, Sprague Avenue Interchange Phase 3, used the combined gradation specification. This project ran from Milepost 284.42 to 286.38 and was completed in 2001. The contract special provisions called for the aggregate grading to be plotted on a 45-power chart, and as necessary, coarse or fine aggregate added to optimize the aggregate gradation. Figure 1 shows the actual aggregate gradations from the project before and after it was adjusted to more closely fit the 45-power chart.

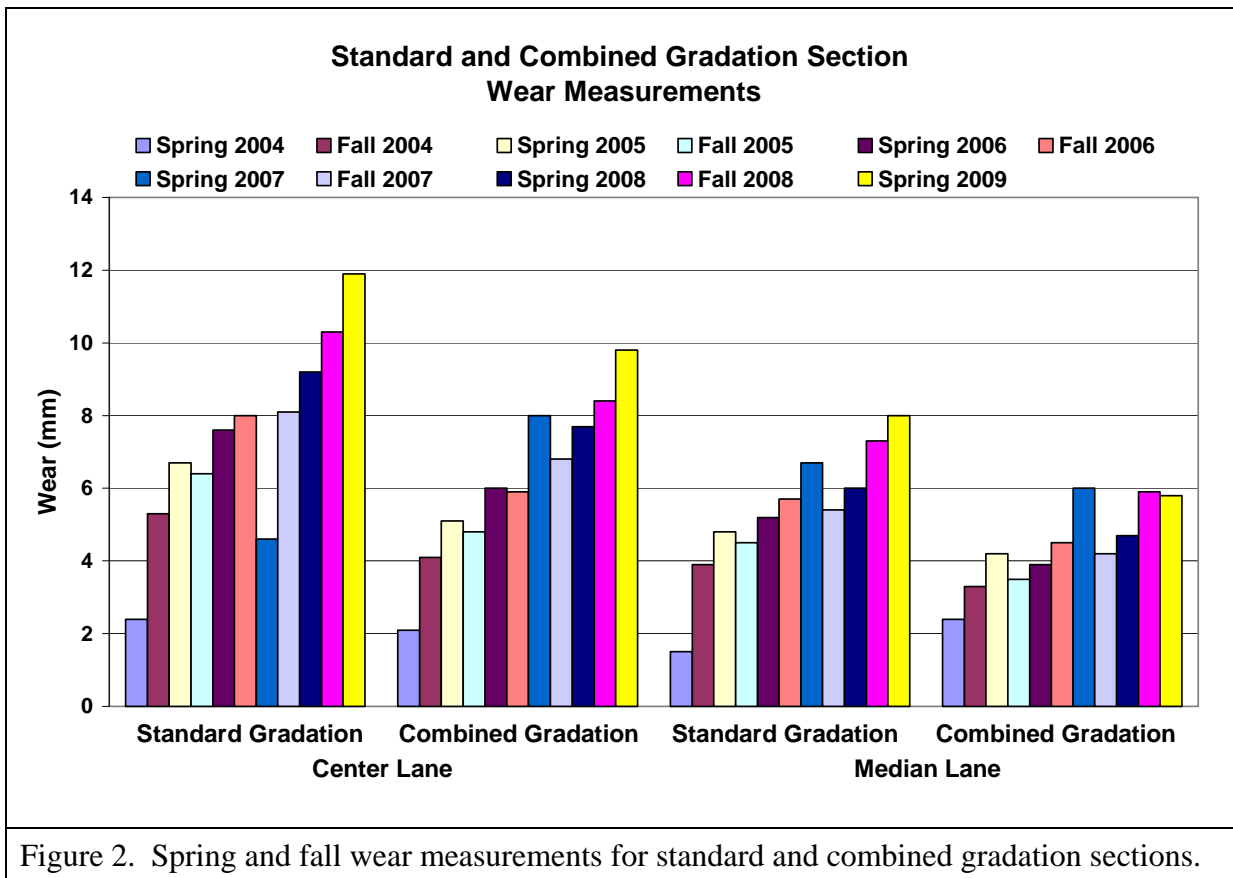
Figure 2. Spring and fall wear measurements for standard and combined gradation sections.

The two projects have been monitored for pavement wear since 2004. The WSDOT Pathway Van was used to collect rutting measurements in the spring and fall of 2004, 2005, 2006, 2007, 2008 and the spring of 2009. These wear measurements are listed in Tables 1 and 2 for the center and median lane, respectively. The tables show the increase in wear over the 5-1/2 years of measurement.

A direct one to one comparison cannot be made between the sections because they are not the same age and have not experienced the same amount of traffic. Two rate of wear calculations can be made, one based on the age of the sections and one based on the traffic experienced by both sections. The section with the standard aggregate gradation was built in 2000 and the section with the combined gradation one year later. Table 3 summarized the rate of wear for each section based on the age of the pavement. The rate of wear is calculated by dividing the average wear for both lanes by the age of the section. The age based rate of wear calculations indicates very little difference between the two sections with a difference of only 0.04 mm per year in favor of the combined gradation.
