technotes

“tech notes” are a product of the State Materials Laboratory to share design and construction technology gained from projects done through WSDOT. This issue is from the Pavements Branch discussing The Use of Rock Cap Material As a Capillary Break.

Use of Rock Cap Material As a Capillary Break

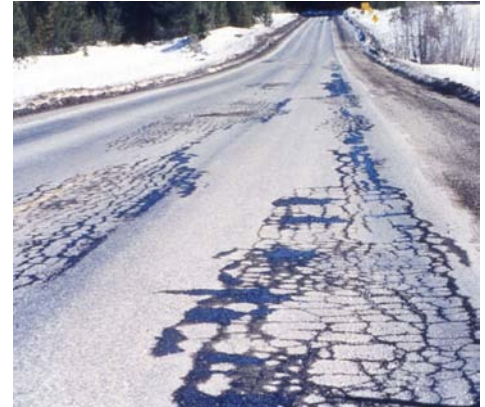
Photo 1. Example of the extent of damage caused by freezing and thawing on SR 20.

On SR 20, from Colville to Tiger Junction, WSDOT recognized the need for an “all-season roadway,” that is, a roadway not subject to road restrictions or closures. Load restrictions on SR 20 were yearly occurrences due to a weak pavement structure. As with many roads built in the 1930’s and 40’s, a minimal thickness of crushed stone base was placed on frost susceptible soils prior to a bituminous surface treatment (BST). Over time, the placement of additional layers of BST has resulted in a bituminous layer that is adequate for low volume roadways during dry seasons. However, this structure does not adequately support truck traffic during the spring thaw, consequently resulting in substantial fatigue cracking and rutting (Photo 1) due to the amount of thawed moisture in the base and subgrade.

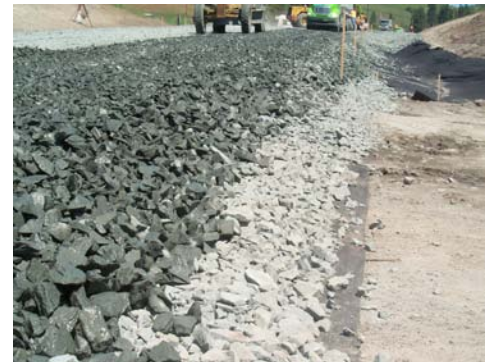
Photo 2. Open graded nature of the rock cap aggregate provides a positive drainage blanket allows excess water to be eliminated.

To reduce the amount moisture allowed to enter the base layers, a capillary break using free draining rock cap material was constructed. Photo 2 shows the open graded nature of the rock cap aggregate and the positive drainage blanket provided.

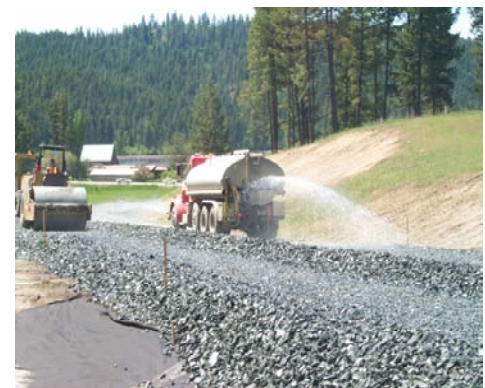
Photo 3. Watering and compaction of rock cap aggregate.

compaction (Photo 3). Typically, a 300 to 500 foot long section is completed to full depth before the entire operation progresses along the roadway.

The rock cap is compacted by using a 10-ton vibratory roller. The use of water during compaction is essential to reduce the inter-particle friction when compaction energy is applied. Idaho DOT had previously described rock cap material, while under traffic, as acting like an arrestor bed on a truck escape ramp. Nevertheless, the projects constructed on SR 20 from 1998 to 2002 exceeded all expectations, and the stability of the roadway for automobiles and construction vehicles was excellent.

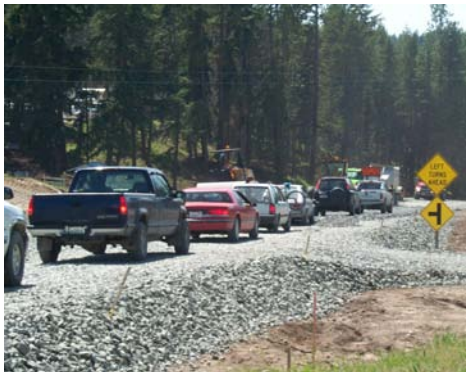
Photo 4. Vehicle traffic driving on the compacted rock cap surface.

WSDOT found that the 2 ½ to 3 inch rock cap material was normally very stable and only experienced two problems: trucks hauling rock cap material occasionally got stuck while dumping and car tires sometimes being punctured by sharp rocks. WSDOT was able to reduce the number of punctured car tires by compacting the material with at least three passes before allowing vehicles on the rock cap surface.

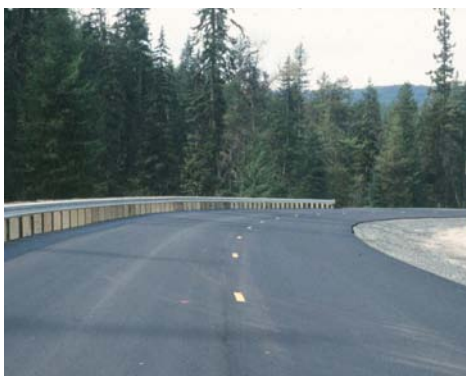
Photo 5. Final asphalt overlay on SR 20 with rock cap material in place.
