# WARRANTED HOT MIX ASPHALT PAVEMENTS:

## Development, Benefits and Risks

# Indiana Warranty

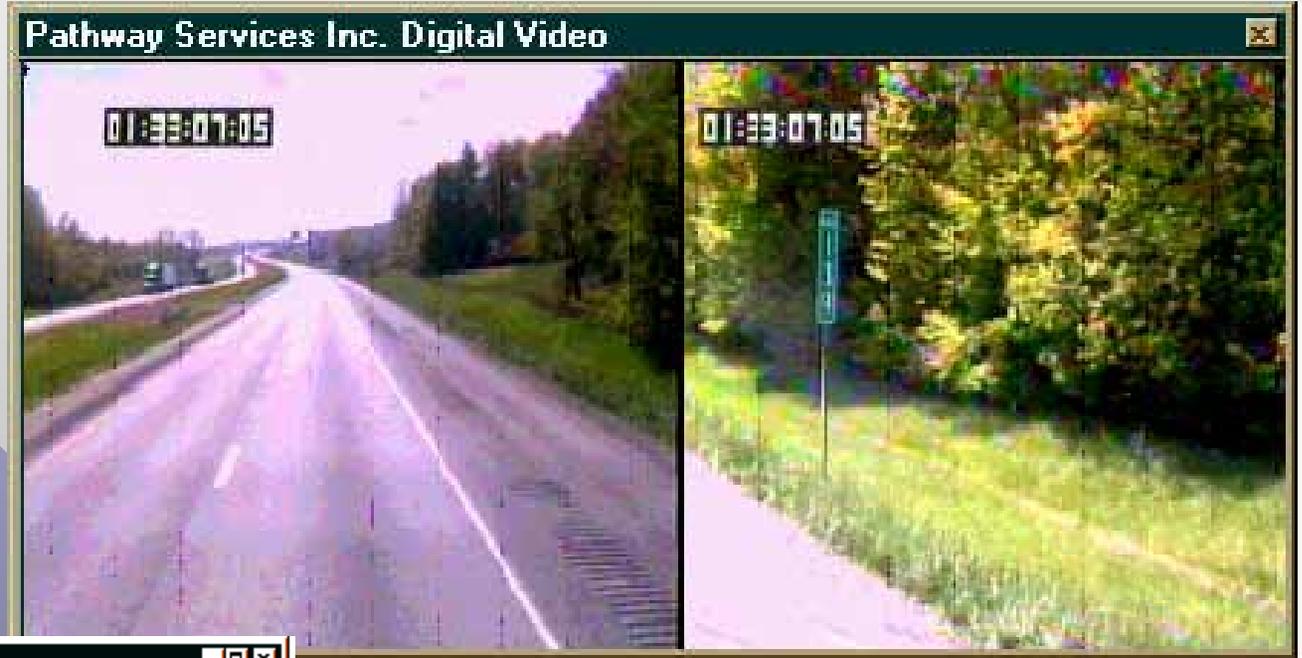
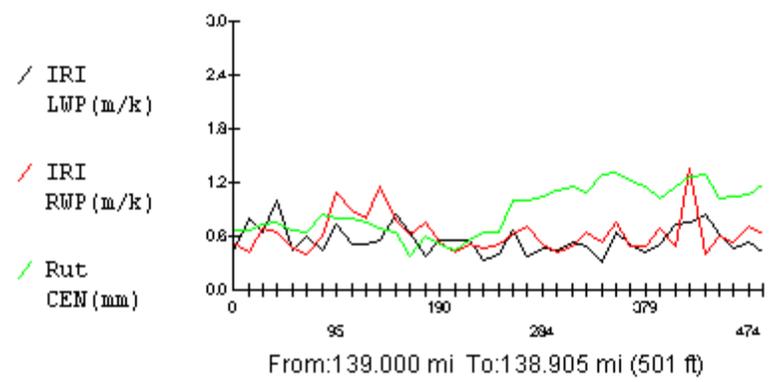
# Warranty Data

01:33:07:05 | 1 | Rec 25 | Set 101  
 Dist 5099.1 ft | 139.034 mi | Sp 0 m/h  
 Lat +41.5105934 | Lon -85.0550766  
 End-Imag 01:33:07:15 | Road-Nail69  
 Road--Fr 139.000 | Road---- 138.000  
 Len 5280.0 | SvyLenq 5440.2  
 IRI L e 34 | IRI R e 41  
 HRI e 28 | RutAvgfir 0.04

Road:I69 Co:1 D:N Ln:1

Pathway Services Inc. Road/Surface Condition Information System.

File	Edit	Options	Image	Samples	Distress	Sensor	Map	Signs/Inv	Help							
Num	Road	From(mi)	To(mi)	Dir	Len(ft)	SvyLen	P	Set	Start-Image	End-Image	SurveyDate	Time	IRI L e	IRI R e	RutAvg(in)	
26	I69	139.000	138.000	D	5280.0	5440.2	A	101	01:33:07:15	01:34:10:17	05/05/98	11:40	34	41	0.04	
27	I69	138.000	137.000	D	5280.0	5275.4	A	101	01:34:10:21	01:35:09:08	05/05/98	11:41	41	51	0.04	
28	I69	137.000	136.000	D	5280.0	5304.2	A	101	01:35:09:08	01:36:05:21	05/05/98	11:42	35	44	0.05	
29	I69	136.000	135.000	D	5280.0	5278.1	A	101	01:36:05:21	01:37:02:09	05/05/98	11:43	37	45	0.04	
30	I69	135.000	134.000	D	5280.0	5267.6	A	101	01:37:02:09	01:38:09:04	05/05/98	11:44	56	59	0.03	
31	I69	134.000	133.000	D	5280.0	5268.1	A	101	01:38:09:04	01:39:10:12	05/05/98	11:45	65	65	0.03	
32	I69	133.000	132.000	D	5280.0	5275.6	A	101	01:39:10:12	01:40:06:26	05/05/98	11:46	40	46	0.03	
33	I69	132.000	131.000	D	5280.0	5304.5	A	101	01:40:06:26	01:41:03:26	05/05/98	11:47	39	44	0.02

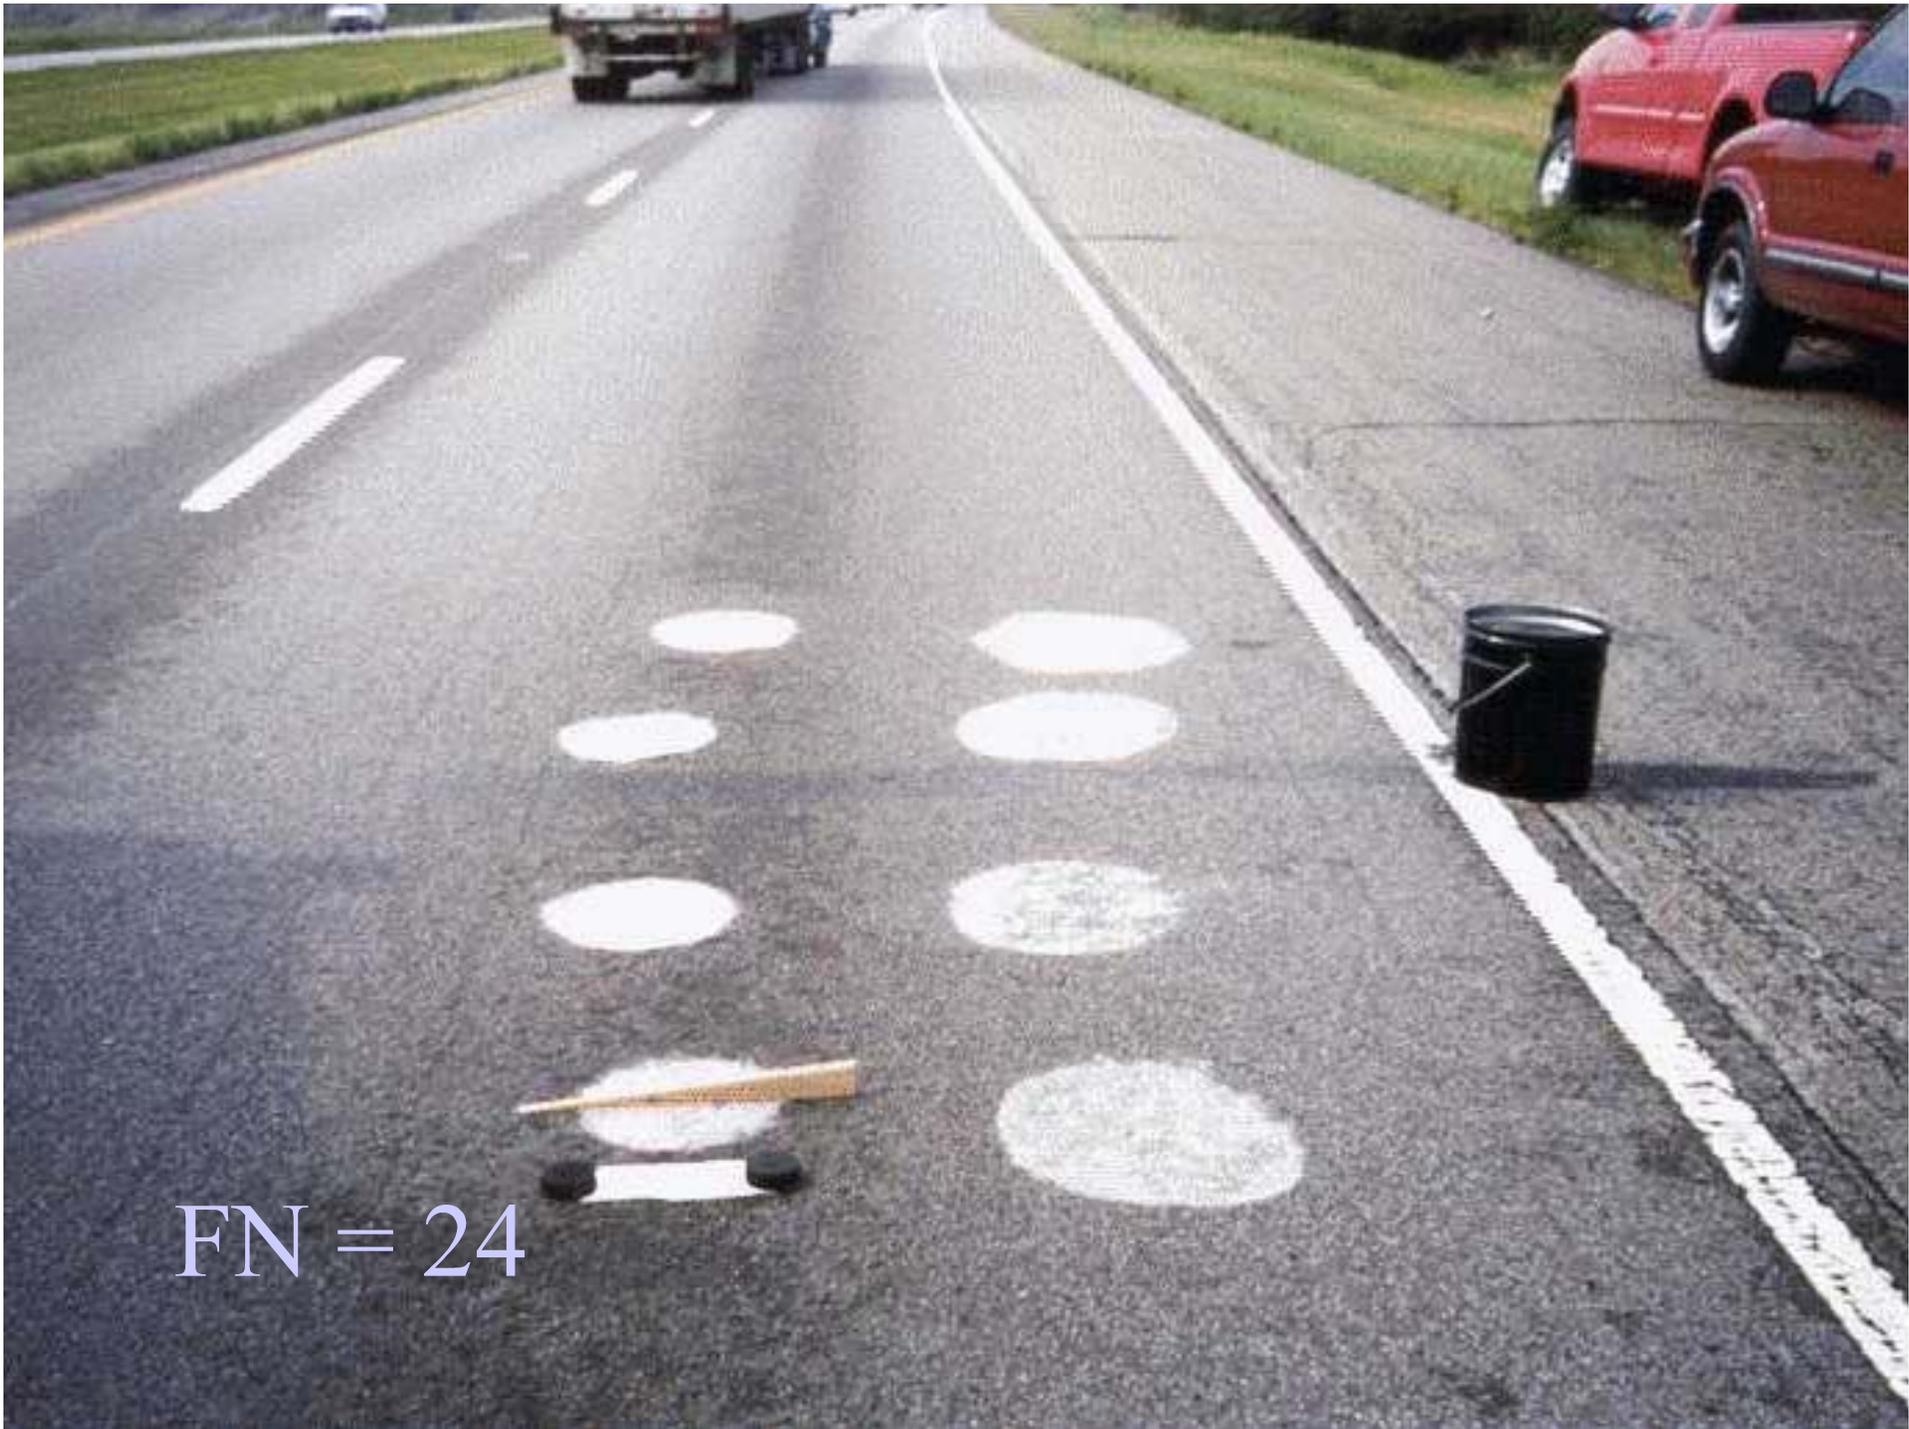
FN = 24

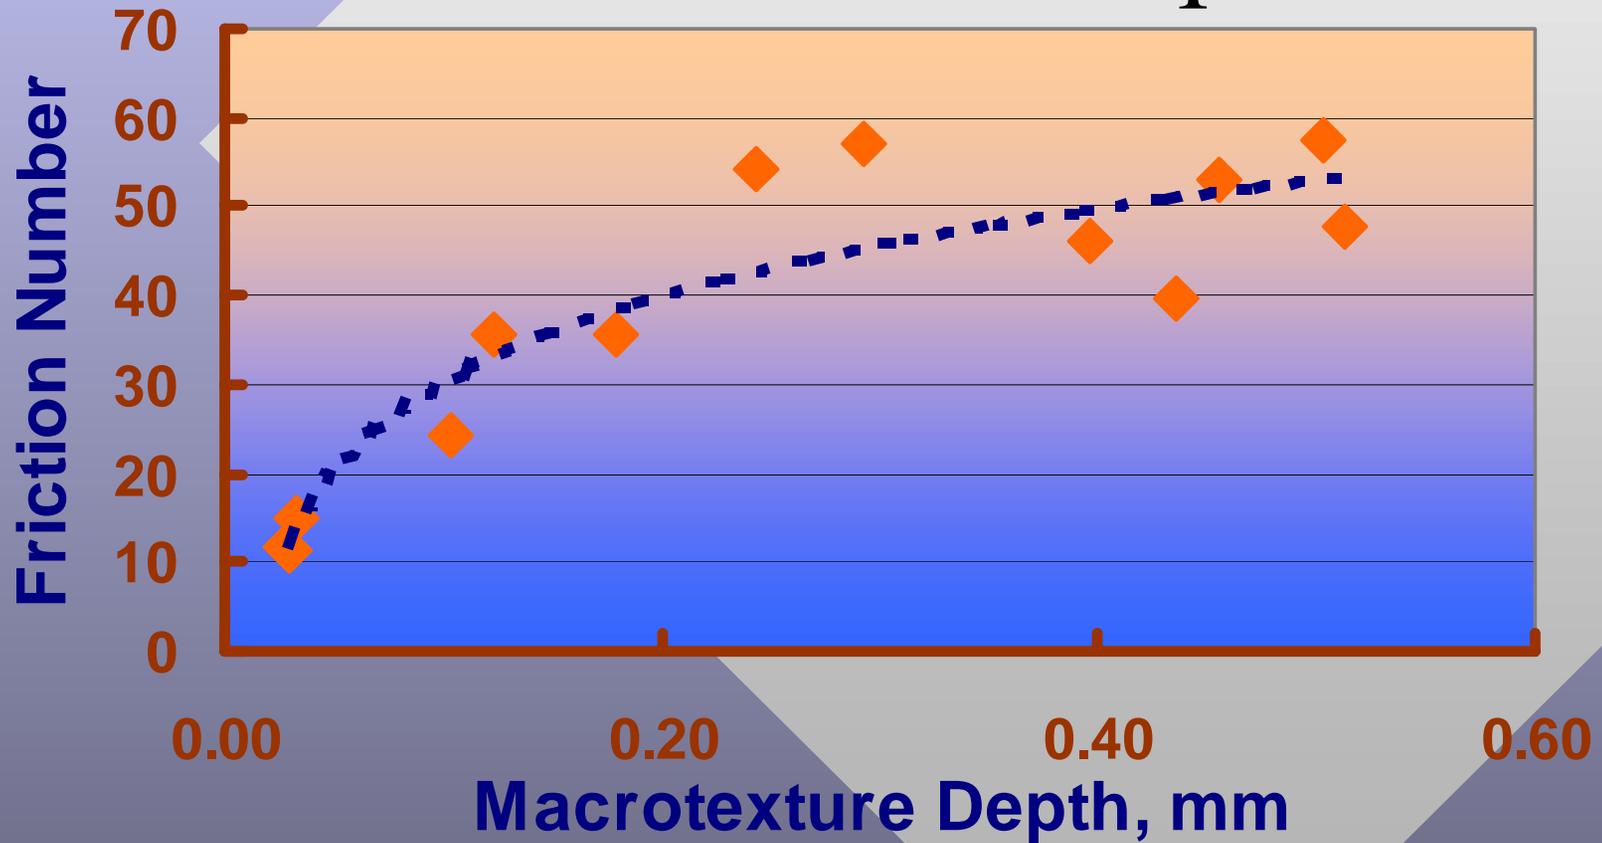
# Correlation of Friction Number to Macrotexture Depth
