P2 Bridge Preservation - Steel Bridge Painting Projects

2009-11 Bien Priority Array

Steel Bridge Paint Form

Bridge Number: 207 / 4		Bridge Name: WENATCHEE RIVER		Milepost: 4.22	Region: North Central
Year Built 1940	Bridge Type: ST CTB		Steel Span Length: 160 ft.	Width (curb-curb): 24 ft.	Steel Tonnage: 145
Paint Age: 20	Paint Color: Evergreen	34097	Steel Surf. Area: 21,750 sqft	BMS Cond State 2: 5,000 sqft	BMS Cond State 3: 1,000 sqft
Next Paint Year: 2013	2007-09 Rank: 18	2009-11 Rank: 17	CPMS Ad date:	Paint Pin Number:	Cost Est\$/Ton: \$4,000
					Future Paint Cost: \$580,000

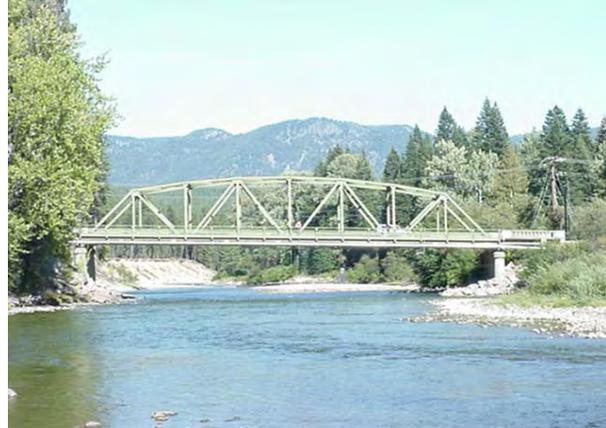
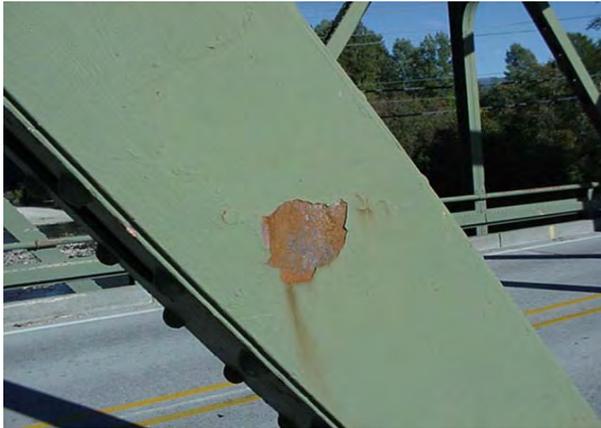
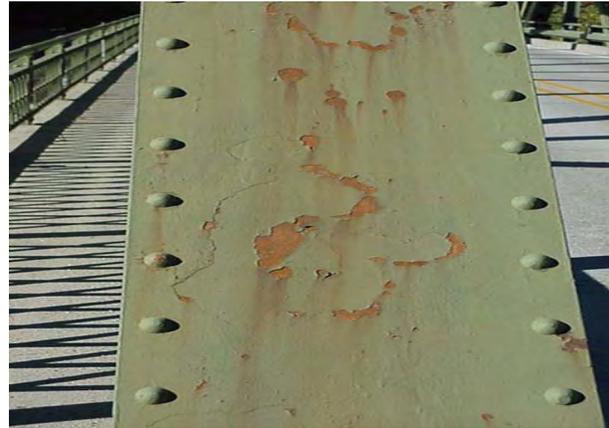
Bridge Inspection Notes:

Small areas of peeling paint and blistered paint on steel stringers. Rust blooms and peeling paint scattered throughout top of truss and upper lateral brace members. A few small areas of peeling paint and rust blooms and areas of light rust between bottom chord built-up members.

STEEL TRUSS - Some rust pitting of panel point gusset plates. Heavy amounts of gravel and sand on the top of and inside of the bottom chord and lower panel point gusset plates.

STEEL FLOOR BEAMS - Minor rust in top flanges at deck interface, due to leaking joints above.

Deck joints need to be sealed as part of the painting project.
