P2 Bridge Preservation - Steel Bridge Painting Projects

2009-11 Bien Priority Array

Steel Bridge Paint Form

2009-11 Biennium Priority Array

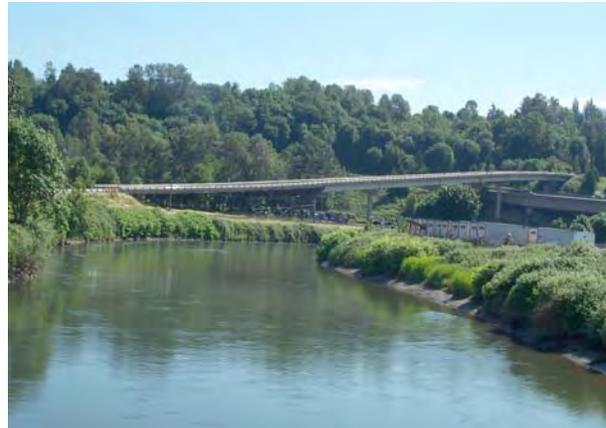
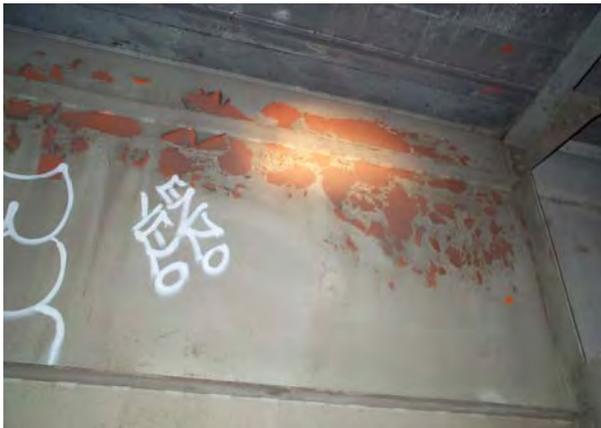
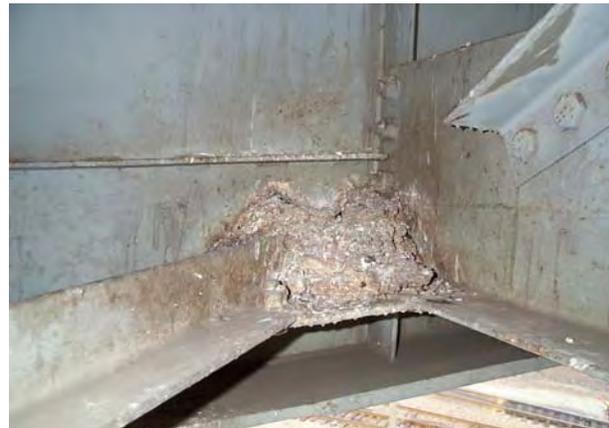
Top flange rust in exterior stringers at sidewalk joints. Rust blooms in both top and bottom flanges. Large piles of pigeon guano on bottom lateral gusset plates. Fire damage at east abutment burnt an area of the paint but no significant damage. Peeling paint is more prevalent in Spans 1 and 2.

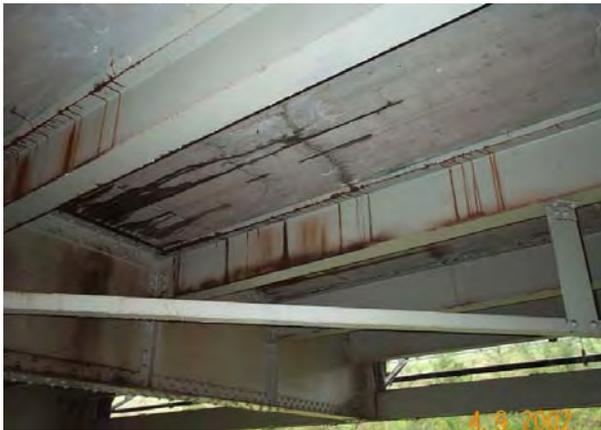
The 1993 painting contract was one of the first in the state that required the containment and disposal of the abrasives used to prepare the steel surfaces. The inspection report says that there is "small rust blooms scattered throughout. Some rust at bottom gusset connections to the bottom chord. Rust staining on top flanges of stringers and floorbeams."

The bridge deck is scheduled to be replaced in the 2013-15 biennium. The bridge painting should be part of the same project.

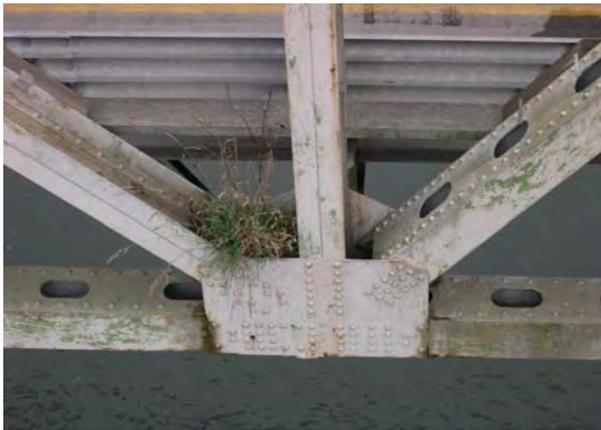
The paint system is chalking, peeling, and curling. Paint has peeled up to 10% of area to exposed rusty metal. Paint has peeled up to 30% of area without exposed metal.

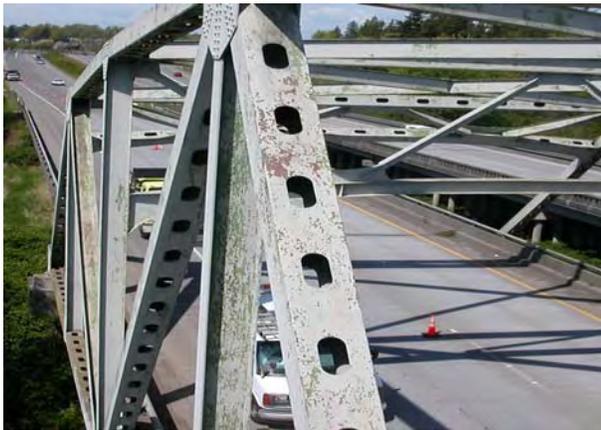
STEEL STRINGERS - Some of the ends near the floor beams are rusting in the top flange.

FLOOR BEAMS - Top flange of the floor beams are rusting with up to 5% section loss. The top flange at the ends has the most advanced rusting.

TRUSS BOTTOM CHORD - Pack rust between the bottom lateral gusset plates and the bottom chord with a few starting to bulge. Paint is peeling with over 40% gone exposing the previous paint. The top paint is not adhering to the bottom paint. Pigeon quano noted.

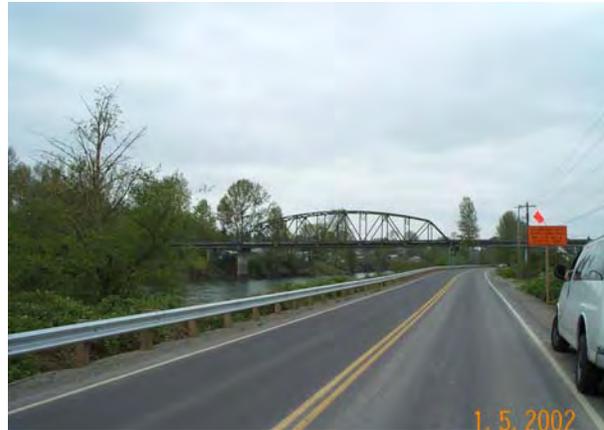
Truss members are moss covered and have peeling paint. Inside faces have more peeling paint than the outside faces. There is bird guano and dirt accumulations up to 3" deep in joint areas. The gray primer is exposed and peeling paint as noted: Top Chord - 80% gone; Diagonals - 40% gone; Bottom Chord - 50% gone.

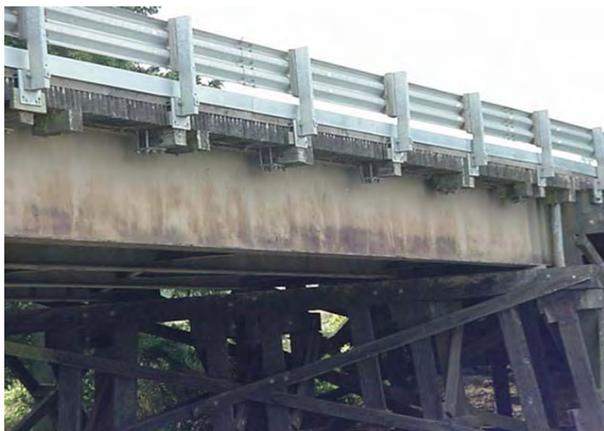
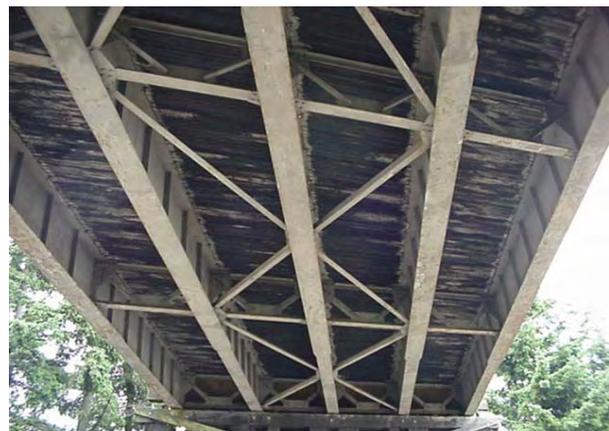
Spots of surface rust throughout. Peeled paint and sheet rust on girder end bottom flanges and on flange edges. Rust freckles on many bolts and end cross bracing elements.

This may be a good candidate for an overcoat with an epoxy rust penetrating sealer.

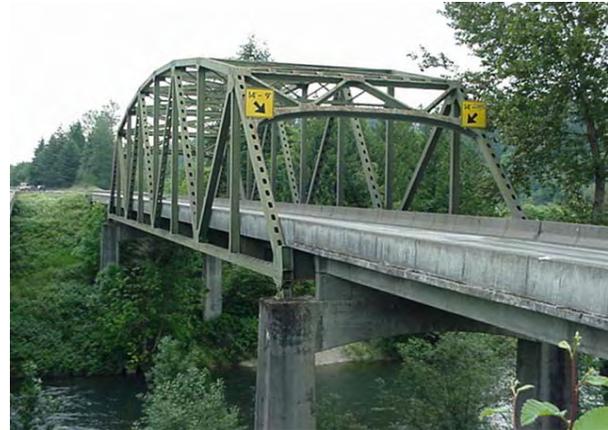
Rusting in sliding joints at stringers and on top flanges of stringer near floor beams. Several stringers (primarily A&E) have fatigue cracks up to 5/8". Rusting in several exposed areas at floor beams.

TRUSS: Mossy growth on paint with a few pits and rust blooms. Rust blooms on portals and top sways throughout. Paint peeling off in sheets on W. portal frame. A few rivets on bottom lateral gusset plates have 15% head section loss.

FLOOR BEAMS: Mud and rust staining on the top flanges, webs and bottom flanges. Sheet rust on the bottom side of the top flange up to 1/8" deep. Top flange has 5-10% section loss, mostly near the end of the floor beams.

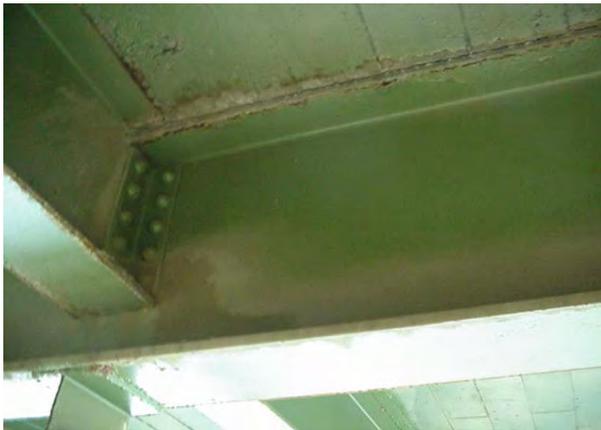
Full removal of the existing paint was required to the floor beams and stringers in the last painting contract.

Up to 10% section loss was noted in the top and bottom flanges of the stringers prior to being painted in 1998. Rust at interface between top flanges and deck. Surface rust with some pitting. Pack rust in the bottom flanges and bearing seats with up to 50% section loss, especially Stringers A and E. There are many areas that are rusting through the paint. Paint preparation and thickness varied greatly throughout the bridge from several layers of paint protection to over spray with no preparation to the metal. Rust stains on several of the members. Surface rust on several of the stringers and truss members.

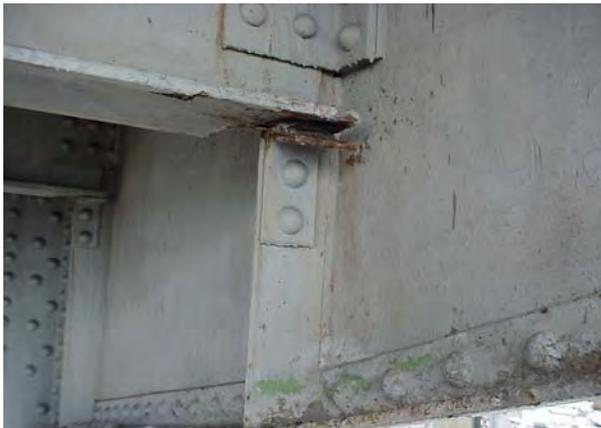
STRINGERS - At the expansion joints (piers 8 and 11, U26, U30 of span 9) 60% section loss in bottom flange. At these locations the stringer web stiffeners and rivet heads have up to 100% section loss. Peeling paint on most of stringers A,B,C,K,L,M.

FLOORBEAMS - The top flanges near the curb lines have been repaired. Pack rust between stringer seats.

DECK TRUSS - A few areas of rust blooms in the gusset plates. Spans 4&5 have large amounts of vines growing on the steel bracing.

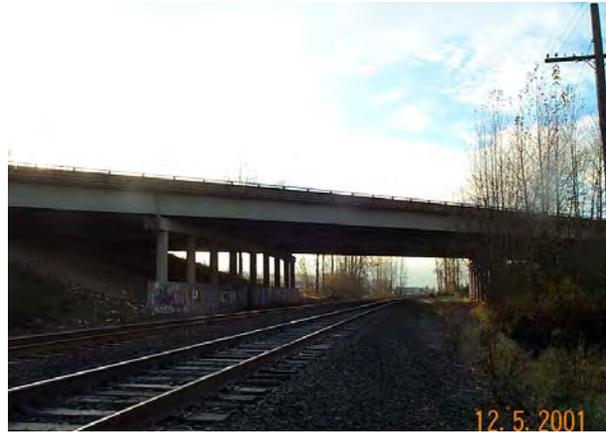
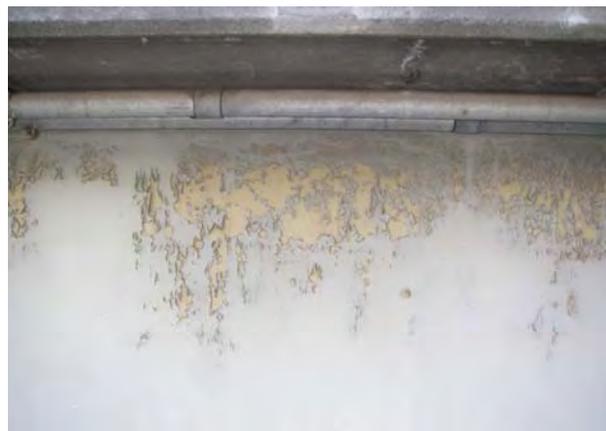
There are rust blooms throughout, especially on the bottom flanges. There is peeling paint in the webs and bottom flanges. Girders E and F were installed when the bridge was widened in 1998. There are a few spots of rust on the original girders where the paint is thin.

This bridge was widened as part of contract 14771. There are two new girders placed on the south side. These girders should be excluded from the next paint contract.

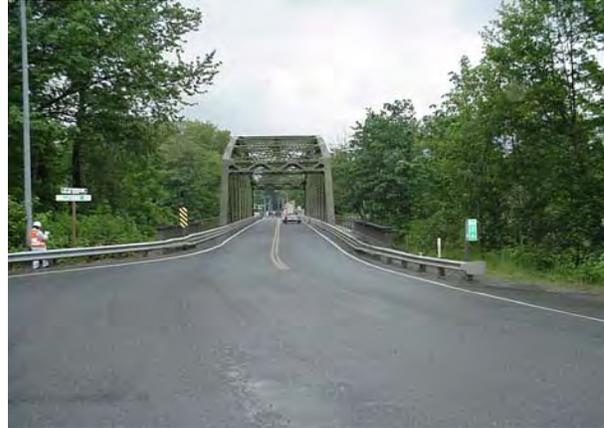
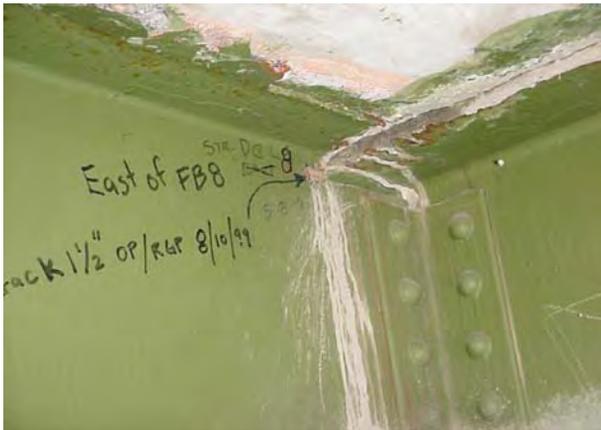
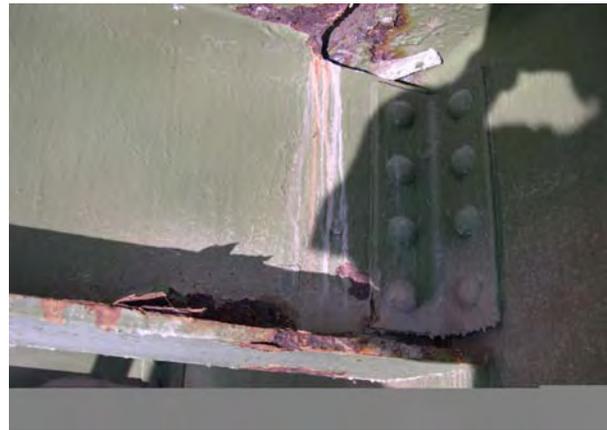
Steel truss has peeling and cracking paint throughout, and rusting in some of the members. Rust in the top and bottom flanges of stringers and floorbeams. Some rust staining along web of sidewalk stringers.

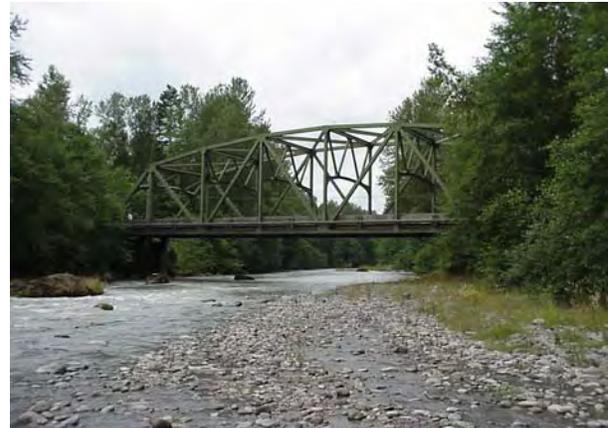
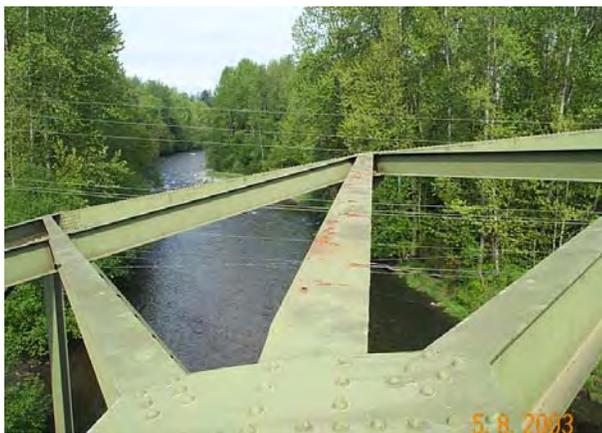
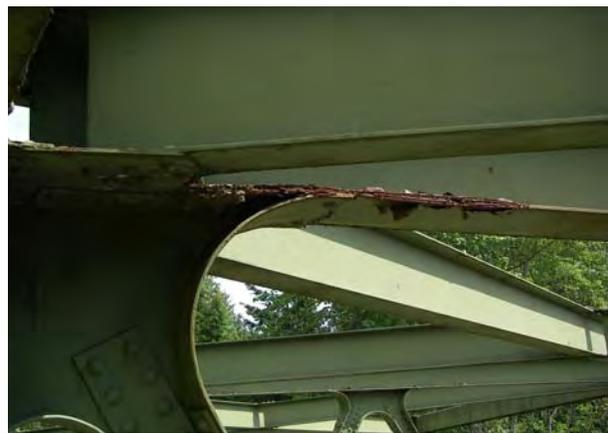
Paint is failing in several areas. The top flange of the bottom sway braces have areas of peeling paint. The top of truss has many rust blooms and areas of peeling paint - chalky throughout. Paint is chipped and peeling on bottom of diagonals and on verticals. Paint is peeling and failing on the bottom chord, bottom lateral gussets, top chord connections, floor beam to truss connections, and bottom of stringer to floor beam connections. There are areas of blistered and peeling paint on floorbeams.

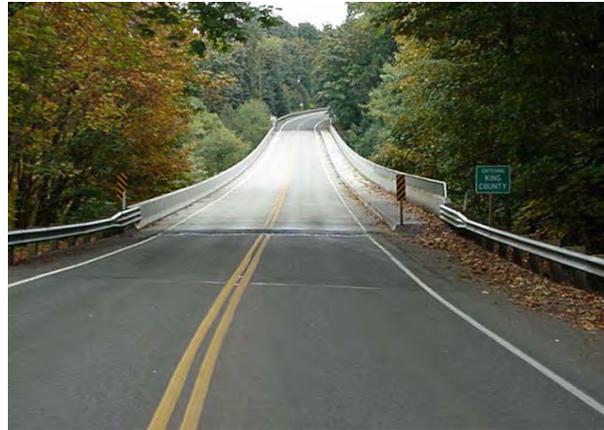
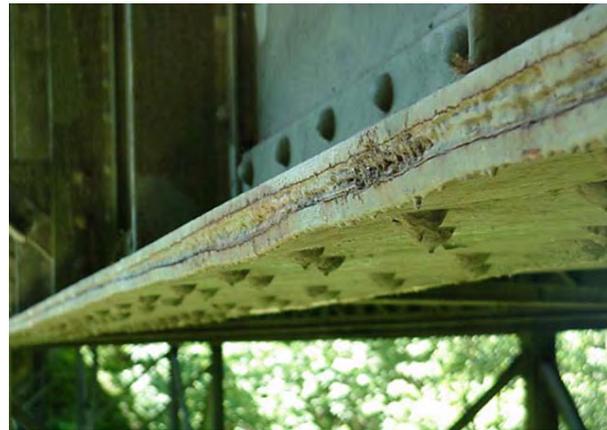
Paint is chalking throughout. Peeling paint, rust blooms, and laminar rust on bottom flange and lower web portion of floorbeams and girders. Up to 2 sq. ft. areas of paint flaking on tower legs and bracing. Exposed metal in many locations.

The bridge deck was replaced in 1996 as part of contract 14713. The top flange of the beams were painted prior to the construction of the new concrete deck. One coat of zinc primer (2.5 mils dry) was used on the top flanges. Full removal of the existing paint system is needed. Full containment will be required.

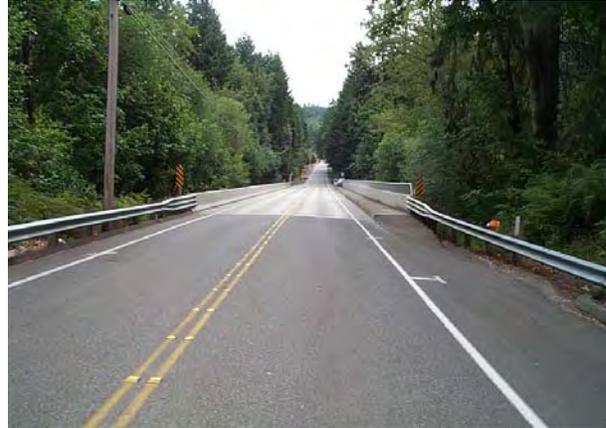
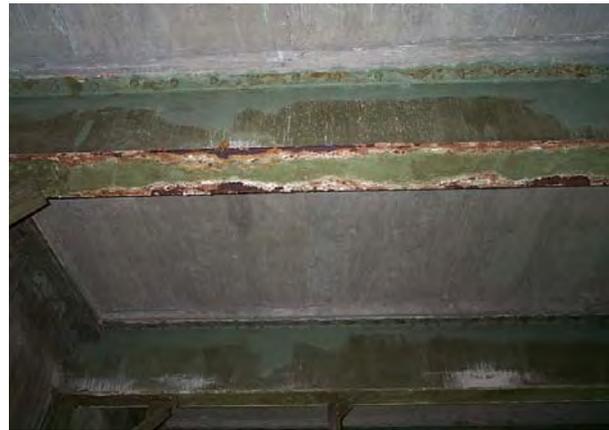
Paint is thin and peeling in places. Rust blooms are common throughout the bridge. Diagonal bracing on columns are rusted on the top surfaces.

Full paint removal is warranted based on the age and condition of the existing paint. Full containment will be required.

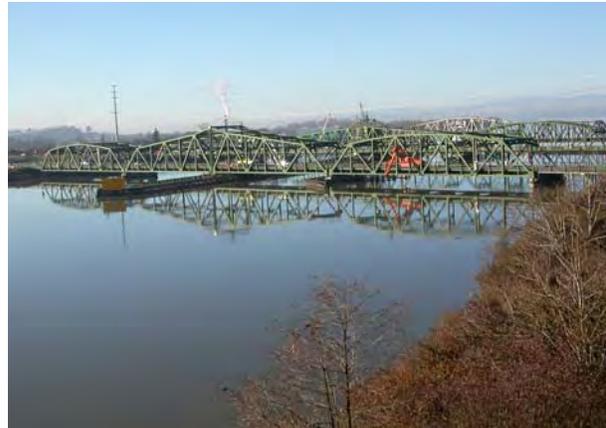
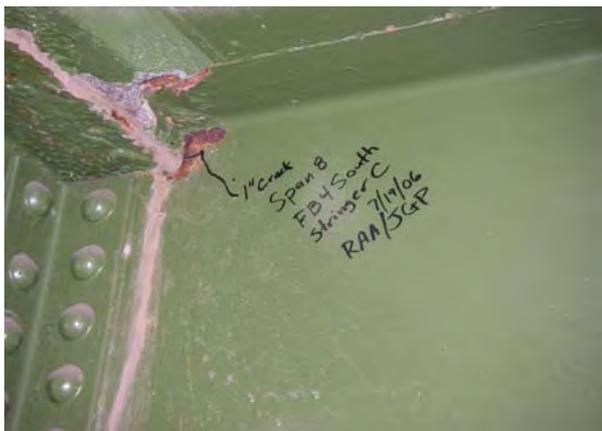
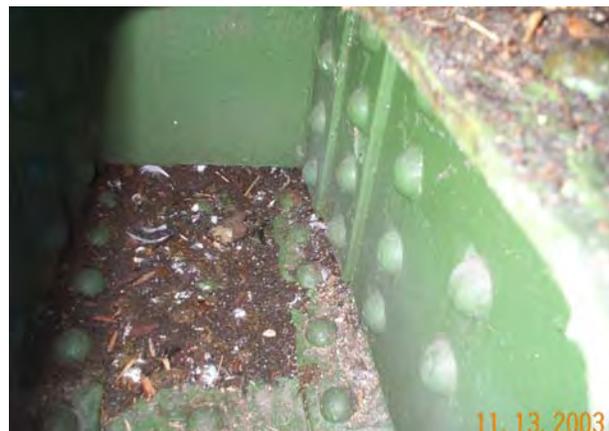
Painting of bridge completed between the April 2001 and November 2003 inspections. The paint is peeling on many of the floorbeam top flanges. The paint is failing at a few stringer copes. The paint is failing inside of Joint L2'W in Span 5. Poor paint inside Member U2E-U3E in Span 5. There is some debris at the lower panel points throughout all of the trusses.

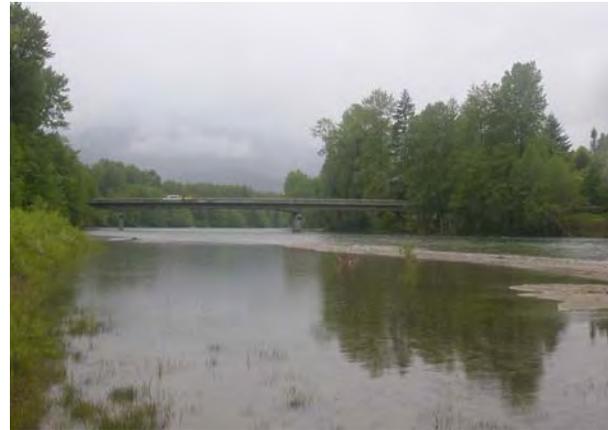
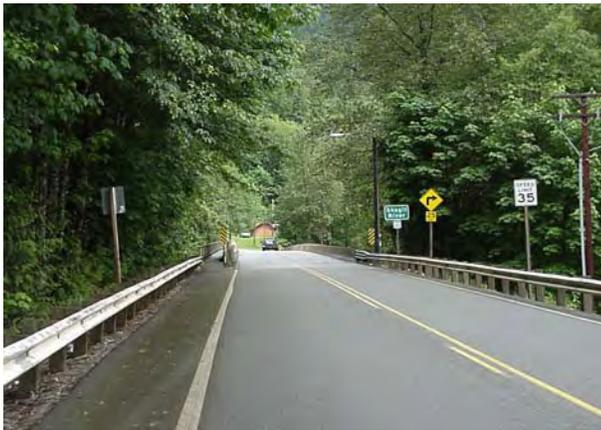
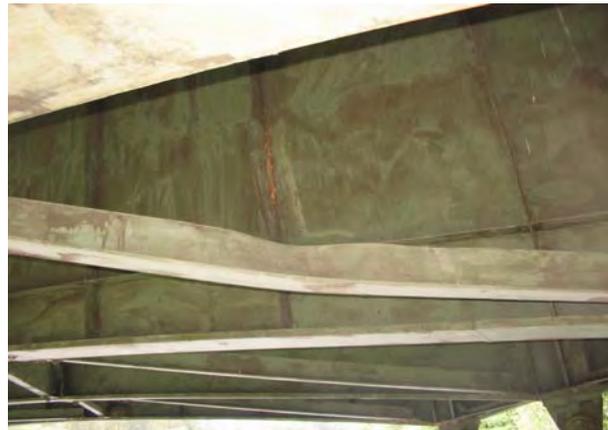
Girder paint system is starting to peel and flake in some locations. The top flange of the outside girders are starting to rust in few areas.

Light rust in bottom flange and diaphragms at hinges. Areas of rust in top flanges at interface with deck.

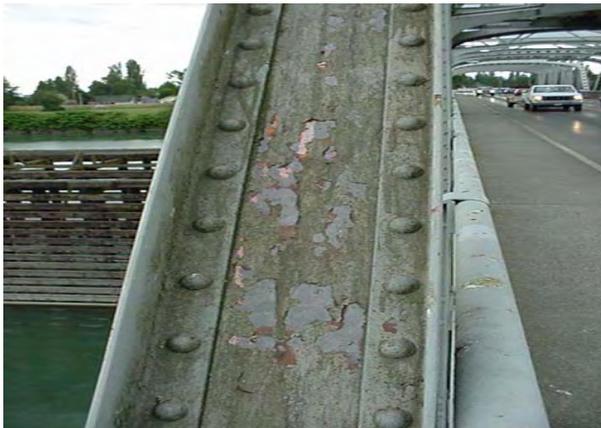
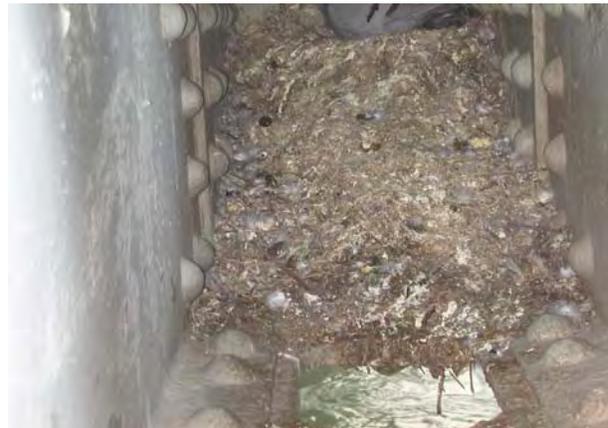
Top layer of paint has failed on the bottom chord. Paint breaking down and steel surface is rusting in hand holds, bottom half of truss diagonals, end posts and portal frames, top chords and sway frames.

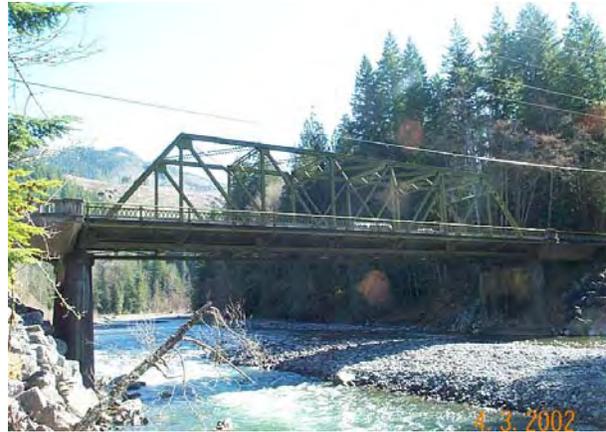
Approximately 65 percent of the truss painted steel surfaces have peeling paint. About 10 percent of the truss has exposed steel. About 40 percent of the floor system has peeling paint. Less than 5 percent of the floor system has exposed steel with pitting and laminar rust.
