P2 Bridge Preservation - Steel Bridge Painting Projects

2009-11 Bien Priority Array

Steel Bridge Paint Form

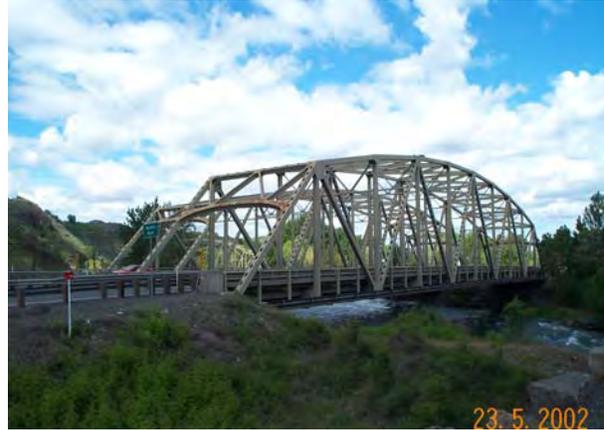
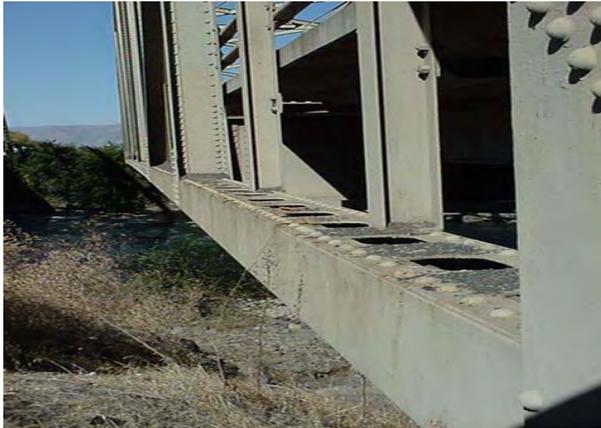
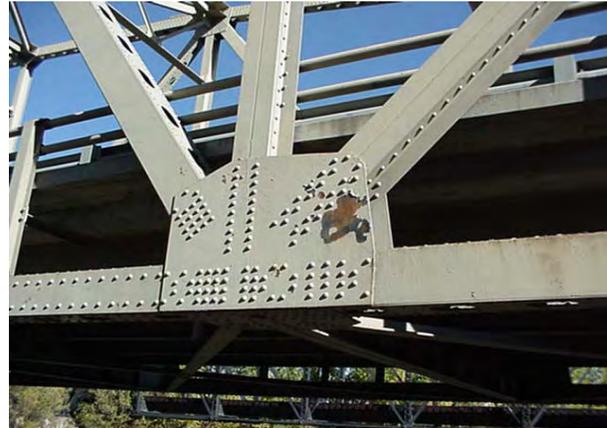
Paint is peeling on all members except stringers, mostly in locations where the pigeons are. The green base paint is exposed along the top of the bottom chords. Surface rust is visible on vertical faces exposed to sunlight.
 Floorbeams - Most have rusting in the top flange. A few small areas of paint peeling scattered throughout.
 Truss - Pack rust in bottom chord splice plate L6-L7.

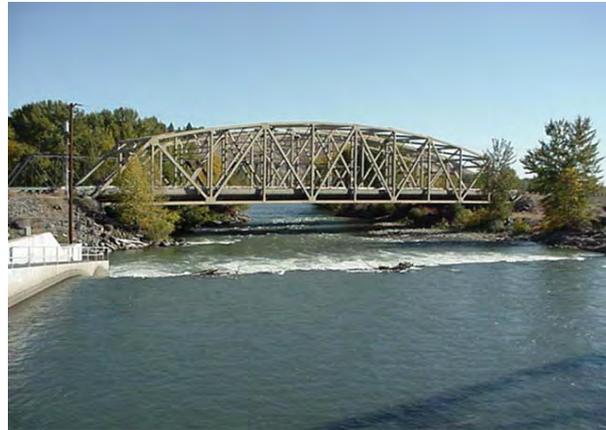
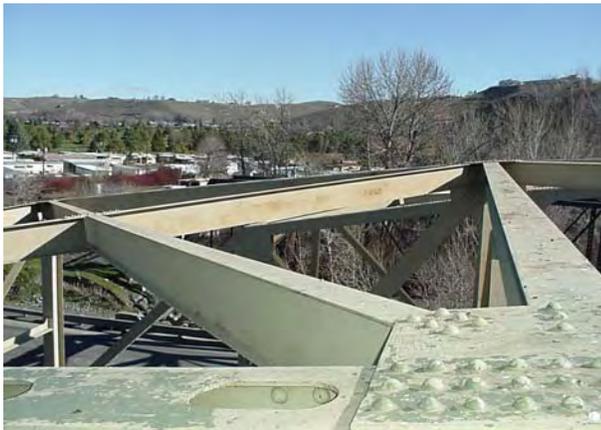
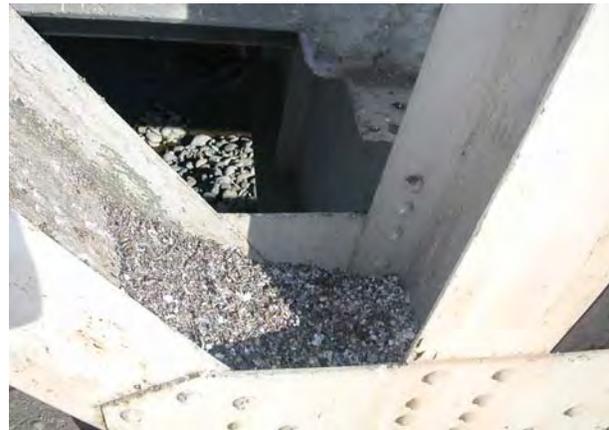
Paint is peeling on all members except stringers, mostly in locations with pigeons guano. The green base paint is exposed along the top of the bottom chords. Surface rust is visible on vertical faces exposed to sunlight.
