P2 Bridge Preservation - Steel Bridge Painting Projects

2009-11 Bien Priority Array

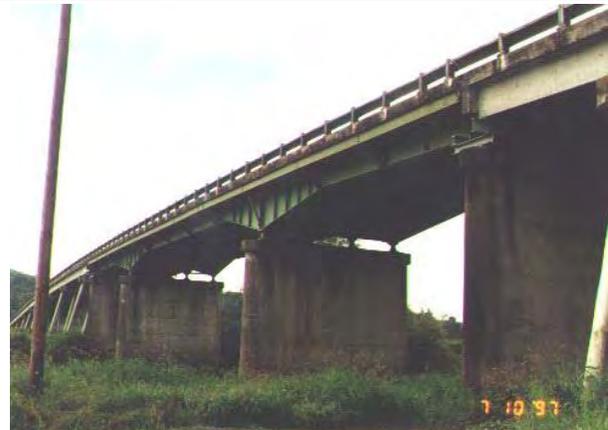
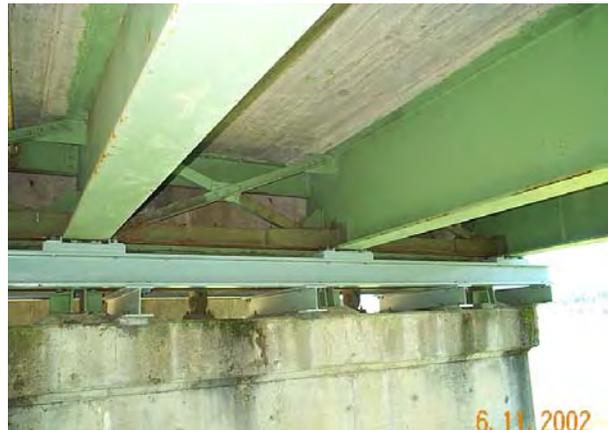
The paint is still in good condition with a few spot rusting areas on the bottom flange of some steel beams. The next paint contract should exclude the steel members constructed as part of the seismic retrofit at the north and south ends of the steel beam spans.

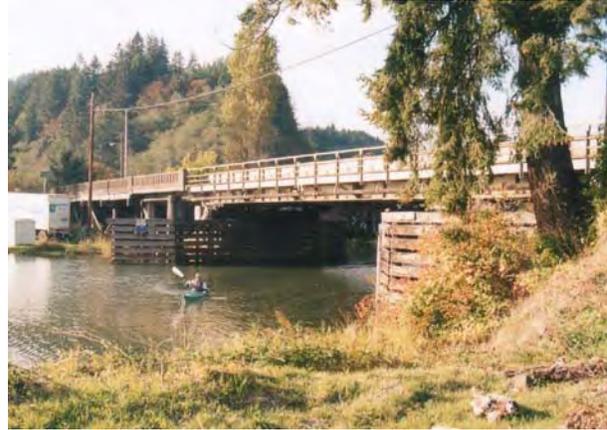
There is dirt and debris up to 6" deep on the bottom flanges of steel through girders at floor beam gussets and next to drain pipes. Many rust spots and blistered paint on top flange. Light rust pack on top flanges of floor beams near ends.

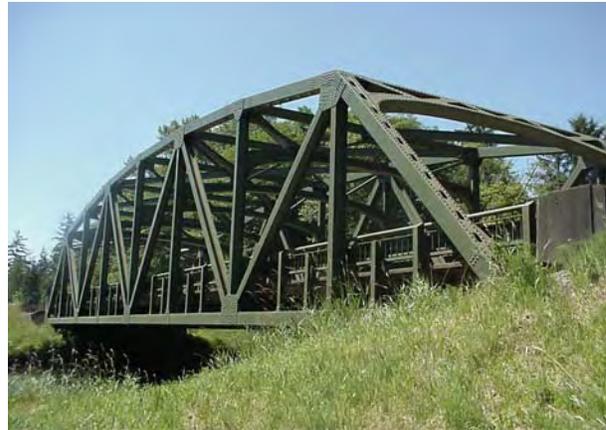
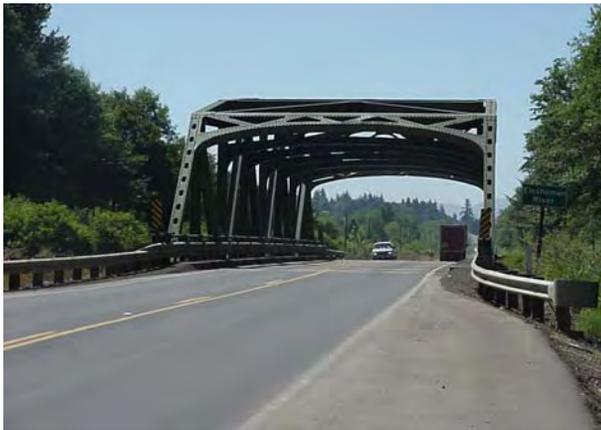
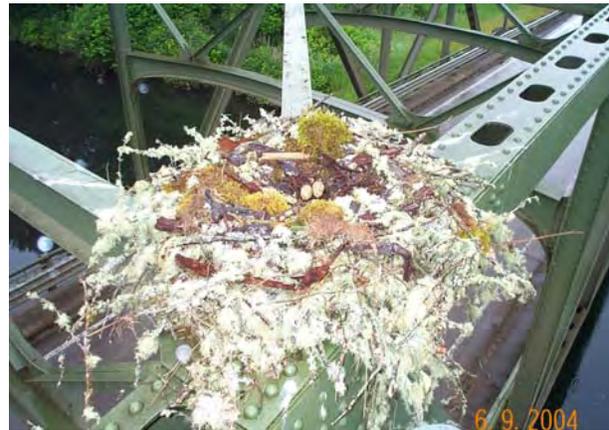
Bridge has a bird nest on the top chord.

Paint in good condition. Seam rust starting along bottom chord gussets and light rust at top flange of stringers and floorbeams. A maximum of 5% section loss at floor beam connections from rust that occurred prior to recent paint job. Seam rust starting along bottom of vertical gusset plates. The connection at L6 south there is up to 15% section loss in the rivet heads.

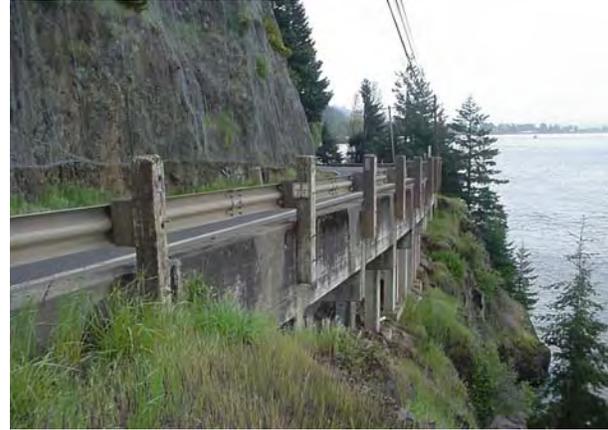
The paint is in fair condition. None of the steel beams have significant rusting but a couple of the bolts in the diaphragms are very rusty.

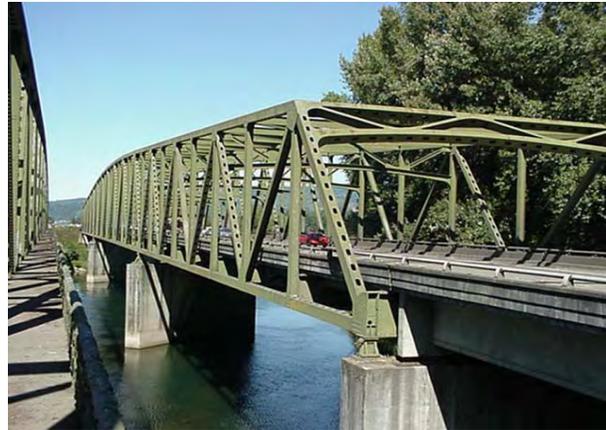
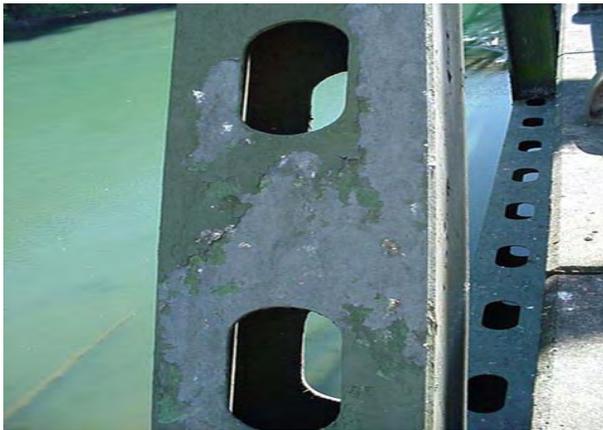
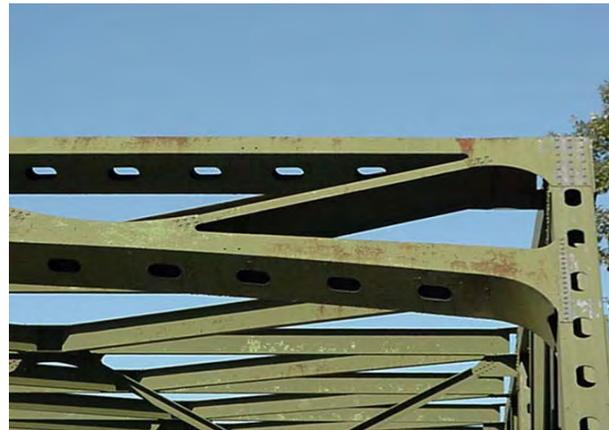
Peeling and cracking paint on stringers and floor beams. Up to 30% of surface area of upper truss has surface rust. Paint is peeling on the inside of the bottom chord. Some blistering on the tops of the diagonals.

The top chords, bottom chords, end posts, end portals and some of the sways need to have full paint removal. The rest of the bridge should be overcoated.

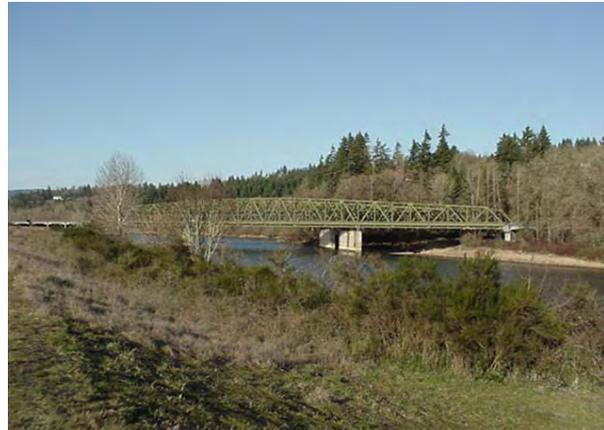
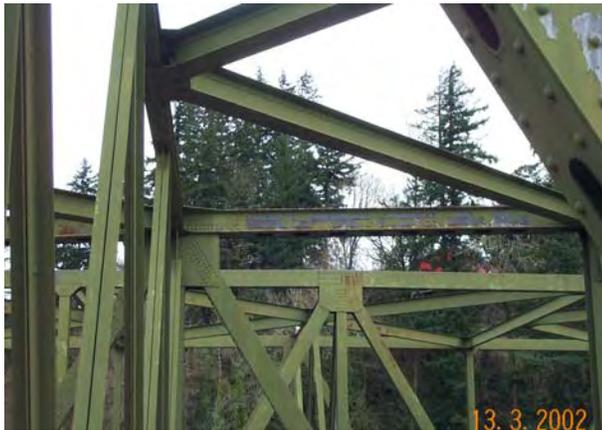
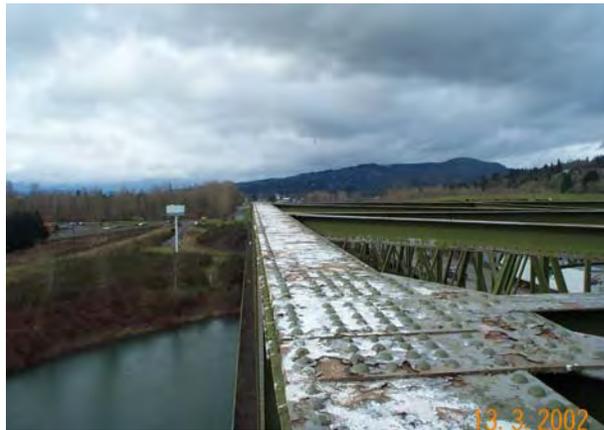
Paint is peeling and cracking over large areas of the steel truss surface. Freckled rust spots throughout the truss. Primer is visible in many areas due to the loss of the top coat. Portal frame faces are rusty. Top chord, top surfaces of top chords from U1 thru U29 have bare metal visible. Sway frames and cross bracing have bare metal visible. Floorbeams and stringers have many areas of peeling paint with surface rust.

The top chords, bottom chords, end posts, end portals and some of the sways need to have full paint removal. The rest of the bridge should be overcoated.

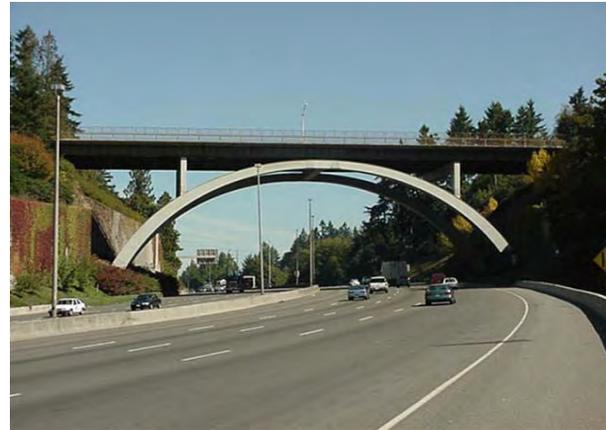
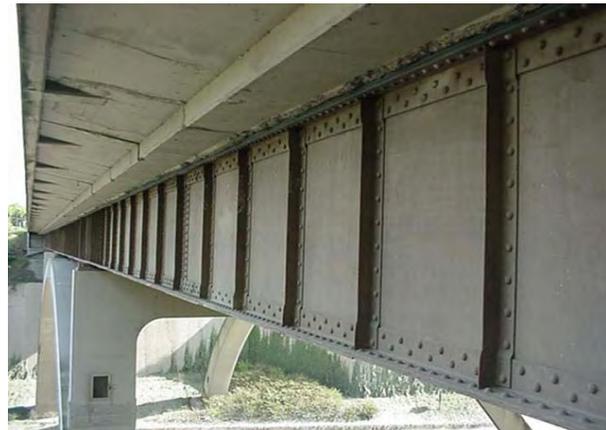
The last inspection notes the paint is flaking on the webs of the steel beams. The top flange is rusting under the expansion joints. Rust blooms on many bolt heads. The deck joints are leaking and need to be repaired with new joint filler.

The bridge was rebuilt in 1988 (C#13214) by adding new steel arches under the bridge. These steel arches are painted with a 5.8 mil thick inorganic zinc primer and a Vinyl top coat. The Arches will not be included in the next painting contract. The galvanized steel bridge rails were painted with an epoxy type paint in 1988. The steel beam weight is approx. 213 tons. The steel beams and pedestrian rail will be painted in the next contract.

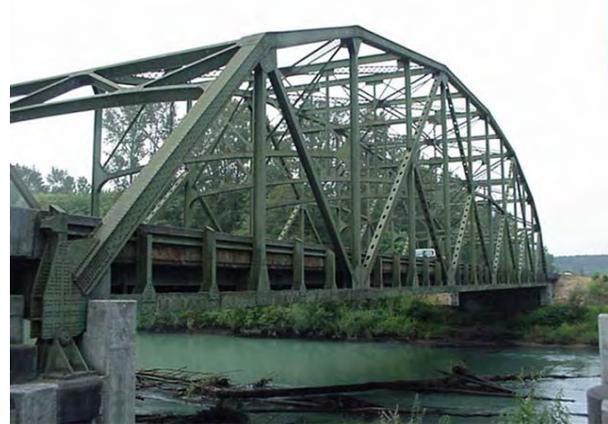
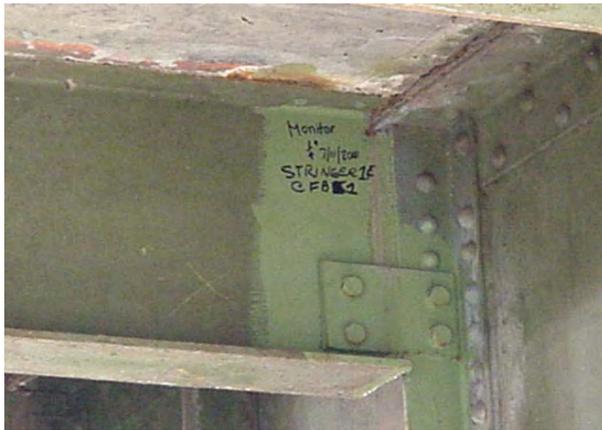
Steel Stringer - Light top flange rust with rust staining on webs of stringers near floor beams. All stringer webs have 90 degree cope detail at floorbeam connections. Several stringers have 1/2"-2" cracks.

Bottom Chord - Dirt and moss growth with a few rust blooms on bottom chord joints. Rust blooms on inside of bottom chord webs of channels near panel points. A few rivet heads have some section loss.

Steel Truss - Chalky paint, areas of peeling paint, rust stains and fungus growth on top chord.

Repair of the fatigue cracks in the stringers is planned for the 2009-11 biennium.

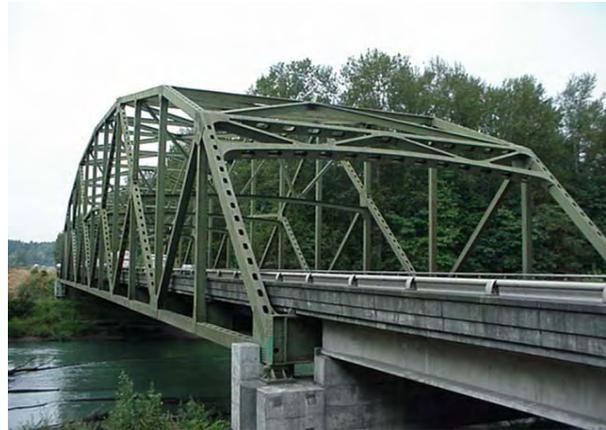
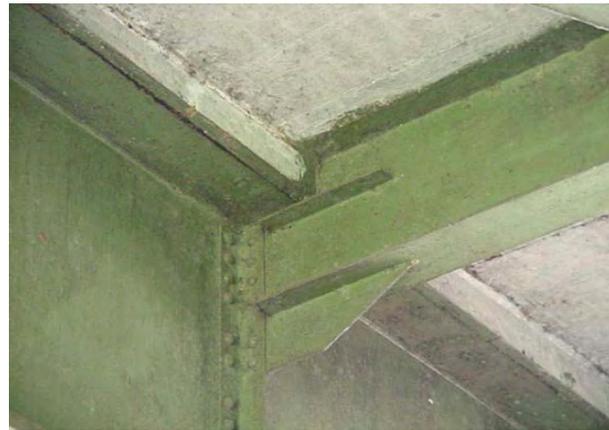
Steel Stringer - Minor surface rust at connections to floor beams.

Floor beams - Surface rust in top flanges, especially @ connections to chords. A couple of floorbeams are rust stained from leaking joints.

Bottom Chord - Dirt and moss growth with a few rust blooms on bottom chord joints. Rust blooms on inside of bottom chord webs of channels near panel points. A few rivet heads have some section loss.

Steel Truss - Chalky paint, areas of peeling paint, rust stains and fungus growth on top chord.

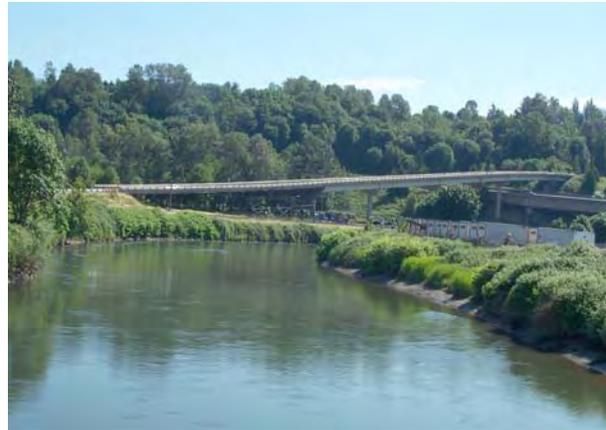
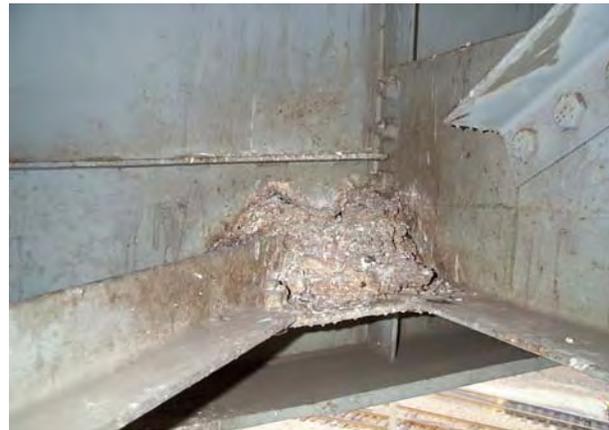
Top flange rust in exterior stringers at sidewalk joints. Rust blooms in both top and bottom flanges. Large piles of pigeon guano on bottom lateral gusset plates. Fire damage at east abutment burnt an area of the paint but no significant damage. Peeling paint is more prevalent in Spans 1 and 2.

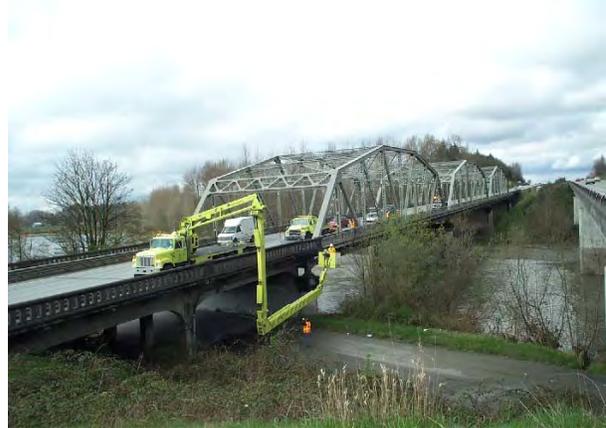
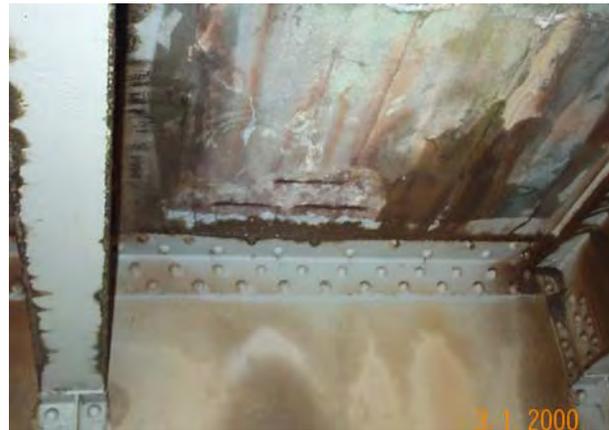
The 1993 painting contract was one of the first in the state that required the containment and disposal of the abrasives used to prepare the steel surfaces. The inspection report says that there is "small rust blooms scattered throughout. Some rust at bottom gusset connections to the bottom chord. Rust staining on top flanges of stringers and floorbeams."

The bridge deck is scheduled to be replaced in the 2013-15 biennium. The bridge painting should be part of the same project.

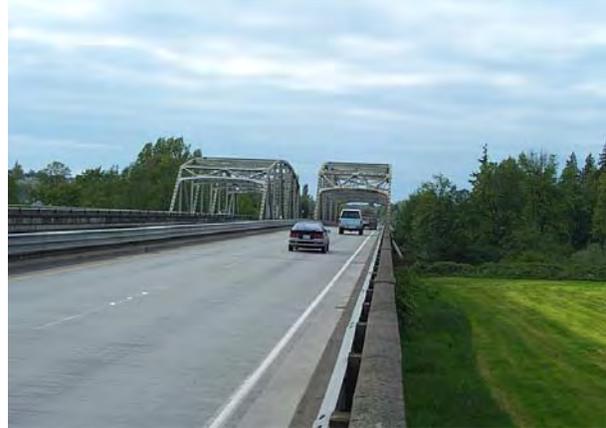
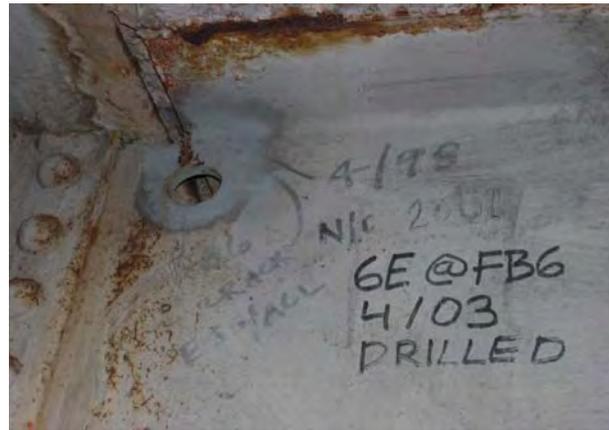
The paint system is chalking, peeling, and curling. Paint has peeled up to 10% of area to exposed rusty metal. Paint has peeled up to 30% of area without exposed metal.

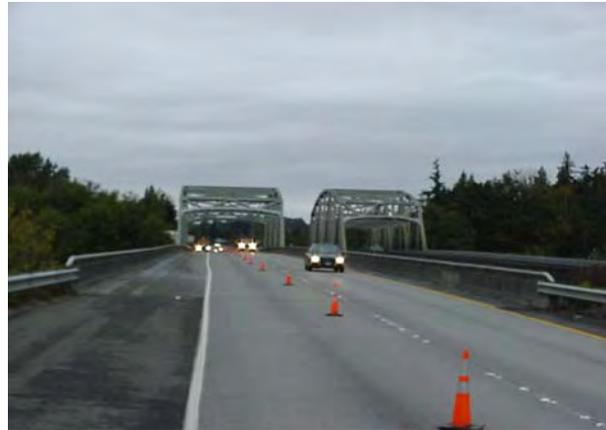
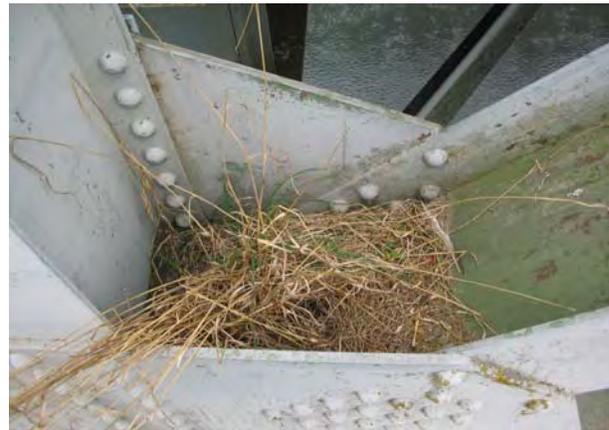
STEEL STRINGERS - Some of the ends near the floor beams are rusting in the top flange.

FLOOR BEAMS - Top flange of the floor beams are rusting with up to 5% section loss. The top flange at the ends has the most advanced rusting.

TRUSS BOTTOM CHORD - Pack rust between the bottom lateral gusset plates and the bottom chord with a few starting to bulge. Paint is peeling with over 40% gone exposing the previous paint. The top paint is not adhering to the bottom paint. Pigeon quano noted.

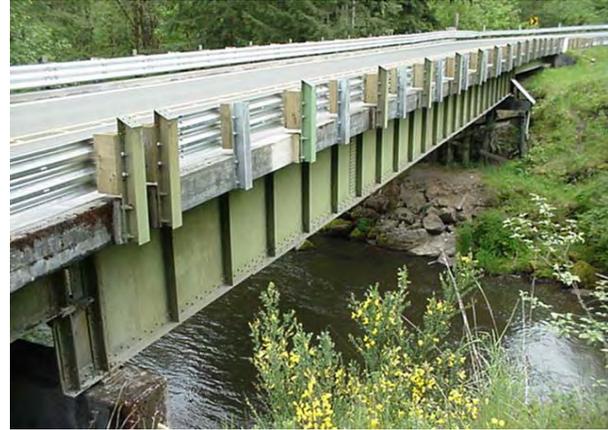
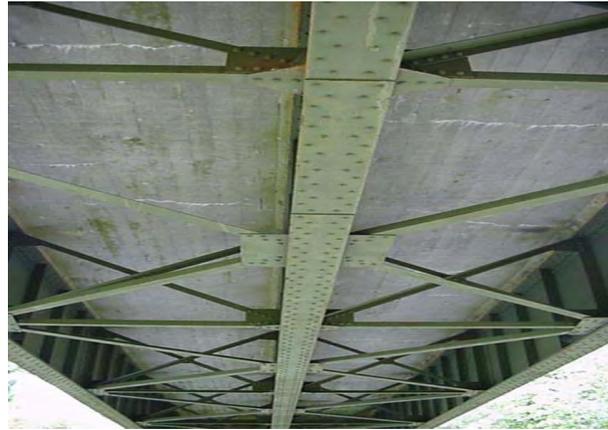
Paint is peeling on the outside edges of bottom flange of rolled girders and riveted girders. Top flange surface rust on steel girders.

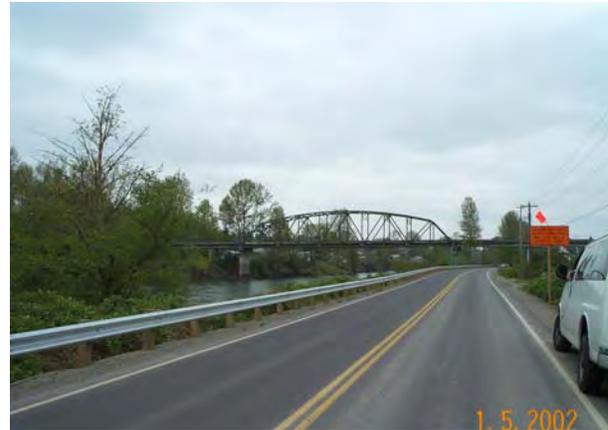
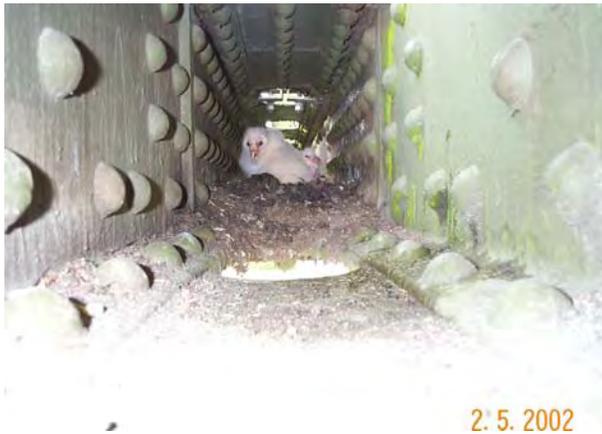
Truss members are moss covered and have peeling paint. Inside faces have more peeling paint than the outside faces. There is bird guano and dirt accumulations up to 3" deep in joint areas. The gray primer is exposed and peeling paint as noted: Top Chord - 80% gone; Diagonals - 40% gone; Bottom Chord - 50% gone.

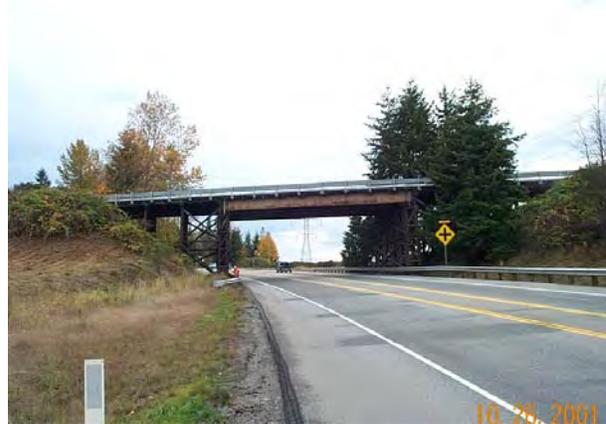
Spots of surface rust throughout. Peeled paint and sheet rust on girder end bottom flanges and on flange edges. Rust freckles on many bolts and end cross bracing elements.

This may be a good candidate for an overcoat with an epoxy rust penetrating sealer.

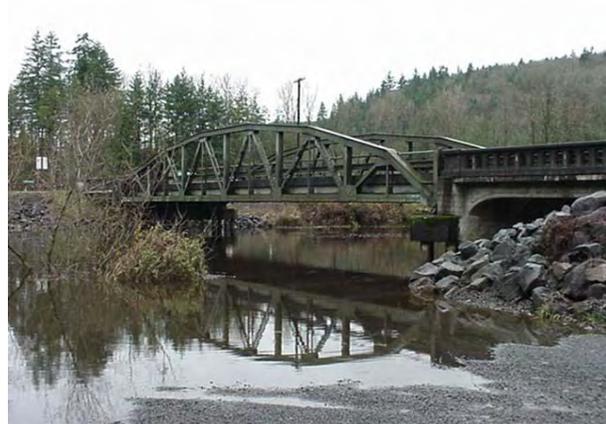
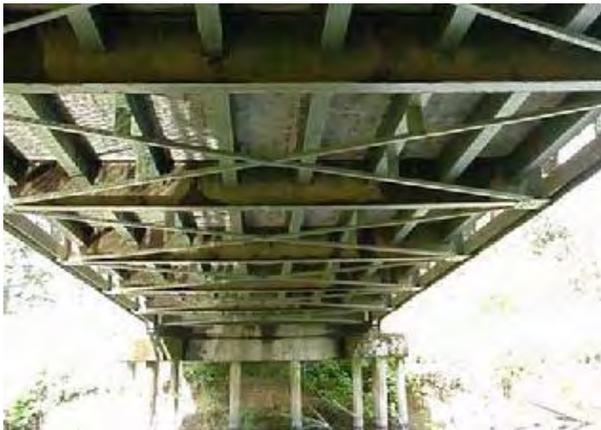
"Rust blooms and peeling paint on outside stringer webs. Top flange of many stringers has some corrosion. Paint is peeling on many truss members."

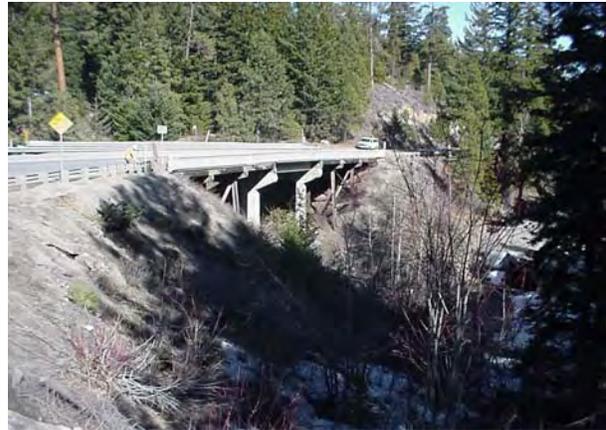
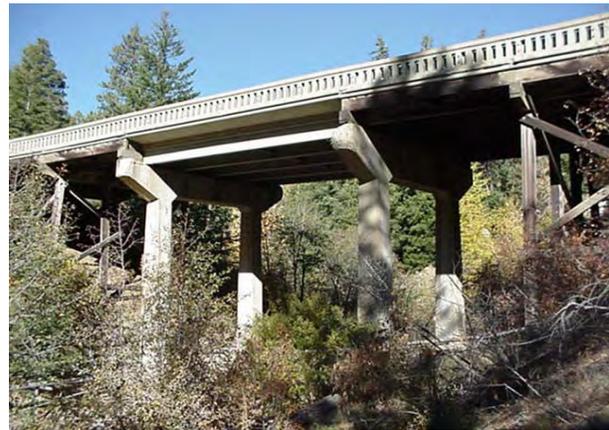
Paint has failed in many areas but mostly at east end of girders and diaphragm over Pier 5. Rust blooms in several areas of the girder flanges.

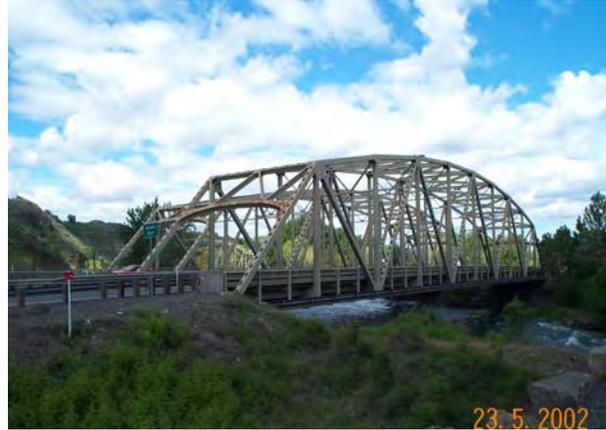
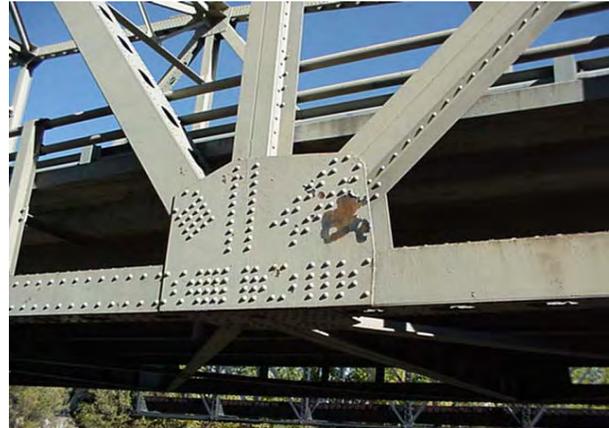
Paint is peeling on all members except stringers, mostly in locations where the pigeons are. The green base paint is exposed along the top of the bottom chords. Surface rust is visible on vertical faces exposed to sunlight.
 Floorbeams - Most have rusting in the top flange. A few small areas of paint peeling scattered throughout.
 Truss - Pack rust in bottom chord splice plate L6-L7.

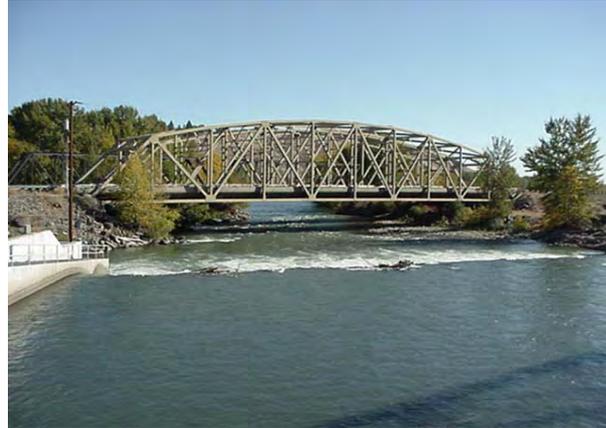
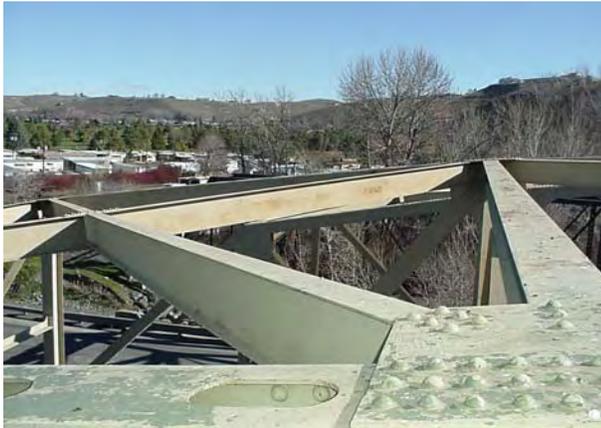
Paint is peeling on all members except stringers, mostly in locations with pigeons guano. The green base paint is exposed along the top of the bottom chords. Surface rust is visible on vertical faces exposed to sunlight.

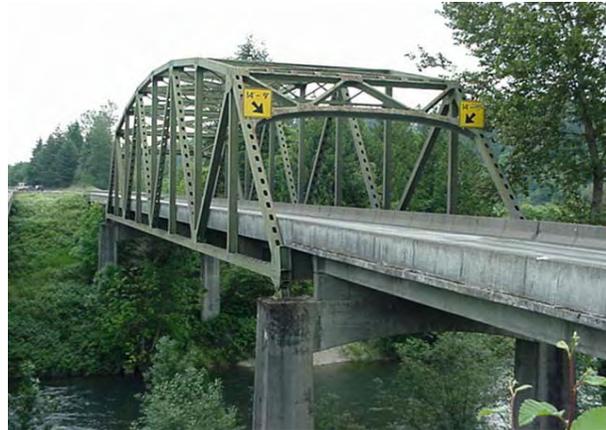
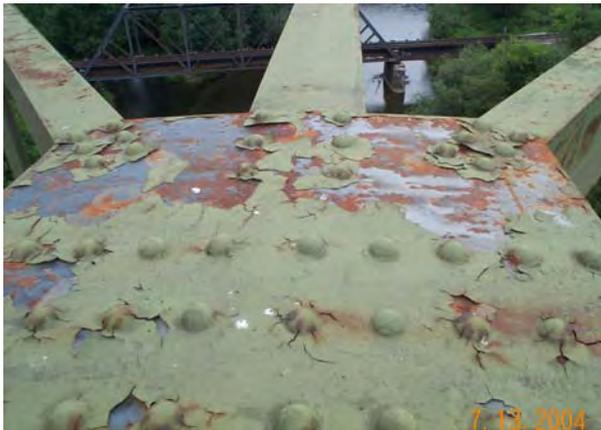
Rusting in sliding joints at stringers and on top flanges of stringer near floor beams. Several stringers (primarily A&E) have fatigue cracks up to 5/8". Rusting in several exposed areas at floor beams.

TRUSS: Mossy growth on paint with a few pits and rust blooms. Rust blooms on portals and top sways throughout. Paint peeling off in sheets on W. portal frame. A few rivets on bottom lateral gusset plates have 15% head section loss.

FLOOR BEAMS: Mud and rust staining on the top flanges, webs and bottom flanges. Sheet rust on the bottom side of the top flange up to 1/8" deep. Top flange has 5-10% section loss, mostly near the end of the floor beams.

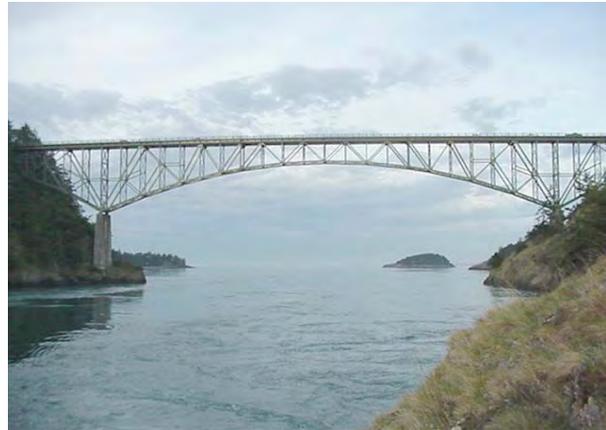
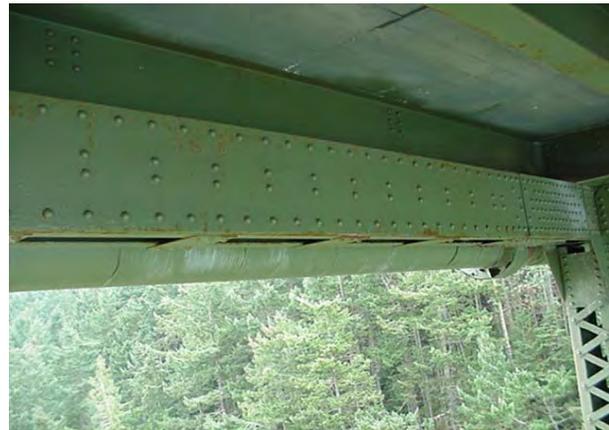
Full removal of the existing paint was required to the floor beams and stringers in the last painting contract.

Up to 10% section loss was noted in the top and bottom flanges of the stringers prior to being painted in 1998. Rust at interface between top flanges and deck. Surface rust with some pitting. Pack rust in the bottom flanges and bearing seats with up to 50% section loss, especially Stringers A and E. There are many areas that are rusting through the paint. Paint preparation and thickness varied greatly throughout the bridge from several layers of paint protection to over spray with no preparation to the metal. Rust stains on several of the members. Surface rust on several of the stringers and truss members.

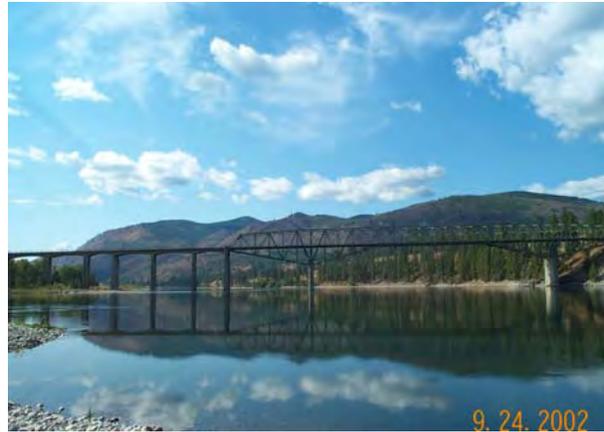
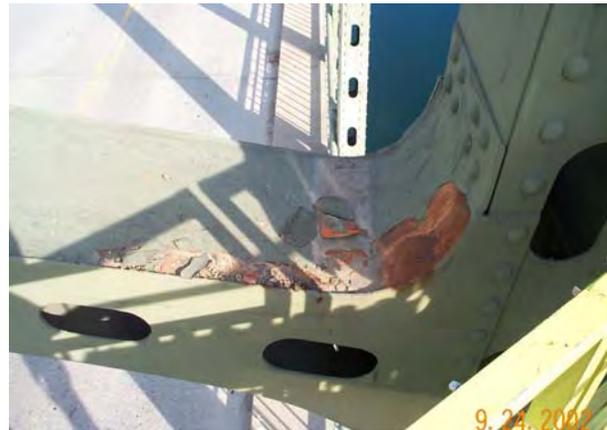
Paint is missing from most steel members due to the impact of snow removal with gravel. Steel Floorbeams; Peeling paint throughout webs. Steel Truss Members; The primer is exposed in places with some light rust where the paint has failed completely. The top paint coat is also peeling off in places with scattered rust blooms, particularly at top sways and laterals and inside top chords. Surface rust on the truss members at the deck level to about 6 ft. off of the deck. Paint is peeling inside most of the enclosed truss members. Metal Bridge Railing; All members are rusty with paint peeling or missing on 30% of the surface.

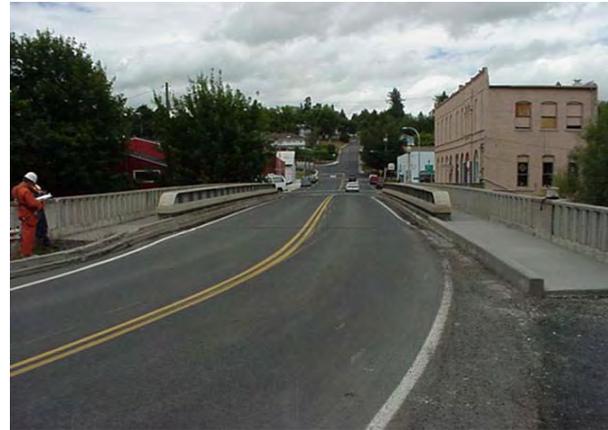
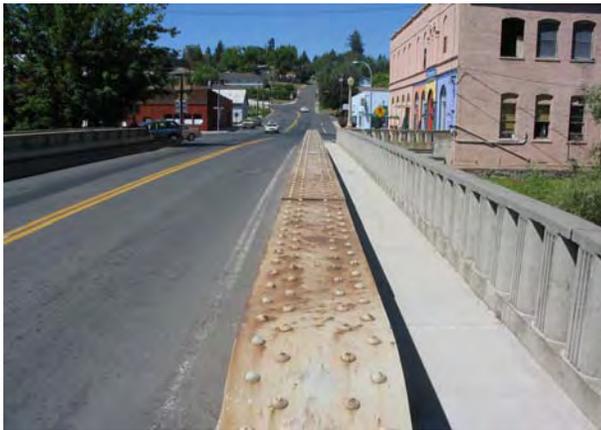
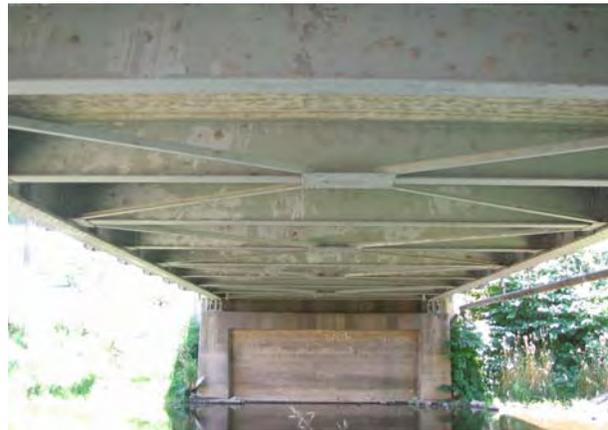
Thin and peeling paint with surface rust on most of the top flange of the girders (Photo 15). Paint is worn and peeling on lower portions of webs and bottom flanges of girders (approximately 20%). Rust blooms on lower webs and bottom flanges of girder (approximately 5%). Top coat of paint is peeling on floorbeams exposing primer (approximately 20% - Photo 22). A few areas of surface rust (less than 5%) on floorbeams.

All the paint on the top flange of the open girder should be removed to bare metal.

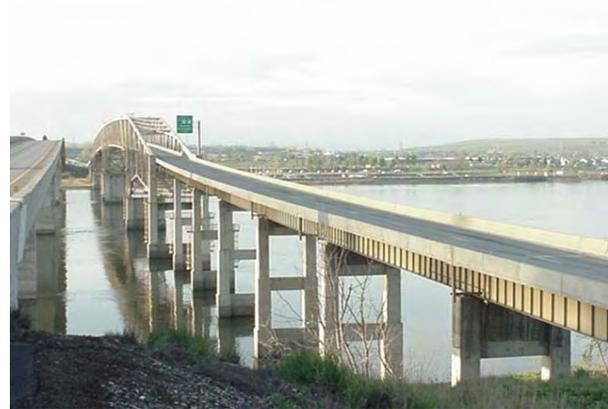
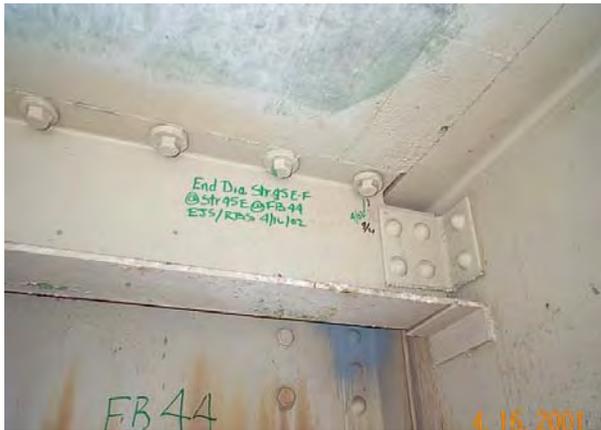
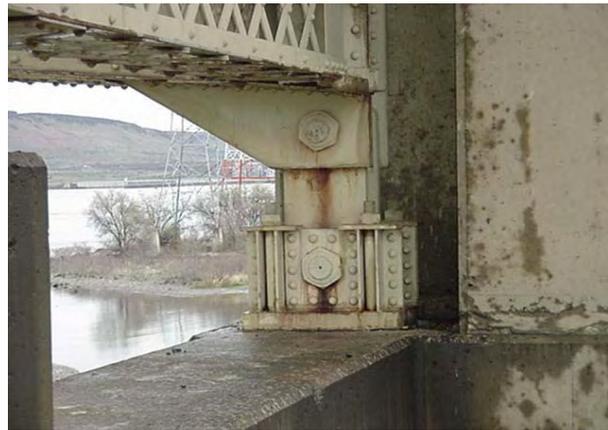
Truss Floor System - The truss stringer diaphragms have flaking paint top coat in many places over approximately 10% of area. Many stringers have very thin paint. Approximately 5% of the stringer area is affected. There is extensive peeling paint on the stringers in the east bays of the east truss span. The truss floor beam bottom flanges have peeled paint in 2 sq.ft. areas (approximately 2% peeling).

Truss Bottom Chord - There are areas on the bottom of the bottom chord and inside the bottom chord that have missing or peeled off top coat, amounting to approximately 5% of the total painted area. The drop in span bottom of the South bottom chord has up to 10% peeled paint. The girder cross brace chord angles have flaking top coat of paint on approximately 5% of the area.

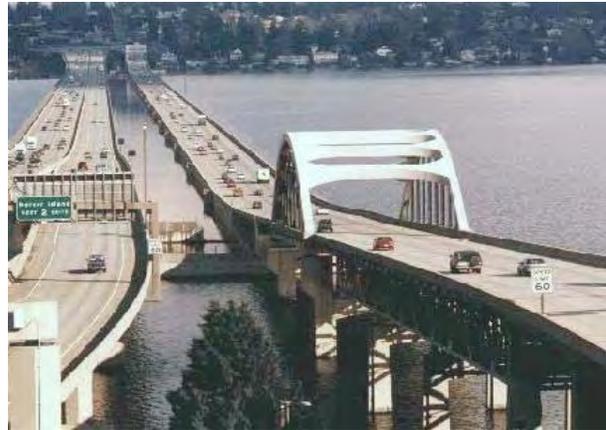
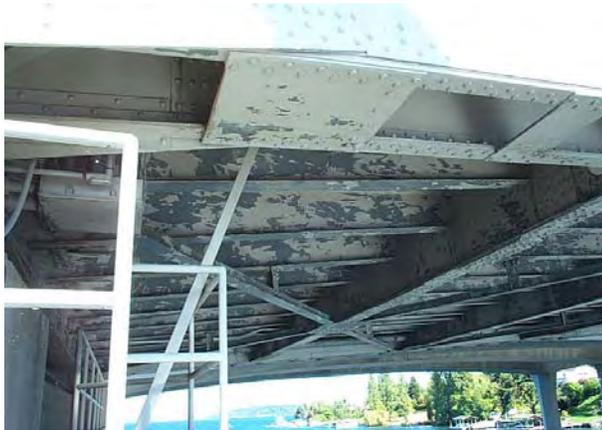
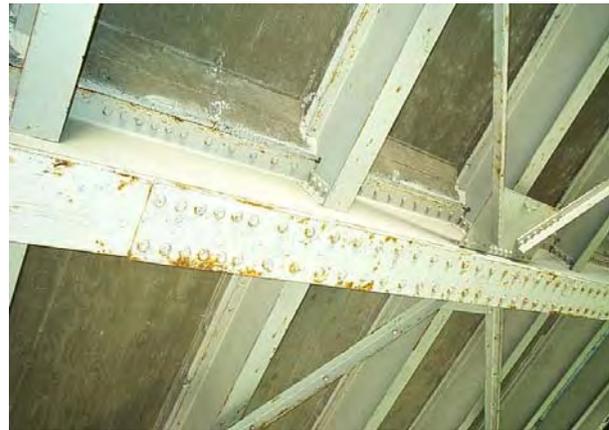
Exterior stringers in the deck truss have approximately 30% of the surface paint layer flaking off and areas of freckle rust. Stringers in the tied arch spans have approximately 50% of the top coat peeling throughout. Surface layer of paint is flaking off on approximately 5% of the truss members. Approximately 10% of the top coat of paint is peeling off of the outside flanges of the tied arch hangers, and 5% off of the arch ties. All floorbeams in deck truss have top layer of paint flaking off.

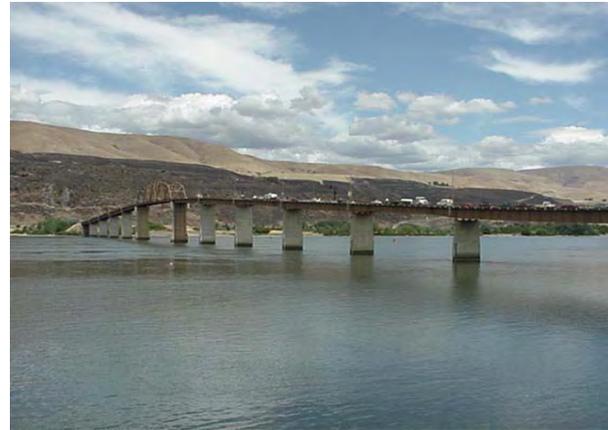
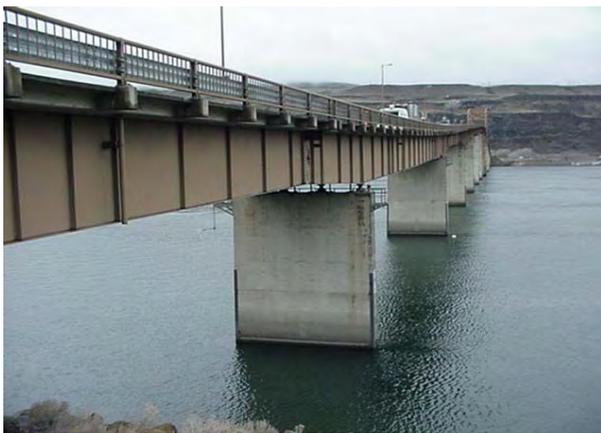
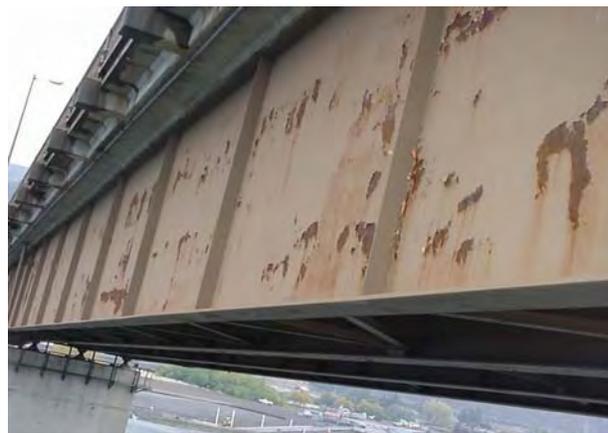
The paint in the approach spans is peeling and curling mainly in the bottom flange. There are several exposed and rusty spots on the webs of exterior girders, less than 10% of the total exterior girder area. Some areas of peeling paint in bottom chord of truss. The truss members are rusting through the paint.

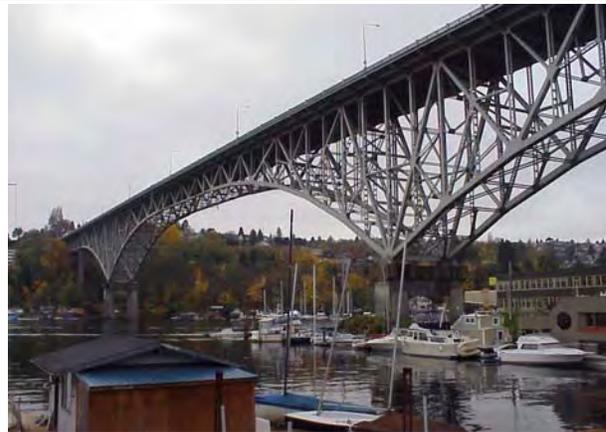
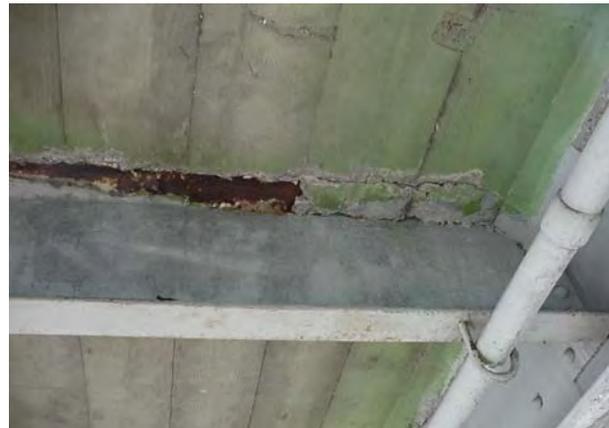
STRINGERS - At the expansion joints (piers 8 and 11, U26, U30 of span 9) 60% section loss in bottom flange. At these locations the stringer web stiffeners and rivet heads have up to 100% section loss. Peeling paint on most of stringers A,B,C,K,L,M.

FLOORBEAMS - The top flanges near the curb lines have been repaired. Pack rust between stringer seats.

DECK TRUSS - A few areas of rust blooms in the gusset plates. Spans 4&5 have large amounts of vines growing on the steel bracing.

In 1995 (C#14547) 0.75' of the sidewalk and 3.75' of the roadway slab on both sides of the bridge was removed and replaced. The steel supporting this area was rehabilitated and painted with a MC Urethane.

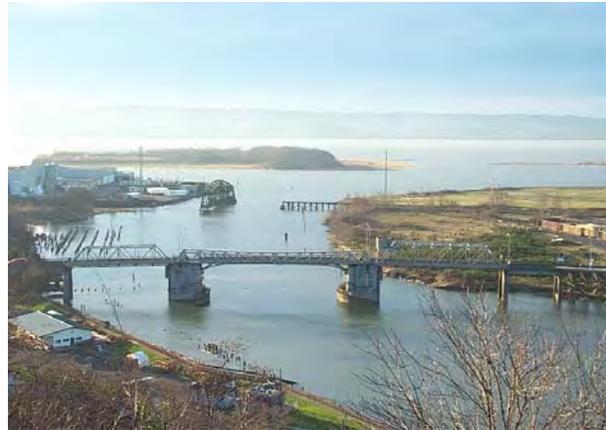
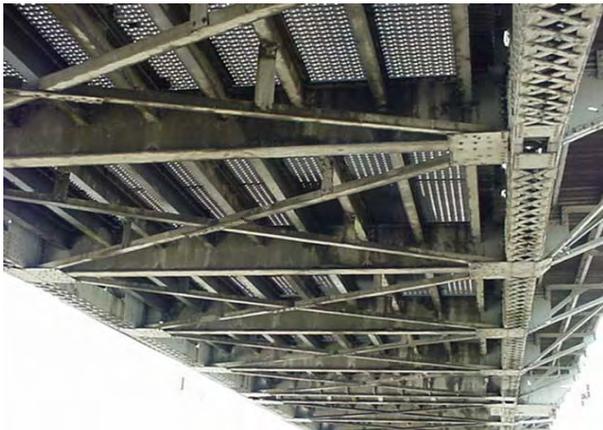
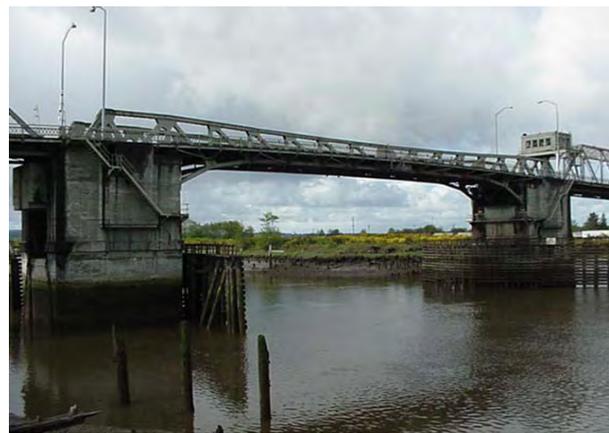
Primer coat on bascule span stringer and floorbeams is failed. Paint is peeled off exposing red lead primer. Paint is failed on floor system bracing. Paint is moldy on the bascule floor system beams and is peeled off in large areas exposing red lead. The paint is covered with wet dirt and moss in many parts of the floor system. Paint on the west 150 ft. steel truss bottom chord is rusted through and blistered along the 4" diameter utility. North approach truss paint on the portal frame is failing or rusty from high load hit damage. Paint is failed and rusty on top flange of floorbeams and stringers at connections. There is seam rust and rust blooms on the bascule top chord.

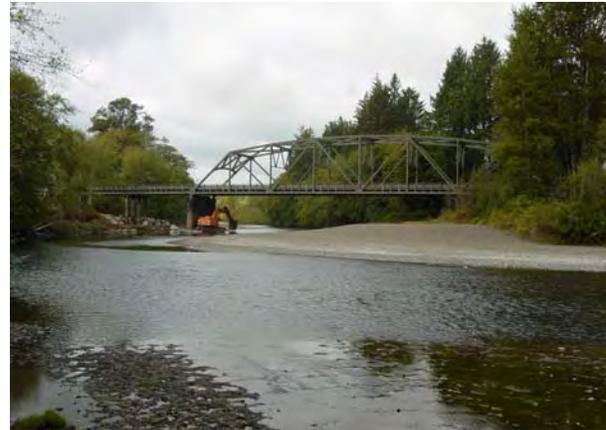
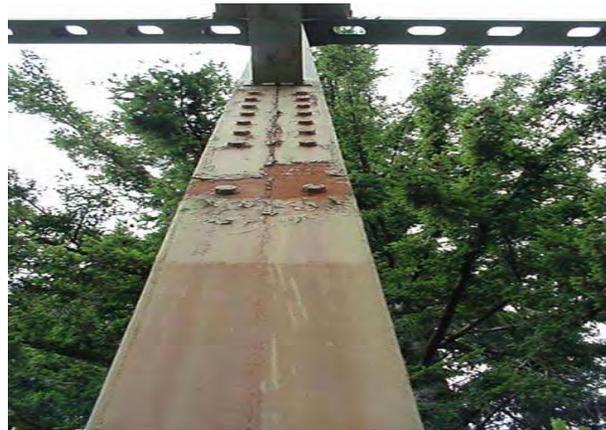
Several areas of peeling paint and rust blooms scattered throughout the truss. Rusty thin paint on verticals below sway braces. Sway braces have paint topcoat peeled off over 60% of surface and gray undercoat is visible throughout. Seam rust along the interface of the top cover plates and channels. Areas of laminar rust on top flanges of channels and top cover plates of chords. There is debris up to 12" deep inside of and on top of the bottom chord at both ends of Floorbeam 2. Laminar rust on top flange of channel and top cover plate at Floorbeam 6 on the east truss. Pack rust up to 0.2" thick between east bottom chord top plate and channel flange on inside of bottom chord over 10 ft. length near Pier 5.

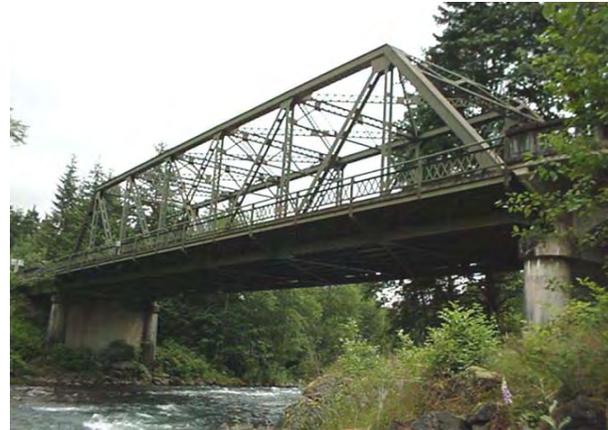
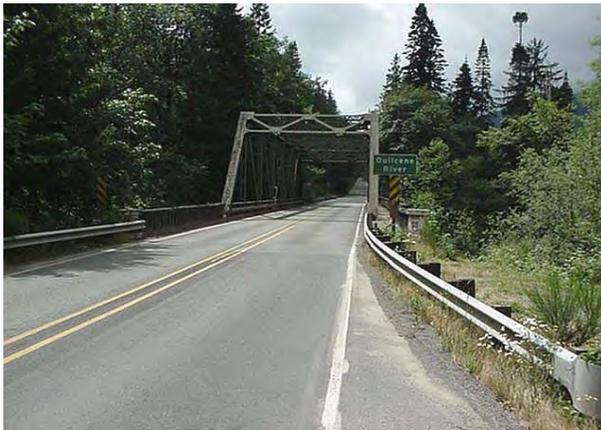
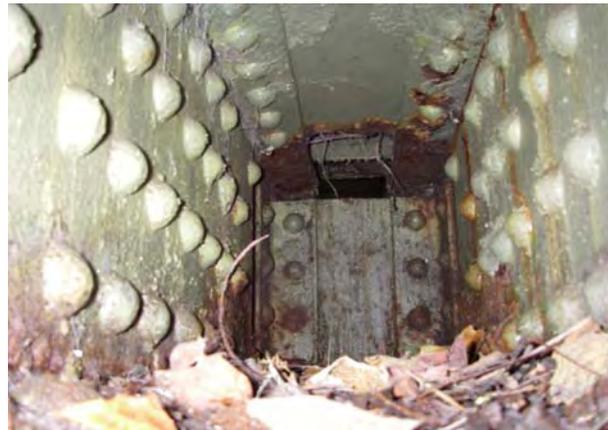
Top coat of paint is peeling on bottom flanges of steel stringers. Paint underneath is still intact with very little rust, mostly on top flange at the deck. Paint peeling on face of top chord of thru truss approximately 30% to previous layer of paint. Extensive peeling throughout the trusses above the deck, especially in the west truss at the south portal.

Floorbeams have some peeling paint on the bottom flanges. Paint is failing at inside bottom chords.

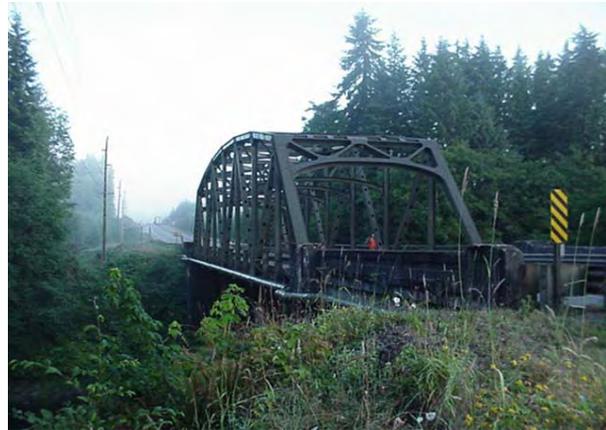
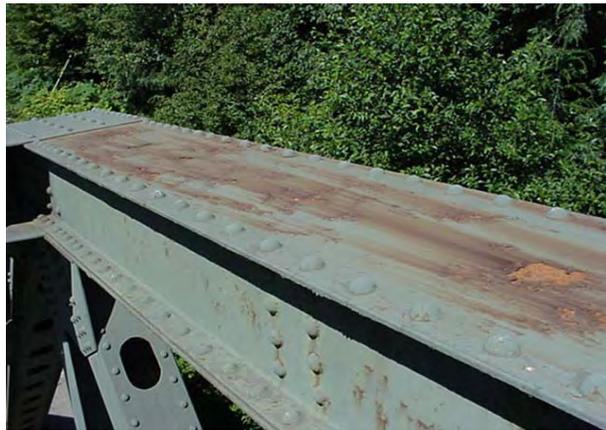
The paint system has widespread flaking, especially on inside surfaces of members. The top surfaces of the top chords, top lateral and sway bracing have extensive areas of exposed rusty steel.

Truss - Rust blooms on all members.

Floorbeams - Areas of Laminar rust on the bottom chords and gusset plates.

L1, L2, L6, L7, and L8 bottom lateral gusset plates have laminar rust with some minor section loss.

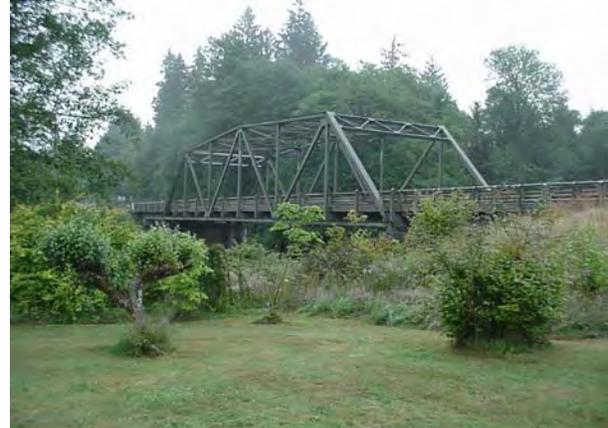
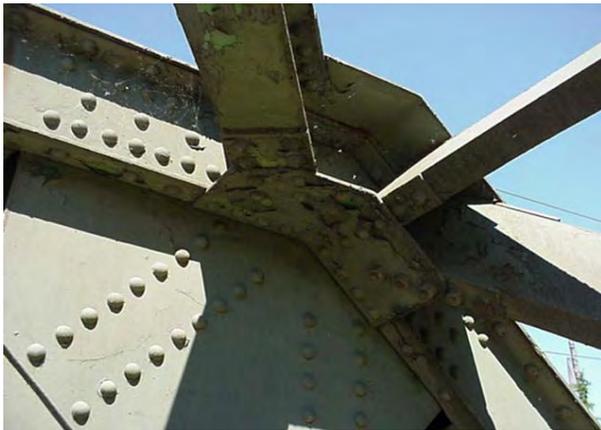
The steel stringers have scattered areas of peeling paint. The top surfaces of the top chord members have rust blooms and peeling paint. The bottom chord interiors have paint failure causing active corrosion on the inside surfaces, at the rivet heads, and at the plate edges.
