P2 Bridge Preservation - Steel Bridge Painting Projects

2009-11 Bien Priority Array

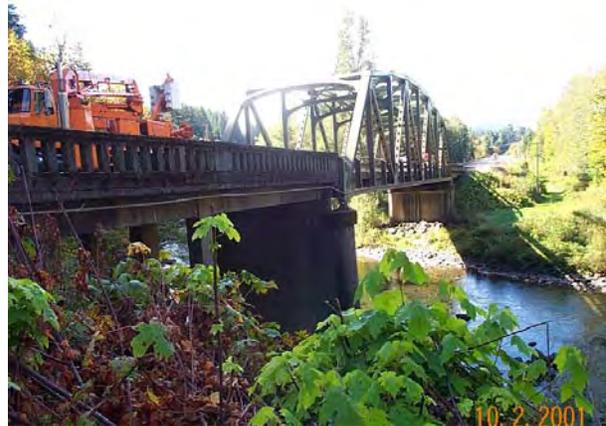
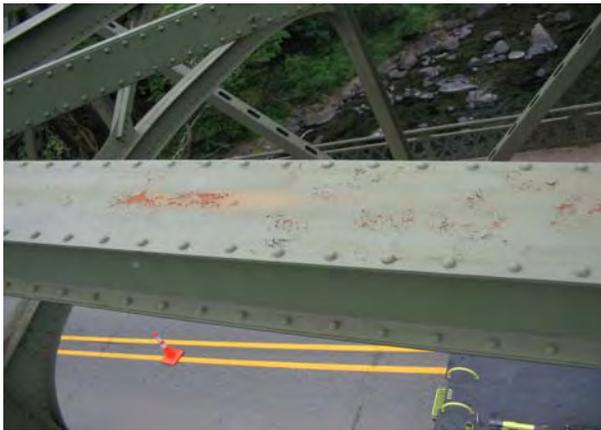
The steel stringers have scattered areas of peeling paint. The top surfaces of the top chord members have rust blooms and peeling paint. The bottom chord interiors have paint failure causing active corrosion on the inside surfaces, at the rivet heads, and at the plate edges.

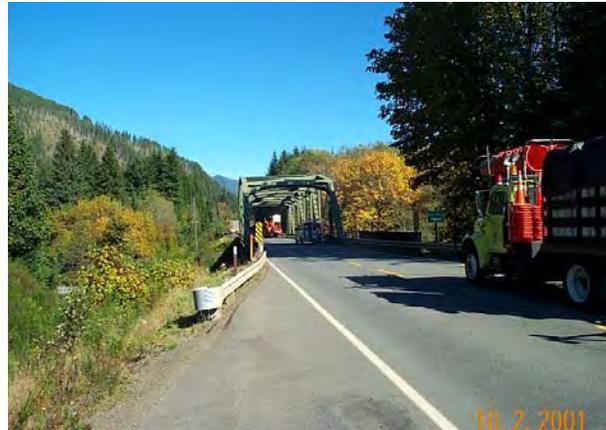
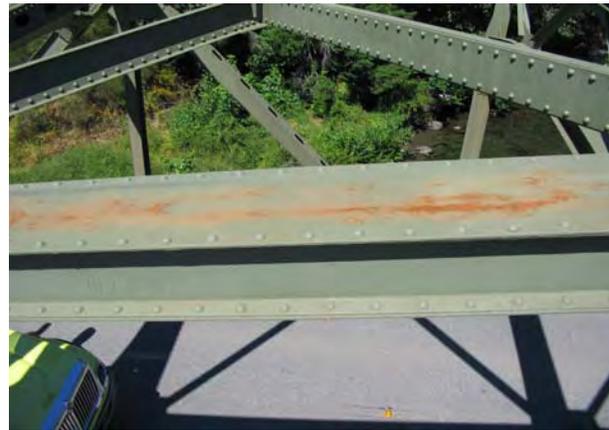
Paint on the stringers is starting to peel in the webs and flanges with light rust. Some areas of the bottom chord has peeling paint. 15% of the paint is missing on the top chords of the truss.

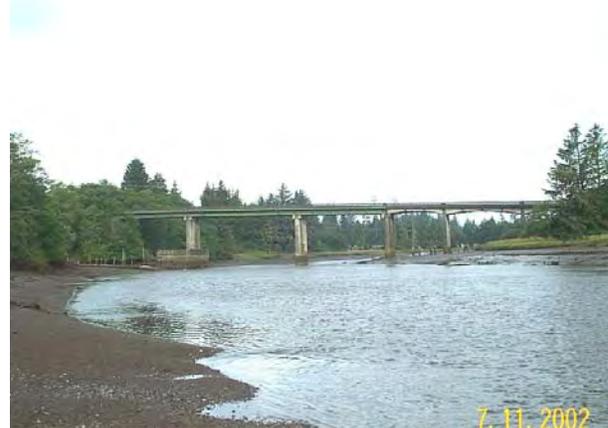
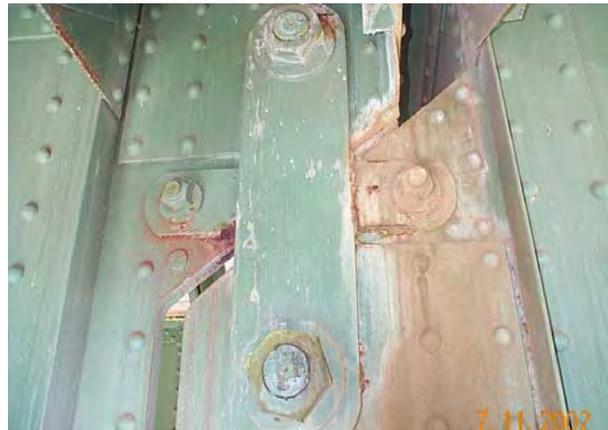
The inspection report indicates that there is surface rusting scattered thru out with some steel section loss.

Full removal of the paint is warranted based on the existing paint condition.

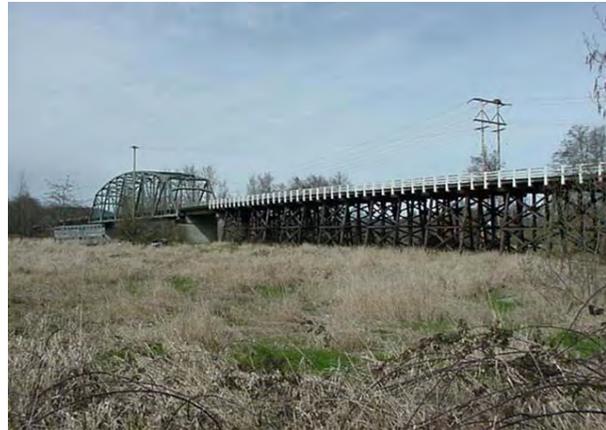
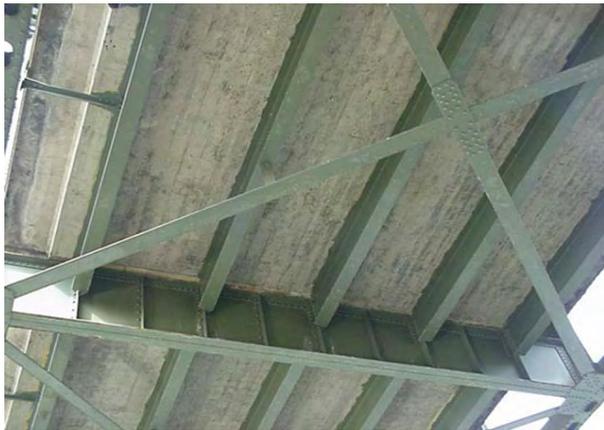
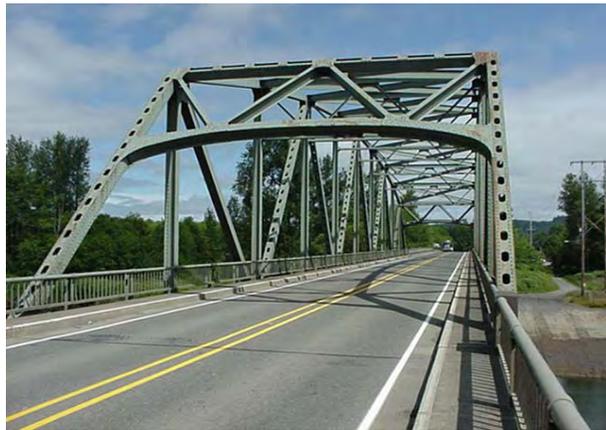
Peeling paint is typical, especially on and in the bottom chords. The stringer and floorbeam top flanges as well as the truss portal tops and west truss above deck members all have surface rust. The truss also has a few rust blooms.

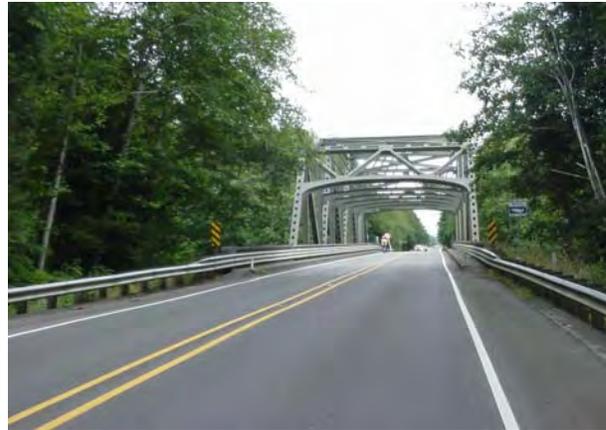
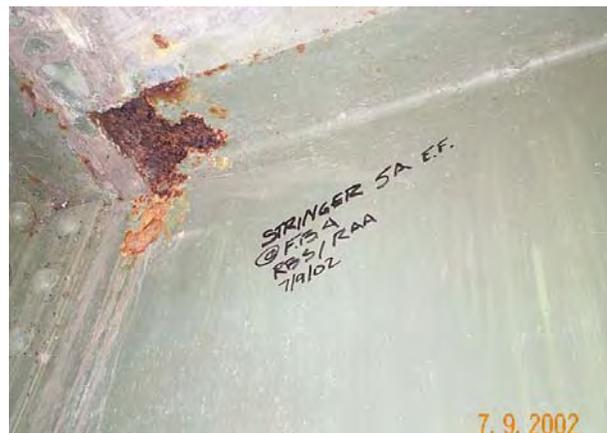
Paint is chalky throughout with scattered rust blooms especially on the upper areas of the truss. Many areas of peeling paint and rusty rivet heads on the bottom chord of the truss with areas of exposed metal. Top flanges of upper cross bracing have areas of peeling paint and exposed metal. Scattered small areas of peeling paint in a few places on lower 10 feet of vertical and diagonal members. Floorbeams have areas of paint missing on both top and bottom flanges exposing metal which is rusting.

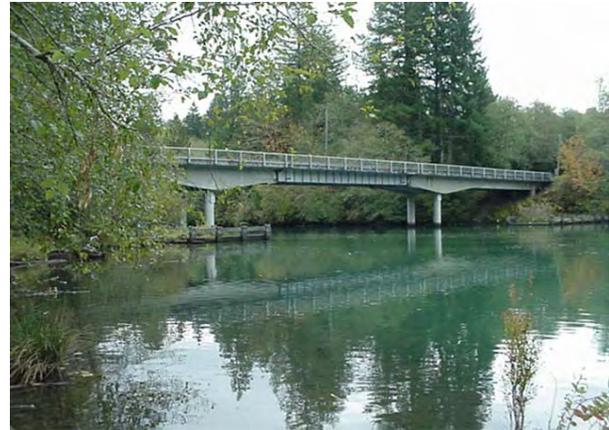
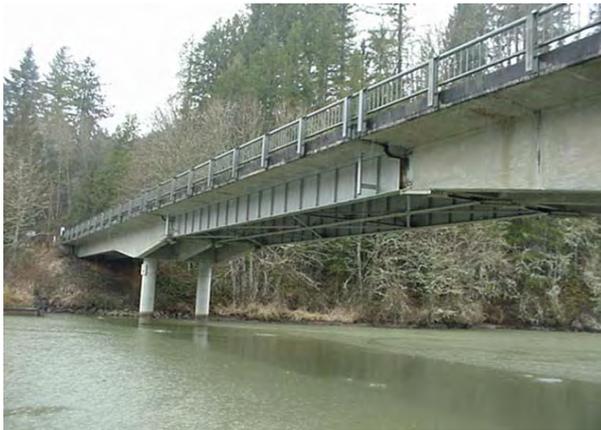
The girders have areas of spot rusting on bottom flanges and at boltheads and nuts at the hanger assemblies.

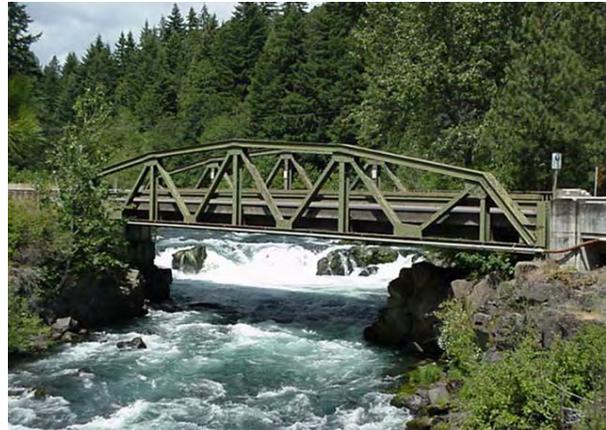
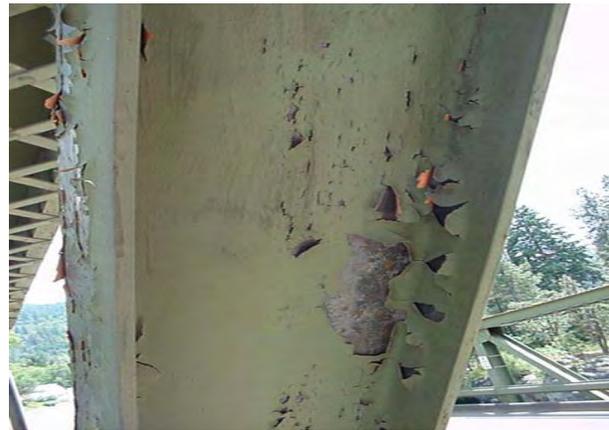
STRINGERS: Rust stains and light rust on the top flanges.

TRUSS: The paint has failed on many members of the steel truss. The top chords have many bare rusty areas. The verticals and diagonals have many areas of peeling paint exposing bare metal. The bottom chord has gravel accumulations at the panel points and some light rusting at the connections.

The failure in the paint on steel above the deck may warrant full removal.

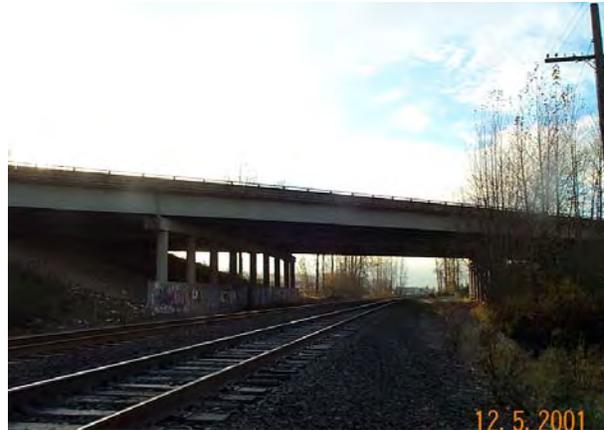
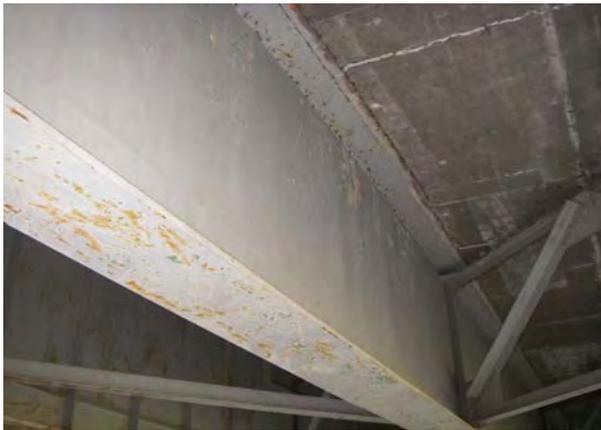
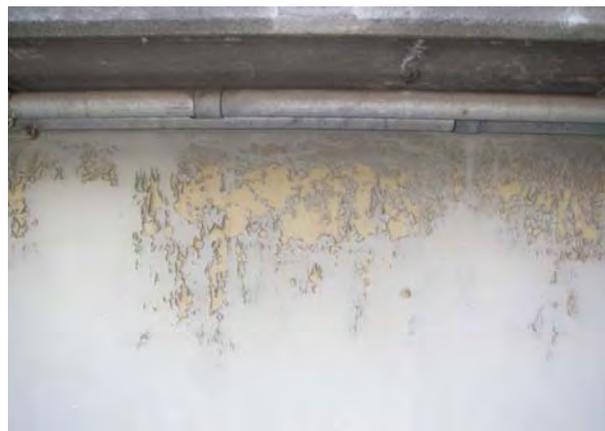
There are rust blooms throughout, especially on the bottom flanges. There is peeling paint in the webs and bottom flanges. Girders E and F were installed when the bridge was widened in 1998. There are a few spots of rust on the original girders where the paint is thin.

This bridge was widened as part of contract 14771. There are two new girders placed on the south side. These girders should be excluded from the next paint contract.

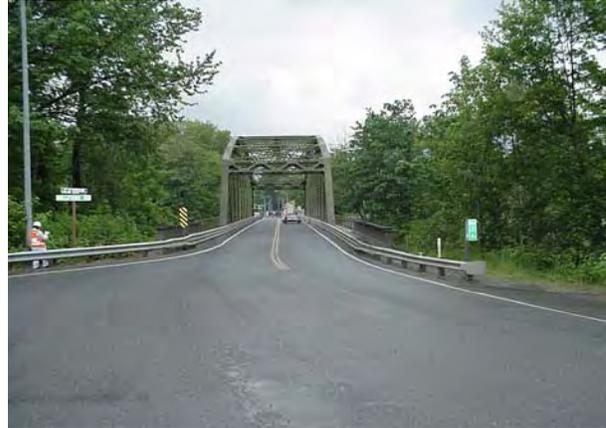
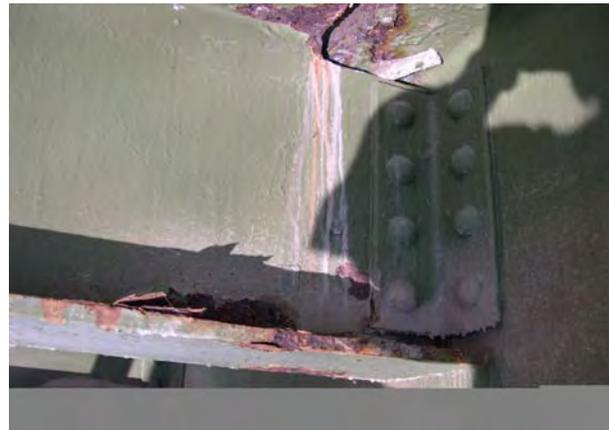
Steel truss has peeling and cracking paint throughout, and rusting in some of the members. Rust in the top and bottom flanges of stringers and floorbeams. Some rust staining along web of sidewalk stringers.

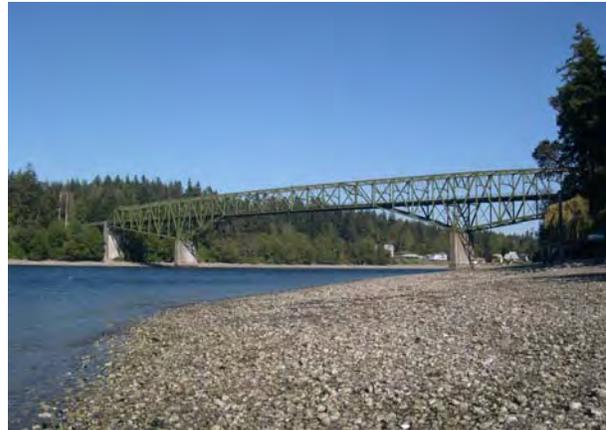
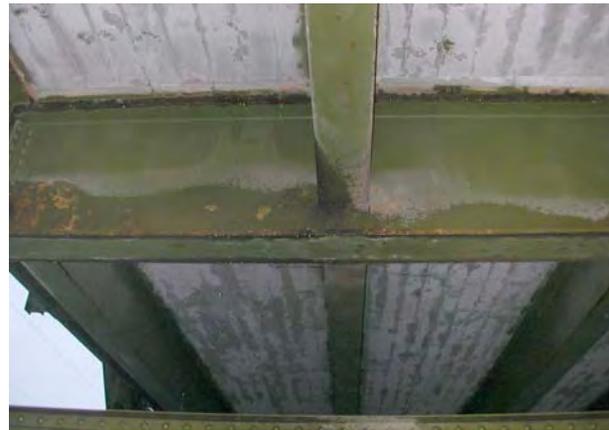
Floorbeams in general have thin chalky paint and essentially no topcoat. Many stringers have thin and flaking paint on flanges. Welded steel girders in Span 13 have small areas of flaking and thin paint as well as holidays. Piers 16 and 17 steel columns have peeling rough paint on struts and cross bracing. Paint is generally in deteriorating condition due to age, weather and poor surface preparation. There are many areas of peeling paint and thin or no paint inside the bottom chord especially at the joints. Thin, missing, peeled off and rusty paint on 25% of the bottom chord and diagonals. Top sways, cross bracing and top chords have many paint holidays in the topcoat, thin paint and rusty spots on 10% of area.

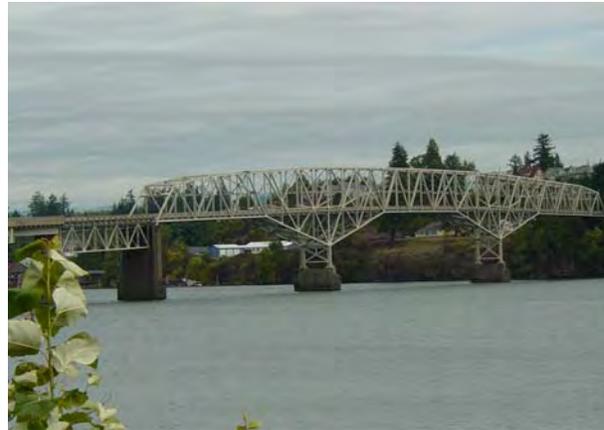
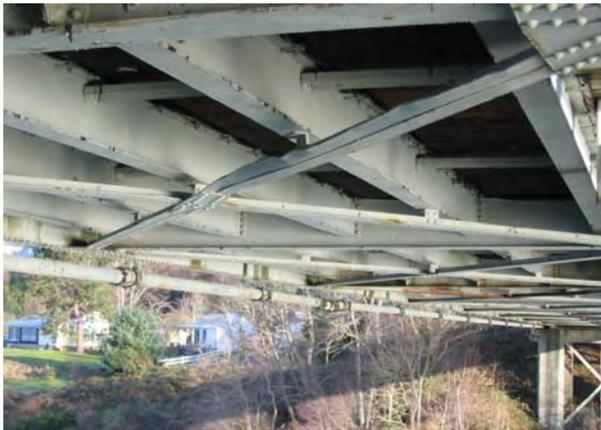
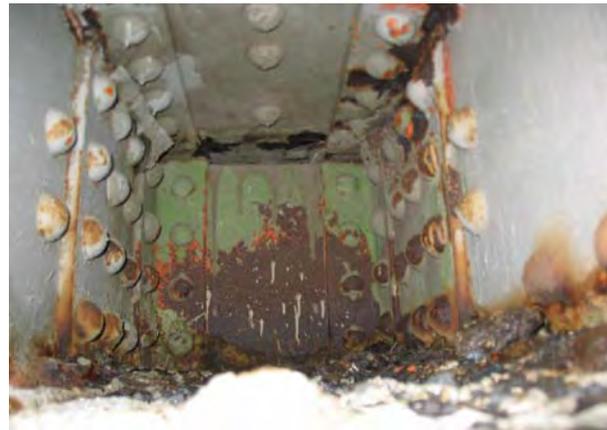
Floorbeams in general have thin chalky paint and essentially no topcoat. Many stringers have thin and flaking paint on flanges. Welded steel girders in Span 13 have small areas of flaking and thin paint as well as holidays. Piers 16 and 17 steel columns have peeling rough paint on struts and cross bracing. There are many areas of peeling paint and thin or no paint inside the bottom chord especially at the joints. Thin, missing, peeled off and rusty paint on 25% of the bottom chord and diagonals. L21-L22 west truss shows typical rust blooms and paint condition of truss members. Top sways, cross bracing and top chords have many paint holidays in the topcoat, thin paint and rusty spots on 10% of area.

Portions of the bridge will require full removal of the exiting paint.

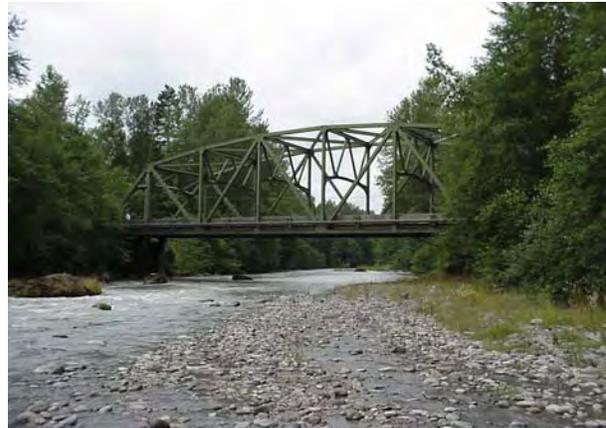
Paint is failing in several areas. The top flange of the bottom sway braces have areas of peeling paint. The top of truss has many rust blooms and areas of peeling paint - chalky throughout. Paint is chipped and peeling on bottom of diagonals and on verticals. Paint is peeling and failing on the bottom chord, bottom lateral gussets, top chord connections, floor beam to truss connections, and bottom of stringer to floor beam connections. There are areas of blistered and peeling paint on floorbeams.

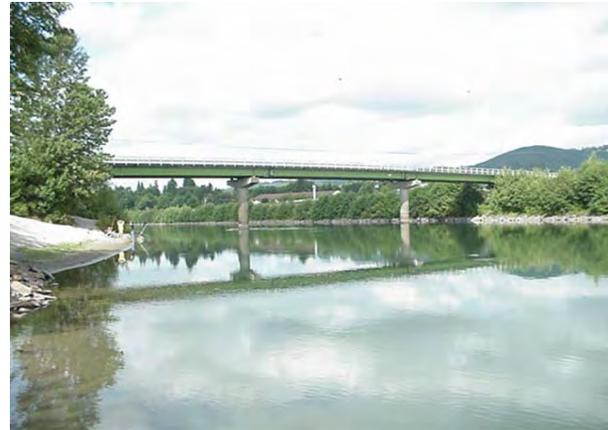
This bridge was transferred from the county to the state as part of the RJT law of 1991. The type of existing paint and the last year it was painted is unknown. There is a suspended center span with expansion joints and hinges that allow water to get onto the beams. The paint has random rust spots and paint chipping throughout the bridge.

The paint is chipped in spots on the webs. There is rust freckling throughout, mostly at the corners and edges. Surface rust and some pitting at the bottom gusset and the lower web area is evidence that the paint system is no longer effective in this area.

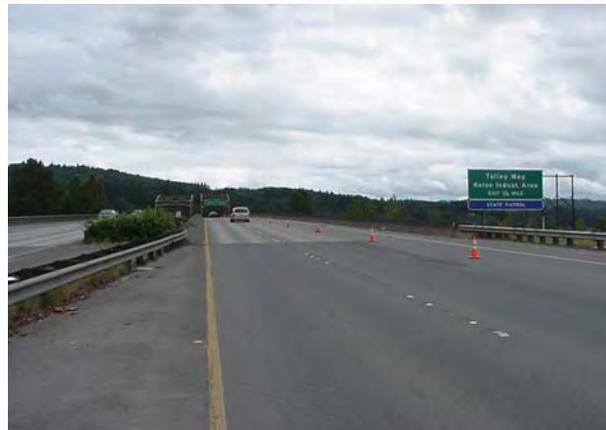
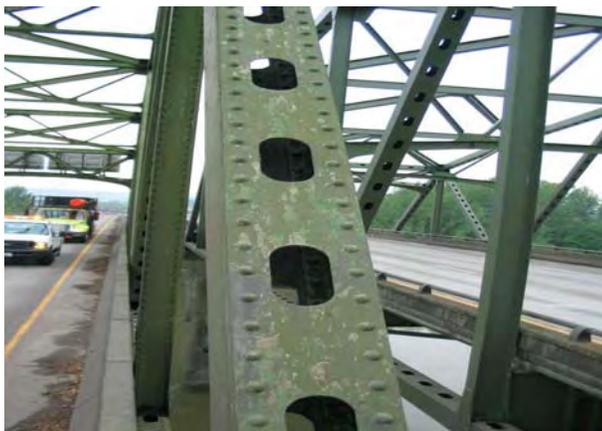
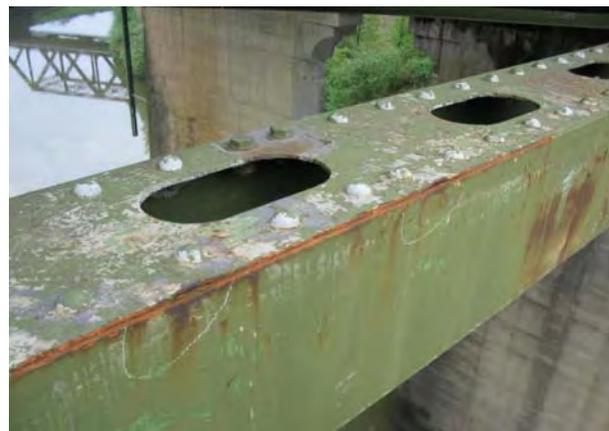
Peeling paint is typical throughout the truss. There is surface rust on the stringers, floorbeams, and sway bracing. The truss shows bare metal in places, especially on the south side surfaces.

Floorbeams - There are eleven 2ft. 10in. deep floorbeams in Span 7 that have rusting top flanges and laminar rust forming at some locations. The floorbeams are covered with mud and rust staining.

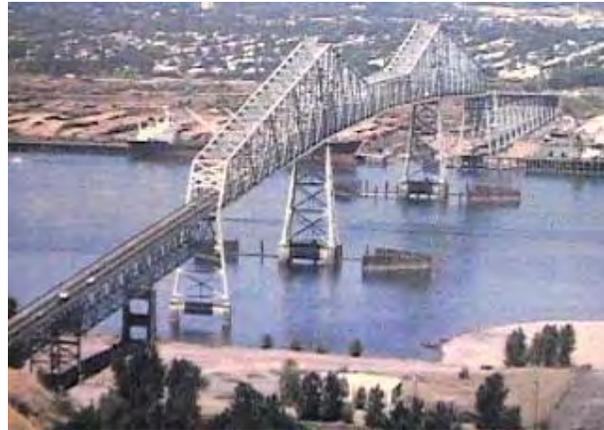
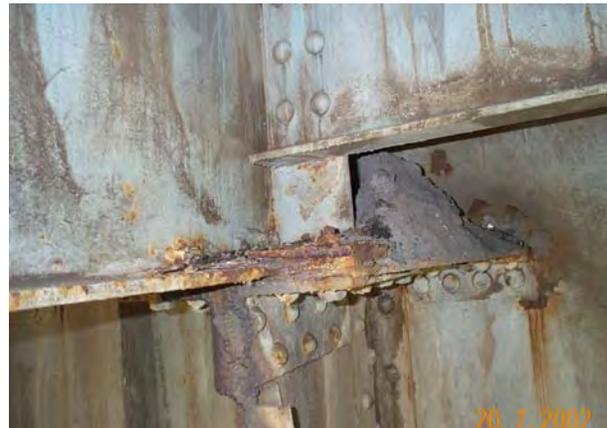
The new steel supporting the new concrete deck was only painted with a zinc primer. Adding top coats of paint to these beams will be included in the future painting project. Some rust blooms and cracking and peeling paint scattered through out the bottom chords. The painting project will be administered by WSDOT with ODOT participating in 1/2 of the total project costs.

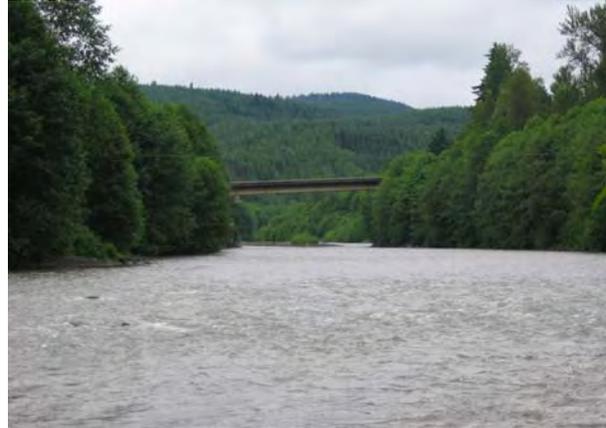
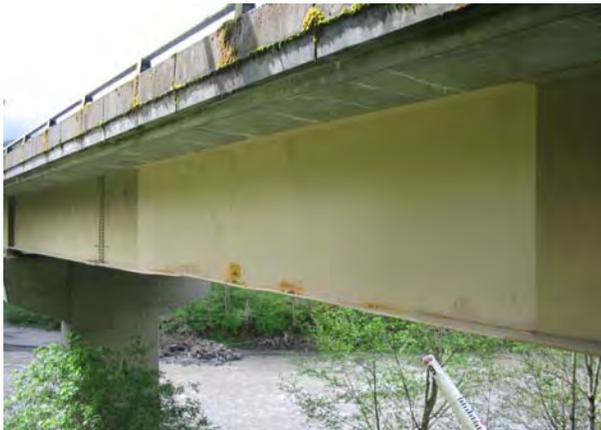
The paint has rusty scatches and occational rust blooms throughout.

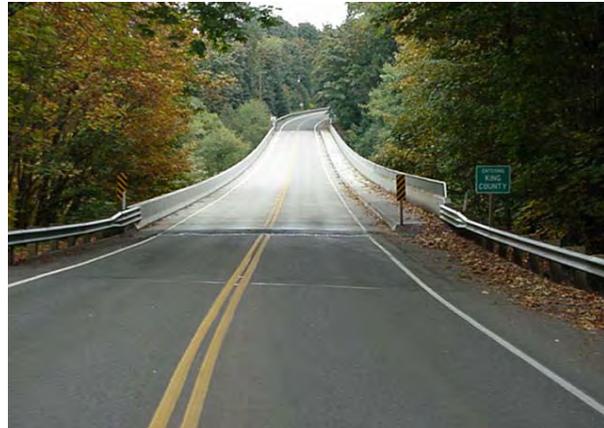
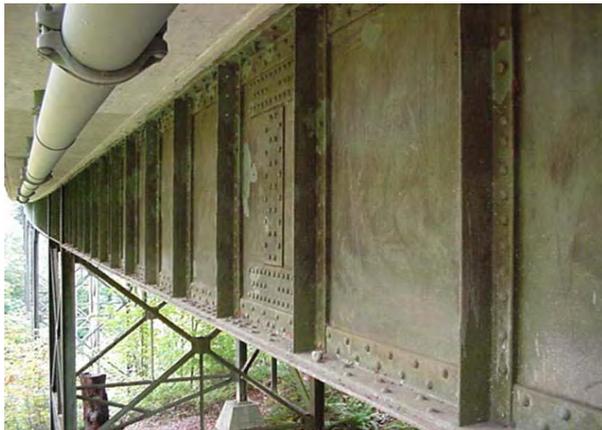
Paint is chalking throughout. Peeling paint, rust blooms, and laminar rust on bottom flange and lower web portion of floorbeams and girders. Up to 2 sq. ft. areas of paint flaking on tower legs and bracing. Exposed metal in many locations.

The bridge deck was replaced in 1996 as part of contract 14713. The top flange of the beams were painted prior to the construction of the new concrete deck. One coat of zinc primer (2.5 mils dry) was used on the top flanges. Full removal of the existing paint system is needed. Full containment will be required.

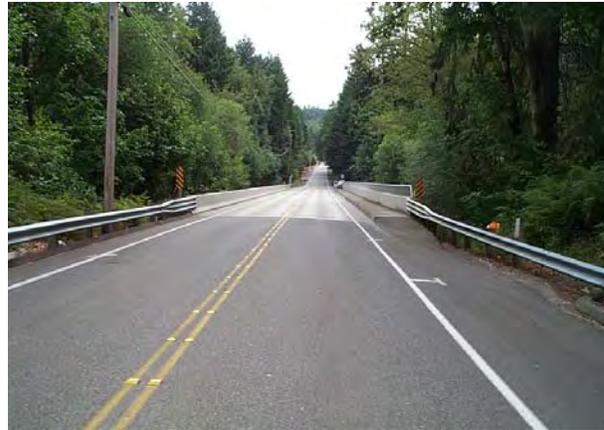
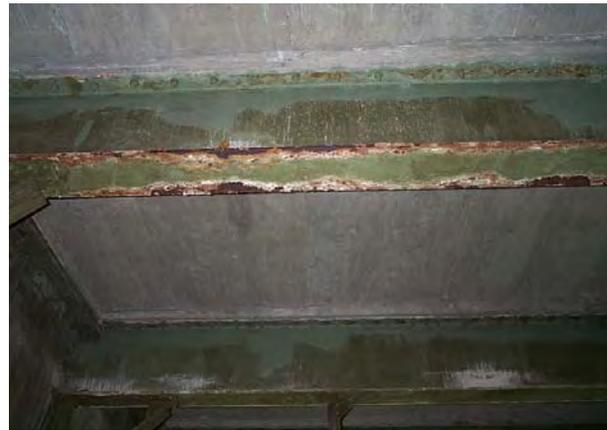
The bridge deck was replaced in 1996 as part of contract 14713. The top flange of the beams were painted prior to the construction of the new concrete deck. One coat of zinc primer (2.5 mils dry) was used on the top flanges.

Full paint removal is warranted based on the age and condition of the existing paint. Full containment will be required.

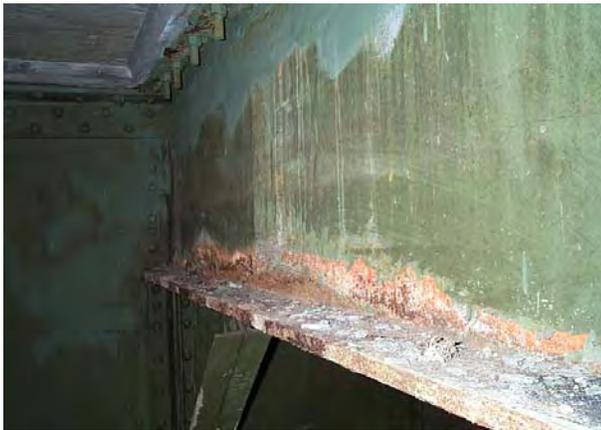
Paint is thin and peeling in places. Rust blooms are common throughout the bridge. Diagonal bracing on columns are rusted on the top surfaces.

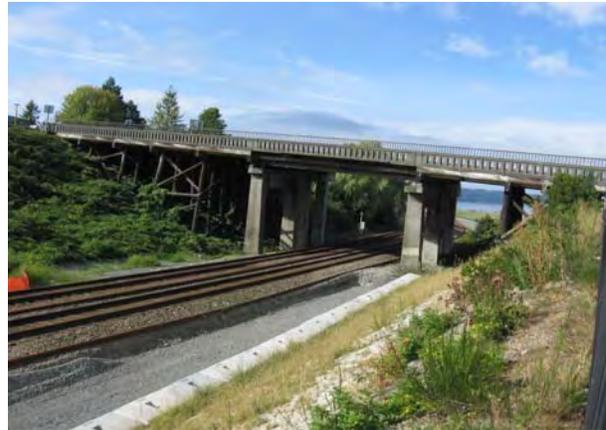
The steel spans are over a railroad that is used extensively. Time allowed to re-paint the steel is very limited. The plan is to use compressed air to remove paint and loose paint then coat with an epoxy rust-penetrating sealer.

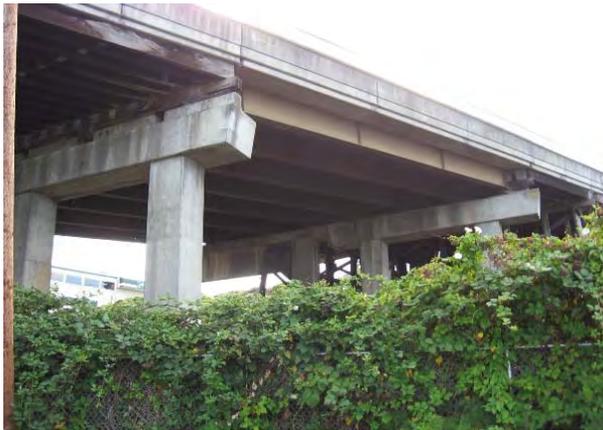
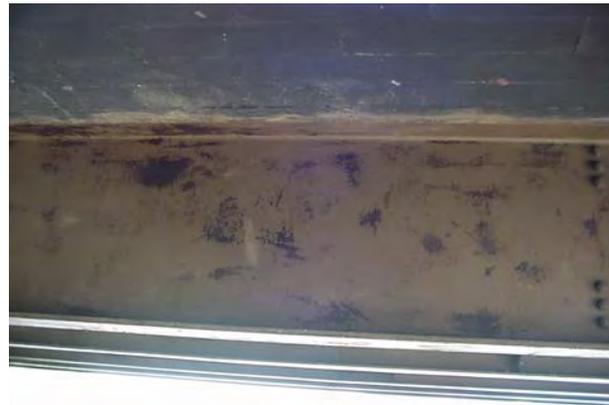
Paint is chalky with areas peeling, blistering and flaking. Areas of rust throughout.

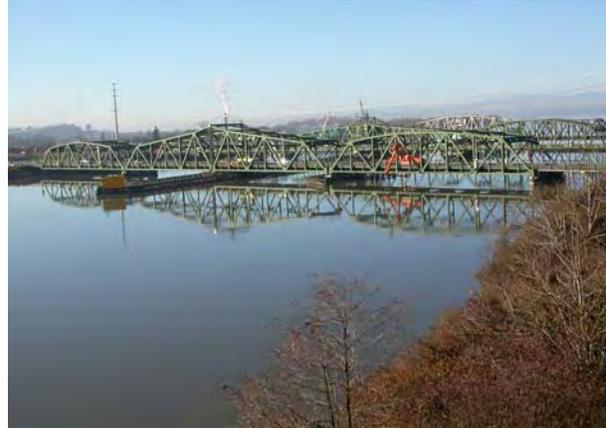
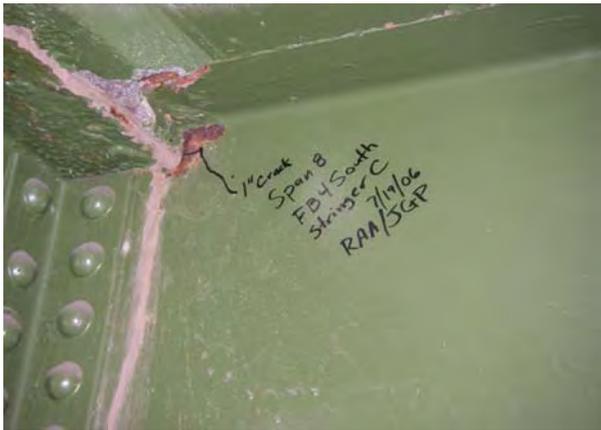
Painting of bridge completed between the April 2001 and November 2003 inspections. The paint is peeling on many of the floorbeam top flanges. The paint is failing at a few stringer copes. The paint is failing inside of Joint L2'W in Span 5. Poor paint inside Member U2E-U3E in Span 5. There is some debris at the lower panel points throughout all of the trusses.

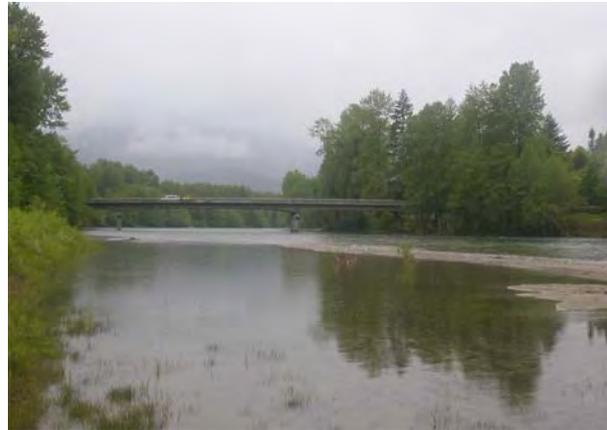
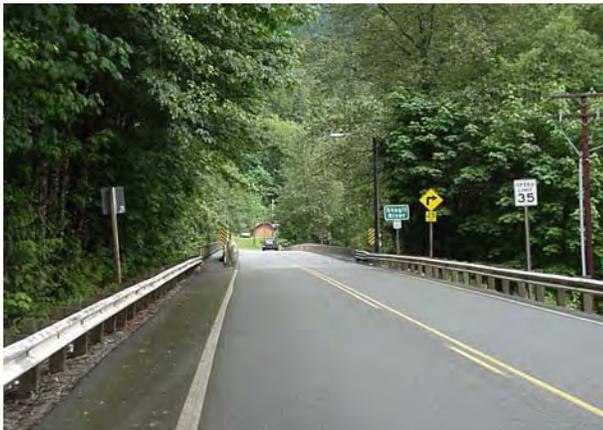
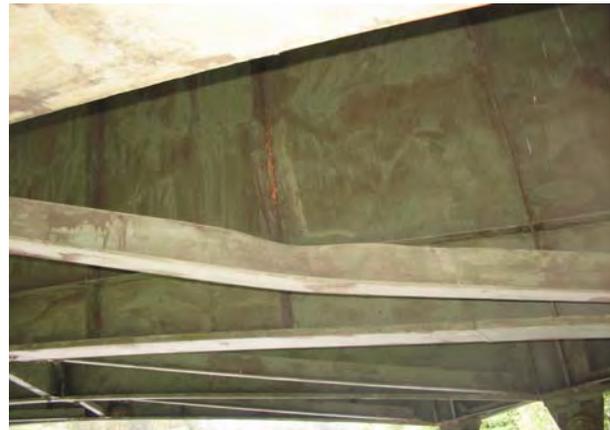
Girder paint system is starting to peel and flake in some locations. The top flange of the outside girders are starting to rust in few areas.

Light rust in bottom flange and diaphragms at hinges. Areas of rust in top flanges at interface with deck.

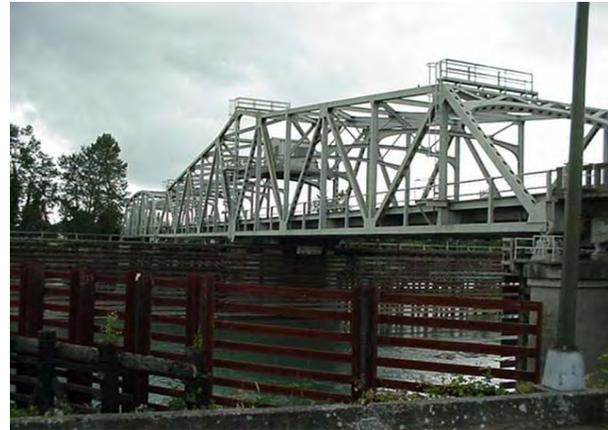
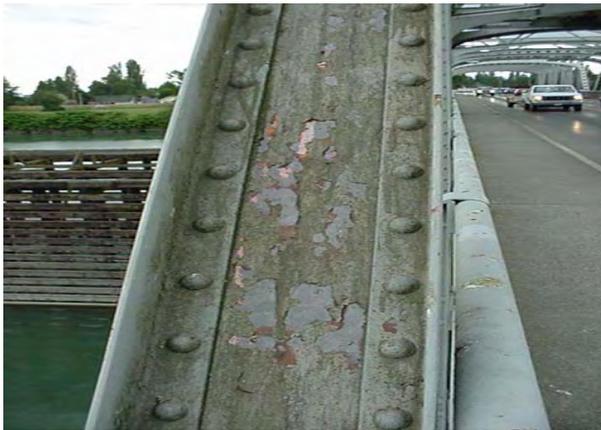
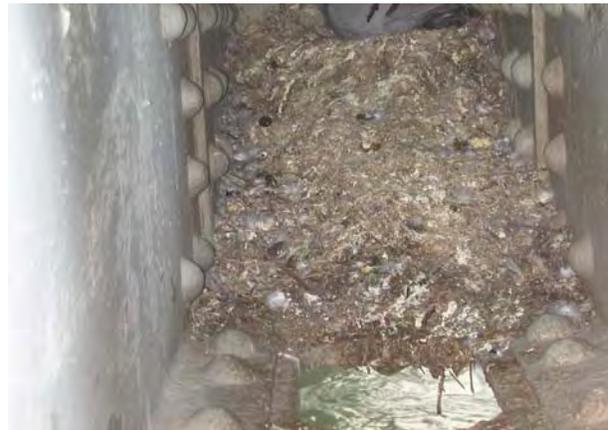
Top layer of paint has failed on the bottom chord. Paint breaking down and steel surface is rusting in hand holds, bottom half of truss diagonals, end posts and portal frames, top chords and sway frames.

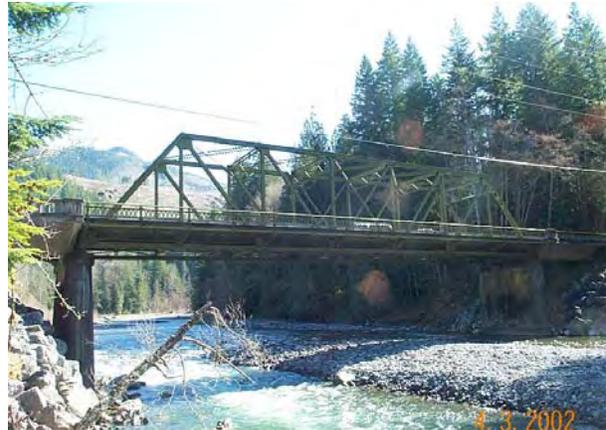
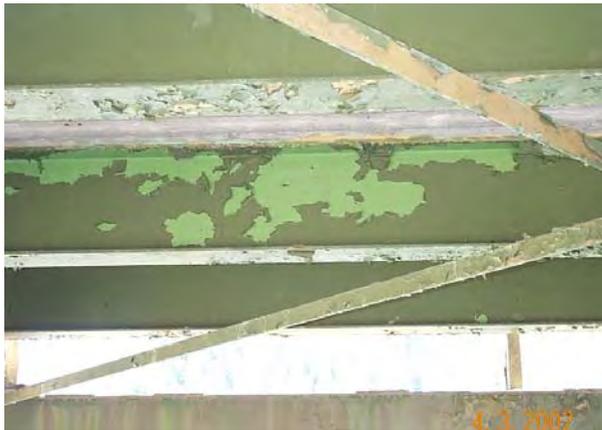
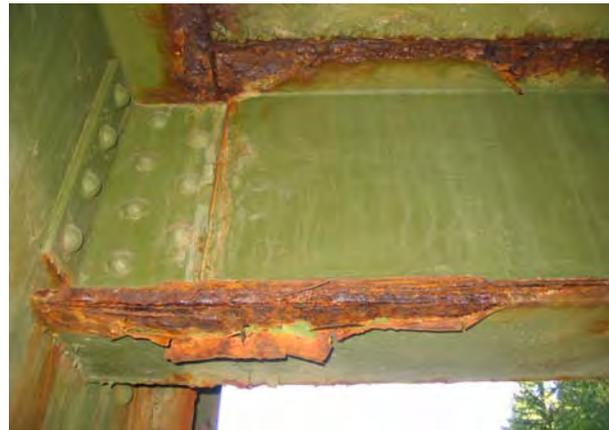
Approximately 65 percent of the truss painted steel surfaces have peeling paint. About 10 percent of the truss has exposed steel. About 40 percent of the floor system has peeling paint. Less than 5 percent of the floor system has exposed steel with pitting and laminar rust.
