# WSDOT Bathymetric Mapping of Waterways

## Facilitating Project Delivery With Cutting Edge Technology

# WSDOT Unstable Slopes Mapping

# WSDOT Emergency Assessment Mapping Facilitating Project Delivery With Cutting Edge Technology

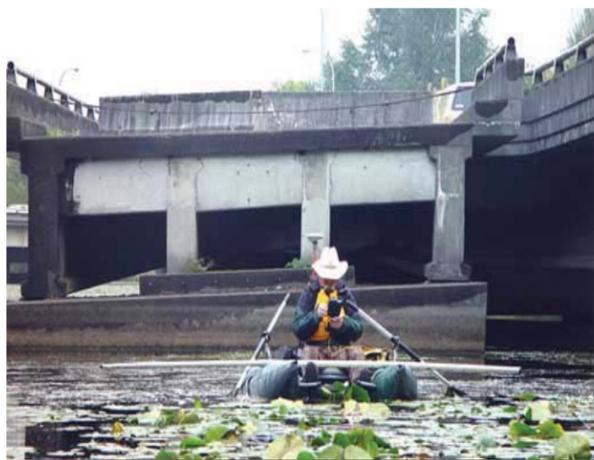
This oar-powered pontoon boat rigged with a GPS and total station tracking was used to conduct bathymetric soundings of the marsh.

The inflatable one-person raft was selected as the best survey platform to allow taking depth measurements and recovery of real time GPS locations.

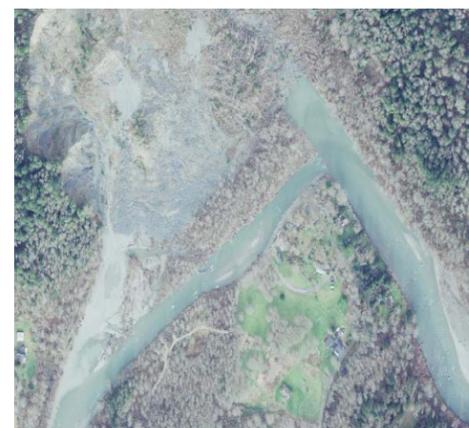
This imagery was taken by WSDOT Geographic Services immediately following the Stillaguamish River flood on 02/07/2006. The image was ortho rectified by WSDOT Photogrammetry Branch and delivered to the Stillaguamish Tribe and consultant, Anchor Environmental. They used the orthophotos to assess the severity and depth of damage and plan repairs. They also used 3D computer maps produced by WSDOT Photogrammetry.

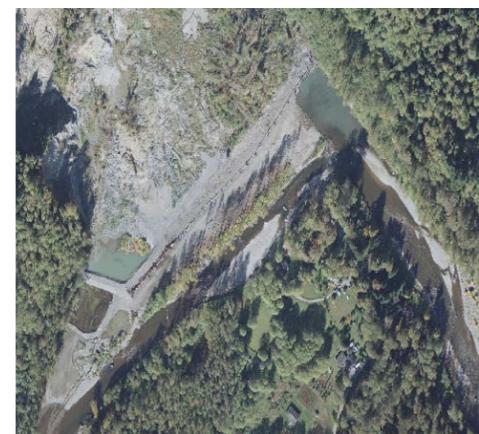
This imagery was taken by WSDOT Geographic Services on 10/12/2006 after repairs to the river had been made. The new orthophoto shows the difference the repairs made in redirecting the river and preventing repeat flood damage. The orthophotos also helped contractors choose safe methods of digging and trenching to avoid unstable areas. There were no worker injuries during the project, and the repairs were made without damage to the environment.

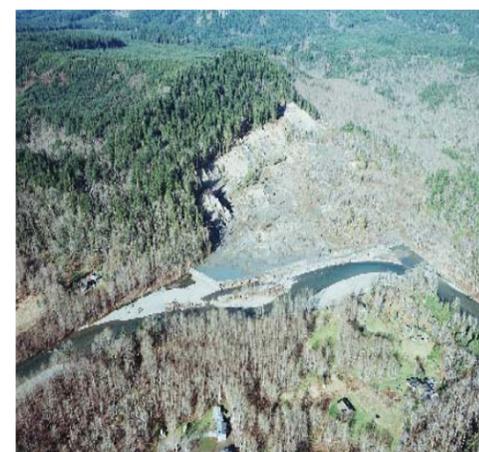
This oblique angle aerial photograph of the repairs from 2007, was provided by the Stillaguamish Tribe GIS Administrator who worked in close conjunction with WSDOT and Consultants throughout the project. This image is used with permission from the tribal authorities.

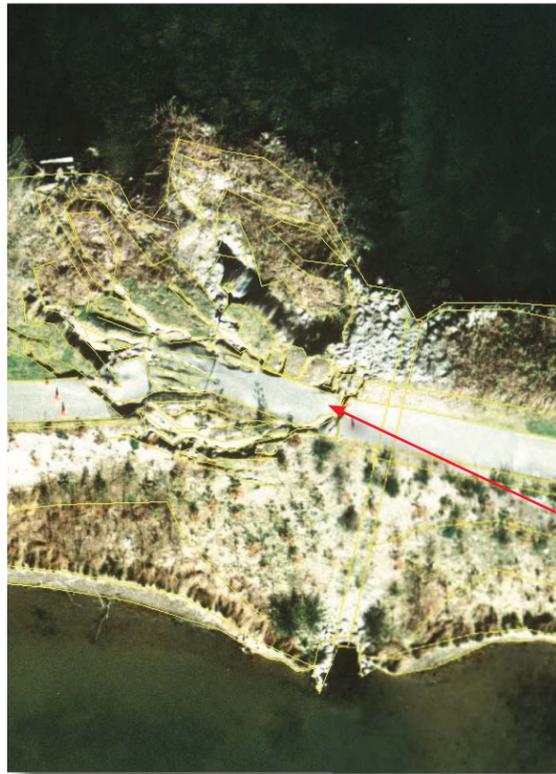
## 2001 Nisqually Earthquake

This Mapping project was requested by the Olympic region immediately following the 2001 Nisqually Earthquake. New, accurate maps were needed to assist in planning and designing the reconstruction of the heavily damaged roadway and adjacent trails.

Geographic Services placed control points accurate to +/- 0.02m and took the aerial photographs at a scale of 1:2400 (1":200'). Photogrammetrists used the photos and control points to make a 3D CAD map accurate to +/- 0.2'. The map was also used to produce an orthophoto at 0.25' resolution. Engineers used the high resolution orthophoto and 3D map to assess the shape and depth of damage.

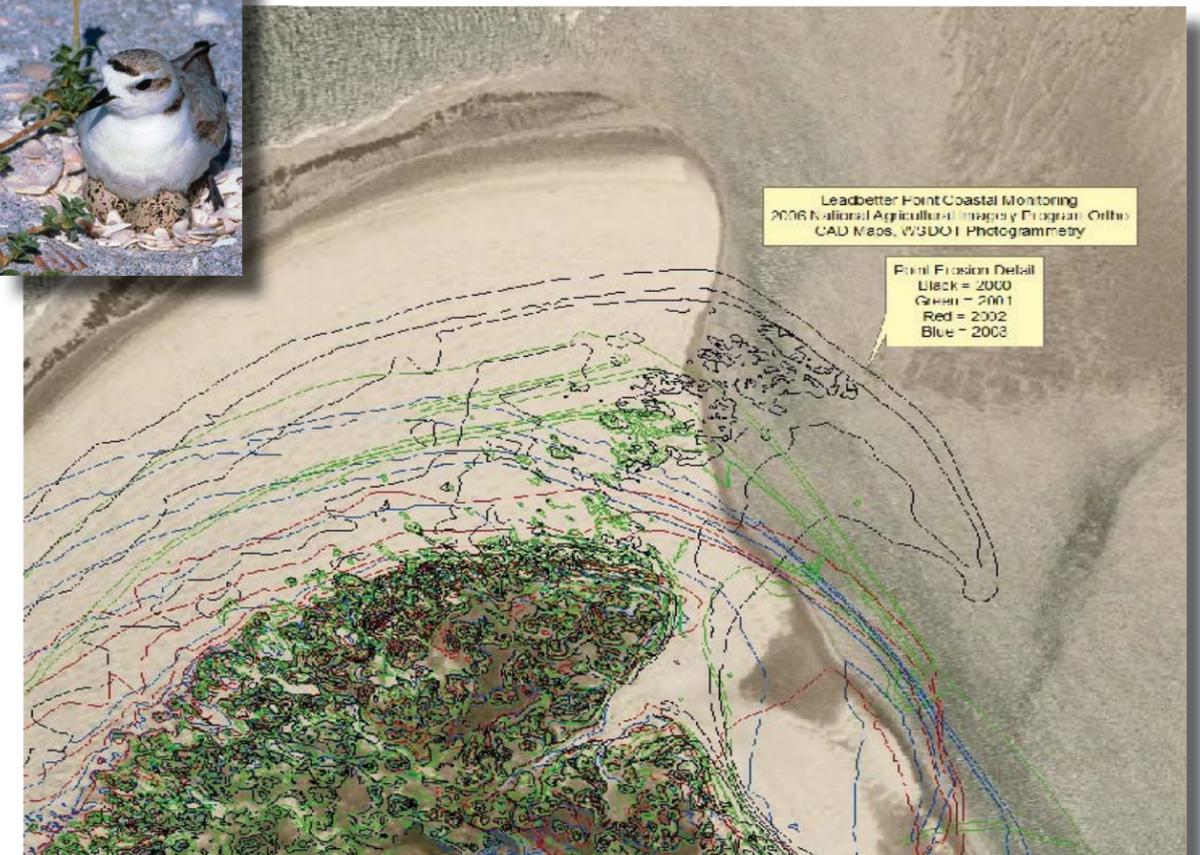
Fluctuation of the coastline, mapped from 2000 to 2003. Black=2000, Green=2001, Red=2002, Blue=2003. Contours are shown projected on the 2006 National Agricultural Imagery Program (NAIP) orthophoto.

Geographic Services placed control points accurate to +/- 0.5m, took the aerial photographs at a scale of 1:6000 (1":500'), and produced a 3D computer aided design map of the area accurate to +/- 0.5' each year from 1999 until 2003.
