WSDOT Emergency Mapping

Unstable Slopes, Slides, Earthquakes, Sink Holes, & Floods

Stillaguamish River Flood & Slide

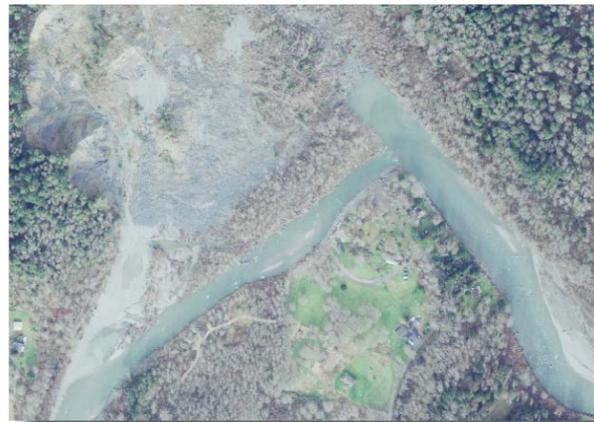
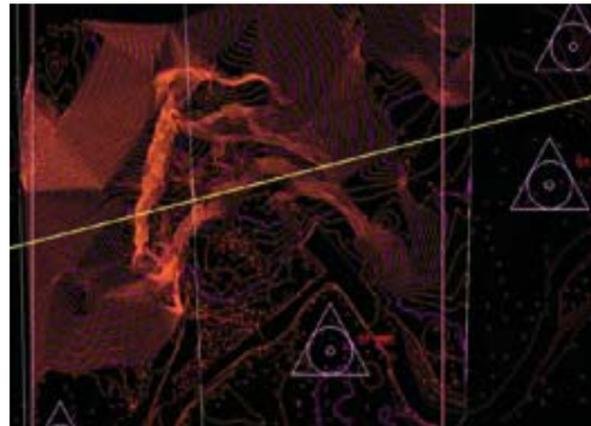
This imagery was taken by WSDOT Geographic Services immediately following the Stillaguamish River flood on 02/07/2006. The image was ortho rectified by WSDOT Photogrammetry Branch and delivered to the Stillaguamish Tribe. They used the orthophotos to assess the severity and depth of damage and plan repairs. They also used 3D computer maps produced by WSDOT Photogrammetry. The orthophotos also helped work crews choose safe methods of digging and trenching to avoid unstable areas. There were no worker injuries during the project, and the repairs were made without damage to the environment.

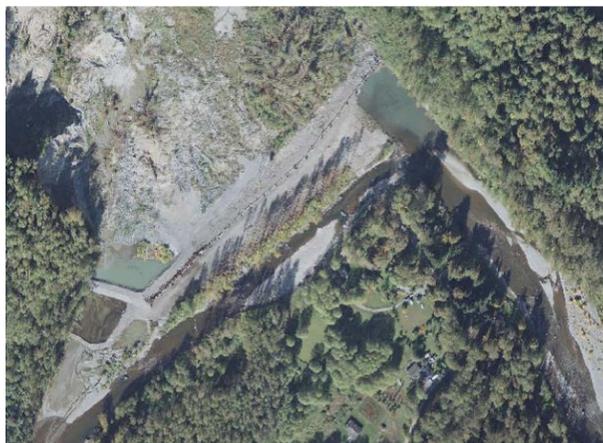
This imagery was taken by WSDOT Geographic Services on 10/12/2006 after repairs to the river had been made. The new orthophoto shows the difference the repairs made in redirecting the river and preventing repeat flood damage.

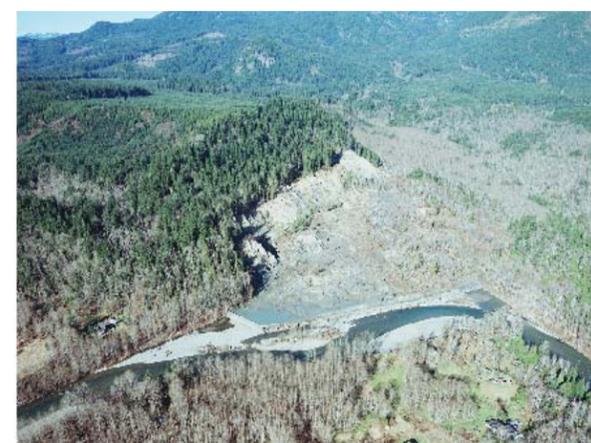
This oblique angle aerial photograph of the repairs from 2007, was provided by the Stillaguamish Tribe GIS Administrator who worked in close conjunction with WSDOT throughout the project. This image is used with permission from the tribal authorities.

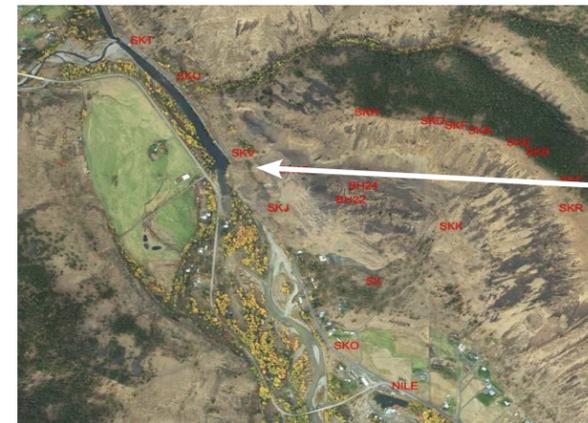
Photo control shown for SR 410 Nile Valley Slide

WSDOT Photogrammetry & Remote Sensing technical section of the Design Office can meet project deadlines even in emergencies. Below depicts the SR 410 Nile Valley Slide which the branch delivered within 3 weeks of the emergency. Products were orthophotos (one new & one created of the pre-slide for comparative analysis), CAD files, Contour files, In-Roads Surface files. We customize each deliverable for the project needs.

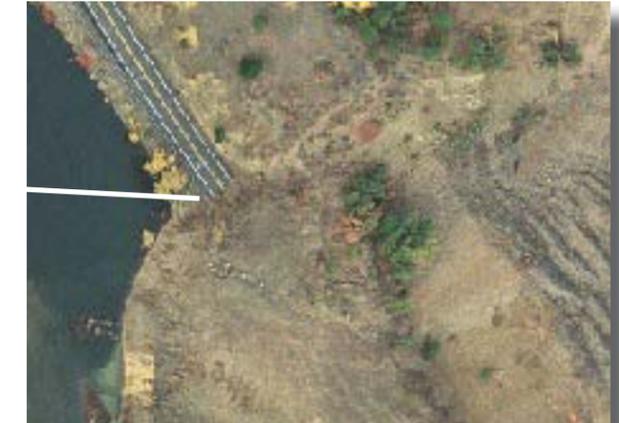
A close up of the slide area from the orthophoto

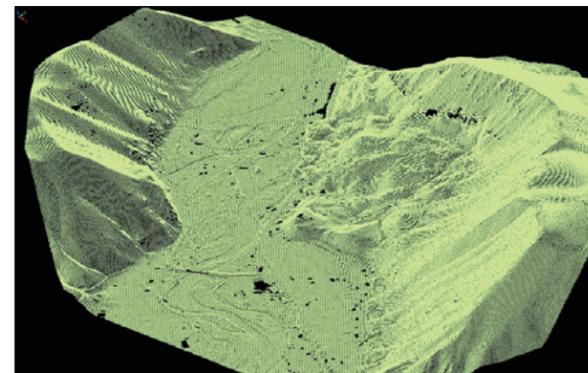
This 10 foot contour was derived from airborne lidar

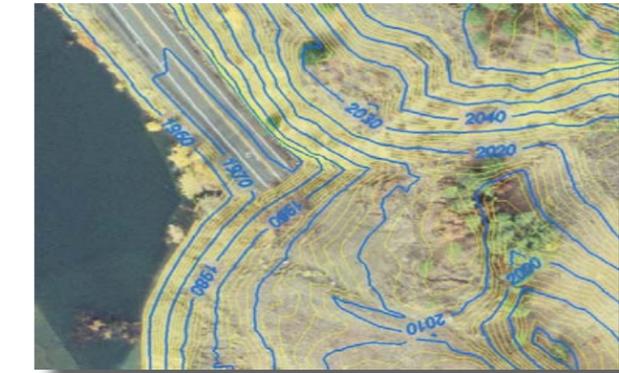
This CAD contour file was created from traditional photogrammetry methods using airborne photography

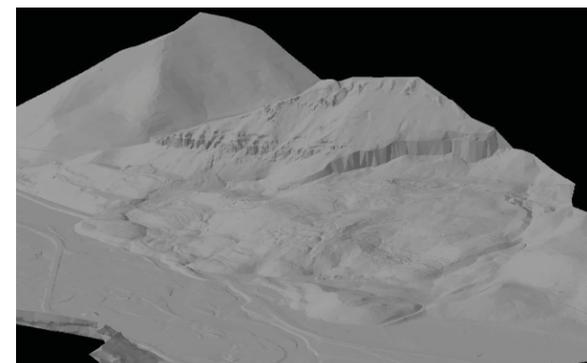
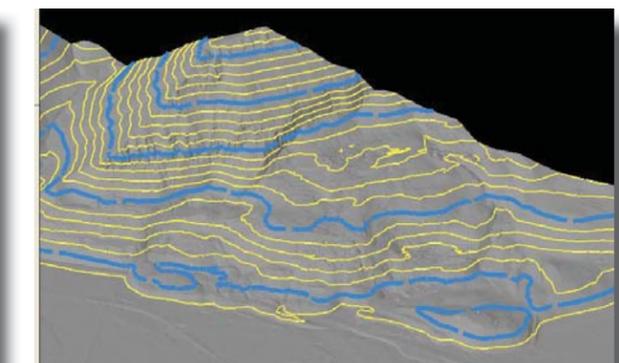
Surface or Data Terrain Model (DTM) with contour overlay

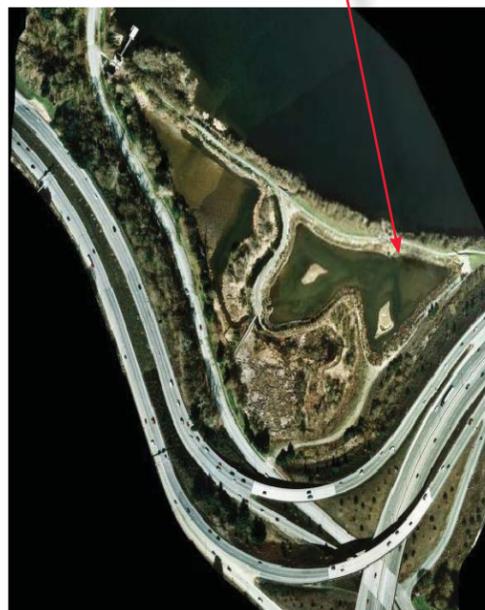
A portion of the damaged area on the Orthophoto

Geographic Services placed control points accurate to +/- 0.02m and took the aerial photographs at a scale of 1:2400 (1"=200'). Photogrammetrists used the photos and control points to make a 3D CAD map accurate to +/- 0.2'. The map was also used to produce an orthophoto at 0.25' resolution. Engineers used the high resolution orthophoto and 3D map to assess the shape and depth of damage.

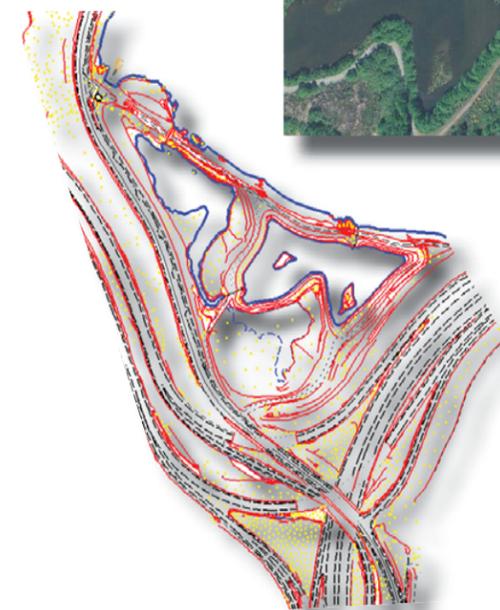
A portion of the projects CAD file

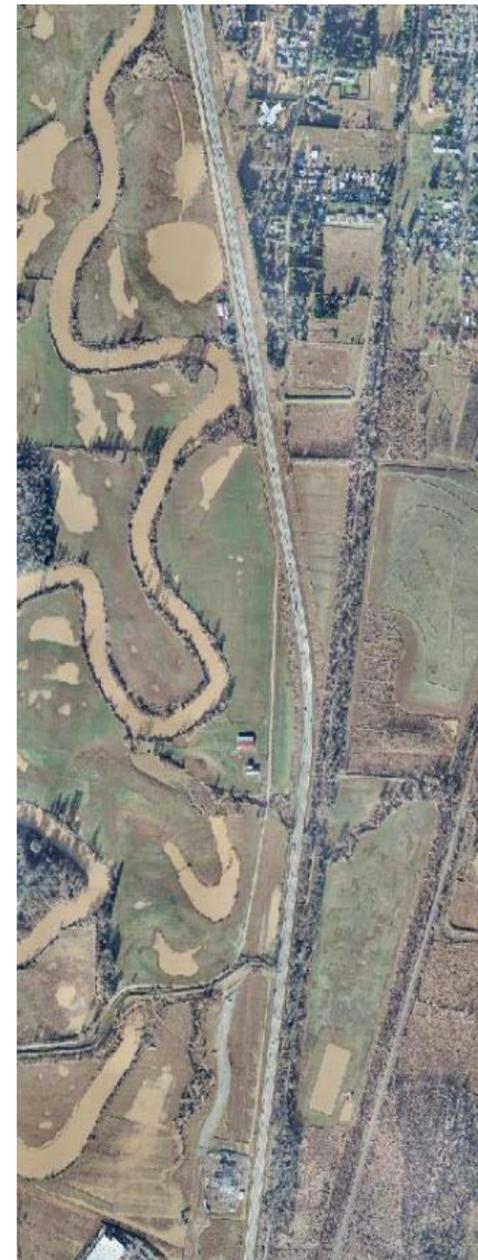
Portion of the orthophoto created on the I-5 corridor.

The Chehalis River Flood occurred on December 3rd, 2007. Helicopter photography, flight planning, bad weather grounding flights, 3D terrestrial scanning, CAD mapping, and orthophoto were all accomplished and delivered in less than 25 days.

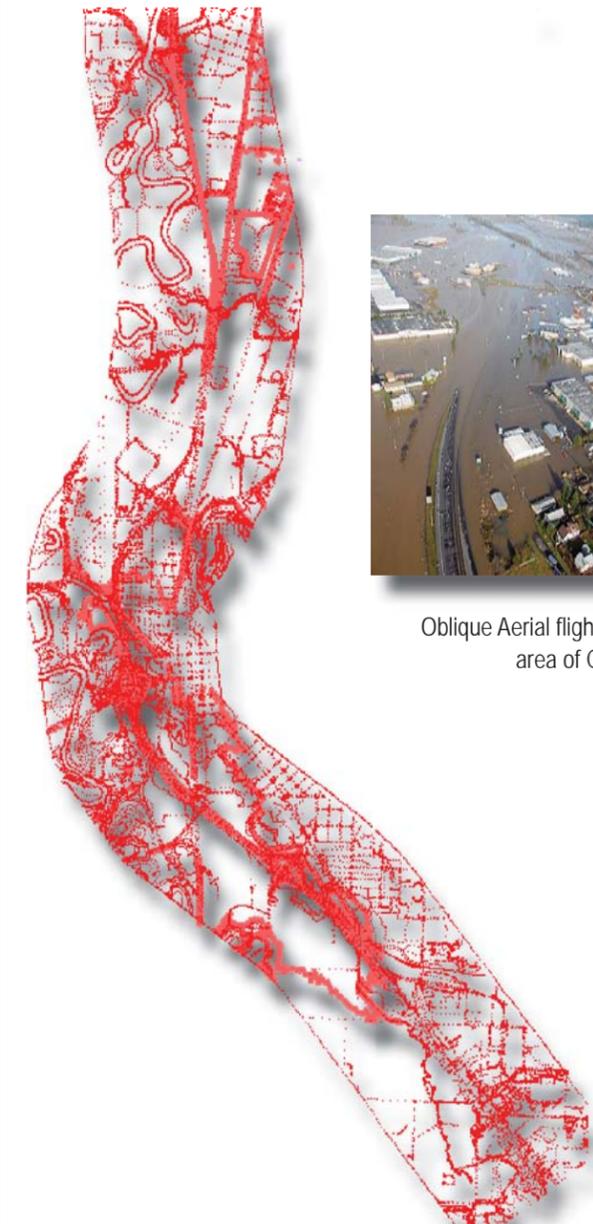
A portion of the CAD file created for project.

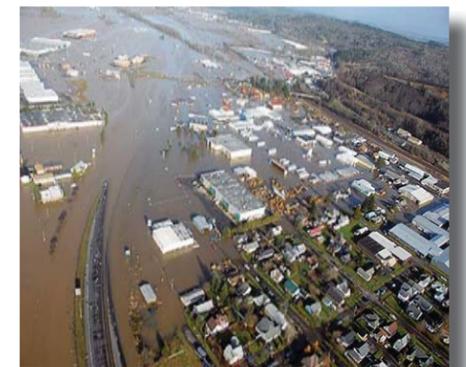
Oblique Aerial flight over the I-5 flood area of Chehalis
