# Roadside Safety Pooled Fund

## TPF-5(114) Roadside Safety Research Program Pooled Fund Study

## Pinned F-Shape Temporary Barrier

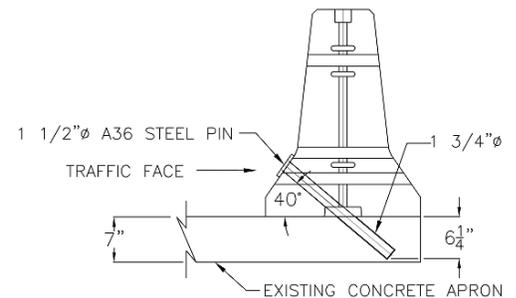
Finite element modeling and simulation was used to evaluate some of the key design parameters of the pinned barrier design. Among these were the drop-pin inclination angle, barrier profile ('F' or New Jersey), barrier segment length, and drop-pin diameter. Based on the results of the analysis, the final design was selected to have an 'F' shape profile with a segment length of 12.5-ft. The steel drop-pins were inclined at an angle of 40 degrees from the ground and had a diameter of 1.5 inches. The pins passed through the barrier and continued 6.25 inches into the concrete pavement as shown in the figure.

Details of Anchoring Mechanism

Based on review of previously developed designs for anchoring temporary concrete barriers to bridge decks and concrete pavements, the research team adopted the drop-pin approach rather than the bolted-down approach for anchoring the barrier. This design concept restricts lateral barrier movement by using steel pins which are simply dropped into inclined holes that pass through the toe of the barrier and continue a short depth into the bridge deck or concrete pavement underneath.

A 1.5-inch diameter steel drop-pin was placed into each hole to pin-down the barrier.

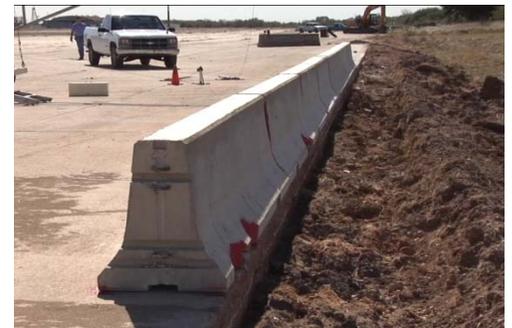
Test Installation of Pinned F-Shape Temporary Barrier

A crash test was performed with a 100-ft long installation to verify the performance of the barrier according to *NCHRP Report 350* TL-3 criteria. The F-shape precast concrete segments used in the test were 12.5 ft long. Adjacent barrier segments were connected using a pin-and-loop type connection. The loops were made of 0.75-inch diameter round stock steel and a 1-inch diameter x 30-inch long ASTM A449 connecting pin was inserted between the loops to establish the connection. Two 1.875-inch diameter holes inclined 40 degrees from the ground, were cast into the traffic face at the toe of each barrier segment. The holes in the barrier were used as a guide to drill 1.75 inch diameter holes into the un-reinforced concrete pavement.

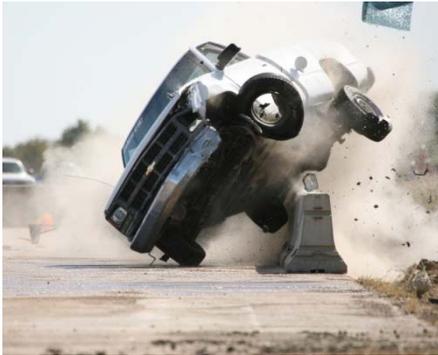
A 2000P vehicle, traveling at an impact speed of 62.7 mi/h, impacted the barrier at an angle of 25.4 degrees. The barrier successfully contained and redirected the vehicle. The vehicle did not penetrate, underide, or override the installation.

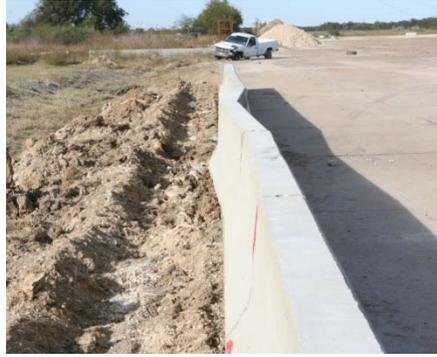
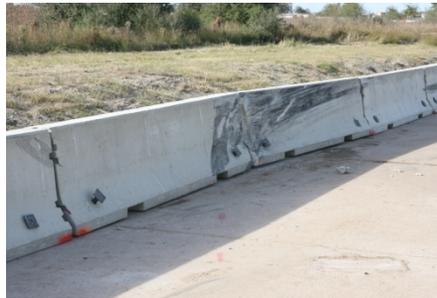
Maximum dynamic and static deflections of the barrier during the test were 11.5 inches and 5.8 inches, respectively. Although the barrier sustained some damage that would require repair, there were no detached elements, fragments, or other debris to penetrate or show potential to penetrate the occupant compartment, or to present undue hazard to others in the area.

Barrier after Test

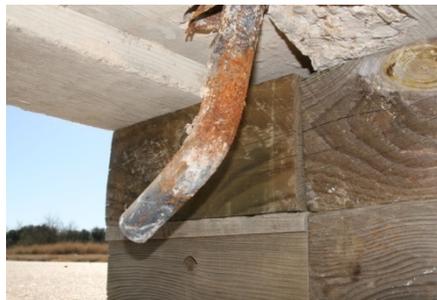
The drop-pins adjacent to the impact joint were deformed as shown in the photograph, but none of the pins pulled out of the concrete pavement. Other than the drop-pins adjacent to the impact joint, none of the pins were deformed. No significant damage was caused to the concrete pavement due to impact. The damage to one of the drilled holes in the concrete pavement is shown in the photograph.

Damage to Drop Pin

For removal or relocation of the barrier, the pins can be removed by hand to free the barrier. In case of a vehicular impact, the deflection of the impacted segments is likely to bend the drop-pins such that they cannot be lifted by hand. Such segments can be lifted using a fork lift and the pins can be removed using a cutting torch. This procedure however is needed for a very small number of drop-pins.

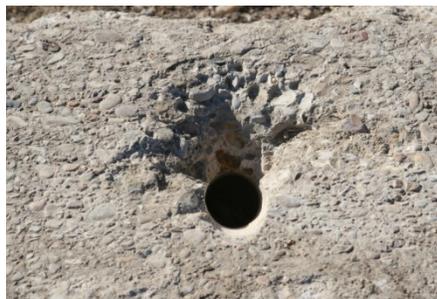
Damage to Drilled Hole

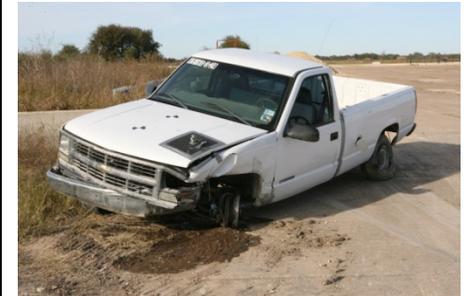
Maximum occupant compartment deformation of the vehicle was 1.1 inches. The vehicle remained upright during and after the collision event. Maximum roll angle was 41 degrees. Occupant risk factors were within the limits specified in *NCHRP Report 350*.

Test Vehicle after Test
