P2 Bridge Preservation - Replacement/Rehab Projects

2013-15 Bien Priority Array

Bridge Repair Form

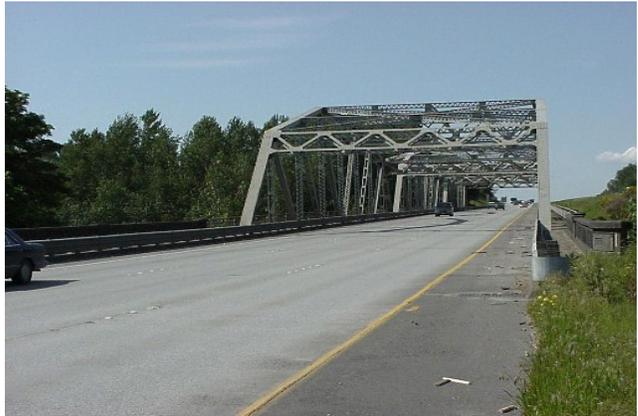
THIS BRIDGE IS CLASSIFIED "SD" BASED ON THE DECK CONDITION.
A modified concrete overlay was applied in 1992. The length of the 3 truss spans is 606 feet. Transverse hairline cracks in most panel points. Soffit: Transverse and map cracking in soffit, some were leaching or had rust stains throughout all steel truss spans of bridge; see photos #5 and #21. Some movement in the deck was observed under heavy traffic in areas of all truss spans, most notably between Panel Points L0 and L1. There are exposed rusty transverse bars with section loss, up to 6 ft. in length with 2" deep spalls; Some areas of delaminated and honeycombed concrete were observed between the stringers. Spalls, up to 10 ft. long, and longitudinal cracks were observed along the east edge of the deck. Spalls were also observed at the interface of the floorbeams and deck.

The proposed project will replace the concrete deck on the three steel truss spans and replace the overlay on the approach spans.

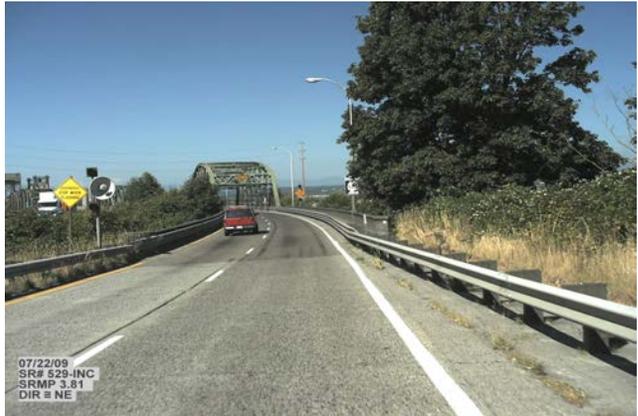
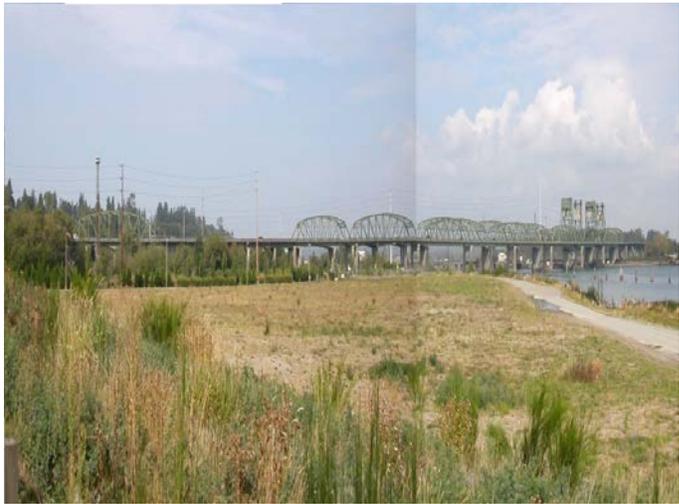
The steel towers in the Movable span have significant corrosion of the steel elements. A future project is needed to remove and replace or rehabilitate the steel tower members that are severely corroded.

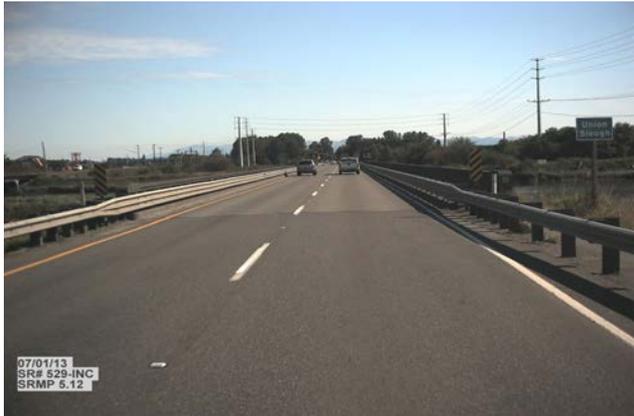
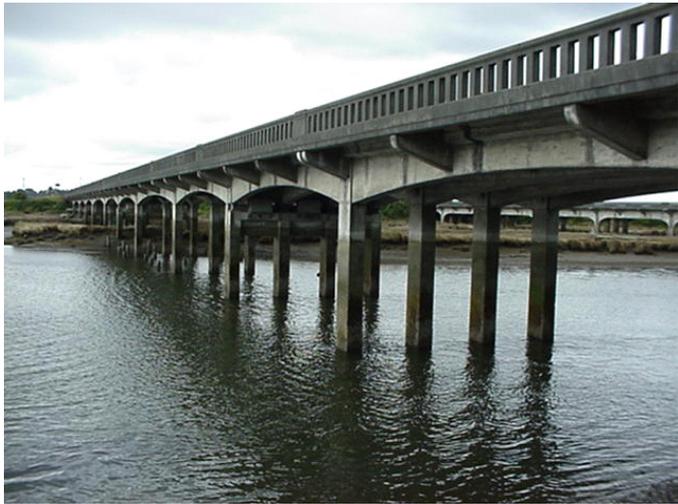
The WSDOT BPO Dive Team completed an underwater interim inspection of the scour conditions at Pier 9 in 2009. Scour conditions have changed at Pier 9 since the previous underwater inspection on June 29, 2005.

The columns have a reddish algae growth above the high water line and moderate barnacle growth from the high water line down. Most columns have vertical rusty edge cracks located around the upper splash zone. Most cracks are typically from hairline to wide, (open from 1/8" to 1/4"). The top edges of the cracked areas are delaminated.

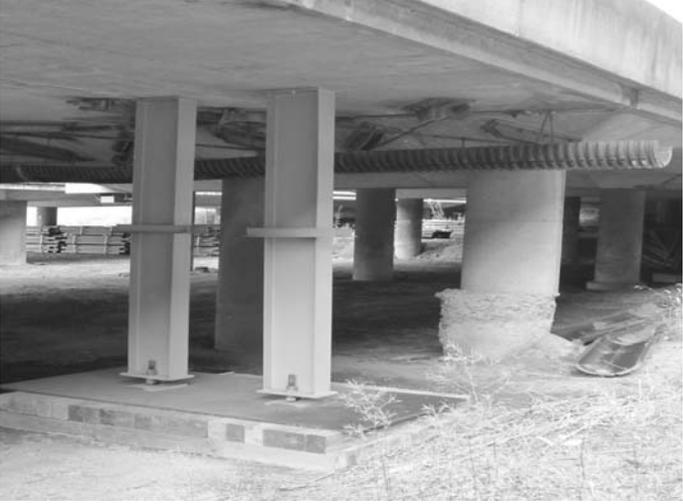
<p>Repair Description: Repair Bearings in span 14.</p>		<p style="text-align: center;">COMMENTS</p> <p>This bridge was widened in 1990 and the bearings were installed incorrectly at that time. An analysis is needed to determine the proper repair to fix the bearings.</p>

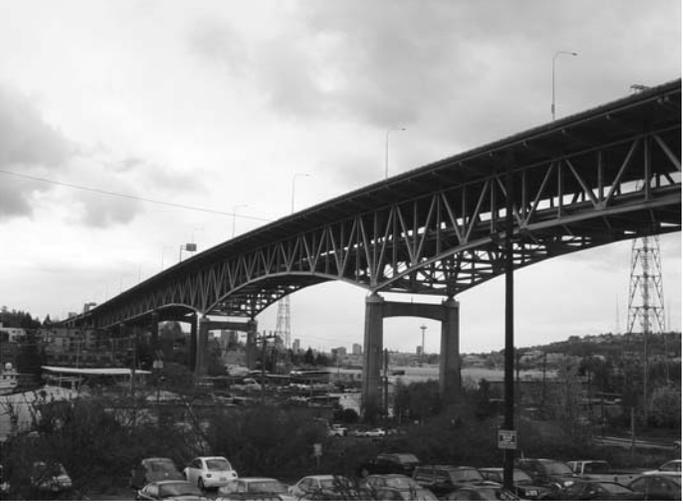
Repair Description:									
Replace poured joint sealant in deck joints of the lower deck express lanes.									
COMMENTS									
There are deck joints at 60 locations in the Steel Truss span. The poured joint sealant needs to be replaced to prevent water leakage and corrosion of the supporting steel elements. The roadway width is 60 feet.

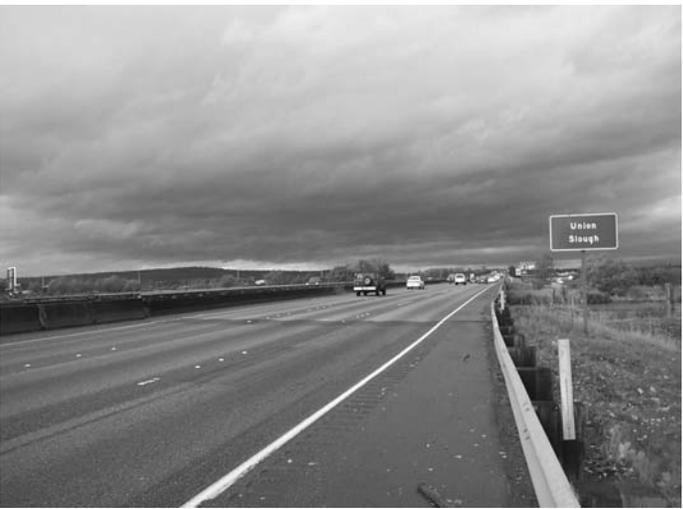
<p>Repair Description: Replace the Rubber Bolt Down expansion joints.</p>									
COMMENTS									
<p>The rubber bolt down expansion joints were installed in 1985 along with the modified concrete overlay. These joints have been repaired many times by Region Maintenance.</p> <p>Bridge Item cost based on \$500 / ft. Total project cost based on \$1,500 / ft.</p>

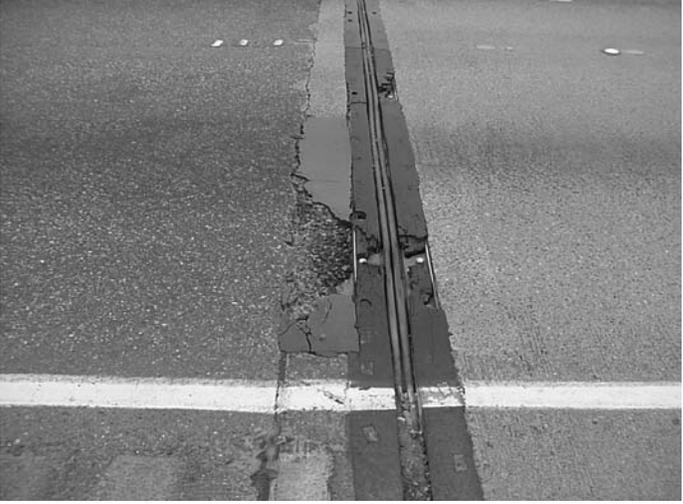
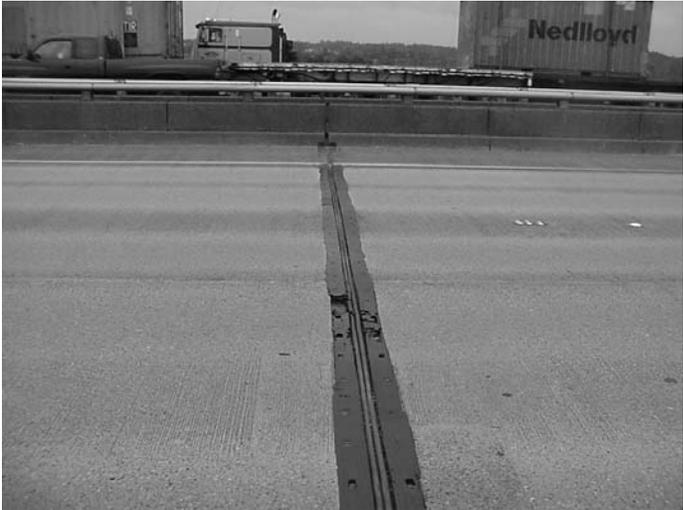
Repair Description: Replace the Rubber Bolt Down expansion joints.															
COMMENTS															
The rubber bolt down expansion joints were installed in 1985 along with the modified concrete overlay. These joints have been repaired many times by Region Maintenance.

Bridge Item cost based on \$500 / ft. Total project cost based on \$1,500 / ft.

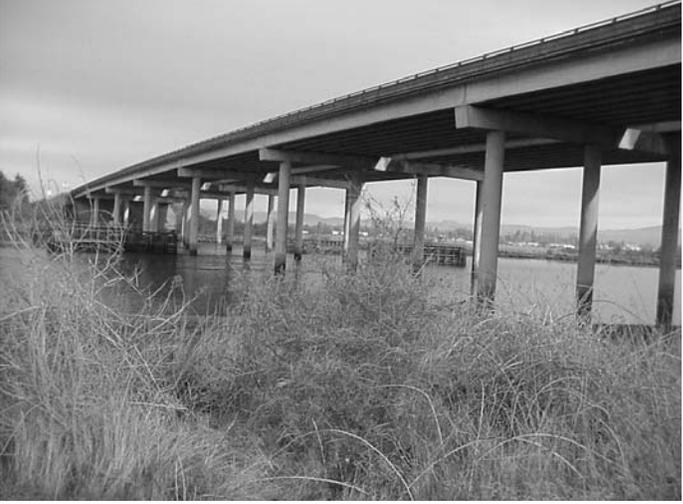
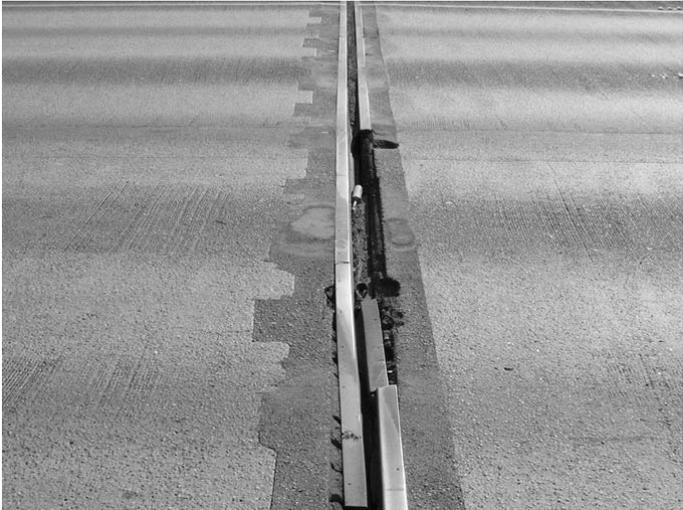
Repair Description:									
Replace strip seal expansion joint at two locations.									
COMMENTS									
The existing steel sliding plate expansion joints have failed and need to be replaced.

Bridge item cost based on \$1,500 per foot. Total project cost based on \$2,500 per foot.

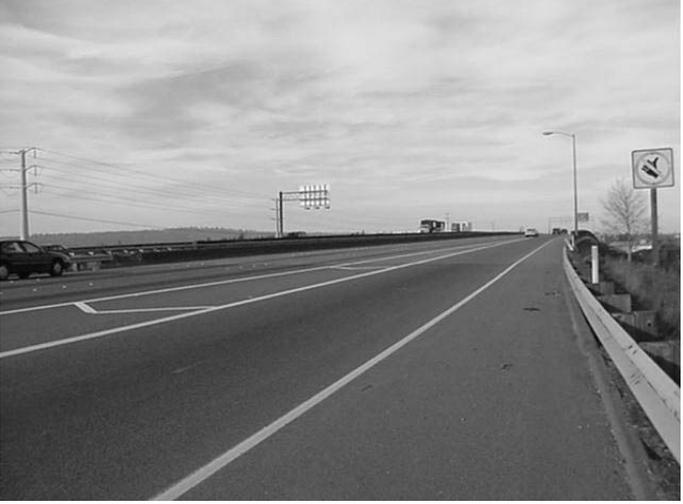
<p>Repair Description: Replace Modular Expansion Joints and strip seal joints.</p>												
<p align="center">COMMENTS</p> <p>Sections of the existing steel sliding plate expansion joints have failed and need to be replaced.</p> <p>Bridge Item cost based on \$1,500 / ft. Total project cost based on \$3,000 / ft.</p>

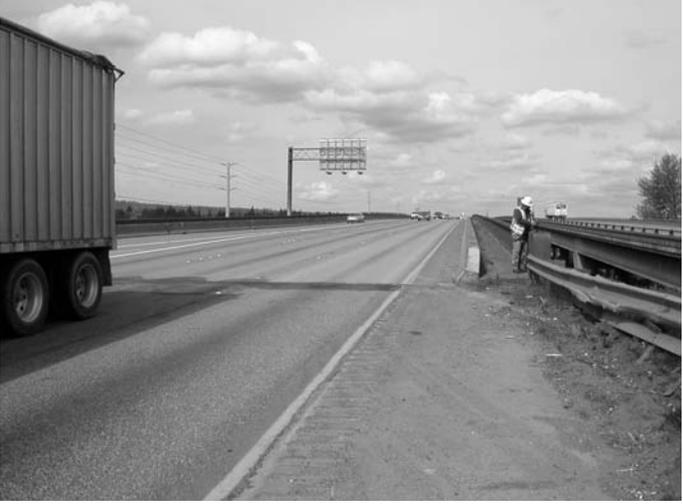
<p>Repair Description: Replace the Rubber Bolt Down expansion joints.</p>				
<p>COMMENTS</p>				
<p>The rubber bolt down expansion joints were installed in 1985 along with the modified concrete overlay. These joints have been repaired many times by Region Maintenance.</p>

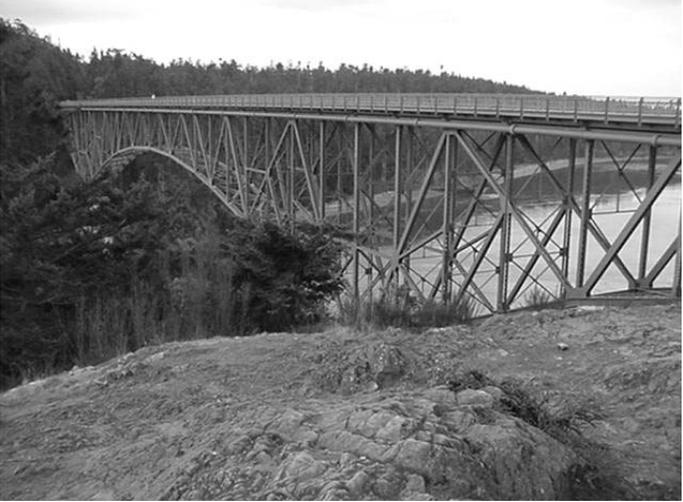
Replace corroded secondary braces.

A review of the most recent inspection report is needed to identify all the secondary members that need to be replaced.

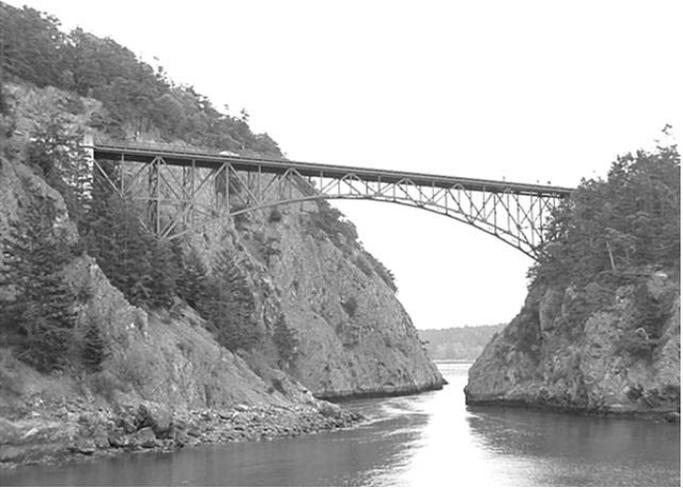
<p>Repair Description: Replace corroded secondary braces.</p>									
<p>COMMENTS</p>									
<p>A review of the latest bridge inspection report is needed to determine the total number of secondary members that need to be replaced.</p>

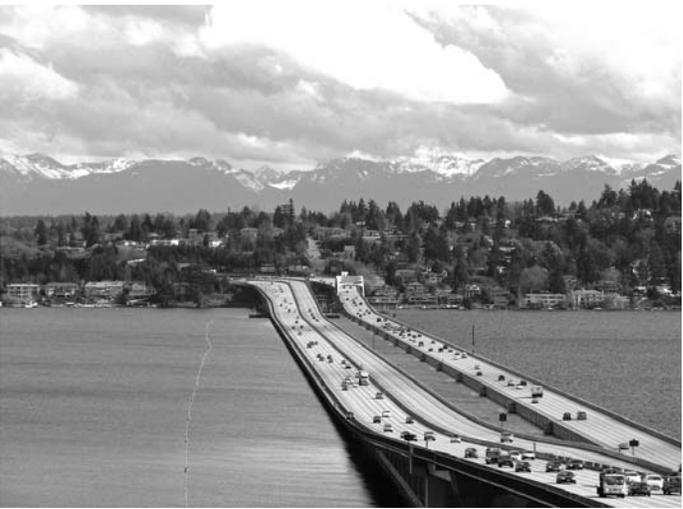
Bridge Number: 90 / 25N		Structure ID 0012271A		Bridge Name: HOMER M. HADLEY		Milepost: 4.24		Region: Northwest	
Year Built / YR Widened: 1989		Bridge Type: CFP POBX SBOX		Bridge Length: 9,559 ft		Bridge Width (curb-curb): 92.0 ft		Sufficiency Rating: 50.79 SD	
Average Daily Traffic 57,401		Truck% 		Freight Route T-1		Num of Lanes 7

Date Inspected: 8/26/2009		Structr Adequacy: 4		Superstr Code: 7		Safe Load: 5			
Substr Code: 4		Scour: 8		BMS Element Num: 148		BMS Element Descr: Floating Bridge - Anchor Cable			
BMS Element Quantity: 11		Project Number: 2013-15 Priority#: 2		Repair Year: 2015		2011-13 Priority#: 21			
CPMS Ad Date:		Bridge \$'s: \$1,980,000		Repair Total\$'s: \$2,280,000

<p>Repair Description: Replace 11 anchor cables. Cables are 2 3/8 inches in diameter.</p>									
<p>COMMENTS</p>									
<p>The Bridge Office recommends the following 11 anchor cable (out of 52) be replaced in the 2013-15 biennium: Fn, Jn, L1n, L2n, L3n, L4n, L5n, L6n, Ms, Ns, Os</p> <p>Bridge Item cost uses \$180,000 for install and cost of each cable ...\$180k x 11 = \$1.98m Use \$300,000 to develop PS&E and construction engineering and contingencies.</p>

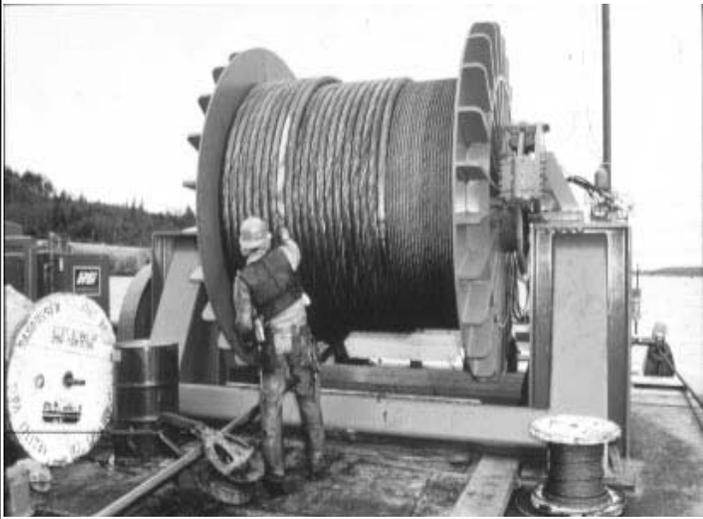
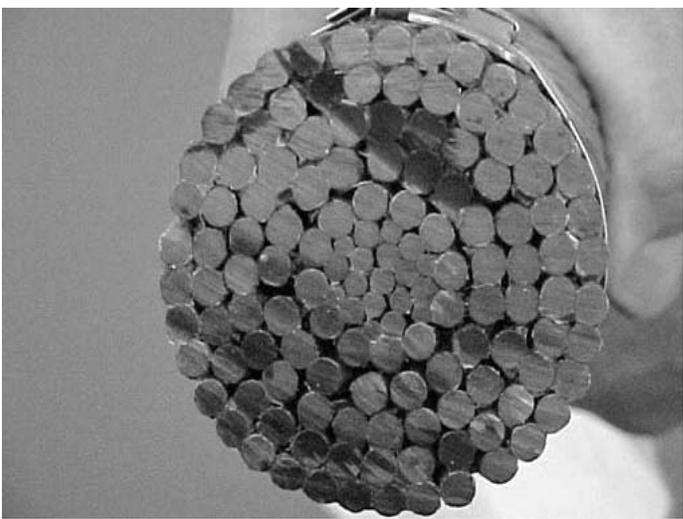
Repair Description: Replace 10 anchor cables.									
COMMENTS									
There are 10 existing anchor cables (out of a total of 52) that were installed in 1983. These anchor cables need to be replaced in the 2015-17 biennium. Cables Ane, Ase, Bs, Pn, Ps, Qs, Rne, Rnw, Rse, Rsw

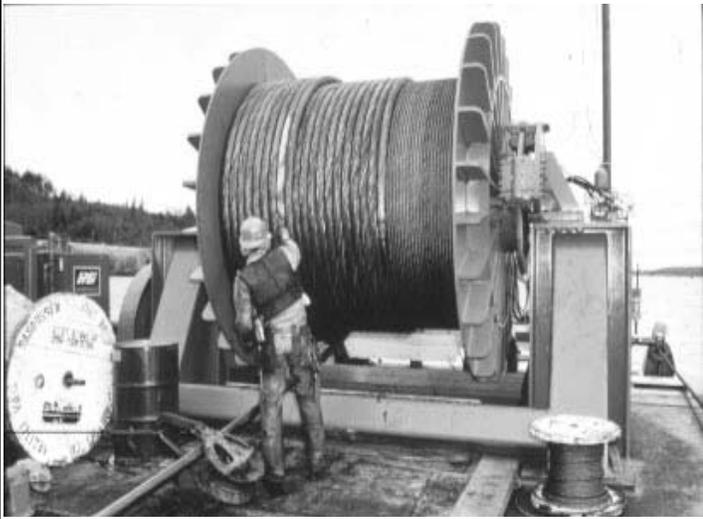
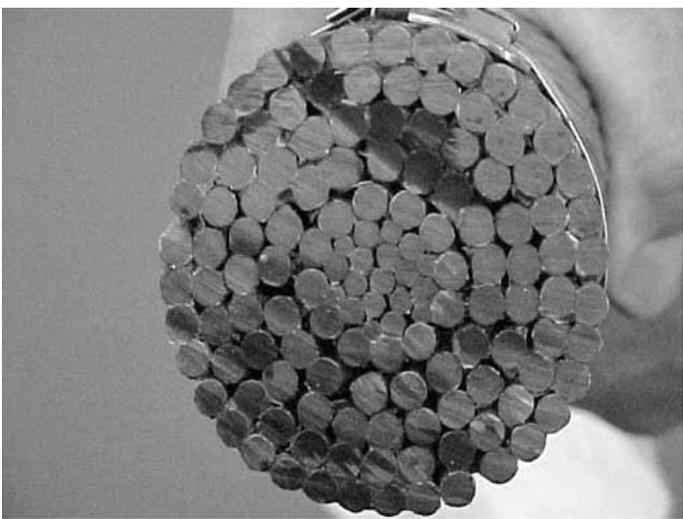
Repair Description:									
Replace 11 anchor cables.									
COMMENTS									
There are 11 existing anchor cables (out of a total of 52) that were installed in 1991. These anchor cables need to be replaced in the 2021-23 biennium. Cables Cs, Hs, Is, Js, Ks, L1s, L2s, L3s, L5s, L6s, Ls.

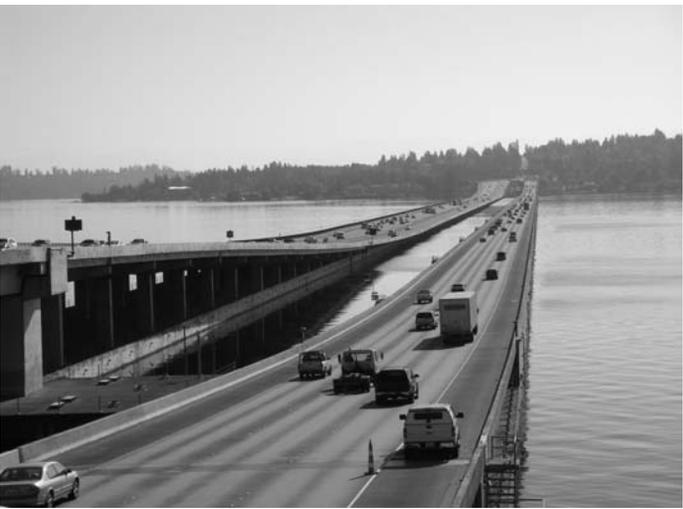
Bridge Number: 90 / 25S		Structure ID 000000KN		Bridge Name: LACEY V. MURROW BR		Milepost: 4.24		Region: Northwest	
Year Built / YR Widened: 1940 / 1992		Bridge Type: CFP SA ST CBOX		Bridge Length: 8,981 ft		Bridge Width (curb-curb): 52.0 ft		Sufficiency Rating: 61.26 SD	
Average Daily Traffic 57,401		Truck% 4%		Freight Route T-1		Num of Lanes 3			
Date Inspected: 8/26/2009		Structr Adequacy: 4		Superstr Code: 7		Safe Load: 5		Substr Code: 4	
BMS Element Num: 148		BMS Element Descr: Floating Bridge - Anchor Cable							
BMS Element Quantity: 10									
Project Number:		2013-15 Priority#: 3		Repair Year: 2015		2011-13 Priority#: 22		Bridge \$'s: \$1,800,000	
CPMS Ad Date:		Repair Total\$'s: \$2,100,000

Repair Description:
Replace 10 existing anchor cables and purchase and store 1 spare cable.

The Bridge Office recommends the following 10 anchor cables (out of 56 total) be replaced along with the purchase of 1 spare cable. Cables: Es , L1n , L2n , L3n , L4n , L5n , L6n , L4s , L5s , L6s

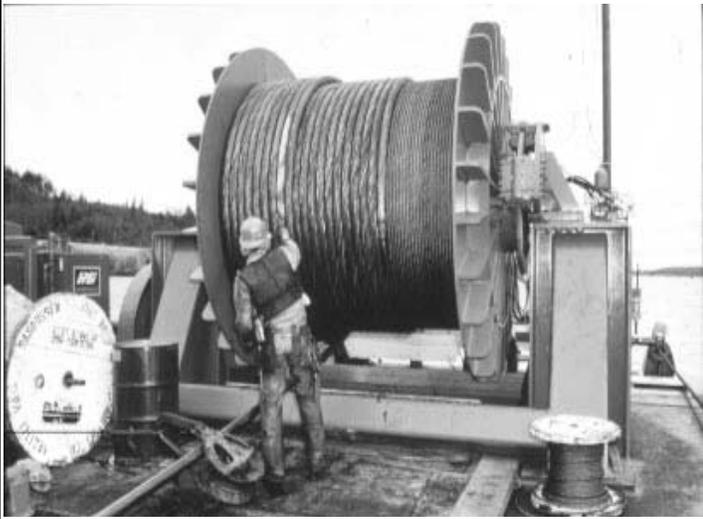
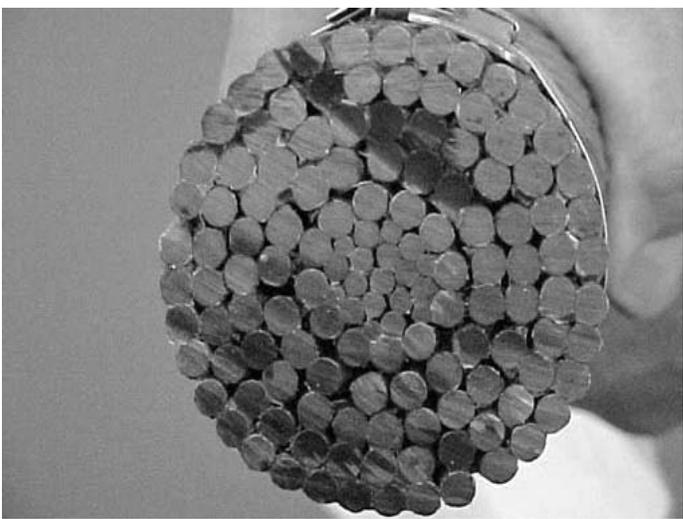
Repair Description:
Replace 15 anchor cables.

The Bridge Office recommends the following 15 anchor cables (out of 56 total) be replaced in the 2015-17 biennium:

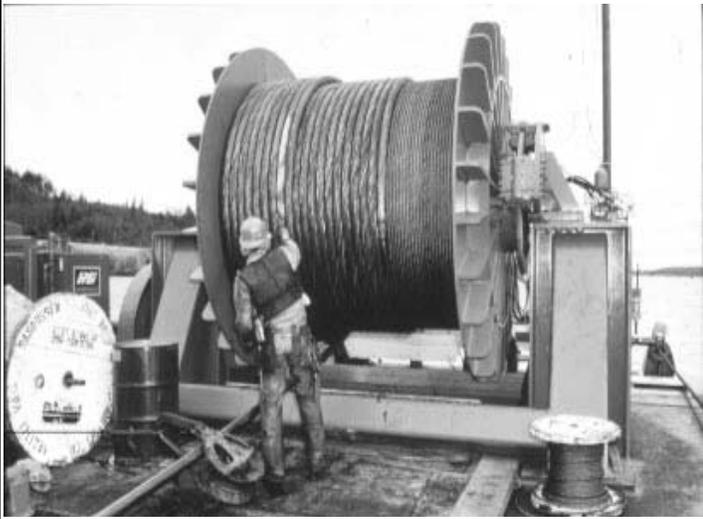
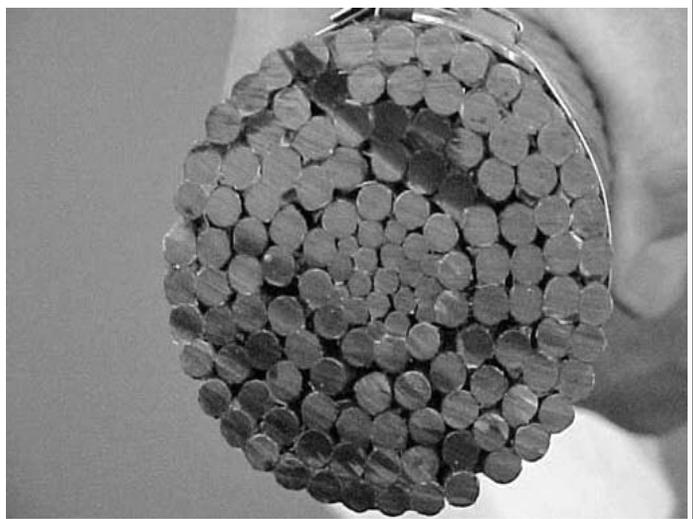
Repair Description: Replace 15 anchor cables.										
COMMENTS										
The Bridge Office recommends the following 15 (out of 56 total) existing anchor cables be replaced in the 2015-17 biennium:

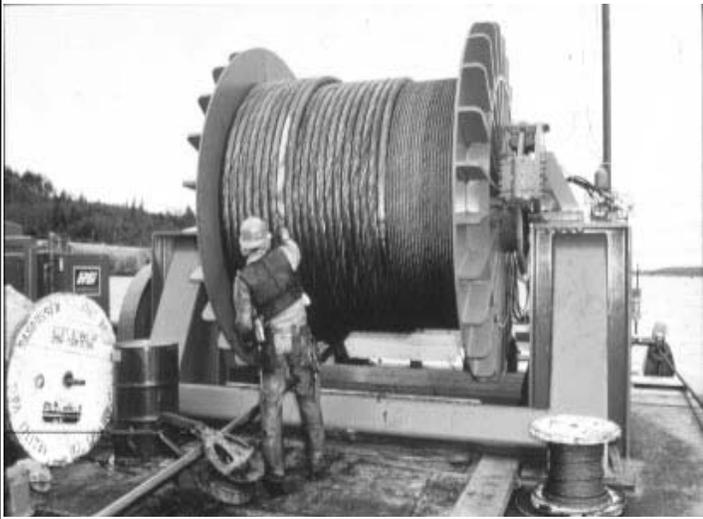
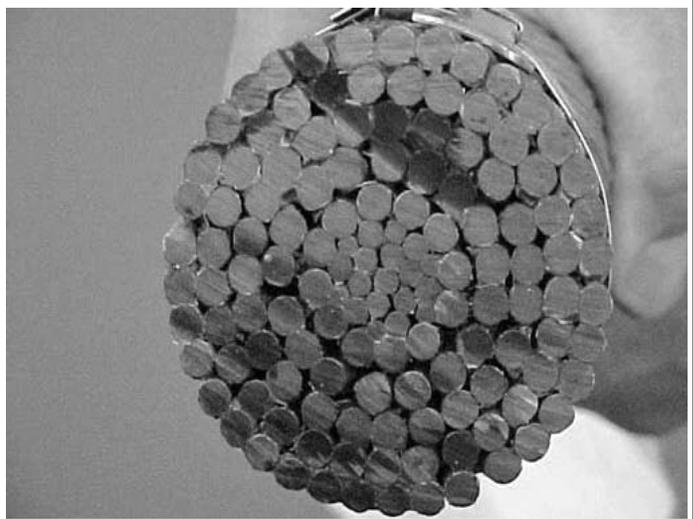
Repair Description:									
Replace 16 anchor cables.									
COMMENTS									
The Bridge Office recommends the following 16 existing anchor cables (out of 56 total) be replaced in the 2019-21 biennium:

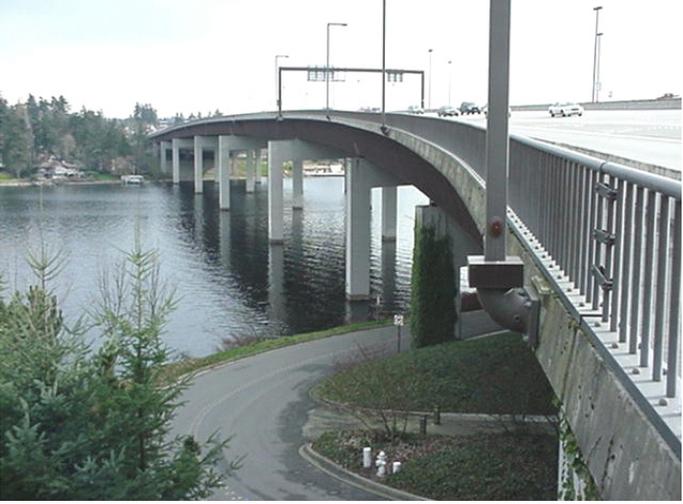
Bridge Number: 90 / 40N	Structure ID 0011490A	Bridge Name: EAST CHANNEL-LK WASH	Milepost: 8.48	Region: Northwest
Year Built / YR Widened: 1981	Bridge Type: Weathering Sbox	Bridge Length: 2,224 ft	Bridge Width (curb-curb): 80.0 ft	Sufficiency Rating: 68.74 FO
Average Daily Traffic: Truck% 67,000	Detour (miles)	Num of Lanes: 5

Date Inspected: 9/20/2010	Structr Adequacy: 4			
Superstr Code: 6	Safe Load: 5			
Substr Code: 7	Scour: 8			
BMS Element Num: 416 BMS Element Descr: Modular Expansion Joint BMS Element Quantity: 160				
Project Number:	2013-15 Priority#: 1			
Repair Year: 2014	2011-13 Priority#:			
CPMS Ad Date:	Bridge \$'s:			
	Repair Total\$'s: \$1,600,000

Repair Description: Replace the two 80 foot in length Modular expansion joints that carry westbound traffic.		Bridge Inspection Report Repair Number and Date: Repair Number: 13484 Repair Date: 9/17/2008		
COMMENTS				
The NW Region Maintenance crews performed a temporary emergency repair in Feb 2012. The expansion joint supports are deteriorating. The existing modular joints in the westbound lanes are showing signs of advanced deterioration and need to be replaced.

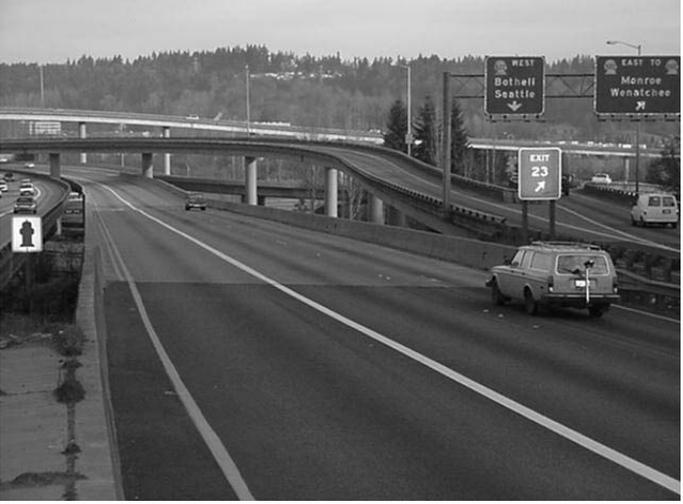
Bridge Number: 405 / 70E		Structure ID 0008382A		Bridge Name: SR 522 OC SMMAMISH R		Milepost: 23.53		Region: Northwest	
Year Built / YR Widened: 1968		Bridge Type: CB0x		Bridge Length: 1,352 ft		Bridge Width (curb-curb): 40.0 ft		Sufficiency Rating: 71.17 FO	
Average Daily Traffic 67,000		Truck% 5%		Freight Route T-1		Num of Lanes 3

Date Inspected: 11/2/2008		Structr Adequacy: 6		Superstr Code: 6		Safe Load: 5			
Substr Code: 7		Scour: 5		BMS Element Num: 415		BMS Element Descr: Exp Jnt - Rubber Bolt down			
BMS Element Quantity: 200		Project Number:		2013-15 Priority#: 16		2011-13 Priority#: 35			
Repair Year: 2014		CPMS Ad Date:		Bridge \$'s: \$100,000		Repair Total\$'s: \$300,000

<p>These expansion joints were installed in 1985 with the existing concrete overlay. Many sections of the joints are missing or have been repaired by Region Maintenance crews.</p> <p>Bridge Item cost based on \$500 / ft. Total project cost based on \$1,500 / ft.</p>

<p>Repair Description: Replace all rubber bolt down expansion joints. There are rubber bolt down expansion joints at 5 separate locations on the bridge.</p>									
<p>COMMENTS</p>

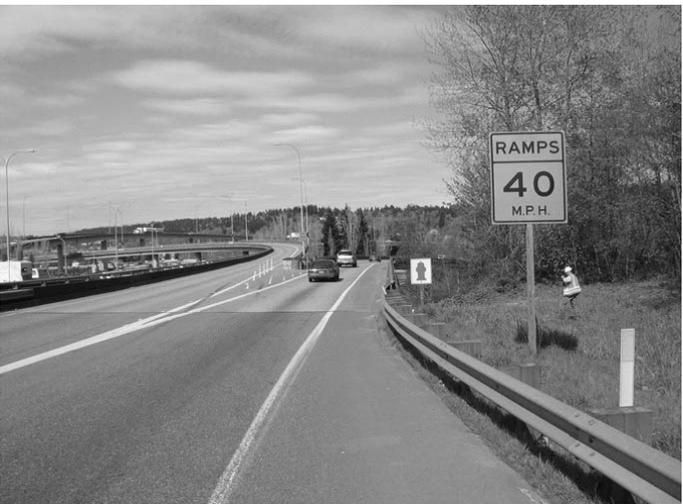
Bridge Number: 405 / 70N-E		Structure ID 0008382C		Bridge Name: N-E RAMP SAMMAMISH R		Milepost: 23.53		Region: Northwest	
Year Built / YR Widened: 1968		Bridge Type: CBox		Bridge Length: 709 ft		Bridge Width (curb-curb): 23.0 ft		Sufficiency Rating: 84.80	
Average Daily Traffic 15,791		Truck% 5%		Freight Route		Num of Lanes 1

Date Inspected: 12/4/2008		Structr Adequacy: 6		Superstr Code: 6		Safe Load: 5			
Substr Code: 7		Scour: 5		BMS Element Num: 415		BMS Element Descr: Exp Jnt - Rubber Bolt down			
BMS Element Quantity: 69		Project Number:		2013-15 Priority#: 17		2011-13 Priority#: 36			
Repair Year: 2014		Bridge \$'s: \$34,500		Repair Total\$'s: \$103,500		CPMS Ad Date:

<p>Repair Description: Replace all rubber bolt down expansion joints. There are rubber bolt down expansion joints at 3 separate locations on the bridge.</p>									
<p>COMMENTS</p>									
<p>These expansion joints were installed in 1985 with the existing concrete overlay. Many sections of the joints are missing or have been repaired by Region Maintenance crews.</p> <p>Bridge Item cost based on \$500 / ft. Total project cost based on \$1,500 / ft.</p>

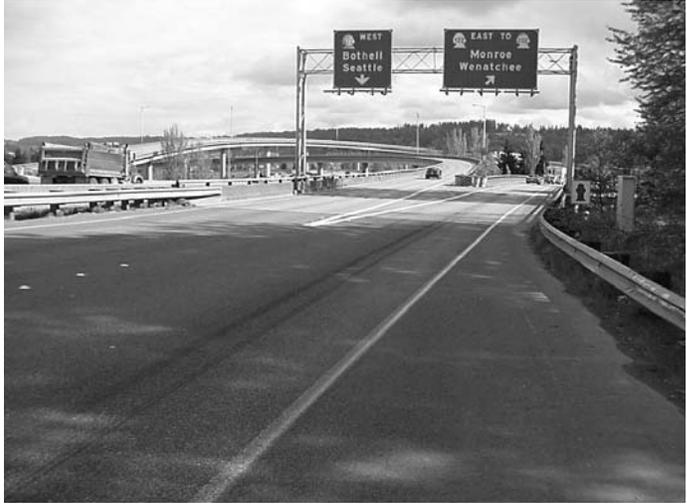
Bridge Number: 405 / 70N-W		Structure ID 0008382D		Bridge Name: N-W RAMP SAMMAMISH R		Milepost: 23.53		Region: Northwest	
Year Built / YR Widened: 1968		Bridge Type: CBox		Bridge Length: 1,469 ft		Bridge Width (curb-curb): 24.0 ft		Sufficiency Rating: 91.02 FO	
Average Daily Traffic 6,569		Truck% 5%		Freight Route		Num of Lanes 1

Date Inspected: 11/2/2008		Structr Adequacy: 6		Superstr Code: 6		Safe Load: 5			
Substr Code: 7		Scour: 5		BMS Element Num: 415		BMS Element Descr: Exp Jnt - Rubber Bolt down			
BMS Element Quantity: 120		Project Number:		2013-15 Priority#: 18		2011-13 Priority#: 37			
Repair Year: 2014		CPMS Ad Date:		Bridge \$'s: \$60,000		Repair Total\$'s: \$180,000

<p>Repair Description: Replace all rubber bolt down expansion joints. There are rubber bolt down expansion joints at 5 separate locations on the bridge.</p>									
<p>COMMENTS</p>									
<p>These expansion joints were installed in 1985 with the existing concrete overlay. Many sections of the joints are missing or have been repaired by Region Maintenance crews.</p> <p>Bridge Item cost based on \$500 / ft. Total project cost based on \$1,500 / ft.</p>

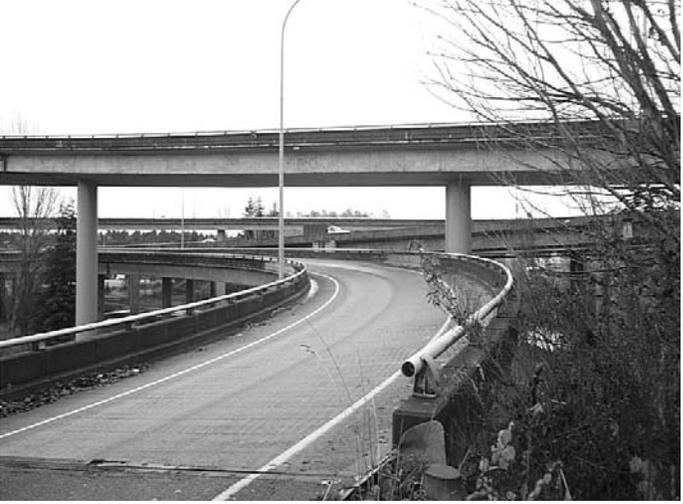
Bridge Number: 405 / 70S-E		Structure ID 0008382E		Bridge Name: S-E RAMP BR		Milepost: 23.53		Region: Northwest	
Year Built / YR Widened: 1968		Bridge Type: CBox		Bridge Length: 433 ft		Bridge Width (curb-curb): 25.0 ft		Sufficiency Rating: 93.18 FO	
Average Daily Traffic 8,568		Truck% 5%		Freight Route		Num of Lanes 1

Date Inspected: 7/15/2009		Structr Adequacy: 7		Superstr Code: 7		Safe Load: 5			
Substr Code: 7		Scour: N		BMS Element Num: 415		BMS Element Descr: Exp Jnt - Rubber Bolt down			
BMS Element Quantity: 50		Project Number:		2013-15 Priority#: 19		2011-13 Priority#: 38			
Repair Year: 2014		CPMS Ad Date:		Bridge \$'s: \$25,000		Repair Total\$'s: \$75,000

<p>Repair Description: Replace all rubber bolt down expansion joints. There are rubber bolt down expansion joints at 2 separate locations on the bridge.</p>									
<p style="text-align: center;">COMMENTS</p> <p>These expansion joints were installed in 1985 with the existing concrete overlay. Many sections of the joints are missing or have been repaired by Region Maintenance crews.</p> <p>Bridge Item cost based on \$500 / ft. Total project cost based on \$1,500 / ft.</p>

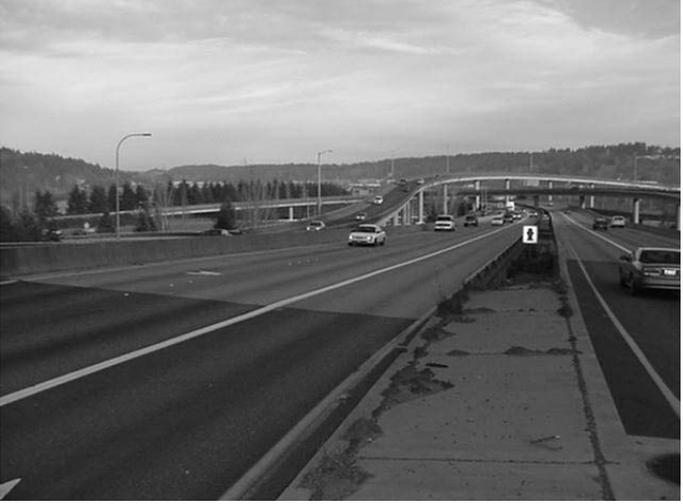
Bridge Number: 405 / 70W		Structure ID 0008382B		Bridge Name: SR 522 OC SMMAMISH R		Milepost: 23.53		Region: Northwest	
Year Built / YR Widened: 1968		Bridge Type: CBox		Bridge Length: 1,410 ft		Bridge Width (curb-curb): 34.5 ft		Sufficiency Rating: 59.07 FO	
Average Daily Traffic 67,000	Truck% 5%	Freight Route T-1	Num of Lanes 3

Date Inspected: 11/1/2008		Structr Adequacy: 5							
Superstr Code: 7		Safe Load: 5							
Substr Code: 7		Scour: 5							
BMS Element Num: 415		BMS Element Descr: Exp Jnt - Rubber Bolt down							
BMS Element Quantity: 192									
Project Number:		2013-15 Priority#: 20							
Repair Year: 2014		2011-13 Priority#: 39							
CPMS Ad Date:		Bridge \$'s: \$100,000							
		Repair Total\$'s: \$288,000

COMMENTS									
These expansion joints were installed in 1985 with the existing concrete overlay. Many sections of the joints are missing or have been repaired by Region Maintenance crews.									
Bridge Item cost based on \$500 / ft. Total project cost based on \$1,500 / ft.

Repair Description:									
Replace all rubber bolt down expansion joints. There are rubber bolt down expansion joints at 5 separate locations on the bridge.

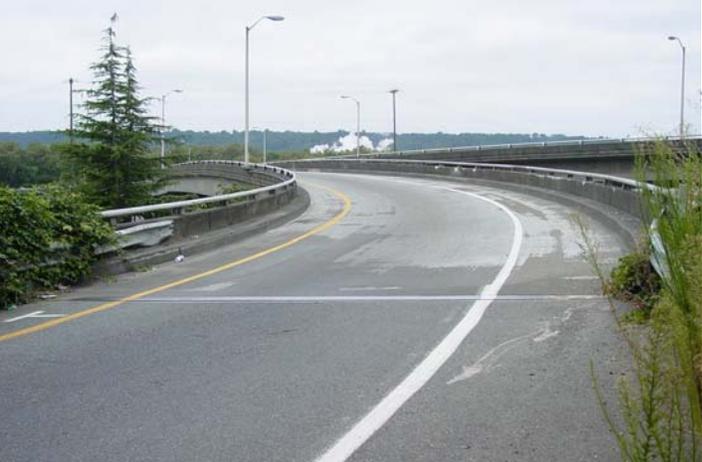
<p style="text-align: center;">BRIDGE DATA</p> <p>BRIDGE NUMBER: 5/534N-W MP: 161.27 BRIDGE NAME: N-W RAMP RR OC REGION: Northwest YEAR BUILT / YR WIDENED: 1967 SUFFICIENCY RATING: 91.66 BRIDGE TYPE: CBox BRIDGE WIDTH: 21.0 ft. BRIDGE LENGTH: 291 ft. AVERAGE DAILY TRAFFIC: 4,416 NUMBER OF LANES: 1 SIDEWALK / CURB WIDTH: 1.3 Lt 1.3 Rt CURB HEIGHT: in</p>	<p style="text-align: center;">BRIDGE PHOTO</p>

1/1/2004	016695	REMOVE THIN PC OVERLAY													
3/16/1990	013737	THIN PC OVERLAY													
<p style="text-align: center;">BRIDGE RAIL</p> <p>BRIDGE RAIL TYPE: Conc Base - Type R RAIL MEETS CURRENT STANDARDS? YES RAIL CONTRACT HISTORY</p>	<p style="text-align: center;">BRIDGE RESURFACING / DECK COMMENTS</p> <p>A 3/8 inch polymer overlay was applied in 1990 (Sika-epoxy) and was removed in 2004.</p> <p>This bridge has nearly 0.5% of the deck with patching and delaminations. In other cases we would wait to schedule a protective overlay until the amount is over 2% but this bridge is connected to Bridge 5/534S-W and 5/534N-W so all three bridges must be included together in the same project.</p>														
<p style="text-align: center;">EXPANSION JOINTS</p> <p>Coordinate with your Region's Maintenance Office to determine if any repairs are required. No modifications required at this time.</p> <p>EXPANSION JOINT CONTRACT HISTORY</p>

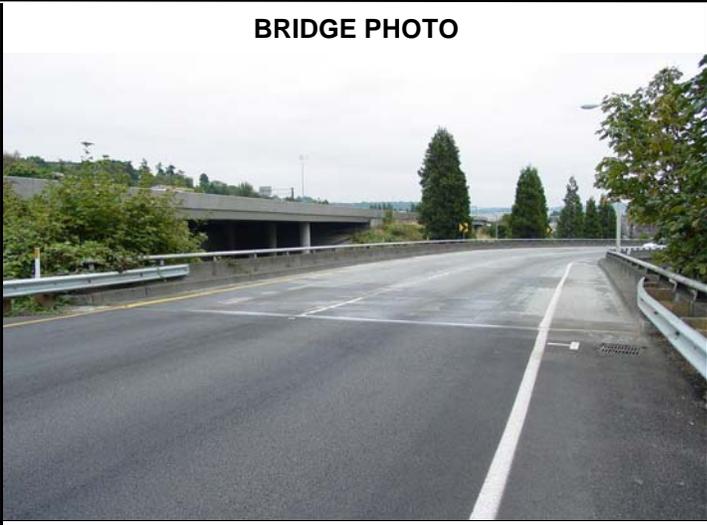
<p style="text-align: center;">BRIDGE DATA</p> <p>BRIDGE NUMBER: 5/534S-W MP: 161.28 BRIDGE NAME: S-W RAMP OVER LUCILE ST REGION: Northwest YEAR BUILT / YR WIDENED: 1967 SUFFICIENCY RATING: 69.86 SD BRIDGE TYPE: CBox BRIDGE WIDTH: 31.0 ft. BRIDGE LENGTH: 550 ft. AVERAGE DAILY TRAFFIC: 12,901 NUMBER OF LANES: 2 SIDEWALK / CURB WIDTH: 1.5 Lt 1.5 Rt CURB HEIGHT: in</p>	<p style="text-align: center;">BRIDGE PHOTO</p>

1/1/2004	016695	REMOVE THIN PC OVERLAY													
3/16/1990	013737	THIN PC OVERLAY													
<p style="text-align: center;">BRIDGE RAIL</p> <p>BRIDGE RAIL TYPE: Conc Base - Type R RAIL MEETS CURRENT STANDARDS? YES RAIL CONTRACT HISTORY</p>	<p style="text-align: center;">BRIDGE RESURFACING / DECK COMMENTS</p> <p>Deck Rehabilitation: Place 1.5" modified concrete overlay using hydromilling. Expansion Joint modification is required.</p>														
<p style="text-align: center;">EXPANSION JOINTS</p> <p>Coordinate with your Region's Maintenance Office to determine if any repairs are required. No modifications required at this time.</p> <p>EXPANSION JOINT CONTRACT HISTORY</p>															
<p>BRG NUMBER: 5 / 534S-W BRIDGE DECK HMA PAVING DESIGN OPTIONS Max. Bridge HMA Depth:</p>															
<table border="1" style="width:100%; border-collapse: collapse;"> <thead> <tr> <th rowspan="2">DESCRIPTION</th> <th rowspan="2">PAVING CLASSIFICATION</th> <th rowspan="2">EXISTING HMA DEPTH</th> <th colspan="2">MAX. PLANE DEPTH</th> <th rowspan="2">PAVING HMA DEPTH</th> </tr> <tr> <th>PART./FULL</th> <th>DEPTH</th> </tr> </thead> <tbody> <tr> <td style="height: 40px;"> </td> <td> </td> <td> </td> <td> </td> <td> </td> <td> </td> </tr> </tbody> </table>		DESCRIPTION	PAVING CLASSIFICATION	EXISTING HMA DEPTH	MAX. PLANE DEPTH		PAVING HMA DEPTH	PART./FULL	DEPTH

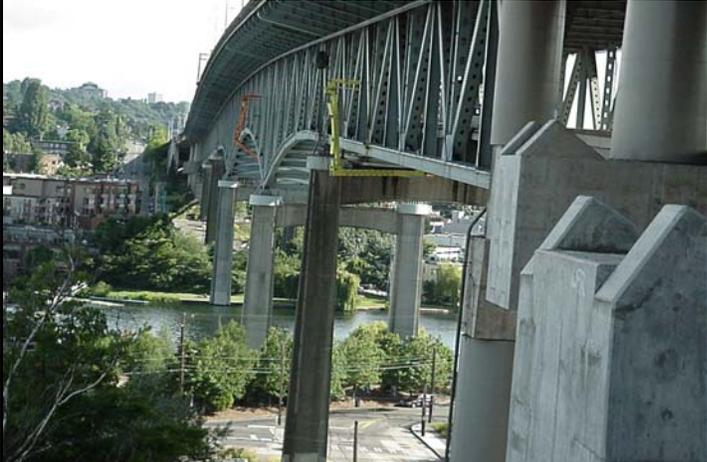
<p style="text-align: center;">BRIDGE DATA</p> <p>BRIDGE NUMBER: 5/570 MP: 169.63 BRIDGE NAME: LAKE WASH SHIP CANAL REGION: Northwest YEAR BUILT / YR WIDENED: 1962 SUFFICIENCY RATING: 52.99 FO BRIDGE TYPE: STrus CBox CS BRIDGE WIDTH: 174.0 ft. BRIDGE LENGTH: 4,429 ft. AVERAGE DAILY TRAFFIC: 198,025 NUMBER OF LANES: 12 SIDEWALK / CURB WIDTH: 0.0 Lt 0.7 Rt CURB HEIGHT: in</p>	<p style="text-align: center;">BRIDGE PHOTO</p>

3/1/1985	012878	LMC OVERLAY													
5/1/1984	012688	LMC OVERLAY - NB													
<p style="text-align: center;">BRIDGE RAIL</p> <p>BRIDGE RAIL TYPE: New Jersey Barrier RAIL MEETS CURRENT STANDARDS? YES RAIL CONTRACT HISTORY</p> <table border="1" style="width:100%; border-collapse: collapse;"> <tr> <td style="width:25%;">10/1/1986</td> <td style="width:25%;">013194</td> <td style="width:50%;">NEW JERSEY BARRIER</td> </tr> <tr> <td>4/1/1970</td> <td>008790</td> <td>TYPE-R RAIL RETROFIT</td> </tr> </table>	10/1/1986	013194	NEW JERSEY BARRIER	4/1/1970	008790	TYPE-R RAIL RETROFIT	<p style="text-align: center;">BRIDGE RESURFACING / DECK COMMENTS</p> <p>The upper deck has a LMC overlay that was applied in 1984. The combination of rutting and maintenance patching will likely require the modified concrete to need to be replaced by 2020.</p> <p>The lower deck does not have an overlay. A 3/4" polyester may be used to overlay this deck.</p>

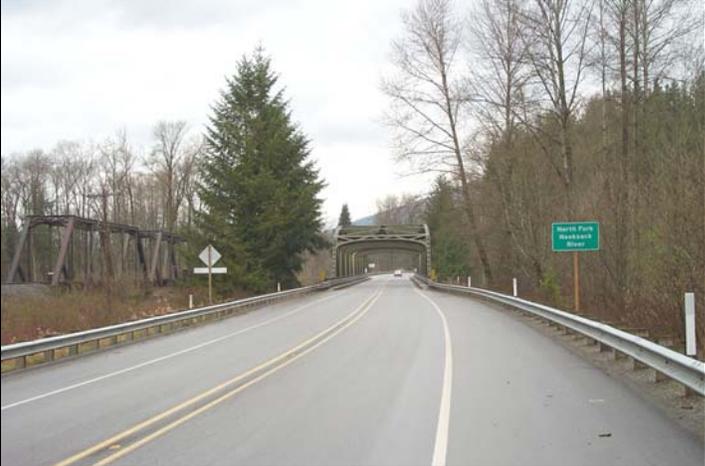
<p style="text-align: center;">BRIDGE DATA</p> <p>BRIDGE NUMBER: 9/315 MP: 78.87 BRIDGE NAME: N FK NOOKSACK R U S REGION: Northwest YEAR BUILT / YR WIDENED: 1954 SUFFICIENCY RATING: 44.48 SD BRIDGE TYPE: STrus CTB BRIDGE WIDTH: 26.0 ft. BRIDGE LENGTH: 410 ft. AVERAGE DAILY TRAFFIC: 3,600 NUMBER OF LANES: 2 SIDEWALK / CURB WIDTH: 2.5 Lt 2.5 Rt CURB HEIGHT: in</p>	<p style="text-align: center;">BRIDGE PHOTO</p>

5/1/1993	014264	THIN PC OVERLAY													
<p style="text-align: center;">BRIDGE RAIL</p> <p>BRIDGE RAIL TYPE: Steel Post - Thrie Beam RAIL MEETS CURRENT STANDARDS? YES RAIL CONTRACT HISTORY</p> <table border="1" style="width:100%; border-collapse: collapse;"> <tr> <td style="width:33%;">5/1/1993</td> <td style="width:33%;">014264</td> <td style="width:33%;">THRIE BEAM RETROFIT</td> </tr> </table>	5/1/1993	014264	THRIE BEAM RETROFIT	<p style="text-align: center;">BRIDGE RESURFACING / DECK COMMENTS</p> <p>A 3/8" Polymer overlay (Degussa-MMA) was applied to the concrete deck in 1993.</p> <p>Bridge Inspection data indicates over 6% of the overlay has deterioration and it is estimated that over 3% of the concrete deck has deterioration.</p> <p>We recommend hydromilling 1" of the existing concrete deck and applying a 1.5" modified concrete overlay.</p>											
5/1/1993	014264	THRIE BEAM RETROFIT

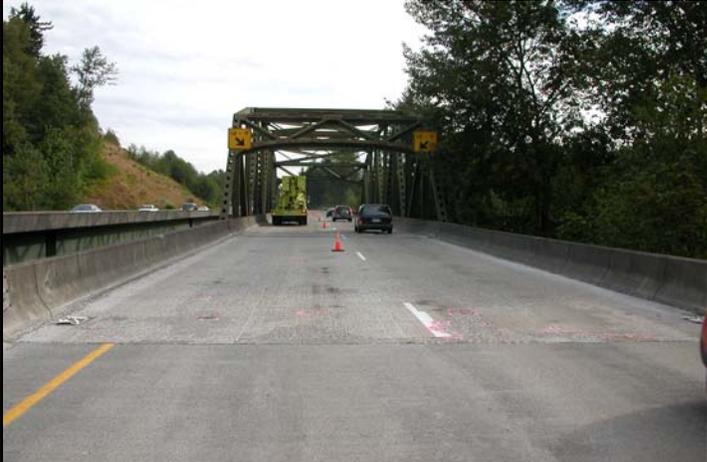
<p style="text-align: center;">BRIDGE DATA</p> <p>BRIDGE NUMBER: 18/17S MP: 6.62 BRIDGE NAME: GREEN R (NEELEY BRIDGE) REGION: Northwest YEAR BUILT / YR WIDENED: 1959 SUFFICIENCY RATING: 35.45 SD BRIDGE TYPE: STrus CBox BRIDGE WIDTH: 29.5 ft. BRIDGE LENGTH: 371 ft. AVERAGE DAILY TRAFFIC: 23,922 NUMBER OF LANES: 2 SIDEWALK / CURB WIDTH: 0.0 Lt 0.0 Rt CURB HEIGHT: in</p>	<p style="text-align: center;">BRIDGE PHOTO</p>

5/1/2003	016590	REMOVE 3/8" THIN PC OLAY																			
2/1/1994	014354	3/8" THIN PC OLAY																			
<p style="text-align: center;">BRIDGE RAIL</p> <p>BRIDGE RAIL TYPE: New Jersey Barrier RAIL MEETS CURRENT STANDARDS? YES RAIL CONTRACT HISTORY</p> <table border="1" style="width:100%; border-collapse: collapse;"> <tr> <td style="width:25%;">7/1/1985</td> <td style="width:25%;">012988</td> <td style="width:50%;">NEW JERSEY BARRIER</td> </tr> </table>	7/1/1985	012988	NEW JERSEY BARRIER	<p style="text-align: center;">BRIDGE RESURFACING / DECK COMMENTS</p> <p>P2 Program will place a 1.5" Modified Concrete overlay with 1.5" hydromill scarification. Joint modifications may be required.</p>																	
7/1/1985	012988	NEW JERSEY BARRIER																			
<p style="text-align: center;">EXPANSION JOINTS</p> <p>Coordinate with the Maintenance office to determine if any repairs are required.</p> <p>EXPANSION JOINT CONTRACT HISTORY</p> <table border="1" style="width:100%; border-collapse: collapse;"> <tr> <td style="width:25%;">5/1/2003</td> <td style="width:25%;">016590</td> <td style="width:50%;">APPLY RCS TO TRUSS DCK JNTS</td> </tr> <tr> <td>2/1/1994</td> <td>014354</td> <td>NEW STRIP SEALS</td> </tr> </table>	5/1/2003	016590	APPLY RCS TO TRUSS DCK JNTS	2/1/1994	014354	NEW STRIP SEALS

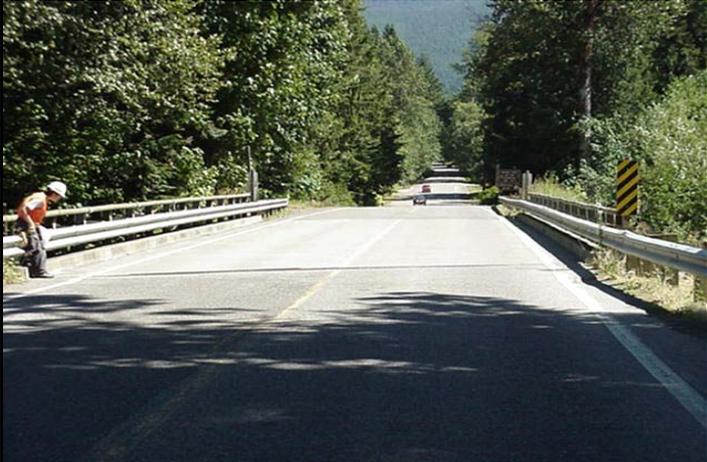
<p style="text-align: center;">BRIDGE DATA</p> <p>BRIDGE NUMBER: 542/33 MP: 33.49 BRIDGE NAME: GLACIER CR REGION: Northwest YEAR BUILT / YR WIDENED: 1956 SUFFICIENCY RATING: 48.98 FO BRIDGE TYPE: SG BRIDGE WIDTH: 26.0 ft. BRIDGE LENGTH: 84 ft. AVERAGE DAILY TRAFFIC: 1,720 NUMBER OF LANES: 2 SIDEWALK / CURB WIDTH: 0.0 Lt 0.0 Rt CURB HEIGHT: in</p>	<p style="text-align: center;">BRIDGE PHOTO</p>

2/1/1985	012865	LMC OVERLAY																	
<p style="text-align: center;">BRIDGE RAIL</p> <p>BRIDGE RAIL TYPE: Steel Post - Thrie Beam RAIL MEETS CURRENT STANDARDS? YES RAIL CONTRACT HISTORY</p> <table border="1" style="width:100%; border-collapse: collapse;"> <tr> <td style="width:33%;">7/1/2004</td> <td style="width:33%;">016821</td> <td style="width:33%;">THRIE BEAM RETROFIT</td> </tr> <tr> <td>2/1/1985</td> <td>012865</td> <td>TYPE 6 BR RAIL</td> </tr> </table>	7/1/2004	016821	THRIE BEAM RETROFIT	2/1/1985	012865	TYPE 6 BR RAIL	<p style="text-align: center;">BRIDGE RESURFACING / DECK COMMENTS</p> <p>Inspection information indicates a significant amount of patching and deterioration in the existing concrete overlay.</p> <p>We recommend removing the existing concrete overlay and replacing it with a new modified concrete overlay.</p>												
7/1/2004	016821	THRIE BEAM RETROFIT

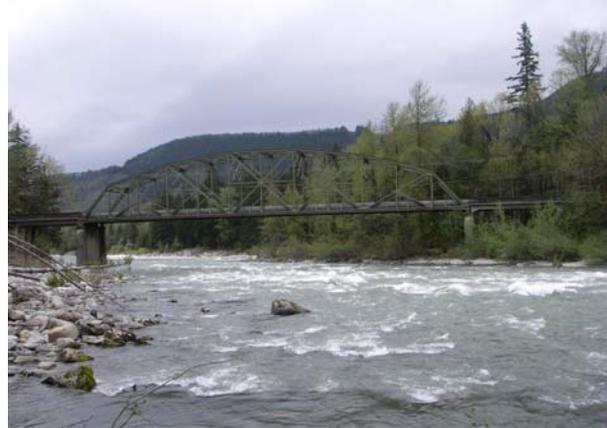
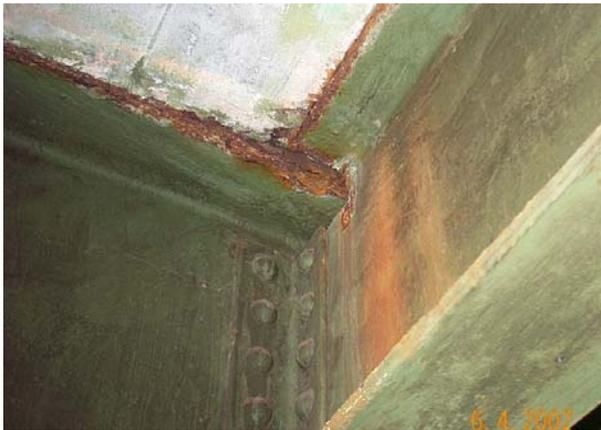
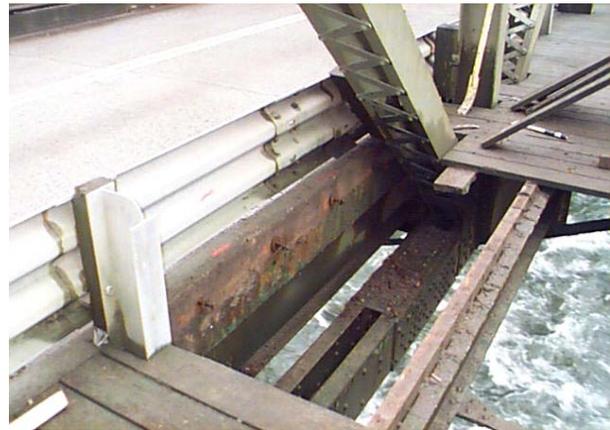
Bridge Inspection Notes:

Painted stringers, floorbeams, and truss has some peeling and curling paint. Paint protection has failed at the floorbeam and stringer top flange to deck interface. Rust with section loss, up to 5%, in top flanges of the stringers at interface with the deck. Floorbeams top flanges show up to 10% section loss.

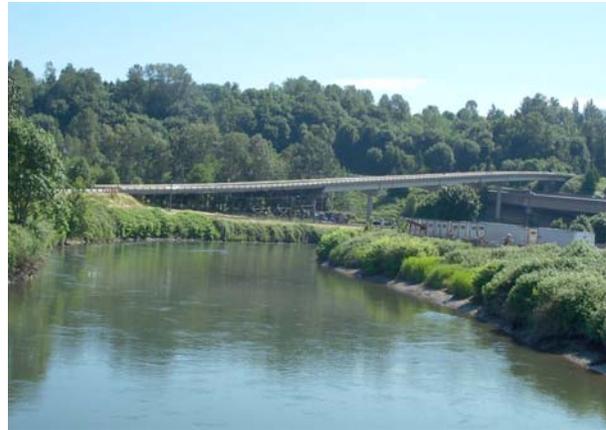
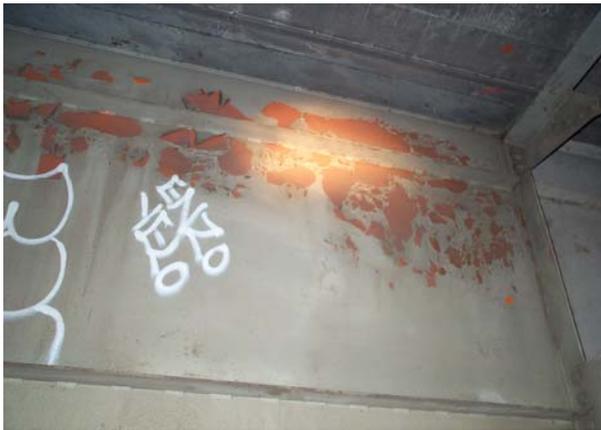
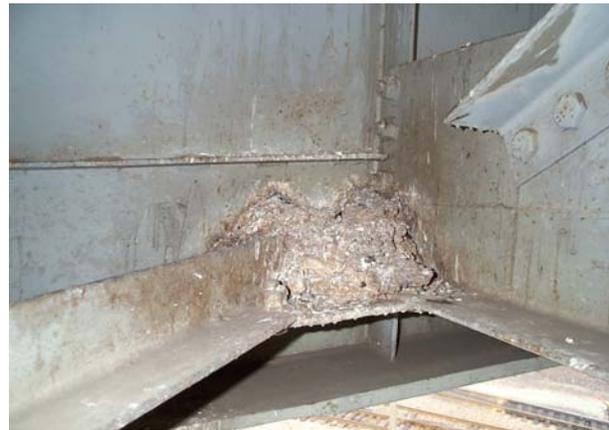
Top flange rust in exterior stringers at sidewalk joints. Rust blooms in both top and bottom flanges. Large piles of pigeon guano on bottom lateral gusset plates. Fire damage at east abutment burnt an area of the paint but no significant damage. Peeling paint is more prevalent in Spans 1 and 2.

Contain steel spans, use a SP7 Sweep blast, overcoat with a 2 coat moisture cured urethane.
