P2 Bridge Preservation - Replacement/Rehab Projects

2013-15 Bien Priority Array

Bridge Repair Form

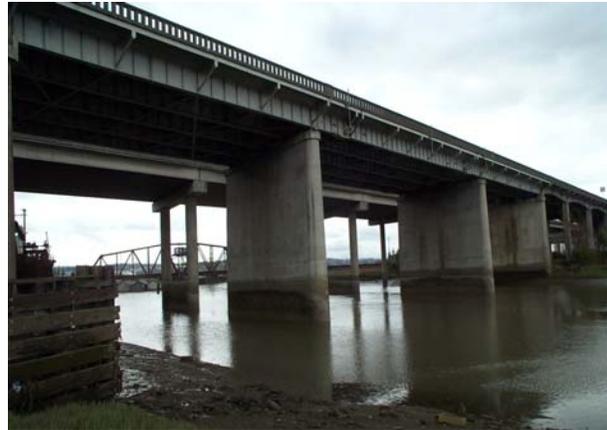
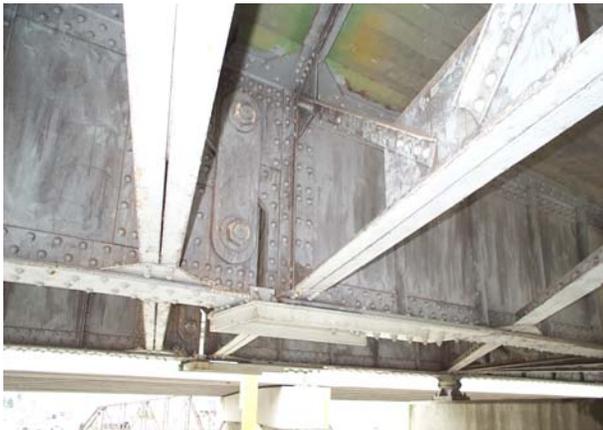
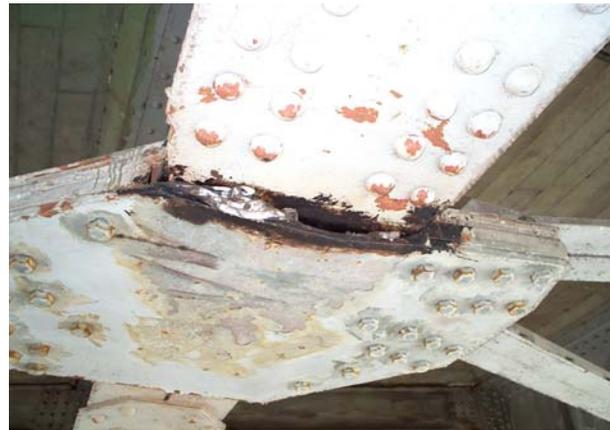
"A few small areas of missing paint on the bottom flanges. Light top flange rust on beams and cross brace channels below the deck slab joint over piers 24 and 25. Pigeon nests and guano on lateral gusset plates and bottom flanges. Center wind locks over plate under south link & pins in span 24 is rusted and jammed with 5/8" of rust pack."

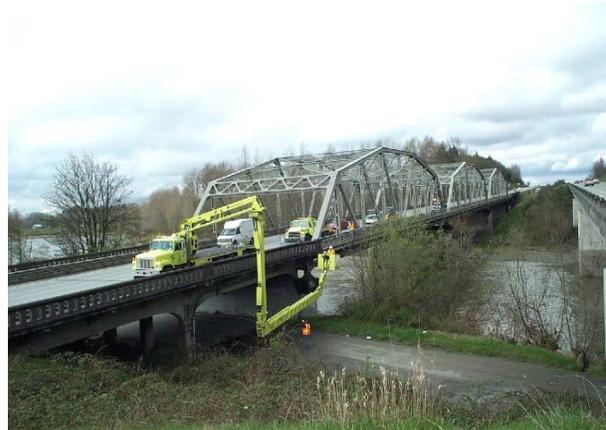
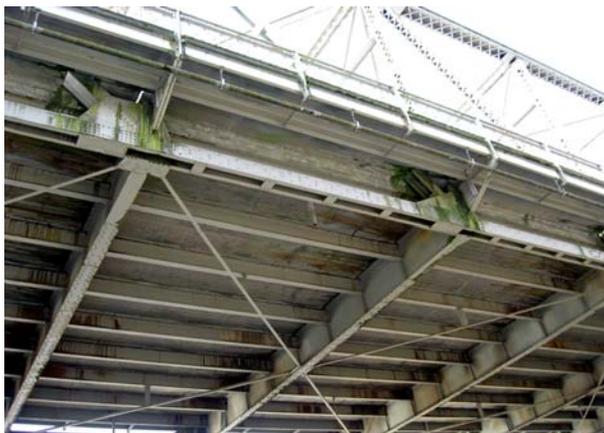
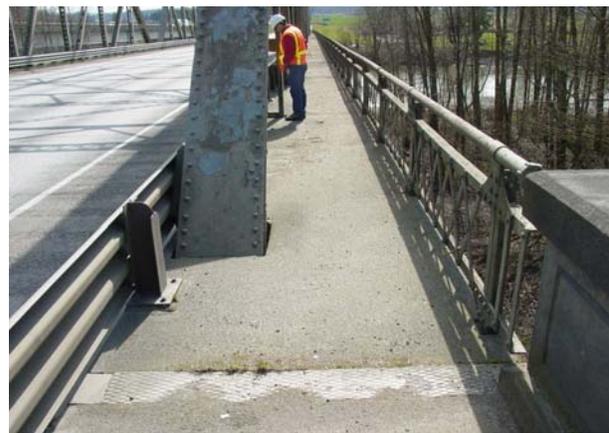
The 1993 painting contract was one of the first in the state that required the containment and disposal of the abrasives used to prepare the steel surfaces. The inspection report says that there is "small rust blooms scattered throughout. Some rust at bottom gusset connections to the bottom chord. Rust staining on top flanges of stringers and floorbeams." As part of the cost estimate for the next painting project, an assumption of 15% of the total steel area will need abrasive blasting.

The bridge deck is scheduled to be replaced in the 2013-15 biennium. The bridge painting should follow the deck replacement in a separate project.

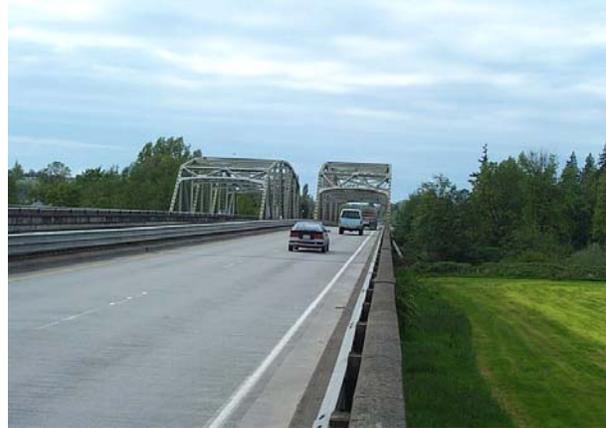
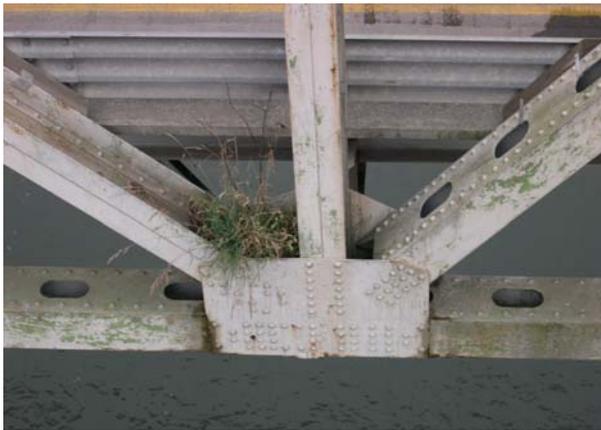
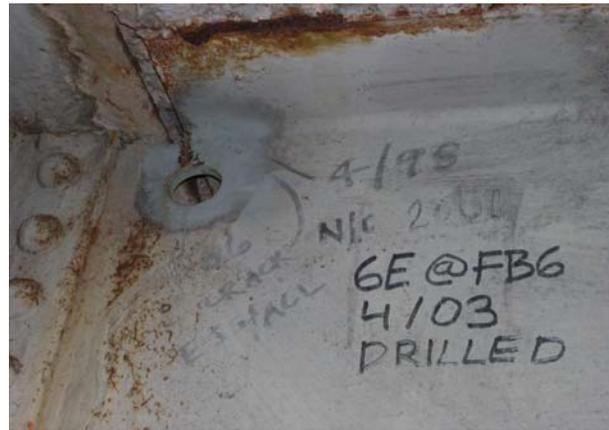
The paint system is chalking, peeling, and curling. Paint has peeled up to 10% of area to exposed rusty metal. Paint has peeled up to 30% of area without exposed metal.

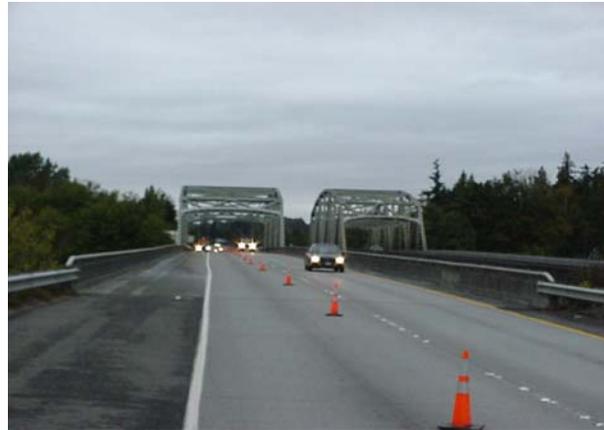
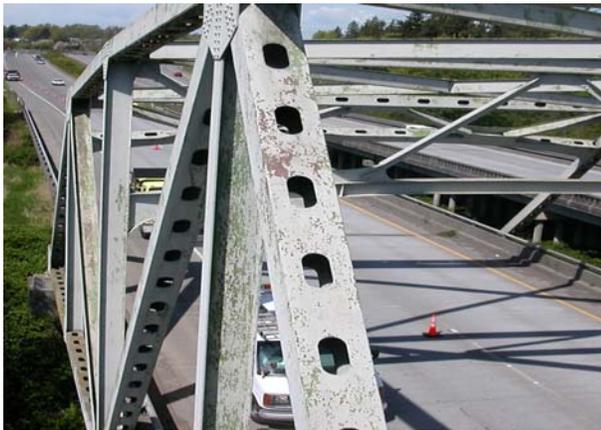
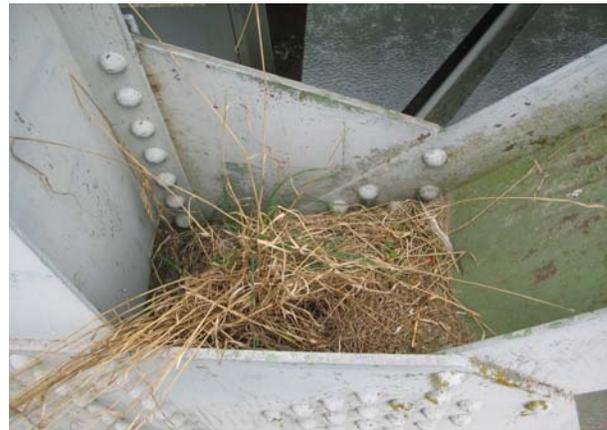
STEEL STRINGERS - Some of the ends near the floor beams are rusting in the top flange.

FLOOR BEAMS - Top flange of the floor beams are rusting with up to 5% section loss. The top flange at the ends has the most advanced rusting.

TRUSS BOTTOM CHORD - Pack rust between the bottom lateral gusset plates and the bottom chord with a few starting to bulge. Paint is peeling with over 40% gone exposing the previous paint. The top paint is not adhering to the bottom paint. Pigeon quano noted.

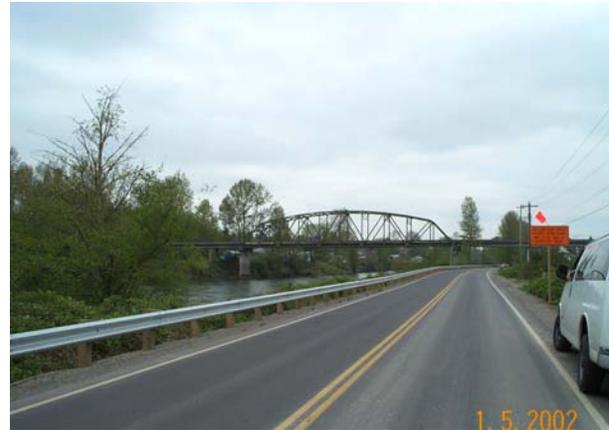
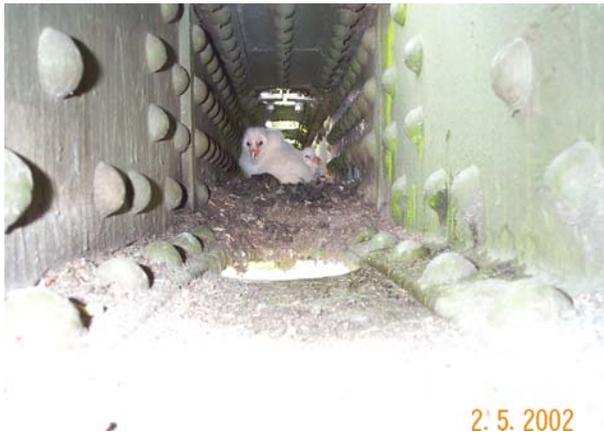
Truss members are moss covered and have peeling paint. Inside faces have more peeling paint than the outside faces. There is bird guano and dirt accumulations up to 3" deep in joint areas. The gray primer is exposed and peeling paint as noted: Top Chord - 80% gone; Diagonals - 40% gone; Bottom Chord - 50% gone.

Full removal of the paint is warranted based on the condition of the existing paint.

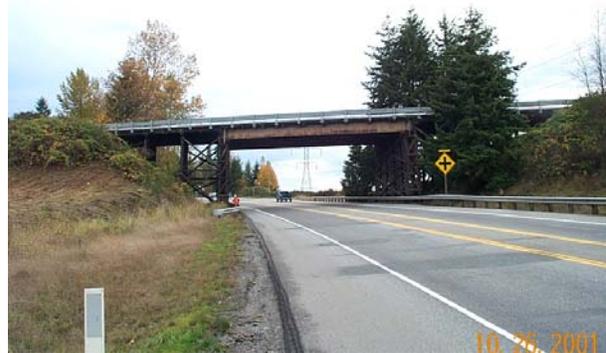
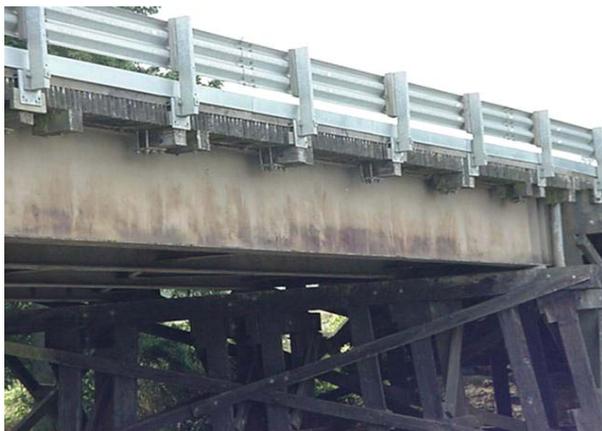
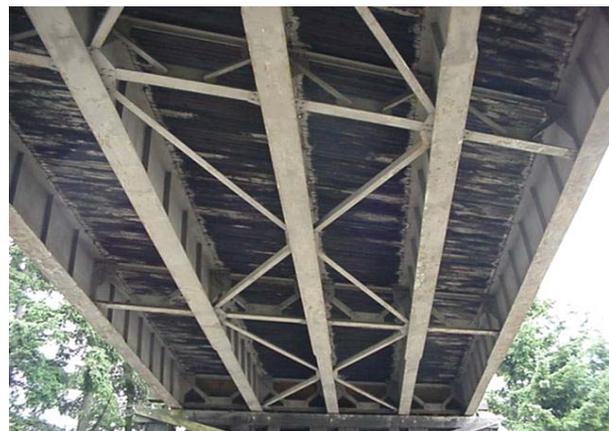
Spots of surface rust throughout. Peeled paint and sheet rust on girder end bottom flanges and on flange edges. Rust freckles on many bolts and end cross bracing elements.

Use a containment system, prepare steel using SP7 Sweep blast, apply a three coat rust penetrating sealer paint system.

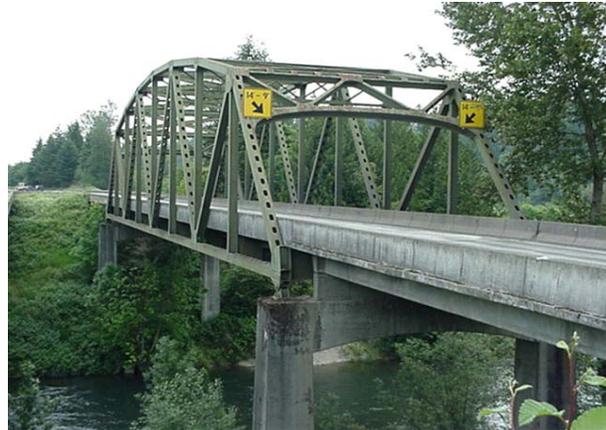
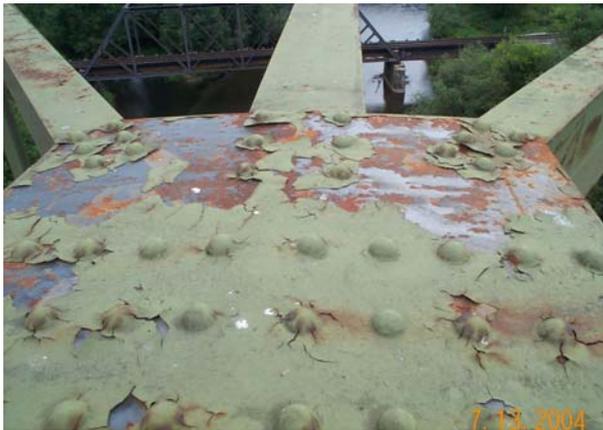
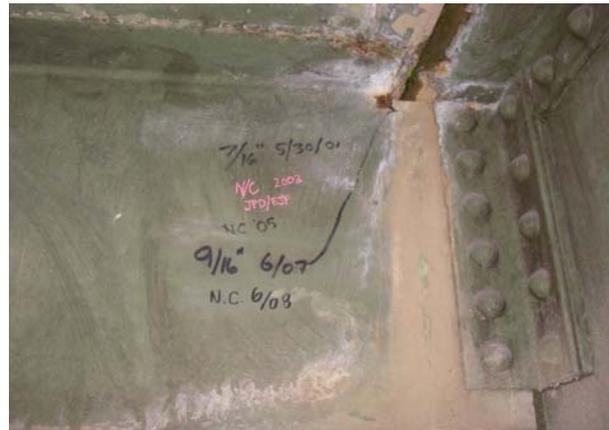
Rusting in sliding joints at stringers and on top flanges of stringer near floor beams. Rusting in several exposed areas at floor beams.

TRUSS: Mossy growth on paint with a few pits and rust blooms. Rust blooms on portals and top sways throughout. Paint peeling off in sheets on W. portal frame.

FLOOR BEAMS: Mud and rust staining on the top flanges, webs and bottom flanges. Sheet rust on the bottom side of the top flange up to 1/8" deep. Top flange has 5-10% section loss, mostly near the end of the floor beams.

Full removal of the paint is warranted based on existing paint condition.

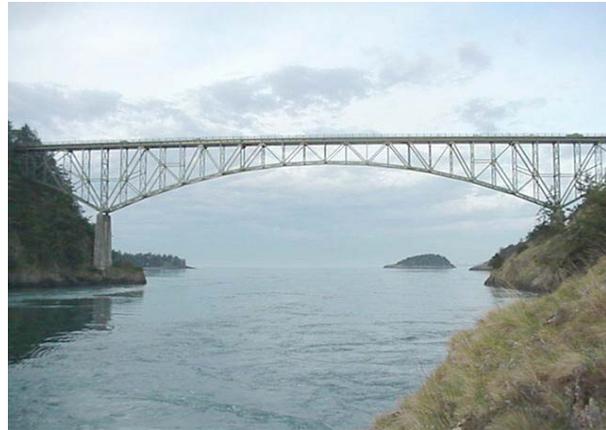
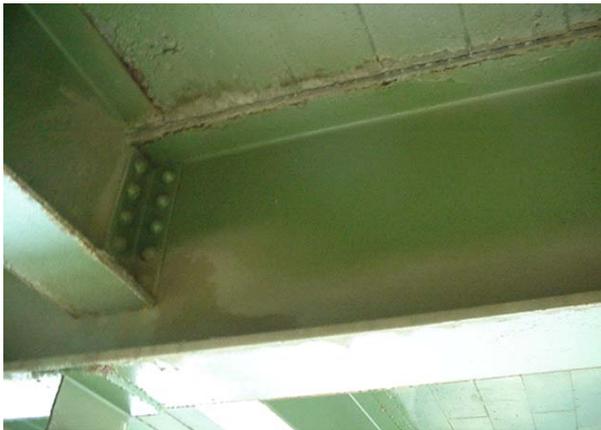
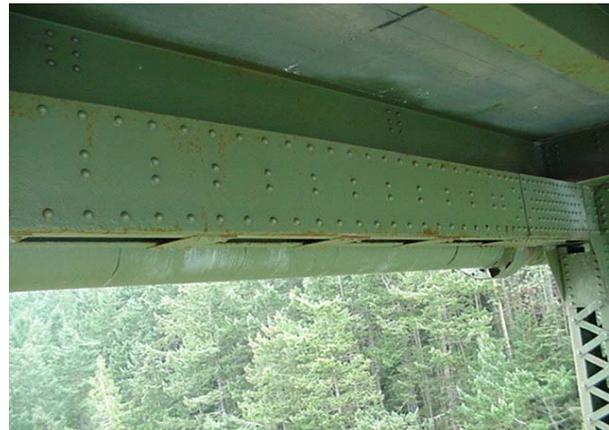
Up to 10% section loss was noted in the top and bottom flanges of the stringers prior to being painted in 1998. Rust at interface between top flanges and deck. Surface rust with some pitting. Pack rust in the bottom flanges and bearing seats with up to 50% section loss, especially Stringers A and E. There are many areas that are rusting through the paint. Paint preparation and thickness varied greatly throughout the bridge from several layers of paint protection to over spray with no preparation to the metal. Rust stains on several of the members. Surface rust on several of the stringers and truss members.

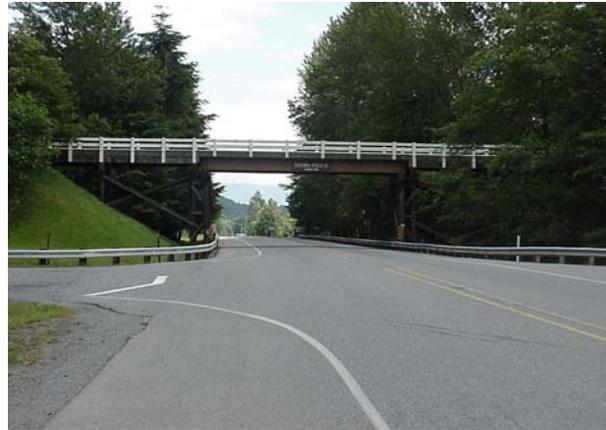
The last inspection report says there are a few small paint blisters on the web of beam 3C. There is also light top flange rust on all stringers.

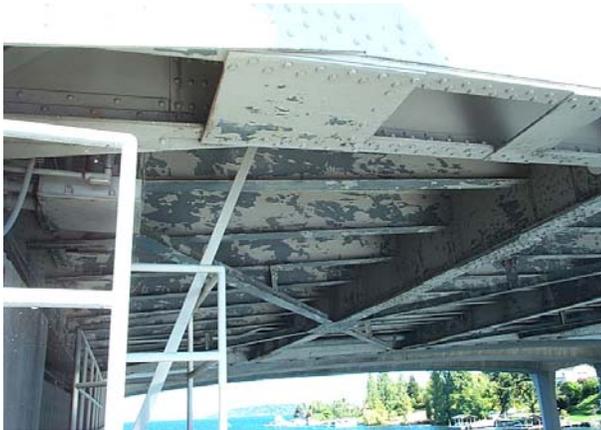
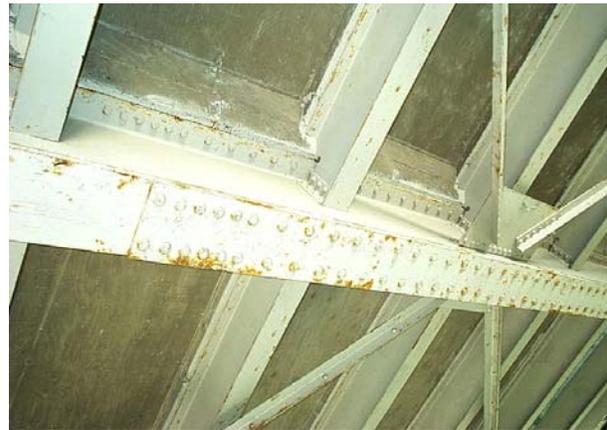
Exterior stringers in the deck truss have approximately 30% of the surface paint layer flaking off and areas of freckle rust. Stringers in the tied arch spans have approximately 50% of the top coat peeling throughout. Surface layer of paint is flaking off on approximately 5% of the truss members. Approximately 10% of the top coat of paint is peeling off of the outside flanges of the tied arch hangers, and 5% off of the arch ties. All floorbeams in deck truss have top layer of paint flaking off.

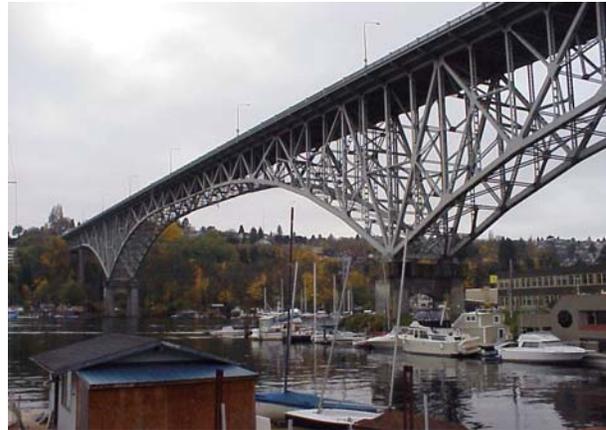
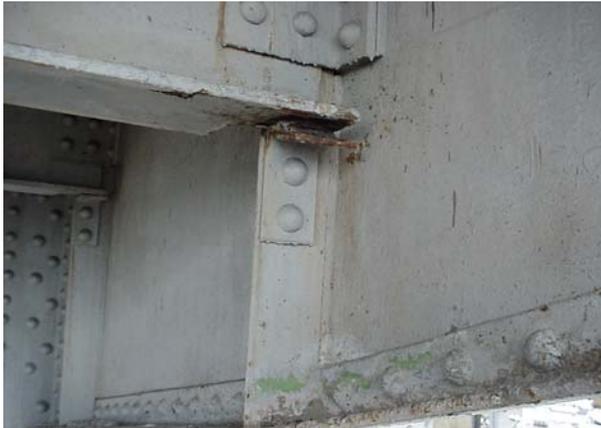
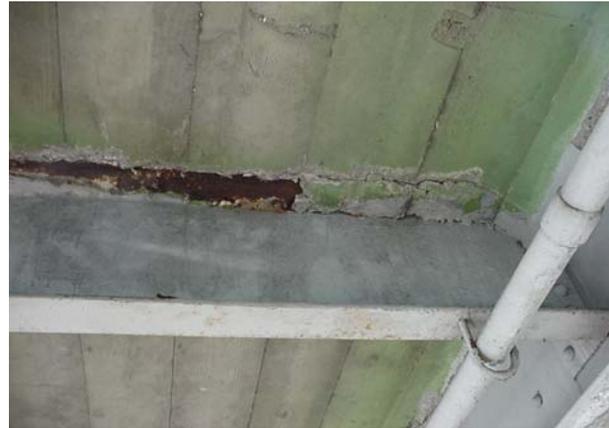
In 1995 (C#14547) 0.75' of the sidewalk and 3.75' of the roadway slab on both sides of the bridge was removed and replaced. The steel supporting this area was rehabilitated and painted with a MC Urethane.

It is assumed that the next painting project will remove the existing paint and prepare the steel to SSPC-SP10 condition then apply a three coat paint system.

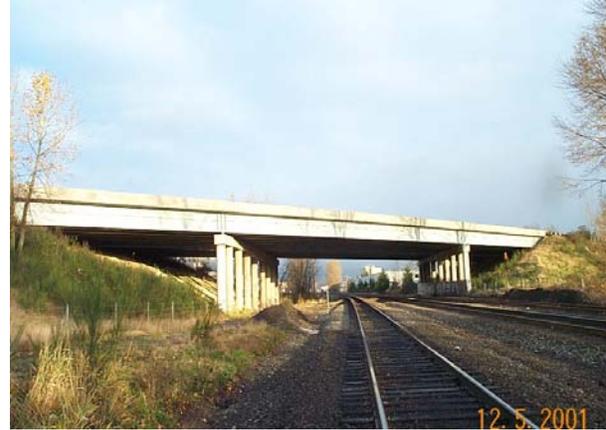
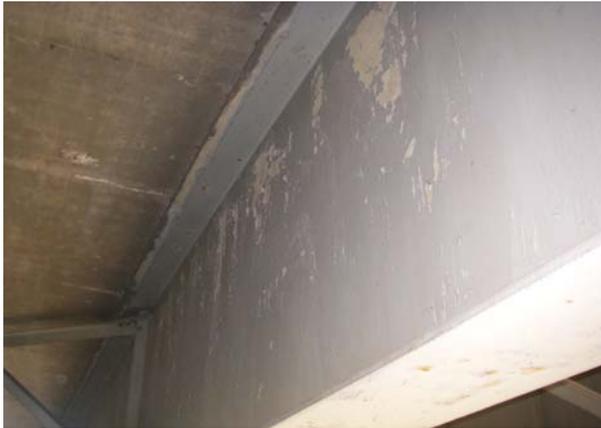
There are several areas of thin, peeling paint and spots of surface rust.

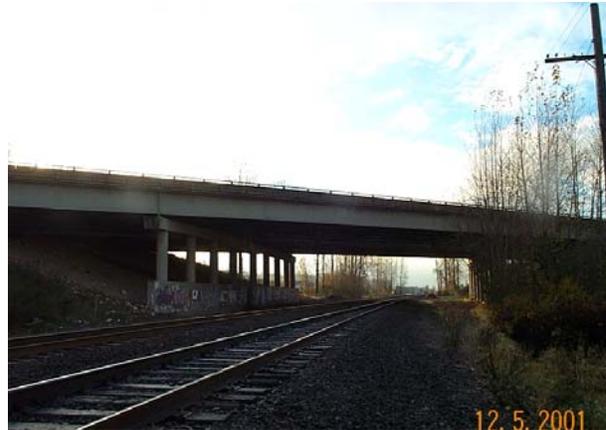
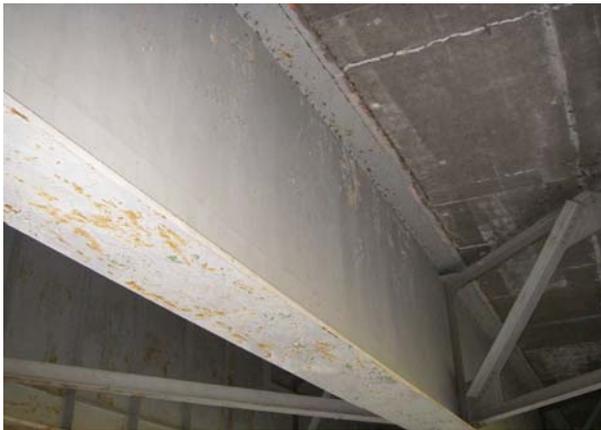
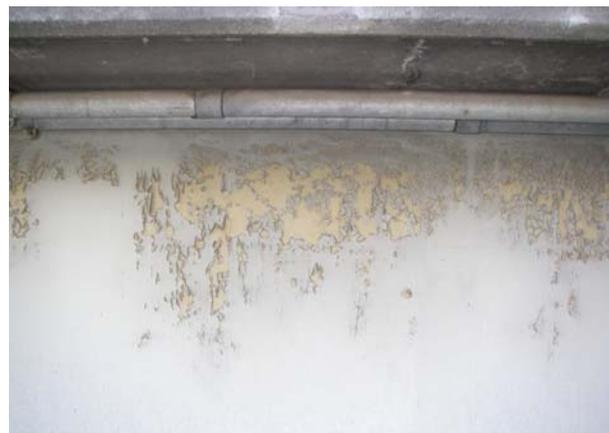
There are rust blooms throughout, especially on the bottom flanges. There is peeling paint in the webs and bottom flanges. Girders E and F were installed when the bridge was widened in 1998. There are a few spots of rust on the original girders where the paint is thin.

The thickness of the paint was not specified in contract 14057. This bridge was widened as part of contract 14771. There are two new girders placed on the south side. These girders should be excluded from the next paint contract.

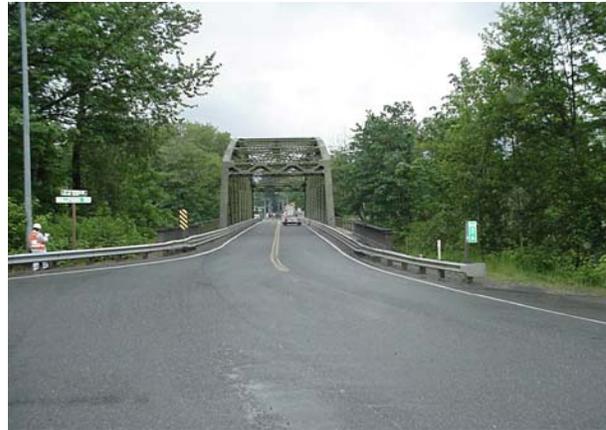
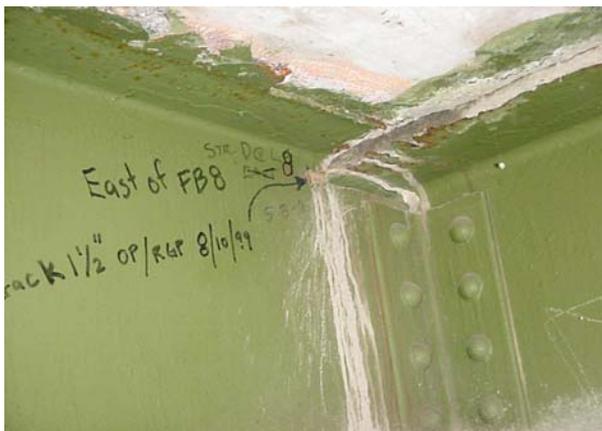
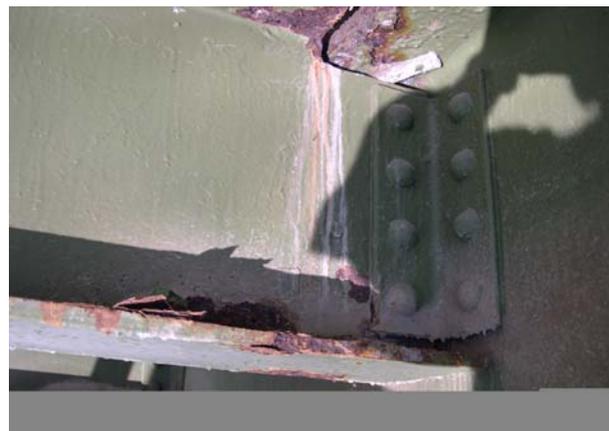
Steel truss has peeling and cracking paint throughout, and rusting in some of the members. Rust in the top and bottom flanges of stringers and floorbeams. Some rust staining along web of sidewalk stringers.

The last paint contract (13767) did not specify the thickness of the paint.

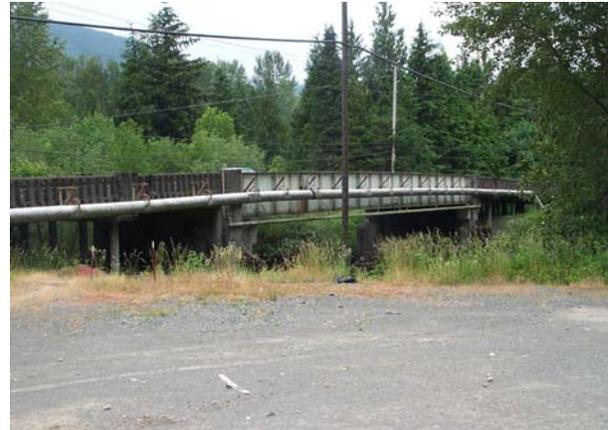
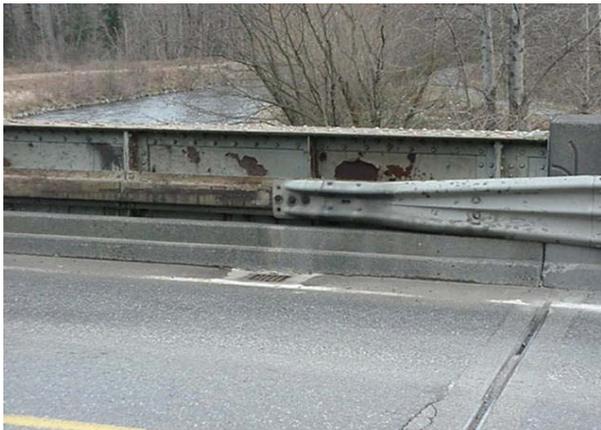
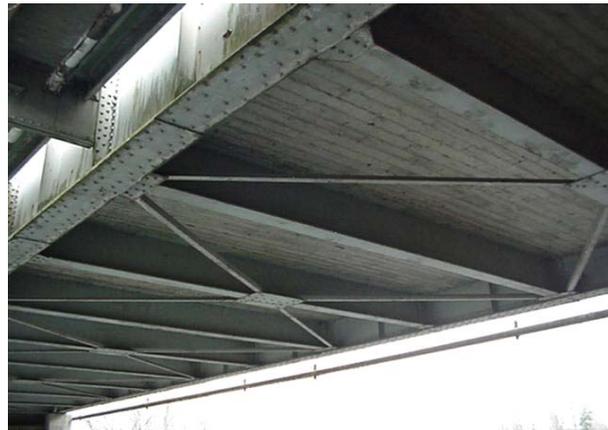
Paint has failed with many paint blister spots on the steel open girder top flanges over 15 percent of the area. The paint blisters range from 1" to 12" in diameter. The steel open girders have areas of surface rust with no section loss. The bottom flanges and crossbraces have built up debris. Girder 9A at Floorbeam 9-8 has minor pack rust pushing the bottom plate out 1/8". Girder 9A at Floorbeam 9-9 has a rivet with 50 percent section loss (not found in 2006). Girder 9B at Floorbeam 9-9 has a rivet with 15% section loss (not found in 2006)."

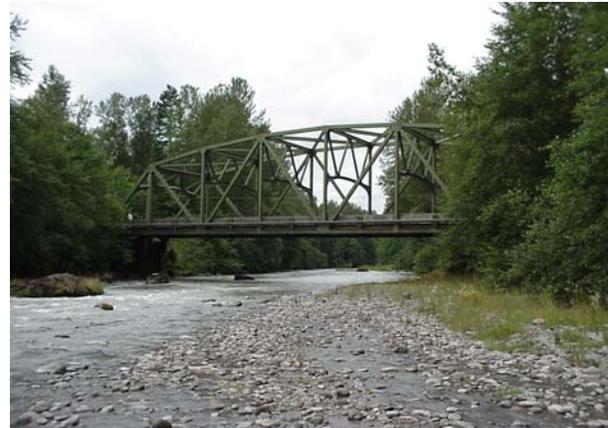
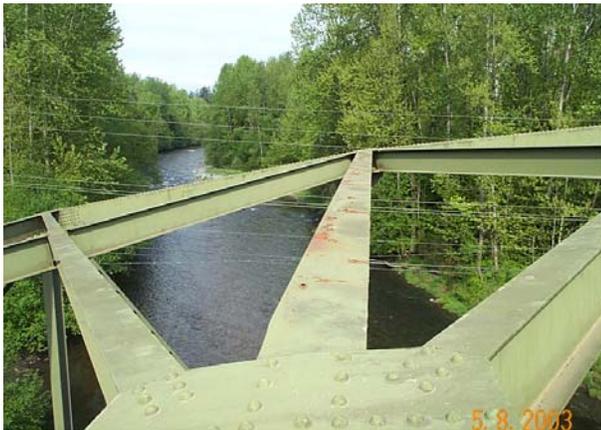
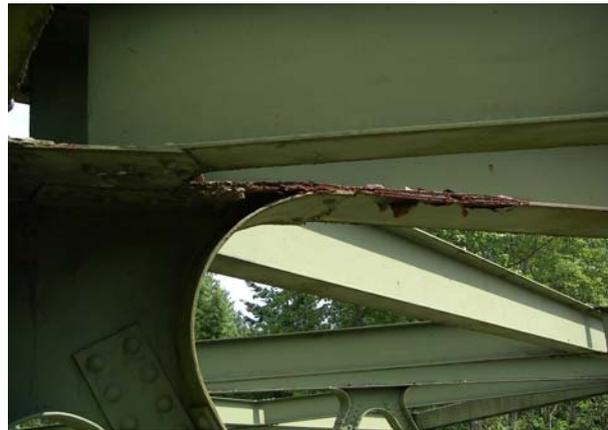
Paint is failing in several areas. The top flange of the bottom sway braces have areas of peeling paint. The top of truss has many rust blooms and areas of peeling paint - chalky throughout. Paint is chipped and peeling on bottom of diagonals and on verticals. Paint is peeling and failing on the bottom chord, bottom lateral gussets, top chord connections, floor beam to truss connections, and bottom of stringer to floor beam connections. There are areas of blistered and peeling paint on floorbeams.

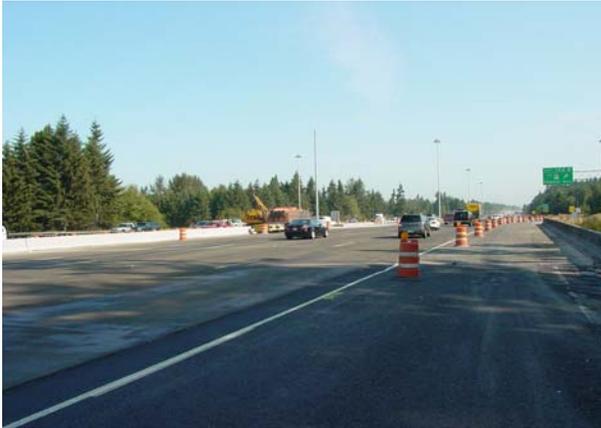
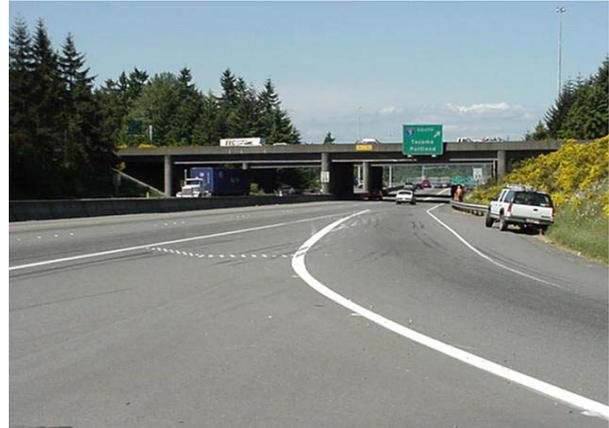
Piers 2, 3, 4 and 5, each has three 3'-0" diameter columns. #3 hoops @ 12". #10 bars with 2'-2" splices. Footing without top mat. (E-21g)

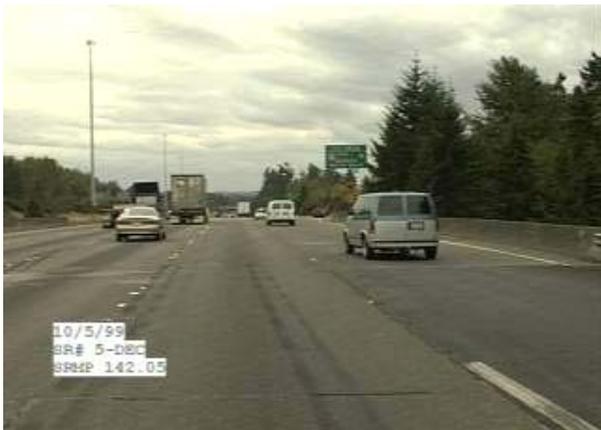
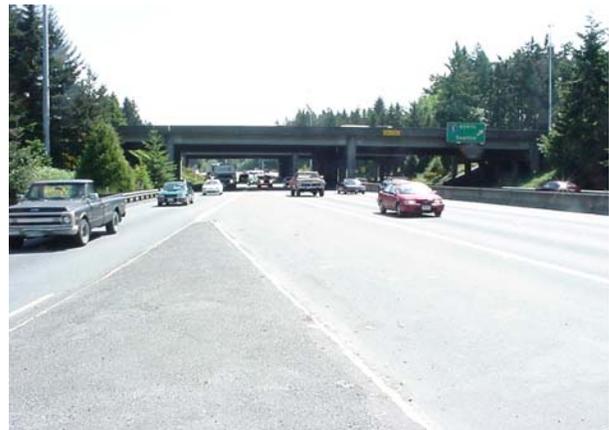
Piers 2, 3 and 4, each has six 3'-0" diameter columns. #3 hoops @ 12". #10 bars with 2'-2" splices. Footing without top mat. (E-21g)

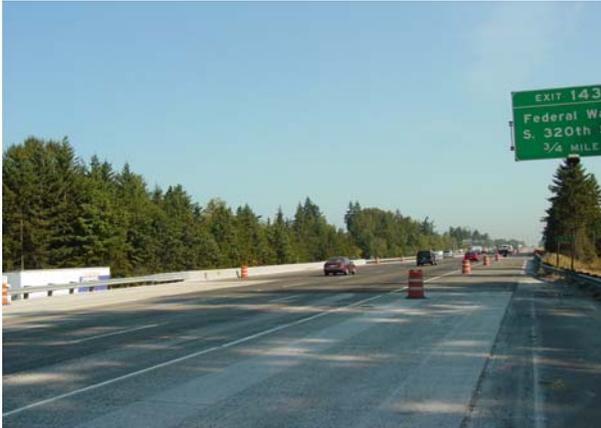
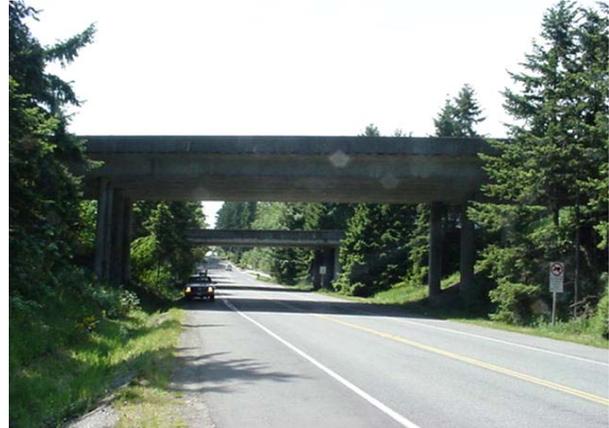
Piers 2 and 3, each has three 3'-0" diameter columns. #4 hoops @ 12". #8 bars with 3'-0" splices. Footing without top mat.

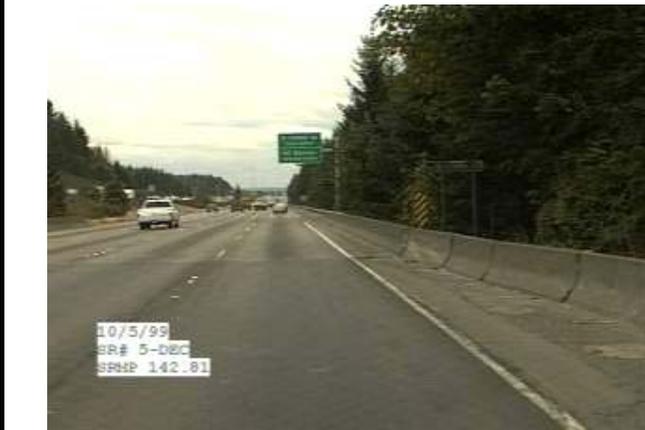
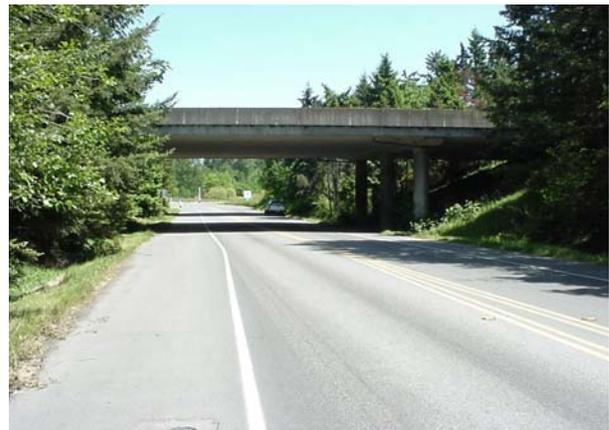
Piers 2 and 3, each has three 3'-0" diameter columns. #4 hoops @ 12". #11 bars with 4'-2" splices. Footing without top mat.

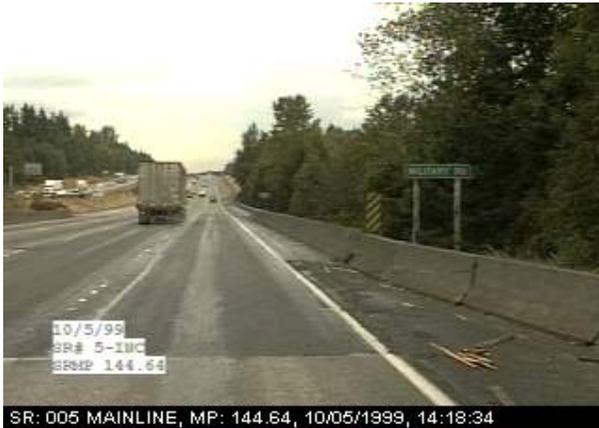
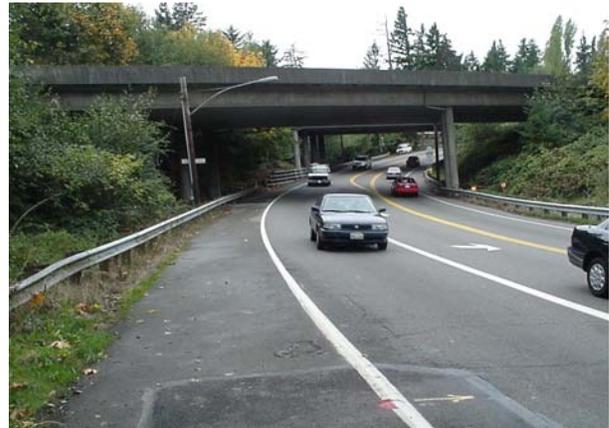
Piers 2 and 3, each has four 3'-0" diameter columns. #3 hoops @ 12". #11 bars with 4'-2" splices. Footing without top mat.

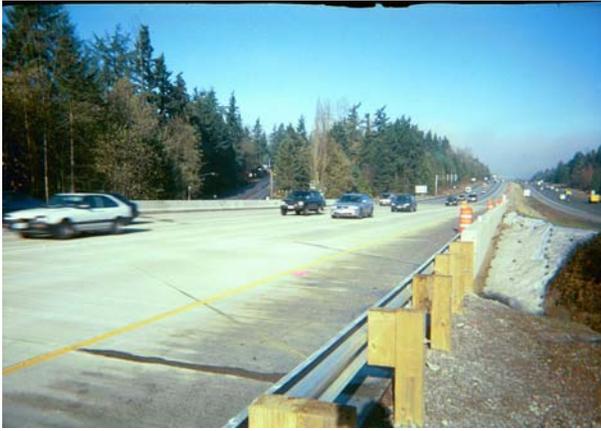
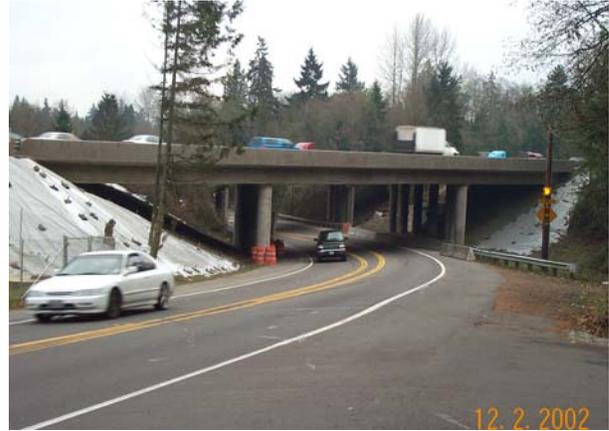
Piers 2 and 3, each has six columns. Retrofit center four 3'-0" diameter columns only. These columns have #3 hoops @ 12". #11 bars with 4'-2" splices. Footing without top mat.

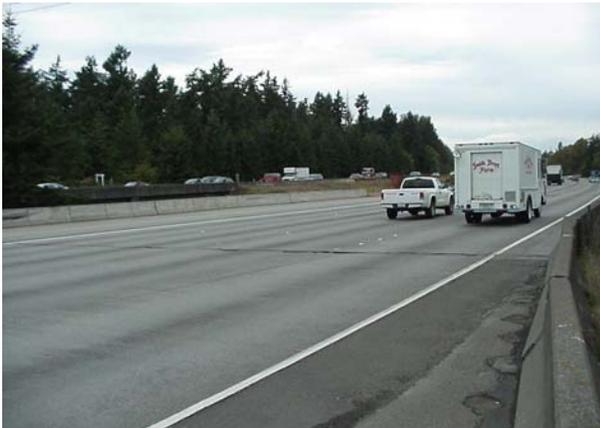
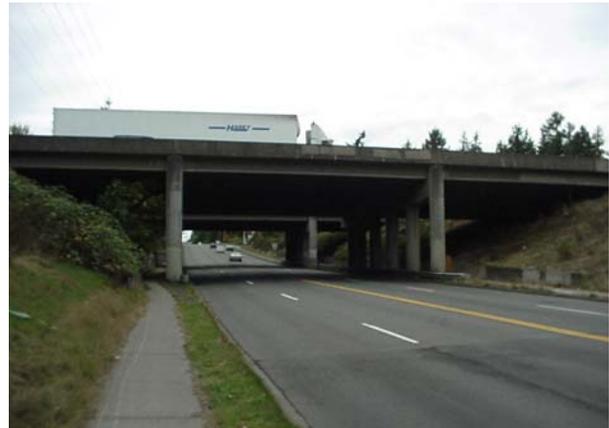
Piers 2 and 3, each has six 3'-0" diameter columns. Retrofit 5 east columns per pier only, these columns has #3 hoops @ 12". #10 bars with 3'-8" splices. Footing without top mat. (E-23h)

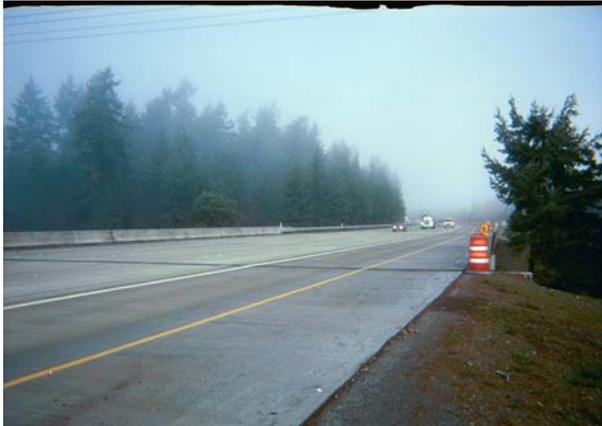
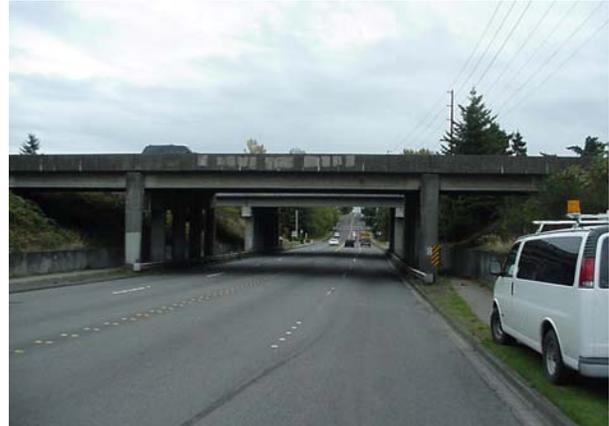
Piers 2 and 3, each has seven columns. Retrofit five center 3'-0" diameter columns per pier only, these columns has #3 hoops @ 12". #10 bars with 3'-8" splices. Footing without top mat. (E-23h)

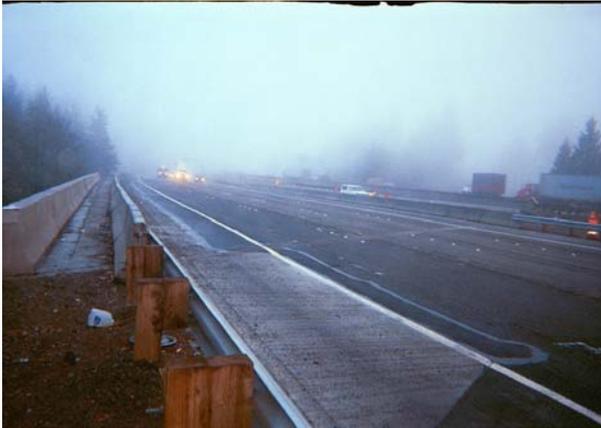
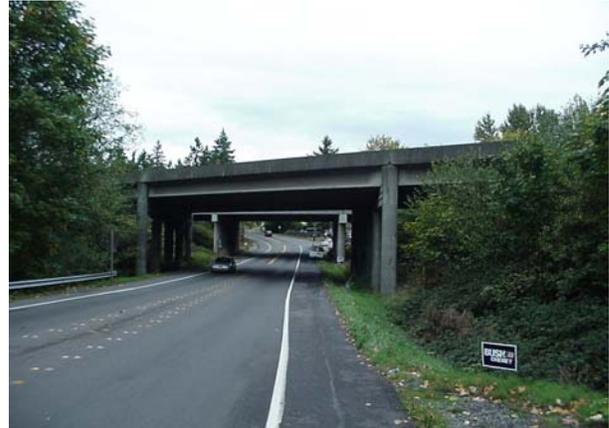
Piers 2 and 3, each has eight columns. Retrofit five center 3'-0" diameter columns. #3 hoops @ 12". #10 bars with 2'-2" splices. Footing without top mat. (E-21g)

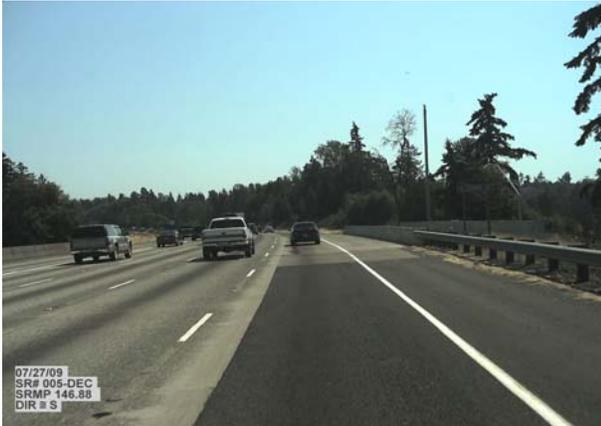
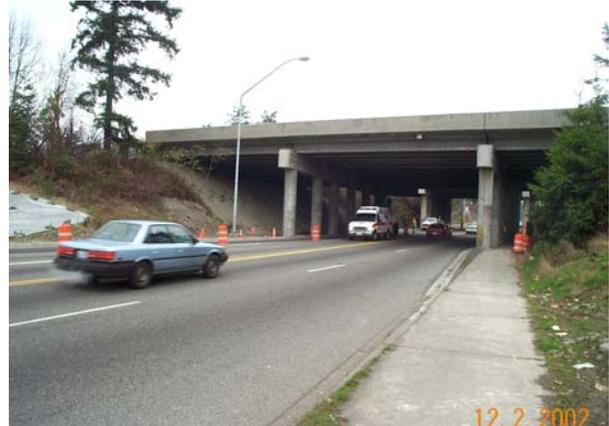
Piers 2 and 3, each has seven columns. Retrofit five east 3'-0" diameter columns. #3 hoops @ 12". #10 bars with 3'-8" splices. Footing without top mat. (E-23h)

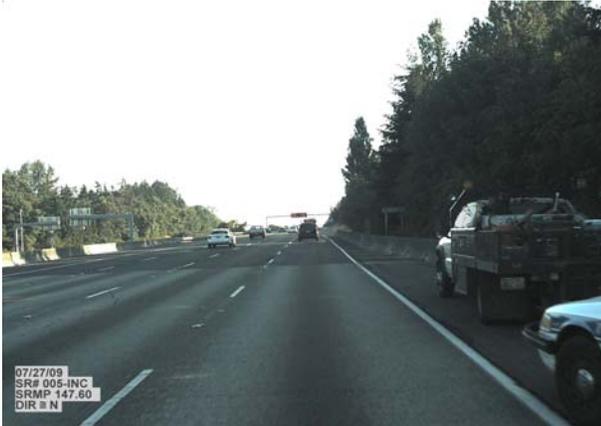
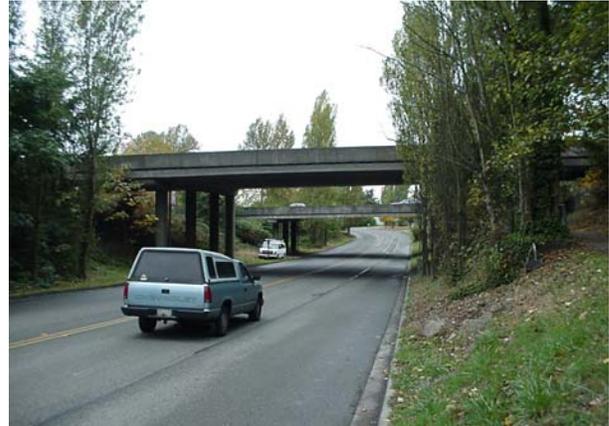
Piers 2 and 3, each has four columns. Retrofit three east 2'-9" diameter columns. #4 hoops @ 12". #9 bars with 3'-4" splices. Footing without top mat.

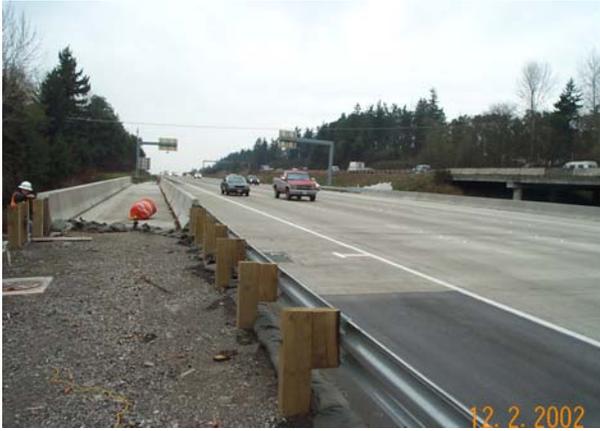
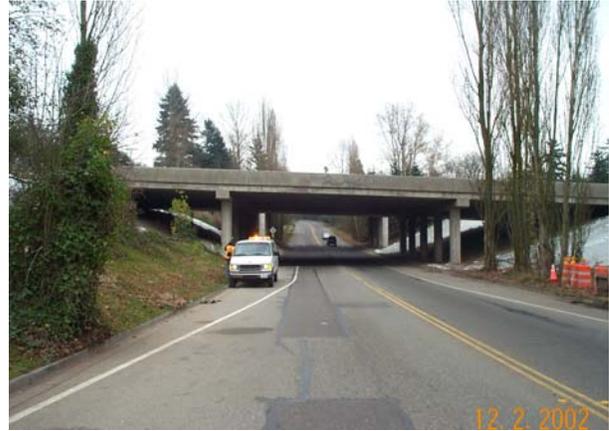
Piers 2 and 3, each has five columns. Retrofit three center 2'-9" diameter columns. #4 hoops @ 12". #9 bars with 3'-4" splices. Footing without top mat.

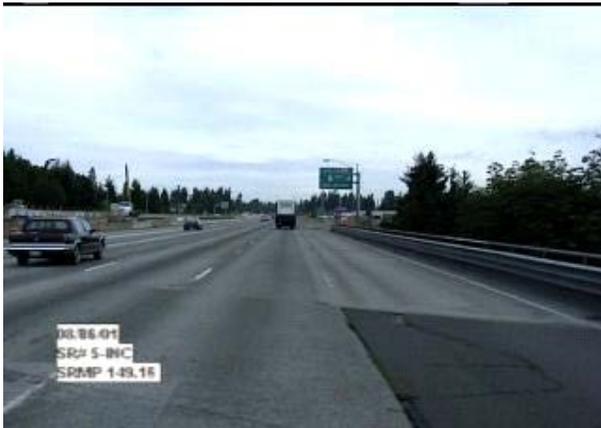
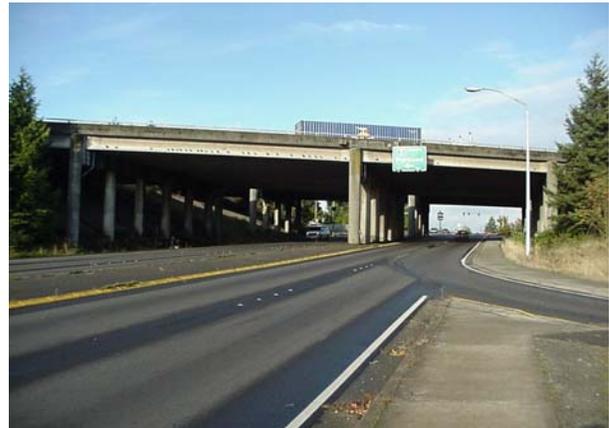
Piers 2, 3 and 4, each has seven 3'-0" diameter columns. Retrofit six east columns only. These columns have #3 hoops @ 12". #10 bars with 3'-8" splices. Footing without top mat. (E-23h)

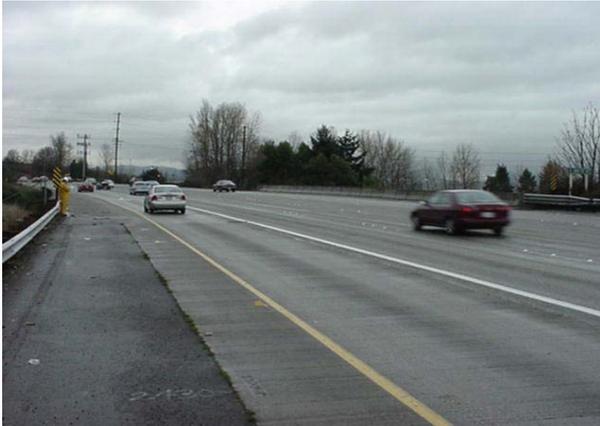
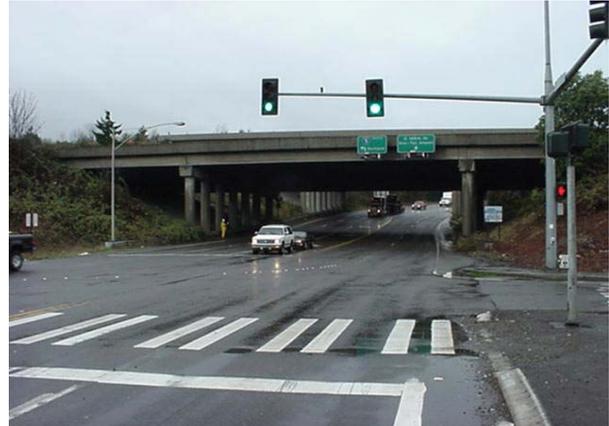
Piers 2 and 3, each has seven 3'-0" diameter columns. Retrofit six east columns only. These 3'-0" diameter columns have #3 hoops @ 12" and longitudinal bars with lap splices. Footing without top mat. (E-54m)

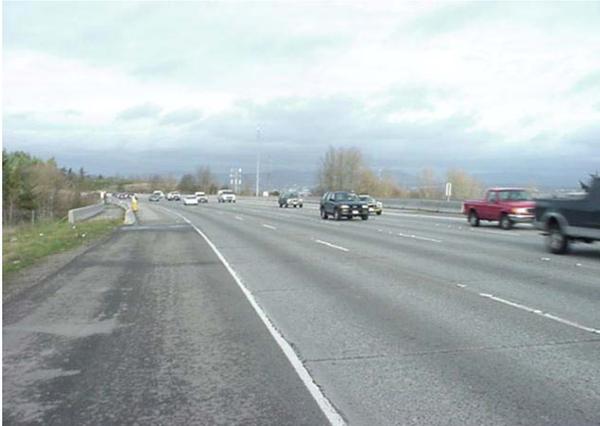
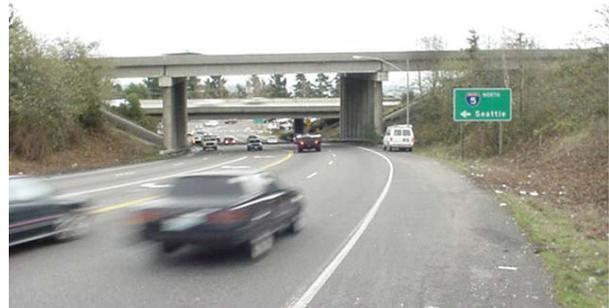
Piers 2 and 3, each has seven 3'-0" diameter columns. Retrofit six west columns only. These 3'-0" diameter columns have #3 hoops @ 12" and longitudinal bars with lap splices. Footing without top mat. (E-54m)

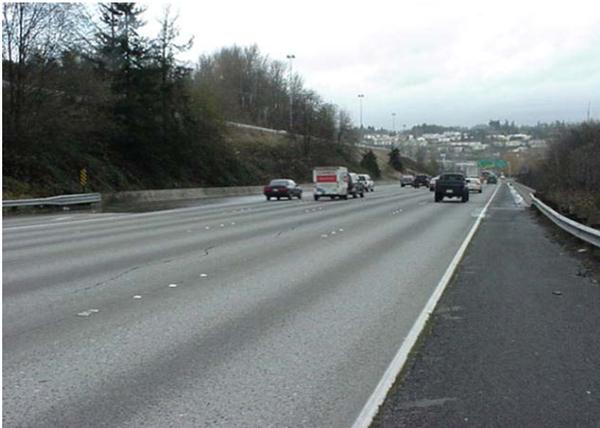
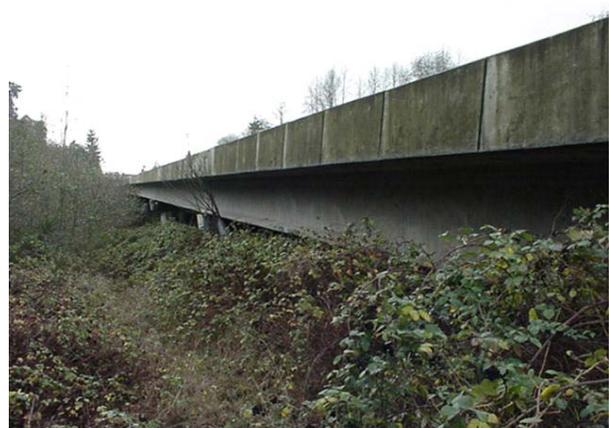
Piers 2, 3, 4 and 5, each has four 4'-6" diameter prestressed conc. Piles and a 4'-6" diameter drilled shaft. Prestressed piles are hollow piles with 5" wall.

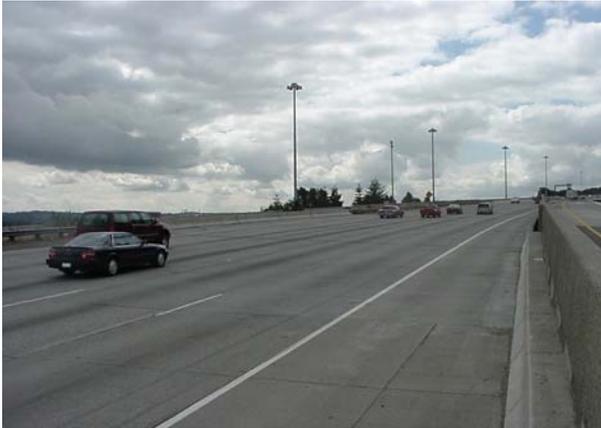
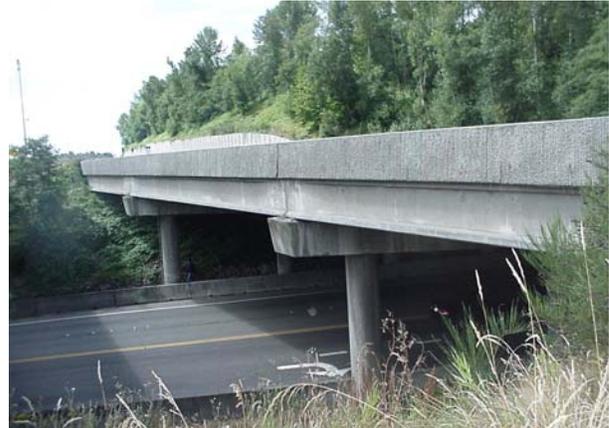
Retrofit five 3'-0" diameter columns at Piers 2 and 3. These columns have #3 hoops @ 12". Longitudinal bars with lap splices. Footing without top mat. (E-54m)

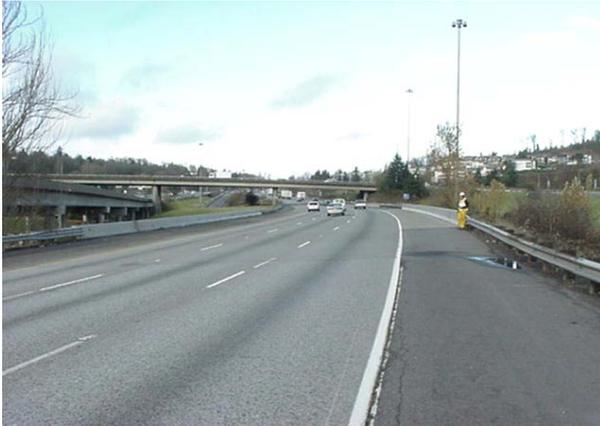
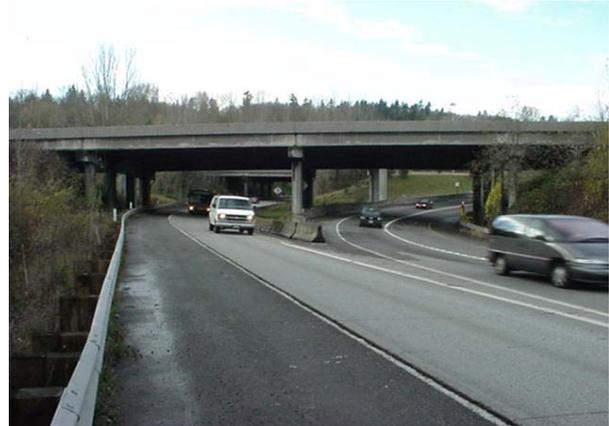
Piers 2, 3 and 4, each has four 3'-0" diameter columns. #3 hoops @ 12". longitudinal bars with lap splices. Footing without top mat. (E-54m)
