P2 Bridge Preservation - Replacement/Rehab Projects

2013-15 Bien Priority Array

Bridge Repair Form

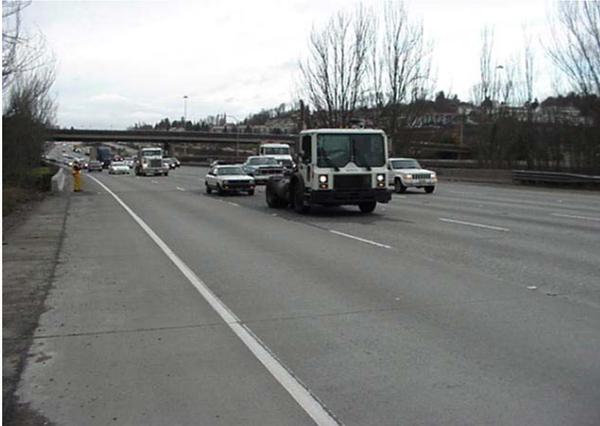
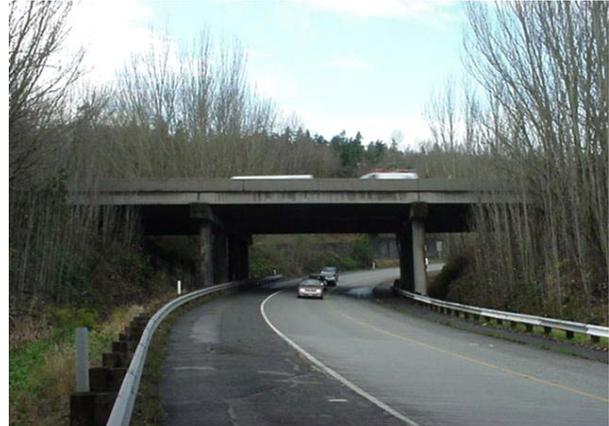
Piers 2 and 3, each has four 3'-0" diameter columns. #3 hoops @ 12". longitudinal #9 bars with 3'-4" lap splices. Footing without top mat.

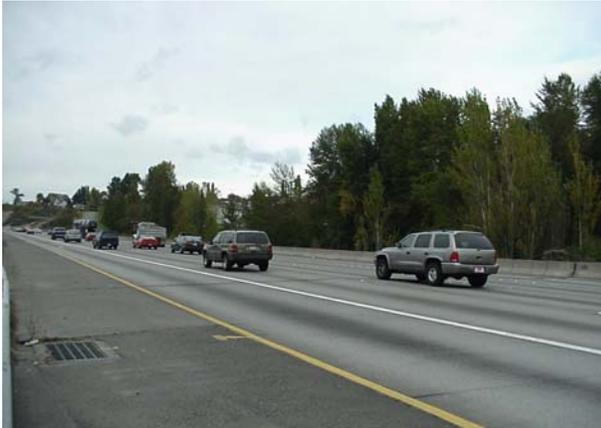
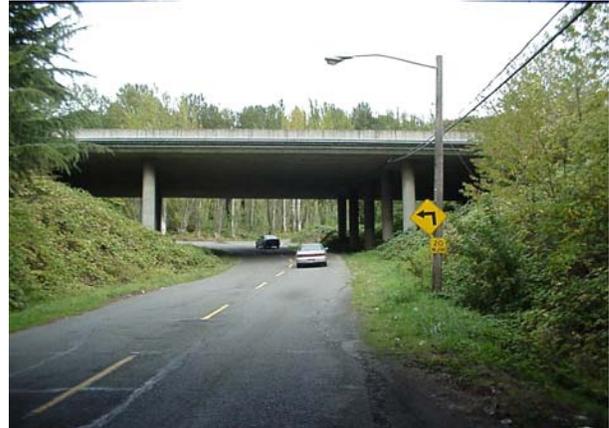
Piers 2 and 3, each has five 3'-0" diameter columns. Retrofit four west columns only. These columns have #4 hoops @ 12". longitudinal #9 bars with 3'-4" lap splices. Footings without top mat.

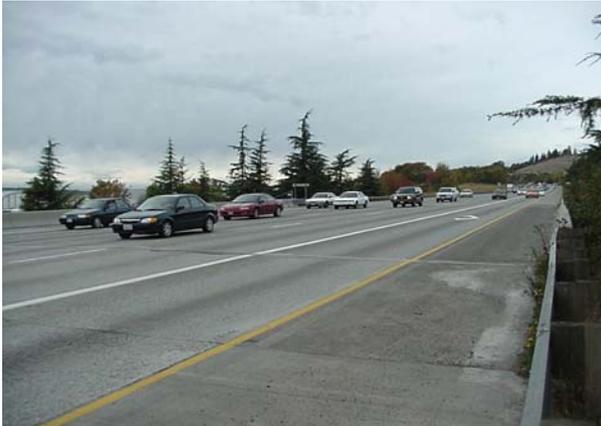
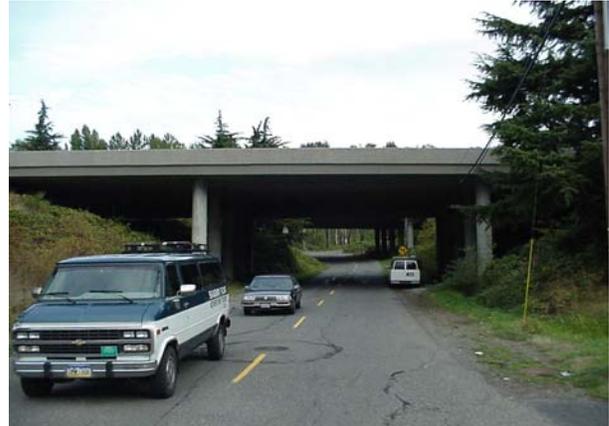
Piers 2 and 3, each has five 3'-0" diameter columns. Retrofit four east columns only. These columns have #4 hoops @ 12". longitudinal #9 bars with 3'-4" lap splices. Footings without top mat.

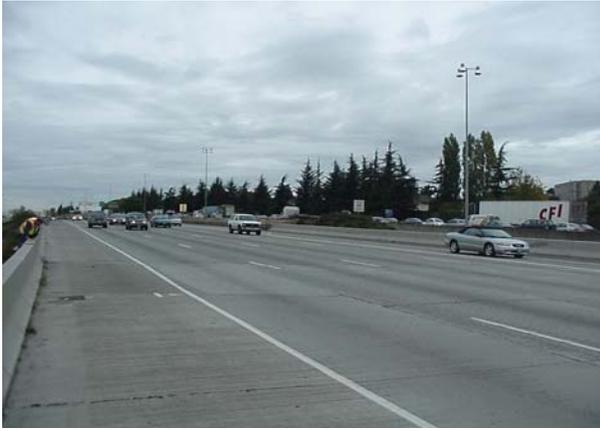
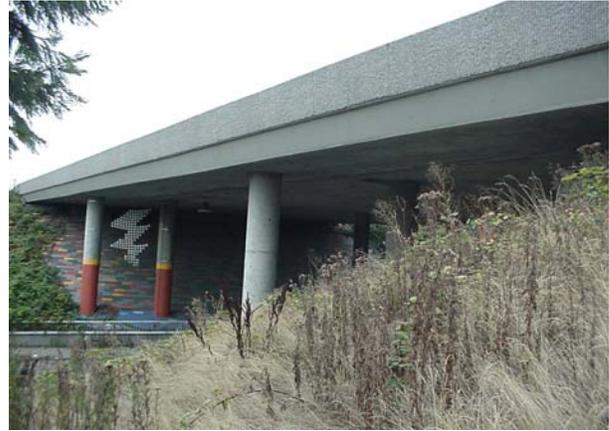
Piers 2 and 3, each has five 3'-0" diameter columns. Retrofit four east columns per pier only. These columns have #4 hoops @ 12". longitudinal #9 bars with 3'-4" lap splices. Footing without top mat.

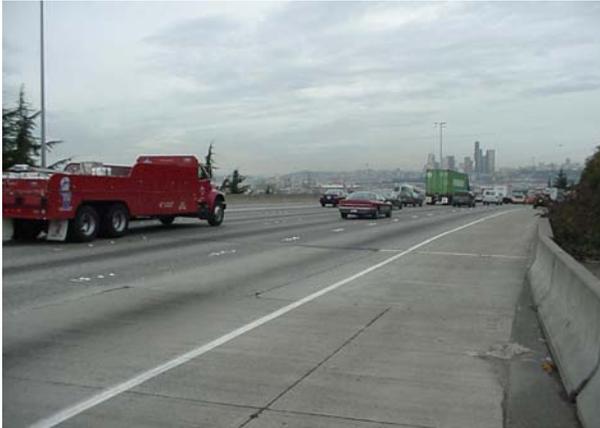
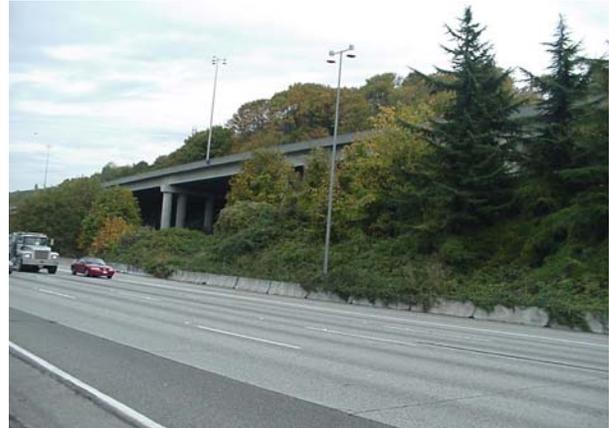
4'-6" (O.D.) x 5" wall prestressed concrete piles, filled with cylinder concrete after piles are set in place at piers 2 thru 9 (4 ea., 32 total). No retrofit recommended.

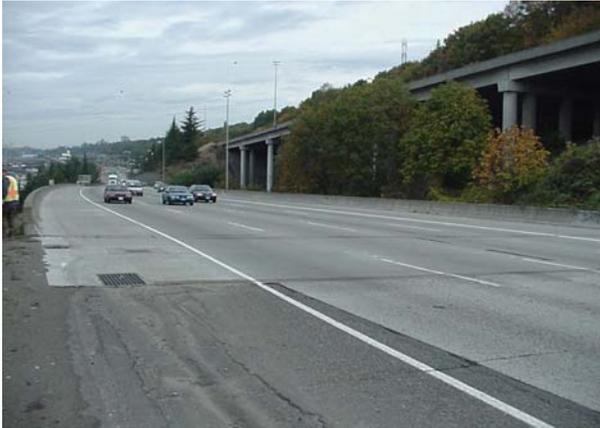
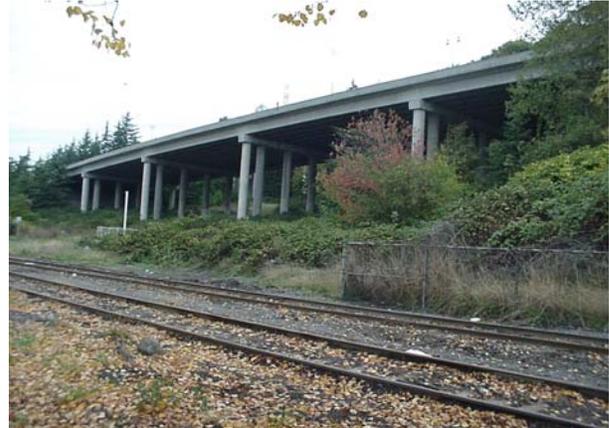
Piers 2 thru 5, each has six 4'-0" diameter columns. Pier 6 has six 4'-6" diameter columns. Retrofit four center columns per pier at piers 2 thru 5 only. These columns have #4 hoops @ 12". longitudinal bars with lap or/and welded splices. Footing with top mat. Pier 6 has four 4'-6" (O.D.) x 5" wall prestressed concrete piles, filled with cylinder concrete after piles are set in place. No retrofit recommended.

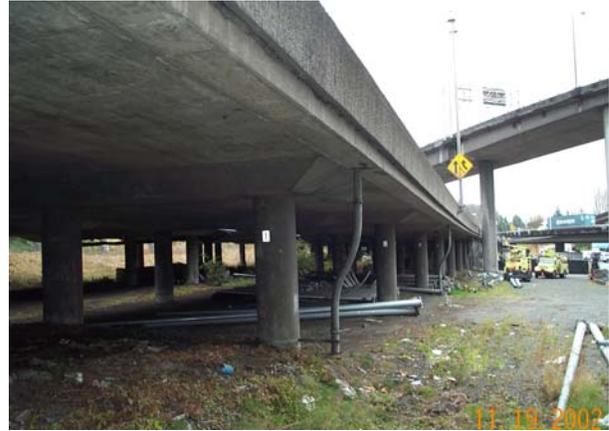
Piers 2 thru 5, each has four 3'-0" dia. columns on 3'-6" dia. drilled shafts. Pier 6 thru 18, each has three 3'-0" dia. columns on 3'-6" dia. drilled shafts. Hoops are #4 @ 12". Longitudinal bars insert 5'-0" into drilled shafts. Max. span length = 42'.

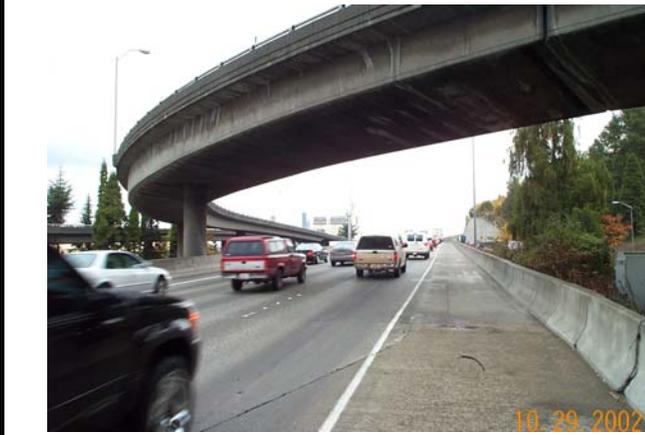
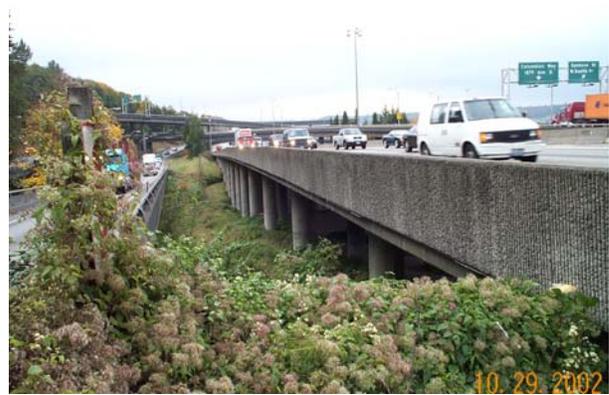
Max. span length = 45'. 4 columns per pier. Retrofit columns built in 1966 only (three west columns per pier). Piers 11 thru 15, each has three 4' dia. columns on 5' dis. drilled shafts. Piers 2 thru 9 and 16 thru 21, each has three 3' dia. columns on 3'-6" dia. drilled shafts. #4 hoops @ 12". Piers 10 thru 17 have horizontal struts.

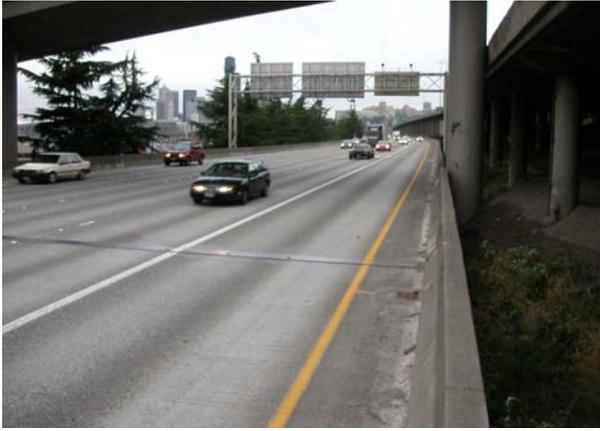
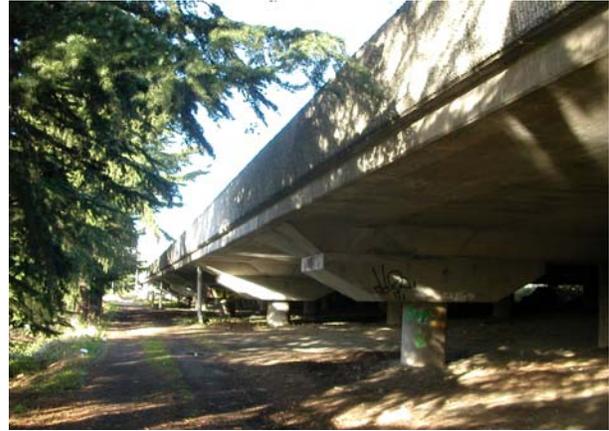
Columns on drilled shafts. Contract 7741: Piers 2 thru 10, 16 thru 30, retrofit four columns each pier (3' dia. column on 3'-6" dia. drilled shaft), pier 11 thru 15, (four 4' dia. column on 5'-0" dia. drilled shaft). Piers 9 thru 18 have horizontal struts. Contract 7686: piers 25 thru 152, 3' dia. Columns except East columns at Piers 146 thru 152 are 4' diameter. Max. span =42'.

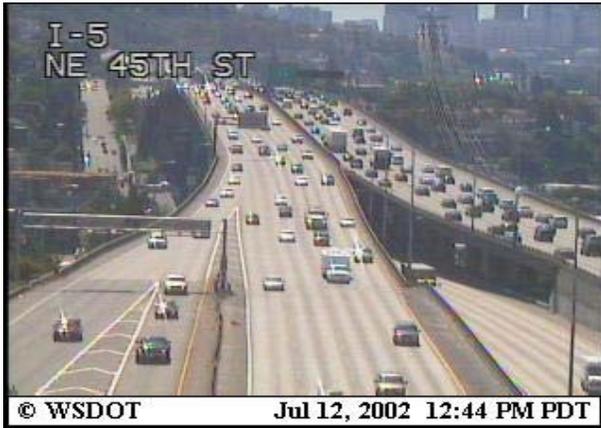
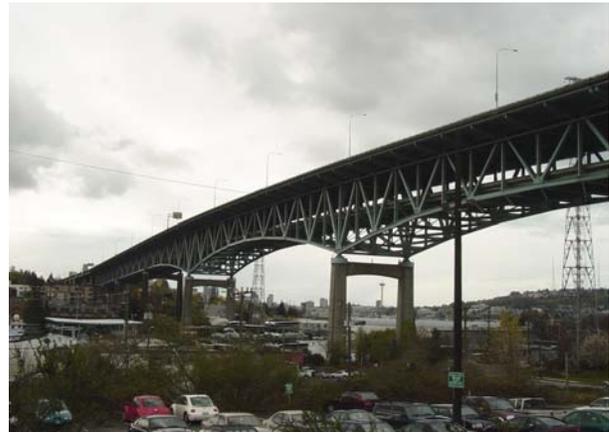
N.B.: Piers 2, 3, 4, 6, 7, 8, each has three 2'-6" sq. columns (E. cols w/2hinges). Pier 5 has three Split columns (2-2'6"x1'9"&2" gap, E. col. has two hinges). Pier 9 has three Split columns (2'6"x1'9", 2'6"x2'3" &2" gap). S.B.: Piers 2, 3, 4, 6, 7, 8, each has three 2'-6" sq. columns (W. cols w/2hinges). Pier 5 has three Split columns (2-2'6"x1'9"&2" gap). Pier 9 has three Split columns (2'6"x1'9", 2'6"x2'3" &2" gap).

SEISMIC RETROFIT - STAGE 2. Install steel jackets for columns at piers 10 thru 18, 24 thru 31. Modify columns and replace bearings with TFE/Fabric Pad bearings at piers 11, 27 and 30. Prestressing X-beam using P/T tendons at piers 15, 16, 17, 25 and 26. Concrete catchers at pier 18 and 24 (conc. approach sides). X-beam connections (longitudinal restrainers) at pier 15.

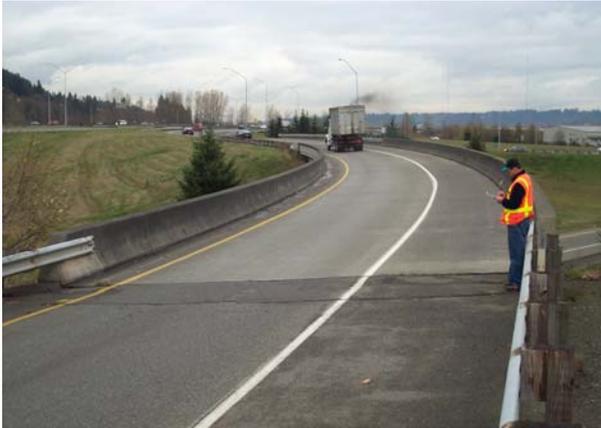
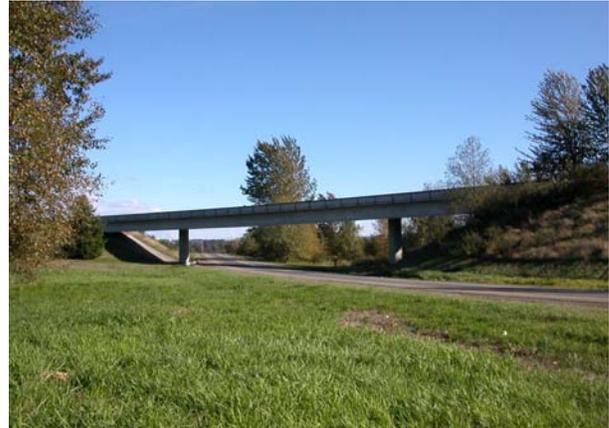
Intermediate Piers, Piers 2 and 3, each has a 5'-0" diameter column on pile footing. #4 hoops spaced at 12" spacing. Vertical #18 bars have staggered field weld splices at 6'-7" above top of footings. Footings have no top mat. End Piers 1 and 4 are stub abutments.

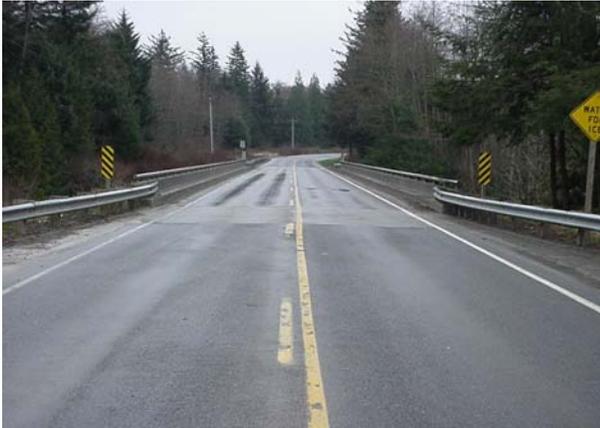
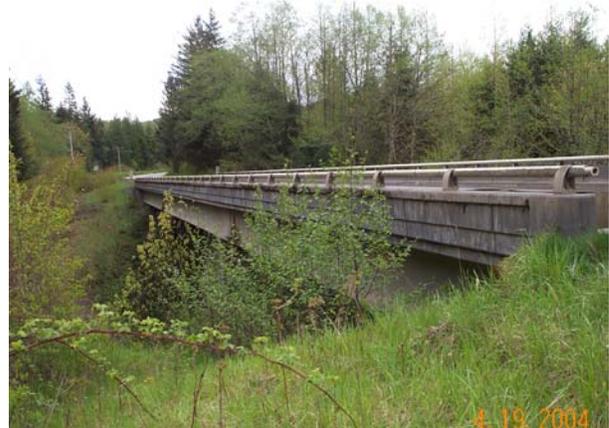
End piers 1 and 4 are on 45 ton steel pile bents. Intermediate Piers, Piers 2 and 3, each has a 5'-0" diameter column on spread footing. #4 hoops spaced at 12" spacing. Vertical #11 bars have 4'-2" lap splices at top of footings. Footings have no top mat.

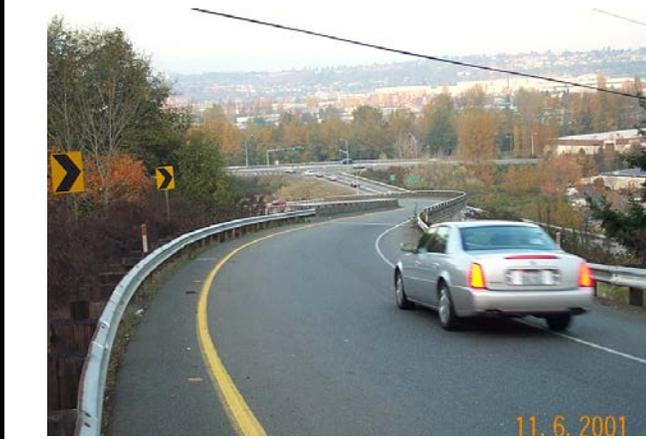
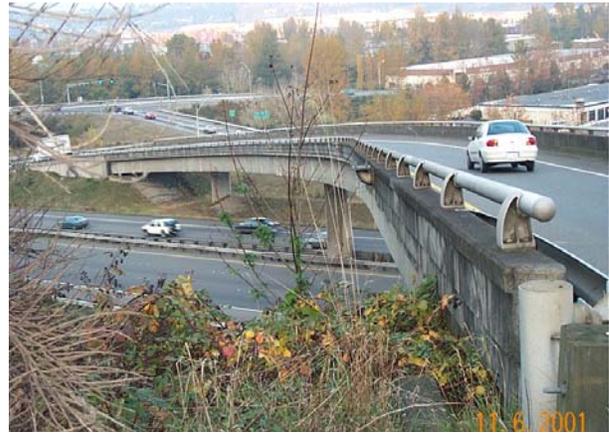
Intermediate Piers, Piers 2, 3 and 4, each has a 8'-0"x3'-0" elliptical column on pile footing. #5 hoops @ 12" and 3 #5 ties @ 24". Vertical #14 bars have staggered field weld splices at 5'-0" above top of footing. Footings have top mat. End Piers 1 and 5 are "L" abutments. Column height various. 35' at pier 2, 20' at pier 4.

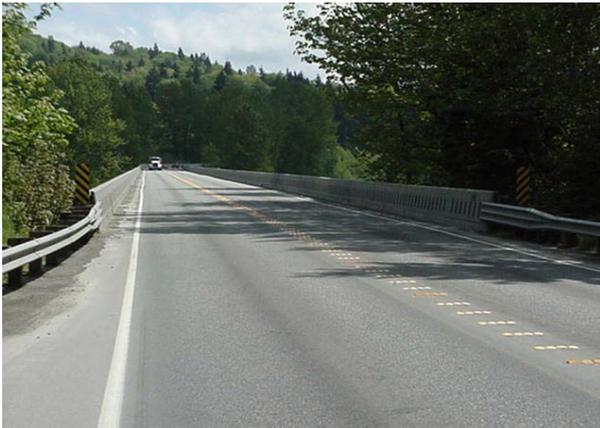
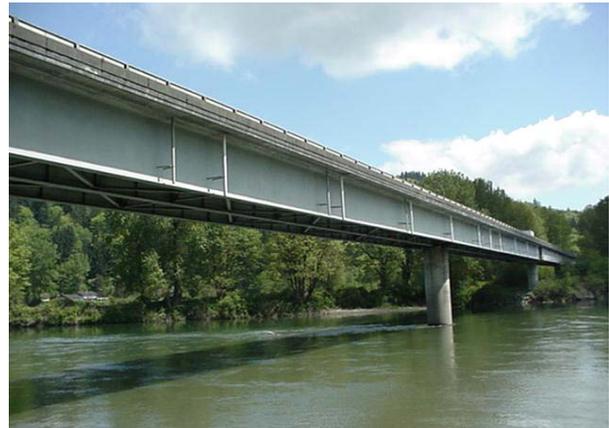
Pier 1 is spill through abutment with two 3'-6" x 3'-3" columns on spread footings. Columns have hinge at top. Piers 2 thru 9 are on spread Piers 2 and 4, each has a 8'-0" dia. Column with #5 hoops @ 6". Piers 5, 6 and 7, each has a 7'-0" dia. column with #4 hoops @ 6". Piers 8 and 9, each has a 6'-0" dia. column with #4 hoops @ 6". Pier 3 has a 10'-0" dia. column with # 6 hoops @ 12". All columns are on spread footings. Vertical bars have staggered field weld splices. Footings have no top mat. In span hinges at spans 2 and 3.

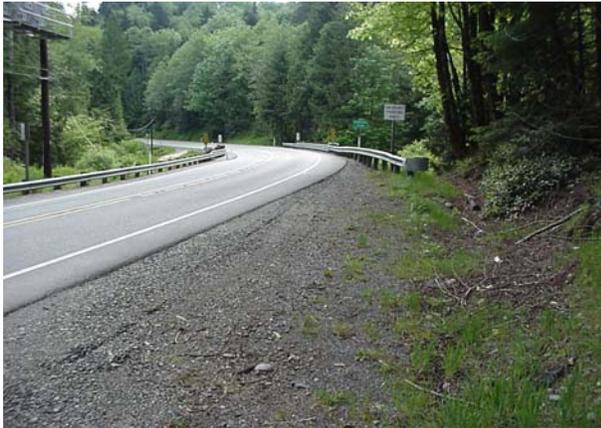
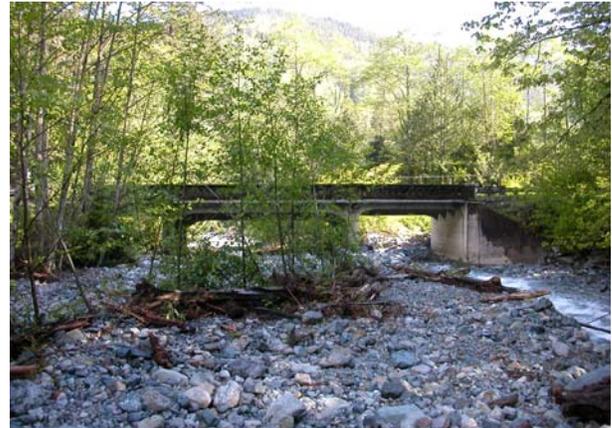
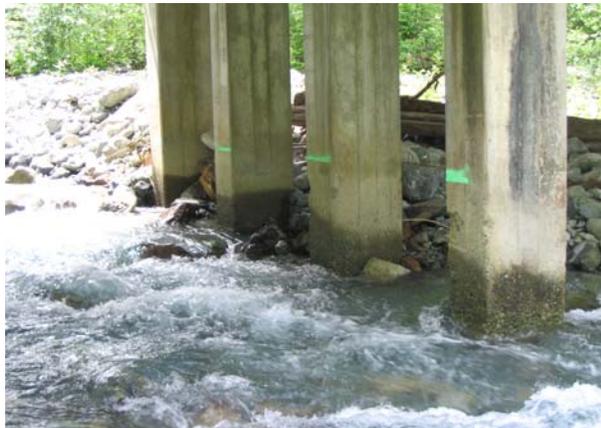
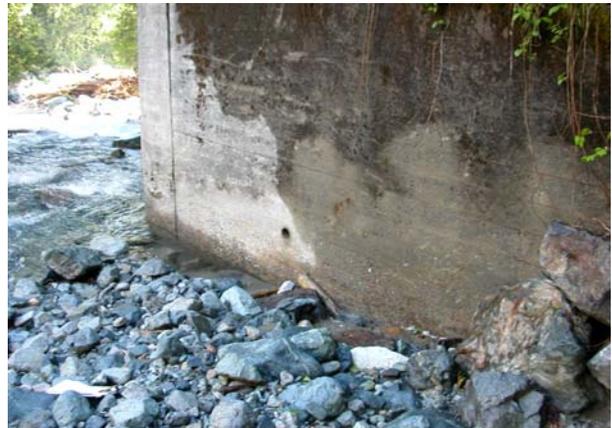
Deficiencies: Photo 1 shows bridge scour, 6/2006. Photo 2 shows exposed footing at SE retaining wall, 4/2004. Piers 2 and 3 are scour critical. Rip rap must be maintained. Thalweg elevation is less than 5' above footing bottom elevation. Last repair by contract was in 1996.	First Noted: 4/28/2004
	BPO Repair List Priority: 1
Recommended Action: BPO - Replace missing rip rap at SE retaining wall. Replace missing rip rap at the downstream side of P3.	Funding - P2 or M: P2
	BPO Repair Num: 11887
	Project PIN:
	11-13 Priority Rank:
	13-15 Priority Rank: 10
	Total Cost Estimate: \$705,567

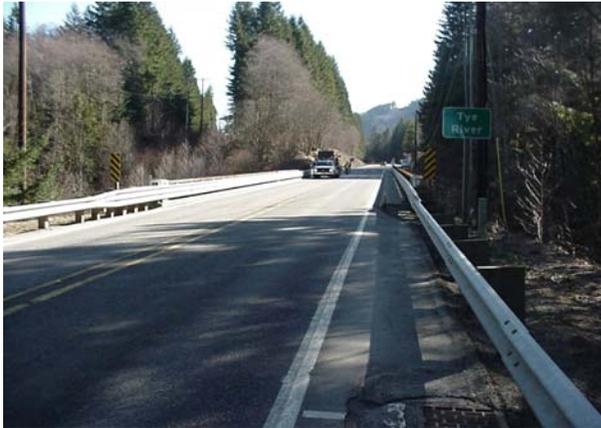
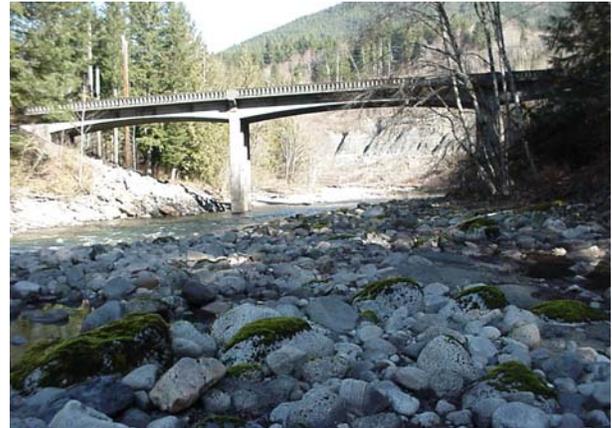
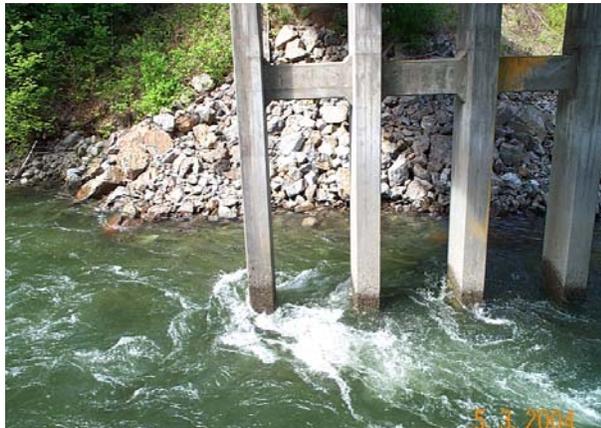
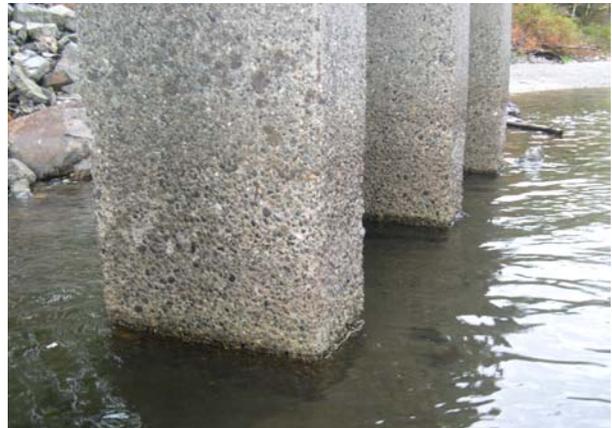
Deficiencies: No rip rap along pier 3 columns. Up to 3 ft. exposed of face on Southeast corner. Top of pile cap is totally exposed. East face stream side footing is totally exposed. Sufficient pile length.	First Noted: 6/12/2006
	BPO Repair List Priority: 1
Recommended Action: BPO - Rip rap along Pier 3 columns. Up to 3 ft. exposed of face on southeast corner. Main Piers have timber pile foundations. Top of pile cap is totally exposed. East face stream side footing is totally exposed.	Funding - P2 or M: P2
	BPO Repair Num: 12912
	Project PIN:
	11-13 Priority Rank:
	13-15 Priority Rank: 12
	Total Cost Estimate: \$744,640

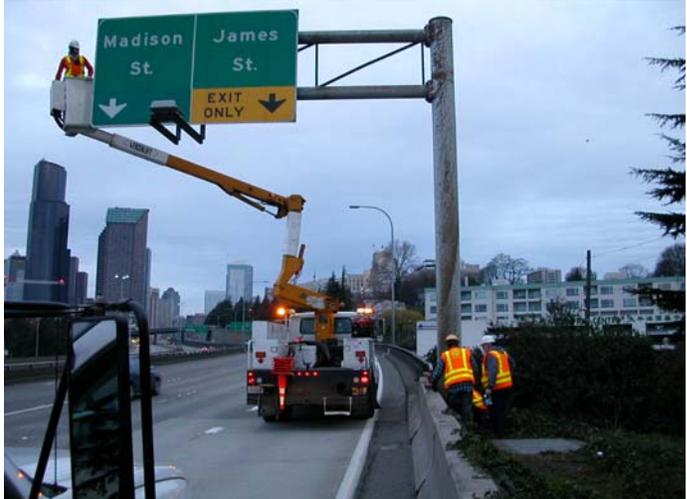
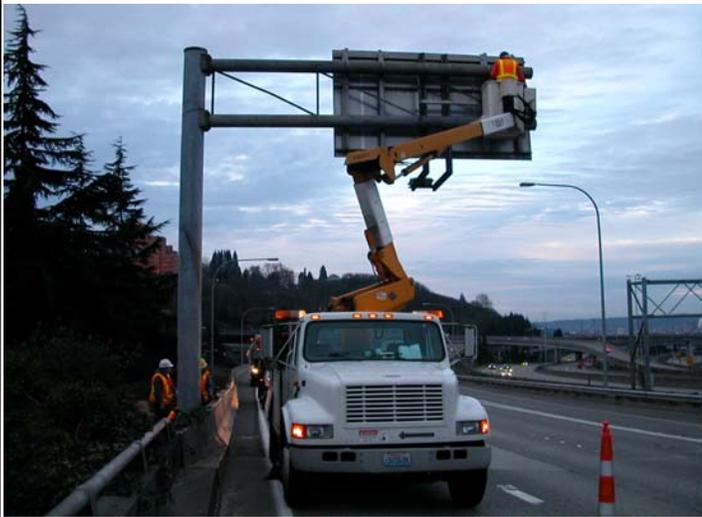
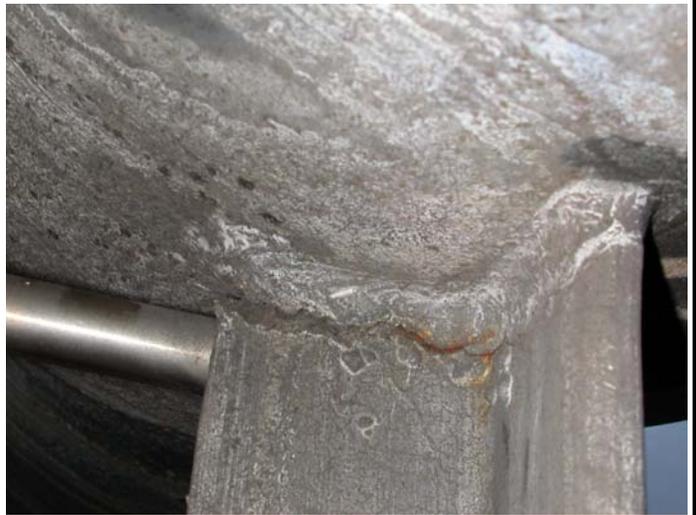
Program due to bent beam, cracked welds, four bolt base. Two 10-1/2" diameter beams, with three truss panels of 2" angles. 22' 8" span, 4' between beams. The bottom beam is 5" out of plane from vertical, away from traffic. The end vertical is cracked/torn at the top and bottom, where it is welded to the two beams. The sign panels have been shimmed to provide a vertical sign.

Replace Cantilever Sign Support

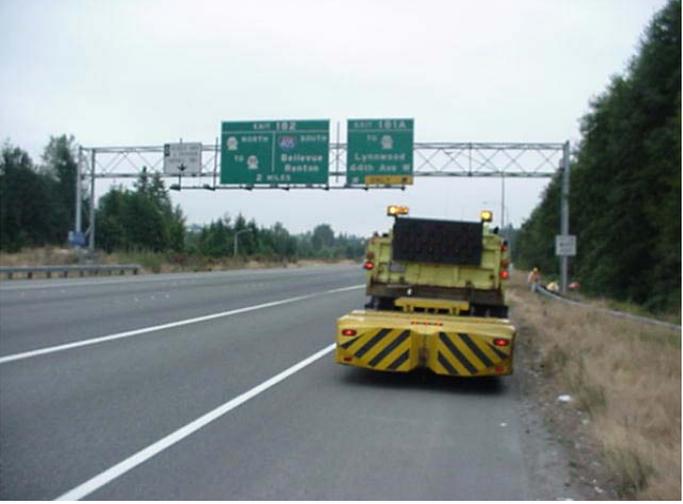
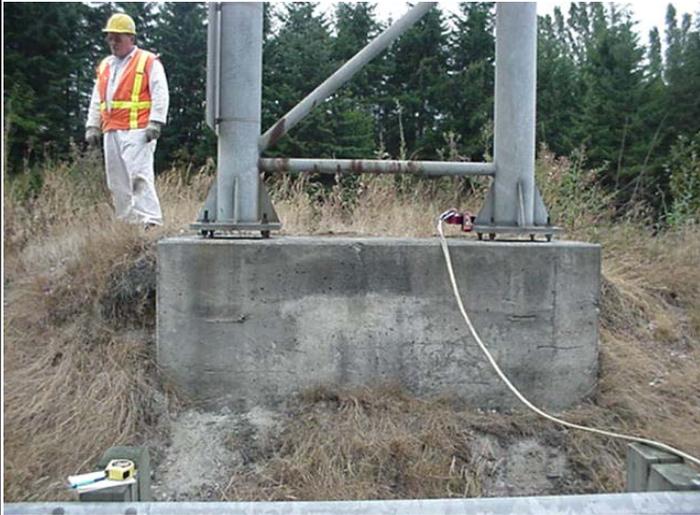
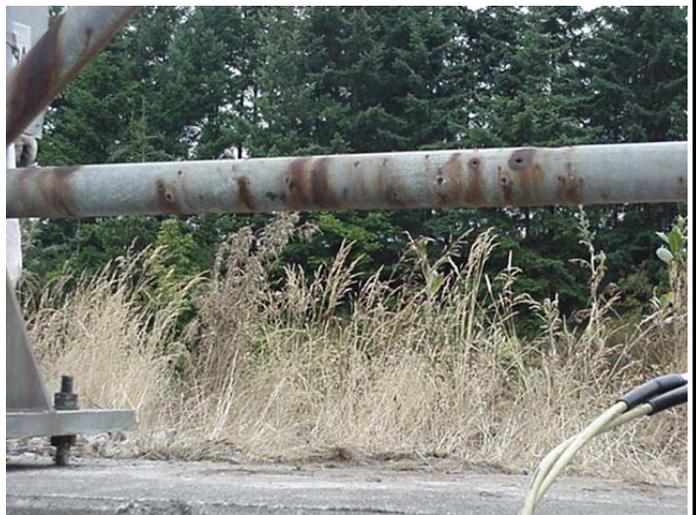
17 panel, 105' span, galvanized double truss, 6'h x 6'w. 5-1/2" chords, 2-1/2" diagonals, 3-1/2" post diagonals. A325 MSC bolts are 3/4" x 3-3/4" with 1-1/4" head. Three MSC. Rust located near the lower north chord of the following members: U13N-L14N @ L14N, U11N-L12N @ L12N, U7N-L8N @ L8N. Four 1" x 33.18" anchor bolts per base. Standoff at east tower is 1-1/4". Standoff at west tower is 1-1/2". Threads are dinged up and filled with grout. Slight areas of rust on bolts below the baseplates. Cleaned and applied rust inhibitor. East tower is on 3' x 9' concrete foundation that is flush with the ground. West tower is on concrete pedestal that is 3' x 9' x 42" high. No UT indications. Program Replacement due to broken down galvanizing, rust holes in members, rusty anchor bolts.

Replace Sign Bridge

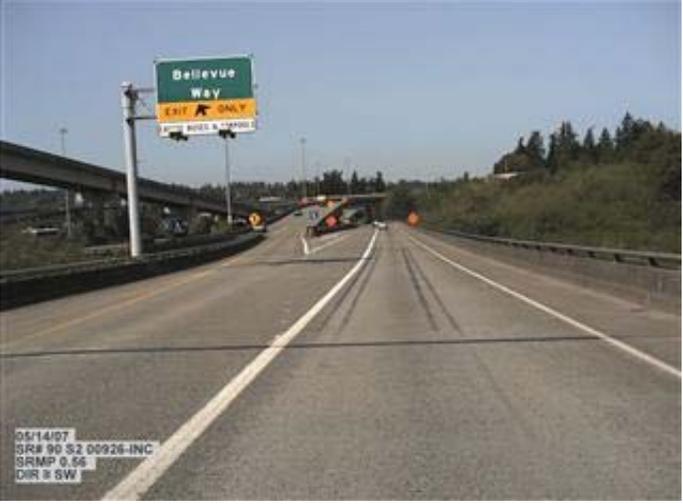
Date Inspected: 8/23/2000	Insp Freq (months): 24	Superstr Code: 6	Foundation Code: 4		
Substr Code: 6	Accessory Code: 4				
Sign Structure Design: Double Truss	Sign Structure Material: Galvanized	# of Posts: 1	# of Bolts per Post: 4		
Project Number:	2013-15 Priority#: 17	Repair Year:	2011-13 Priority#: 52	CPMS Ad Date:	Bridge \$'s: \$150,000 Repair Total\$'s: \$400,000
<h1>No Photo Available</h1>			<h1>No Photo Available</h1>		
Repair Description: Replace Cantilever Sign Support					
COMMENTS					
<p>Mounted on top of bridge 90/43WCD on the left shoulder of exit to Bellevue Way. Sign reads "Bellevue Way/ Exit Only". Four 1 3/4" x 42" anchor bolts ut'd with no indications. All bolts are very corroded below the leveling nuts, with complete loss of threads. 5 panel 4' x 3'-6" x 2'-6" truss made up of 3" dia top/bottom chords; 1 5/8" dia vertical/lateral diagonals. Galvanizing has light brown discoloration and alligating on top surfaces of members. 1" crack at end of truss from previous report considered.</p>

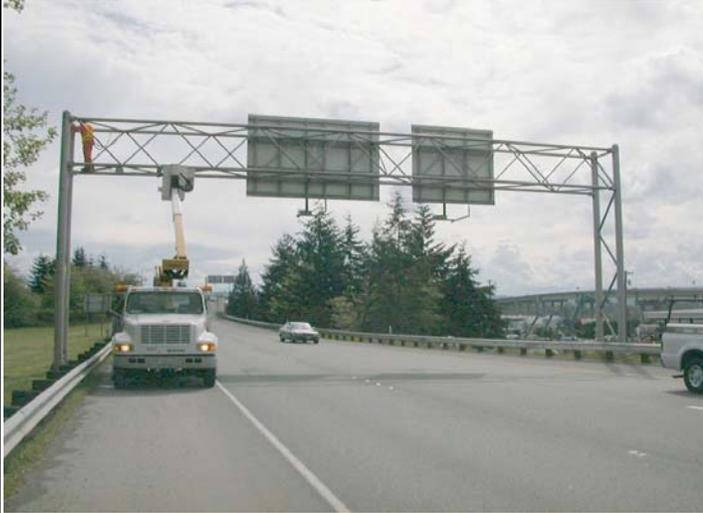
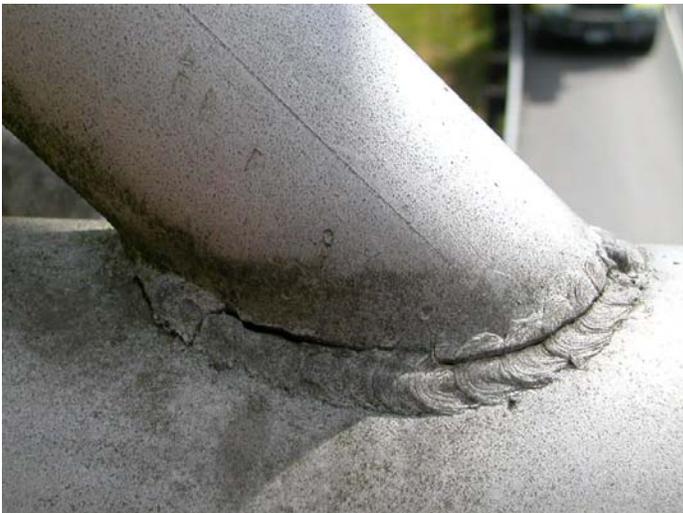
Repair Description: Replace Sign Bridge					
COMMENTS					
Program for replacement due to growing weld cracks in superstructure, incorrectly fabricated ECC plate, aluminum construction.					
Thirteen panel, 64' span, aluminum double truss, 5'h x 5'w. 4-3/4" chords, 2 1/2" vertical and 2-3/4" horizontal diagonals, tower diagonals. L12W-U13W is cracked for 75% of the weld circumference. L6W-U5W is cracked for 75% of the weld circumference. Both cracks have grown since the 2000 inspection. The ECC plate at L10W was not fabricated perpendicular, has a 3/8" gap.

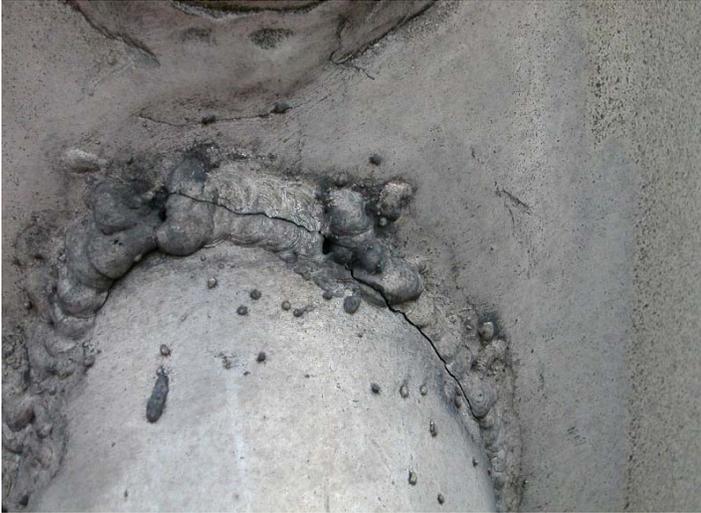
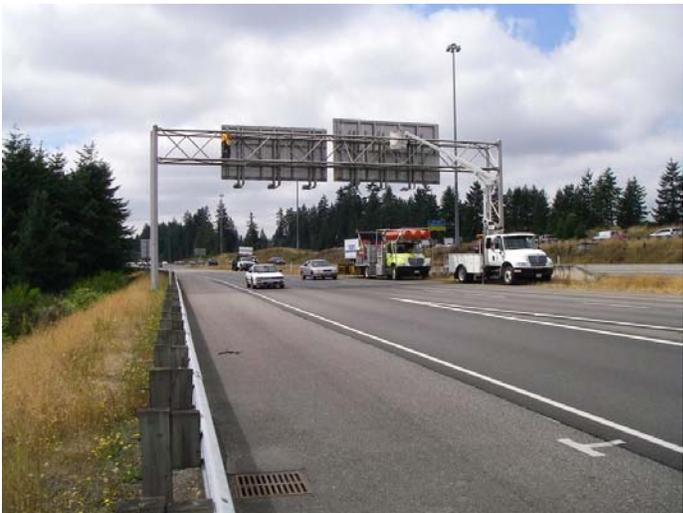
Repair Description: Replace Sign Bridge					
COMMENTS					
13 panel, 63' 10" span, aluminum double truss, 5'h x 5'w. 5" chords, 2½" vertical and 3" horizontal diagonals, 3½" tower diagonals. There is a 6" long ice burst in vertical diagonal L11S-U12S. The 5" ice burst in bottom diagonal L6N-L7S listed in 1991 report has been repaired as of the 2000 inspection.

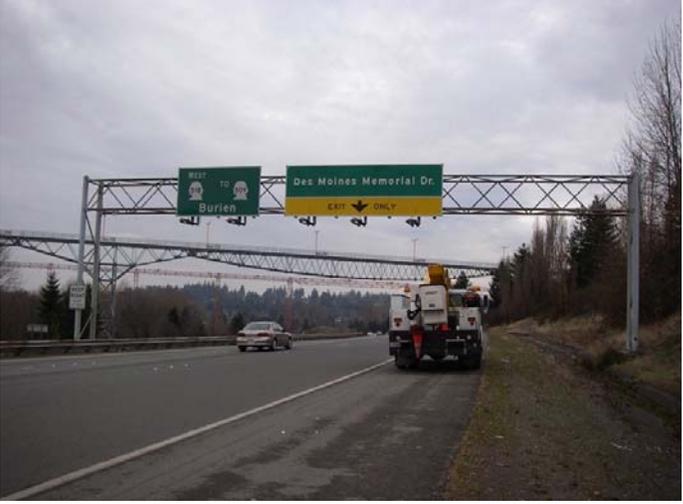
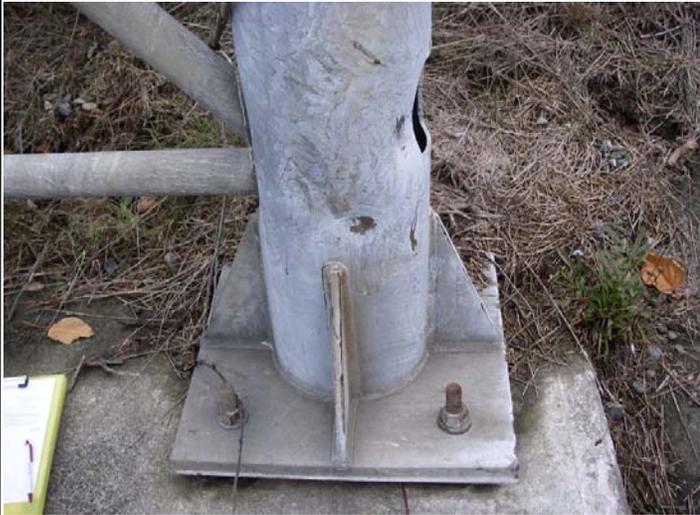
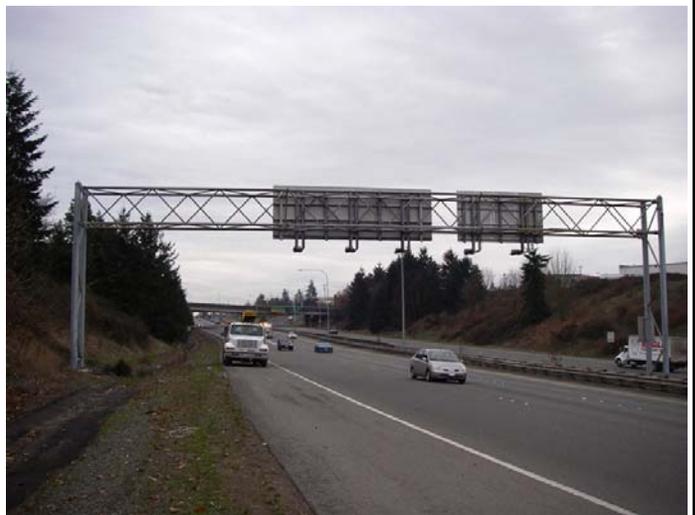
There are four 1" x 33" anchor bolts per tower post. The southeast and southwest anchor bolts of the northeast tower post have strong indications at 5.62" from top. The bolts have been bent and almost sheared from a traffic impact to the side of the post. The grout pads under north tower posts are all but gone. Posts are 10", webs are 3". Top web of south tower has rust holes, section loss minor to moderate. Final cap at southeast post is rusting through. 18 panel 5' x 5' truss. Chords are 4-1/2", diagonals are 2-1/2". Small gaps (1/32") exist in the inspan connections; U12E, U6E, and L6W. Some spots of surface rust on bottom horizontal diagonals on north end.

Replace Sign Bridge

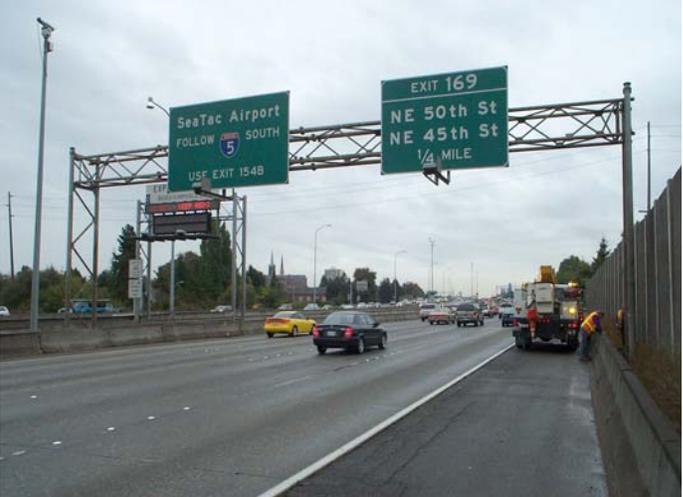
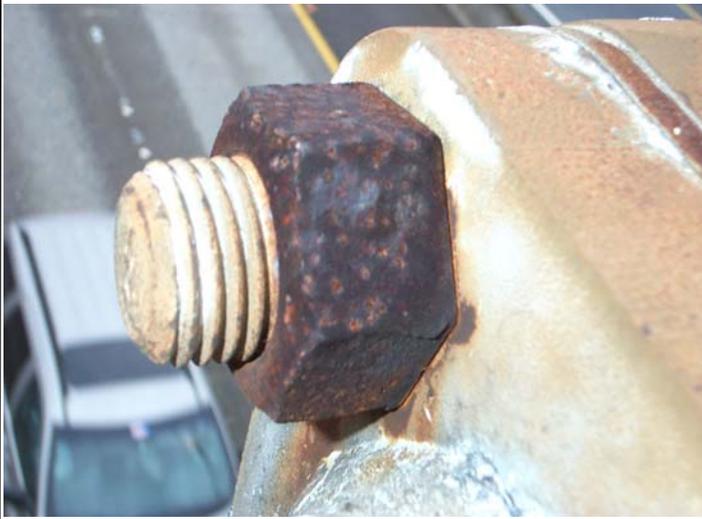
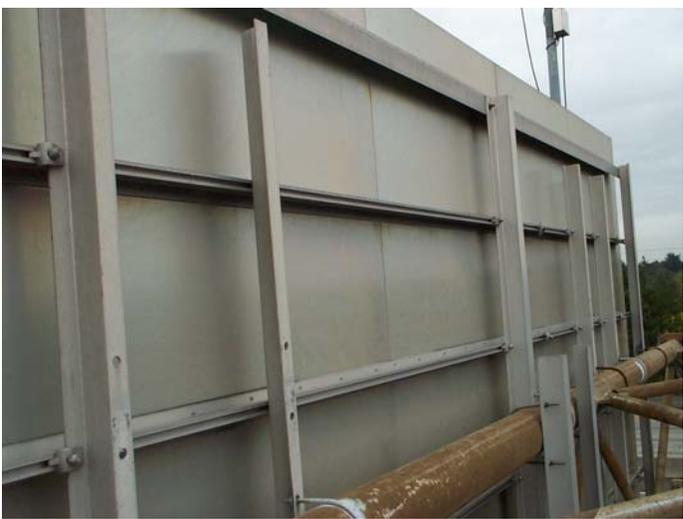
Replacement of this structure is included in the "Downtown Seattle Sign Structures" project. Superstructure is a galvanized, 75' 6" span, 18 panel double truss, 3' 4" square. Chords are tapered from 4" to 7", diagonals are 2 1/2", tower diagonals are 3-1/2". Diagonals are notched for chord gussets. Three MSC, with 1 1/4" x 4-3/4" bolts, no markings, 1-7/8" & 2" head. There is a 4" x 6" laminar rust spot on member U8-U9. The MSC bolts have very rusty nuts, and two of the bolt heads have fractures. Grout pad has been removed.

Replace Sign Bridge

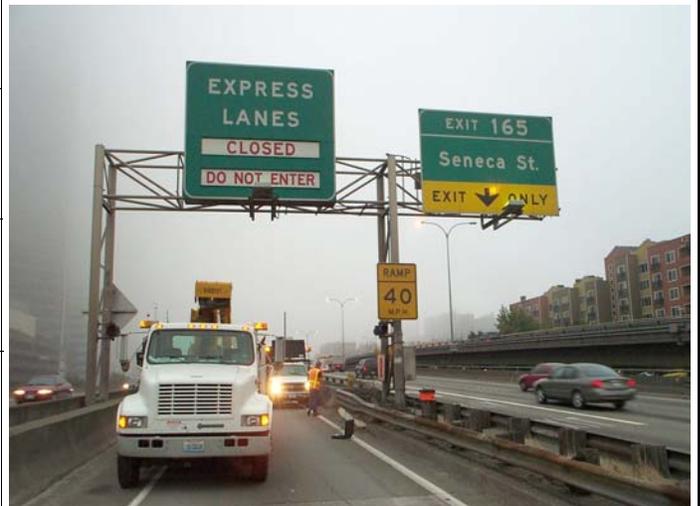
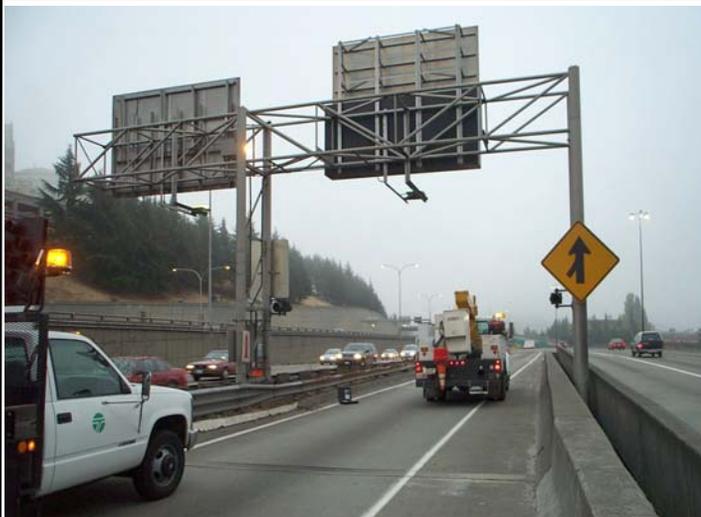
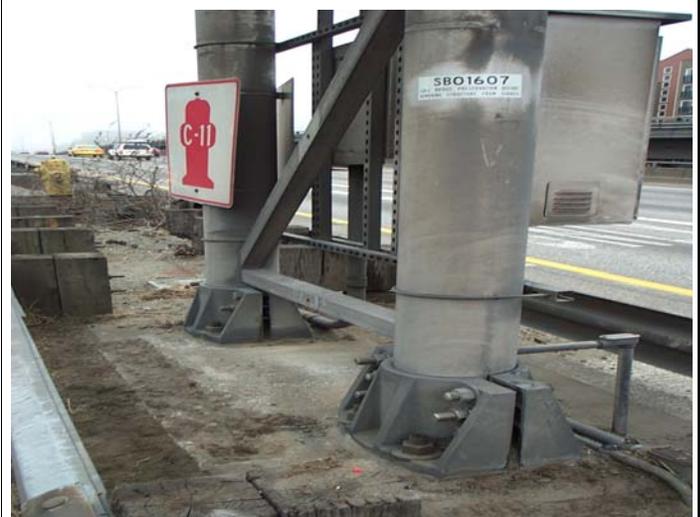
Replacement of this structure is included in the "Downtown Seattle Sign Structures" project. Non-standard superstructure, ECC, and foundation. Many avenues for water entry into aluminum members. 4 & 3 panel, aluminum double truss, 4'h x 4'w. 3 1/2" chords, 3" diagonals. Superstructure is continuous for a 27' span and an 18' 6" cantilever. Members U2S-U3N, U3S-U3N, and U3N-U4S are split and flattened on the ends, bolted in place with aluminum hardware. Four 1-1/2" x 61" anchor bolts, right base. Four 1-1/2" x 8-1/8" anchor bolts, right base (double nutted). Bolts are in good condition. Washers are in place. Good nut engagement. No standoff. No UT indications. Right concrete foundation is 94" x 36" with no notable defects. Left steel plate foundation is 86" x 24".

Replace Sign Bridge

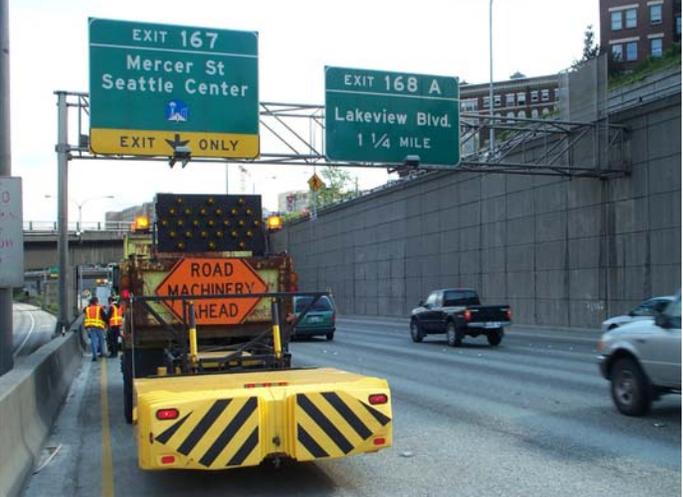
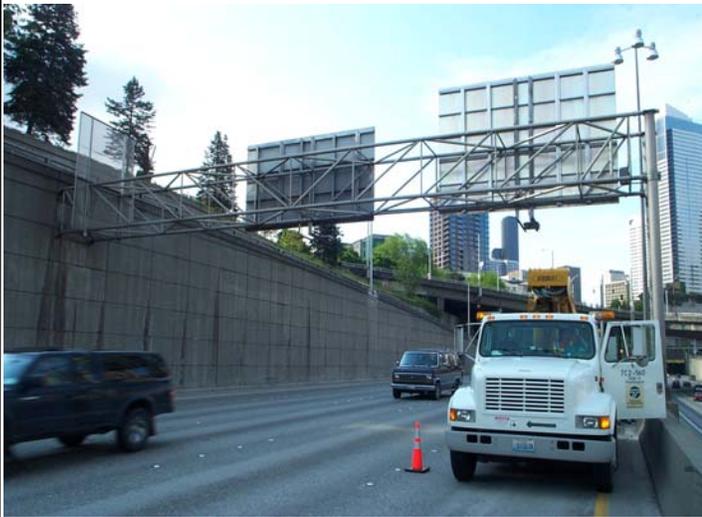
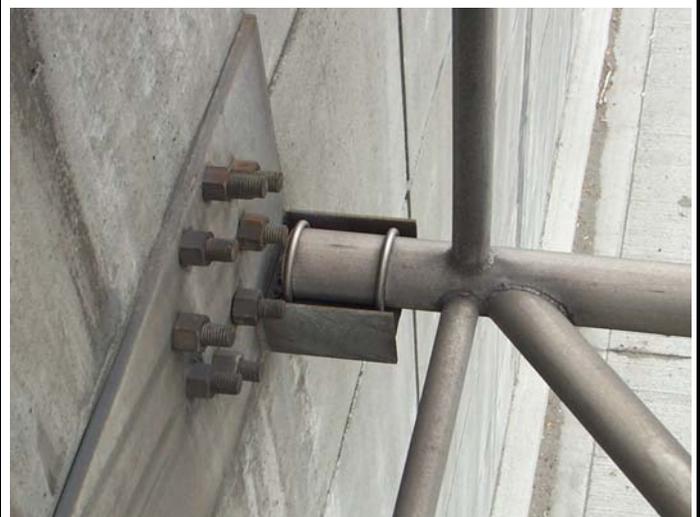
Replacement of this structure is included in the "Downtown Seattle Sign Structures" project. 10 panel, 69' 6" span, aluminum double truss, 5.33'h x 5.33'w. 4 1/2" chords, 2 1/2" diagonals. Vertical member U5N-L5N is completely broken away at U5N, and the pipe is full of water. 4 bolts per post, left base. Right base/foundation is on the retaining wall, similar to 5/165.18NCD, SB01818. Four 1 1/2" x 34.5" anchor bolts per base at west tower. Bolts are in good condition. Washers are in place. Good nut engagement. Standoff is 1/4". Bolts were tightened past snug tight with hand wrench. No UT indications. East base has no foundation (ECC bolts to retaining wall).

Replace Sign Bridge.

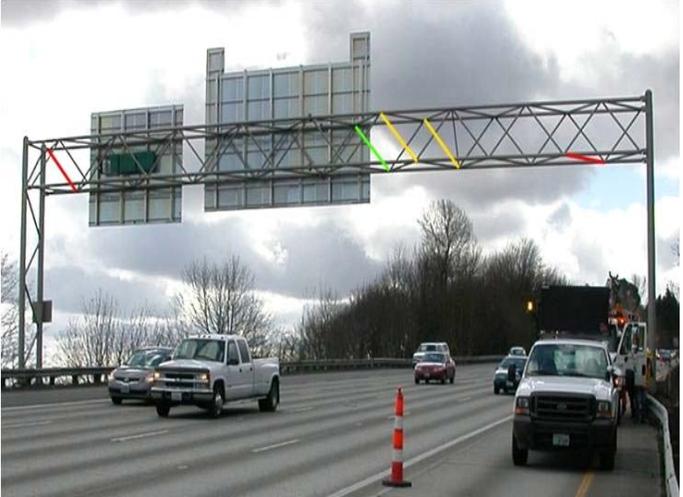
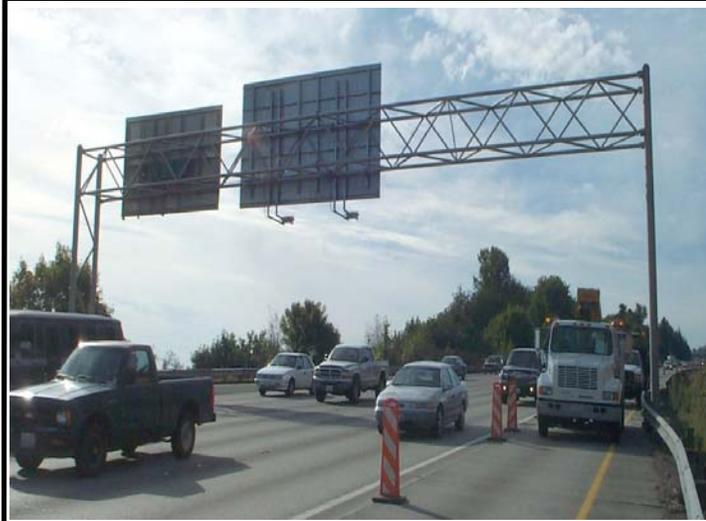
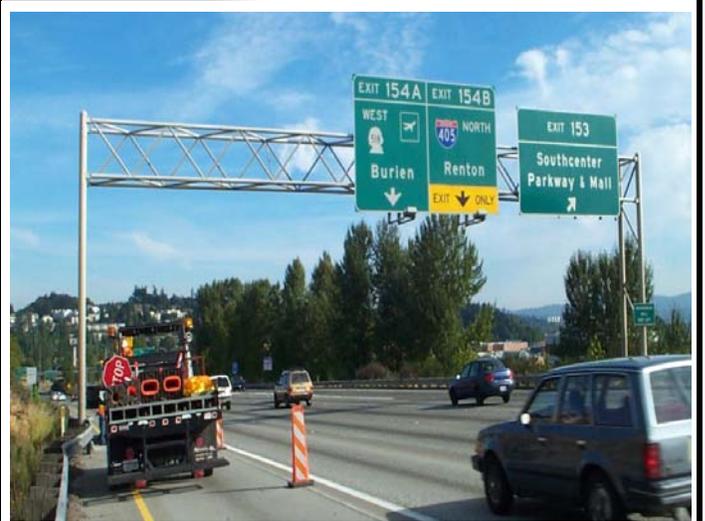
Aluminum truss with cracked welds. Picture above shows red highlighted aluminum members that are 100% disconnected, yellow that are 50%, green member has ice burst. One cracked weld noted in 2002 inspection, four in 2010 inspection.

Replace Sign Bridge

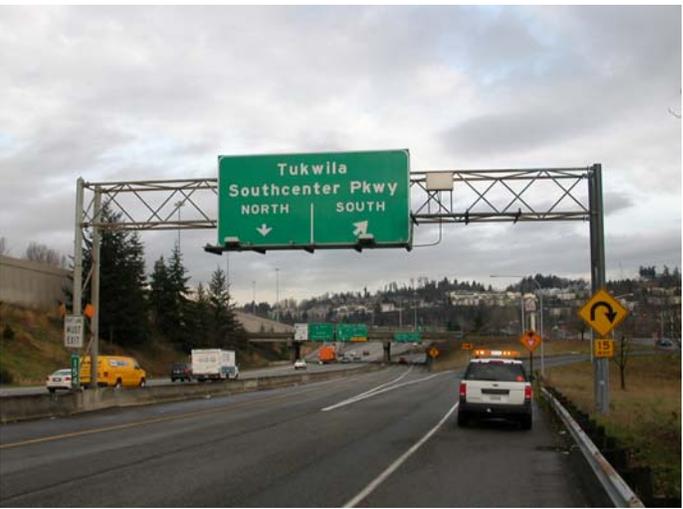
Repair Description:					
Replace Sign Bridge					
COMMENTS					
Twelve panel, 60' span, galvanized double truss, 5'h x 5'w. 4½" chords, 2½" diagonals, 3" post diagonals. One MSC. Contract 4812 included spot blasting and painting surface rust. The previous sign received a high load impact, bending the W4x13, in 2009.

Reduced inspection frequency from standard 60 months due to damaged SW post, and impact to previous sign. Damage inspection performed 07/20/2009 after high load hit damaged previous sign.
