P2 Bridge Preservation - Replacement/Rehab Projects

2013-15 Bien Priority Array

Bridge Repair Form

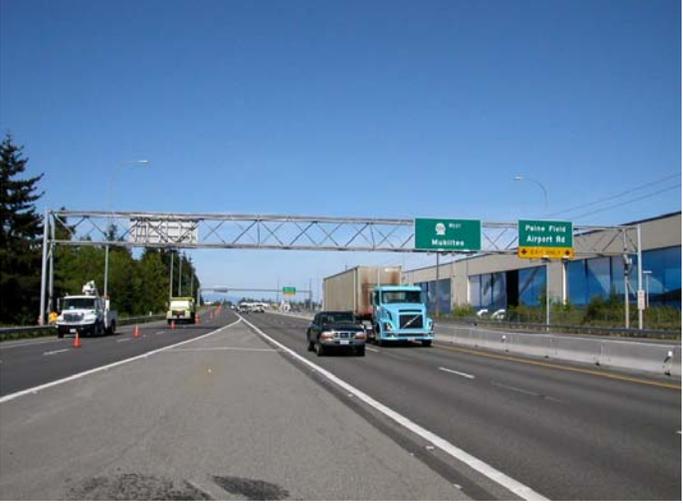
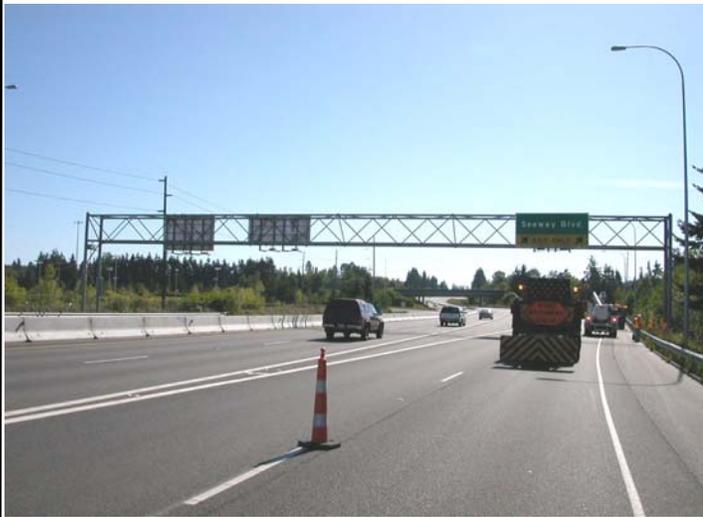
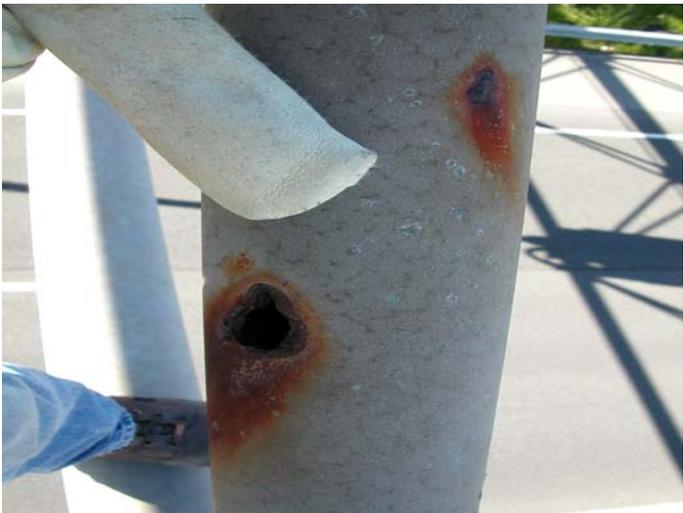
21 panel, 145' span, galvanized double truss, 7'h x 7'w. 6½" chords, 3" diagonals, 4" post diagonals. A325 MSC bolts are ½" x 2¾" with 7/8" head. Five MSC. Sections 1, 4, & 5 are 27' 7", sections 2, 3, & 6 are 20' 9". Diagonal members with localized significant corrosion include U7-L8E, L10-U11E, U10-L11W, U12-L13W, U15-L16E, L15-U16W. Several of these members show distress in more than one location.

Repair Description:

Replace Sign Bridge
