P2 Bridge Preservation - Replacement/Rehab Projects

2013-15 Bien Priority Array - South Central Region

Bridge Preservation Program (P2)

Bridge Replacement Form

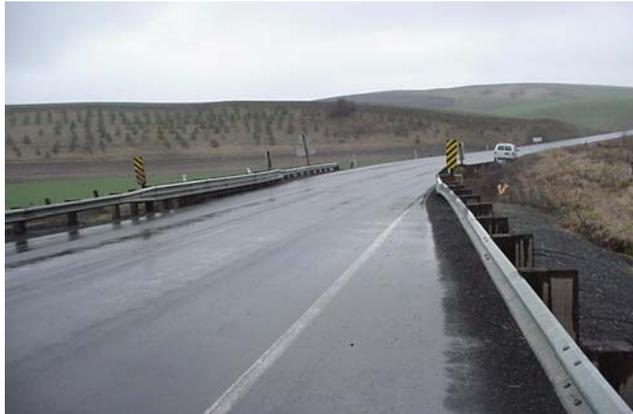
THIS BRIDGE IS CLASSIFIED "SD" DUE TO THE SUBSTRUCTURE CODE.

Calculations show the bridge to be scour critical. Very old bridge with 2 feet of ACP over the bridge deck. The channel is almost all silted in which makes it difficult to inspect under the bridge. The waterway opening is too restrictive and allows water over the approach roadway during high flows. The 1996 flood flow water splashed over the concrete rail at upstream side.

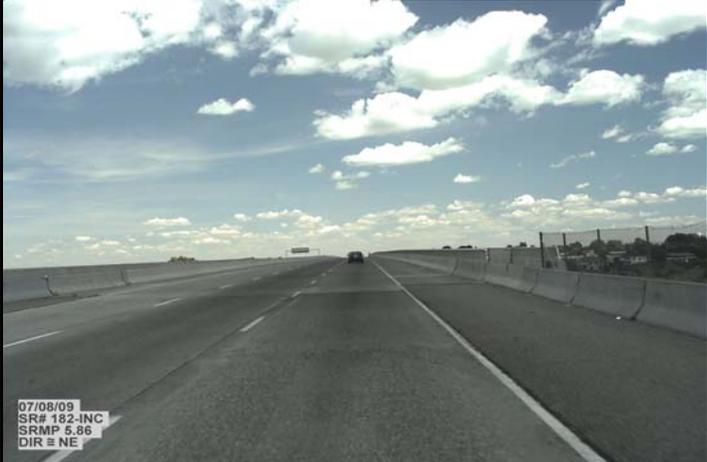
<p style="text-align: center;">PAVING VERTICAL CLEARANCE</p> <p>VC to pavement under bridge: Not Available VC over bridge deck: Not Available</p>	<p style="text-align: center;">WEARING SURFACE or DECK PROTECTION</p> <p>SURFACE TYPE: LMC & ECR 1ST YEAR BRIDGE OVERLAY 1984 OVERLAY CONTRACT HISTORY</p>														
<p style="text-align: center;">BRIDGE RAIL</p> <p>BRIDGE RAIL TYPE: New Jersey Barrier RAIL MEETS CURRENT STANDARDS? YES RAIL CONTRACT HISTORY</p>	<p style="text-align: center;">BRIDGE RESURFACING / DECK COMMENTS</p> <p>The existing LMC overlay that was applied in 1984 when the bridge was constructed has over 17% of the area that sounds debounded from a chain drag survey.</p> <p>It is likely that rutting and deterioration in the overlay will require it to be removed and replaced by 2020.</p>

<p style="text-align: center;">EXPANSION JOINTS</p> <p>There are two modular joints. No work is required at this time.</p> <p>EXPANSION JOINT CONTRACT HISTORY</p> <table border="1" style="width:100%; border-collapse: collapse;"> <tr> <td style="width:15%;">8/6/2007</td> <td style="width:15%;">017397</td> <td style="width:70%;">REM. AND REPLACE MODULAR EXP. JT.</td> </tr> <tr> <td>4/1/2002</td> <td>016351</td> <td>REPLACE MOD JNT @ PIER6</td> </tr> </table>	8/6/2007	017397	REM. AND REPLACE MODULAR EXP. JT.	4/1/2002	016351	REPLACE MOD JNT @ PIER6									
8/6/2007	017397	REM. AND REPLACE MODULAR EXP. JT.													
4/1/2002	016351	REPLACE MOD JNT @ PIER6													
<p>BRG NUMBER: 182 / 016S BRIDGE DECK HMA PAVING DESIGN OPTIONS Max. Bridge HMA Depth:</p> <table border="1" style="width:100%; border-collapse: collapse;"> <thead> <tr> <th rowspan="2">DESCRIPTION</th> <th rowspan="2">PAVING CLASSIFICATION</th> <th rowspan="2">EXISTING HMA DEPTH</th> <th colspan="2">MAX. PLANE DEPTH</th> <th rowspan="2">PAVING HMA DEPTH</th> </tr> <tr> <th>PART./FULL</th> <th>DEPTH</th> </tr> </thead> <tbody> <tr> <td></td> <td></td> <td style="text-align: center;">0.13</td> <td></td> <td></td> <td></td> </tr> </tbody> </table>		DESCRIPTION	PAVING CLASSIFICATION	EXISTING HMA DEPTH	MAX. PLANE DEPTH		PAVING HMA DEPTH	PART./FULL	DEPTH			0.13

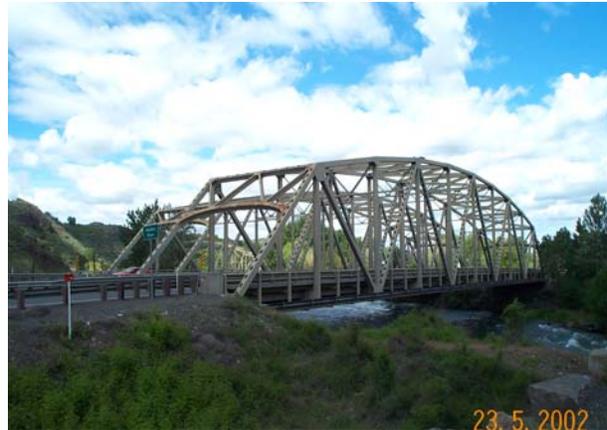
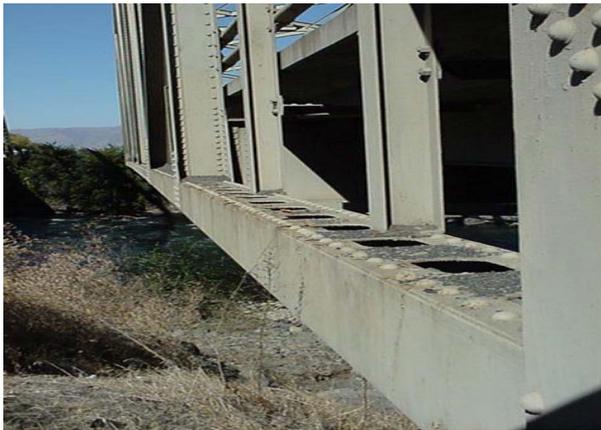
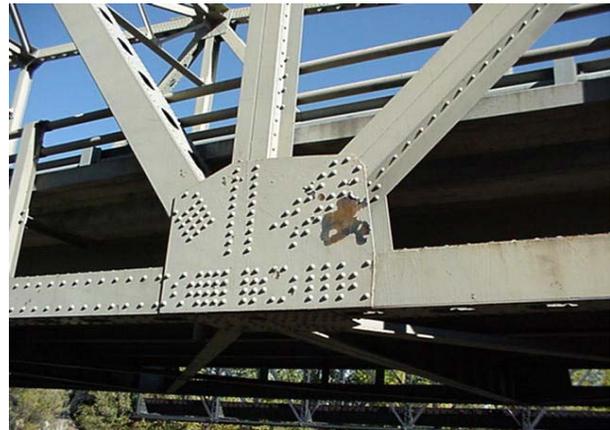
Bridge Inspection Notes:

Paint is peeling on all members except stringers, mostly in locations where the pigeons are. The green base paint is exposed along the top of the bottom chords. Surface rust is visible on vertical faces exposed to sunlight.
 Floorbeams - Most have rusting in the top flange. A few small areas of paint peeling scattered throughout.
 Truss - Pack rust in bottom chord splice plate L6-L7.

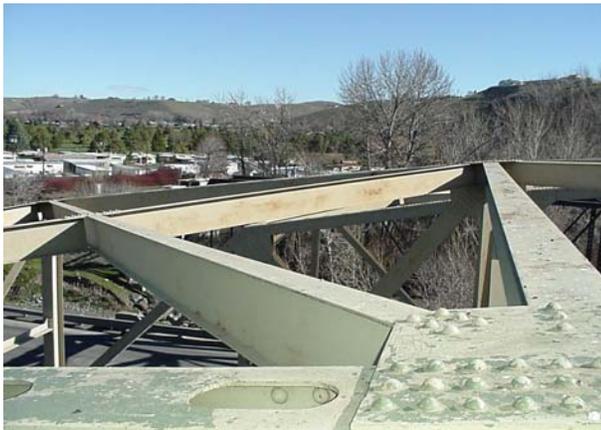
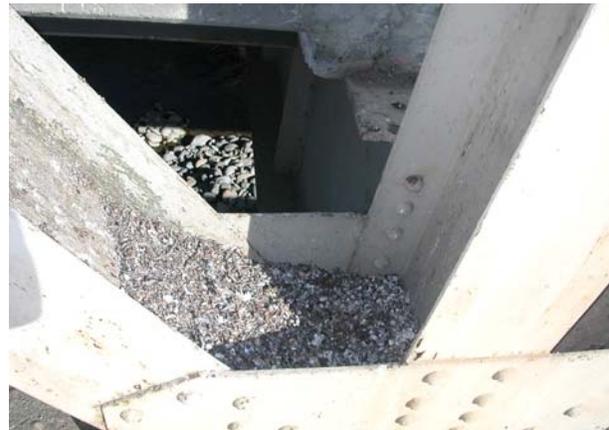
Bridge Inspector's notes:

Paint is peeling on all members except stringers, mostly in locations with pigeons guano. The green base paint is exposed along the top of the bottom chords. Surface rust is visible on vertical faces exposed to sunlight.

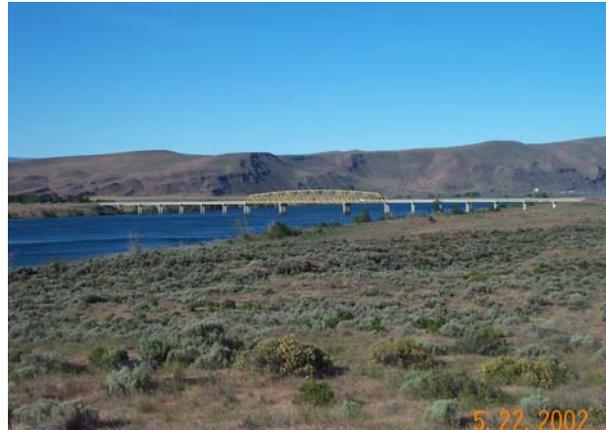
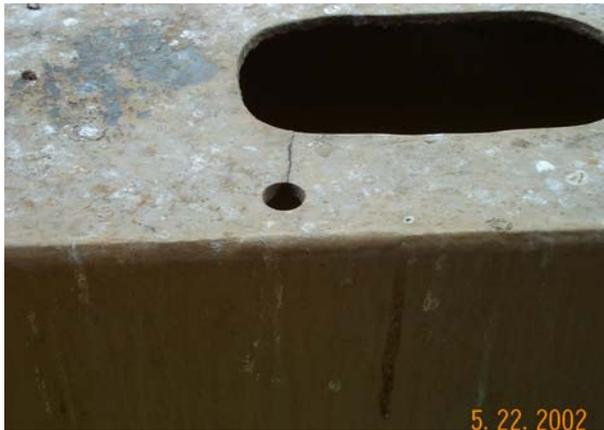
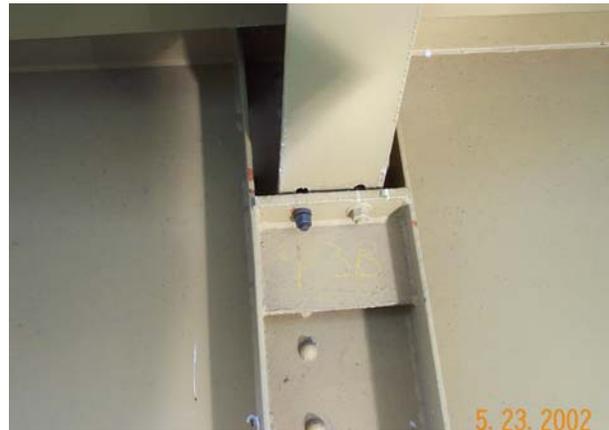
Bridge Inspection Notes:

Stringers - Bottom flanges have up to 12 square inch areas of peeling paint. A few small areas of peeled rusty paint. Some paint chips.

Bottom Chord -The paint is thin in places and has small areas of peeling; a few rusty. Rusty peeling paint in isolated areas of the bottom chord for total of 1% of area. Through Truss - There are scattered small areas of peeling paint on a few diagonals. There are small areas of thin paint on the top chord total area less than 3%. The top chord has peeling paint on the bottom side. Truss diagonals and verticals have scattered peeling rusty areas 2% of total area. Truss top laterals have peeling paint with some rust on 5% of the area. Floorbeams - There is peeling paint on the bottom flanges, and within the bottom chord, and on the lateral bracing.

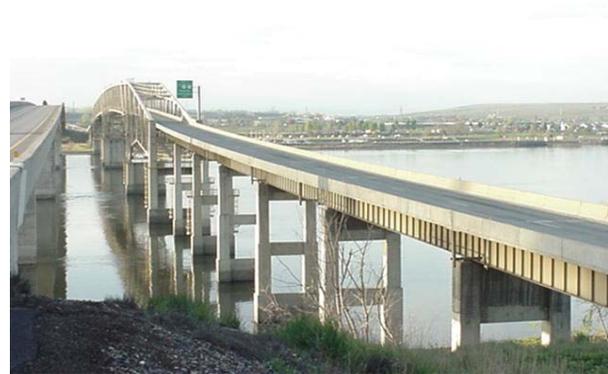
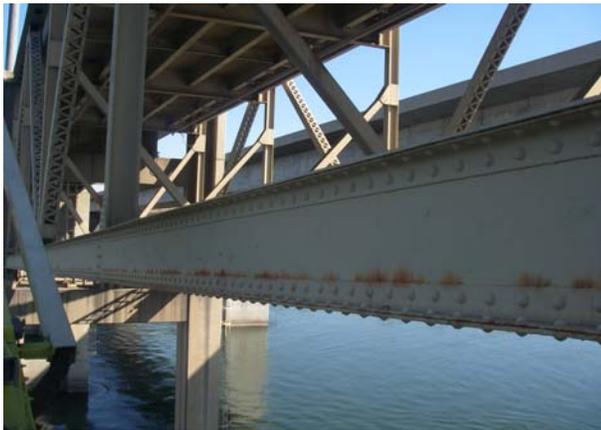
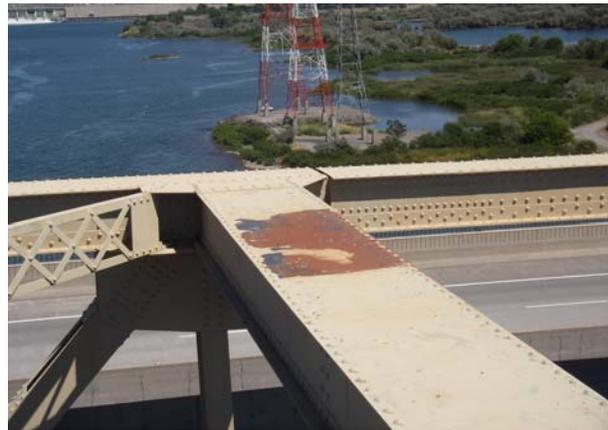
Bridge Inspection Notes:

Truss Floor System - The truss stringer diaphragms have flaking paint top coat in many places over approximately 10% of area. Many stringers have very thin paint. Approximately 5% of the stringer area is affected. There is extensive peeling paint on the stringers in the east bays of the east truss span. The truss floor beam bottom flanges have peeled paint in 2 sq.ft. areas (approximately 2% peeling).

Truss Bottom Chord - There are areas on the bottom of the bottom chord and inside the bottom chord that have missing or peeled off top coat, amounting to approximately 5% of the total painted area. The drop in span bottom of the South bottom chord has up to 10% peeled paint. The girder cross brace chord angles have flaking top coat of paint on approximately 5% of the area.

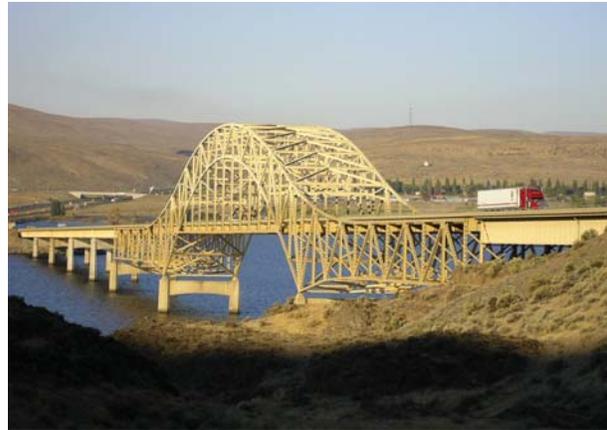
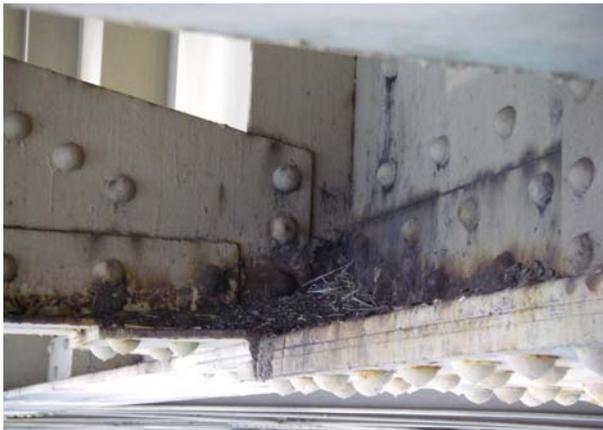
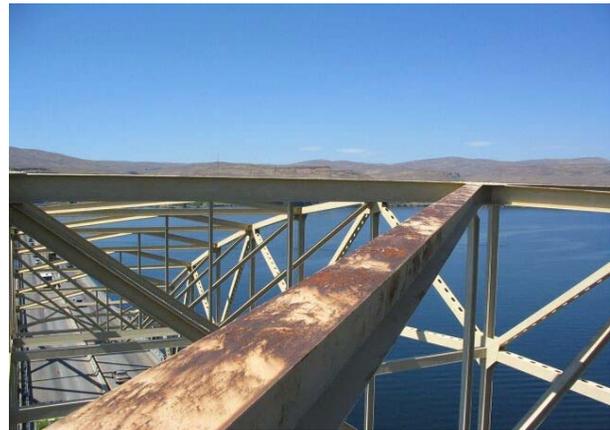
The paint on the steel girder approaches and the upper portion of the truss was last painted in 1984. These elements still should be coded with the BMS element 901.

A 2002 project (contract 16387) painted the steel elements under the deck in the truss spans and truss elements 10' above the roadway deck. The quantity was approximately 141,400 sq ft.

The steel surface above the roadway deck and the steel girder approach spans need to be painted (271,000 sq ft). The paint in these areas can be overcoated. There are some areas of rust that will be addressed by full removal.

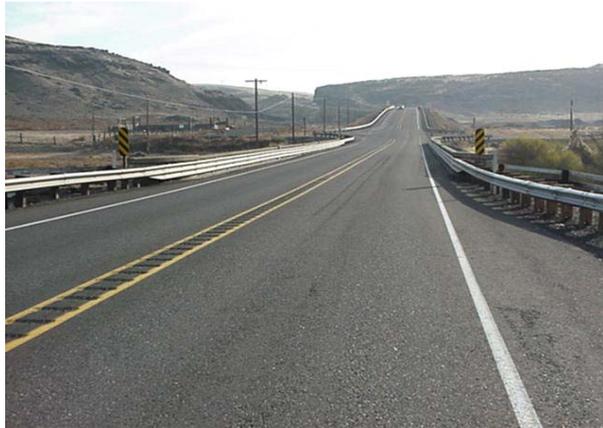
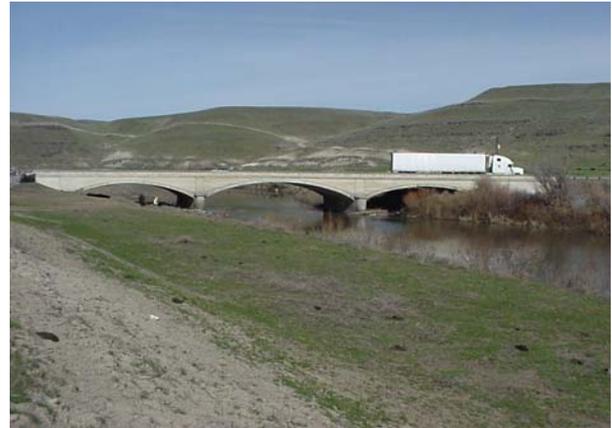
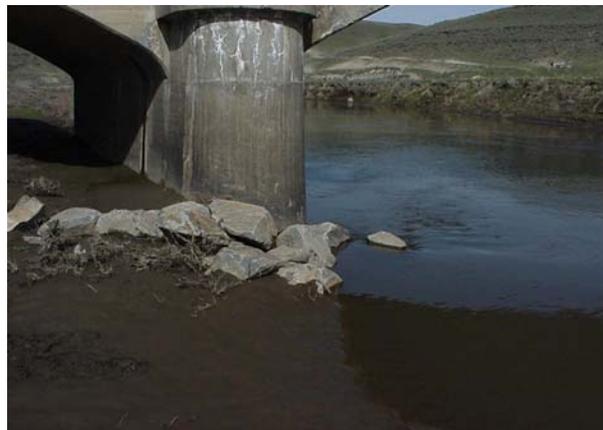
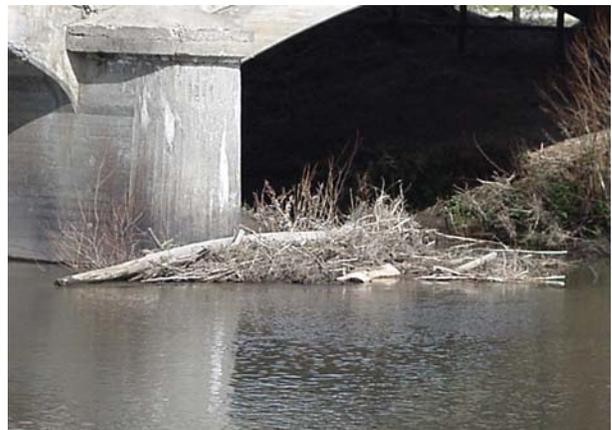
<p>Deficiencies:</p> <p>Scour hole at pier 2 south end of east face has large riprap in place (photo 1). Contraction scouring at the south nose of pier 3 caused by a 2' tall brush pile (photo 2). 4' vertical cut bank in the silt at the north end of pier 3. Design Plan check indicates "Solid Rock" at Piers 1 and 2, pile foundations Piers 3 and 4.</p>	First Noted: 12/22/2006
	BPO Repair List Priority: 2
	Funding - P2 or M: P2
	BPO Repair Num: 11832
<p>Recommended Action:</p> <p>BPO - A scour repair is required at Pier 3 where the pile cap is exposed full length to a depth of 4.75'.</p>	Project PIN:
	11-13 Priority Rank:
	13-15 Priority Rank: 11
<p>Total Cost Estimate: \$573,611</p>

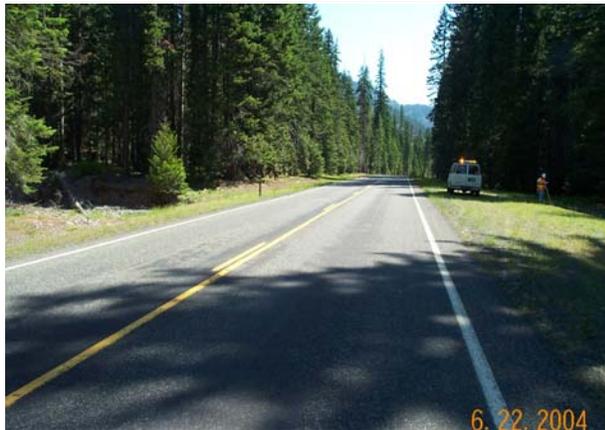
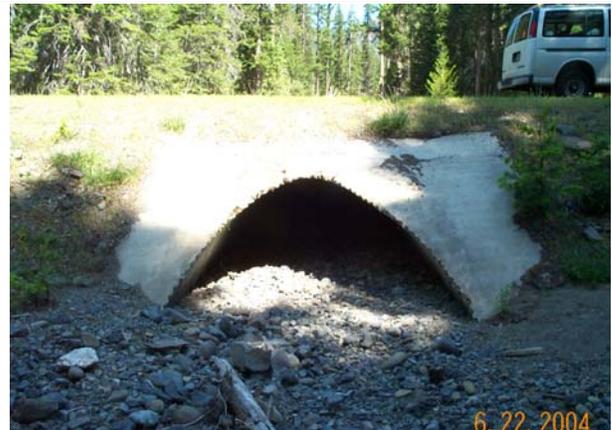
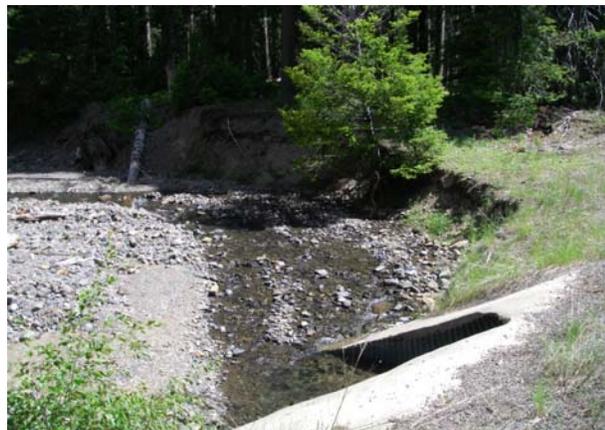
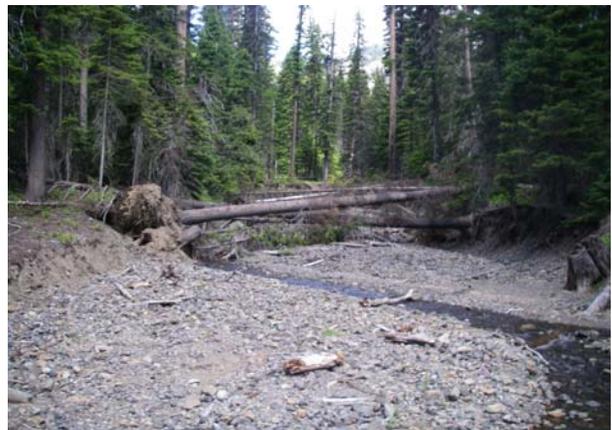
Deficiencies: Channel is much wider upstream, approximately 50 ft. wide. Upstream, there are several large trees have been uprooted on both sides of the stream channel forming a significant debris blockage. Channel is directed towards the east approach and has eroded the northeast corner of the culvert up to 4 ft. vertically. The culvert has aggraded.	First Noted: 6/28/2010
	BPO Repair List Priority: 1
Recommended Action: Remove large trees blocking upstream channel. Place riprap at the northeast upstream corner to prevent further erosion of the east bank .	Funding - P2 or M: P2
	BPO Repair Num: 10001
	Project PIN:
	11-13 Priority Rank:
	13-15 Priority Rank: 7
	Total Cost Estimate: \$732,967

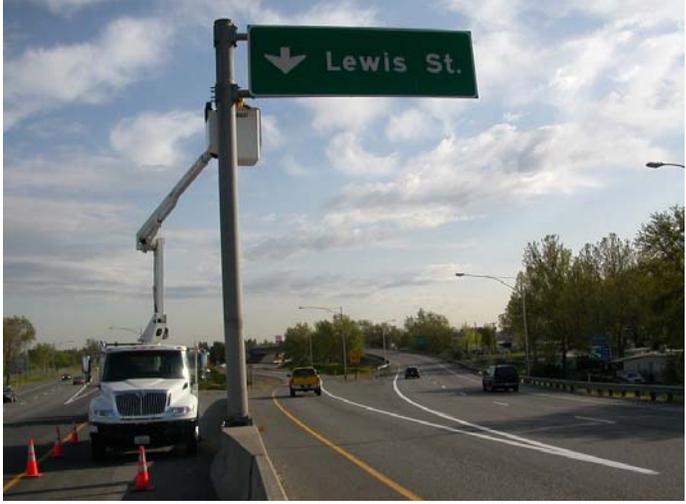
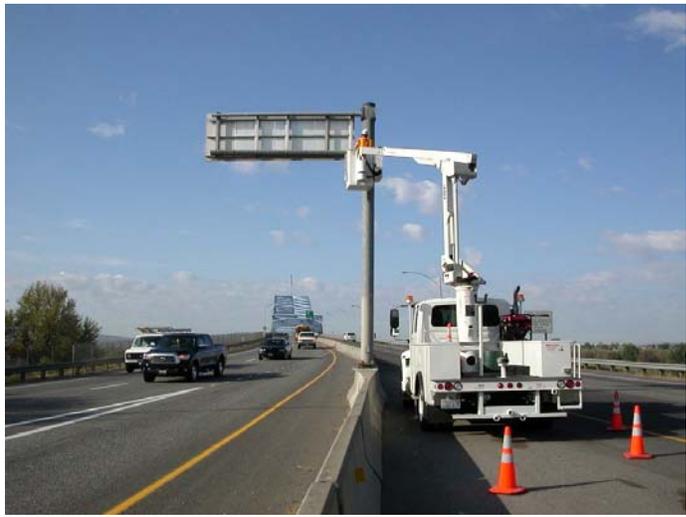
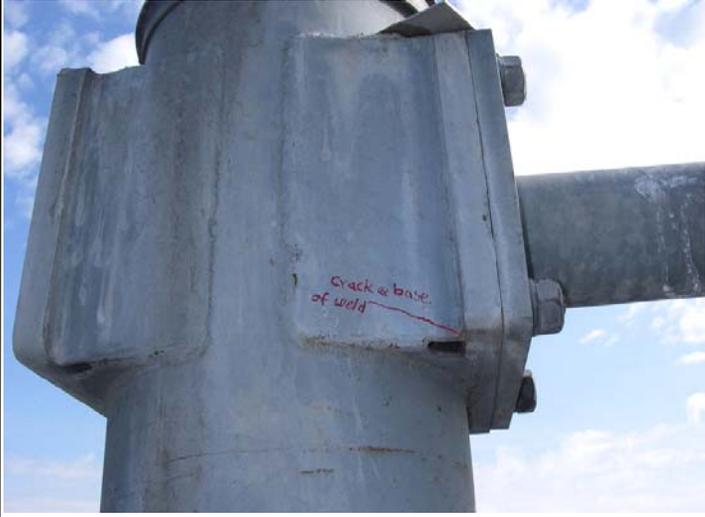
Repair Description:						
Replace Cantilever Sign Support						
COMMENTS						
<p>Top horizontal z-bar with + connection to sign. Two windbeams. Aluminum wbc hardware. Vertical z-bar are torch cut across top. Top 1-1/8" x 4" upper ECC bolts threaded into plates. 1-1/4" x 5-1/4" bottom ECC bolts appear to be extending all the way through the post and sticking out other side where the structure used to be a butterfly. UTd all ECC bolts with 1/2" diameter x 2.25 MHz transducer; no indications. Top old butterfly ECC has open holes where birds nest. Cracks in end of weld in the upper beam both north and south sides at the lower corner of the plate to pipe flange connection.</p>
