Research Project WA-RD 491.1  
Soil Bioengineering for Slopes

### **SOIL BIOENGINEERING FOR UPLAND SLOPE STABILIZATION**

February 2001

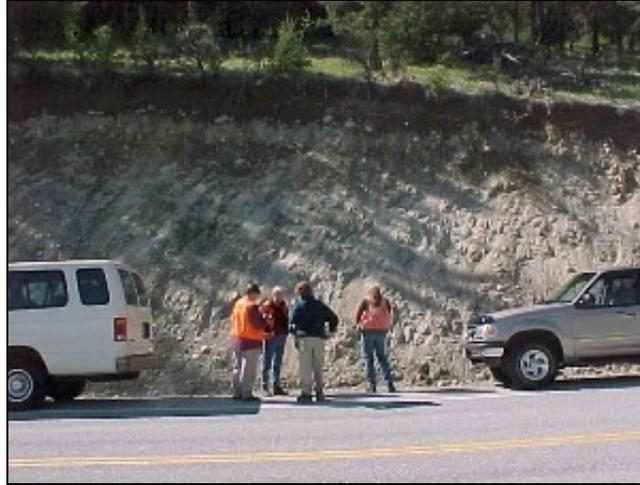
**Figure 2. SR 971, Mile Post 8.22 vicinity, June 1999**

Located at Mile Post 8.22 on State Route 971, above Lake Chelan, this 630 foot long by 70 feet high, north-facing slope has been a chronic source of surface erosion and ditch maintenance needs.

Soils on site are composed of glacial deposits and volcanic ash overlying granitic bedrock. The glacial deposits are composed of sand, gravel, cobbles, and boulders. The weathering of the granite bedrock into rocks, fragments, and mineral components is called grus; in particular the feldspar minerals weather rapidly to a fine or "ashy" size. There is evidence, as seen in Figure 2, of chronic surface erosion with rilling and associated accumulated debris in the ditch line.

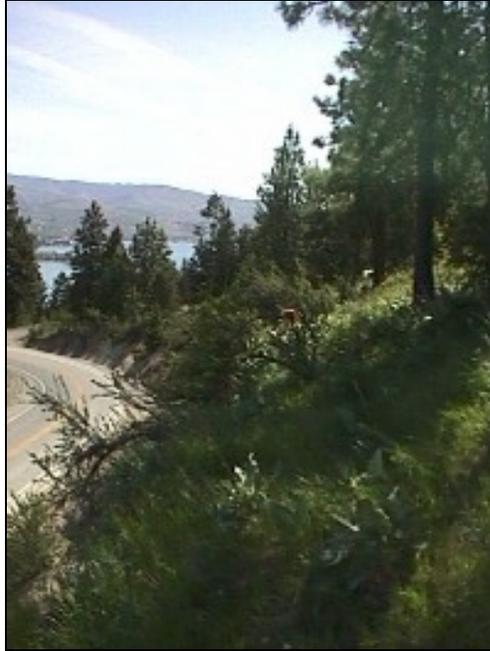
**Figure 3. Vegetation community on stable soils**

There was sparse existing vegetation on the slope face consisting of a bitterbrush (*Purshia tridentata*) and ponderosa pine (*Pinus ponderosa*) community and one willow (*salix exigua*). See Appendix G. This vegetation was located on portions of the slope that were at an angle of repose of 1.5(V):1(H). Where the slope was steeper, there was no vegetation growing.

The slope above the vertical lip has a ponderosa pine community established. The vegetation, especially the mature trees, growing on the edge are at risk because of continual erosion.

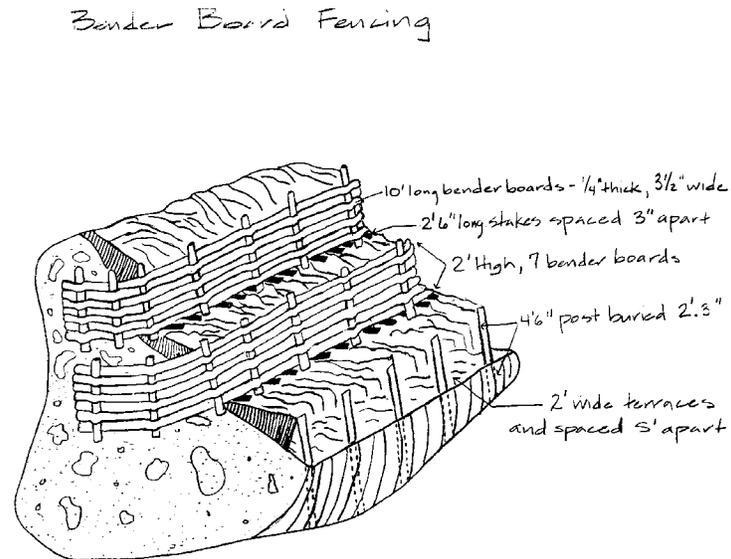
**Figure 4. Bender board fencing**

The PI's original bender board fencing detail and specifications are found in Figure 4:

*Material: Redwood or Cedar*

After consultations with fellow scientists and lumber experts, the PI's solution was to use cedar bender board fencing. The consensus was that the slope would benefit from terracing, but traditional soil bioengineering plant species, such as willow, would not be appropriate for these site conditions. As a result, cedar bender board fencing was used as an alternative to willow walls to reduce the length and steepness of the slope and to create stable planting platforms for easier establishment of native (dry climate) vegetation.

Further hand construction was delayed until after the first week in December when the PI, the OSC Roadside and Site Development Manager, and Department of Ecology Soil Scientist Mark Cullington could examine the slope conditions. They made the on site decision to continue using rebar to reinforce the terraces and to adjust bender board structures from two feet to a one foot height (3 boards instead of 6).

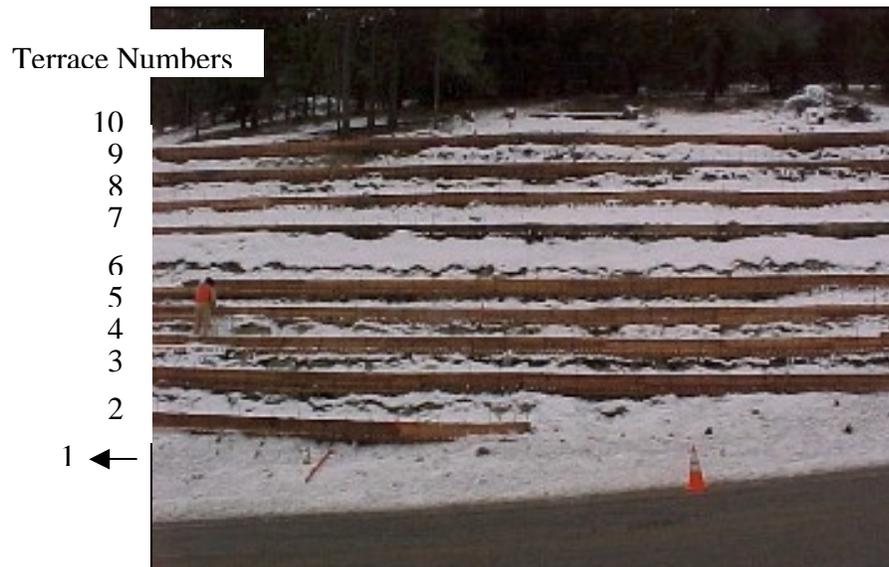
**Figure 5. End of season - January 13, 2000**

The Crew continued to construct the terraces and bender board fencing until the ground froze too deeply to work. They quit for the season on January 13, 1999. The photo below shows the site at that time.

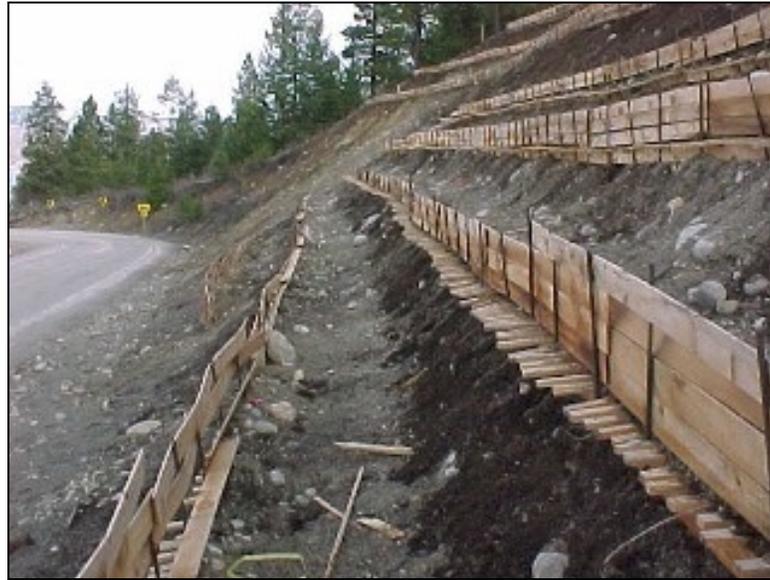
**Figure 6. Status before Spring construction - March 15, 2000**

The Landscape Designer checked the site on March 15, 2000 to determine if the soil had thawed and to check for disturbance to the site during winter. Without snow mixed into the soil, the soil had settled, allowing some of the boards to fall back onto the terrace. This can be seen in Figure 6. With the addition of water, areas on the control section had liquefied and moved down slope. However, where compost had been applied, there was no visible movement of soil.

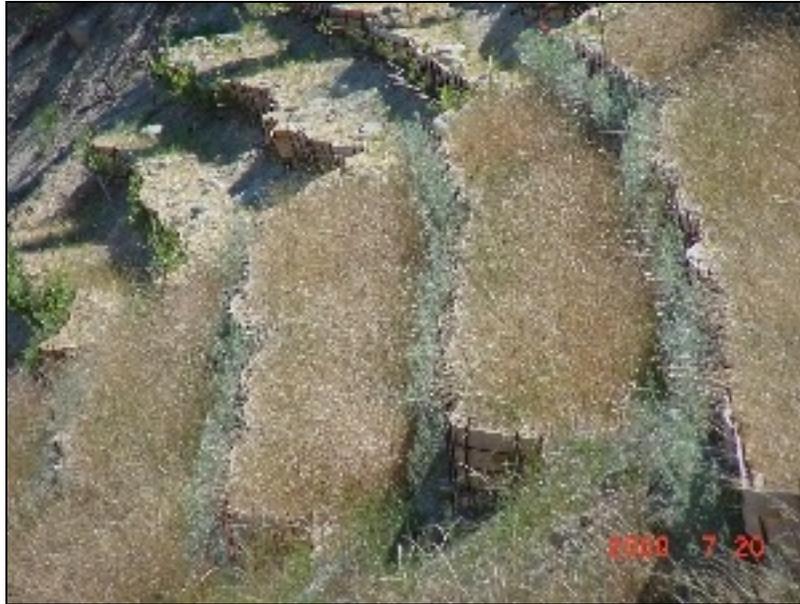
**Figure 7. Grass communities differ with biosolids**

By the end of June the bender board appeared to have stabilized the surface erosion and grass was growing on all terraces, however, where the composted biosolids were applied, The annual rye was thicker, greener and withstanding drought conditions better than the control section without compost as seen in the photo below. The predominant vegetation on the control section was Idaho fescue.

As of October 2000, trees planted on the landowners' property were green, as seen from below, and grass and trees were growing in the soil disturbed by the bobcat.

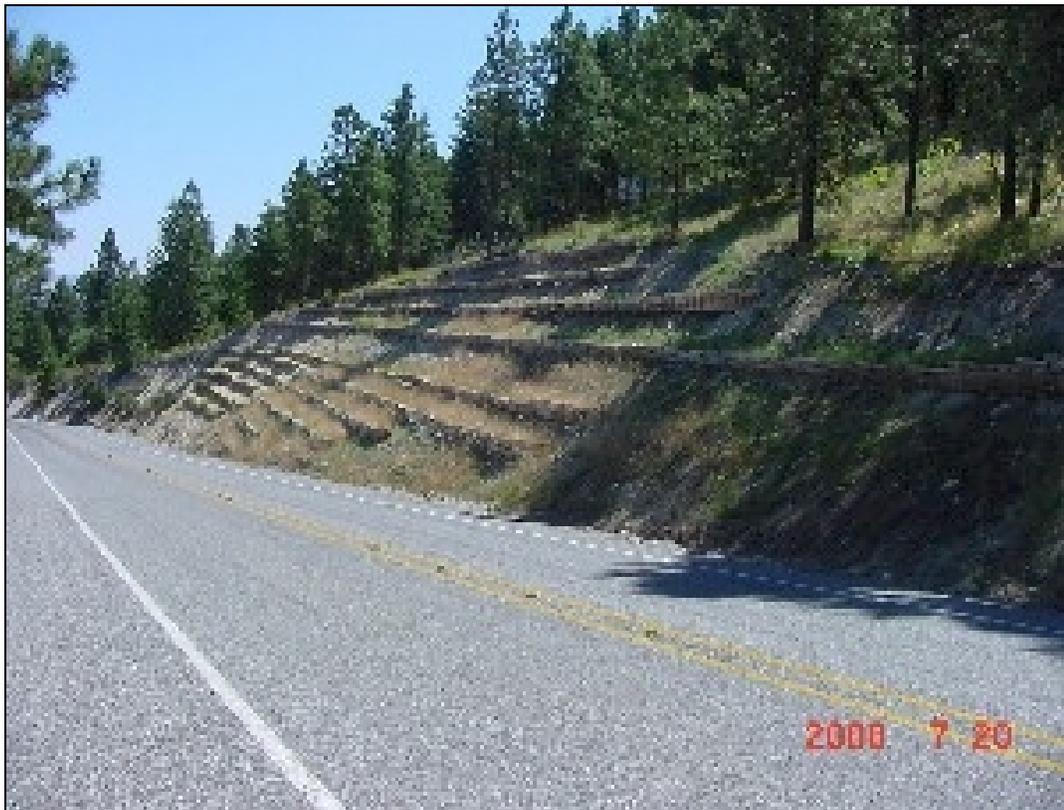
**Figure 8. Chelan, July 20, 2000**

Long-term monitoring will allow WSDOT to determine long term slope stability and to further understand the relationship between native plants, native soil, and biosolids. The status of this site in July 2000 is shown in Figure 8.

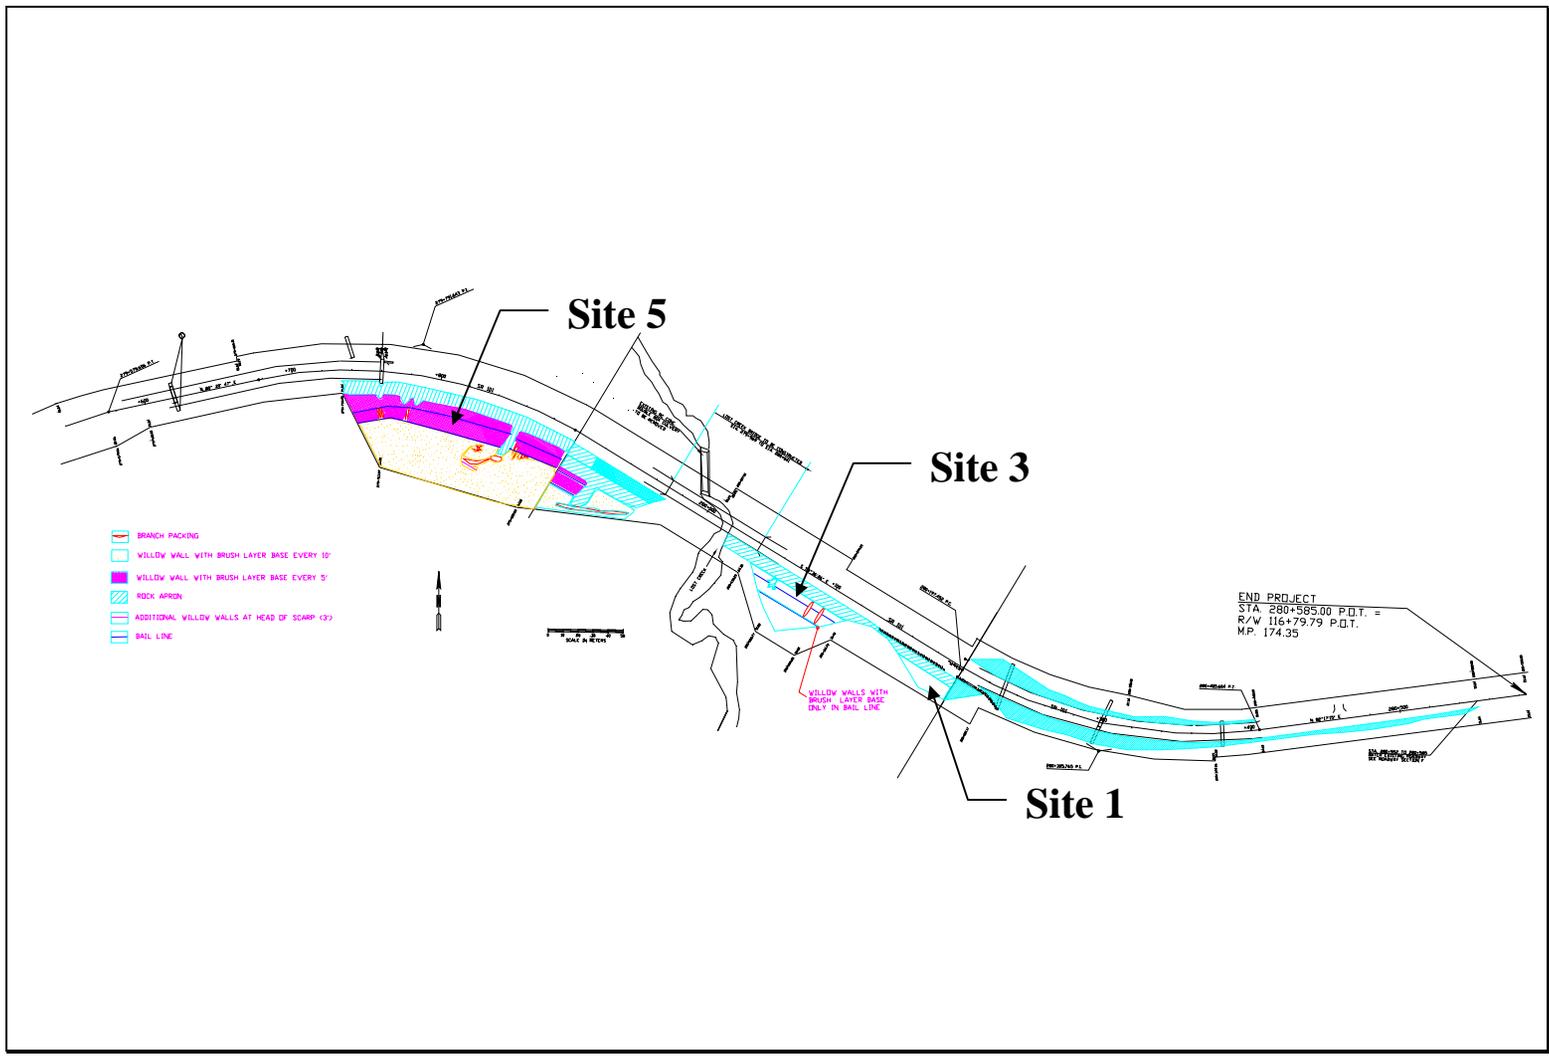
Figure 9. Lost Creek Project Areas

The Lost Creek project was divided into three sub-sites, Site 1, Site 3, and Site 5. Locations of these sites are shown in Figure 9.

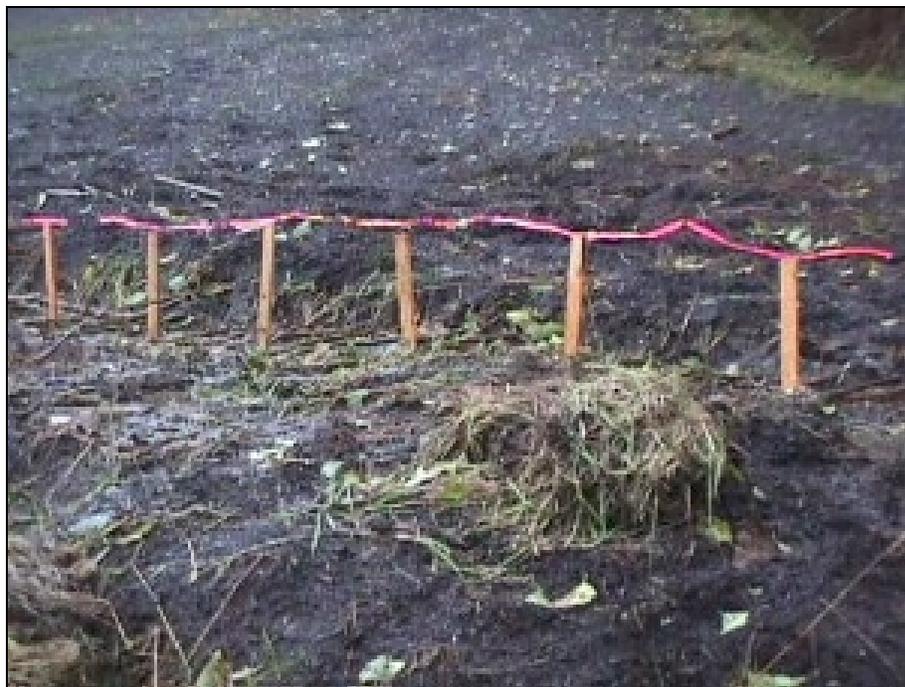
**Figure 13. Site 3 - Stakes placed below level terrace marking tape**

The original plan called for willow wall construction in the same general location as existing hay bales. However, the hay bale rows were not level and encouraged runoff beginning from the center of the hay bale row and extending to the edges of each row. This resulted in erosion of material from behind the hay bales and at each end. After consultation with the PI, the Crew was to begin at the highest point of the hay bale row and continue constructing the willow walls level with that highest point. The RA used a laser level to stake all terraces for the Crews with pink flagging tape as seen in Figure 13. At this point, the RA had to leave for Chelan. While she was gone, the Crew did not follow the RA's instructions and continued to construct the willow wall in the straw bale line. The Crew constructed two additional rows of willow wall that were also not level. The Crew did not understand how to keep the terraces level on a convex surface. For example, Figure 13, below, shows the marking tape where the wall should have been constructed above and behind the stakes the Crew placed.

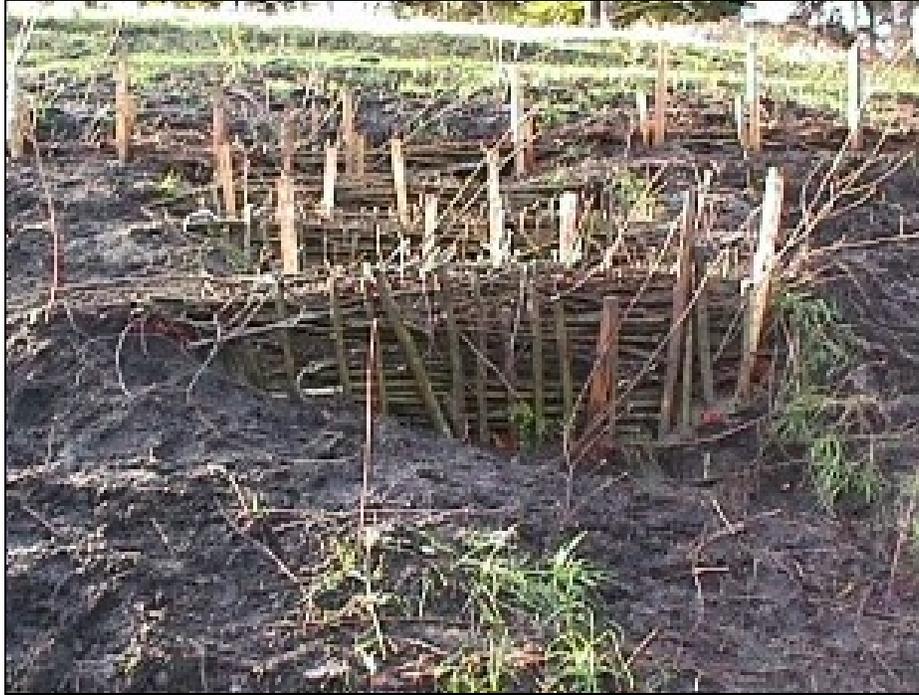
**Figure 14. Branch packing Parallel to Contours**

Due to the amount of surface water received by the gullies on Site 3, the original branch packing design washed out. Additional willow walls were constructed at the head of this gully and the branch packing design was changed to the design seen below.

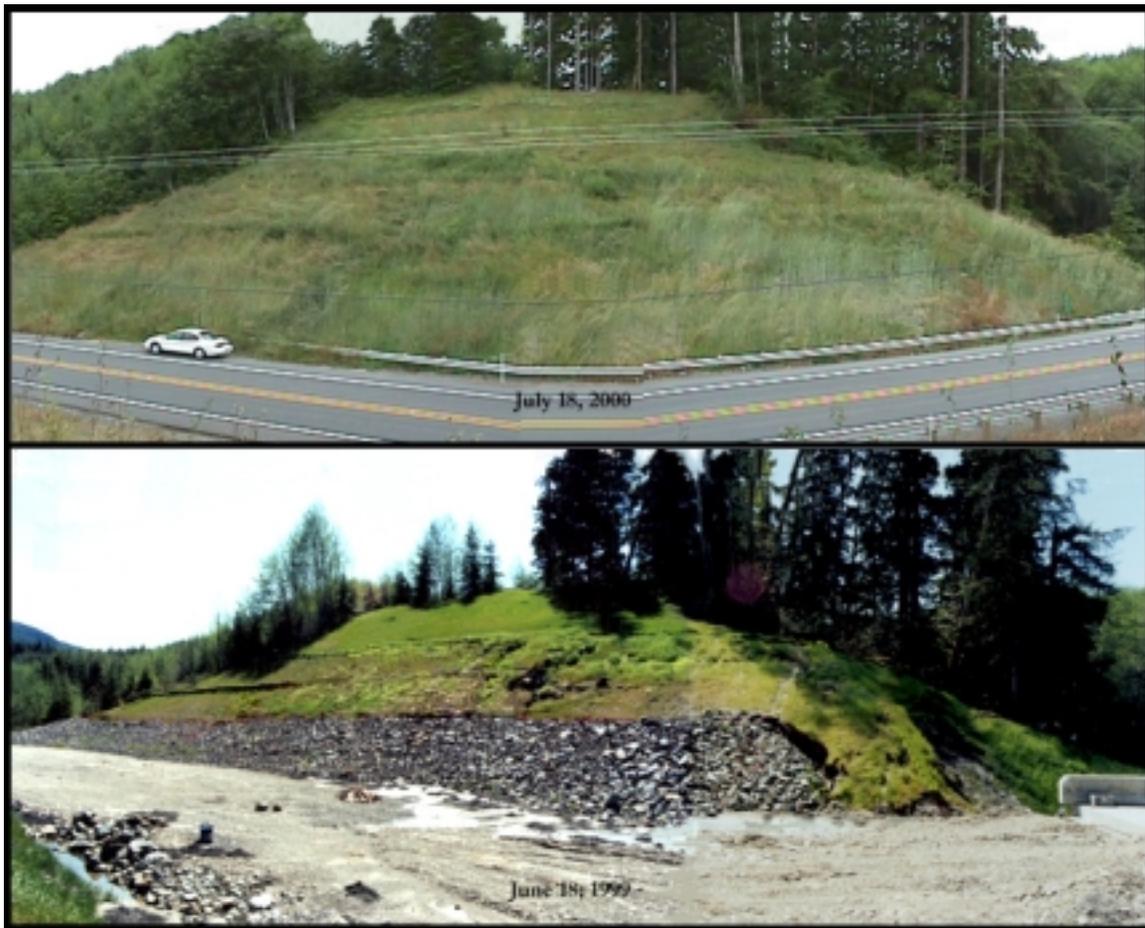
**Figure 16. Site 3 Before and After Soil Bioengineering**

In Figure 16 the top photo shows the site 6 months after construction. The lower photo shows the site prior to construction.

As of July, the head scarp was stabilizing with grasses, shrubs, trees, and willow structures.

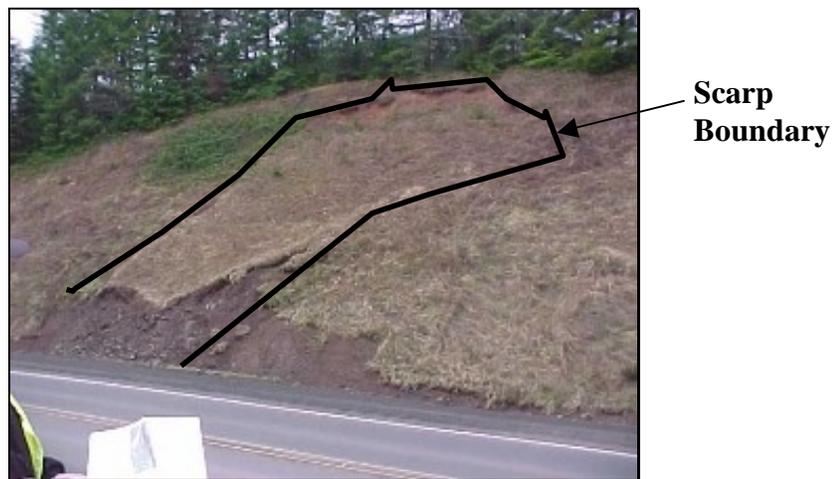
**Figure 17. Area of Instability**

Soils on this 591 feet long by 112 feet high east-facing slope are composed of marine sedimentary rocks that are weathered. Small shallow rapid landslides have occurred where these weathered clay layers have left slope sections exposed to water movement. With excess surface and subsurface moisture, these layers slipped and moved downhill into the ditch. To manage stormwater runoff, maintenance activities required clearing of these plugged ditch lines. In doing so, the base of the shallow rapid landslide was undercut, leaving a portion of the area with an exposed vertical face. During the year, the slope would “adjust,” move again into the ditch line, leaving a larger head scarp exposed to surface and subsurface water movement.

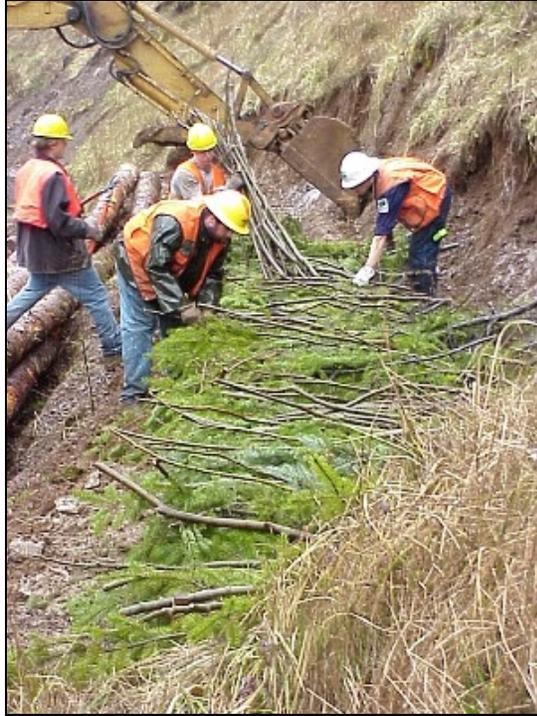
**Figure 19. Cordon Construction**

Construction began with region Maintenance personnel using heavy equipment and two WCC crews using hand equipment on February 1, 2000. They began by excavating at the northern end of the site and installing the first cordon. Figure 19 shows the cordon construction after the bottom two logs have been placed in the terrace parallel to the slope.

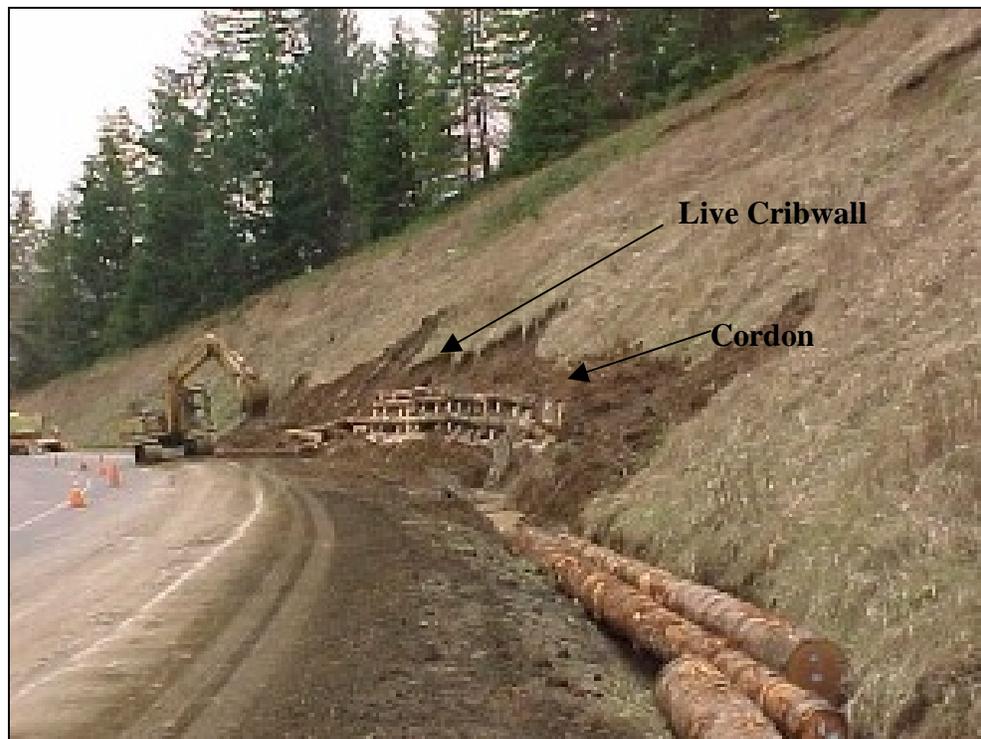
**Figure 20. End of first week of construction.**

Figure 20 was taken on February 10, 2000. It shows cribwall construction at the end of the first week of construction.

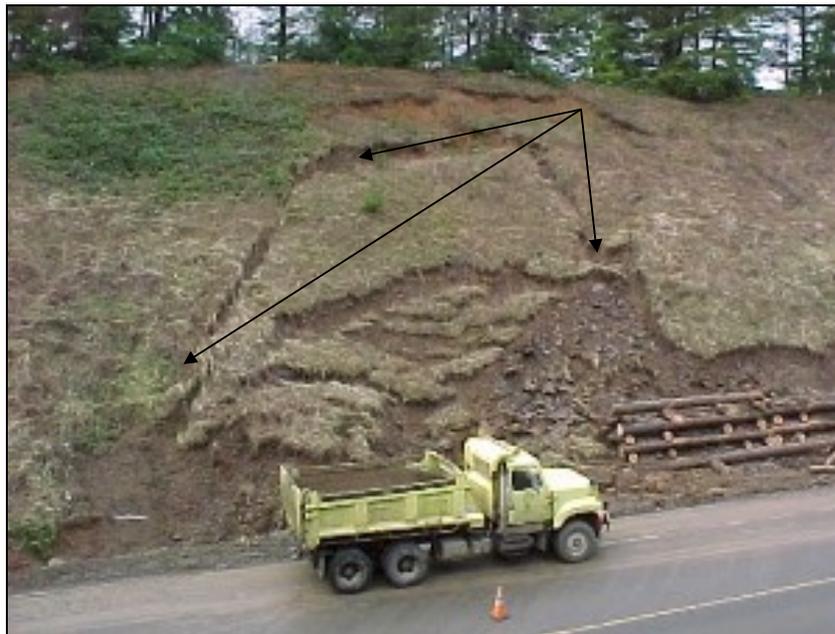
**Figure 21. Slope Failure**

Some excitement here in Raymond this morning. About 80' into the 6X6 section of cribwall, an area approximately 70'W x 90' high began to slide as the excavator was removing the toe. It slid in one piece about 4' vertically in less than 30 seconds. I really hesitate to excavate any more of this area until we have a plan. I instructed the operator to continue to fill in the cribwall that has already been completed (to the right of the slide) as much as possible to counter weight the movement. The current cribwall is about 20' under the slide zone. Additional comments on the movement: the borders of the slide zone on the left is flaking away fairly normally (in response to the oversteepening and removal of the toe), but the one on the right seems to border a fracture area. The border on the right is almost vertical and the two areas are moving independently.

During site preparation for the base of the cribwall, the heavy equipment operator removed a portion of the slope toe the night before. The fresh cut was left unsupported overnight and when excavation resumed the next morning, the slope moved. The slope was oversteepened in the adversely oriented bedrock causing failure of the bedrock and colluvial soils overlying the bedrock. In different material this might now have happened, and if the site had not been excavated and left exposed overnight, this slope movement might have been prevented. For future projects, on sites of this size and with propensity for large movement, however, it is recommended that a slope stability analysis be a part of project design.

The research team recommended, and the PI approved construction could continue but with excavating no more than 10 to 15 feet of the slope toe at any one time. It was also recommended that exposure of personnel to the slope be avoided or minimized. Mike Whipple, Maintenance Area Superintendent, devised a plan to construct the log cribwall frames off site and to install them onsite in modules. No crew members were allowed behind or inside the cribwalls at any time.

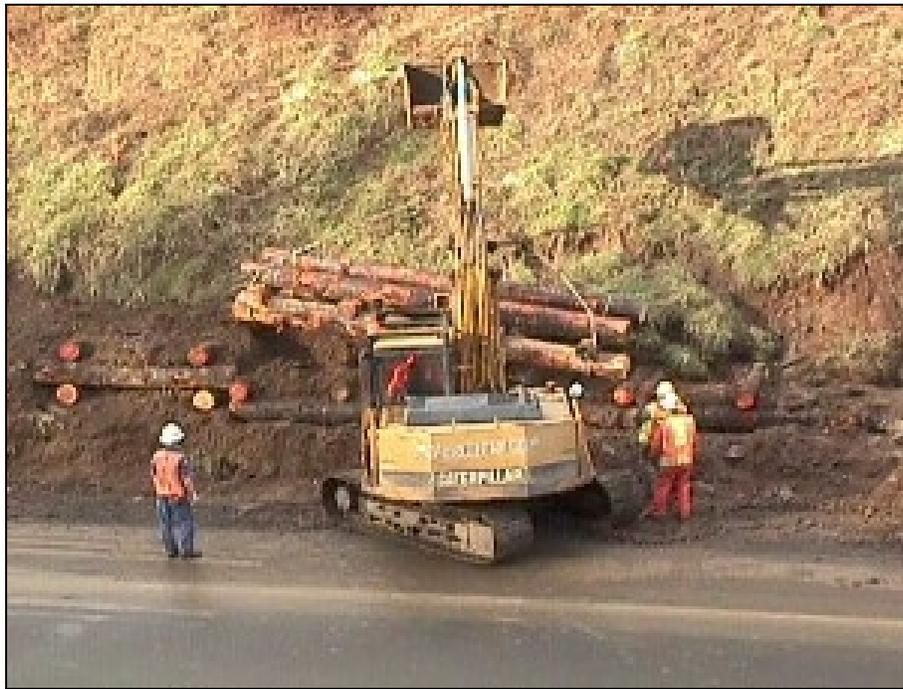
**Figure 22. Installation of modular live cribwall sections**

The modular cribwall frames were constructed off-site by February 28, 2000. They were installed in two vertical sections so willow branches could be installed between the lifts and soil could be added and compacted with the excavator bucket. Installation can be seen in Figure 22. Each 15 foot cribwall framed section was cabled to the adjacent unit and to the ones above and below it.

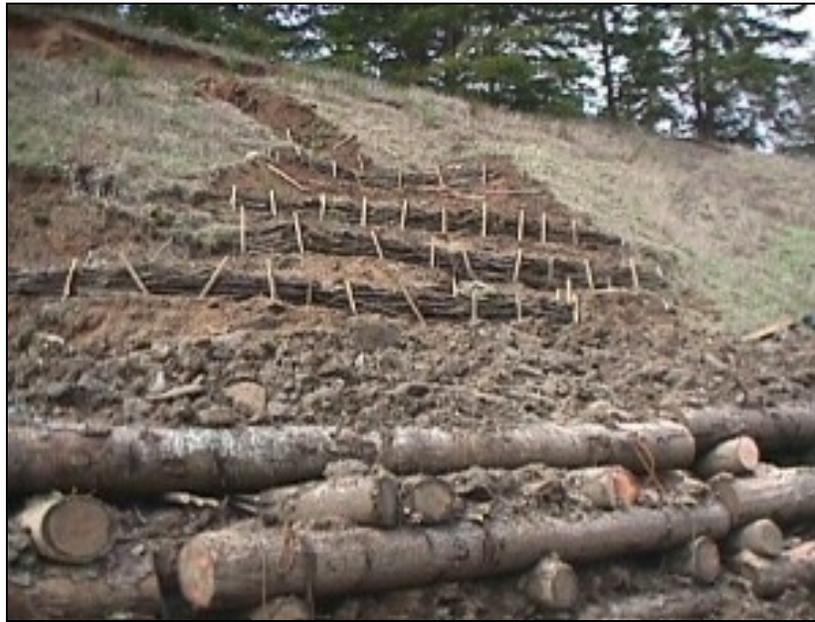
**Figure 23. Live Cribwall and Willow Walls**

The live cribwall and cordon construction was completed with these changes, without incident, on March 2, 2000. The Crews finished the Raymond project, with willow wall construction further up the slope and with plantings and straw mulch application, on March 28, 2000. Figure 23 shows the willow walls constructed above the live cribwalls.

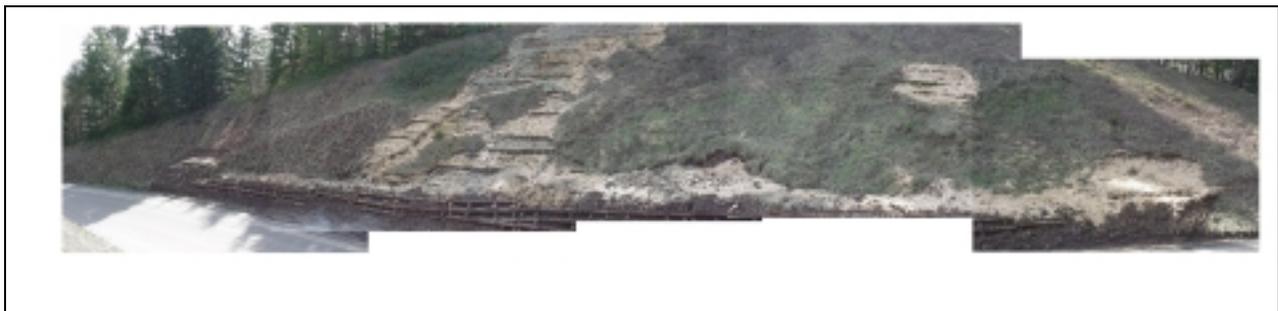
**Figure 24. Completed Soil Bioengineering Research Site**

Figure 24 shows the entire project after completion.

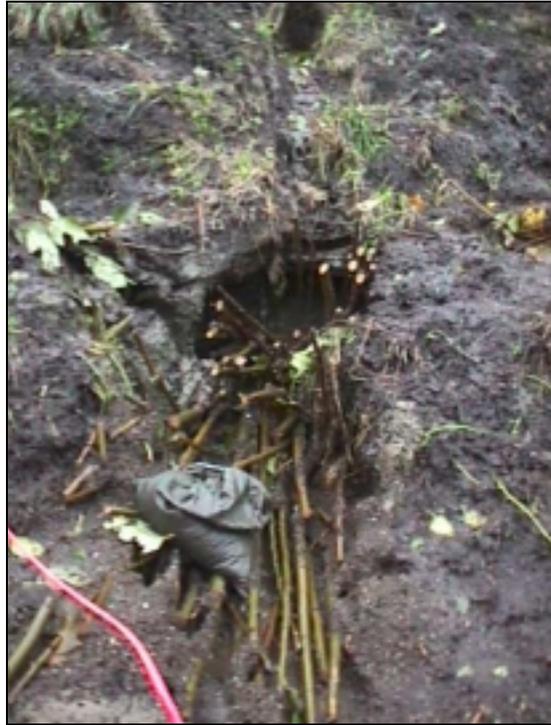
**Figure 25. Brushlayers failed when placed perpendicular to slope.**

Construction on the Lost Creek project began October 25, 1999 and concluded December 27, 1999. The original design was altered because heavy rains caused springs to flow from areas in the slope, which drained directly through the conventional brush layers placed perpendicular to the slope contour, as seen in Figure 25.

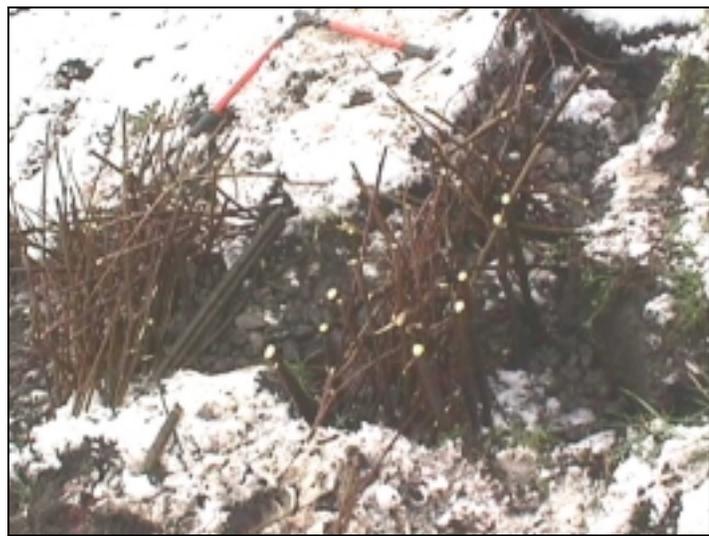
**Figure 26. Branch packing parallel to slope contours.**

The design was changed so the brush layers were laid parallel with the slope contour to better manage surface flow. This is shown in Figure 26.

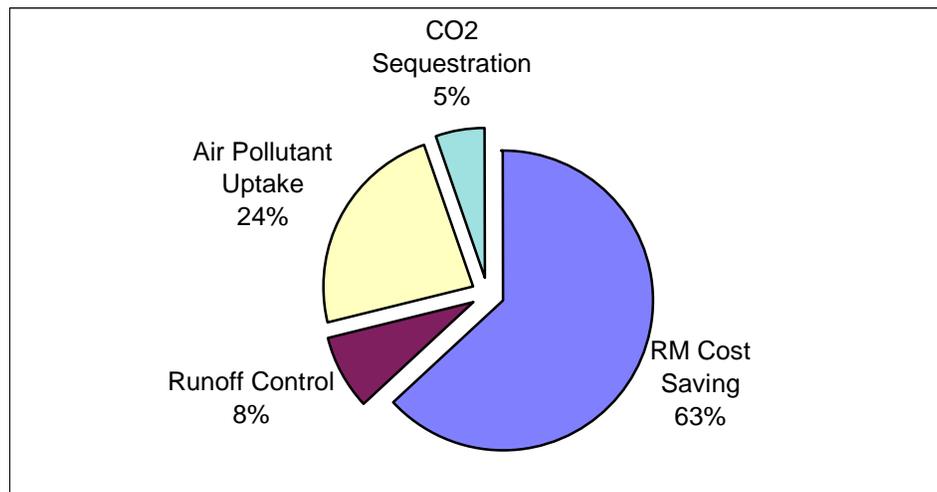
**Figure 30. Benefit Composition**

The benefits were broken into the categories seen in the following figure. (RM stands for Roadside Maintenance). Cost saving is the dominant source of the benefits of soil bioengineering projects compared to traditional alternatives.

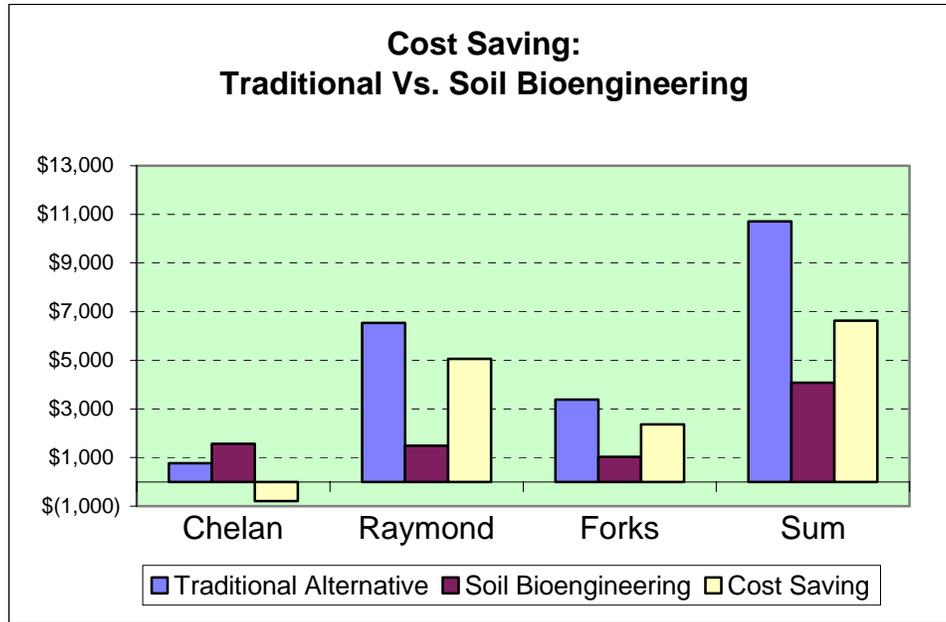
**Figure 31. Initial Construction Cost Saving**

Initial construction costs for the three soil bioengineering research sites are shown below as they compare to the traditional engineering treatment that would have been used if WSDOT had chosen to stabilize those slopes.

Annualized cost, which includes maintenance savings, between soil bioengineering and traditional engineering shows that all three projects were cost effective.
