Washington State Cable Median Barrier

Richard B. Albin, P.E.

ABSTRACT

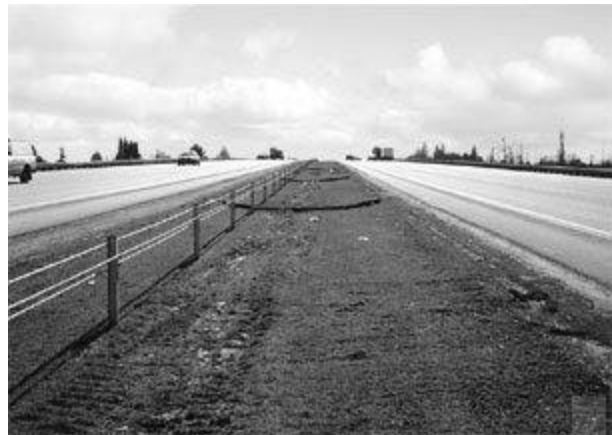
FIGURE 1 Typical cable median barrier installation.

In the early 1990's, the Washington State Department of Transportation (WSDOT) became interested in using this design for medians that are over 10 m in width as is shown in Figure 1. As a result of this interest, WSDOT sponsored crash tests to evaluate the performance of this barrier in accordance with NCHRP Report 350. Presented in this paper are the results of these crash tests.

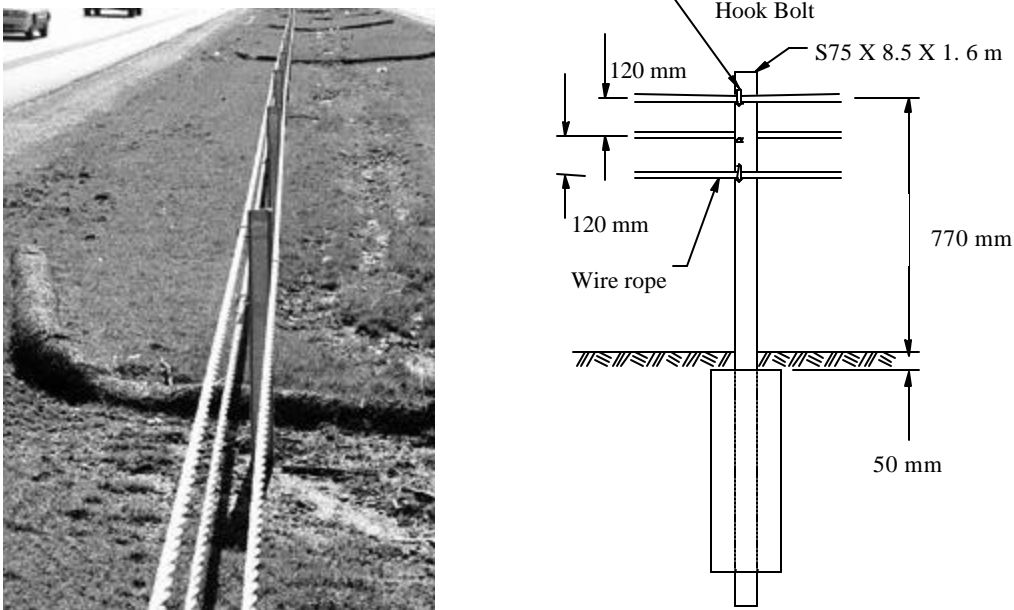
The Washington State cable median barrier (see Figure 2) consists of three 19 mm diameter cables supported by S75 x 8.5 x 1.6 m long posts. Installation height from the ground surface to the bottom and top cables is 530 mm and 770 mm respectively with the middle cable evenly spaced between them. The middle cable is mounted on the opposite side of the posts. The posts in this system are spaced 5.0 m on-center.

FIGURE 2 Typical cable median barrier installation and details.

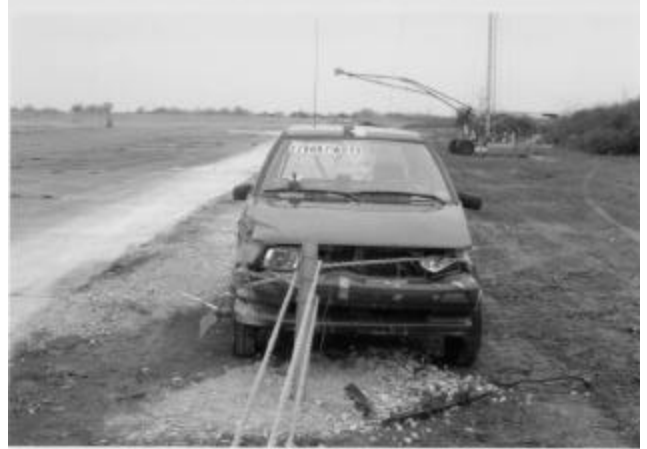
FIGURE 3 Small car at rest.

cable to deflect, the vehicle went over the top and bottom cables. The maximum dynamic deflection of the cable was 2.6 m. As the vehicle continued forward it stayed between the cables, coming to rest with the nose of the vehicle at post 20 (approximately 35 m downstream from the point of impact). The vehicle remained upright and stable during and after the collision (see Figure 3).

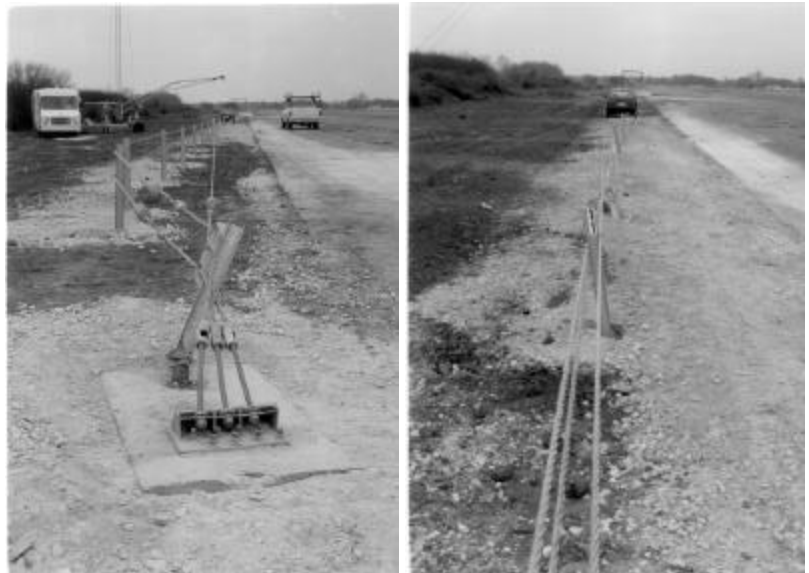
Most of the damage to the cable median barrier was to the posts and anchor system. Five posts were bent laterally and another five were disturbed (see Figure 4). The concrete foundations on the anchors were pulled up 25mm to 38 mm. The downstream anchor post was bent and twisted (see Figure 4). The springs on the downstream anchor were pulled out 41 mm to 108 mm.

FIGURE 4 Barrier damage from small car test.

Other than damage to the posts, damage to the cable median barrier was minimal. Seven posts were bent and another nine were disturbed (see Figure 7). The upstream anchor had minor stress cracks radiating from the anchor bolts in the concrete footing. The downstream foundation moved 5 mm upstream. The downstream anchor post was bent and twisted similar to the damage shown in Figure 4. The cables were slack throughout the length of the installation.

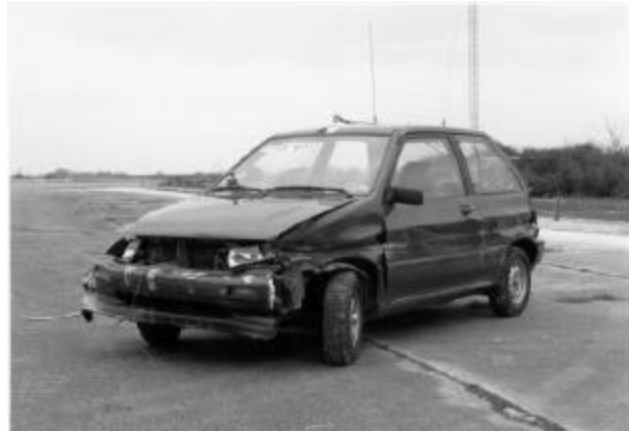
The vehicle received minimal damage. The front bumper, grill, headlights, and both front fender panels were damaged (see Figure 5). Both doors were jammed and the undercarriage was scraped by contact with the cables. Maximum crush to the exterior of the vehicle was 280 mm

deep above the bumper on the left side. The maximum deformation of the occupant compartment was 10 mm at the center front floorpan area.

FIGURE 5 Small car damage.

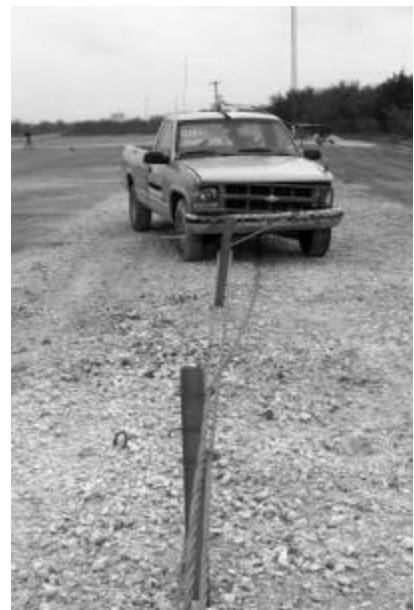
FIGURE 6 Pickup truck at rest.

maximum dynamic deflection during the test was 3.4 m. The vehicle began to be redirected parallel with the test installation and then was pulled back sideways toward the posts. The vehicle came to rest on top of post 22, approximately 50 m downstream from the point of impact (see Figure 6).

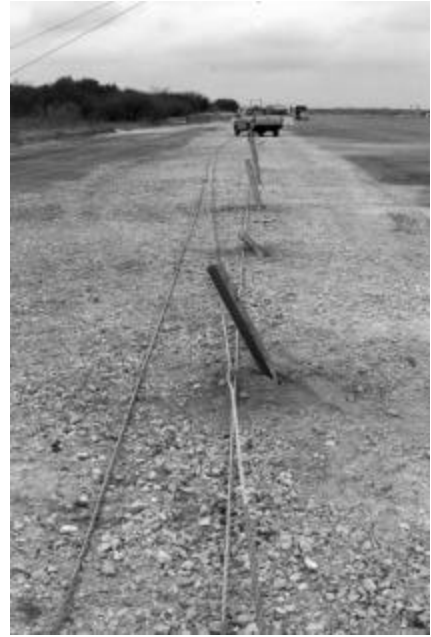
FIGURE 7 Barrier damage from pickup truck test.

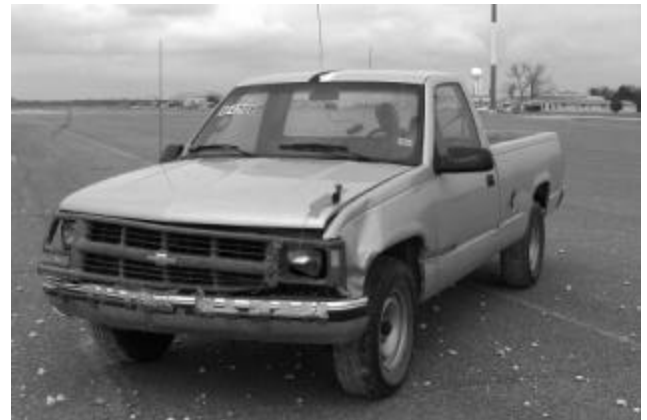
The vehicle sustained minor damage. There were scuff marks on the left front and rear quarter panels and left door (see Figure 8). In addition, the left front and rear tires were cosmetically damaged. Maximum exterior crush to the vehicle was 320 mm above the front bumper at the left front corner. No deformation or intrusion into the occupant compartment occurred from the impact with the cable barrier.

FIGURE 8 Pickup truck damage.

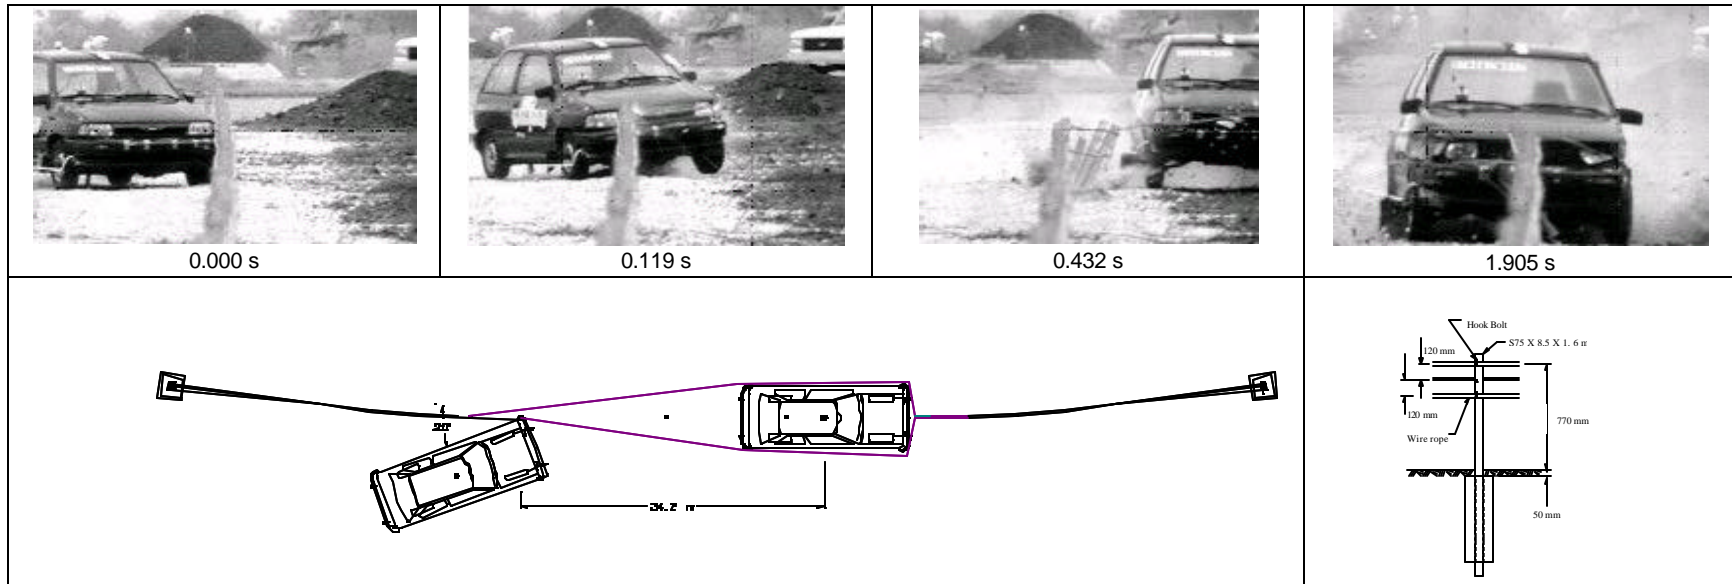
Speed (km/h)..... 99.7
 Angle (deg) 20.4

Impact Velocity (m/s)
 x-direction 4.1
 y-direction 2.9
 THIV (optional).....
 Ridedown Accelerations (g's)
 x-direction -3.6
 y-direction 3.9
 PHD (optional).....
 ASI (optional).....
 Max. 0.050-s Average (g's)
 x-direction -2.5
 y-direction 2.8
 z-direction -2.2

Dynamic..... 2.58
 Permanent 1.10

FIGURE 10 Small car test results.

A 1991 Ford Festiva, traveling at a speed of 99.7 km/h, impacted the cable median barrier at post 12 at an angle of 20.4 degrees. (See Figure 10 for summary information.) The impact on the post forced the top and bottom cables (installed on the opposite side of the posts) downward. The middle cable engaged the front grill and fender panel of the vehicle and began redirecting the vehicle. As the force caused the middle

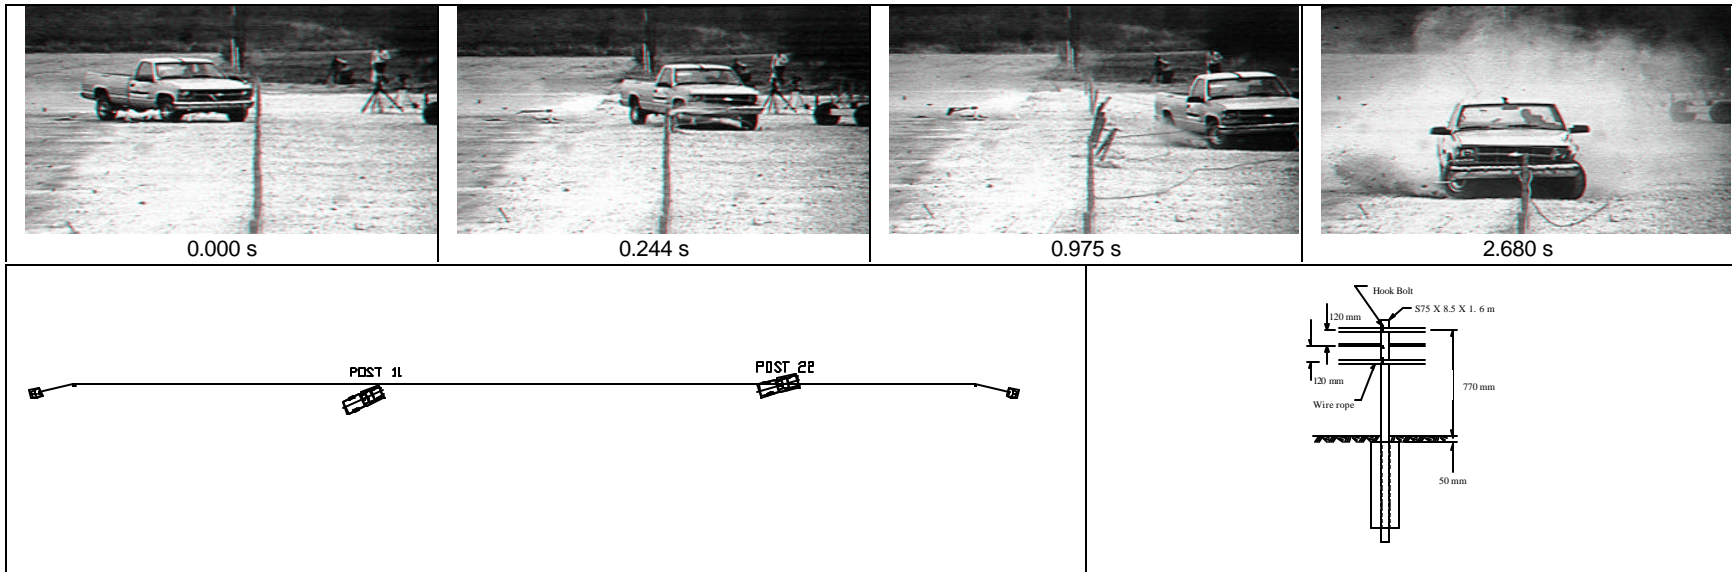
Speed (km/h) 101.4
 Angle (deg)..... 24.8

Impact Velocity (m/s)
 x-direction..... 2.2
 y-direction..... 2.9
 THIV (km/h) 12.0
 Ridedown Accelerations (g's)
 x-direction..... -2.7
 y-direction..... 4.9
 PHD (g=s) 5.2
 ASI 0.26
 Max. 0.050-s Average (g's)
 x-direction..... -1.6
 y-direction..... 2.1
 z-direction..... -1.2

Dynamic..... 3.4
 Permanent 0.7

FIGURE 11 Pickup truck test results.

A 1995 Chevrolet 2500 pickup truck, traveling at a speed of 101.4 km/h, impacted the cable median barrier at post 11 at an angle of 24.8 degrees. (See Figure 11 for summary information.) As the vehicle contacted the barrier, the top and middle cable engaged the front grill and fender panel of the vehicle. The bottom cable was forced down to the ground and as the vehicle deflected the other 2 cables it went partially over the bottom cable. The
