# Washington State Cable Median Barrier

## ABSTRACT

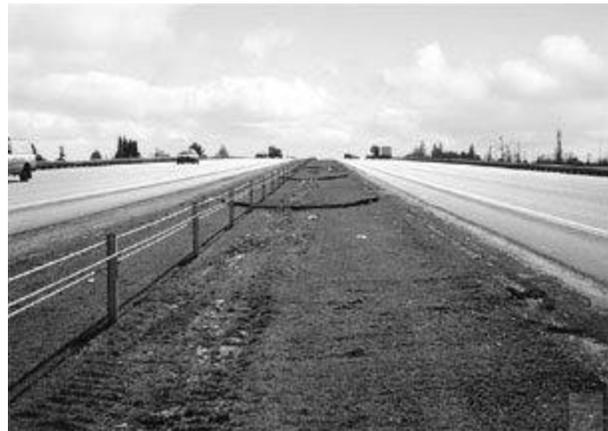
**FIGURE 1 Typical cable median barrier installation.**

In the early 1990's, the Washington State Department of Transportation (WSDOT) became interested in using this design for medians that are over 10 m in width as is shown in Figure 1. As a result of this interest, WSDOT sponsored crash tests to evaluate the performance of this barrier in accordance with NCHRP Report 350. Presented in this paper are the results of these crash tests.

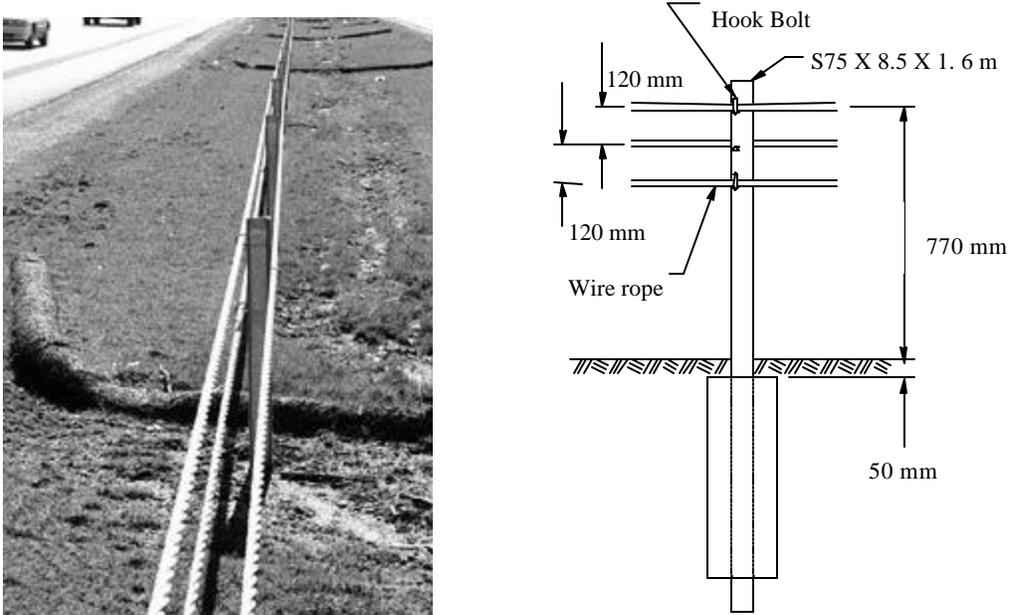
The Washington State cable median barrier (see Figure 2) consists of three 19 mm diameter cables supported by S75 x 8.5 x 1.6 m long posts. Installation height from the ground surface to the bottom and top cables is 530 mm and 770 mm respectively with the middle cable evenly spaced between them. The middle cable is mounted on the opposite side of the posts. The posts in this system are spaced 5.0 m on-center.

**FIGURE 2 Typical cable median barrier installation and details.**

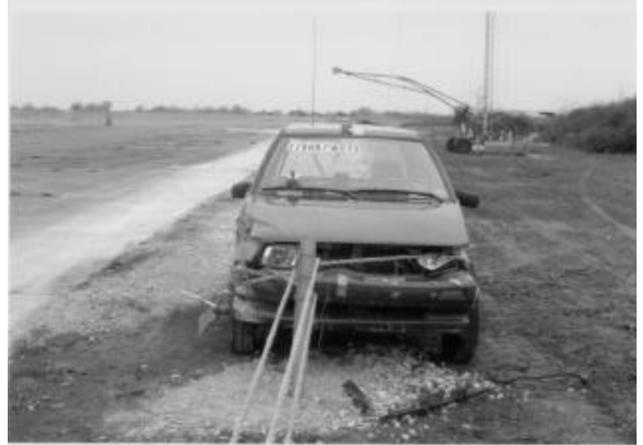
**FIGURE 3 Small car at rest.**

cable to deflect, the vehicle went over the top and bottom cables. The maximum dynamic deflection of the cable was 2.6 m. As the vehicle continued forward it stayed between the cables, coming to rest with the nose of the vehicle at post 20 (approximately 35 m downstream from the point of impact). The vehicle remained upright and stable during and after the collision (see Figure 3).

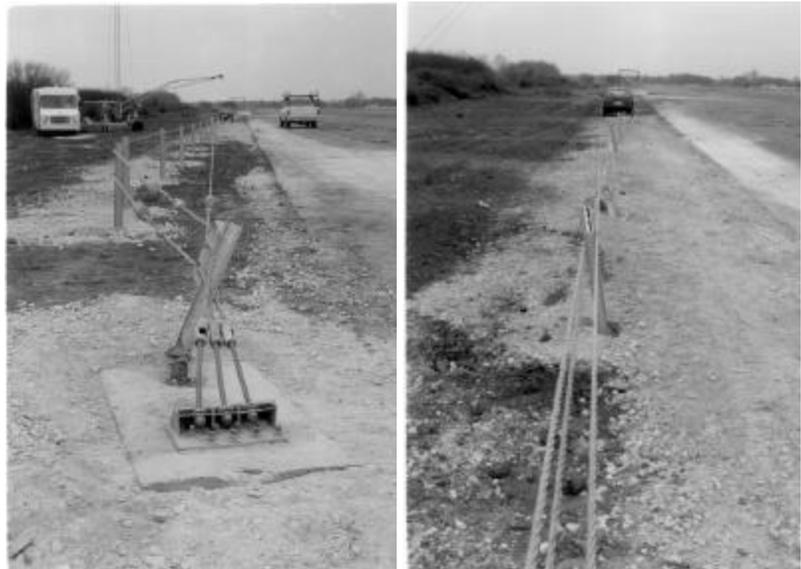
Most of the damage to the cable median barrier was to the posts and anchor system. Five posts were bent laterally and another five were disturbed (see Figure 4). The concrete foundations on the anchors were pulled up 25mm to 38 mm. The downstream anchor post was bent and twisted (see Figure 4). The springs on the downstream anchor were pulled out 41 mm to 108 mm.

**FIGURE 4 Barrier damage from small car test.**

Other than damage to the posts, damage to the cable median barrier was minimal. Seven posts were bent and another nine were disturbed (see Figure 7). The upstream anchor had minor stress cracks radiating from the anchor bolts in the concrete footing. The downstream foundation moved 5 mm upstream. The downstream anchor post was bent and twisted similar to the damage shown in Figure 4. The cables were slack throughout the length of the installation.

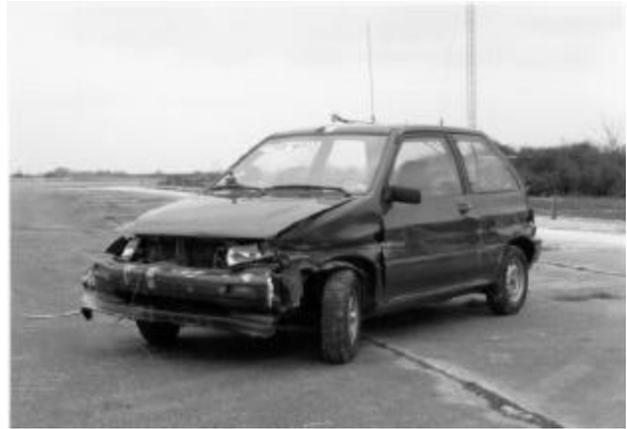
The vehicle received minimal damage. The front bumper, grill, headlights, and both front fender panels were damaged (see Figure 5). Both doors were jammed and the undercarriage was scraped by contact with the cables. Maximum crush to the exterior of the vehicle was 280 mm

deep above the bumper on the left side. The maximum deformation of the occupant compartment was 10 mm at the center front floorpan area.

**FIGURE 5 Small car damage.**

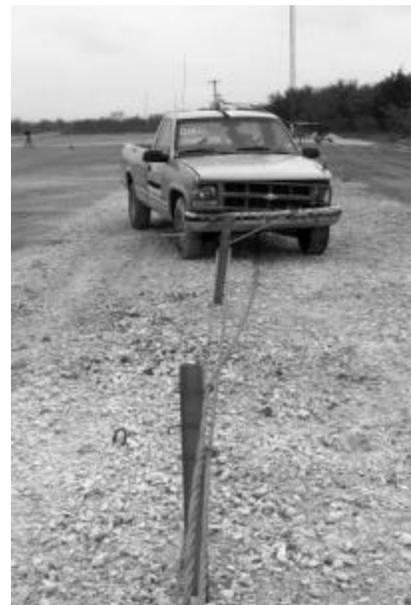
**FIGURE 6 Pickup truck at rest.**

maximum dynamic deflection during the test was 3.4 m. The vehicle began to be redirected parallel with the test installation and then was pulled back sideways toward the posts. The vehicle came to rest on top of post 22, approximately 50 m downstream from the point of impact (see Figure 6).

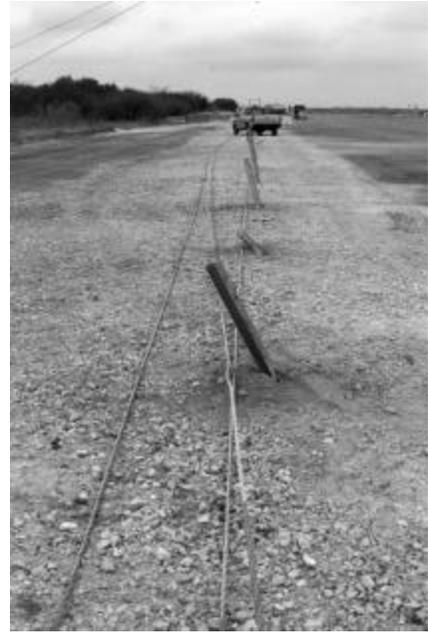
**FIGURE 7 Barrier damage from pickup truck test.**

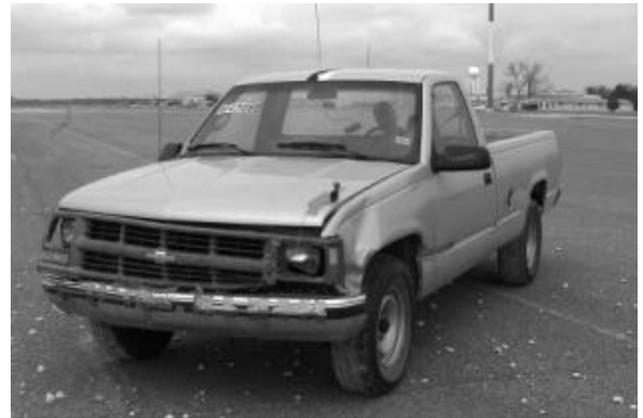
The vehicle sustained minor damage. There were scuff marks on the left front and rear quarter panels and left door (see Figure 8). In addition, the left front and rear tires were cosmetically damaged. Maximum exterior crush to the vehicle was 320 mm above the front bumper at the left front corner. No deformation or intrusion into the occupant compartment occurred from the impact with the cable barrier.

**FIGURE 8 Pickup truck damage.**

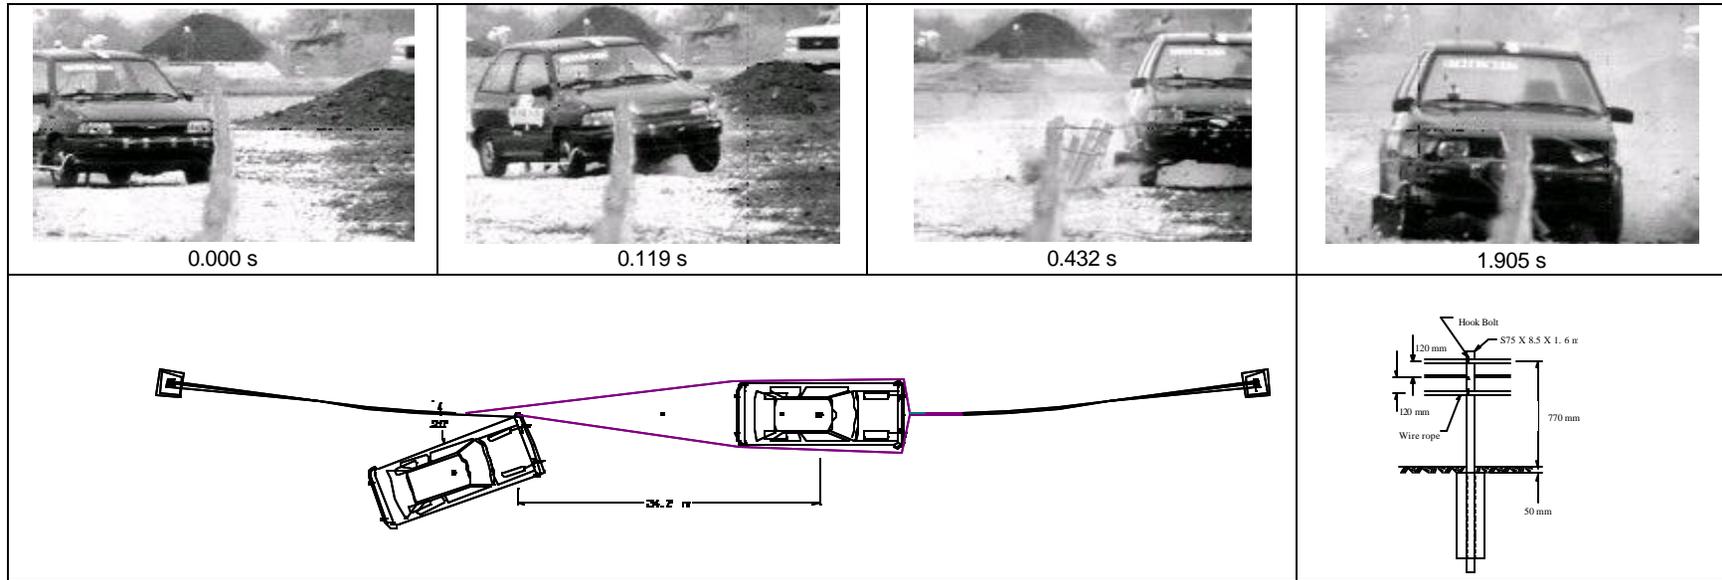
Speed (km/h)..... 99.7  
 Angle (deg) ..... 20.4

Impact Velocity (m/s)  
 x-direction ..... 4.1  
 y-direction ..... 2.9  
 THIV (optional).....  
 Ridedown Accelerations (g's)  
 x-direction ..... -3.6  
 y-direction ..... 3.9  
 PHD (optional).....  
 ASI (optional).....  
 Max. 0.050-s Average (g's)  
 x-direction ..... -2.5  
 y-direction ..... 2.8  
 z-direction ..... -2.2

Dynamic..... 2.58  
 Permanent ..... 1.10

**FIGURE 10 Small car test results.**

A 1991 Ford Festiva, traveling at a speed of 99.7 km/h, impacted the cable median barrier at post 12 at an angle of 20.4 degrees. (See Figure 10 for summary information.) The impact on the post forced the top and bottom cables (installed on the opposite side of the posts) downward. The middle cable engaged the front grill and fender panel of the vehicle and began redirecting the vehicle. As the force caused the middle

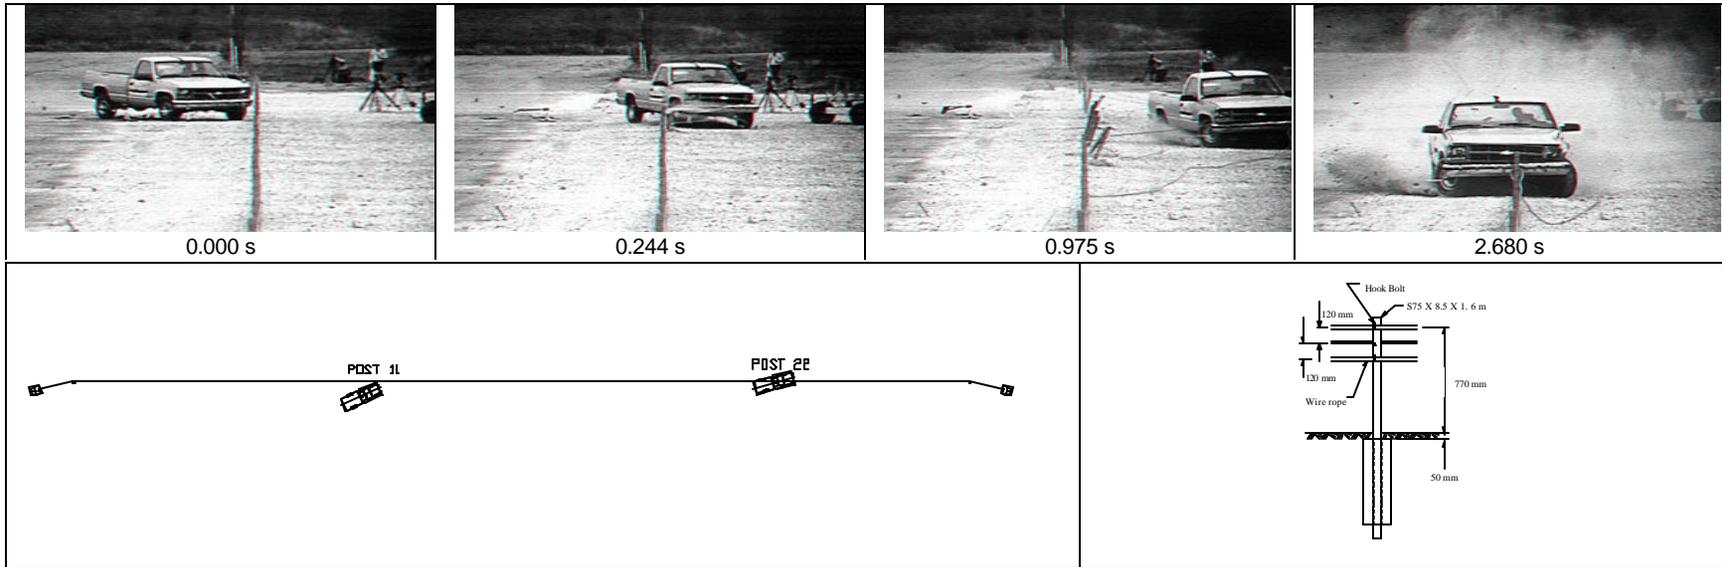
Speed (km/h) ..... 101.4  
 Angle (deg)..... 24.8

Impact Velocity (m/s)  
 x-direction..... 2.2  
 y-direction..... 2.9  
 THIV (km/h) ..... 12.0  
 Ridedown Accelerations (g's)  
 x-direction..... -2.7  
 y-direction..... 4.9  
 PHD (g=s) ..... 5.2  
 ASI ..... 0.26  
 Max. 0.050-s Average (g's)  
 x-direction..... -1.6  
 y-direction..... 2.1  
 z-direction..... -1.2

Dynamic..... 3.4  
 Permanent ..... 0.7

**FIGURE 11** Pickup truck test results.

A 1995 Chevrolet 2500 pickup truck, traveling at a speed of 101.4 km/h, impacted the cable median barrier at post 11 at an angle of 24.8 degrees. (See Figure 11 for summary information.) As the vehicle contacted the barrier, the top and middle cable engaged the front grill and fender panel of the vehicle. The bottom cable was forced down to the ground and as the vehicle deflected the other 2 cables it went partially over the bottom cable. The
