Washington State Precast Concrete Barrier

ABSTRACT

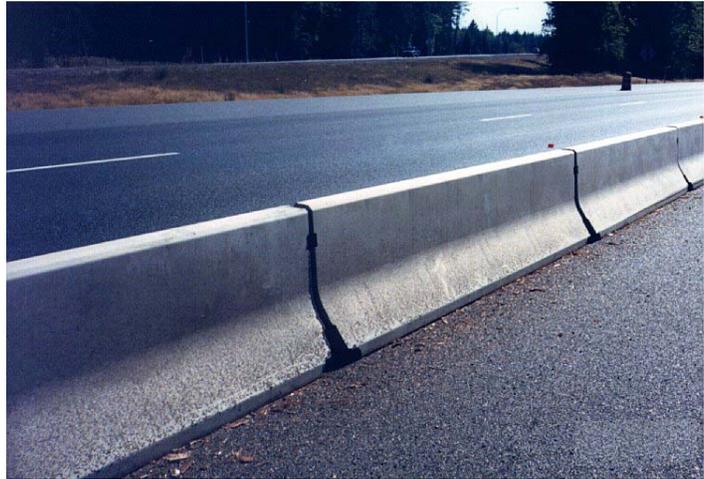
Since the early 1970's, the Washington State Department of Transportation (WSDOT) has used precast concrete barrier (as shown in Figure 1) for both temporary and permanent installations.

FIGURE 1 Typical precast barrier installation-

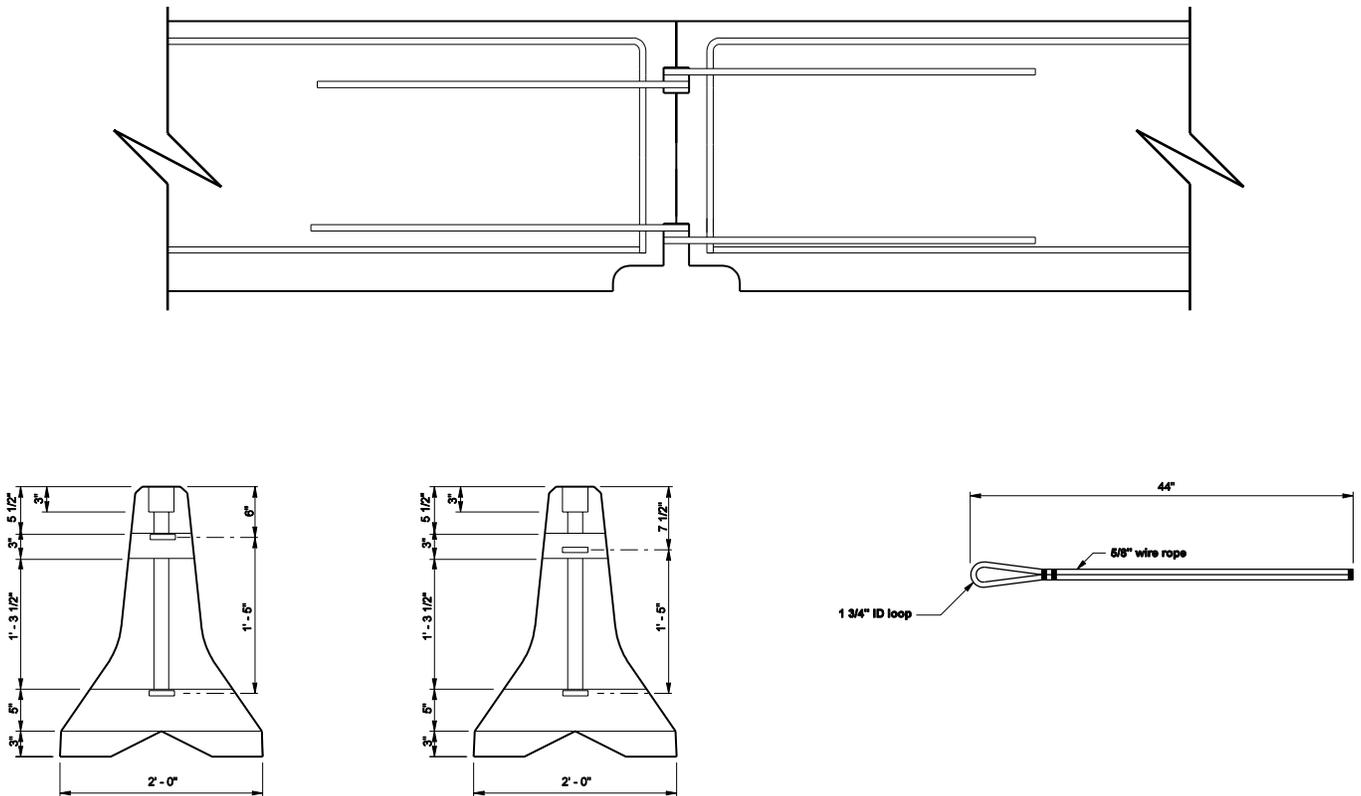
The current Washington State precast concrete barrier (see Figure 2) has a New Jersey shaped face and a pin and loop connection. The barrier segments are 610 mm (24 inches) wide at the base, 810 mm (32 inches) tall, and 3.8 m (12.5 feet) long. The width at the top of the barrier is 150 mm (6 inches). The connection between the segments consists of 2 sets of 2 loops. A connecting pin is passed through the loops to join adjacent barrier segments and transfer the tensile and moment loads from one segment to another. The connection is designed to have “nested” loops, where the loops from one barrier segment are positioned between the loops of the connecting segment. The loops are made of 16 mm (5/8 inch)

FIGURE 2 Current WSDOT precast barrier details.

diameter wire rope and the connecting pins are 25 mm (1 inch) diameter steel rods. No restraint is provided at the bottom of the pin.

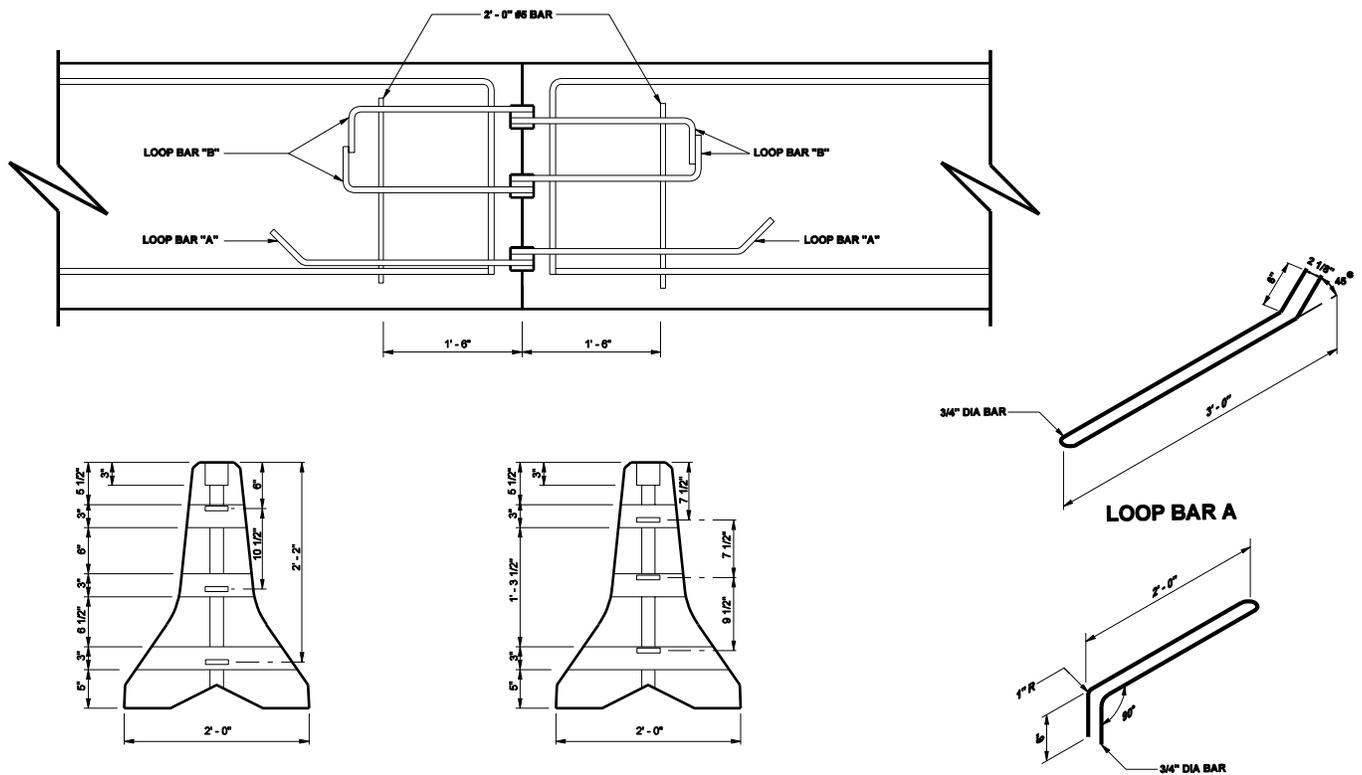
FIGURE 3 Alternate barrier connection (3 sets of 2 loops). LOOP BAR B

All of the simulated designs used the same shape and length of barrier. The first two simulations involved minor changes to the current design (a larger connecting pin and steel loops). The current design was not simulated based on the results of the first simulation with the larger pin. The third simulation was on an alternate design that used steel bar loops and an additional loop was added to each barrier end to create 3 sets of 2 loops as is shown in Figure 3. The fourth simulation was on an alternate design that also used steel bar loops and an additional loop was added to each barrier end to create 2 sets of 3 loops as is shown in Figure 4. The fifth simulation was of the most promising of the alternate designs (simulation 3) with a larger connecting pin. The alternate connection designs with the additional loops were designed to be compatible with the current design to make it possible to connect to existing barrier.

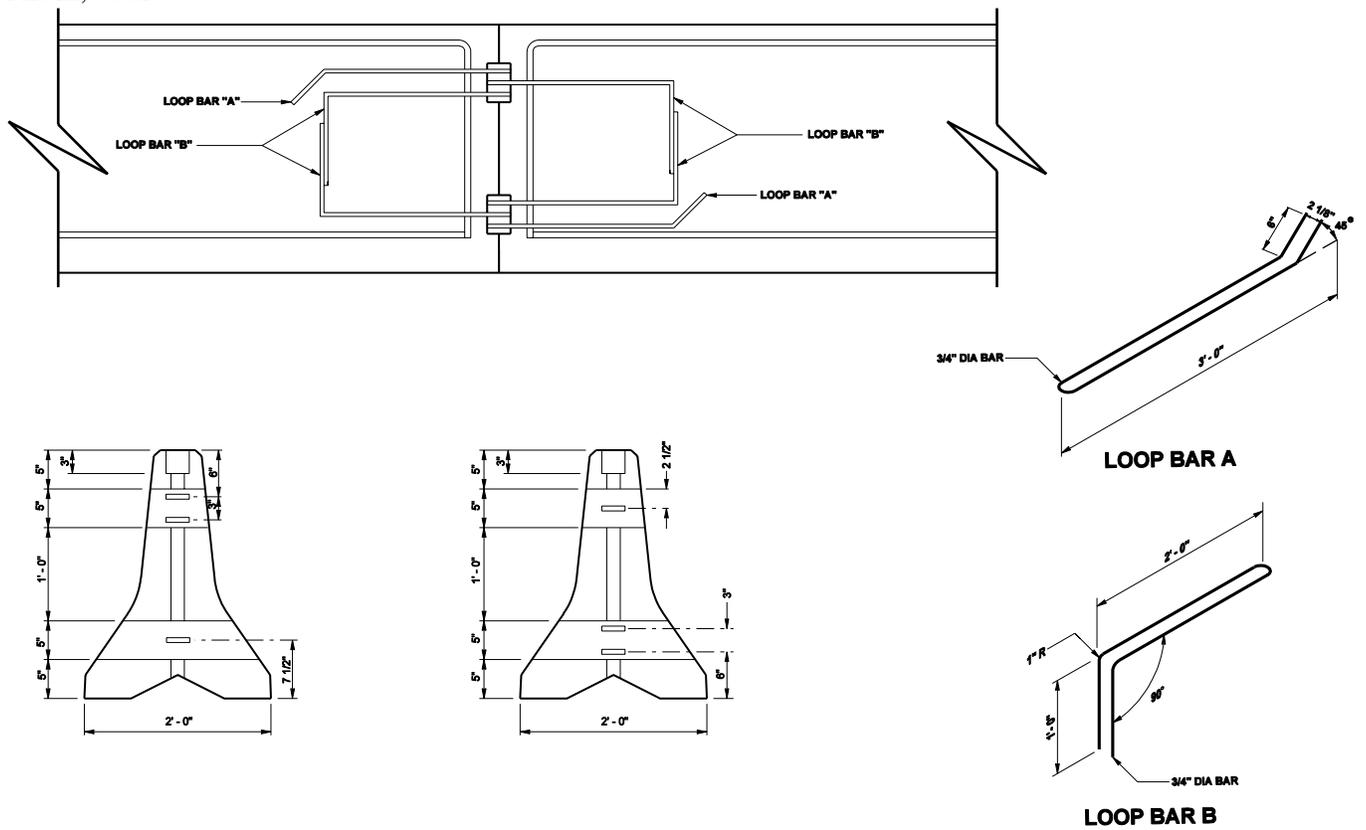
FIGURE 4 Alternate barrier connection (2 sets of 3 loops).

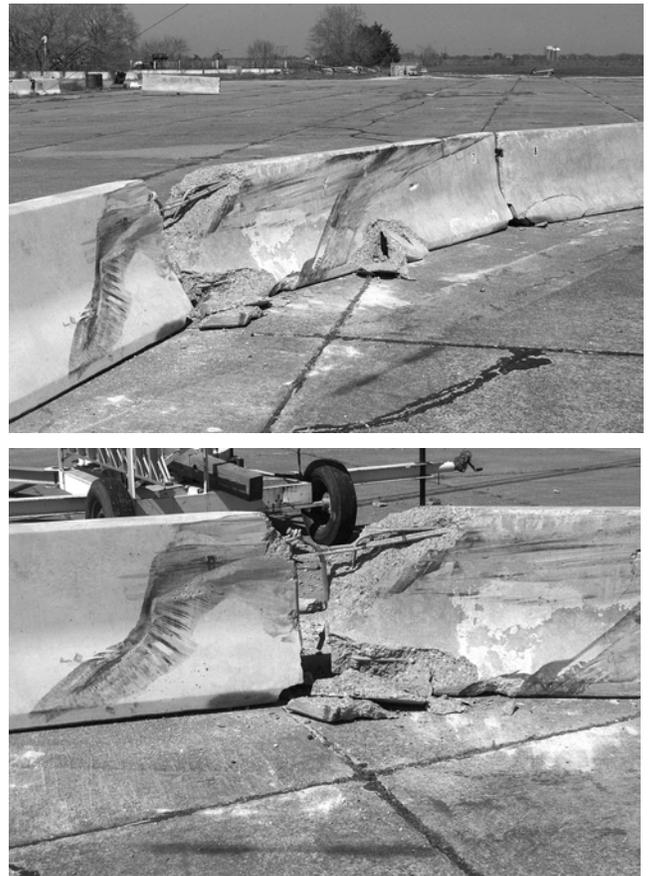
FIGURE 6 Barrier damage – current

The concrete barrier segments sustained moderate damage as shown in Figure 6. The joint edges of segments 5, 6, 7, and 8 were chipped and spalled. The connecting pin at the joints 5-6, 6-7, 7-8 and 8-9 were deformed. The pin pulled out of the lower loop on the upstream segment at joint 6-7, but remained attached to the lower loop on the end of the downstream segment and both upper loops. The maximum lateral movement of the barriers was 1.41 m (4.6') at the joint between segments 6 and 7. The lateral movement at joints 5-6 and 7-8 was 0.265 m (0.8') and 1.195 m (3.9') respectively.

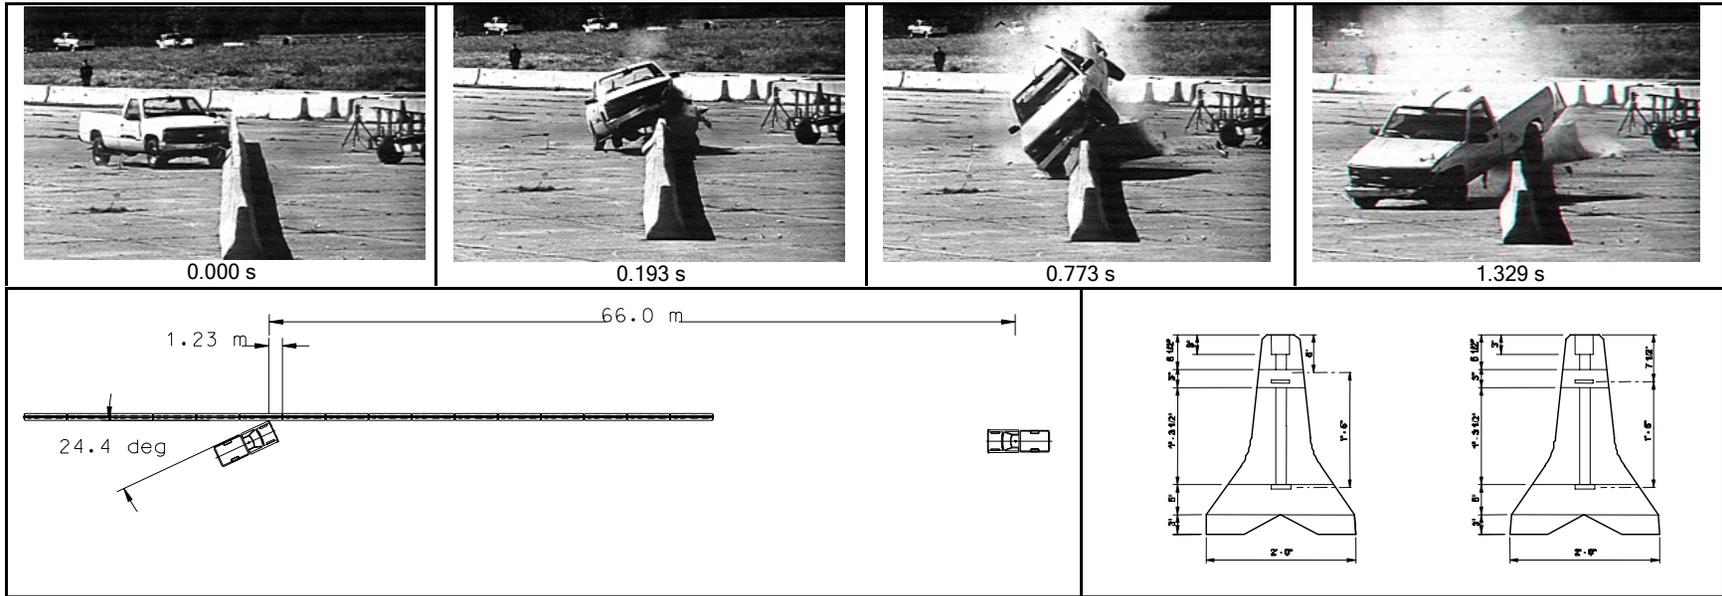
Speed (km/h)..... 99.6
 Angle (deg) 24.4

Impact Velocity (m/s)
 x-direction 3.7
 y-direction 4.9
 THIV (km/h) 20.9
 Ridedown Accelerations (g's)
 x-direction -4.8
 y-direction -8.5
 PHD (g's) 8.6
 ASI 0.87
 Max. 0.050-s Average (g's)
 x-direction -5.4
 y-direction 7.2
 z-direction -3.8

Dynamic 1.44
 Permanent 1.41
 Working Width 1.75

FIGURE 5 Crash test summary – current design.

The current design with the 2 sets of 2 wire rope loops and a 25 mm (1") connecting pin was crash tested with a 1996 Chevrolet 2500 pickup truck, traveling at a speed of 99.6 km/h (61.9 mph). The vehicle impacted the concrete barrier at an angle of 24.4 degrees. (See Figure 5 for summary information.) During the impact, the vehicle rode up the barrier and all of the tires were lifted off of the road surface. The vehicle was redirected parallel to the barrier installation traveling at a speed of 78.5 km/h (48.8 mph). The undercarriage of the vehicle contacted the

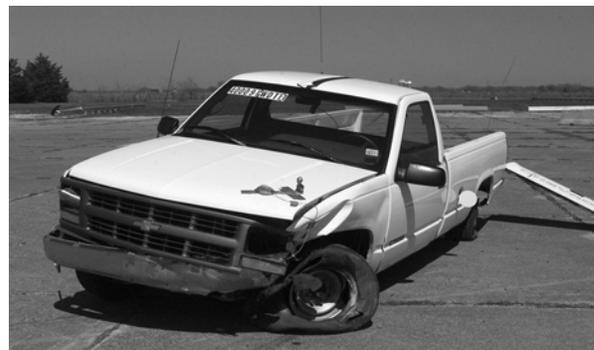
The vehicle sustained damage to the left front as shown in Figure 7. Structural damage was imparted to the stabilizer bar, upper and lower A-arms, rod ends, rear spring U-bolts and the frame rail. Also damaged were the front bumper, fan, radiator, left front quarter panel, left door, and the left front and rear tires and rims. Maximum exterior crush to the vehicle was 380 mm (15") at the left front corner at bumper height. Maximum occupant compartment deformation was 24 mm (1") in the firewall area.

FIGURE 7 Vehicle damage – current design.

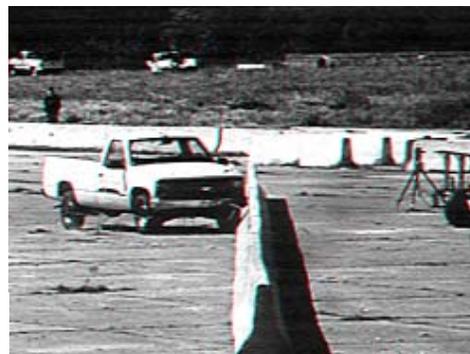
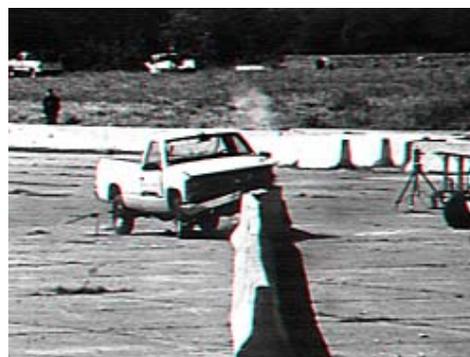
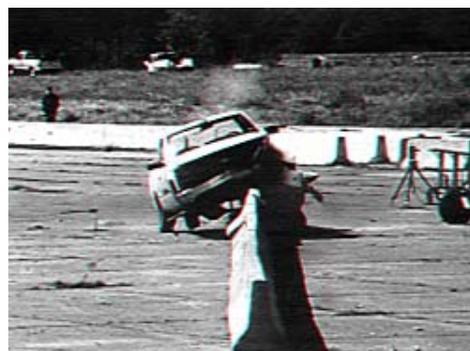
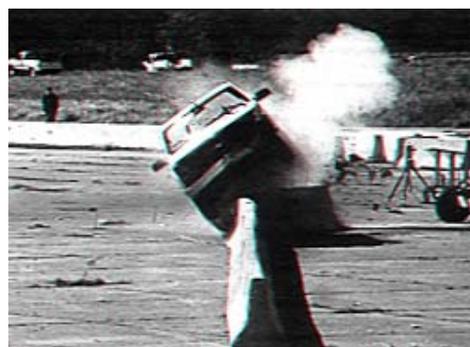
Figure 8 shows a comparative sequence of both simulation 1 and the crash test of the concrete barrier design with two sets of two wire loops. The pictures indicate very good correlation between test and simulation up to 0.387 seconds, at which time the dynamics of the vehicle start to differ. In the simulation, the vehicle exhibited less roll than exhibited in the crash test. The simulation of the two sets of wire ropes and a 32 mm (1¼ inch) pin (simulation 1)

FIGURE 8 Simulation and crash test comparison – current design.

indicated the pin would completely pull out of the bottom loops and the maximum deflection would be approximately 1.8 m (6'). In the crash test with the two sets of wire ropes and a 25 mm (1 inch) pin, the pin did not completely pull out of the bottom loops and the deflection was 1.41 m (4.6').

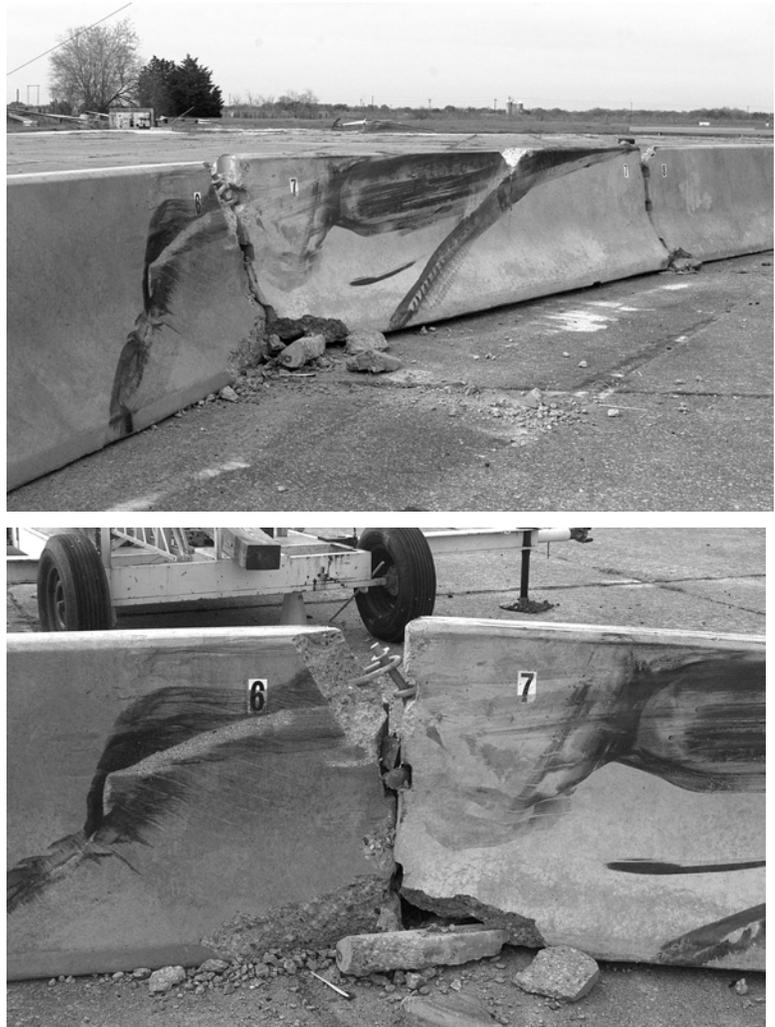
FIGURE 10 Barrier damage – alternate design.

The concrete barrier segments sustained moderate damage as shown in Figure 10. The joint edges of segments 5, 6, 7, 8 and 9 were chipped and spalled. The connecting pin at the joints 5-6 and 7-8 were deformed but none of them pulled out of the loops. The maximum lateral movement of the barriers was 1.17 m (3.8') at the joint between segments 6 and 7. The lateral movement at joints 5-6 and 7-8 was 0.510 m (1.7') and 0.790 m (2.6') respectively.

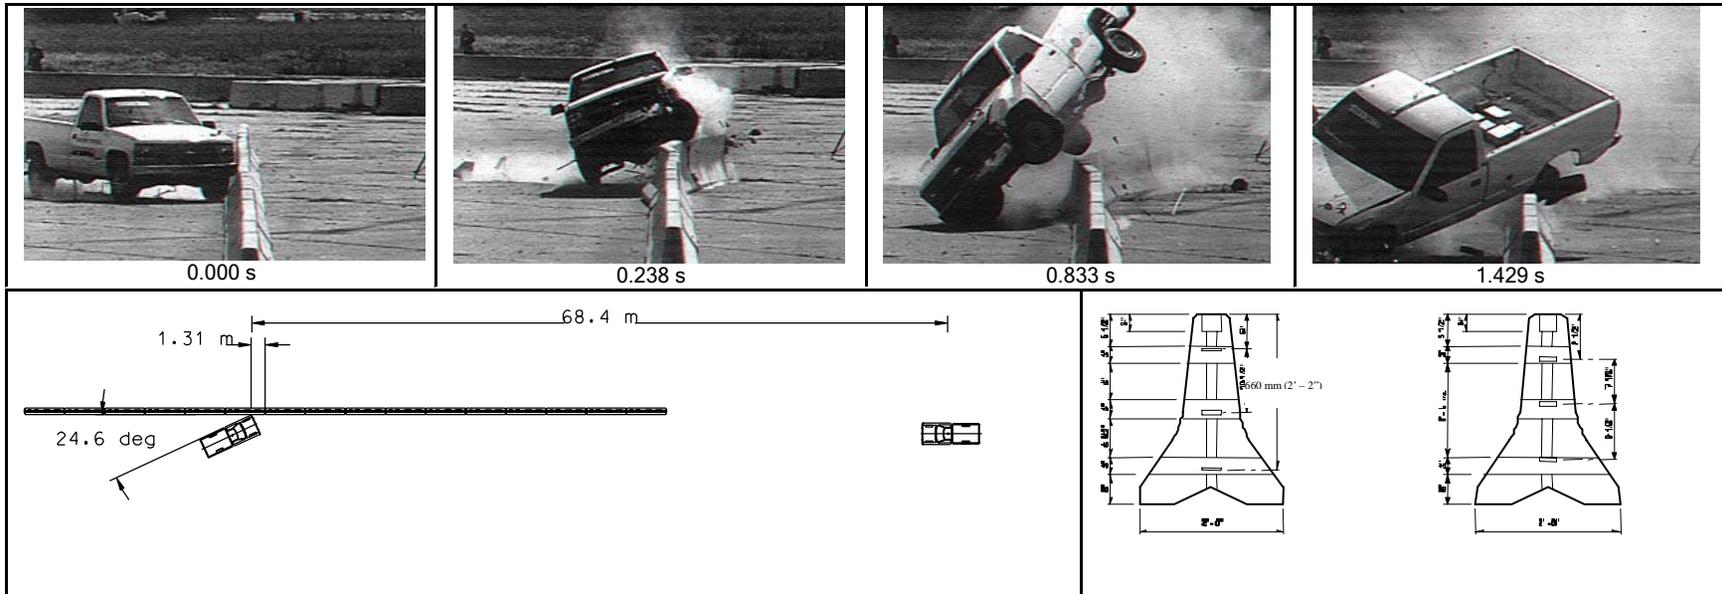
Speed (km/h)..... 98.9
 Angle (deg)..... 24.6

Impact Velocity (m/s)
 x-direction 4.1
 y-direction 5.6
 THIV (km/h) 24.1
 Ridedown Accelerations (g's)
 x-direction -5.8
 y-direction -7.1
 PHD (g's) 7.8
 ASI 1.01
 Max. 0.050-s Average (g's)
 x-direction -5.5
 y-direction 8.4
 z-direction -4.1

Dynamic 1.25
 Permanent 1.17
 Working Width 1.87

FIGURE 9 Crash test summary – alternate design

24.6 degree angle. (See Figure 9 for summary information.) During the impact, the vehicle rode up the barrier

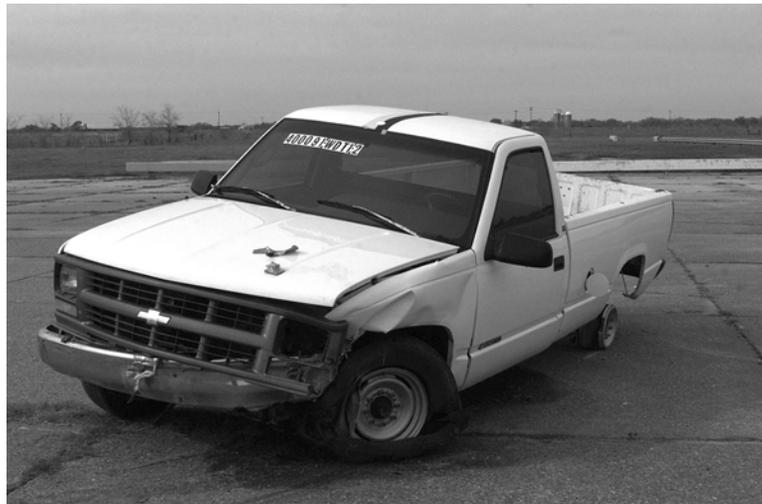
The vehicle sustained damage to the left front as shown in Figure 11. Structural damage was imparted to the stabilizer bar, upper and lower A-arms, rod ends, and the frame rail. Also damaged were the front bumper, fan, radiator, left front quarter panel, left and right doors, the left front and rear tires and rims, and the left side of the floor pan. Maximum exterior crush to the vehicle was 420 mm (16.4") at the left front corner at bumper height.

Maximum occupant compartment deformation was 20 mm (¾") in the firewall area.

FIGURE 11 Vehicle damage – alternate design.

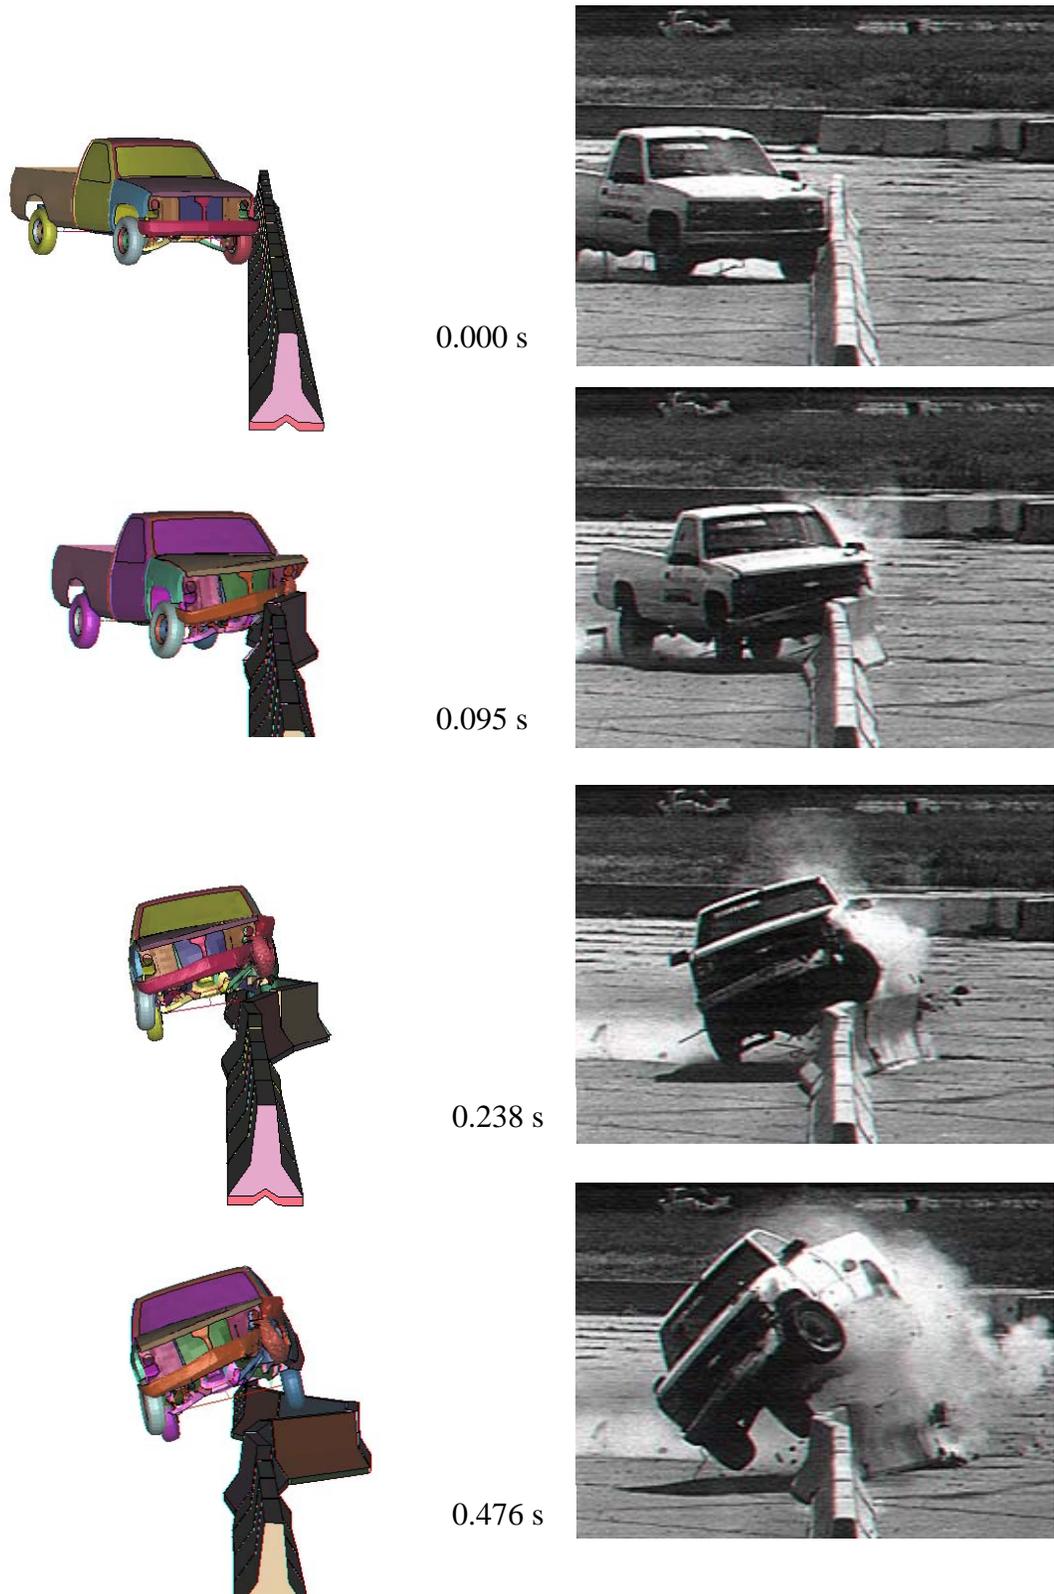
Figure 12 shows a comparative sequence of both simulation and test of the concrete barrier design with three sets of two steel bar loops. The pictures indicate very good correlation between test and simulation until 0.476 seconds at which time the vehicle begins to exhibit more roll in a the crash test than in the simulation. The predicted deformation pattern in the simulated pin was observed in the full-scale test. Simulation 3 predicted a maximum deflection of approximately 1.1 m (3.6'). The actual deflection was very close to the simulation.

FIGURE 12 Simulation and crash test comparison – alternate design
