Washington State Precast Concrete Barrier

ABSTRACT

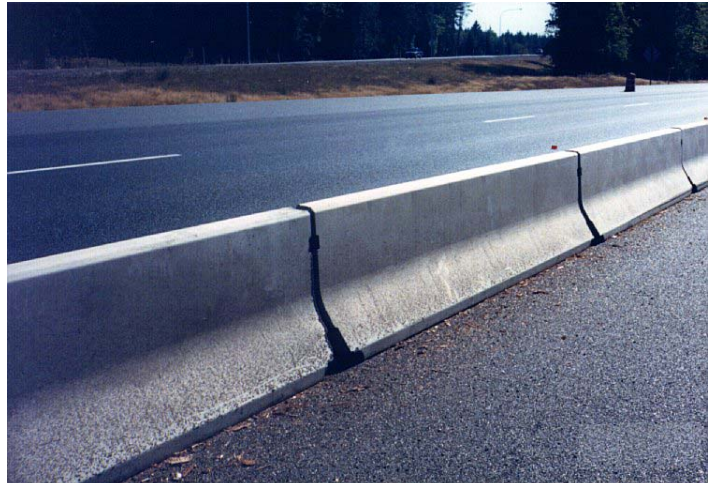
Since the early 1970's, the Washington State Department of Transportation (WSDOT) has used precast concrete barrier (as shown in Figure 1) for both temporary and permanent installations.

FIGURE 1 Typical precast barrier installation-

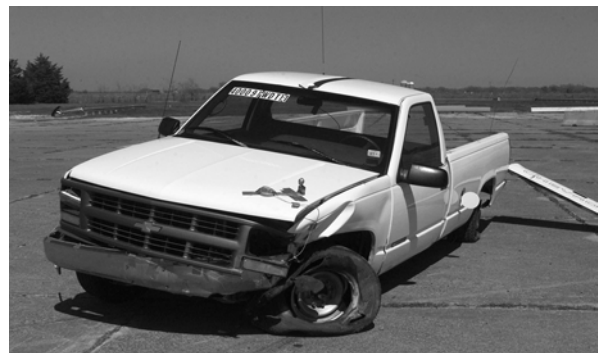
The vehicle sustained damage to the left front as shown in Figure 7. Structural damage was imparted to the stabilizer bar, upper and lower A-arms, rod ends, rear spring U-bolts and the frame rail. Also damaged were the front bumper, fan, radiator, left front quarter panel, left door, and the left front and rear tires and rims. Maximum exterior crush to the vehicle was 380 mm (15") at the left front corner at bumper height. Maximum occupant compartment deformation was 24 mm (1") in the firewall area.

FIGURE 7 Vehicle damage – current design.

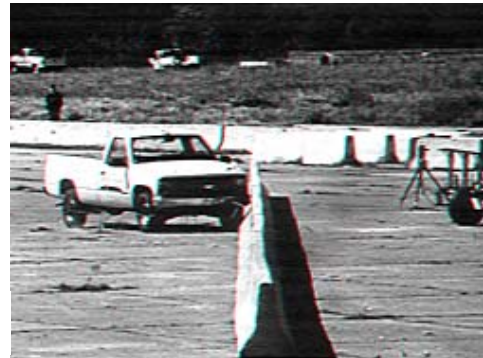
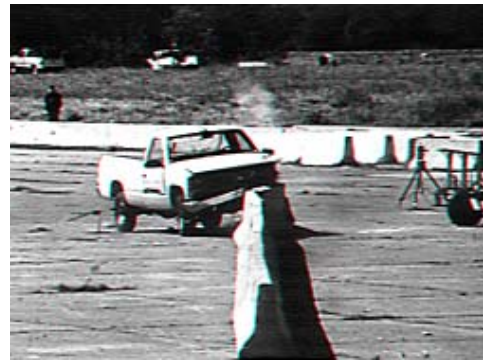
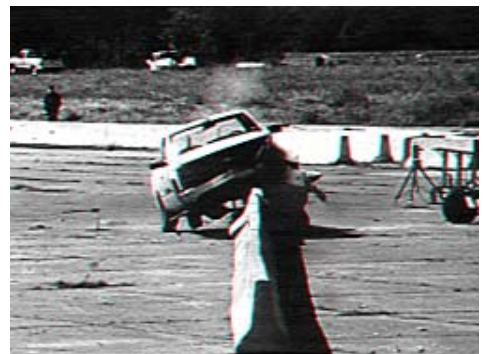
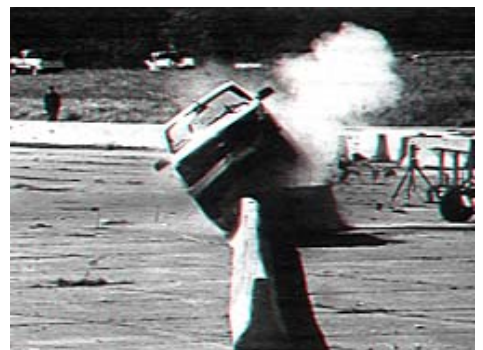
Figure 8 shows a comparative sequence of both simulation 1 and the crash test of the concrete barrier design with two sets of two wire loops. The pictures indicate very good correlation between test and simulation up to 0.387 seconds, at which time the dynamics of the vehicle start to differ. In the simulation, the vehicle exhibited less roll than exhibited in the crash test. The simulation of the two sets of wire ropes and a 32 mm (1¼ inch) pin (simulation 1)

FIGURE 8 Simulation and crash test comparison – current design.

indicated the pin would completely pull out of the bottom loops and the maximum deflection would be approximately 1.8 m (6'). In the crash test with the two sets of wire ropes and a 25 mm (1 inch) pin, the pin did not completely pull out of the bottom loops and the deflection was 1.41 m (4.6').

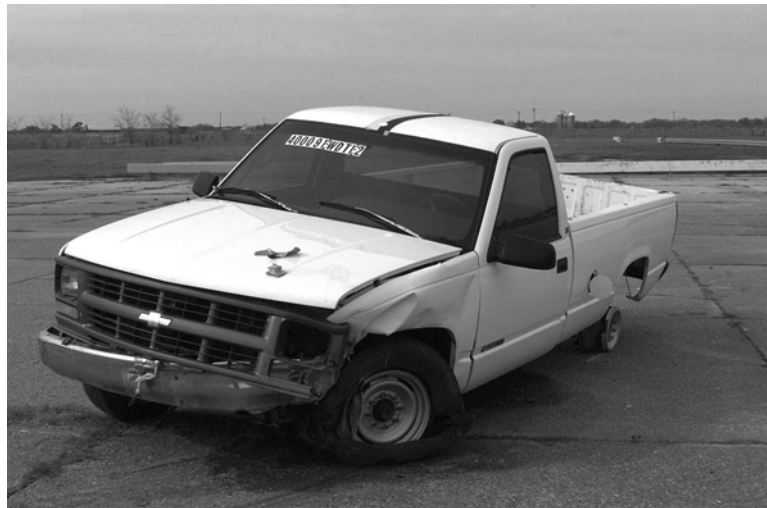
The vehicle sustained damage to the left front as shown in Figure 11. Structural damage was imparted to the stabilizer bar, upper and lower A-arms, rod ends, and the frame rail. Also damaged were the front bumper, fan, radiator, left front quarter

panel, left and right doors, the left front and rear tires and rims, and the left side of the floor pan. Maximum exterior crush to the vehicle was 420 mm (16.4") at the left front corner at bumper height.

Maximum occupant compartment deformation was 20 mm (¾") in the firewall area.

FIGURE 11 Vehicle damage – alternate design.
