Washington State Cable Median Barrier In-Service Study

Submitted for presentation at the 83rd Annual Meeting of the National Transportation Research Board, Washington D.C., 2004.

November 2003

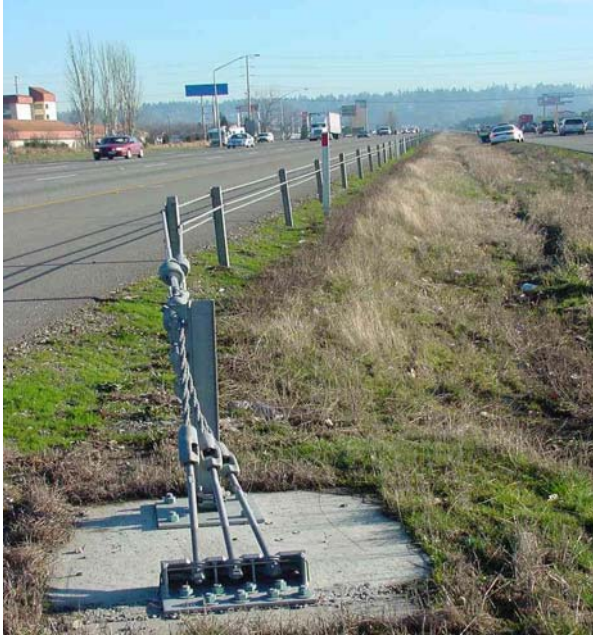
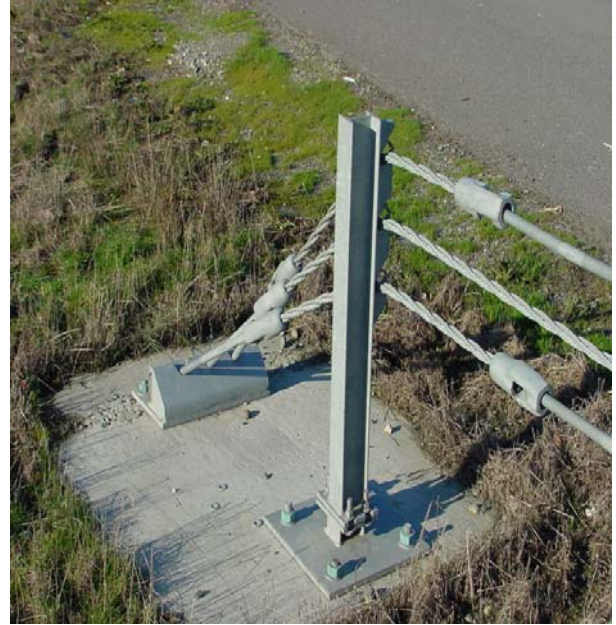
FIGURE 2 Washington State cable barrier terminal

The terminal designs used by WSDOT for cable barriers are nearly identical to the terminals approved by the FHWA (7). The ends of the cables are attached to turnbuckle assemblies that are bolted to a breakaway anchor angle and anchored rigidly to a concrete footing (see Figure 2). Spring cable end assemblies are installed on the ends of the cables and the barrier runs are limited to 2000' between the terminals. Compressing the springs introduces tension in the cables, and thus they are designed to compensate for temperature variations. The WSDOT has also developed a transition to W-beam guardrail, based on South Dakota's design (see Figure 3).
