# US 2 STEVENS PASS PEDESTRIAN BRIDGE & EASTBOUND RIGHT TURN LANE

## Visual Discipline Report

December 2008

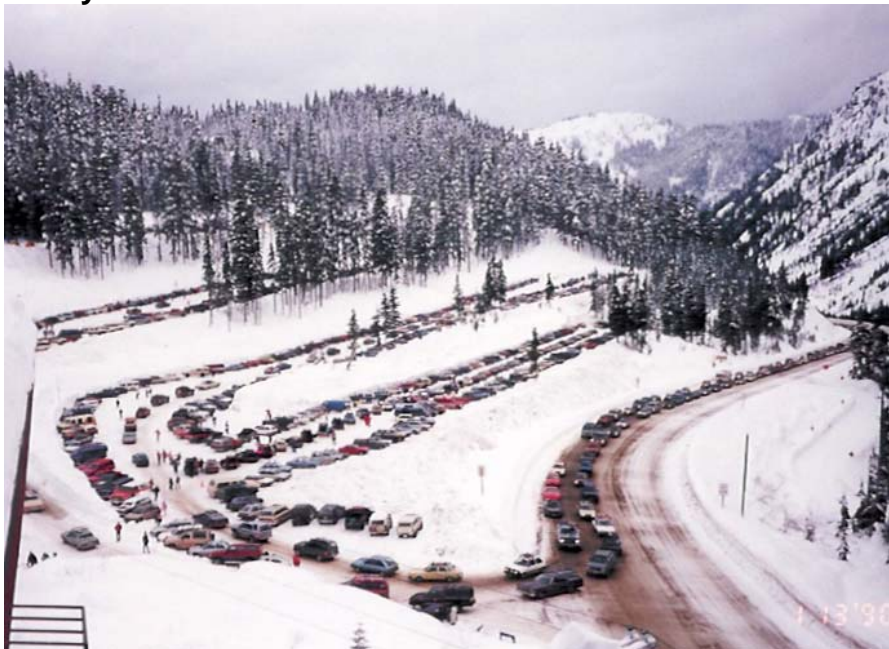
Exhibit 1-1  
**Heavy Winter Traffic Conditions**

Stevens Pass is a major ski and recreation area. During winter months there is significant traffic, principally coming from the west, to park in the lots west of the ski lodge buildings. This can be seen in Exhibit 1-1.

In heavy snowfall, US 2 becomes so congested that cars must stop. Many become stuck, which results in a backup that extends farther west.

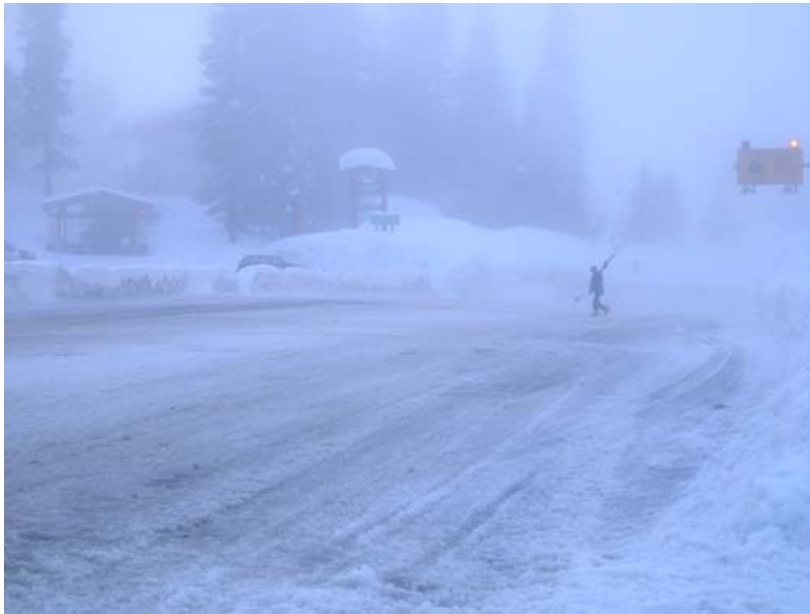
Exhibit 1-2

There are also several parking lots east of the ski lodge buildings. Many skiers walk across US 2 to access the Stevens Pass Ski Area from one of its primary parking lots across the highway. This can be seen in Exhibit 1-2. During the winter the at-grade crossing poses a particular hazard to both pedestrians and motorists because of low visibility and icy conditions.

**Skier crossing US 2 at Stevens Pass in low visibility conditions**

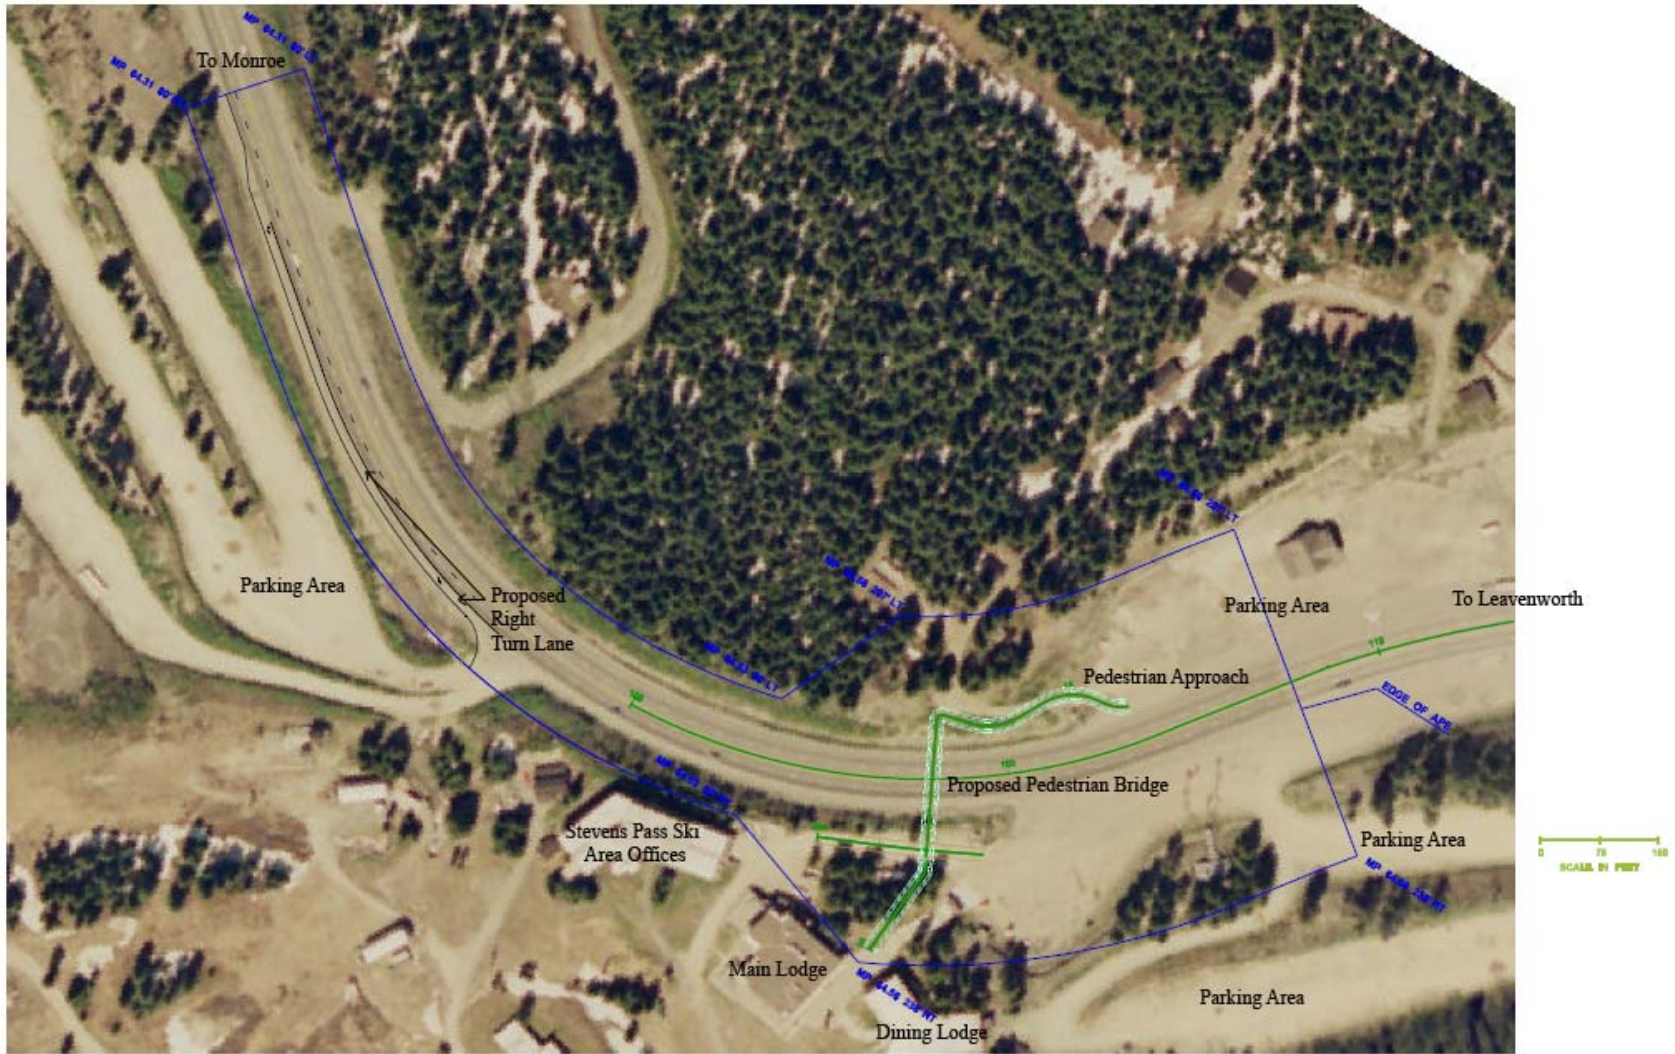
Exhibit 1-3  
US 2 Stevens Pass – Project Vicinity

The proposed project will construct a pedestrian bridge over US 2 at the crest of the pass and an eastbound right turn lane into the western parking lots for the ski area.

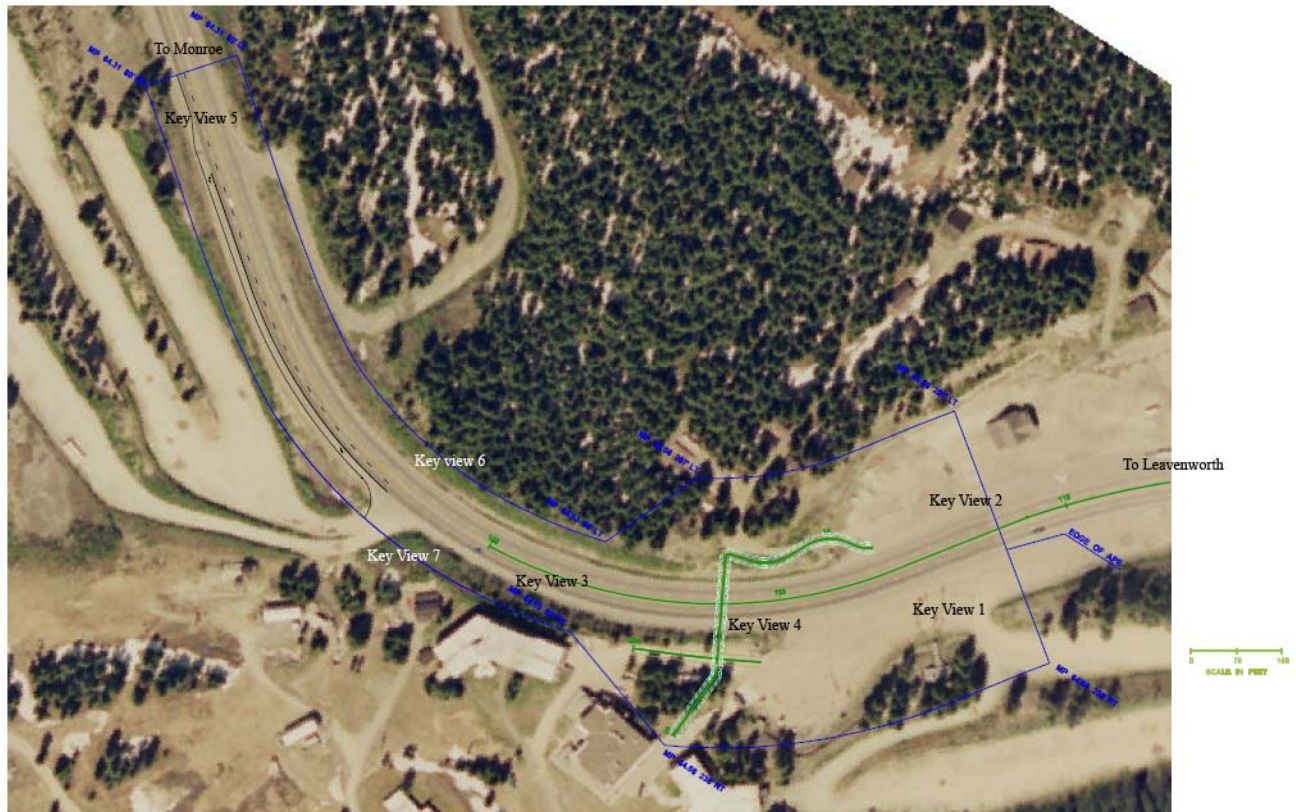
**Exhibit 3-1  
Key View Locations**

Information on visual quality was collected during site visits in the spring and summer of 2008 and from photographs.

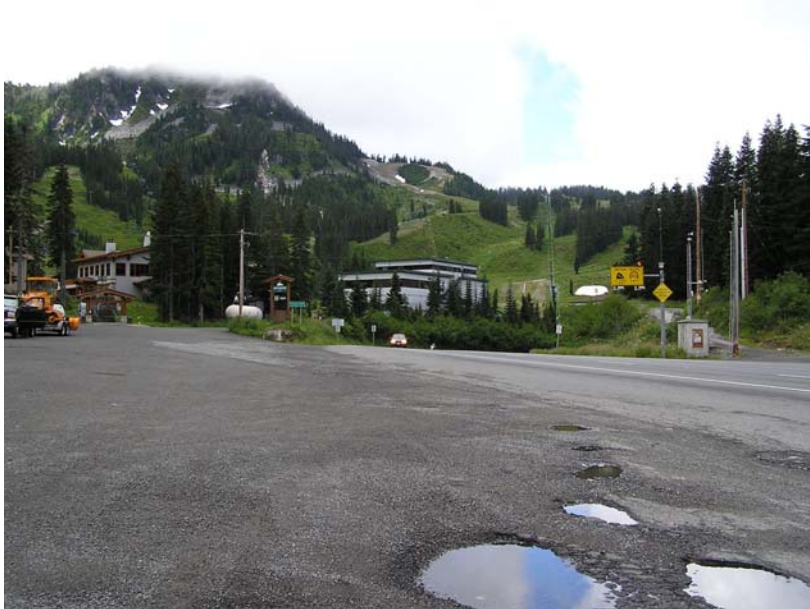
Exhibit 3-2

**Key View 1 – View of Pedestrian Bridge from the South Parking Lot off US 2**

The total visual quality in Key View 1 is moderately high, at 4.1. The landform in this photo is highly vivid because of the mountain scene. The vegetative cover is average and the manmade development vividness is moderately low. The intactness of the scene is moderately high but the unity is average. The unity score is brought down some by the presence of the utility poles and power lines.

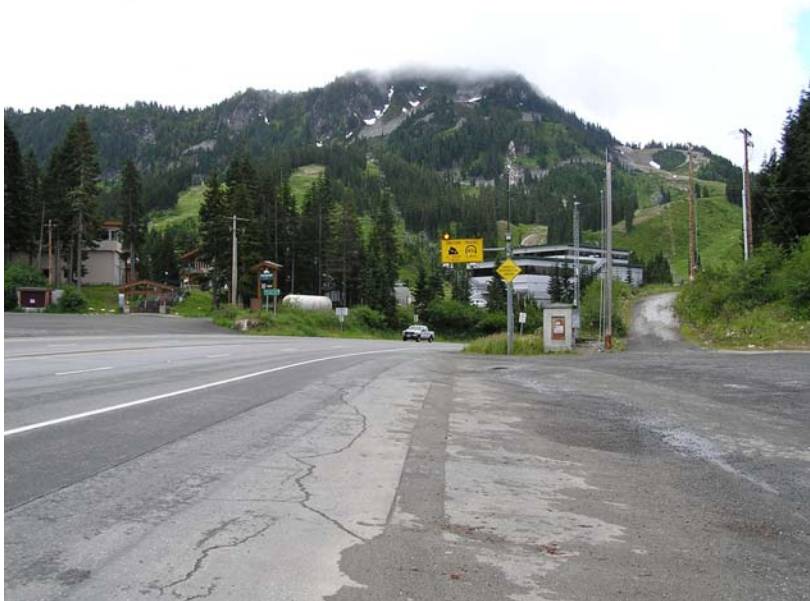
Exhibit 3-3

**Key View 2 – View of pedestrian bridge from parking lot on north side of US 2 at Mile Post 64.62**

The total visual quality rating from Key View 2 is moderately high to high at 4.5. The landform is highly vivid due to the mountains. The vegetation vividness is moderately high due to the vegetation in the middle ground and the back ground. The intactness and unity are moderately high. The encroachment of the utility poles and power lines detract somewhat from the scene.

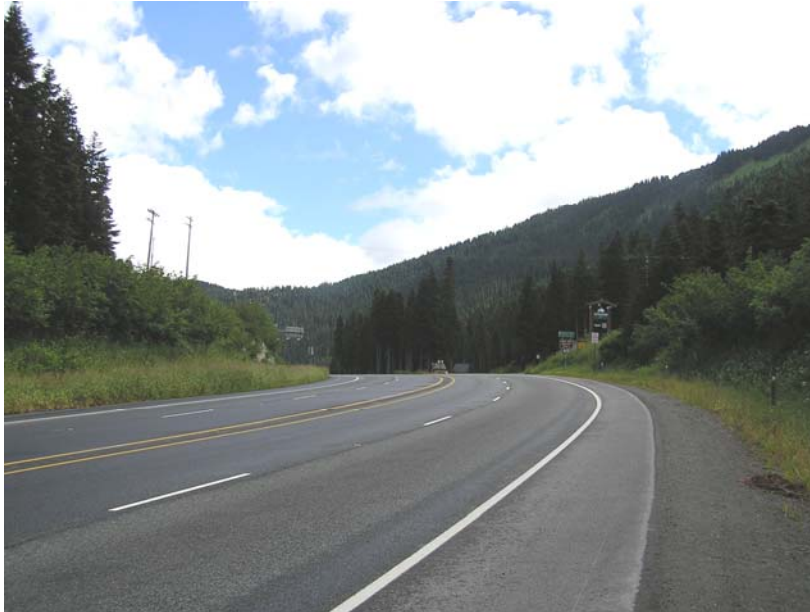
Exhibit 3-4

**Key View 3 – View East toward the Proposed Bridge  
from the Shoulder of US 2 at Mile Post 64.50**

The unity of the scene is high however there is some human development in the view in the form of utility lines and signs. The overall visual rating of the view is high at 4.9.

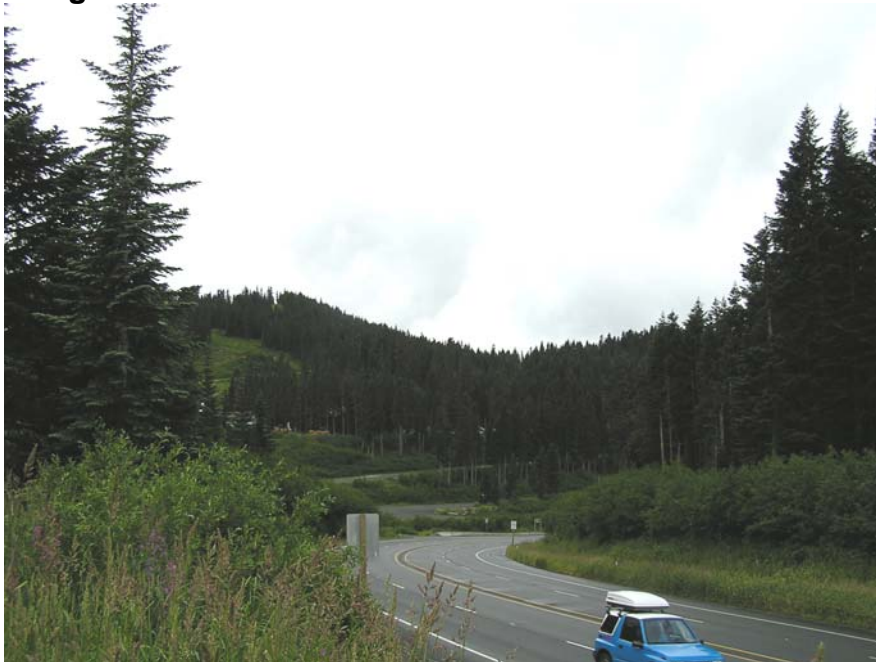
Exhibit 3-5

### **Key View 4 – View West from the Proposed Pedestrian Bridge**

Visual quality from Key View 4 is moderately high to high at 4.7. There is very little development or encroachment evident in this view. The vividness is average and the unity is moderately high.

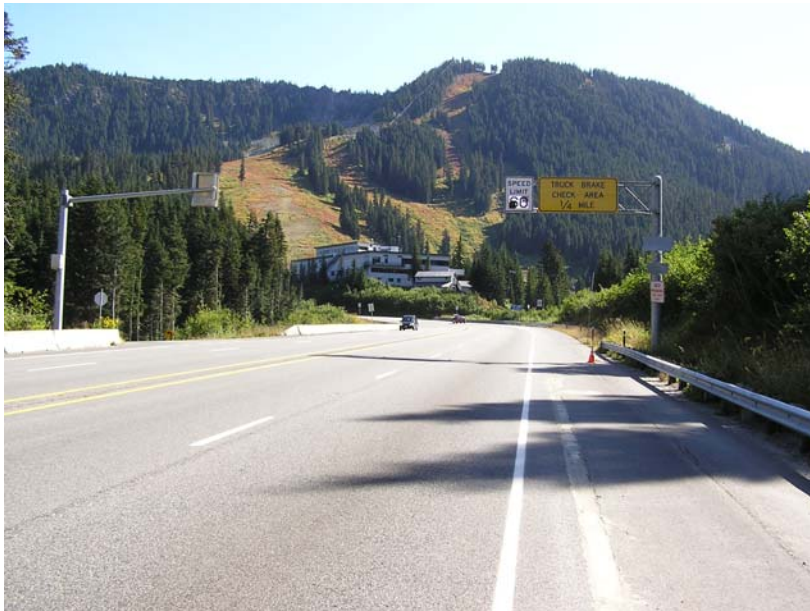
Exhibit 3-6

**Key View 5 – View Eastbound on US 2 toward Summit from Mile Post 64.26**

The total visual quality rating from this view is moderately high, at 4.6, due to the form of the land and the large amount of vegetation in the view. The moderate level of development lowers the intactness rating.

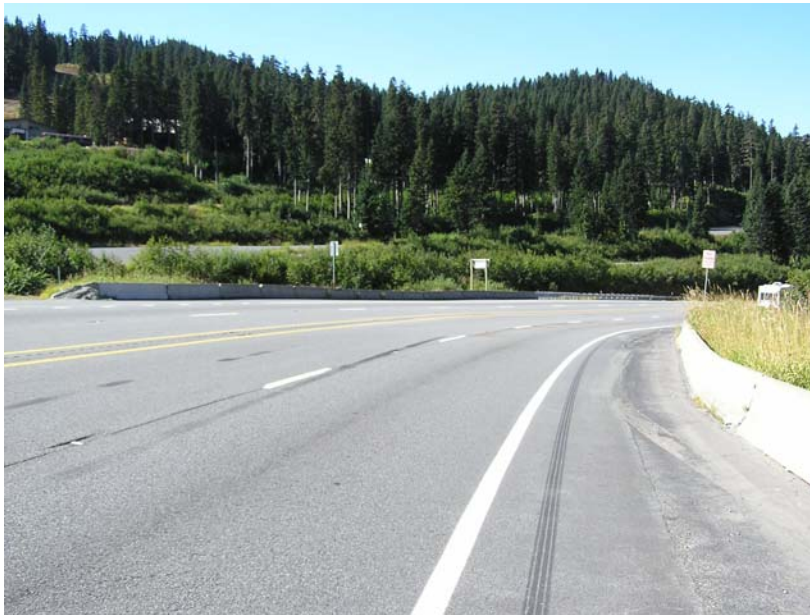
Exhibit 3-7

**Key View 6 - View toward West from US 2 at Mile Post 64.47**

The total visual quality rating is 4.7, a moderately high rating. The expanse of pavement and the parking area lowers the intactness rating from its potential.

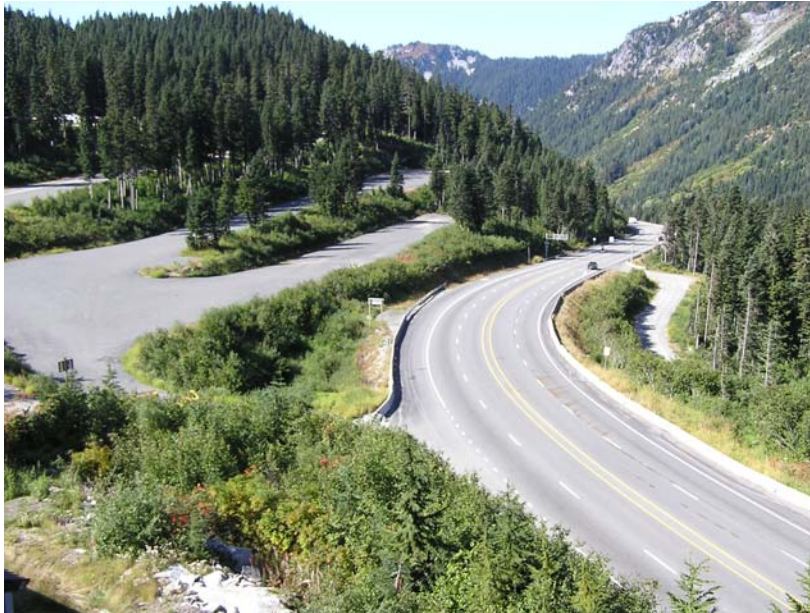
Exhibit 3-8

**Key View 7 - View toward Western Parking Area and US 2 from the Ski Area offices**

The large amount of pavement in this view gives this a total visual quality rating of 3.9 because it disrupts the intactness and unity of the natural environment.

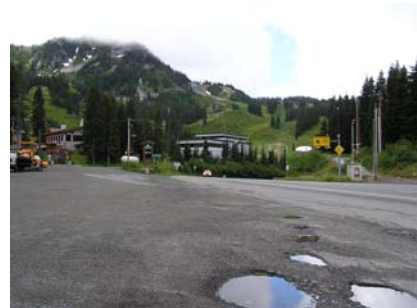
Construction of the bridge will require the removal of the trees on the left center of the photo. These trees currently obscure the Stevens Pass lodge. The trees will be replaced, but there will be visual impacts especially until the replacement trees grow up large enough to obscure the view of the pedestrian bridge approach and building.

*Key View 1 – View Of Pedestrian Bridge From Parking Lot South Of US 2*

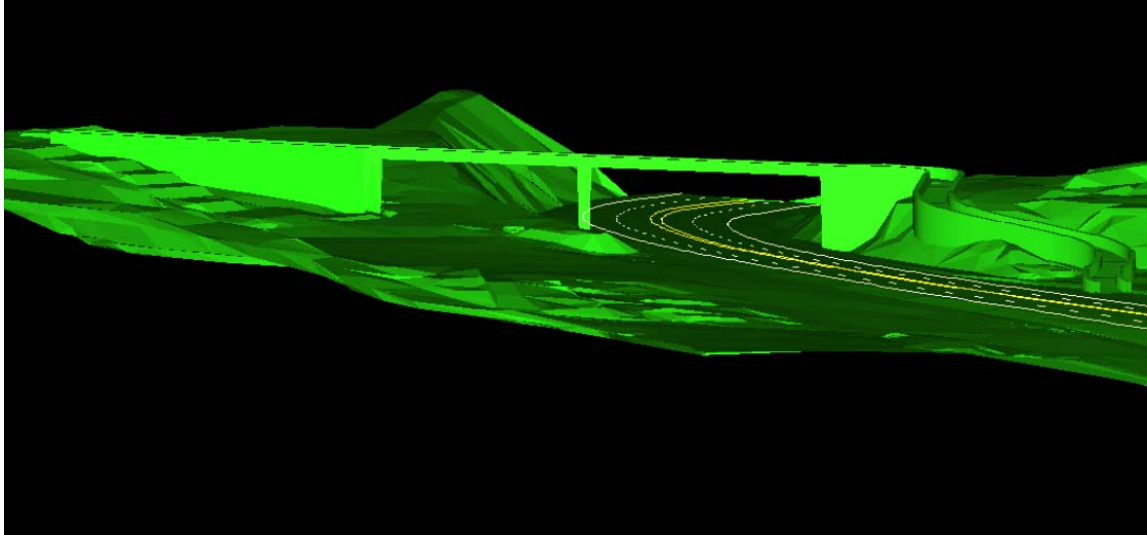
A retaining wall will be built to minimize the footprint of the approach from the building to the bridge. The face of the retaining wall will be either a rock face or a cast in place structure that blends with the Stevens Pass lodge. The approach on the north side of US 2 will also require a retaining wall on the road side of the approach. This wall will be faced with a rock treatment that will blend with the rock outcrop that the bridge will rest on. Exhibit 4-2 shows the location of the walls.

**Exhibit 4-2**  
**Design Visualization of Bridge Location**

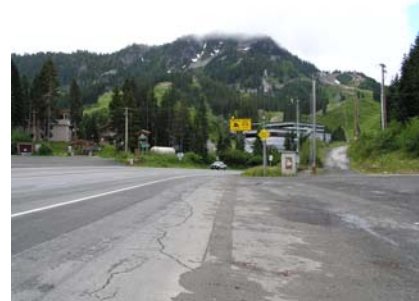
The pedestrian bridge will bisect this view from the knoll on the right to the lodge on the left. Construction of the bridge will require the removal of the trees in the middle ground on the south side of the highway. The removal of these trees will be very visible from this angle and will be the greatest impact to the visual quality from this viewpoint. This impact will be mitigated by planting trees to replace the ones that will be removed. The retaining wall for the bridge approach on the south side of the road will also be visible from this location. The retaining wall will be treated with a rock face or a cast in place treatment that will blend with the lodge.

The approach ramp to the bridge on the north side of US will also be highly visible from this angle. The ramp will follow the path of the existing driveway, visible on the right side of the photo. This will require that the drive be pushed to the right and will increase the amount of pavement visible from the road and parking lot and will cause the removal of more vegetation. In addition, there will be a standard concrete barrier between the highway and the parking lot and pedestrian walkway. It will be approximately 32 inches high, will be tinted brown with a pigmented sealer, and will run up the center of this view.

The utility poles and wires will be placed underground or suspended under the bridge. This will improve the intactness and unity of the scene. The total visual quality of the view will drop from 4.5 to 4.1 because of the increase in the level of development in this view. 4.1 is an moderately high rating.

*Key View 2 – View of Pedestrian Bridge from Parking Lot on North Side of US 2 at Mile Post 64.62*

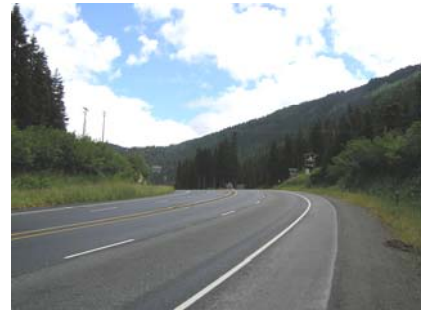
The bridge will be the prominent visual element in this view and will cut the view in half horizontally. The scene currently has high intactness and high unity, although there is some encroachment by utility poles and signs at this time. The bridge will lower the scores in both cases. The architectural treatment of the bridge will be the Cascadian Theme and help blend it into the context of the scene. Because of the placement of the bridge and the view from this angle there is not much else that can be done to mitigate the visual effects of the structural mass. Because of this, the total visual quality of the scene is significantly lowered from high at 4.9 to moderately high at 3.9. The bridge will act as a visual cue that there is some development ahead and may help to slow down cars.

*Key View 3 – View East toward the Proposed Bridge from the Shoulder of US 2 at Mile Post 64.50*

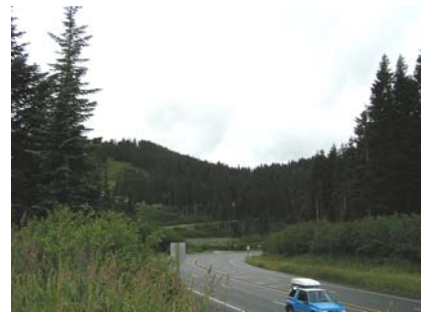
This viewpoint is an approximation of the view from atop the proposed pedestrian bridge. This view will be seen by pedestrians only. The view will not be changed by the bridge but it will add a view point that doesn't exist currently. Because of this, views for pedestrians will be enhanced by the bridge over current views. The total visual quality rating remains moderately high, at 4.7

*Key View 4 – View West from the Proposed Pedestrian Bridge*

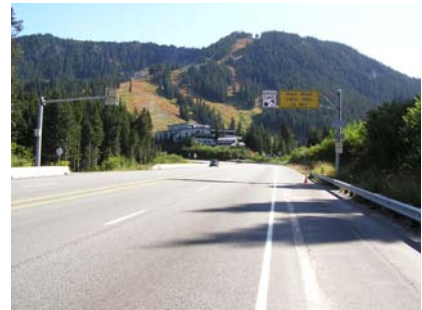
From Key View 5, the new right turn lane would be visible. This will increase the pavement width by approximately 12 feet and will remove the shrubs at the right in the photo. The increase in pavement will decrease intactness ratings but the total visual quality rating will remain moderately high at 4.4, down from 4.6.

*Key View 5 – View Eastbound on US 2 toward Summit from Mile Post 64.26*

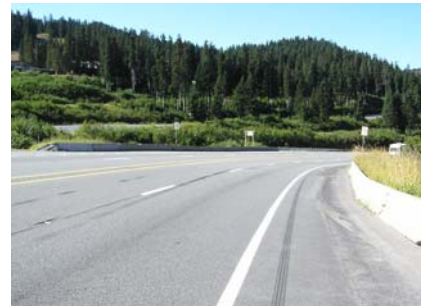
Key View 6 looks toward the entrance to the west parking lots and the new right turn lane. Any change in this view will be due to the removal of some shrubs on the shoulder between the highway and the parking lot. The total visual quality rating will decrease slightly from 4.7 to 4.6, both moderately high ratings.

*Key View 6 – View toward West from US 2 at Mile Post 64.47*

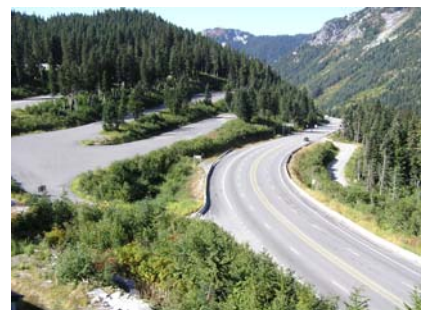
The additional lane will be visible from Key View 7 as an increase in the width of pavement and a narrowing of the vegetation between the highway and the parking lot. The total visual quality rating will decrease from 3.9 to 3.8 because of the decrease in vegetation.

*Key View 7 – View toward Western Parking Area and US 2 from the Ski Area offices*

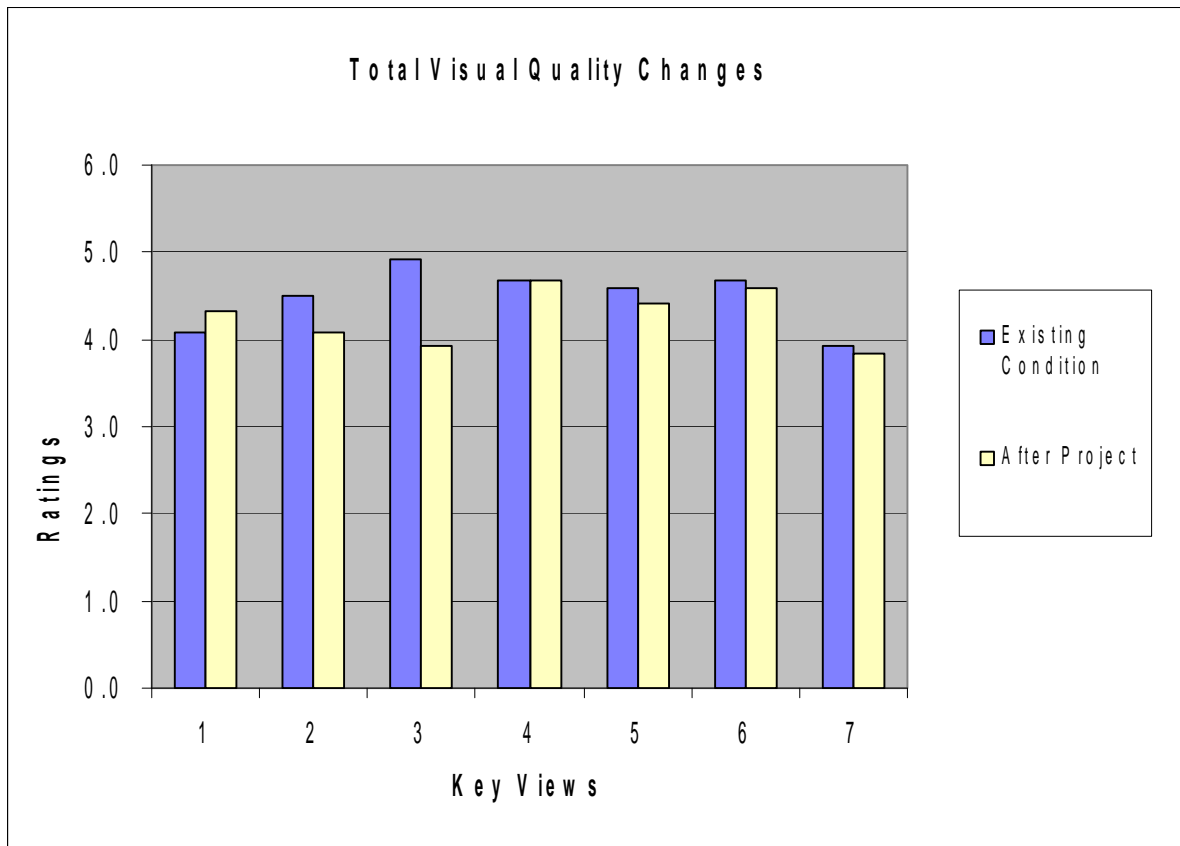
Exhibit 4-3  
**Direct Effects on Visual Quality**

In Key View 3, the visual change reaches the level of significance with changes of 1.0. The rest of the ratings have changes less than 1 point and are not significant. The changes can be seen in Exhibit 4-3.

This project will lower the visual quality in the project area from 4.5 to 4.3. This slight decrease in overall visual quality is due primarily to the large decrease in Key View 3. The overall unity of the views at the summit will increase due to the removal of the power lines and other utilities and placing them either underground or attached to the structure of the pedestrian bridge.
