PAVEMENT RESEARCH
at the
WASHINGTON STATE UNIVERSITY
TEST TRACK

EXPERIMENTAL RING NO. 2: A STUDY OF UNTREATED,
EMULSION TREATED, AND ASPHALTIC-CEMENT TREATED BASES

Report to the Washington State Department of Highways
on Research Project Y-651

Milan Krukar and John C. Cook

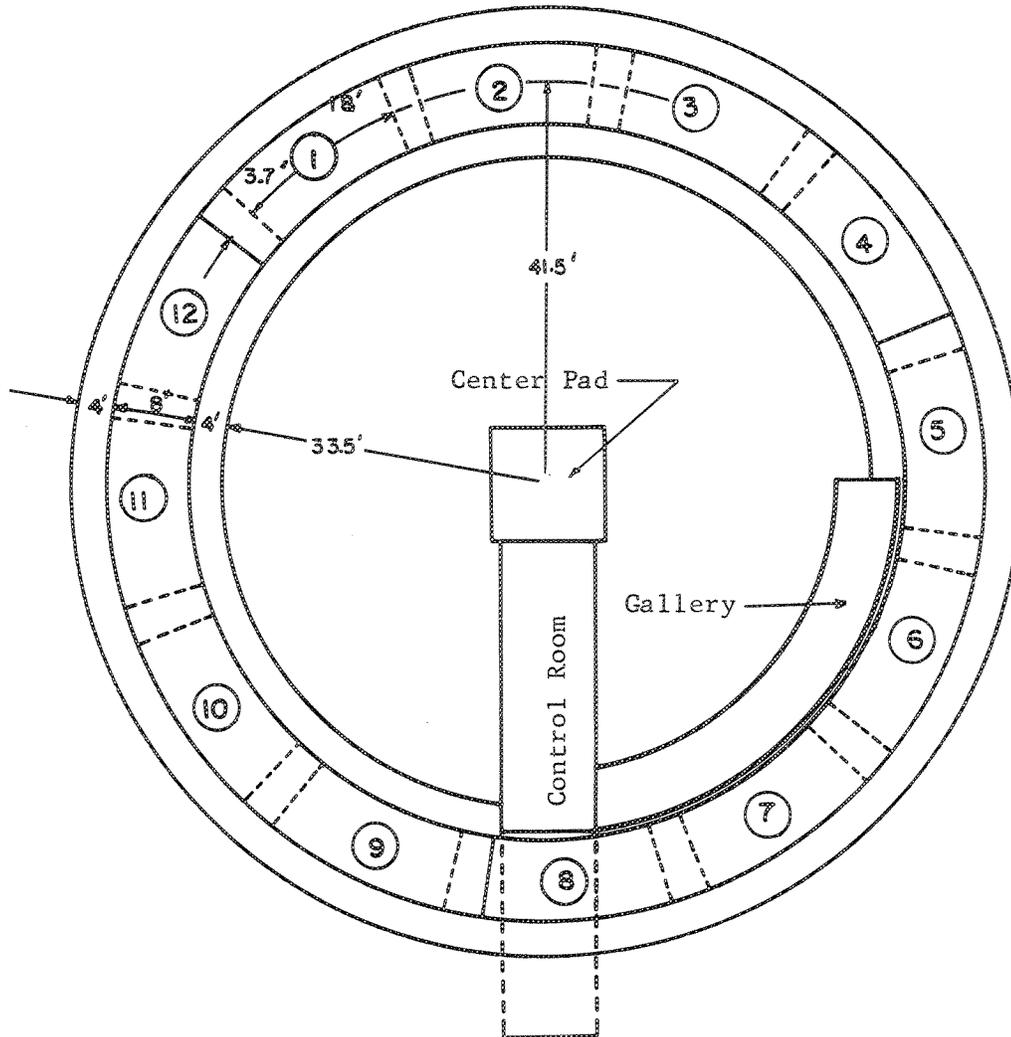
FIGURE 1.--PERMANENT STRUCTURES AND PAVEMENT SECTIONS
TEST RING NO. 2

PLAN VIEW

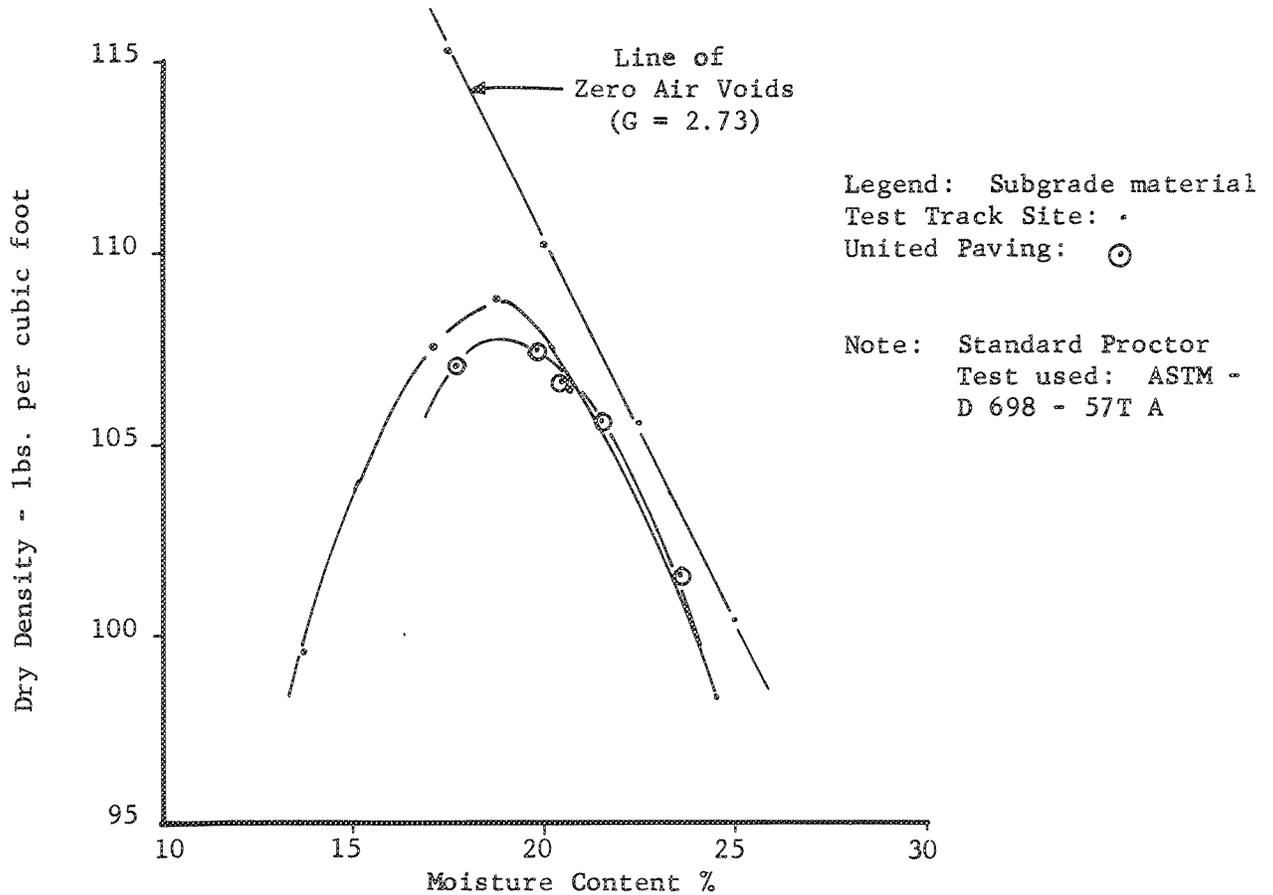
FIGURE 3.--DENSITY - MOISTURE CURVES
(Subgrade Soil Characteristics)

of this report. Soil moisture-density curves are shown in Fig. 3 and Table II. Characteristics and classifications are shown in Table III. Some of the soil came from the contractor's local pit and the curve for this soil is also shown in Fig. 3. The slight difference in density may be attributed to a difference in the clay contents of the two silts or to testing variance.

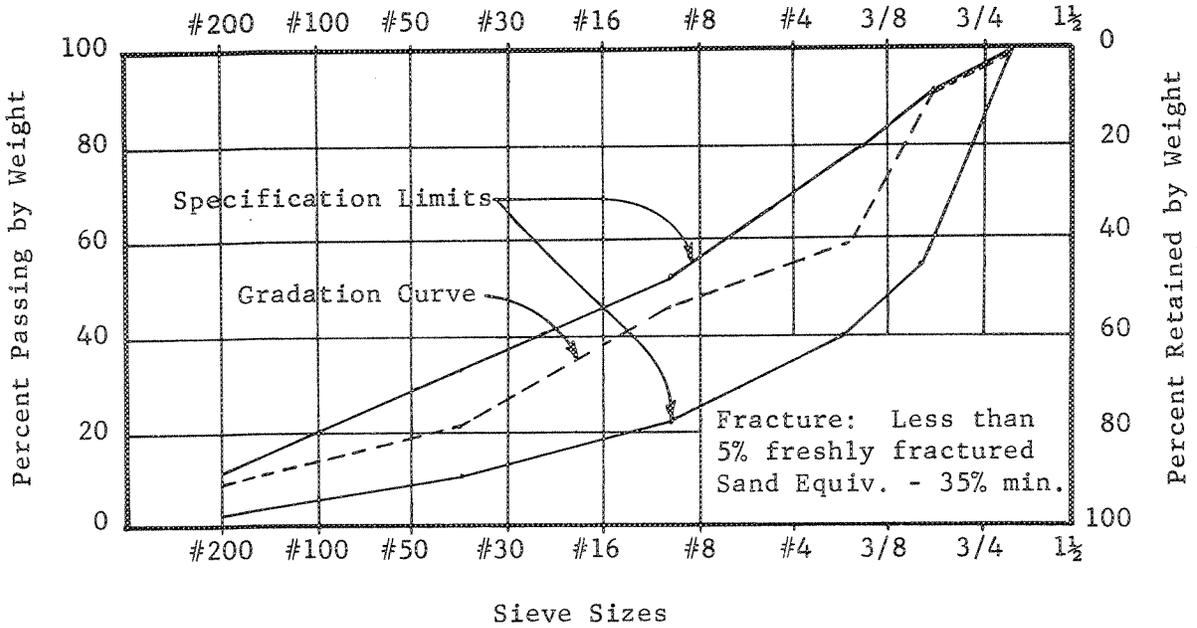
FIGURE 6.--GRADATION CURVE FOR SPECIAL NON-FRACTURED SCREENED AGGREGATE - SPECIAL A.T.B. SECTIONS 9 - 12

It is a river-run gravel and contains less than 5% freshly fractured surfaces. Figure 6 shows the gradation curve for this aggregate. Fig. 11 (photo) shows its appearance and size. Although this type of aggregate is uncommon in Eastern Washington, it is prevalent on the west side of the state. Since good aggregate is becoming scarce in the populated western areas of the state, the highway department wants to make use of more readily available glacial gravels-- and therefore has included them for study as base aggregates.

These sections were laid the afternoon of September 1 and the morning of September 2. Figure 6 shows the gradation for this special non-fractured aggregate; Fig. 11 (photo) shows its appearance; and Table VI shows the mix design

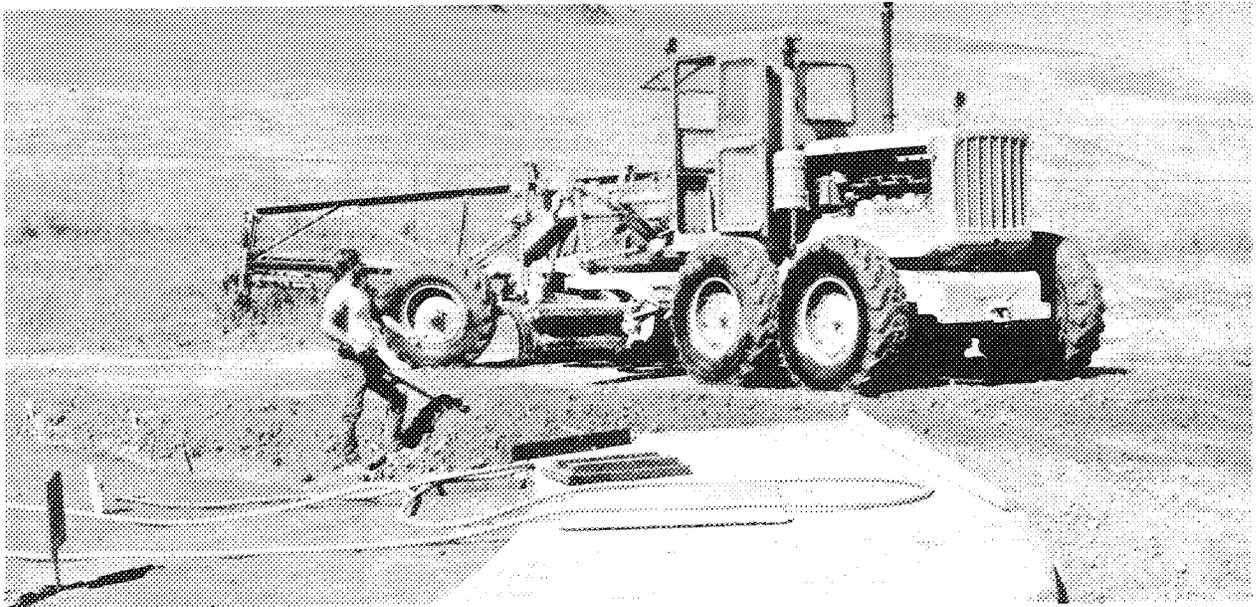
FIGURE 8.--LEVELING OF THE SUBGRADE BY MAINTAINER.

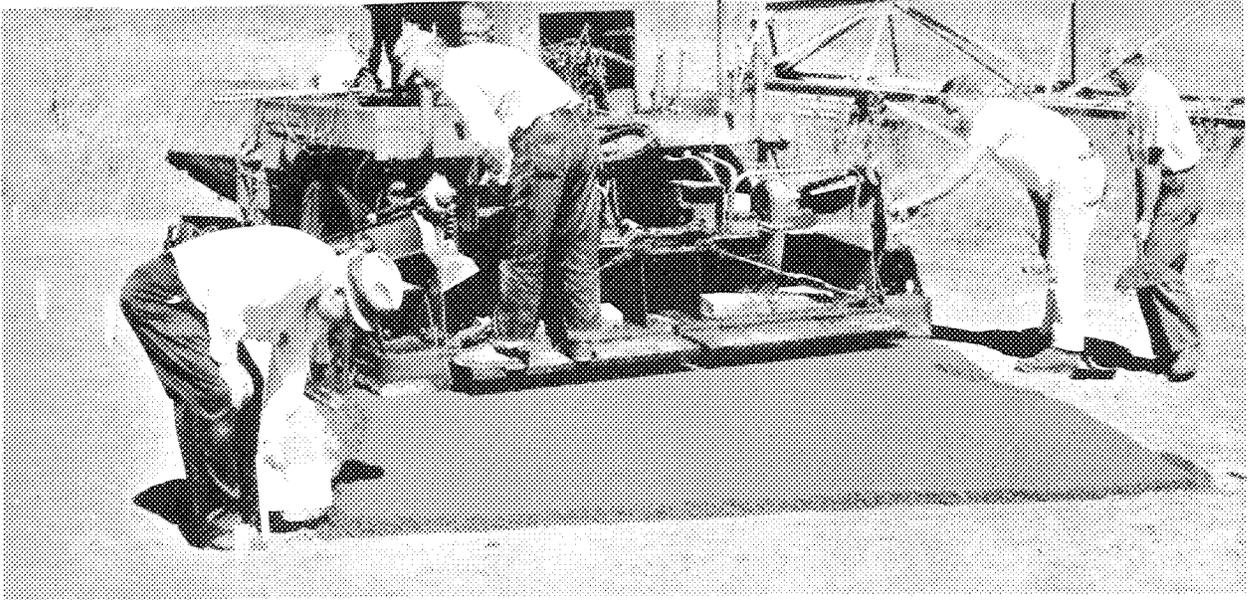
FIGURE 10.--THE PLACING OF THE CRUSHED SURFACE TOP COURSE IN SECTION 4 WITH A BLAW KNOX PAVER.

Laying of the crushed top course in sections 1 to 4 began September 1. The aggregate was processed and laid in three lifts with a Blaw-Knox paver (as shown in Fig. 10). Each lift was compacted with a 5-ton Huber steel roller--with compaction being controlled by nuclear density methods. On the last lift, both a steel and pneumatic tired roller were used for compaction. The base was found to contain 9.4% moisture, making it too wet to work, so it was allowed to cure. The final density obtained is shown in Table V. It was later checked for grade and elevation and cut and filled where necessary.

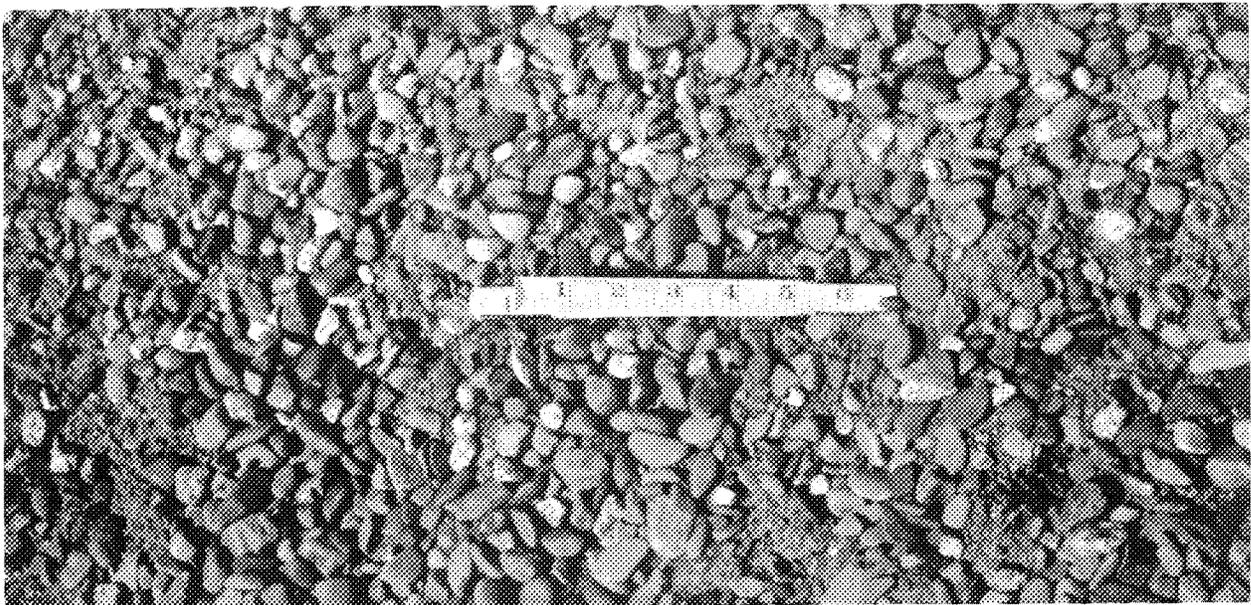
FIGURE 11.--THE APPEARANCE OF THE SPECIAL SCREENED NON-FRACTURED AGGREGATE AT THE TEST TRACK STOCKPILE.

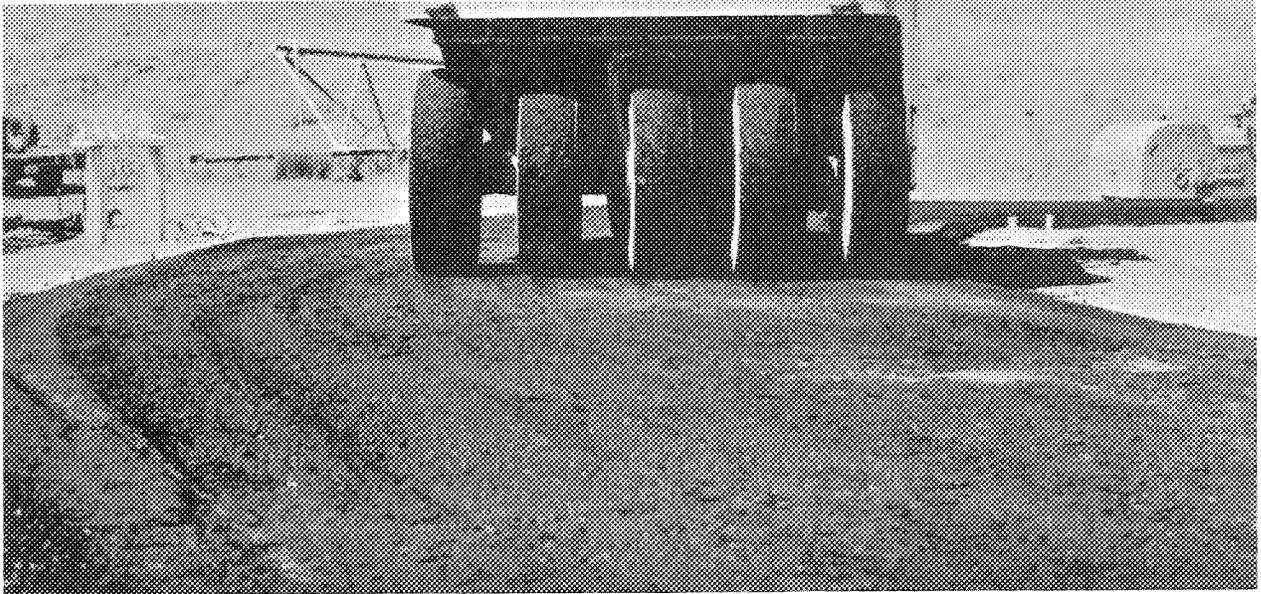
FIGURE 12.--COMPACTING THE SPECIAL ASPHALT-TREATED
BASE SECTIONS 10-11. NOTE THE FLATTENED EDGES.

Some difficulty was experienced in obtaining the correct grade with the paver and a fifth lift was necessary to correct grade deficiencies. Since no berms were used to hold the sides, the edges moved transversely when the base was rolled, causing an overrun. Small surface transverse cracks appeared as the base was rolled with the steel roller. These cracks were caused by the continuous turning of the roller, which induced tension and separation of the surface of the asphalt base (Fig. 13). Table V shows the final average density measured and is compared with the required or laboratory density.

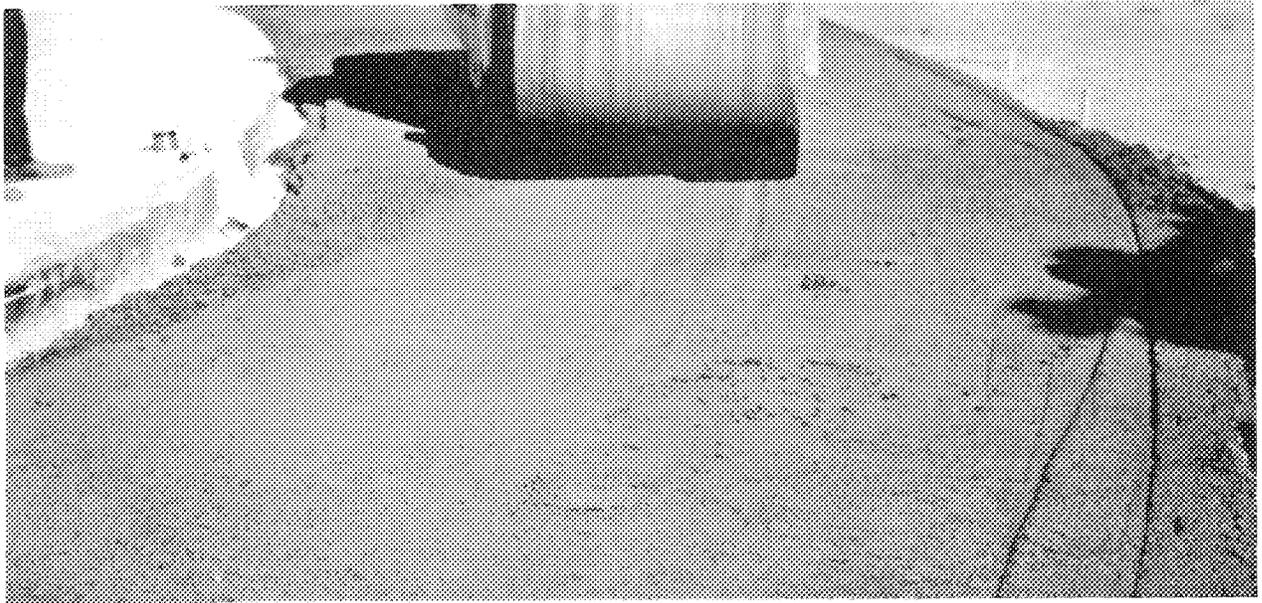
FIGURE 14.--ATTEMPTING TO ROLL THE EMULSION-TREATED BASE AFTER A 3-HOUR CURING PERIOD. NOTE THE PICK-UP OF THE MATERIAL AND THE WET AREAS.

The first lift was laid with a Blaw-Knox paver on the Morning of September 2. The aggregate was the same as that used for the untreated bases. The gradation and density curves are shown in Figs. 4 and 5, and the design mix requirements are tabulated in Table VI. The asphalt emulsion SS-Kh was diluted with water on a 50-50 basis, instead of adding water to the mix. The aggregate, which was not predried, and 5% of the diluted emulsion were cold-mixed in 3,000-pound batches. The loose thickness of this first lift was $4\frac{1}{2}$ inches in section 8 (9.0 inches of ETB) and $2\frac{3}{4}$ inches in section 7 (7.0 inches of ETB). After a three-hour curing period, the sections were rolled with a 5-ton Huber steel roller. As water was still pumping out of section 8, compacting operations were halted and the emulsion base was allowed to cure overnight. This condition is shown in Fig. 14.

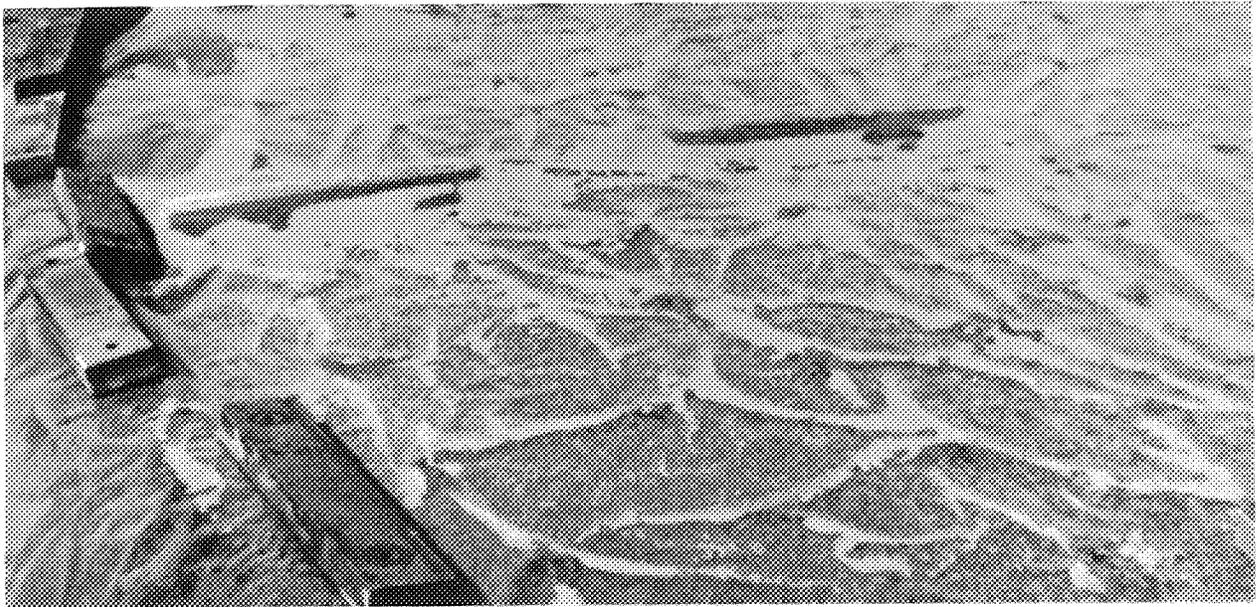
FIGURE 15.--THE FIRST TWO LIFTS OF EMULSION-TREATED BASE IN SECTION 8 BEING CURED BY VISQUEEN PLASTIC COVERING. NOTE THE CONDENSED MOISTURE ON THE BOTTOM OF THE PLASTIC.

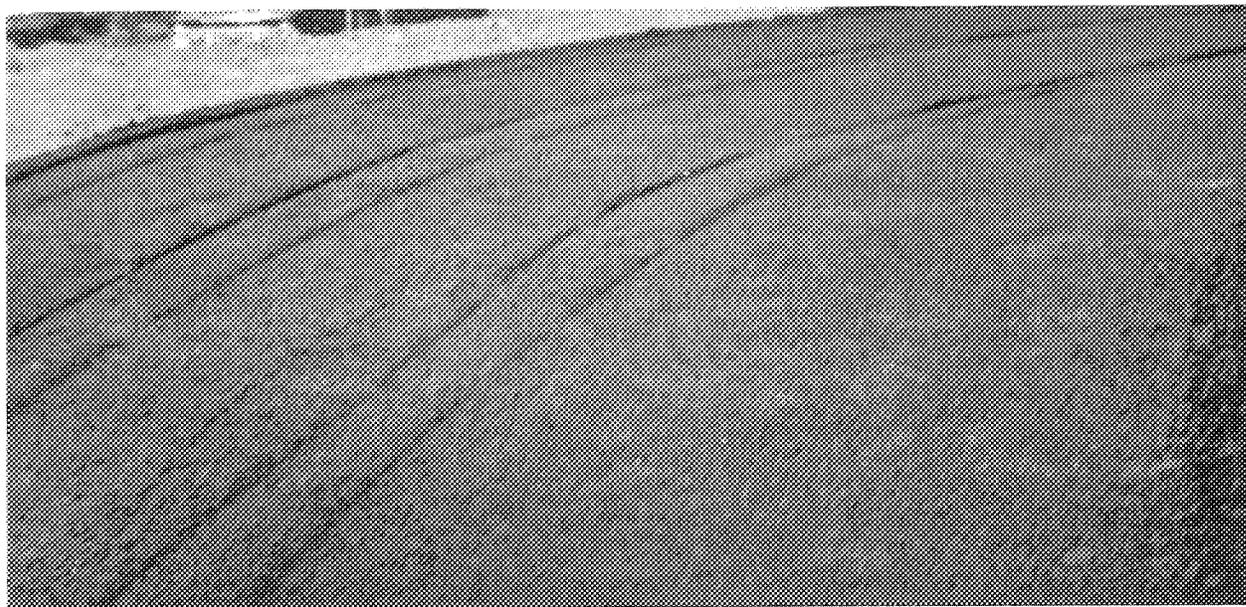
FIGURE 16.--THE APPEARANCE OF THE 3RD LIFT OF EMULSION-TREATED BASE IN SECTIONS 7 AND 8 AFTER ROLLING. PICTURE WAS TAKEN 2 HOURS AFTER LAYING.

On Monday, September 12, after the application of a slight tack coat of emulsion SS-1 on the emulsion base surface, the third lift was placed on sections 5, 6, 7 and 8. This mix differed in that the aggregate was partially dried then mixed with the diluted SS-Kh emulsion asphalt. The temperature of this mix was 100°F at placing and contained 10.9% water, a 3% reduction in water content. Rolling began after an hour of curing and immediately some pumping and shoving occurred in sections 7 and 8. (See Fig. 16) On section 5 where the lift was laid on the dry subgrade, curing was very rapid and there was no problem with compaction.

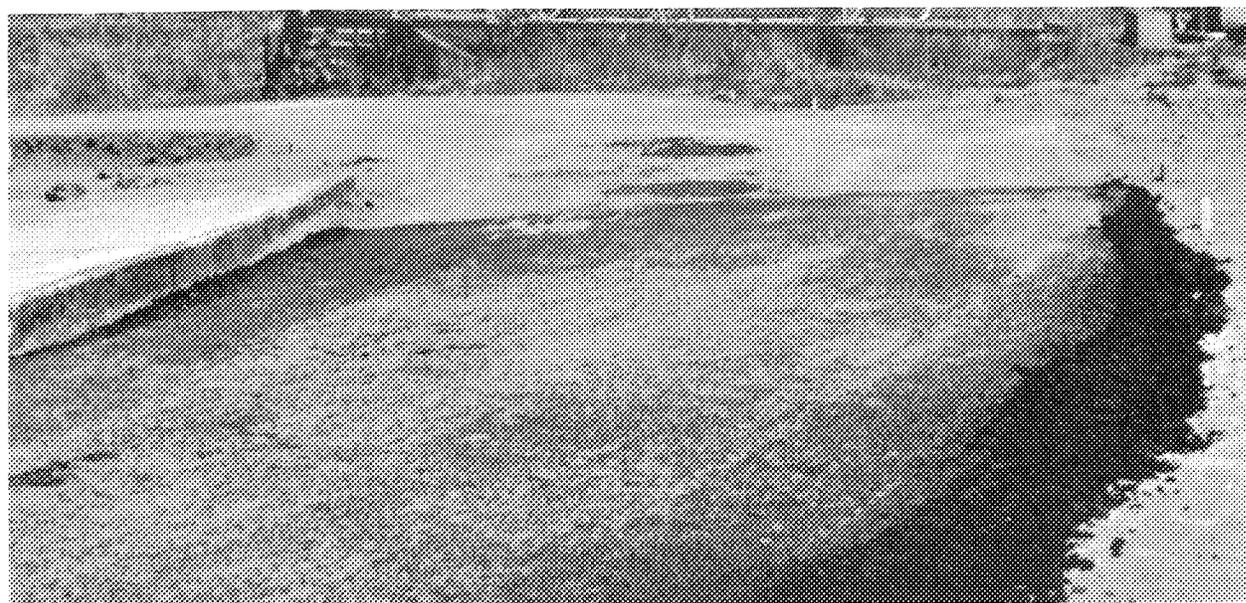
FIGURE 17.--APPEARANCE OF THE EMULSION-TREATED BASE IN SECTION 6 AFTER BEING CURED AND ROLLED. NOTE THE GRANULAR APPEARANCE OF EMULSION.

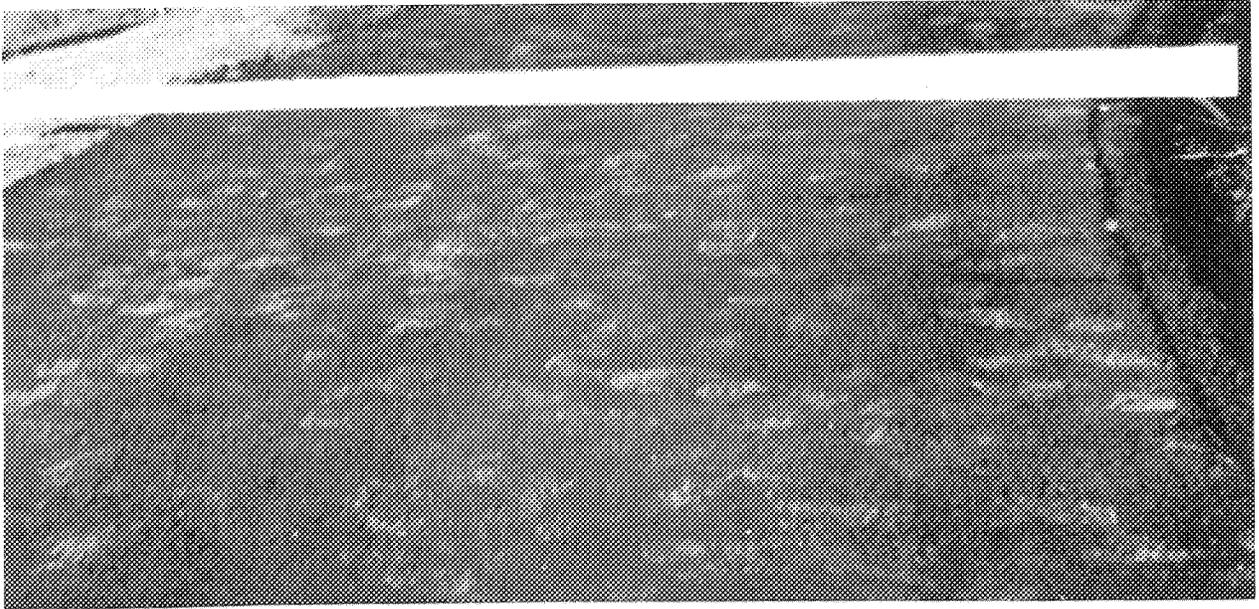
FIGURE 18.--A VIEW OF THE FINAL GRADE AFTER THE 3.0" CLASS "B" ASPHALT CONCRETE WEARING COURSE WAS LAID BEING CHECKED BY STRAIGHT-EDGE. NOTE THE GROOVES LEFT IN THE MAT FOR INSTRUMENTATION.

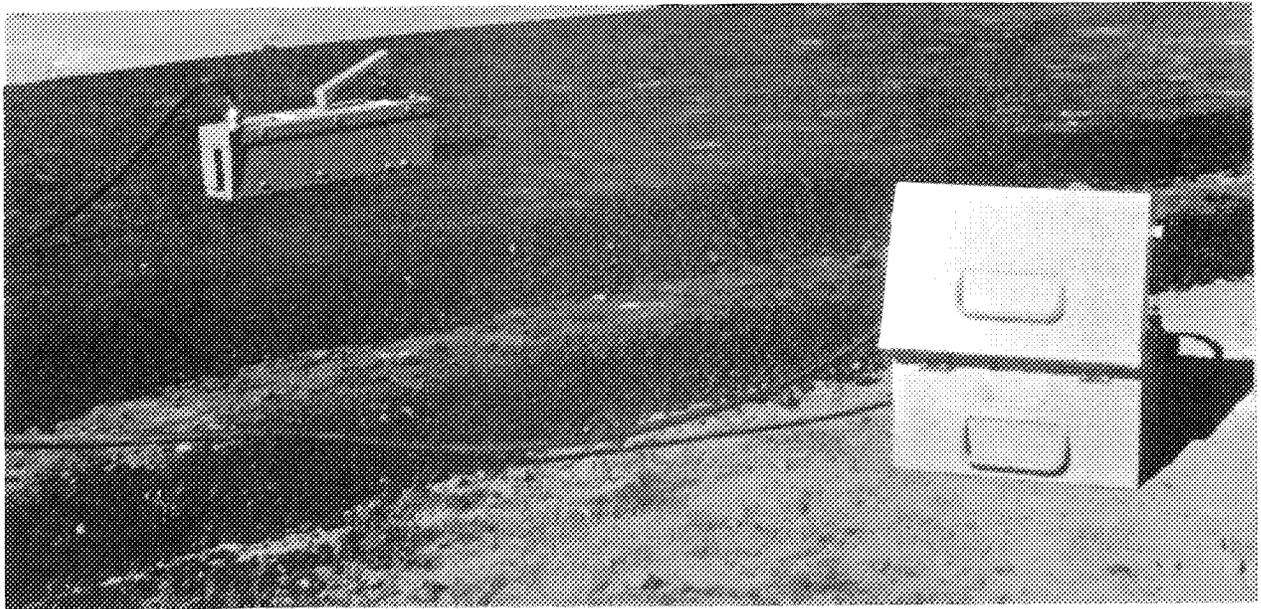
FIGURE 19.--DENSITY OF THE CLASS "B" MAT BEING MEASURED BY THE NUCLEAR ASPHALT GAGE AND SCALER.

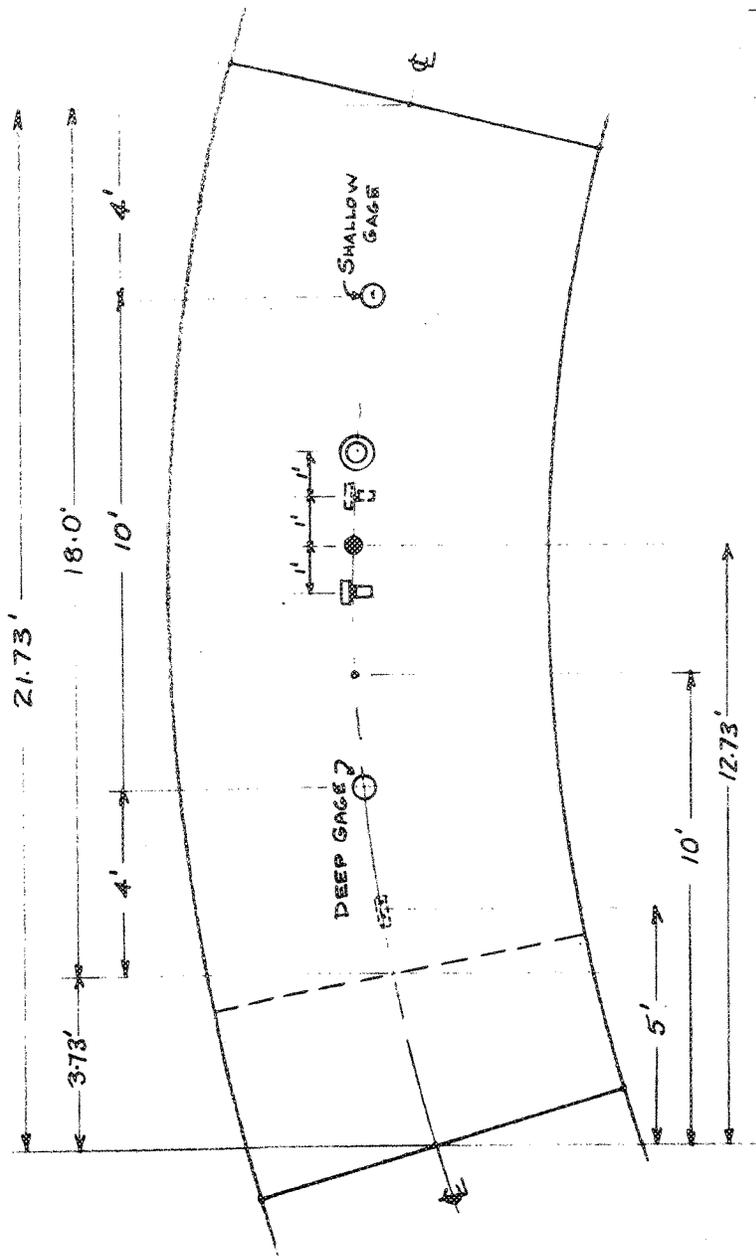
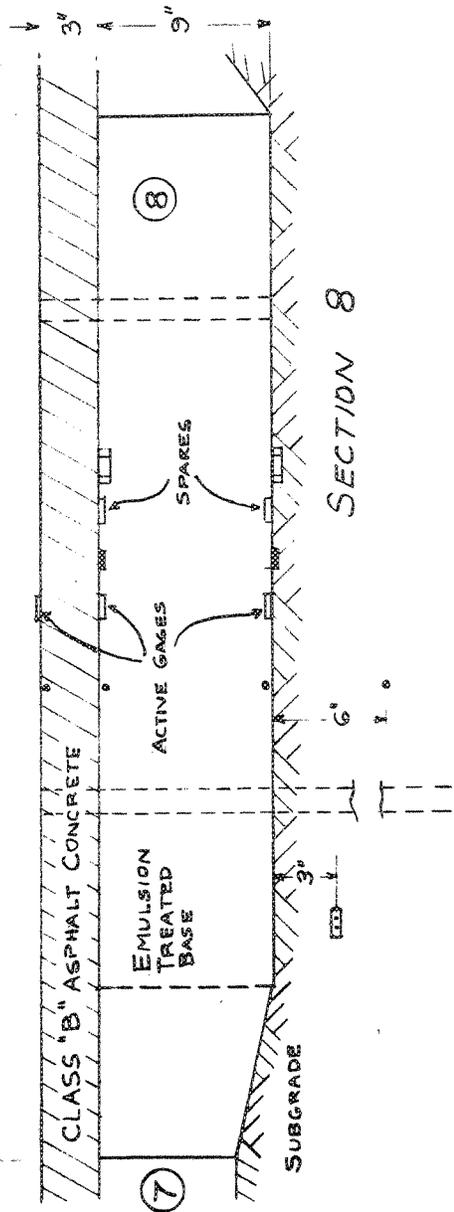
FIGURE 20. ...
 HIGHWAY RESEARCH SECTION
 RING No. 2 Y-651
 WASHINGTON STATE UNIVERSITY
 JULY 28, 1966
 M. KRUKAR
 INSTRUMENTATION FOR SECTION 8 - E.T.B.

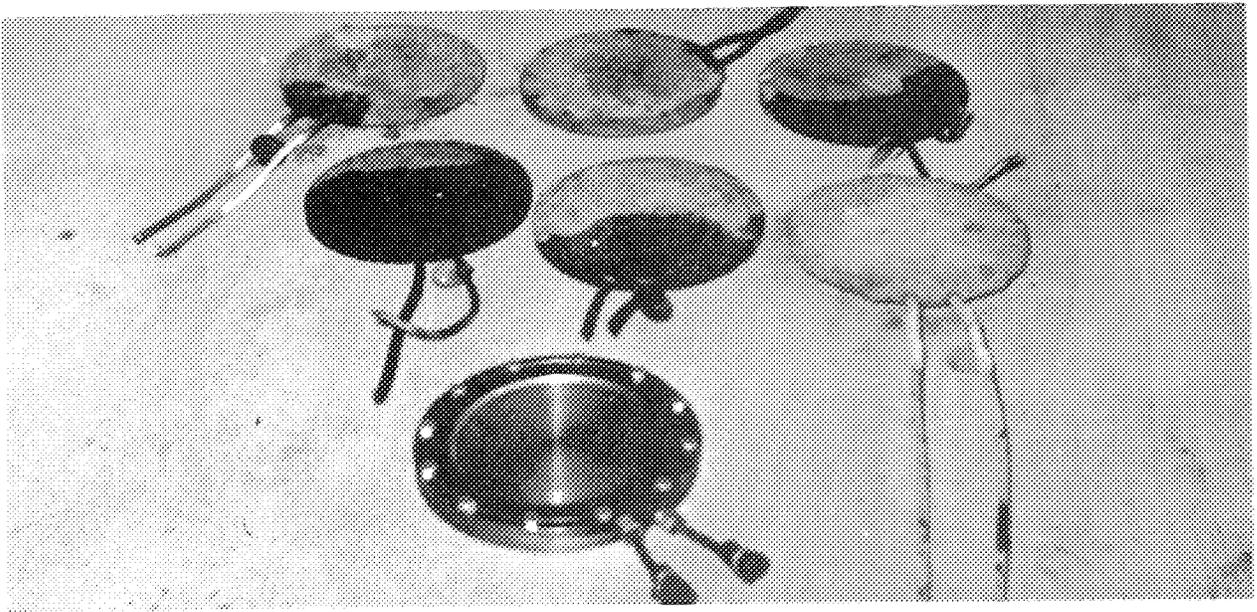
FIGURE 22.--A COMPARISON OF THE NEW WSU PRESSURE CELL WITH THE OLD CELLS USED IN RING NO. 1.

WSU pressure cells:--These cells are similar to those used in Ring #1 and are shown in Figs. 22 and 23. Calibration of these cells was accomplished in an air pressure chamber. A typical calibration unit is shown in Fig. 24. During ring construction the subgrade and the base where they were to be placed was leveled then covered with a layer of fine silica sand. The cells were placed in position and covered with another layer of fine silica sand to protect the cell from any pressure points that might develop from the aggregates in the base. The system was connected to a manometer board.

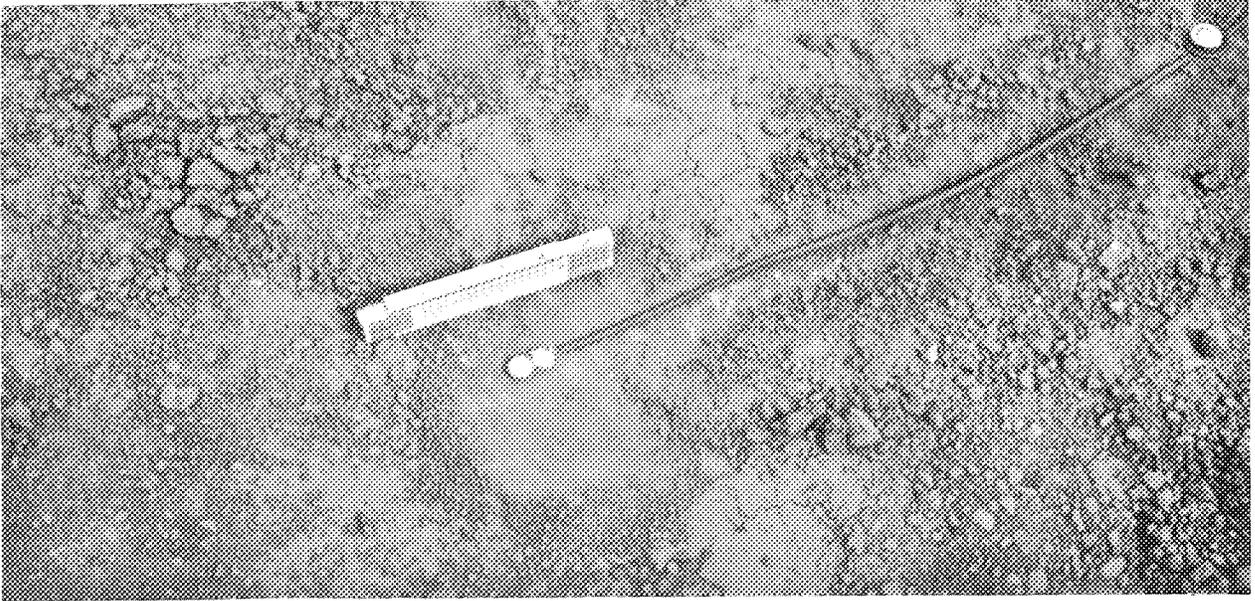
FIGURE 26.--A VIEW OF THE SIZE OF THE FILPIP PRESSURE TRANSDUCER.

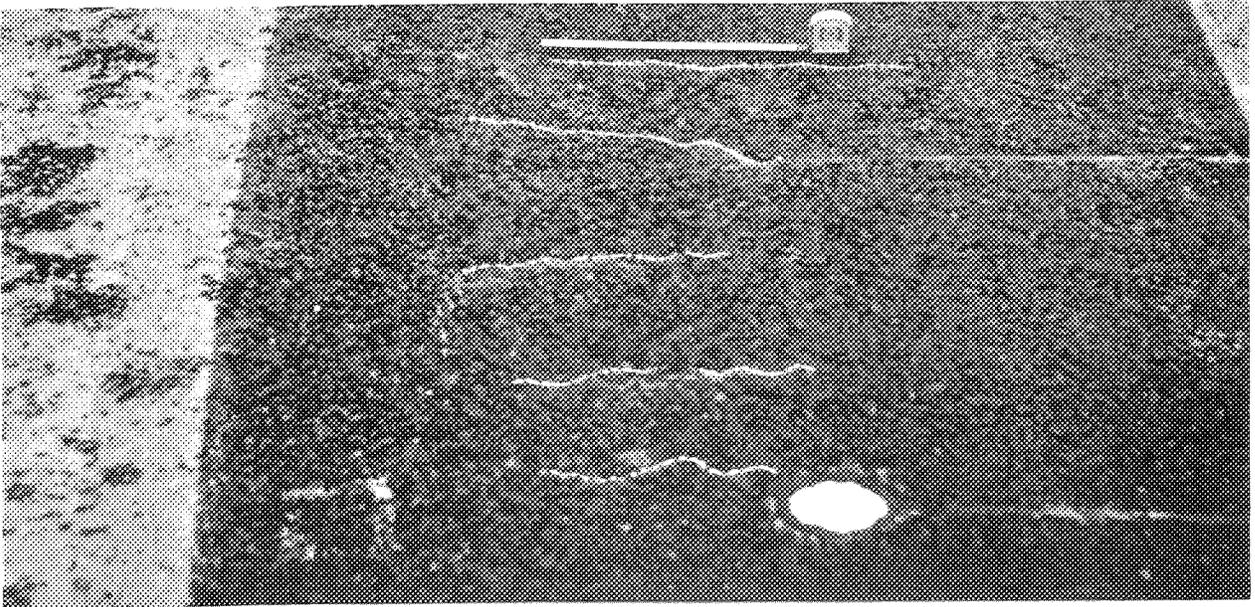
FIGURE 37.--THE APPEARANCE OF THE TRANSVERSE CRACKS AT 100,000 WHEEL LOADS IN 7.0 INCHES OF UNTREATED BASE, SECTION 2. THIS OCCURRED DURING THE FALL PERIOD.

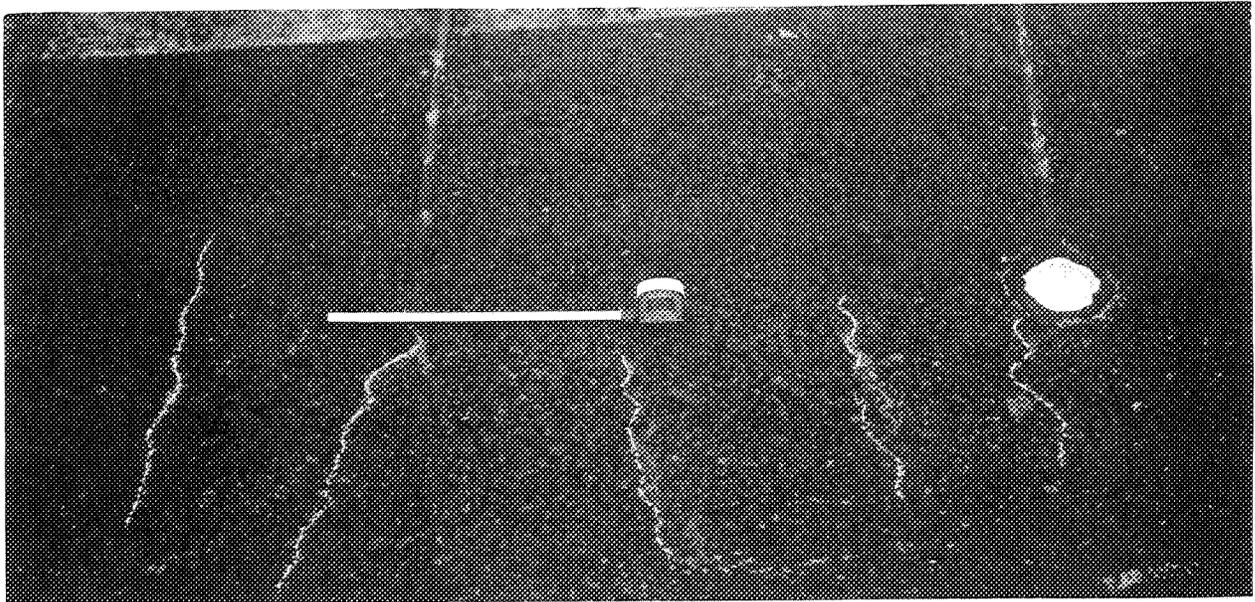
FIGURE 38.--ANOTHER VIEW OF THE TRANSVERSE CRACKING IN SECTION 2. NOTE THE PUMPING OF MUD THROUGH THE CRACKS. THIS IS STAGE 2.

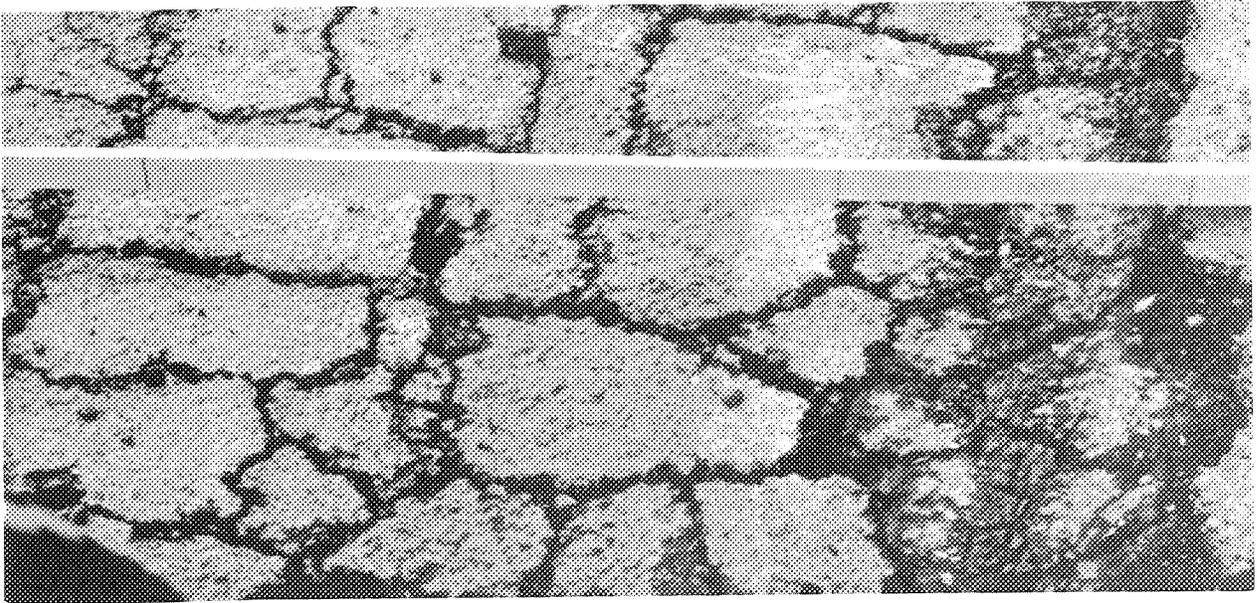
FIGURE 39.--THE APPEARANCE OF SECTION 2 AT ULTIMATE FAILURE JUST BEFORE BEING REMOVED FROM SERVICE AT 206,750 WHEEL LOADS. NOTE THE ALLIGATOR CRACKING PATTERN AND THE LONGITUDINAL CRACKING ALONG THE WHEEL PATH. THIS IS STAGE 7.

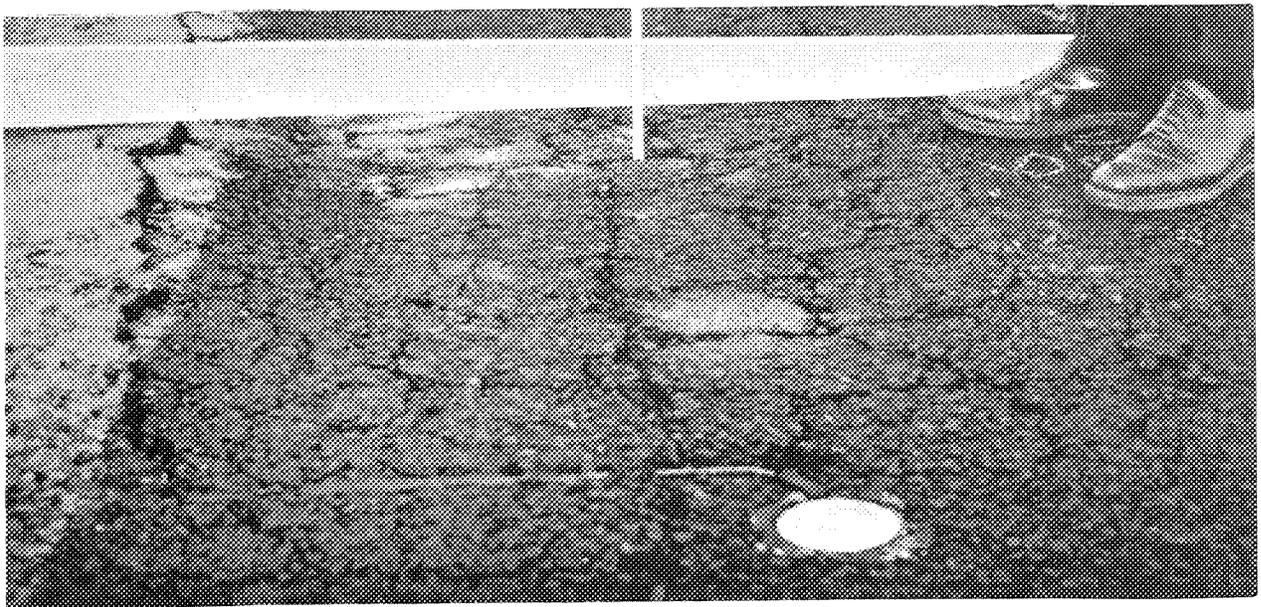
FIGURE 40.--SUBSIDENCE IN THE 5.0 INCHES OF EMULSION-TREATED BASE AFTER 133,700 WHEEL LOADS. NOTE THE ALLIGATOR CRACKING PATTERN AND THE LONGITUDINAL CRACKS IN THE CENTER AND IN WHEEL PATH. THIS IS STAGE 5.

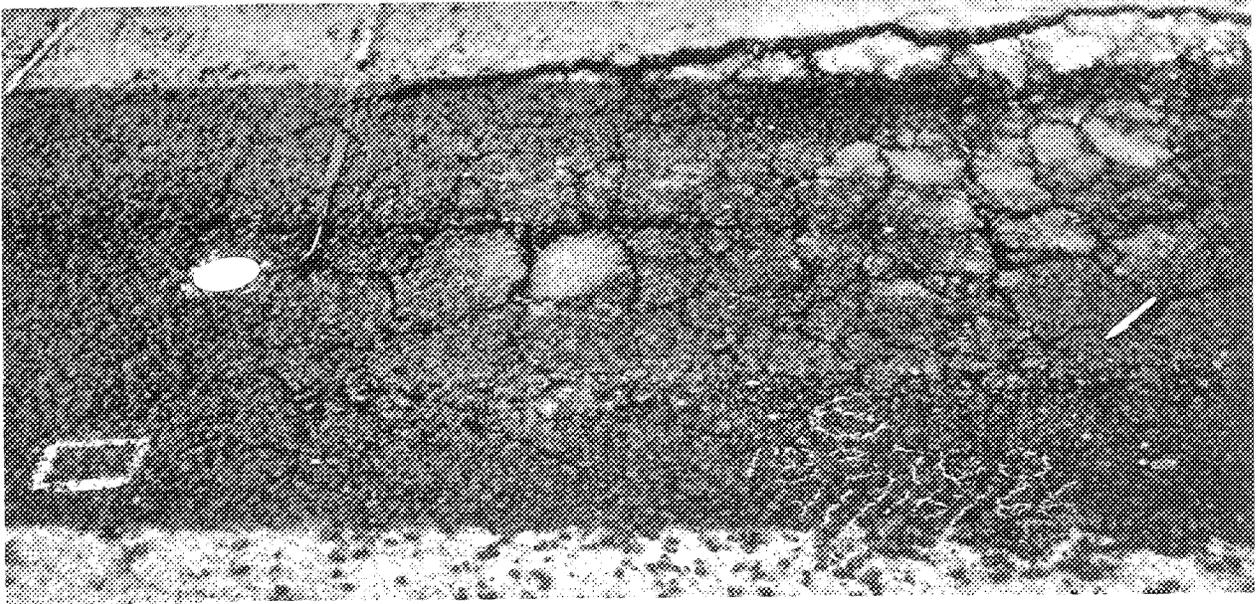
FIGURE 41.--ANOTHER VIEW OF SECTION 6 AT 133,700 WHEEL LOADS.

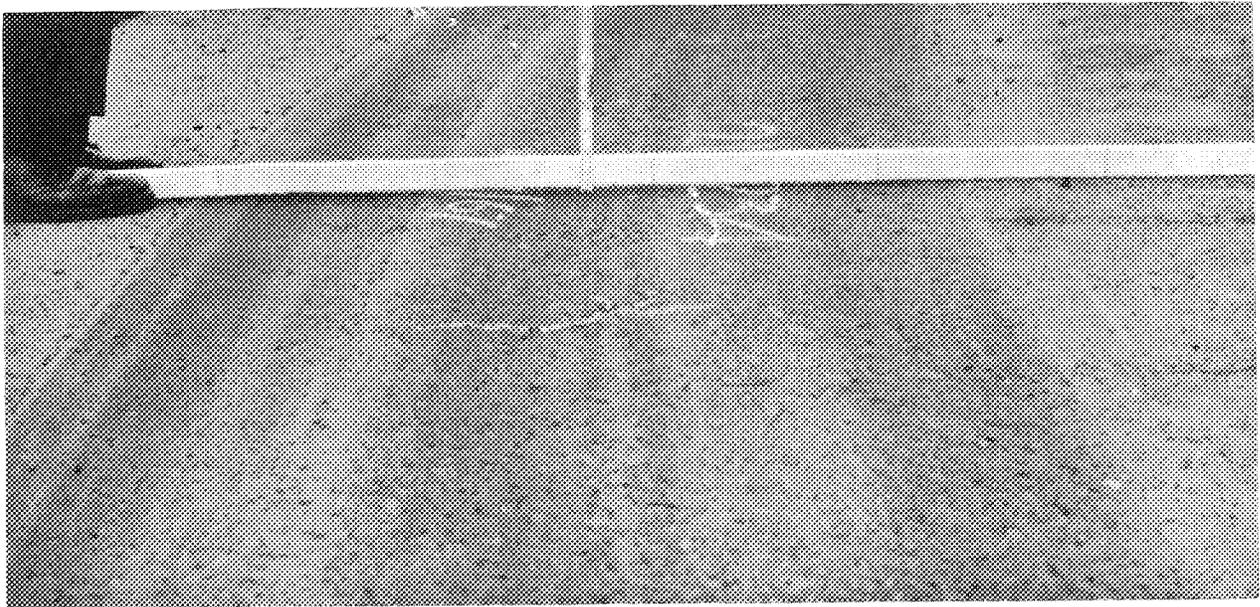
FIGURE 42.--THE DEVELOPMENT OF RUTS AND SOME TRANSVERSE CRACKS IN THE 3.5 INCHES OF SPECIAL ASPHALT-TREATED BASE, SECTION 10 AFTER 210,234 WHEEL LOADS. THIS WAS IN THE SPRING PERIOD.

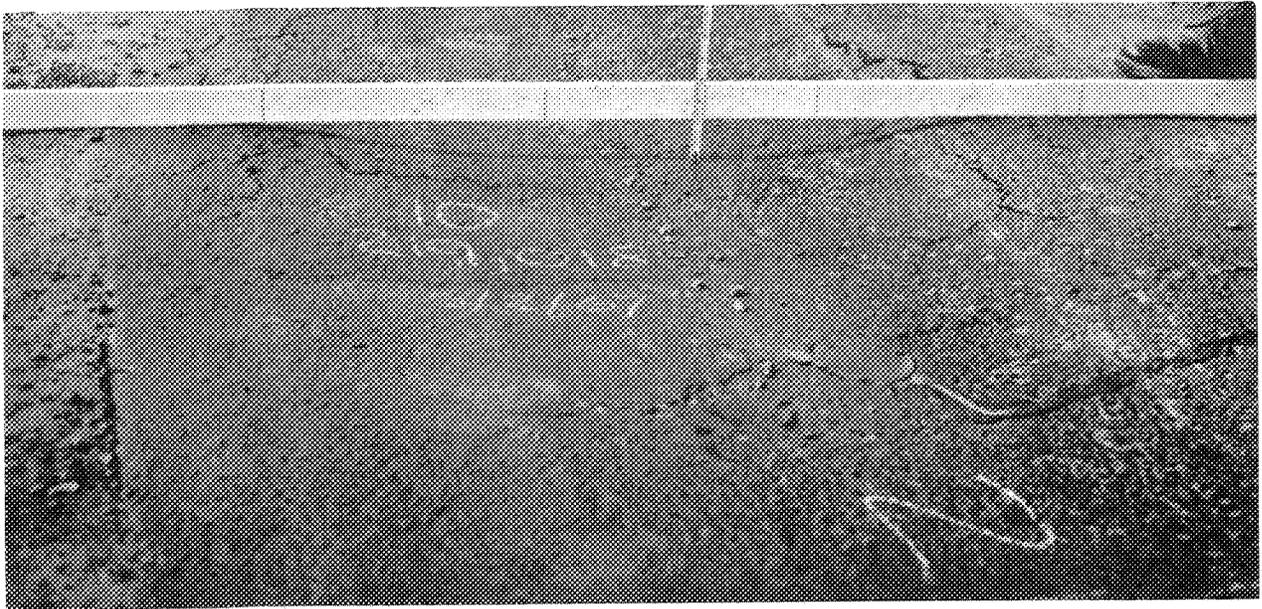
FIGURE 44.--CONTINUED DETERIORATION OF SECTION 10 AT
219,018 WHEEL LOADS. NOTE THE DEFORMATION AND LONGITUD-
INAL CRACKING.

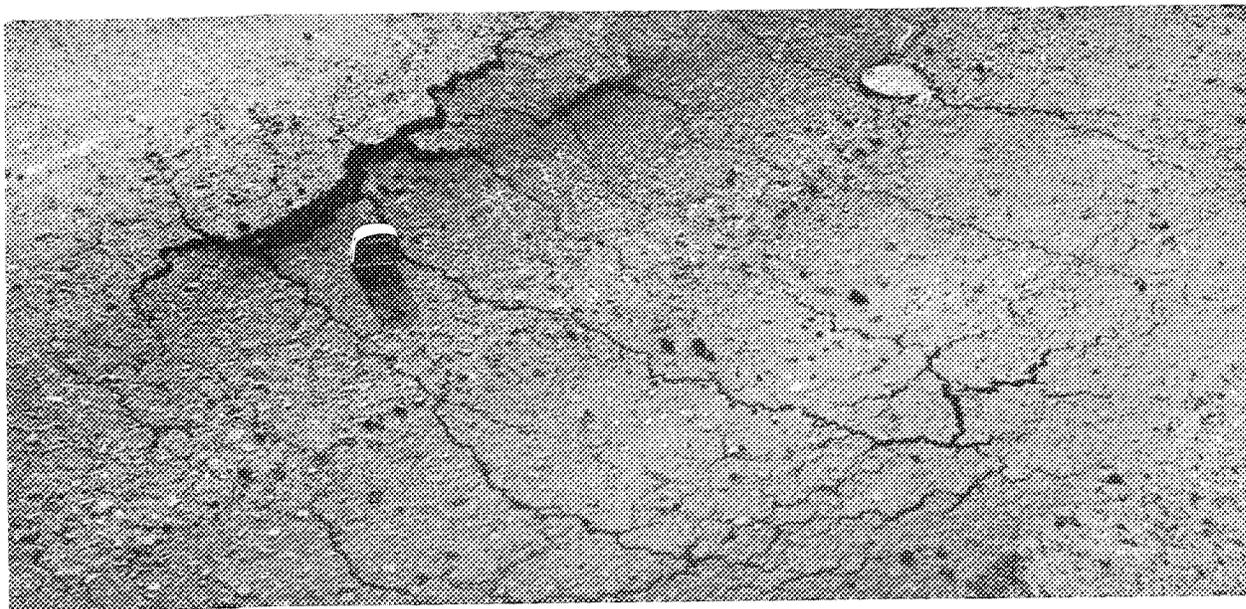
FIGURE 45.--THE APPEARANCE OF SECTION 10 AT ULTIMATE FAILURE AFTER 219,123 WHEEL LOADS.

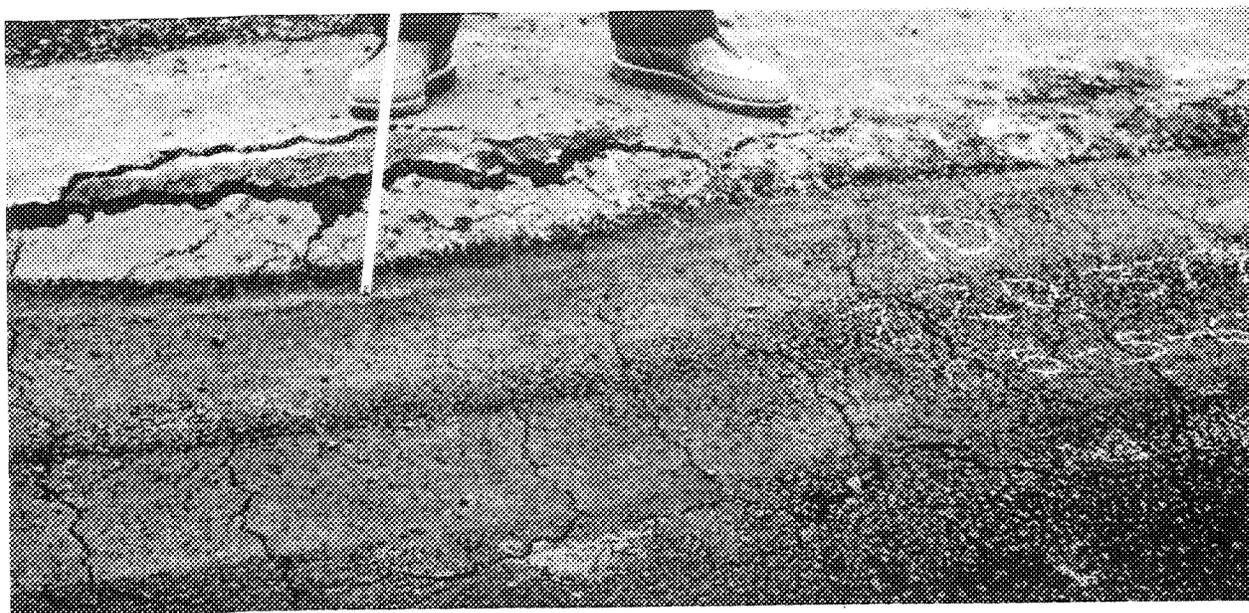
FIGURE 46.--CONTINUED FAILURE AT 220,377 WHEEL LOADS OF SECTION 10 AFTER AN ASPHALT OVERLAY WAS PUT ON.
