PAVEMENT RESEARCH
at the
WASHINGTON STATE UNIVERSITY
TEST TRACK

EXPERIMENTAL RING NO. 2: A STUDY OF UNTREATED,
EMULSION TREATED, AND ASPHALTIC-CEMENT TREATED BASES

Report to the Washington State Department of Highways
on Research Project Y-651

Milan Krukar and John C. Cook

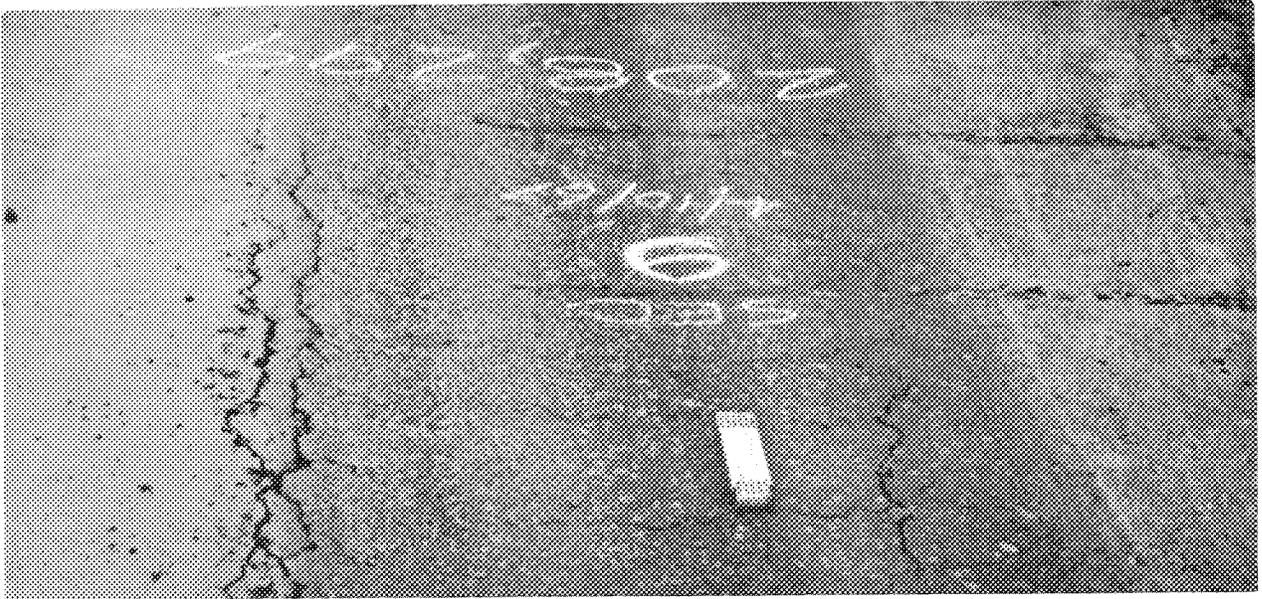
FIGURE 47.--OVERALL APPEARANCE OF SECTION 9 (2.0 INCHES OF SPECIAL AGGREGATE ASPHALT-TREATED BASE) AFTER 208,299 WHEEL LOADS.

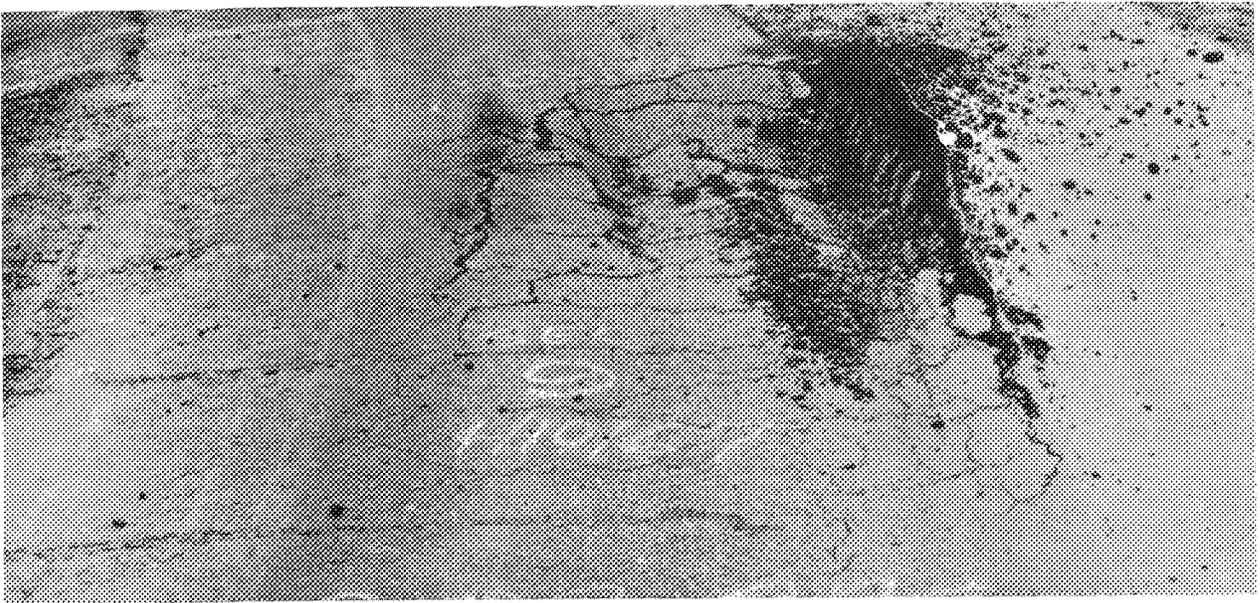
FIGURE 48.--SPECTACULAR FAILURE OF SECTION 9 AFTER 208,876 WHEEL LOADS. NOTE THE UPLIFT OF THE OUTSIDE UNTRAVELLED PART OF THE SECTION.

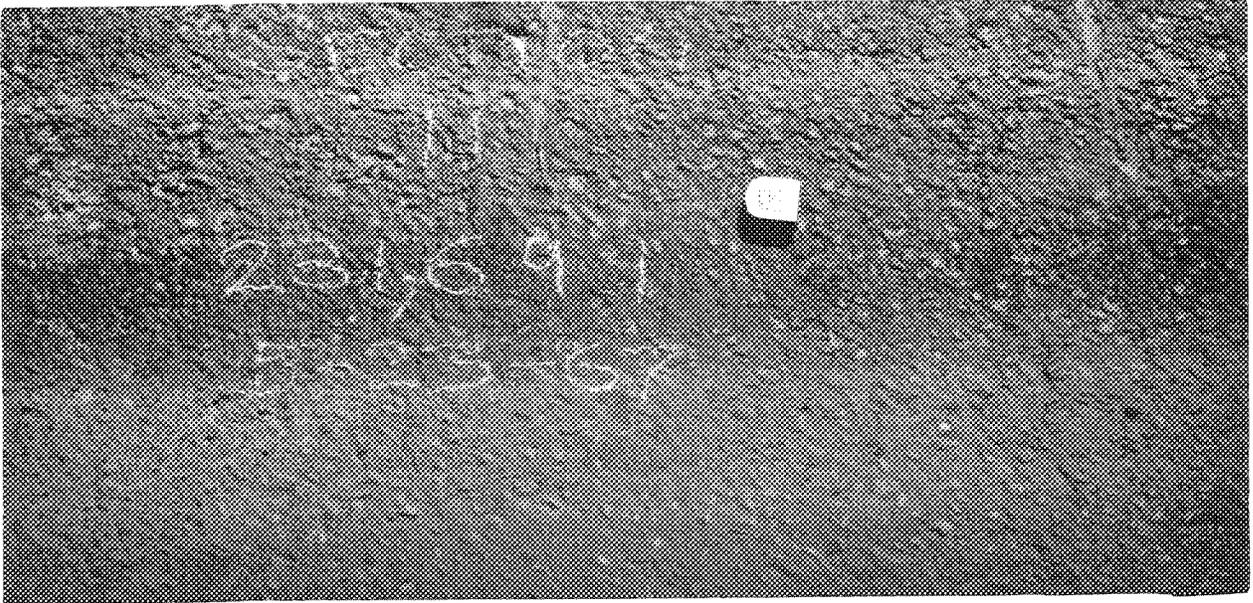
FIGURE 49.--THE START OF TRANSVERSE CRACKS IN SECTION 11
(5.0 INCHES OF A.T.B.) AT 231,691 WHEEL LOADS.

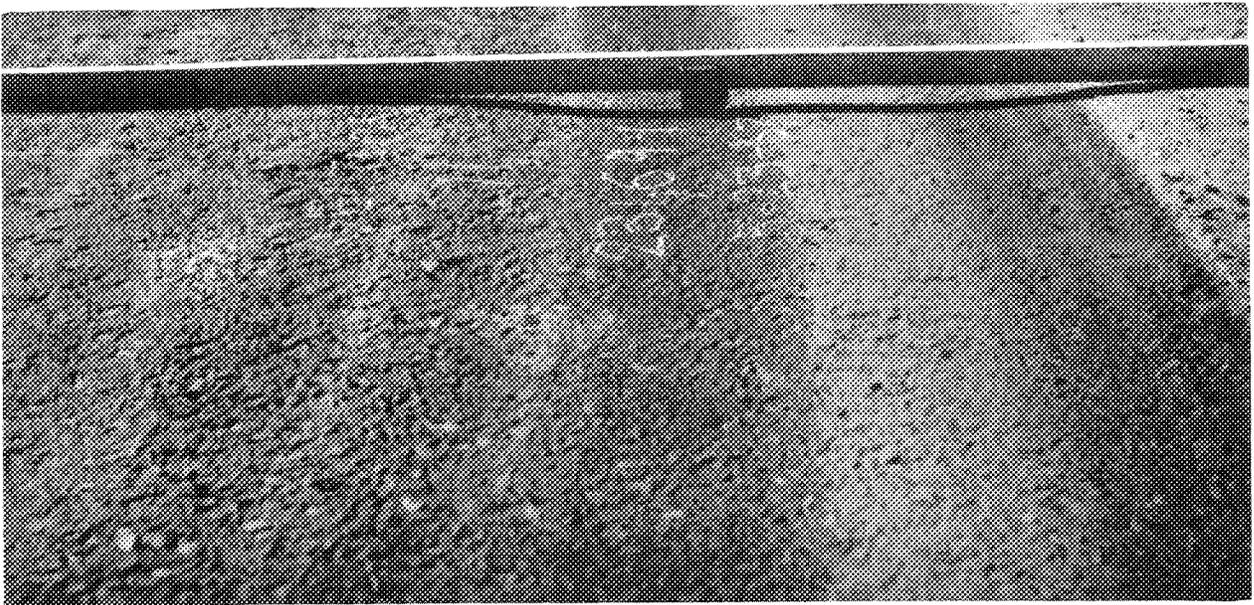
FIGURE 50.--THE PERMANENT DEFORMATION IN SECTION 11
AFTER 231,691 WHEEL LOADS.

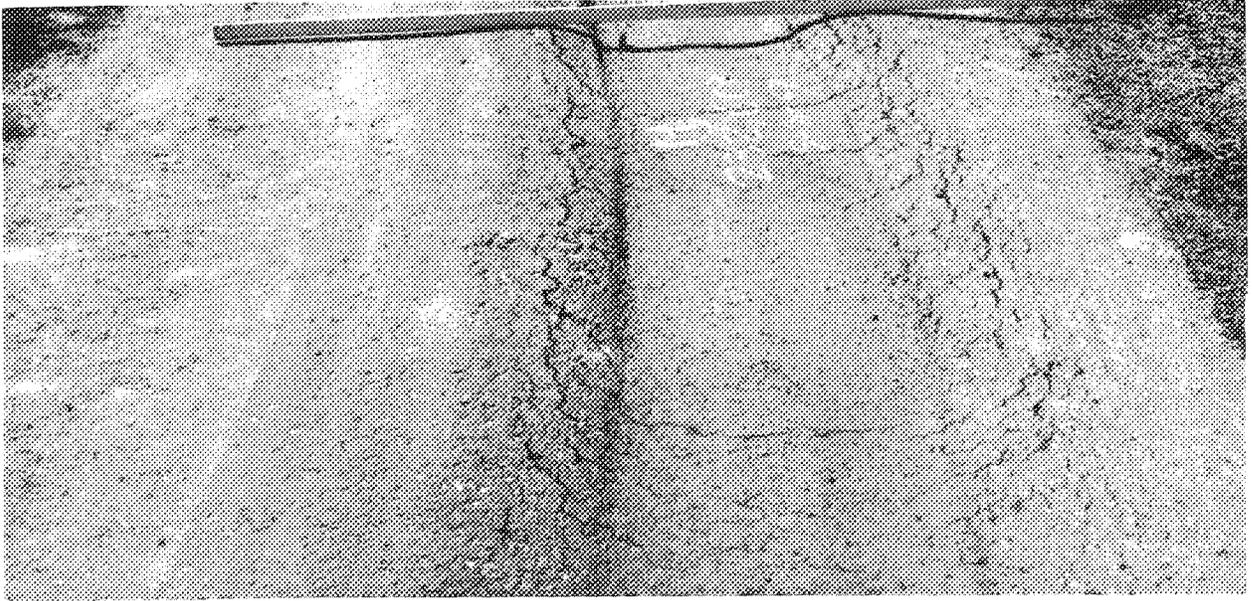
FIGURE 51.--ULTIMATE FAILURE OF SECTION 11 AFTER 232,608 WHEEL LOADS. NOTE THE LONGITUDINAL SHEAR FAILURES AND DEPTH OF DEFORMATION.

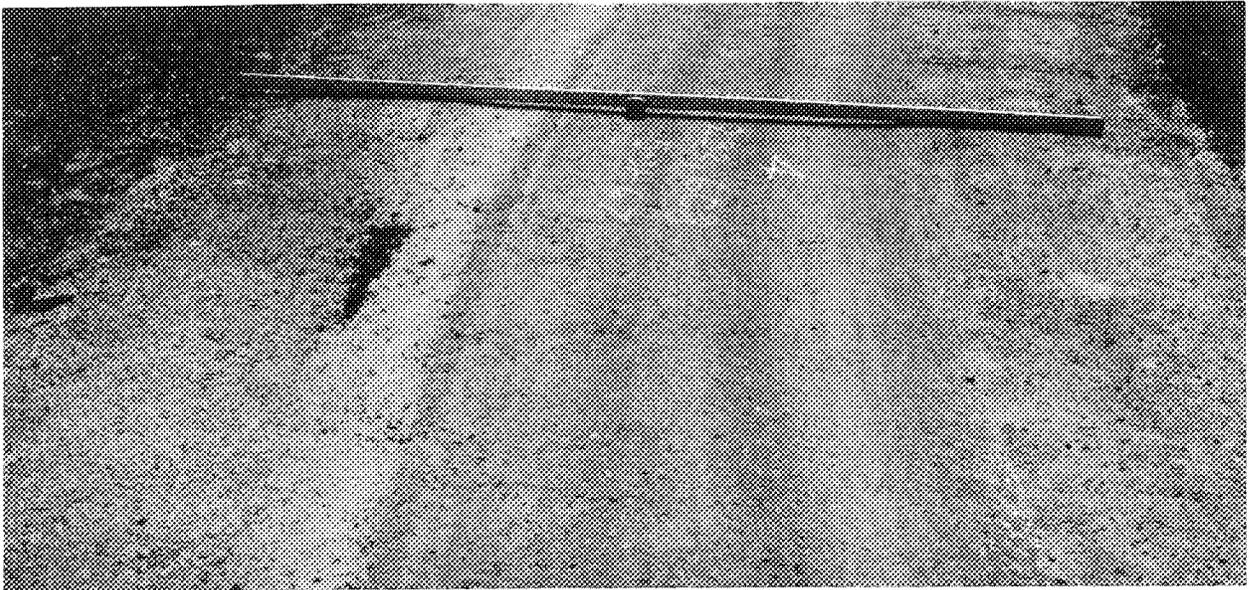
FIGURE 52.--APPEARANCE OF SECTION 4 (12 INCHES OF UNTREATED BASE) AFTER 232,608 WHEEL LOADS.

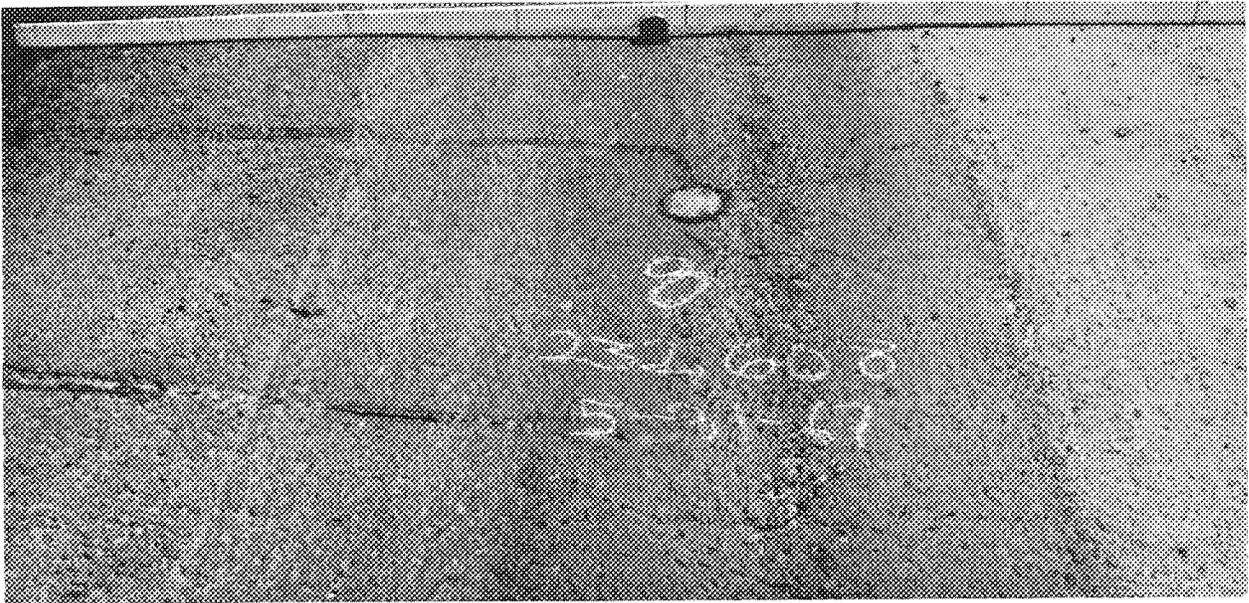
FIGURE 53b--A VIEW OF SECTION 8 SHOWING THE PERMANENT DEFORMATION AND CRACKING AT COMPLETION OF TESTING AT 232,608 WHEEL LOADS.

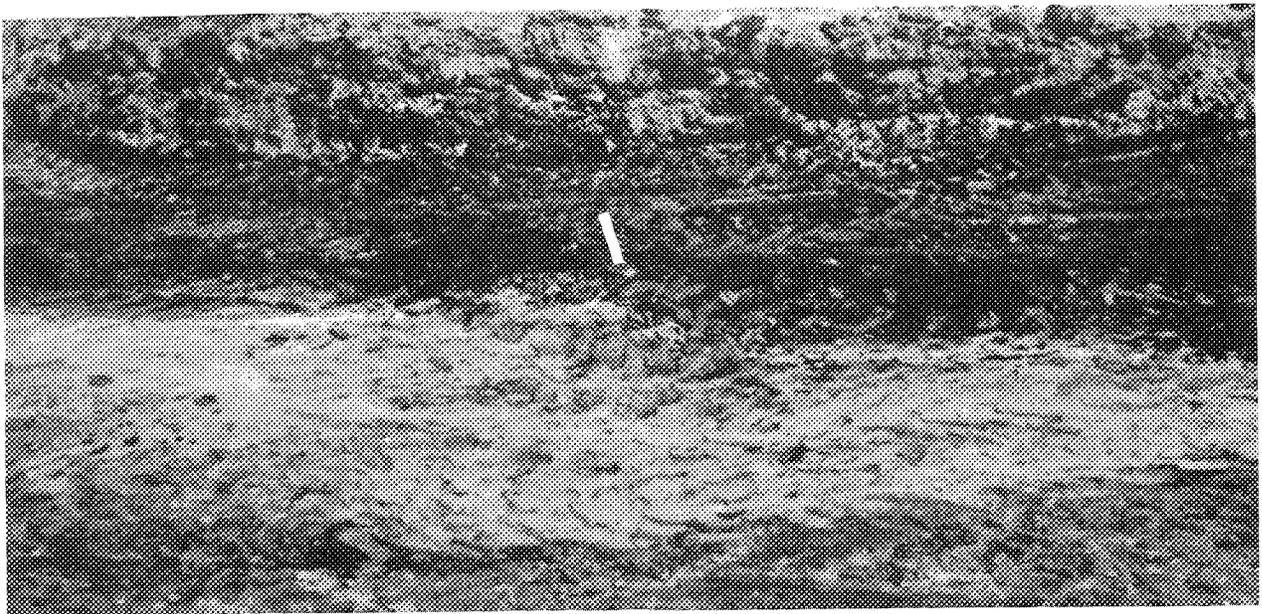
FIGURE 65.--THE APPEARANCE OF SUBGRADE IN SECTION 10
AND 11 AFTER THE EXISTING TEST SECTION HAD BEEN REMOVED.
NOTE THE DIFFERENT COLORING INDICATING VARIATIONS IN
MOISTURE CONTENTS.

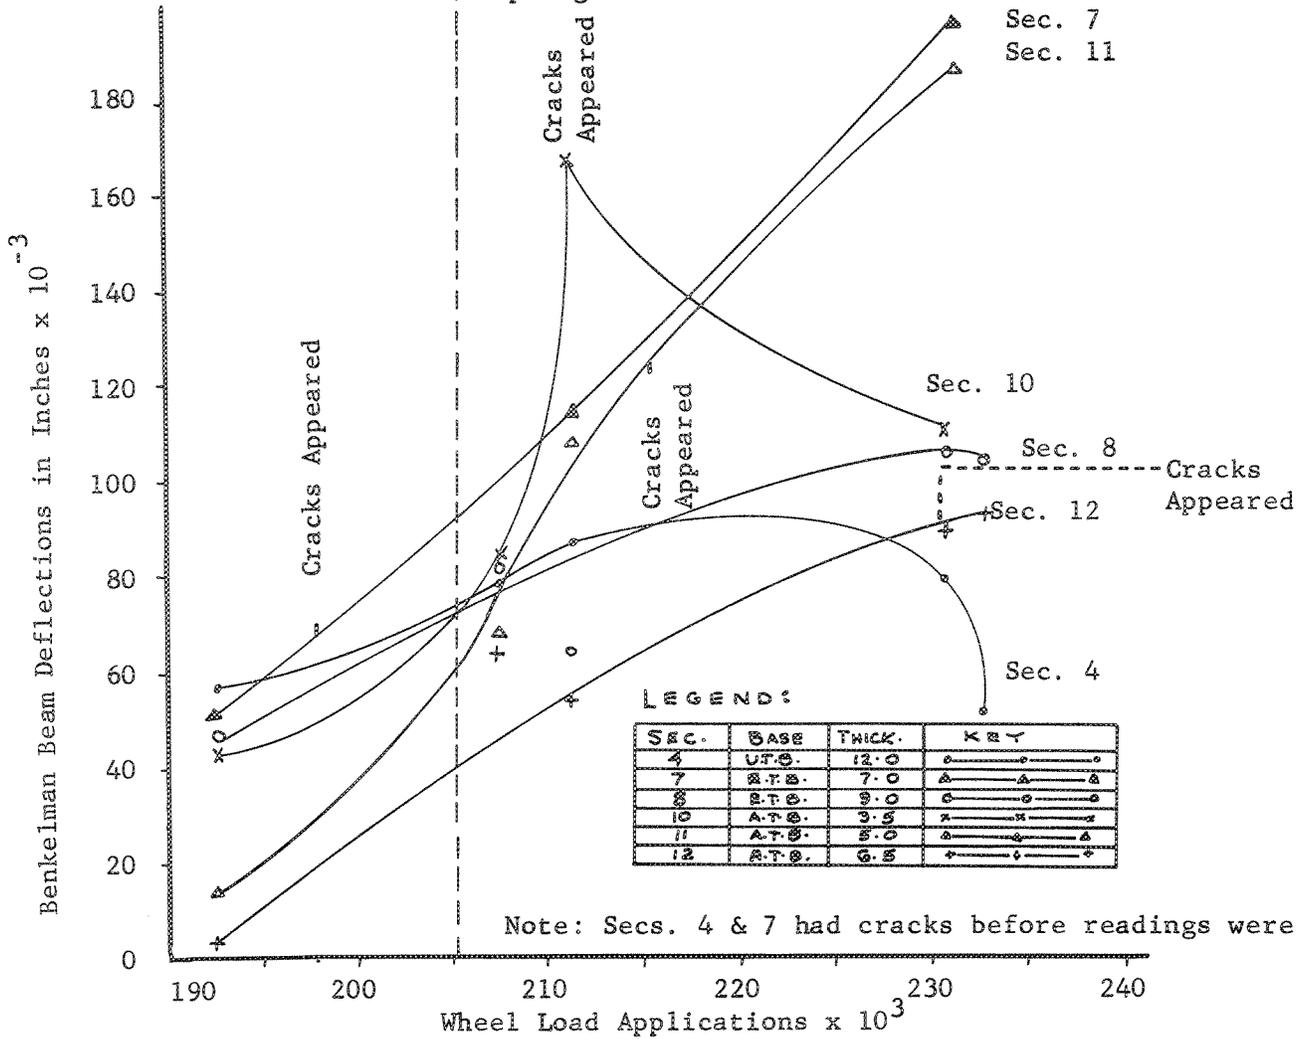
FIGURE 66.--DEFLECTIONS VS WHEEL LOADS
Fall 1966 Spring 1967

valid for cracked pavements as for uncracked pavements. This may be due to the fact that the subgrade has deformed to such an extent that further deformation is almost nil. Drying out of the subgrade through the cracks with a resulting in density possibly may have occurred. Thus overall deflections may have decreased, and the cracked portions of the pavement may start acting as separate entities rather than a unified slab. Sections 4, 10 and 12 in Figures 66 and 67 seem to show this effect.

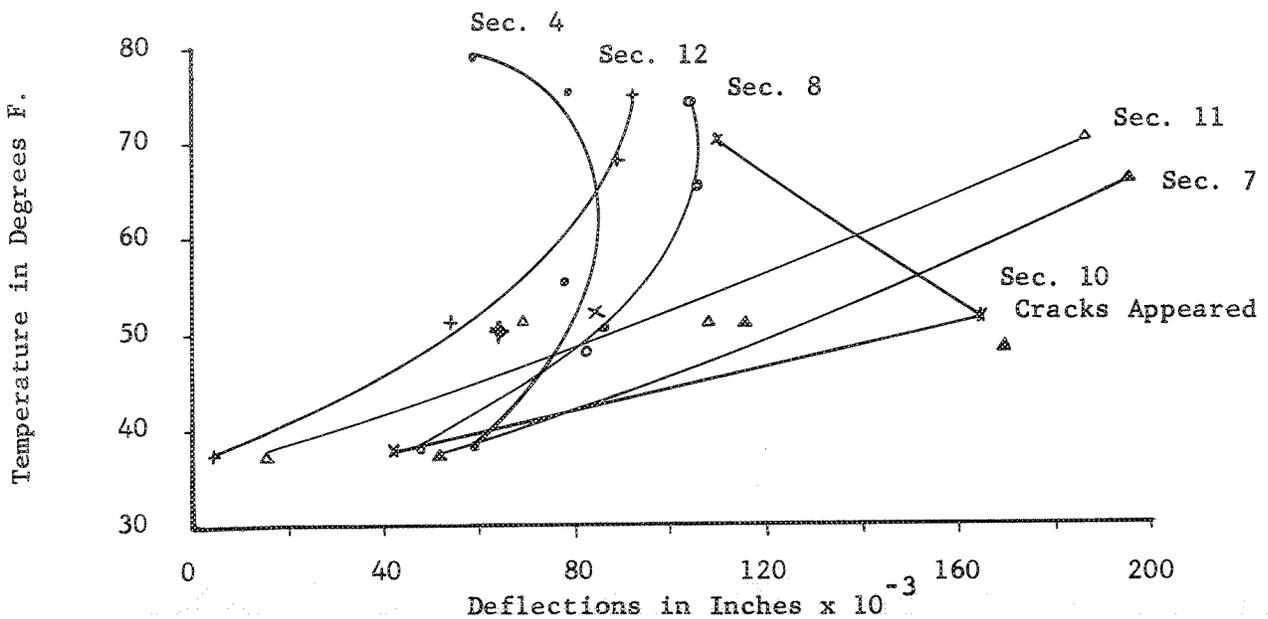
FIGURE 67.--TEMPERATURE VS DEFLECTIONS (BENKELMAN BEAM)

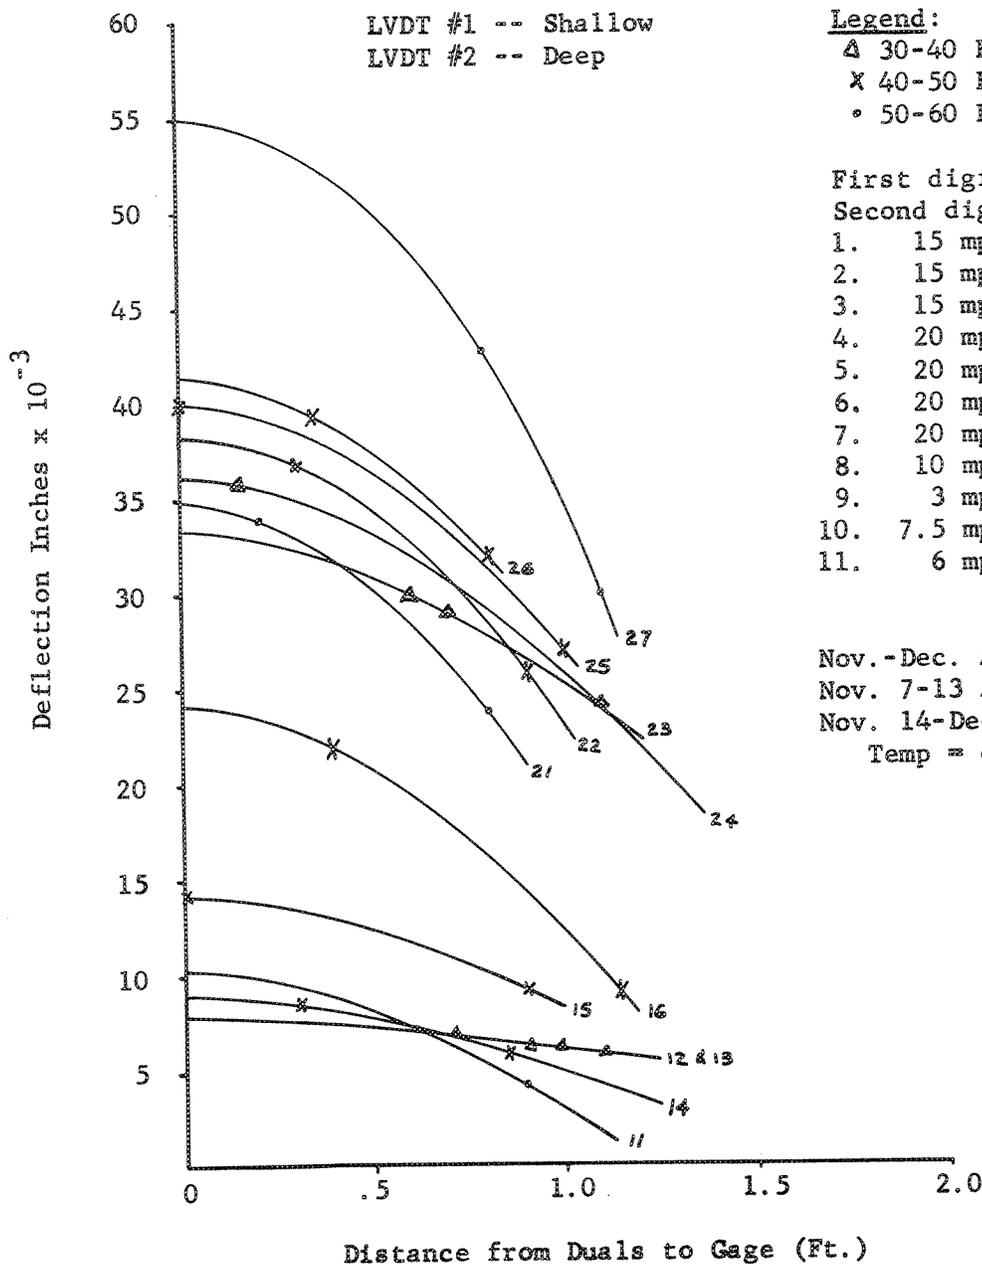
FIGURE 68.--DYNAMIC DEFLECTIONS AGAINST
TRANSVERSE DISTANCE FOR LVDT #1 & 2 IN
SECTION 2 (7.0" of Untreated Crushed Stone)

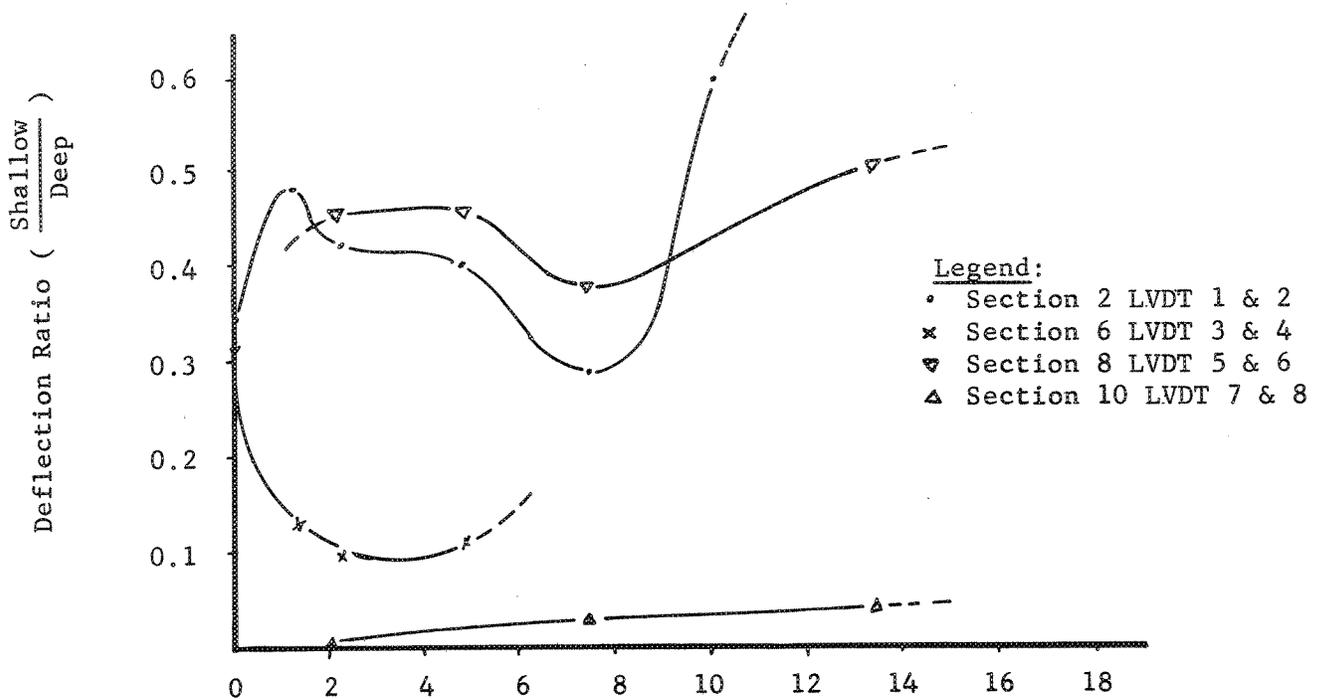
FIGURE 75.--DYNAMIC DEFLECTION RATIO ($\frac{\text{Shallow}}{\text{Deep}}$)
RING 2

The increase in the ratios shows that the increase in shallow deflections is greater than for the deep deflections; that is, the proportion of deflection occurring within the pavement structure increases.

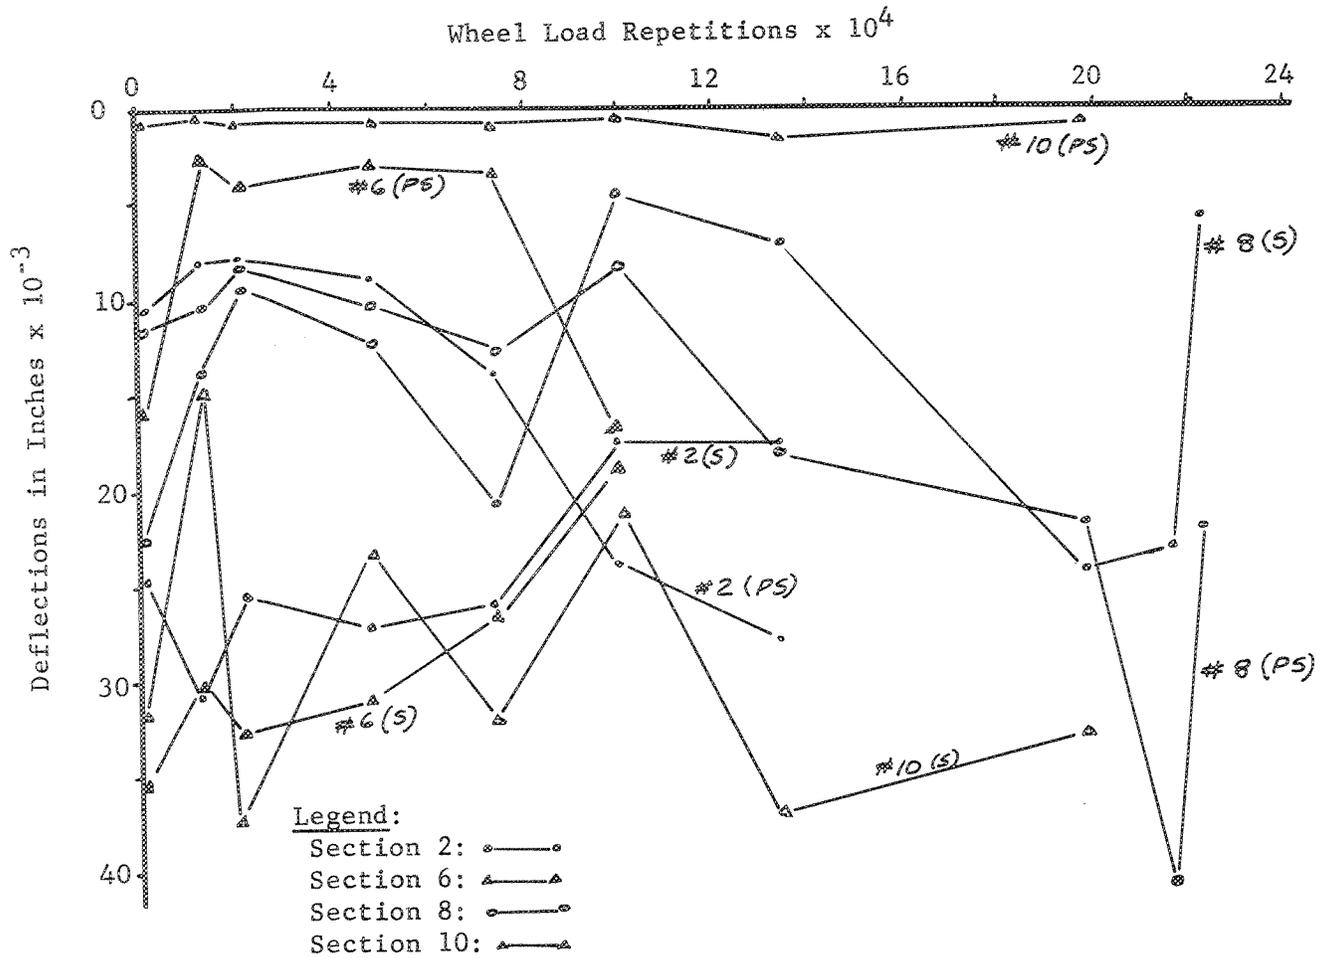
FIGURE 75(A).--DEFLECTIONS - PAVEMENT SYSTEM (PS)
VERSUS SUBGRADE (S)

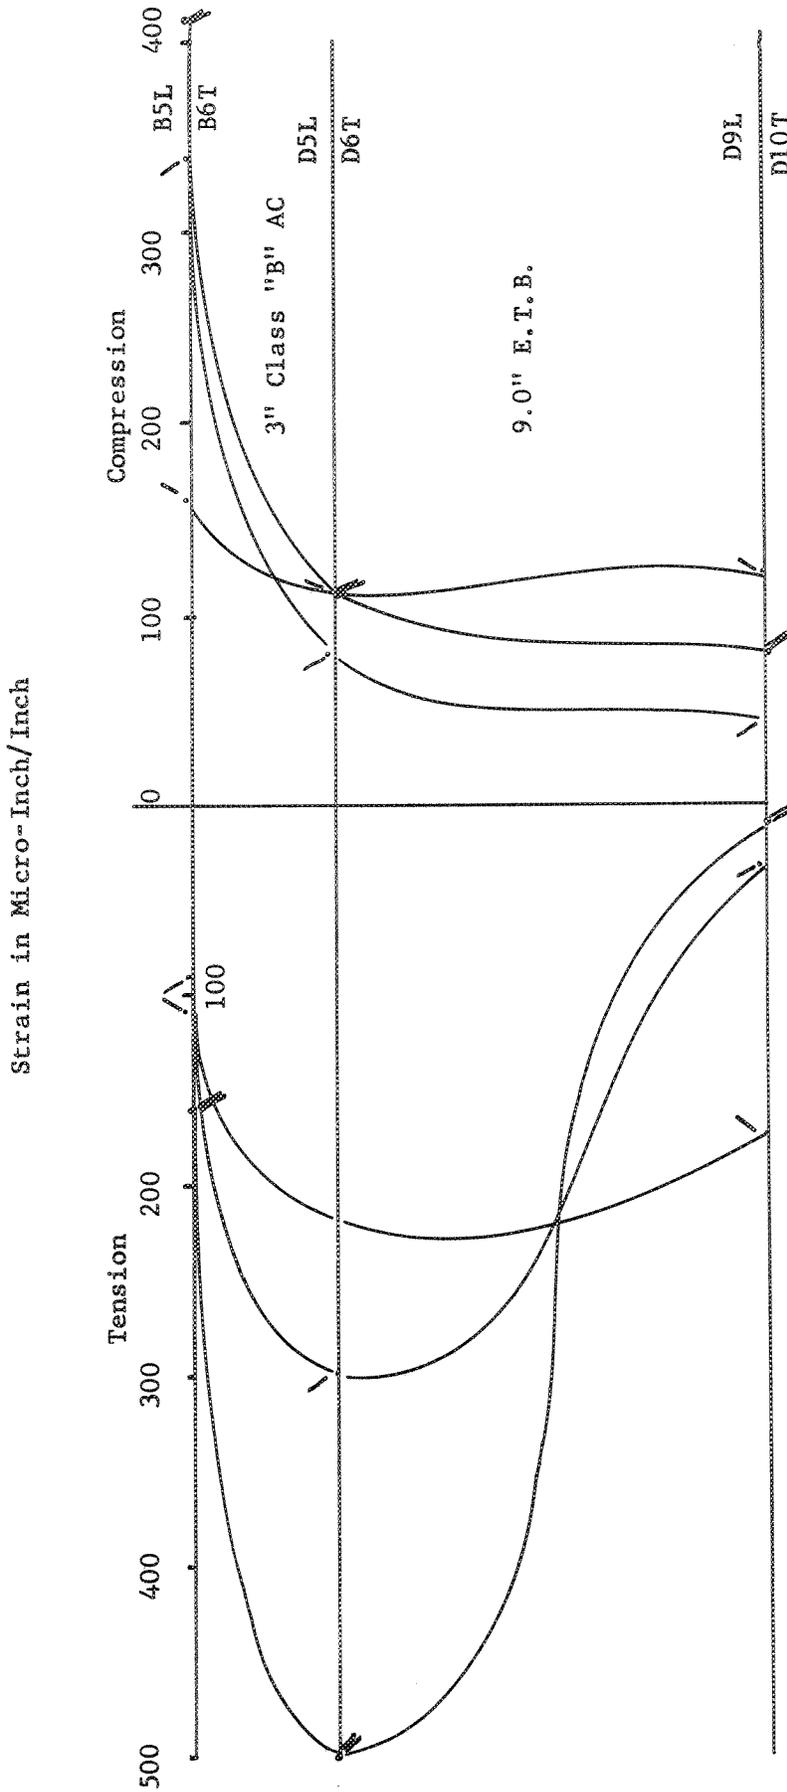
FIGURE 95. --MAXIMUM STRAIN VS DEPTH--SECTION 8 9" EMULSION-TREATED BASE
