Internally Sealed Concrete Using Wax Beads

Final Report
WA-RD 132.1

October 1987

Washington State Department of Transportation
Planning, Research and Public Transportation Division

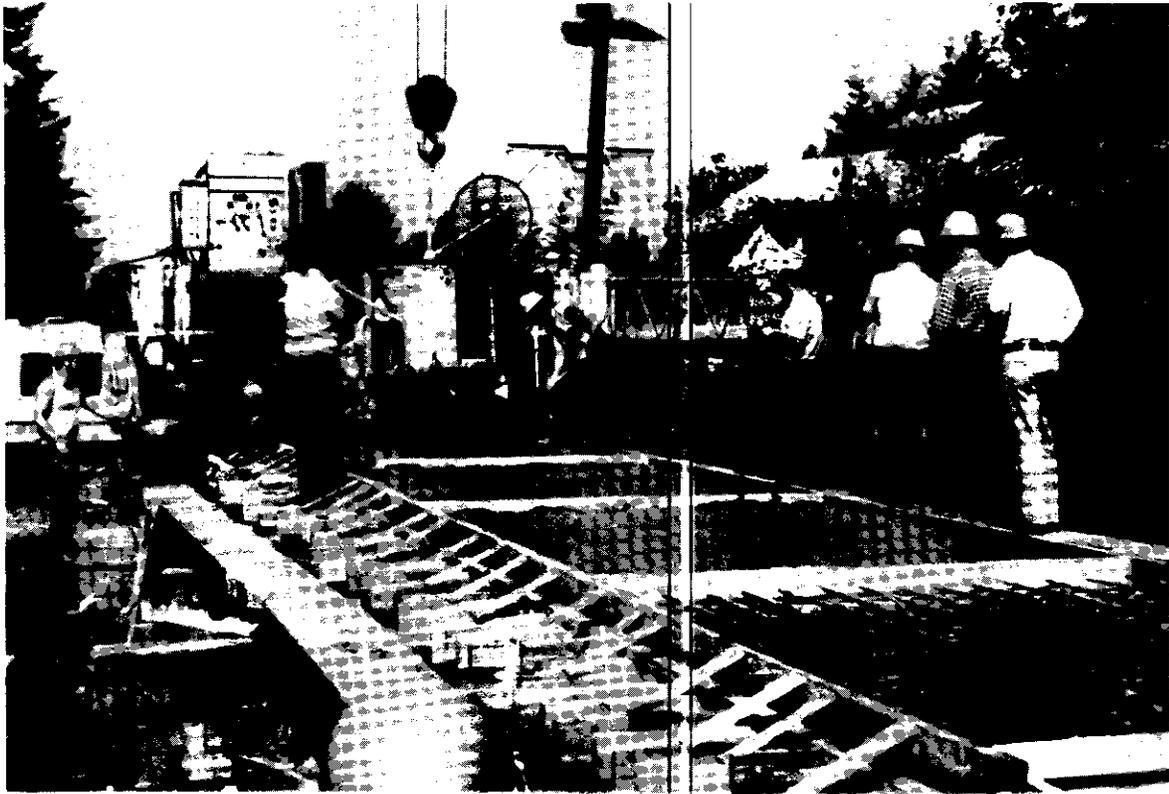
Concrete Placement at Test Site

The bridge deck concrete was placed on November 11, 1975. The contractor used two concrete pump trucks. One truck pumped the Class AX concrete and the other truck pumped the wax bead concrete. The wax bead concrete pour started approximately 30 feet (9.1 m) behind the Class AX concrete pour. The distance between pours was reduced to 15 feet (4.5 m) with no noticeable displacement of the Class AX concrete during the placement of the wax bead concrete.
