Bridge No. 513/32

**SR 5 Overcrossing
NE 145th Street**

High Early Strength Latex
Modified Concrete Overlay

Post Construction and Annual Reports
January 1992

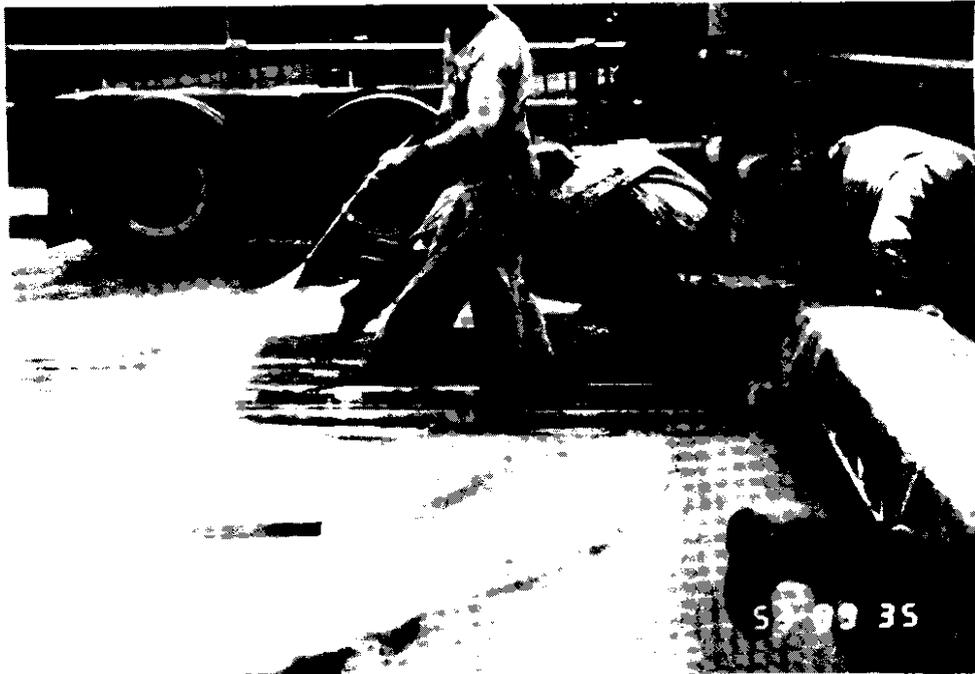
Keeping Burlap Moist with Fog Sprayed Water

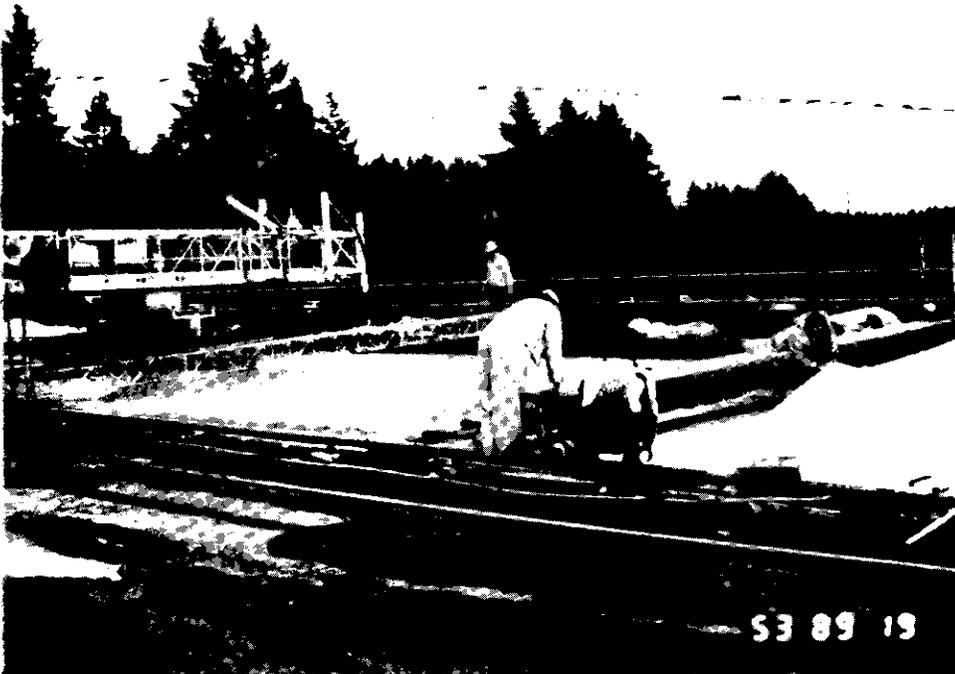
Roadway Covered with Plastic for Curing
