# **Performance of a 41-Foot High Geotextile Wall**

WA-RD 257.1

Final Report  
March 1992

**Washington State Department of Transportation**  
Planning, Research and Public Transportation Division

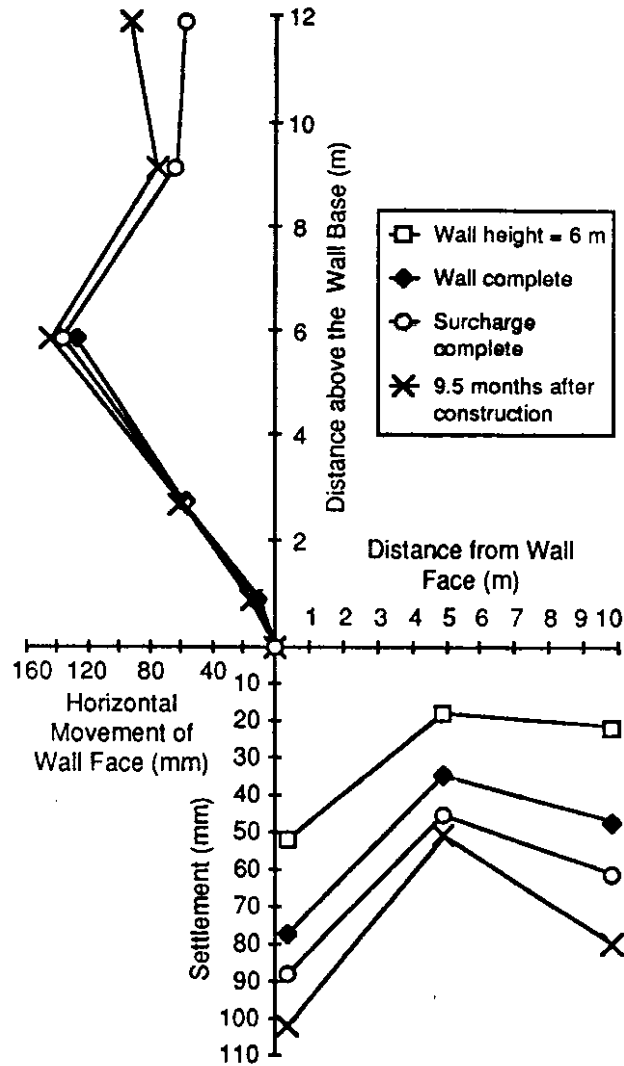
Figure 12. Settlement of the wall based on liquid settlement devices and lateral movement of the wall face as determined by optical surveys.

casing, which is a fixed reference. The optical survey readings shown in Figure 12 are incremental, in that the measured deflections are relative to the initial survey readings taken for each specific optical target. This is the basic reason for the different shapes of the curves in Figures 12 and 13. Such incremental deflections can be compared with measured geotextile strains, while total deflections from inclinometer measurements can be used to estimate overall wall movements.

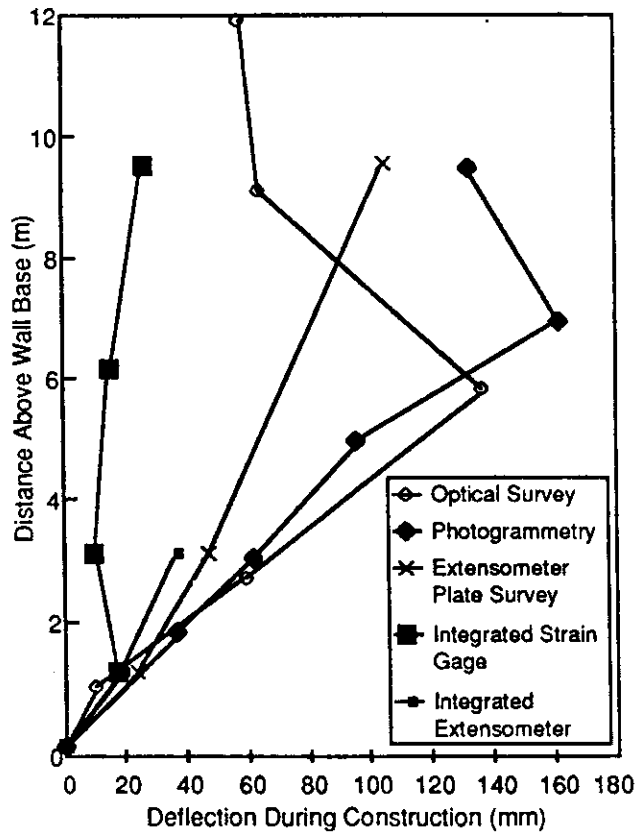
Figure 14. Wall face deflection during construction as determined from various methods.

Wall face deflections as measured by optical survey and photogrammetric methods were on the order of 140 to 160 mm (5.5 to 6.3 in.) during construction, and this maximum occurred near the mid-height of the wall as shown in Figure 14. It is interesting to note that the region of maximum horizontal movement, i.e., at one third to one half the height of the wall, corresponds quite well to the region of maximum horizontal strain observed by others (Christopher, et.al., 1989). The magnitude of the horizontal wall face displacement was estimated using an empirical relationship suggested by Christopher, et. al. (1989), which was developed from finite element analyses, small scale model tests, and very limited field evidence on walls up to 6 m high. Without a surcharge, this relationship predicts horizontal face

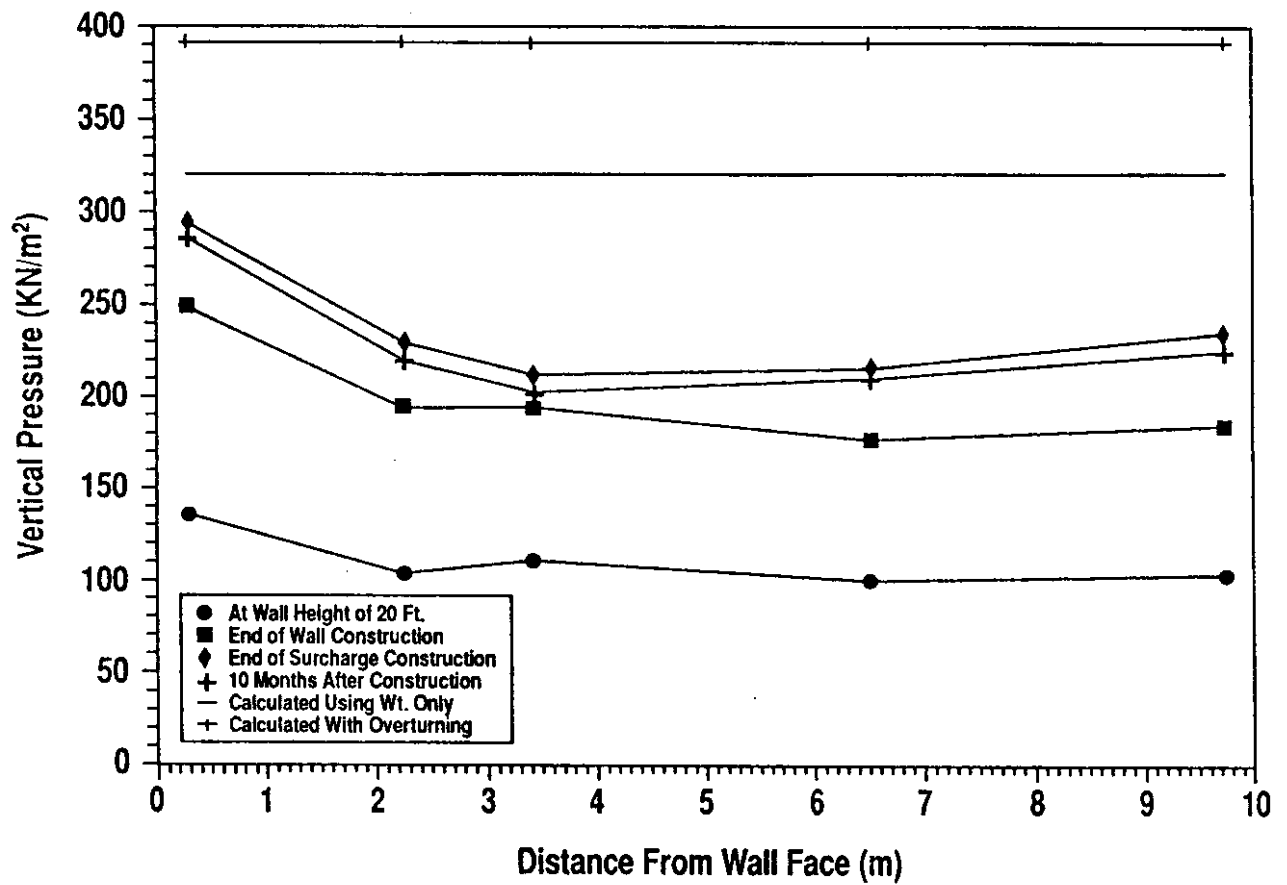
Figure 16. Vertical pressure beneath the wall.

Vertical stresses beneath the wall were measured using Glötzl stress cells. The measured stresses are summarized in

Figure 16, which shows that toe stresses were approximately 20 % higher than in the middle or back of the wall. This corresponds well to the settlement profile at the base of the wall as shown in Figure 12. Such a profile is typical of flexible footings on granular soils (Perloff and Baron, 1976). Higher toe stresses could result from the tendency of the reinforced section to rotate outward about its toe. Vertical stresses were lower than the stresses predicted by overall wall weight and overturning calculations, and this point is still under investigation. Furthermore, vertical stresses remained constant after the surcharge was complete, providing additional proof that long-term changes in geotextile strain were due to creep and not due to changes in soil pressures.
