1. REPORT NO. <b>WA-RD 482.1</b>	2. GOVERNMENT ACCESSION NO.	3. RECIPIENT'S CATALOG NO.	
4. TITLE AND SUBTITLE <b>Retrofit of Split Bridge Columns</b>	5. REPORT DATE <b>February 11, 2000</b>

Research Project 9902-26  
Split Columns

**RETROFIT OF SPLIT BRIDGE COLUMNS**

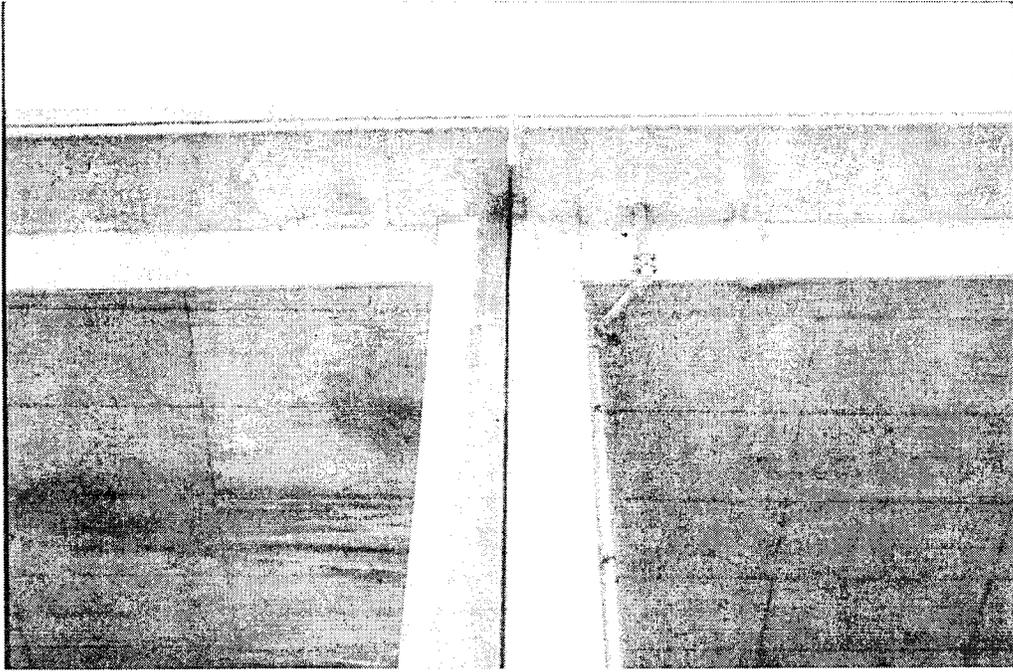
Figure 1 Split Concrete Column from Spokane Street Overcrossing

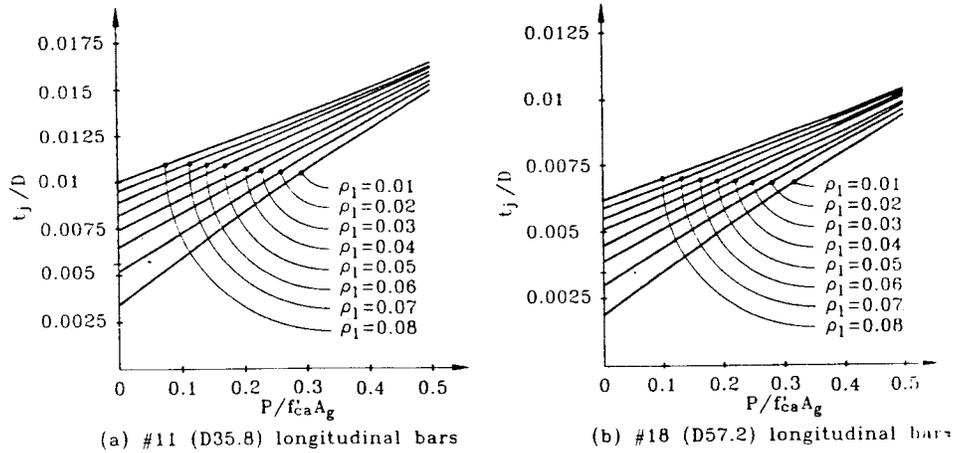
Figure 3 Steel Jacket Thickness For Hinge Confinement In A Circular Column (from Priestley, et al, 1996)

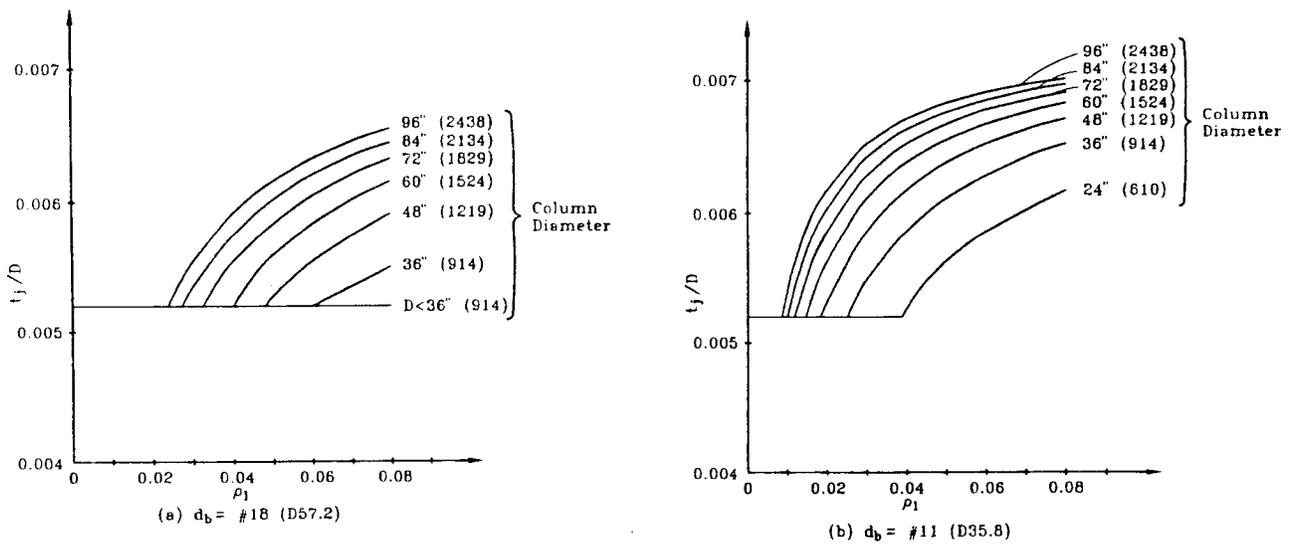
Figure 4 Steel Jacket Thickness For Lap Splice Retrofit In A Circular Column (from Priestley, et al, 1996)

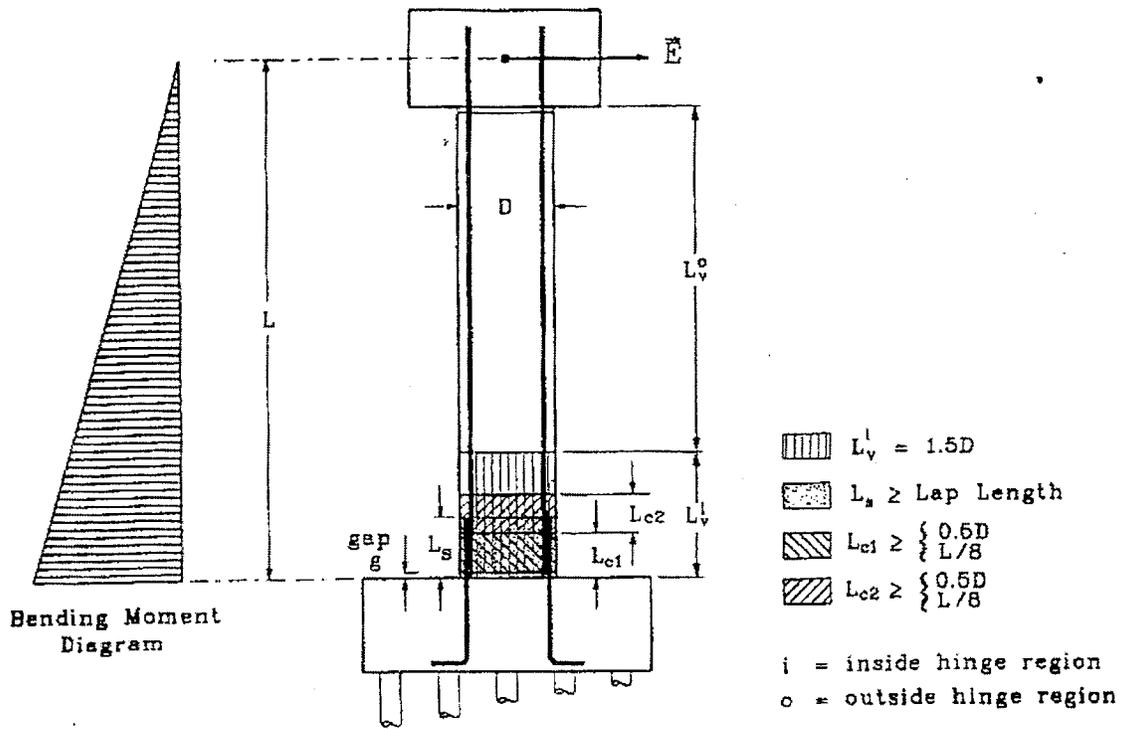
Figure 5 Single Bending Retrofit Regions (Seible, et al, 1995)

For each mode of failure, a required jacket thickness must be determined. Each failure mode affects different regions of the column and each of these regions needs to be evaluated. Figures 5 and 6 define these regions for columns subject to single bending and double bending. In these figures,

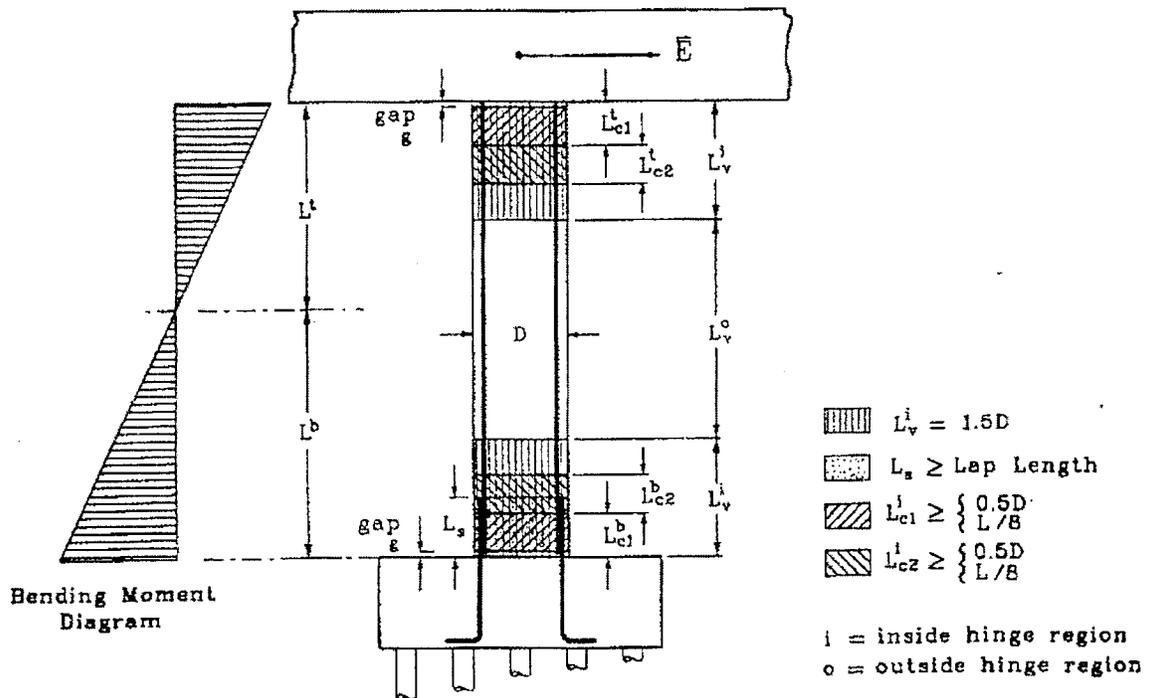
Figure 6 Double Bending Retrofit Regions (Seible, et al, 1995)

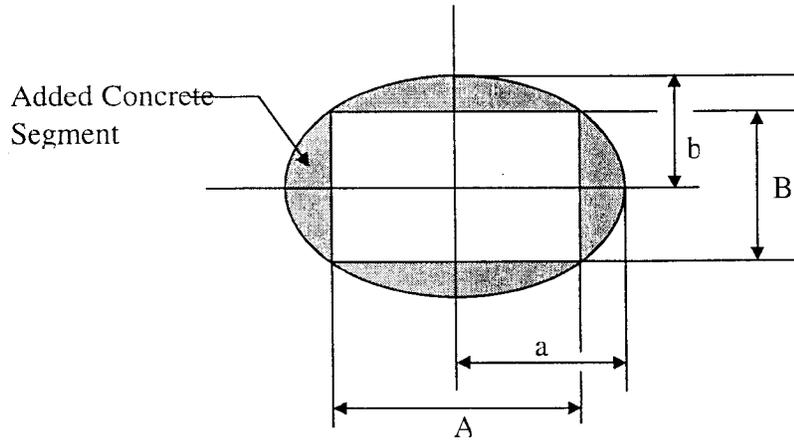
Figure 7 Dimensions Used to Calculate  $D_e$  (Seible, et al, 1995)

$D$  is the diameter of a circular column. The same equation is used for rectangular columns fitted with elliptical jackets, but  $D$  is replaced with the effective column diameter  $D_e$  (Seible, et al, 1995). Figure 7 illustrates the dimensions needed to calculate  $D_e$  using Equations 7 through Equation 10.

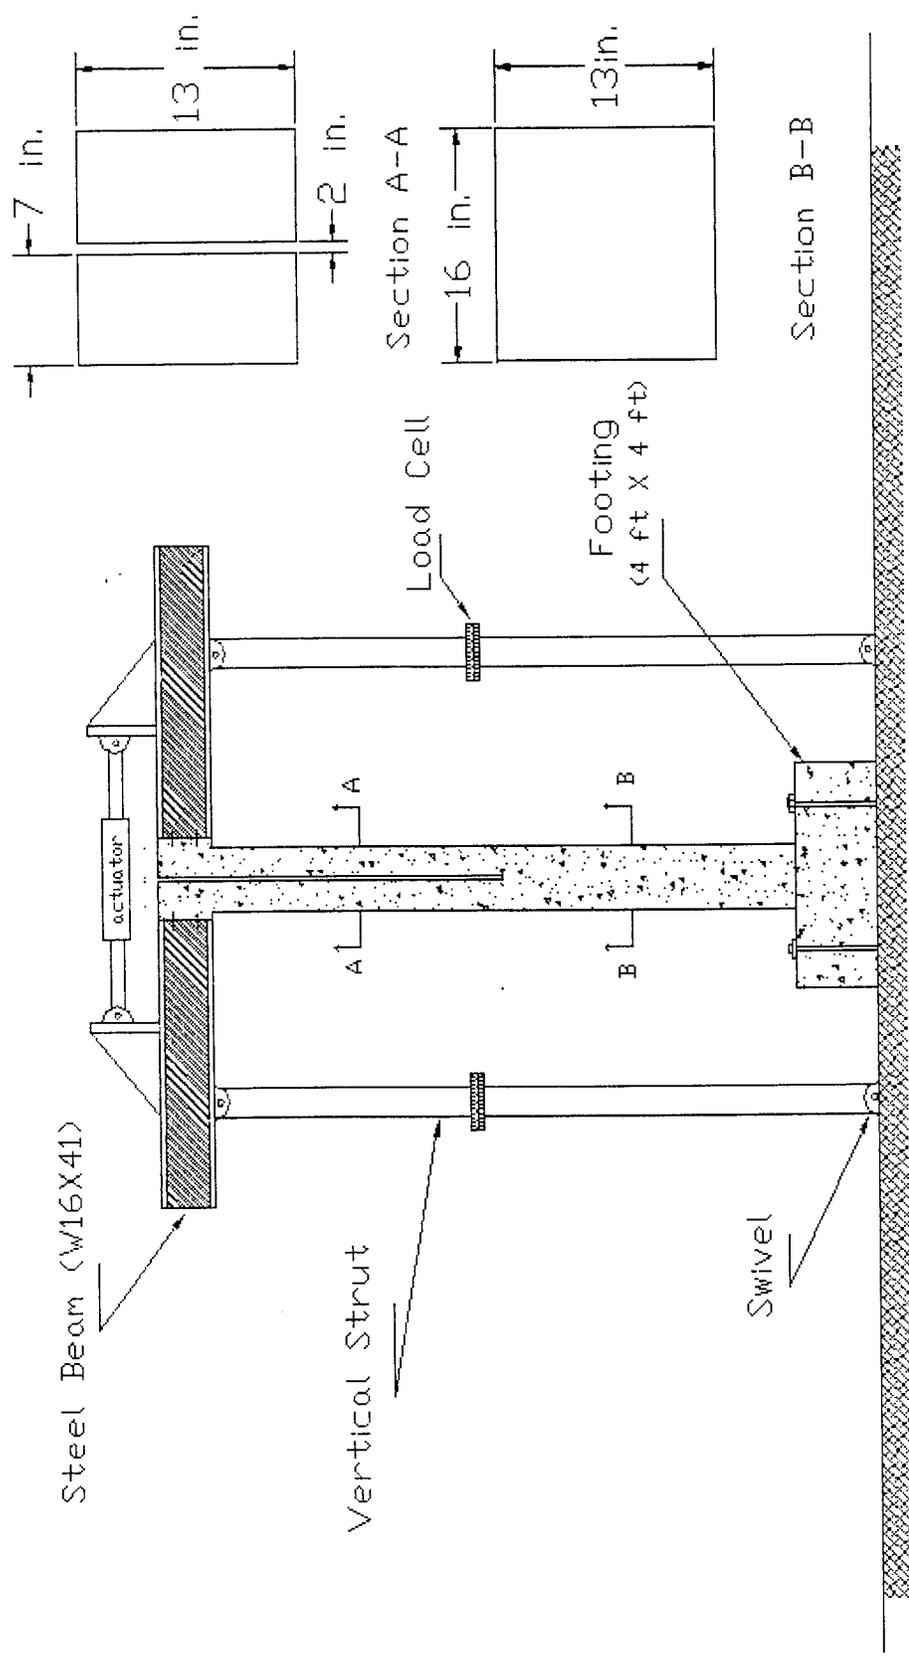
Figure 8 Out-of-Phase Test Setup

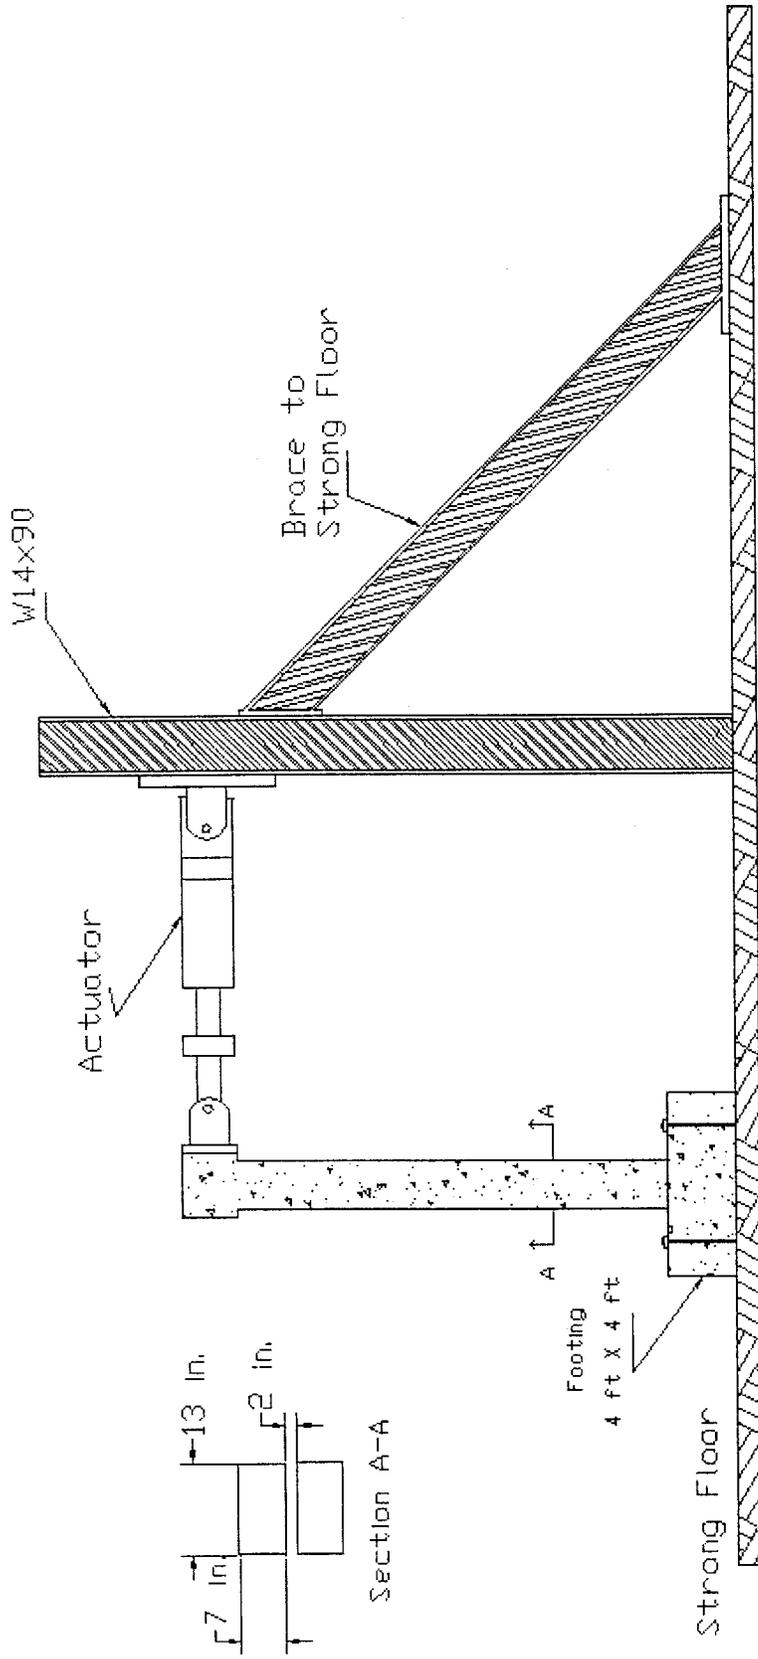
Figure 9 Transverse Test Setup

The transverse test setup shown in Figure 9 was utilized to simulate loading in the transverse direction of the bridge where both of the split sections move in the same direction perpendicular to the bridge's longitudinal axis. The test setup creates a single bending condition in the column. Bending moments vary linearly from zero at the applied load to a maximum at the base of the column. The transverse specimens were subjected to displacement-controlled, reversed-cyclic lateral loading. The loading rate was pseudo-static and controlled manually. At each displacement interval, 3 cycles of loading were completed. Lateral displacements were applied to  $\pm 1.3$ -cm (0.5 in.), then increased by  $\pm 1.3$ -cm (0.5-in.) intervals up to 7.6cm ( $\pm 3$  in.). Displacements were then increased by 2.5-cm (1-in.) intervals until the column failed. Failure was defined as a 20% drop in load capacity from the peak applied load. Load and displacement data were collected at 1-second intervals from the actuator load cell and LVDT.

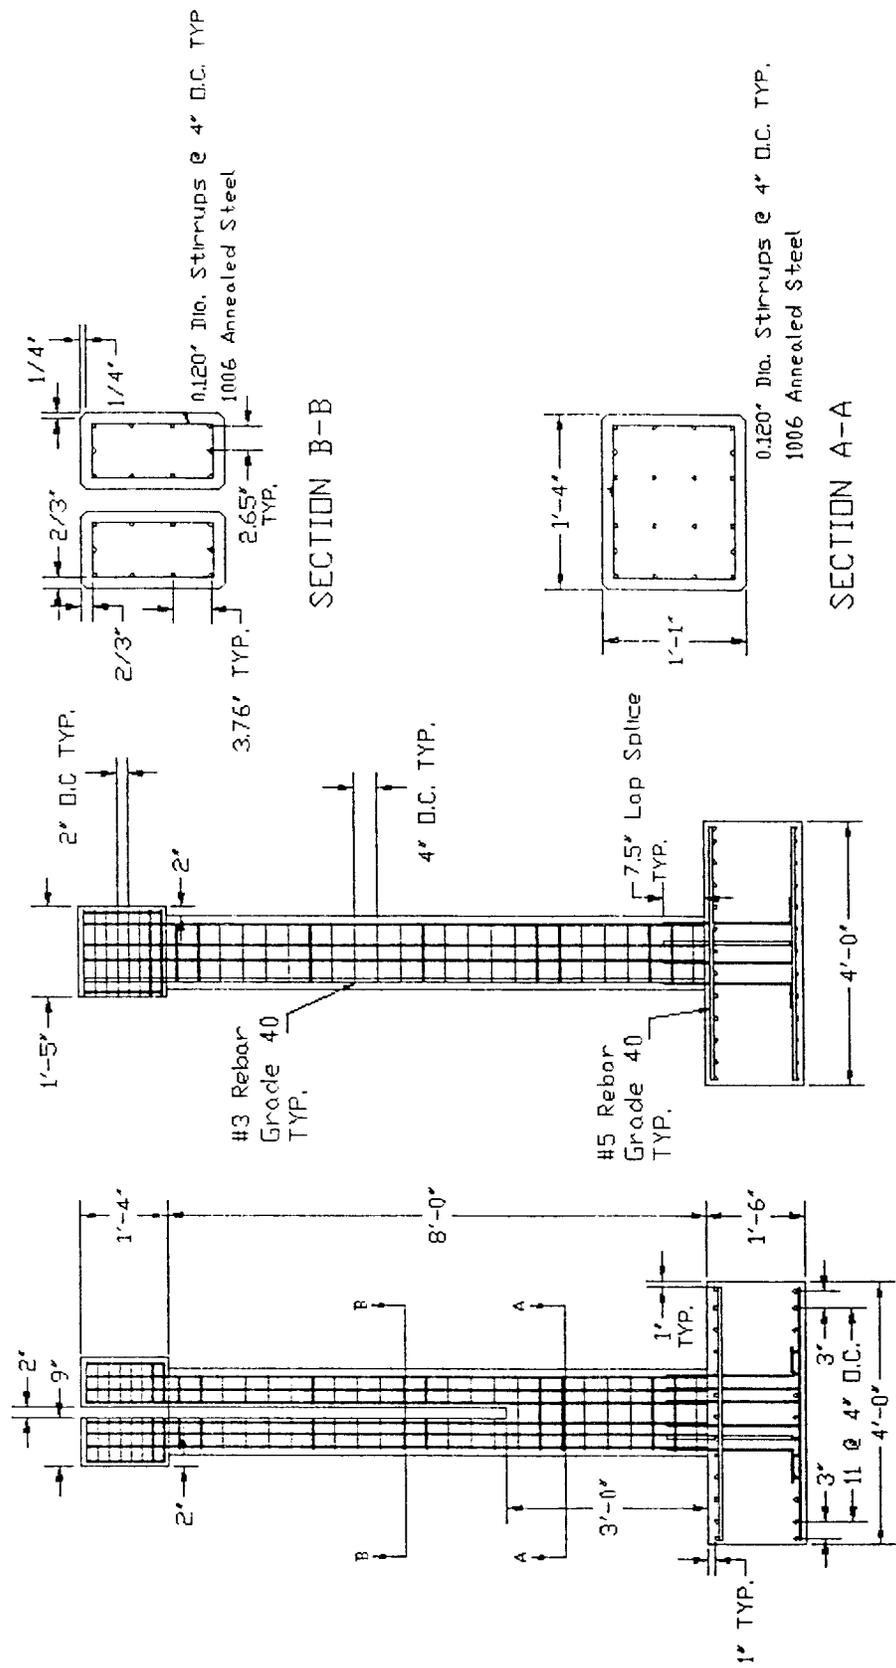
Figure 10 Details of Specimen AB1

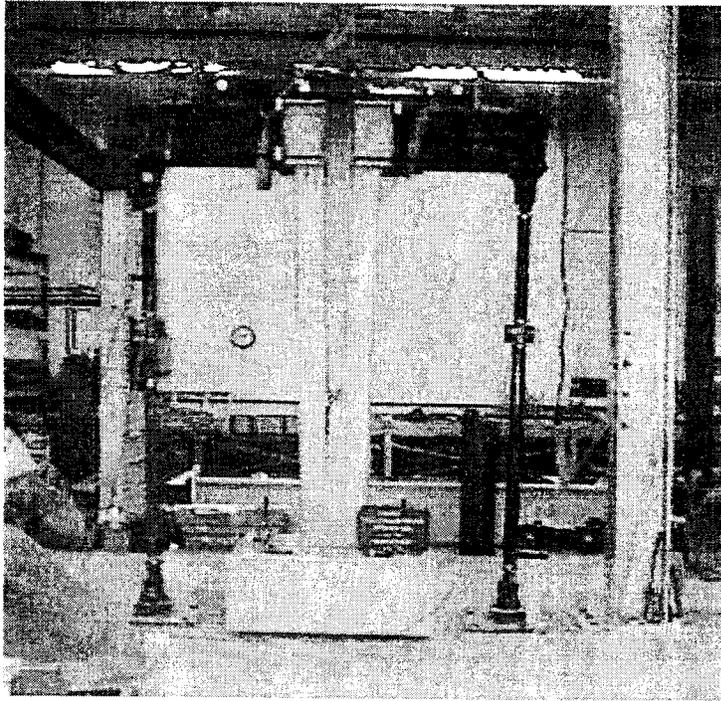
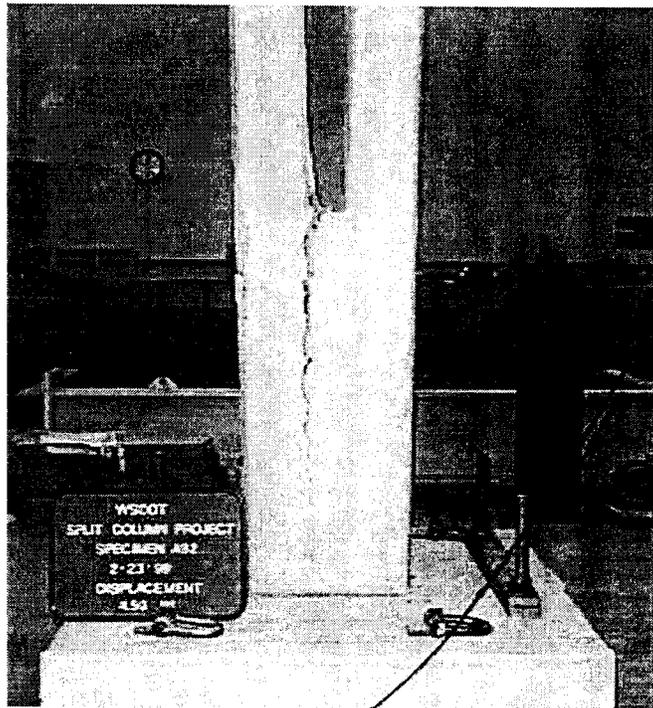
(a) Testing of Specimen AB1

(b) Crack Propagation at the Base of the Split

Figure 11 Specimen AB1 Testing Photographs

Specimen AB1 reached a maximum displacement of 13 cm (5 in.) with no significant drop in load. However, the specimen did experience very significant damage as shown in Figure 11. A crack began to

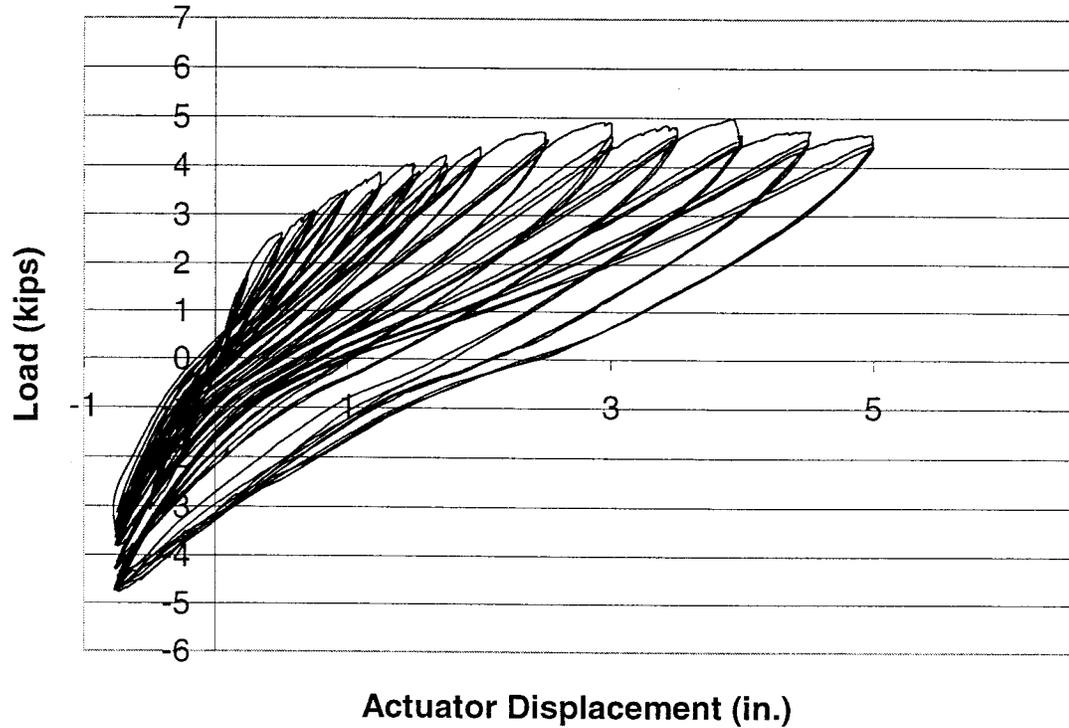
Figure 12 Load-Displacement Curves for Specimen AB1

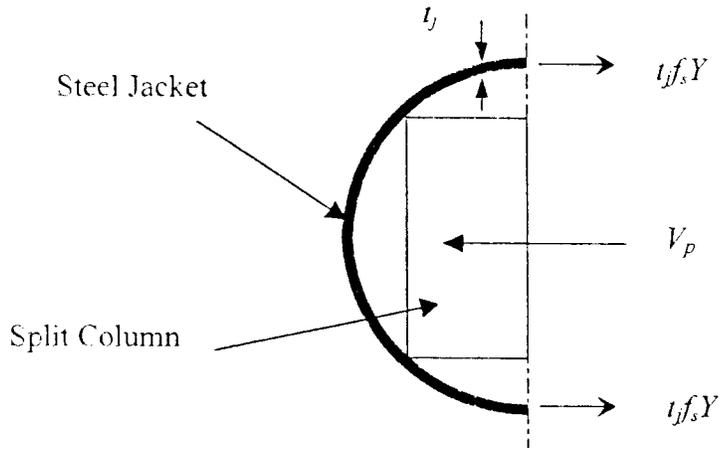
Figure 13 Basis of Retrofit to Prevent Crack Propagation from Split

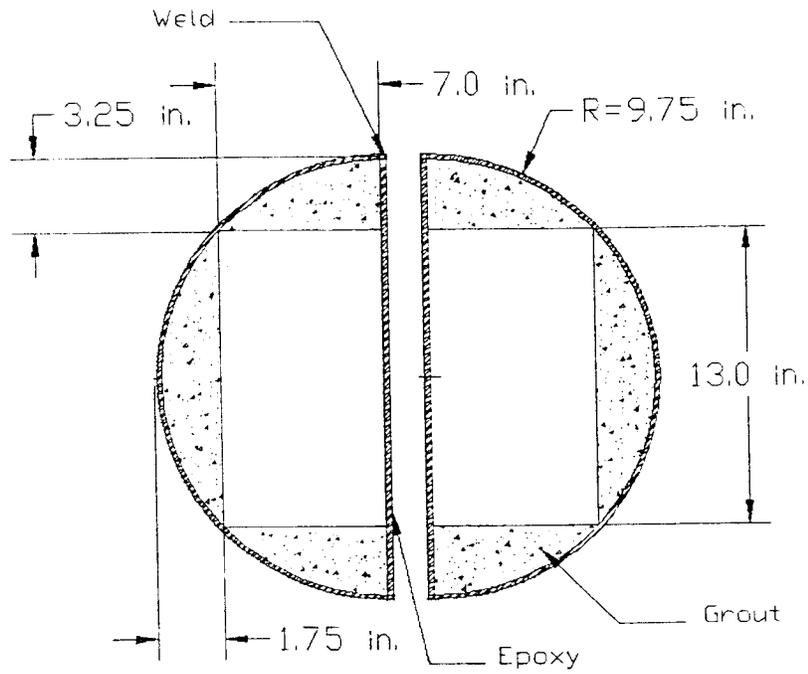
Figure 14 "D" Section Steel Jacket Retrofit of Split Sections

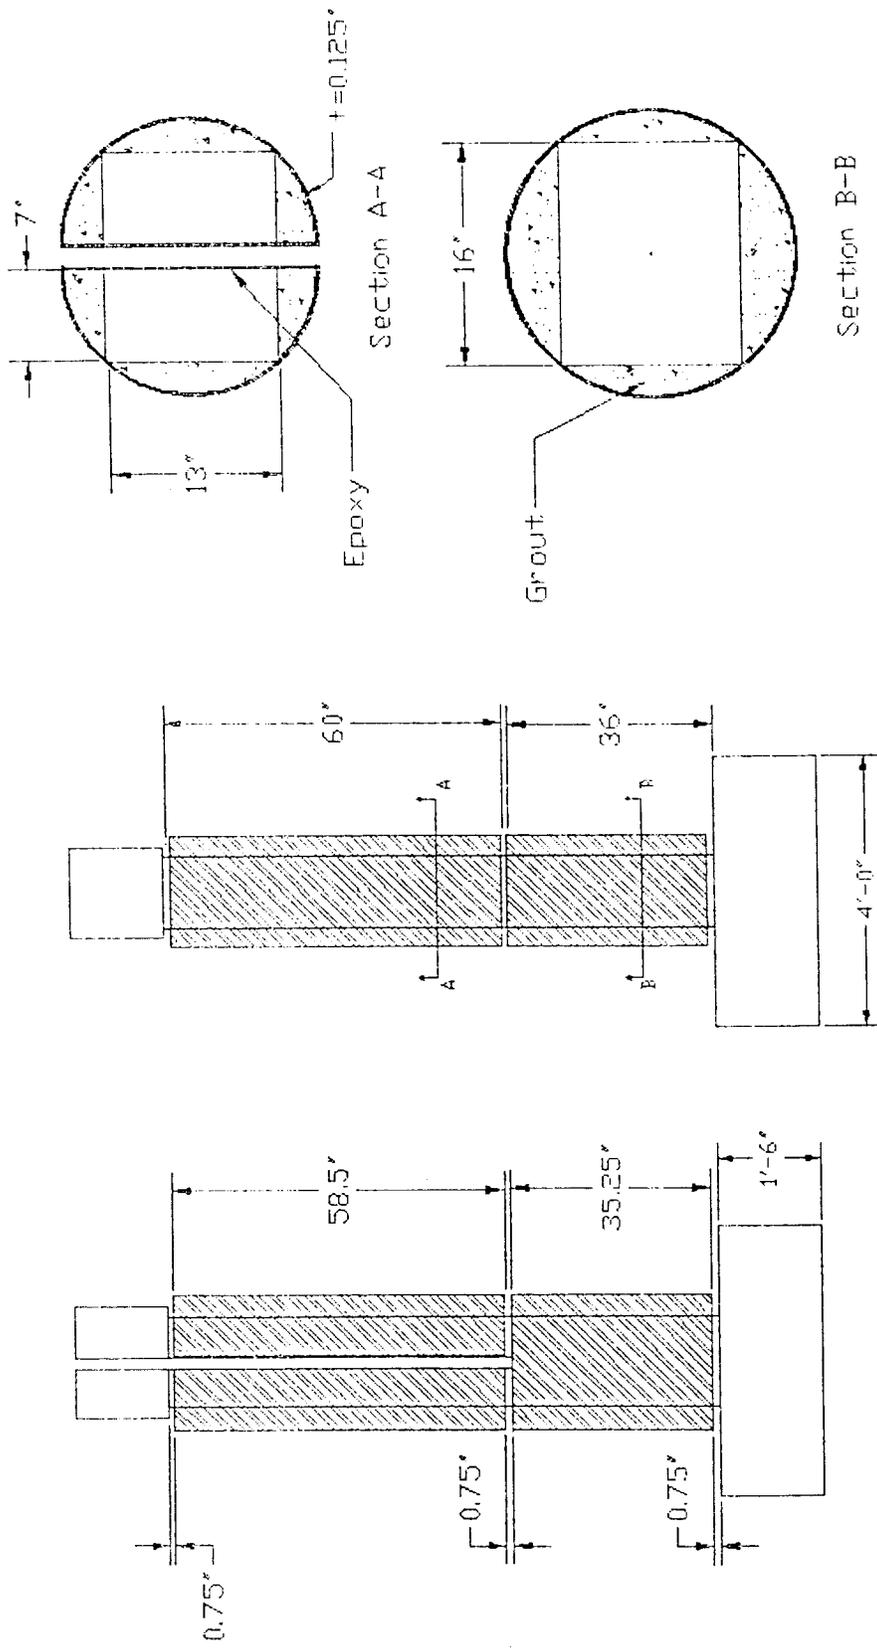
Figure 15 Retrofit Details for Specimen SJI

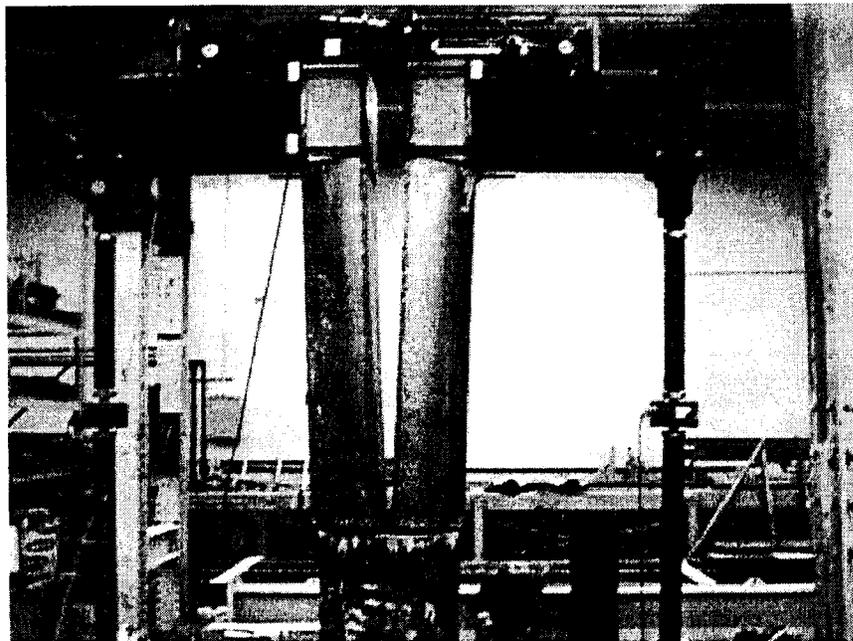
Figure 16 Specimen SJ1 Test Photographs

Photographs of Specimen SJ1 during testing are shown in Figure 16. The resulting load-deflection hysteresis curves for the specimen are given in Figure 17. The peak applied load to the specimen was 29 kN (6.5 kips) and occurred at a lateral displacement at the top of specimen of 7.6 cm (3.0 in.). The specimen continued to carry approximately the same load up to a displacement of 15 cm (6 in.) when testing was stopped because the actuator reached its maximum displacement stroke. No significant damage of any kind was observed in the specimen. Ductile flexural hinges formed at the retrofitted bases of the split sections. No significant bulging of the steel jacketing inside the split was observed. Based upon a yield displacement of 1.5 cm (0.6 in.), the specimen demonstrated a displacement ductility capacity,  $\mu_{\Delta}$  of 10. The hysteresis curves indicate significant improvement in energy dissipation when compared to the hysteresis curves for the as-built Specimen AB1.

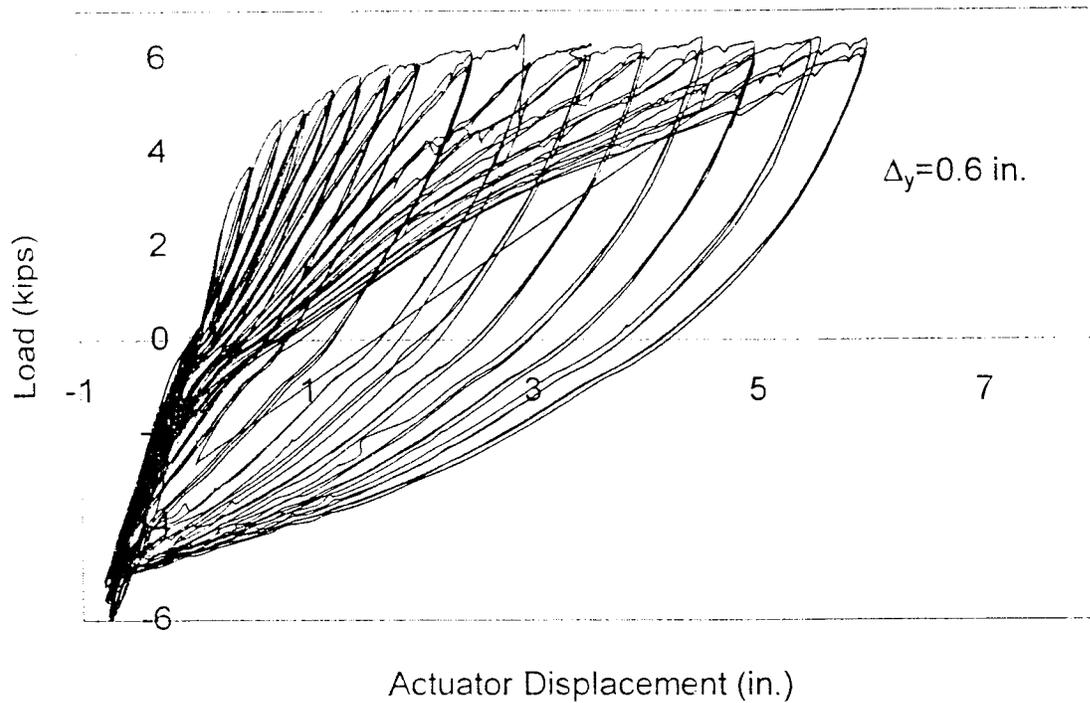
Figure 17 Load-displacement Curves for Specimen SJ1

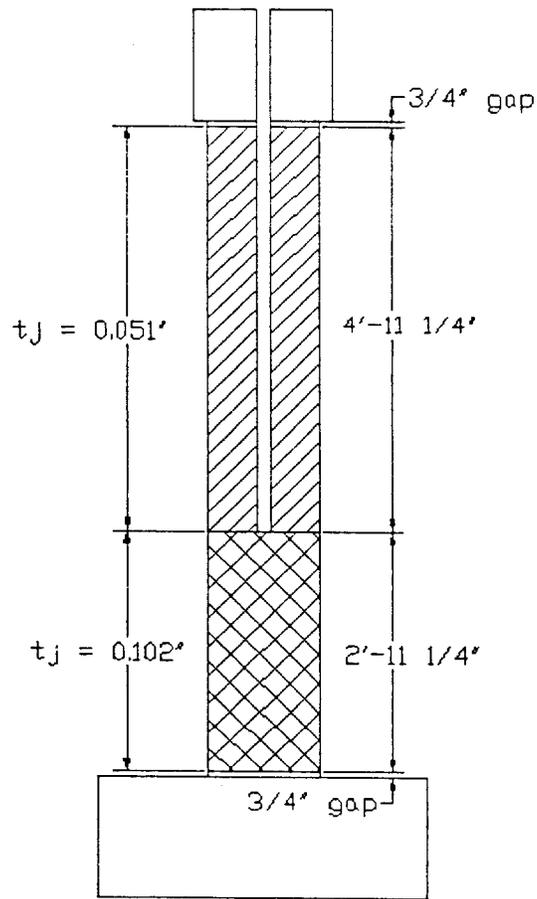
Figure 18 Retrofit Details for Specimen FW1.

two plies ( $t_j = 0.102$  in.) of composite material, installed on the entire unsplit portion of the column, would be sufficient to prevent crack propagation. The plastic hinge confinement design for the split sections of Specimen FW1 was done in accordance with the provisions set forth by Priestley, et al (1996). The controlling jacket thickness was due to a required ultimate compressive strain in the concrete of 0.00466. Fyfe Company installed one ply ( $t_j = 0.051$  in.) of material in the primary and secondary plastic hinge regions. Shear strength design for the specimen was performed in accordance with the SEQAD Provisions (1993). It was conservatively assumed that the composite material jacket would provide the entire shear strength required. Shear strength designs inside and outside of the plastic hinge regions were therefore identical, yielding a required jacket thickness of 0.06 cm (0.0239 in.). This corresponds to a requirement of one ply ( $t_j = 0.051$  in.) of composite material. Inside of the plastic hinge regions, one ply was required for plastic hinge confinement; therefore shear strength requirements did not control. Outside of the plastic hinge regions, one ply of material was installed.

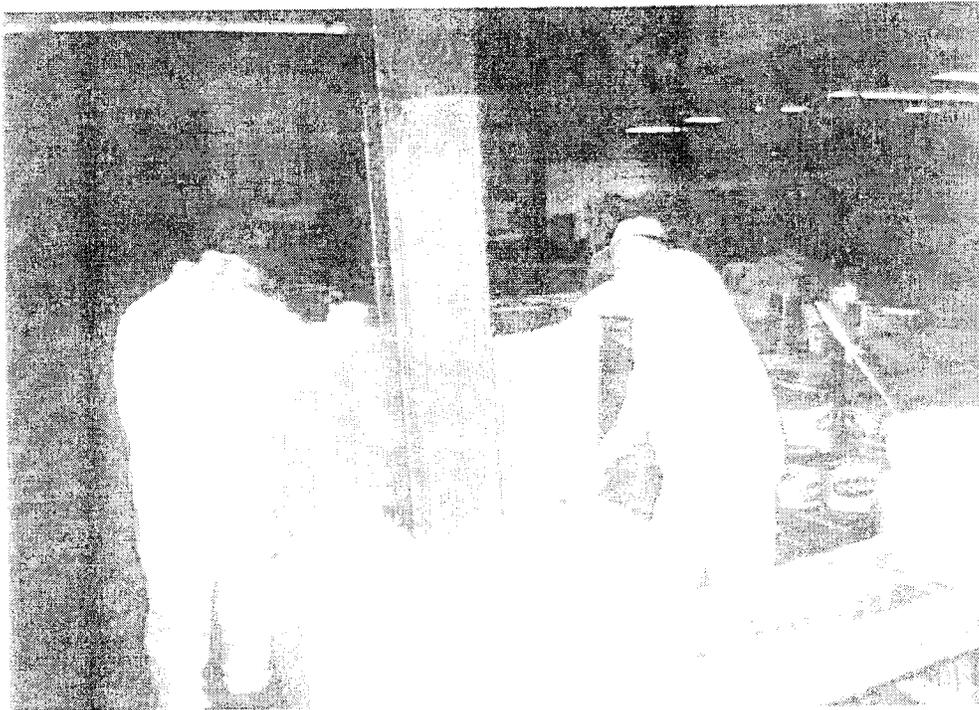
(a) Application of Epoxy

(b) Application of Fiberglass Material

Figure 19 Fyfe Company Retrofit Installation Photographs

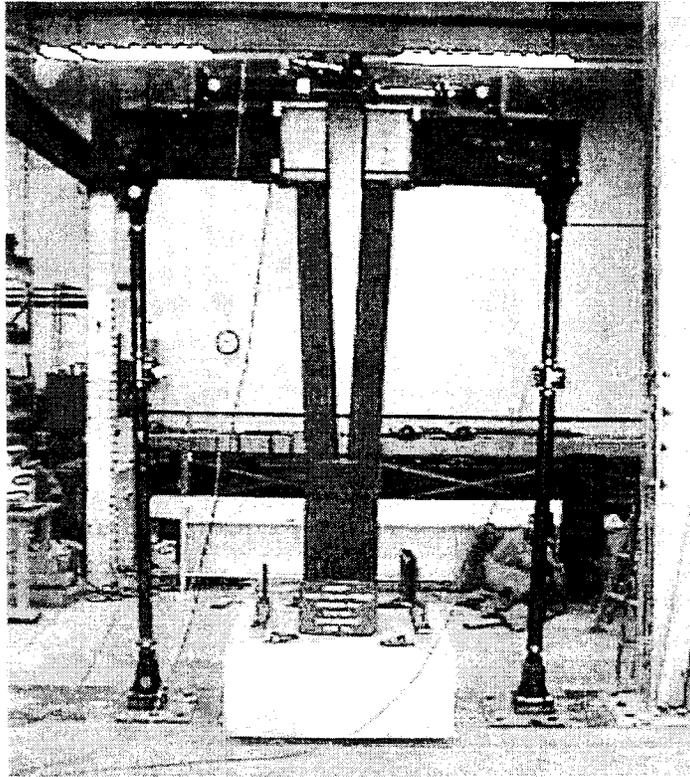
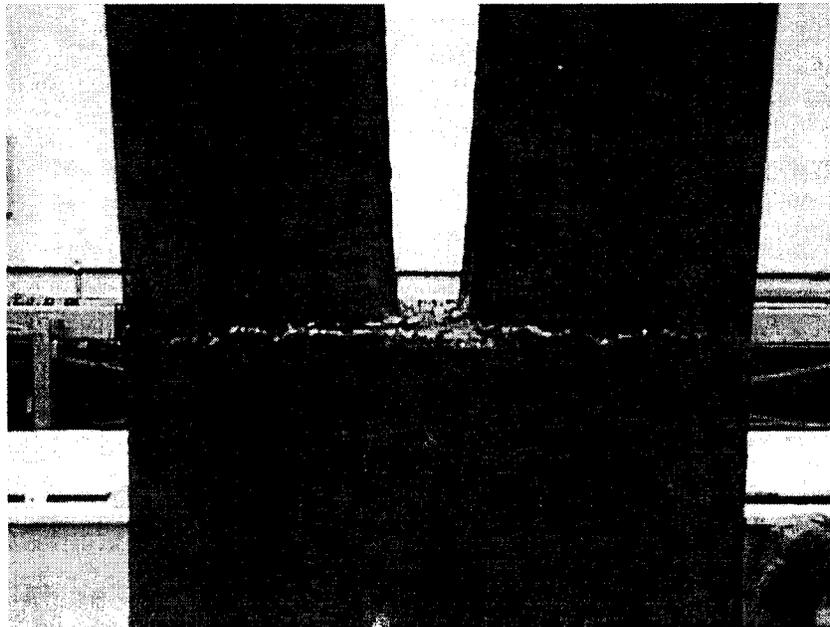
(a) Testing of Specimen FW1

(b) Horizontal Flexure Cracking

Figure 20 Specimen FW1 Testing Photographs

Photographs of Specimen FW1 during testing are shown in Figure 20. The load-displacement hysteresis curves for Specimen FW1 are presented in Figure 21. During initial testing, the loading caps on both split sections experienced severe cracking due to the applied moment. The test was terminated at a displacement of 10 cm (4 in.). The cap was repaired, the testing hardware was modified to prevent such failures, and the test was repeated. The data from the first test was used up to a displacement of 1.9 cm (0.75 in.), and the remainder of the data came from the second test. The peak horizontal load the specimen experienced was 27.6 kN (6.21 kips) at a displacement of 5.5 in. The specimen experienced no significant drop in load up to a final displacement of 15 cm (6 in.) with a corresponding displacement ductility, based on a yield

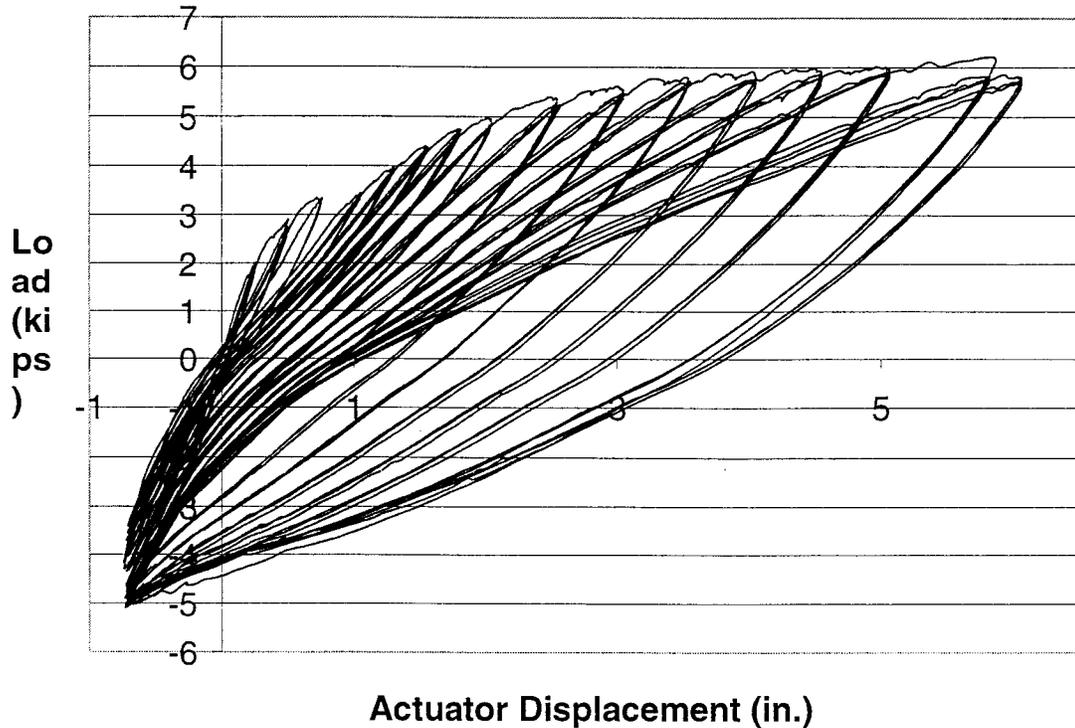
Figure 21 Load-Displacement Curves of Specimen FW1

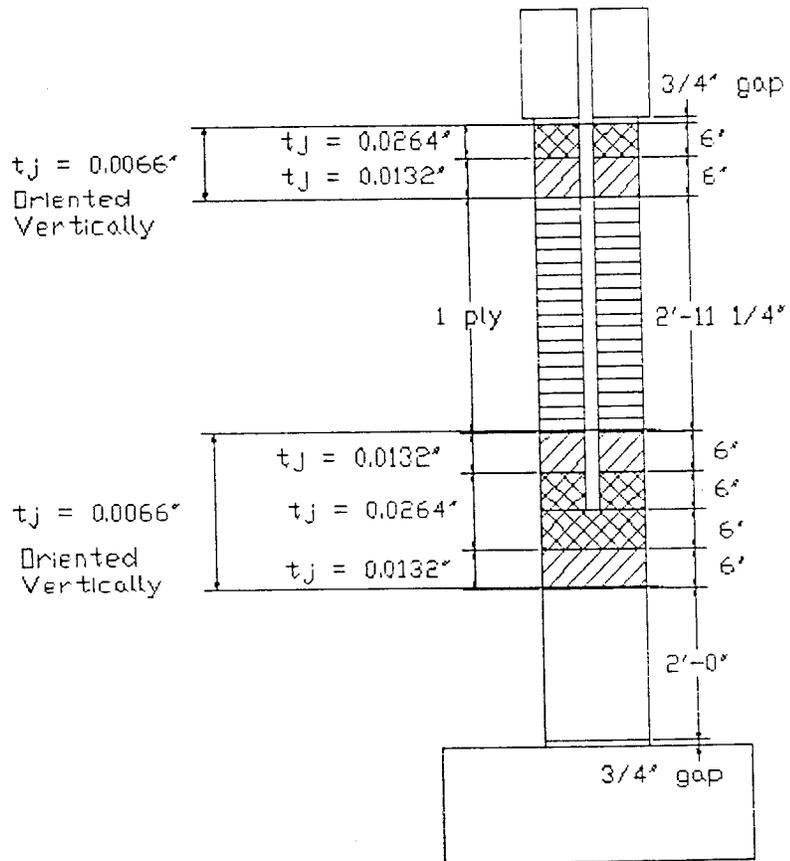
Figure 22 Retrofit Details for Specimen FW2

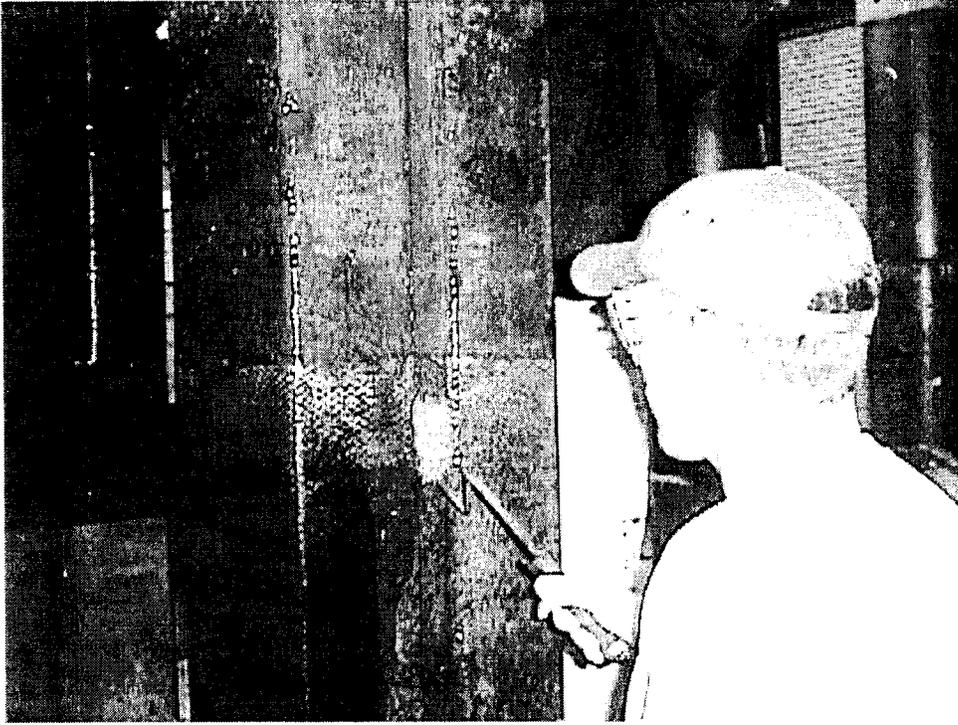
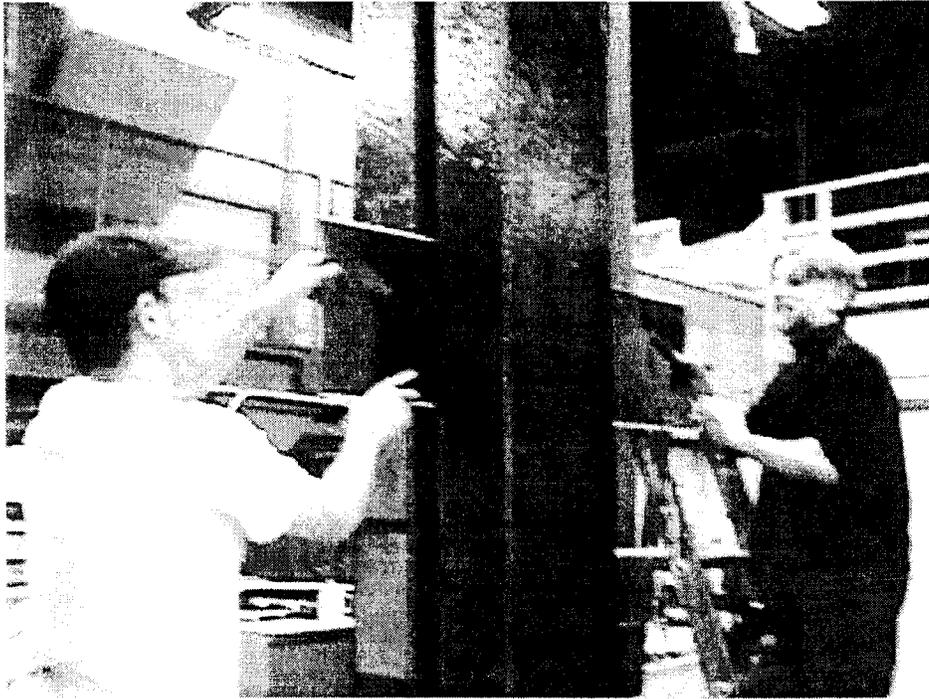
(a) Application of Epoxy

(b) Application of Carbon Fiber Material

Figure 23 Sumitomo Retrofit Installation Photographs

Figure 23 shows photographs taken during the Sumitomo retrofit installation. Sumitomo supplied all of the materials used in the retrofit installation. The installation procedure for Sumitomo's carbon fiber/epoxy jackets went as follows. The corners of the columns were ground to a 2.5-cm (1-in.) radius. The smooth

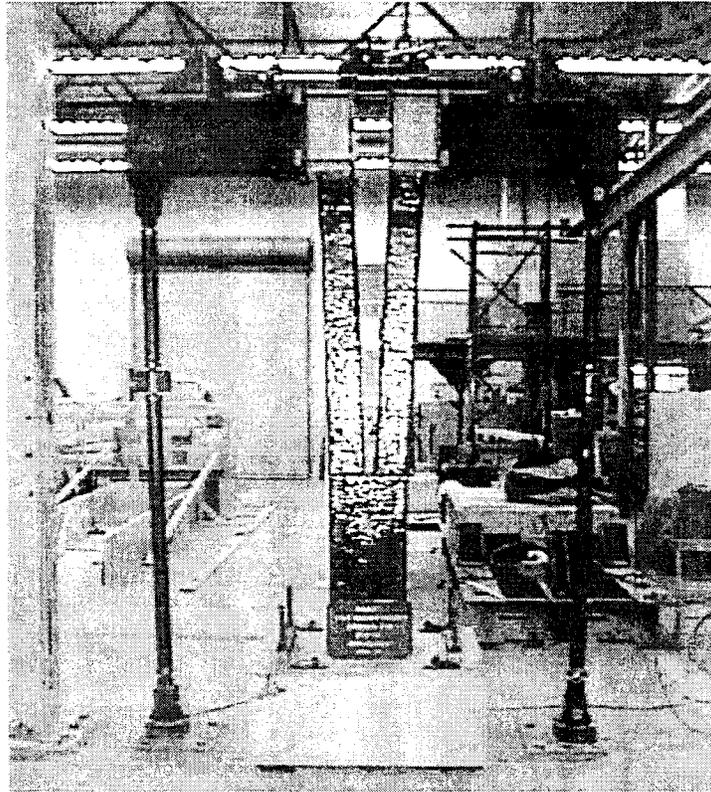
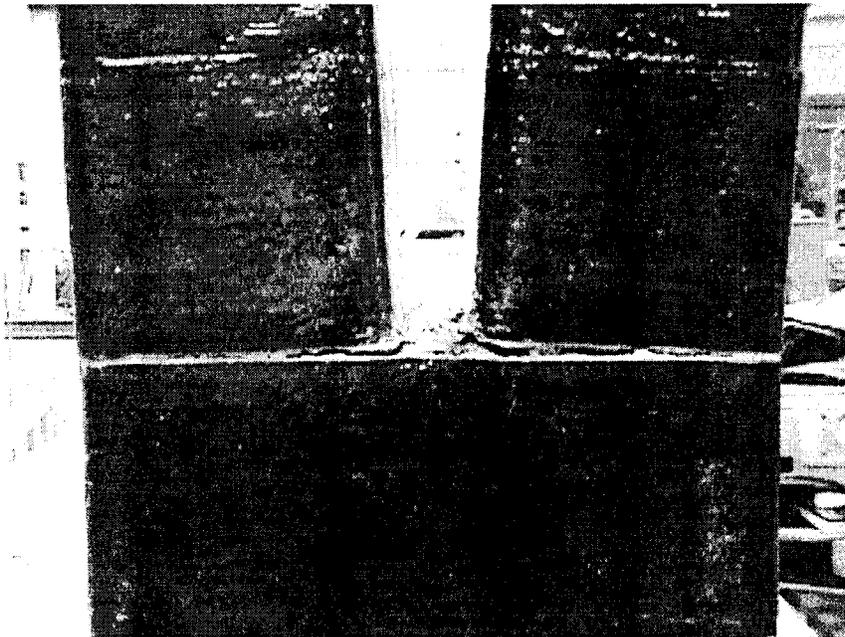
(a) Testing of Specimen FW2

(b) Horizontal Flexure Cracking

Figure 24 Specimen FW2 Testing Photographs

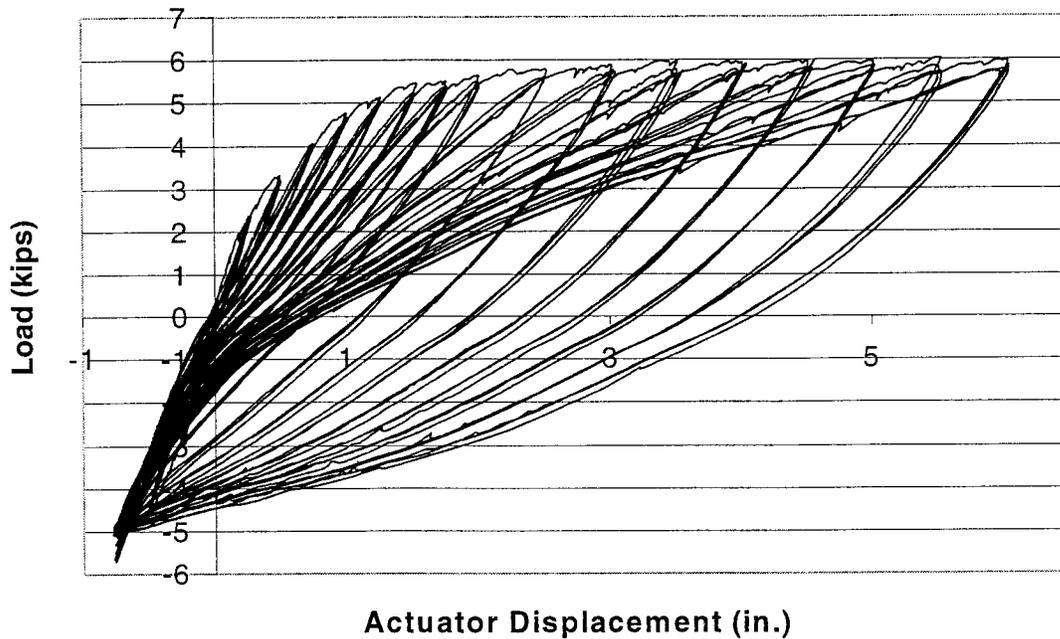
Figure 25 Load-Displacement Curves of Specimen FW2

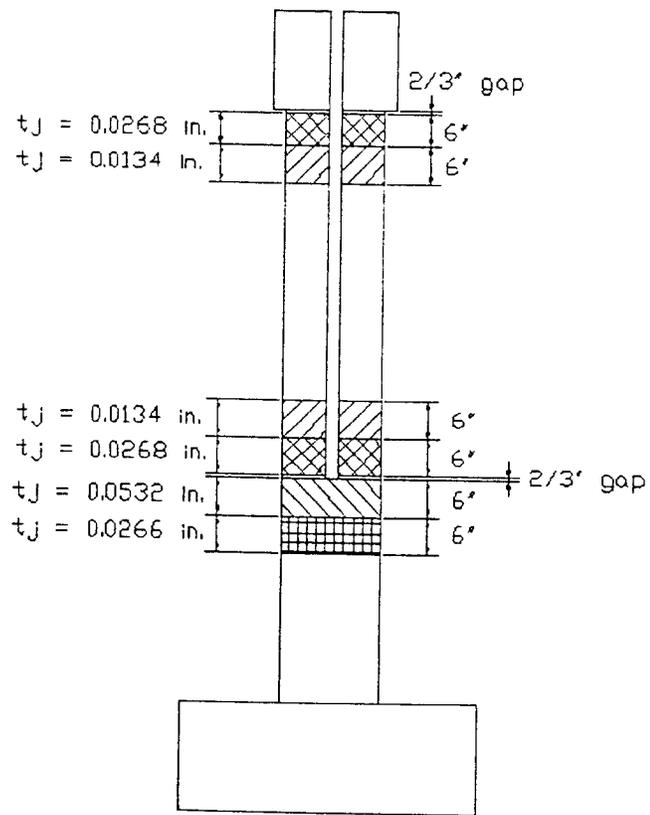
Figure 26 Retrofit Details for Specimen FW3

distributed over a 15-cm (6-in.) deep region. A 15-cm (6-in.) strip of 0.053-in. thick material was installed directly below the split, and a 15-cm (6-in.) strip of 0.0266-in. thick material was installed directly below that. The plastic hinge confinement design in the split sections was also performed in accordance with the ACTT-95/08 Provisions (Seible, et al, 1995). The controlling jacket thickness was due to a required ultimate compression strain in the concrete of 0.0052. A 15-cm (6-in.) strip of 0.0268-in. thick material was installed in the primary plastic hinge regions, and a 15-cm (6-in.) strip of 0.0134-in. thick material was installed in the secondary plastic hinge regions. Shear strength design was done in accordance with the ACTT-95/08 Provisions (Seible, et al, 1995). The required jacket thickness for shear strength in the plastic hinge regions of the specimen was 0.02 cm (0.008 in.) and therefore did not control. Outside of the plastic hinge region no jacket was required or installed.
