1. REPORT NO. <b>WA-RD 482.1</b>	2. GOVERNMENT ACCESSION NO.	3. RECIPIENT'S CATALOG NO.	
4. TITLE AND SUBTITLE <b>Retrofit of Split Bridge Columns</b>	5. REPORT DATE <b>February 11, 2000</b>

Research Project 9902-26  
Split Columns

**RETROFIT OF SPLIT BRIDGE COLUMNS**

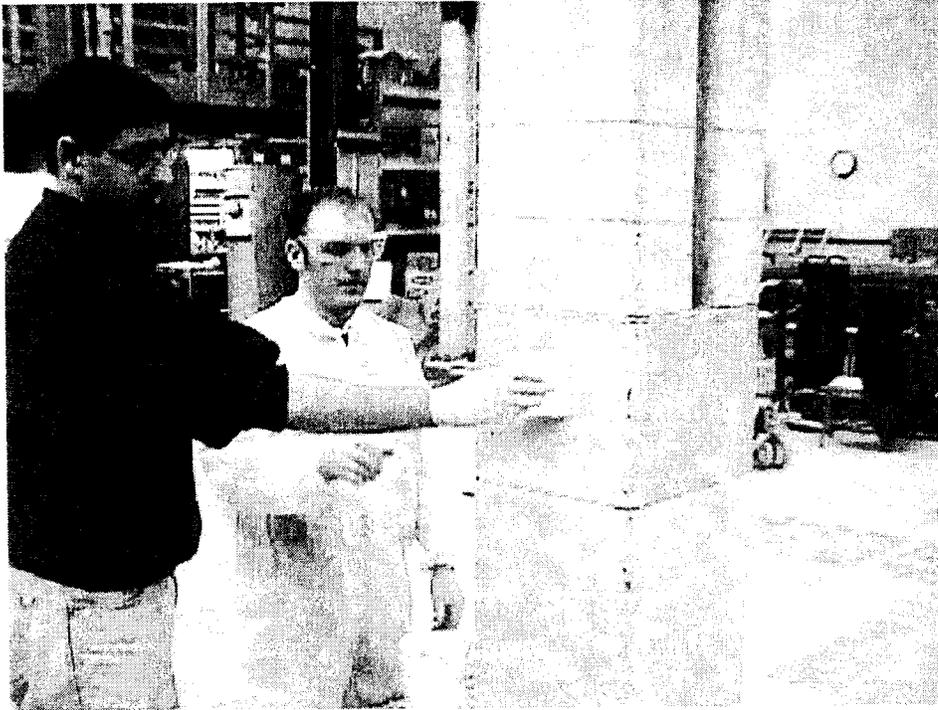
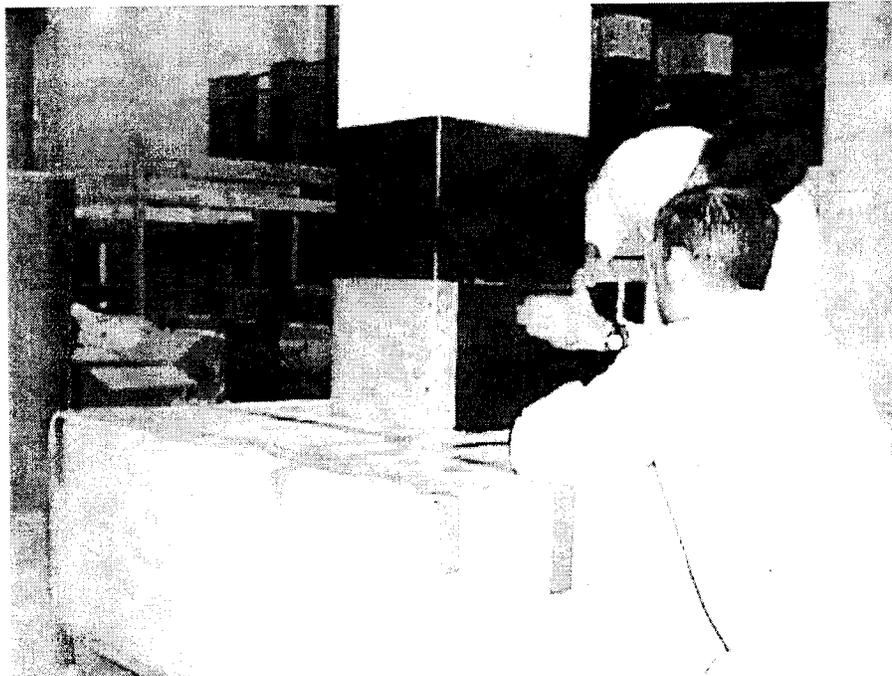
(a) Application of Adhesive

(b) Application of Carbon Fiber Material

Figure 27 XXSys Retrofit Installation Photographs

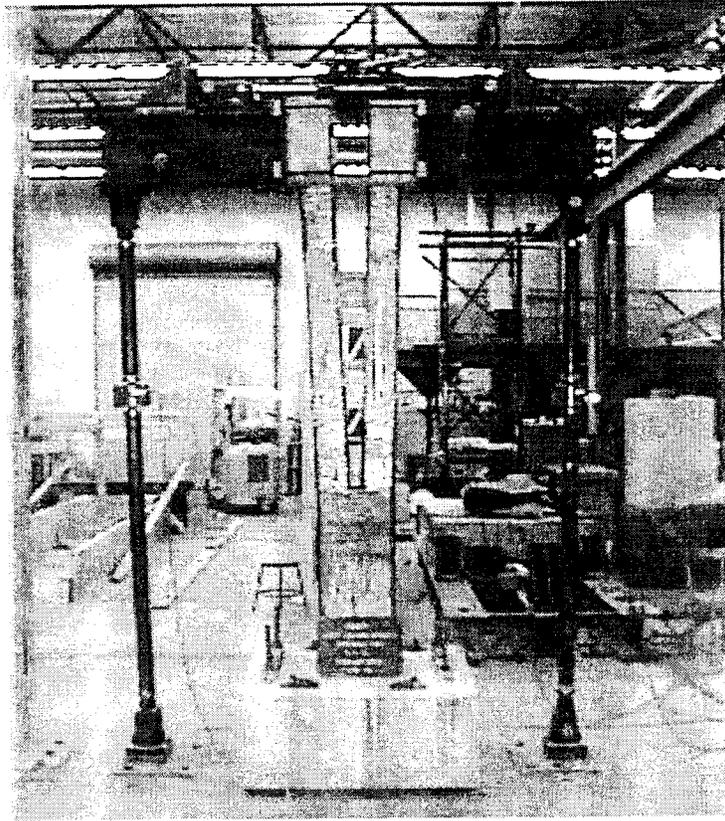
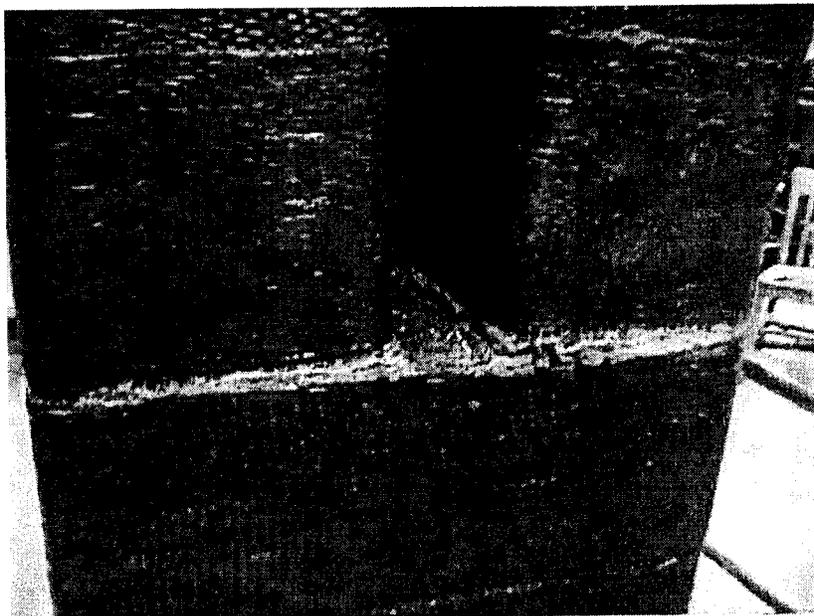
(a) Testing of Specimen FW3

(b) Horizontal Flexure Cracking

Figure 28 Specimen FW3 Testing Photographs

Testing photographs of Specimen FW3 are shown in Figure 28. The load-displacement hysteresis curves for Specimen FW3 are provided in Figure 29. The specimen experienced a peak load of 26.3 kN (5.91 kips) at a displacement of 15 cm (6 in.), corresponding to displacement ductility of approximately 10. The peak load for each displacement interval was above 24.5 kN (5.5 kips) for all displacements greater than 5 cm (2 in.). The specimen experienced no significant drop in load and the test was terminated due to actuator stroke limitations. There was no visible crack formation at the base of the split. Significant horizontal flexure cracking at the top and bottom of the split sections developed due to plastic hinge formation at the location of gaps in the composite material. The material did not bulge in the flat sections of the plastic hinge regions. The load-displacement hysteresis curves for Specimen FW3 show a significant increase in energy dissipation when compared to the curves for the as-built specimen.

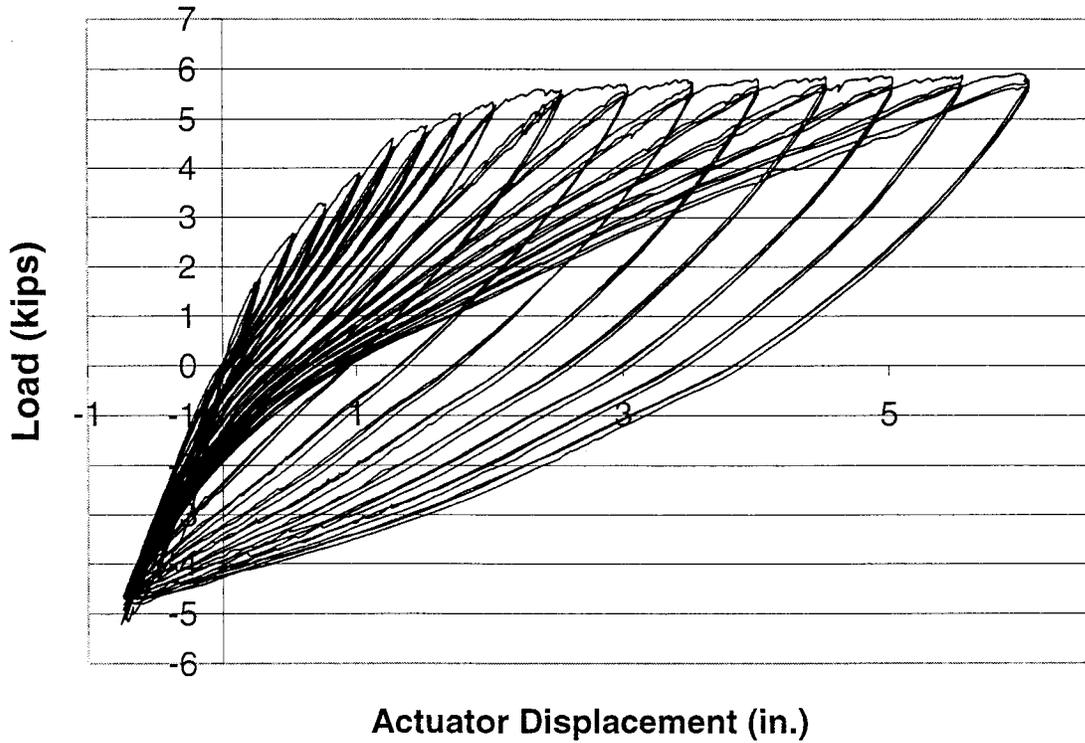
Figure 29 Load Displacement Curves of Specimen FW3

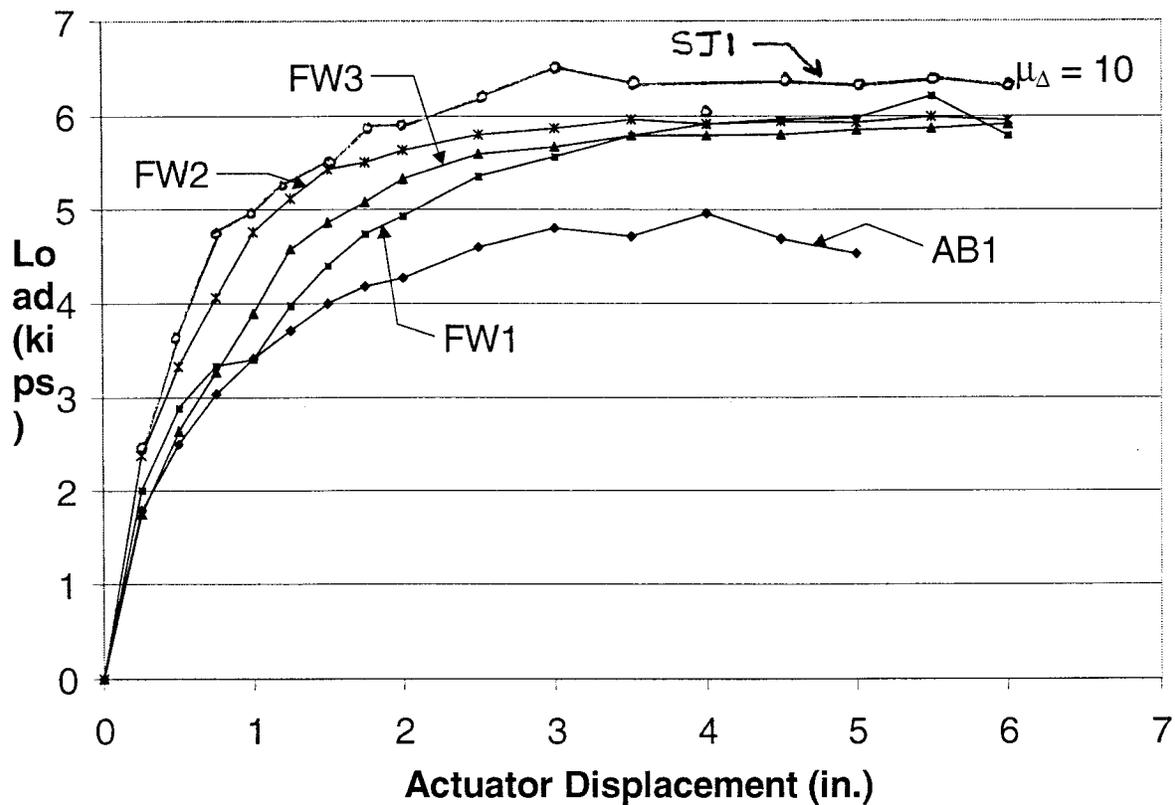
Figure 30 Peak Load-Displacement Envelope of Out-of-Phase Specimens

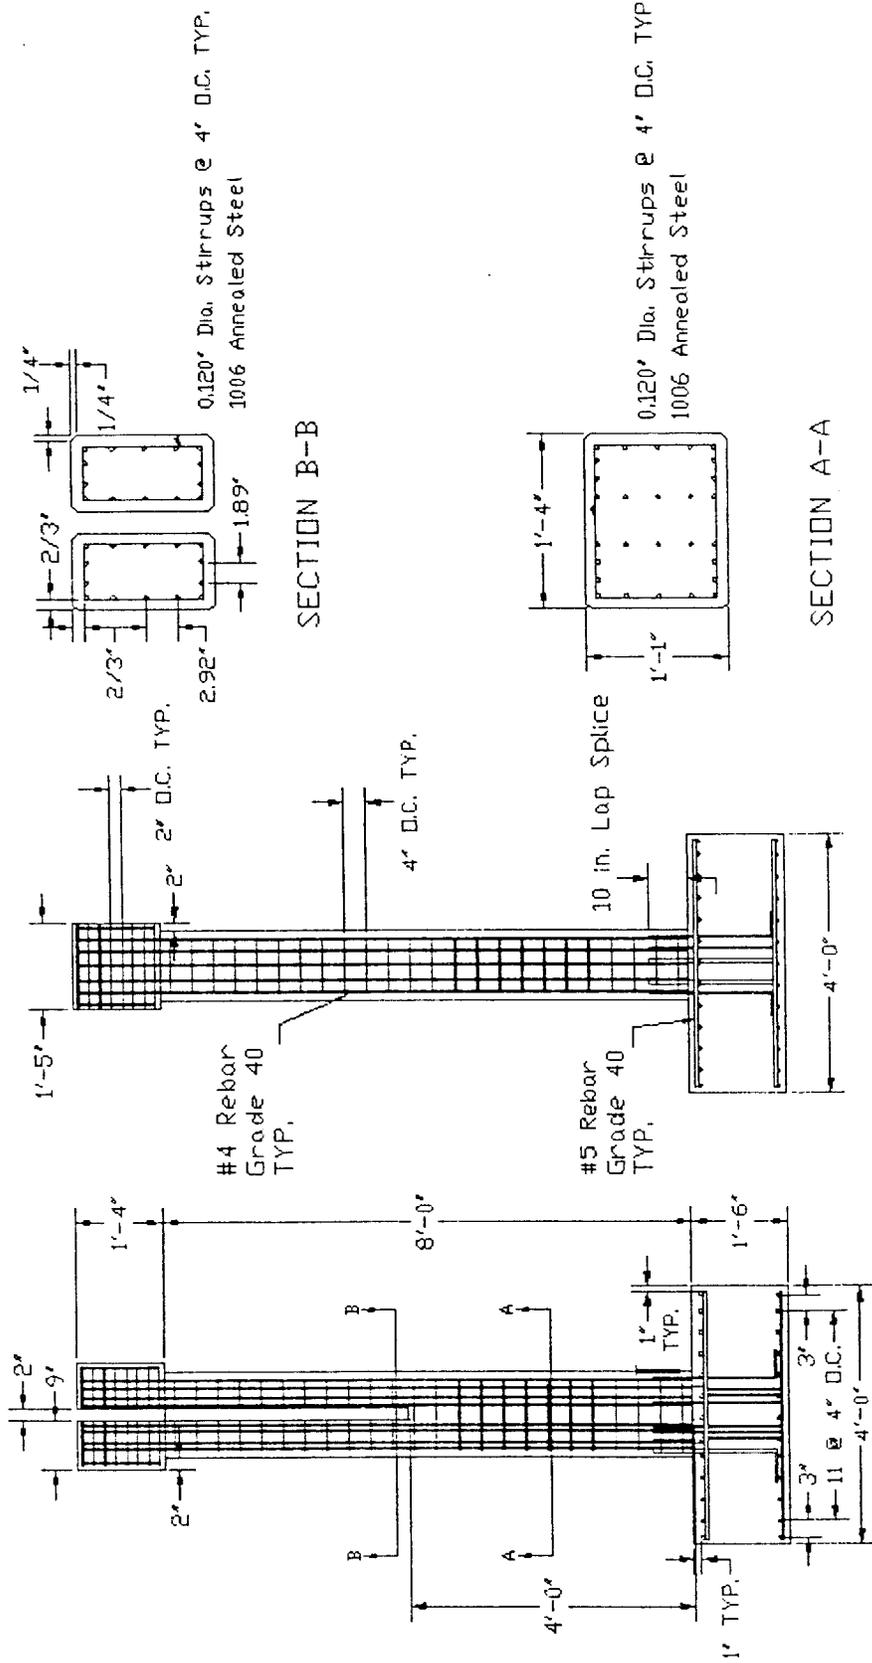
Figure 31 Details of Specimen AB3

Specimen AB3 was constructed to be representative of the split columns in the Spokane Street Overcrossing, with a split over approximately half of the column height and for which there is concern of a brittle shear failure in the split sections. Details of the specimen are given in Figure 31. The column longitudinal reinforcing ratio was 0.037. The bottom non-split section was retrofitted with a 0.64-cm (0.25-in.) thick circular steel jacket to prevent crack propagation from the base of the split in order to reveal the shear response of the two split sections. Specimen AB3 was tested under out-of-phase loading.

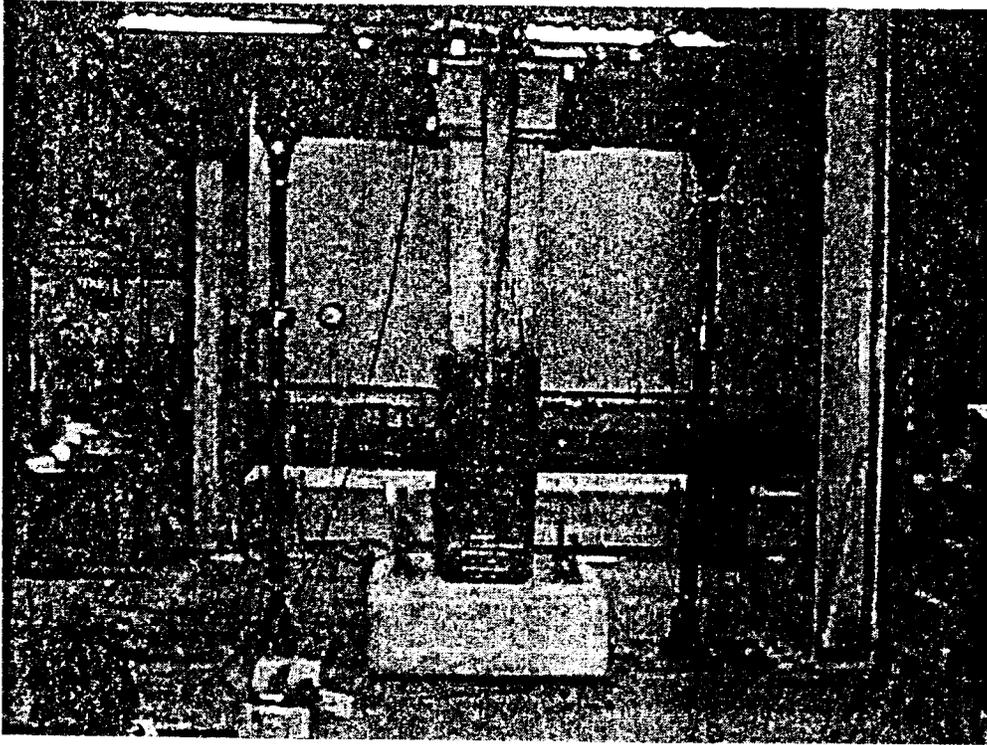
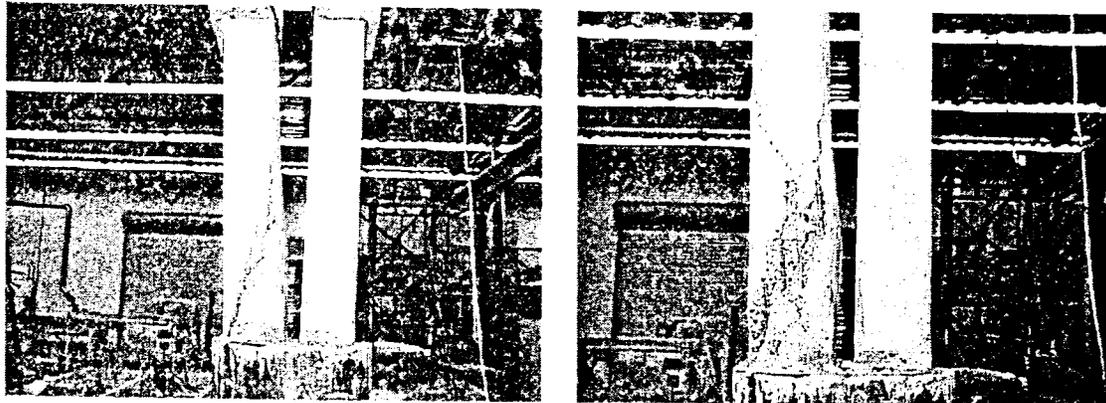
(a) Specimen AB4

(b) Shear Failure

Figure 32 Specimen AB3 Test Photographs

Photographs taken during the testing of Specimen AB3 are shown in Figure 32. The load-displacement curves for the specimen are given in Figure 33. As was expected, Specimen AB3 failed in a shear mode. Inclined cracks at approximately  $45^\circ$  were observed at a displacement of 3.8 cm (1.5 in.). Brittle shear failure occurred at a displacement of 10.2 cm (4 in.) with an applied peak horizontal load of 73.8 kN (16.6 kips). No significant cracks were observed in the plastic hinge regions. The load-displacement curves indicate relatively poor energy dissipation.

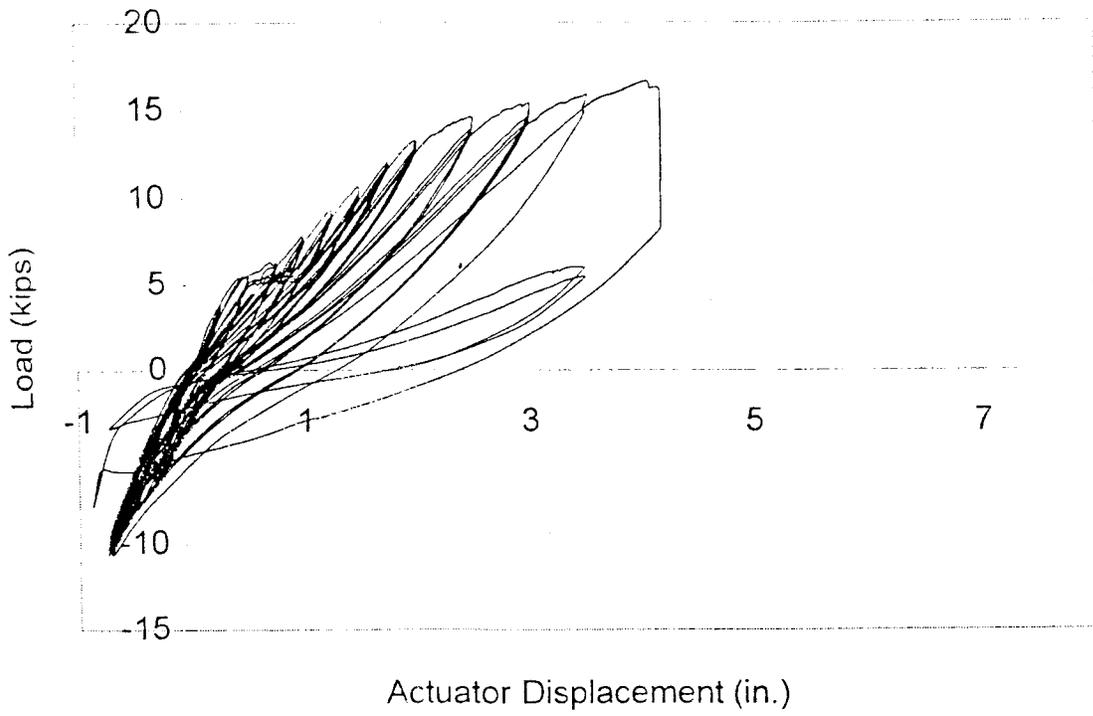
Figure 33 Load-displacement Curves for Specimen AB3

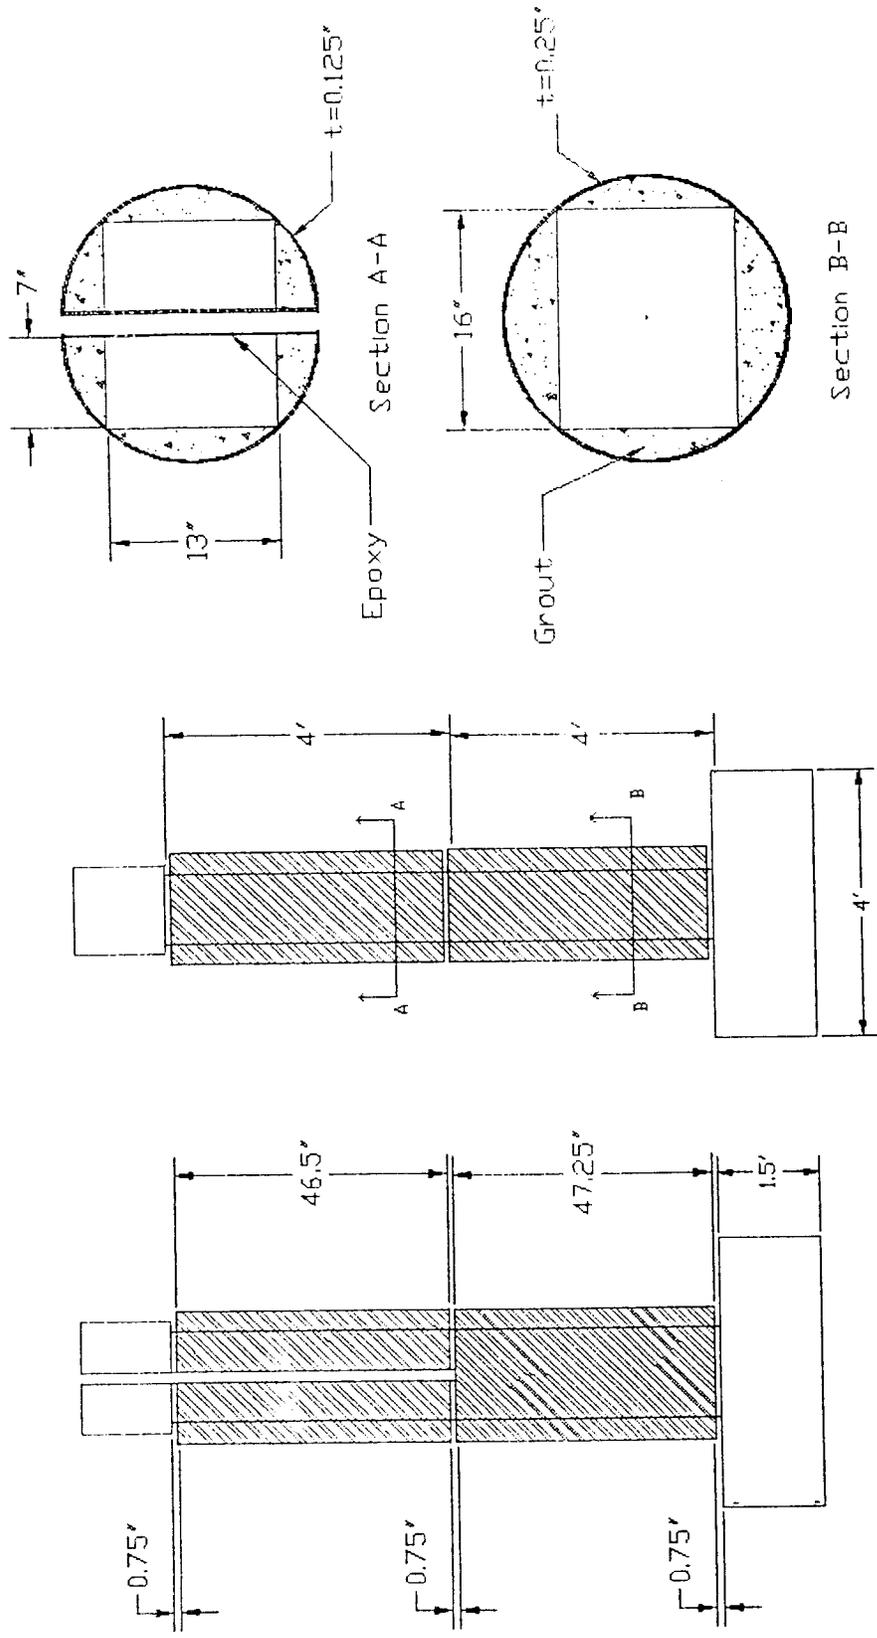
Figure 34 Retrofit Details for Specimen SJ3

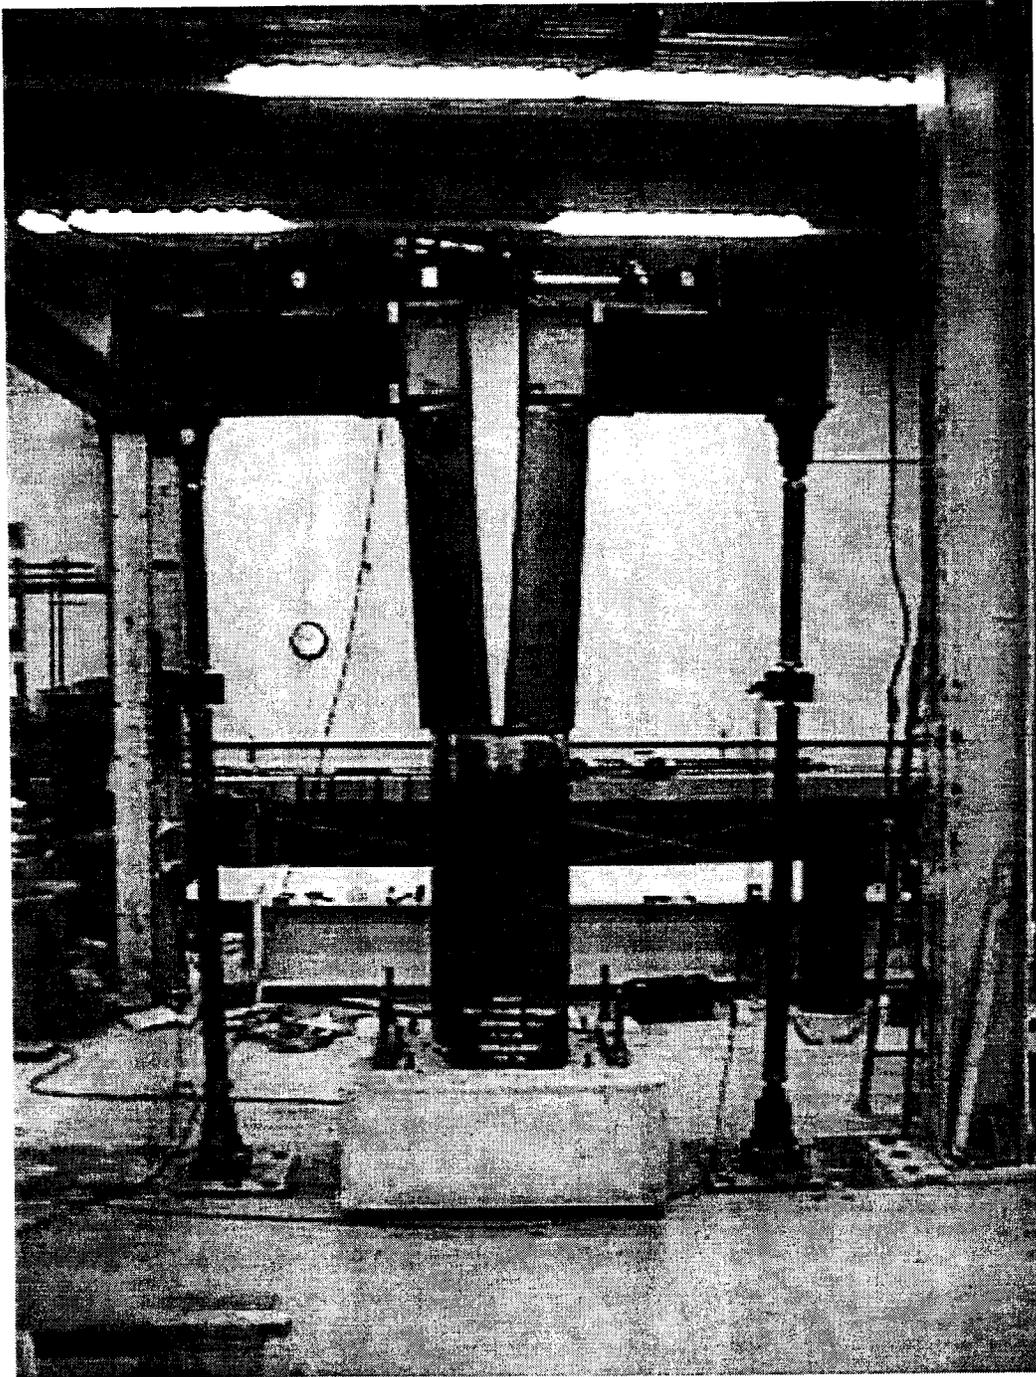
Figure 35 Specimen SJ3 Test Photograph

A photograph of Specimen SJ3 during testing is shown in Figure 35. Load-displacement curves are given in Figure 36. The specimen carried a peak load of approximately 80 kN (18 kips) at a displacement of 18 cm (7 in.), when testing was stopped due to the actuator reaching its maximum stroke. Horizontal cracks were evident at the construction gaps at the top and bottom of the split sections. The retrofit was successful in converting the brittle shear failure observed in the as-built specimen to a ductile response with flexural hinging at the top and bottom of the split sections.

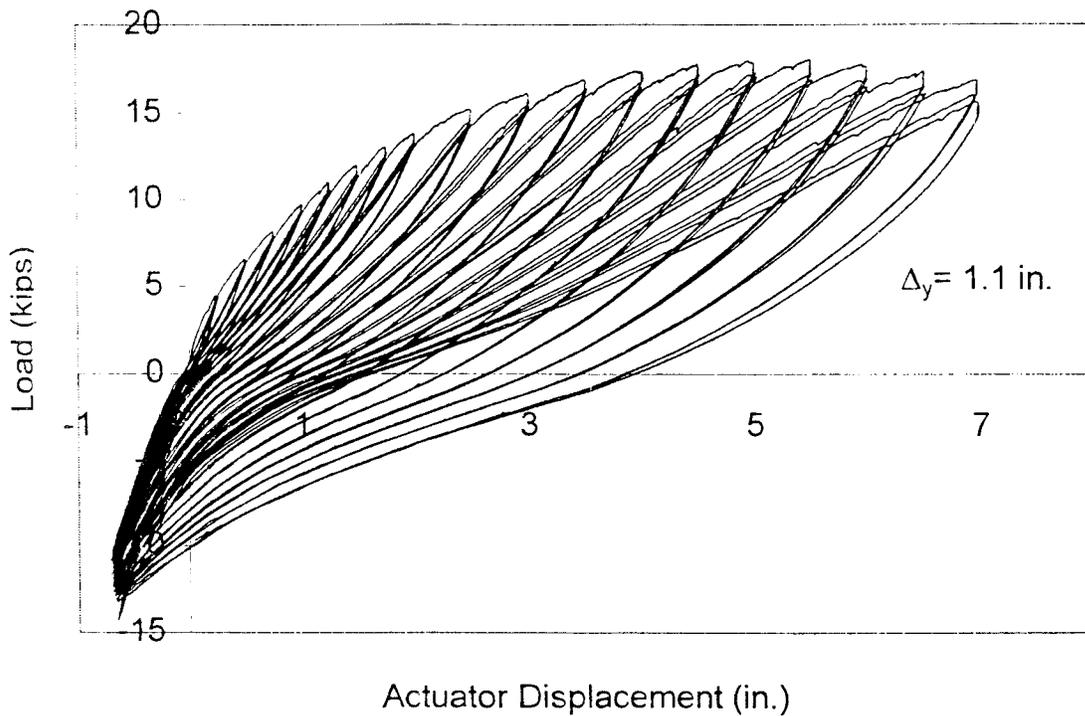
Figure 36 Load-Displacement Curves for Specimen SJ3

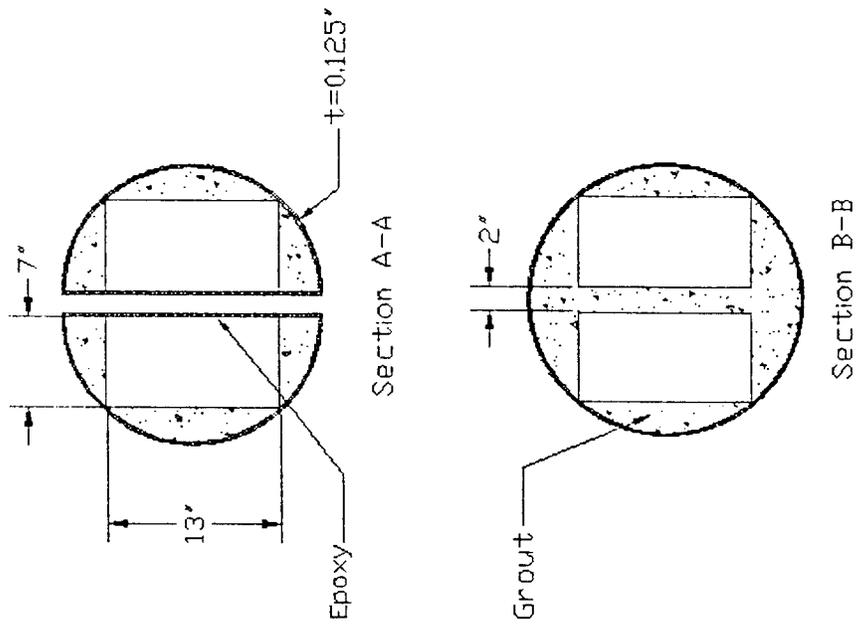
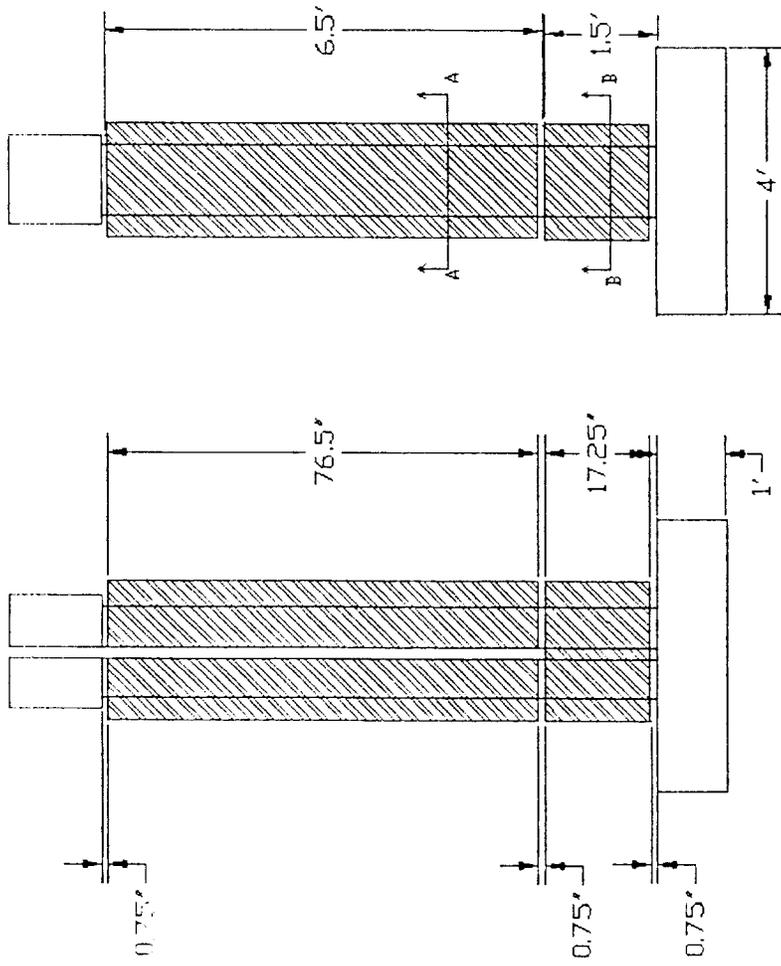
Figure 37 Retrofit Details for Specimen SJ2

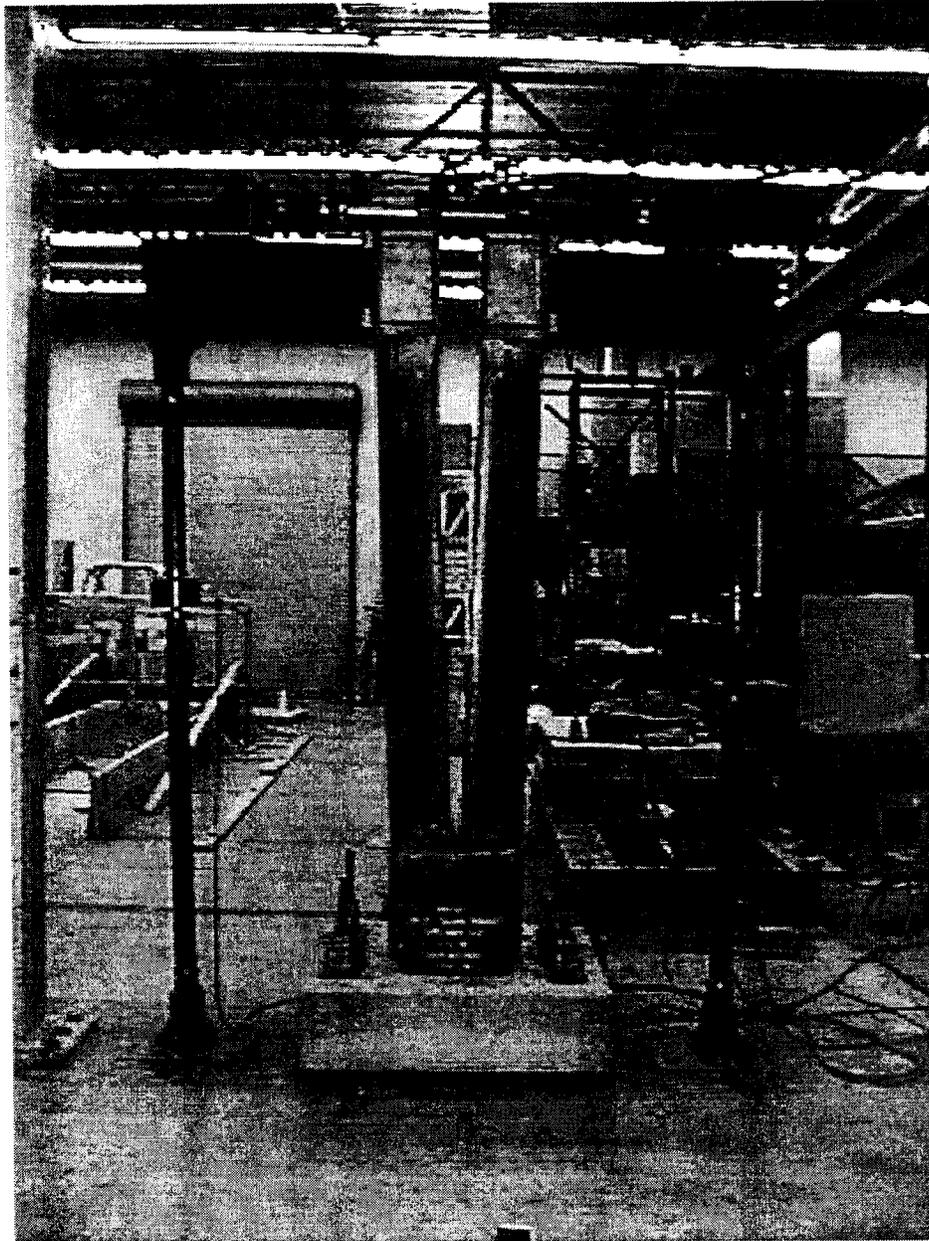
Figure 38 Photograph of Specimen SJ2 During Testing

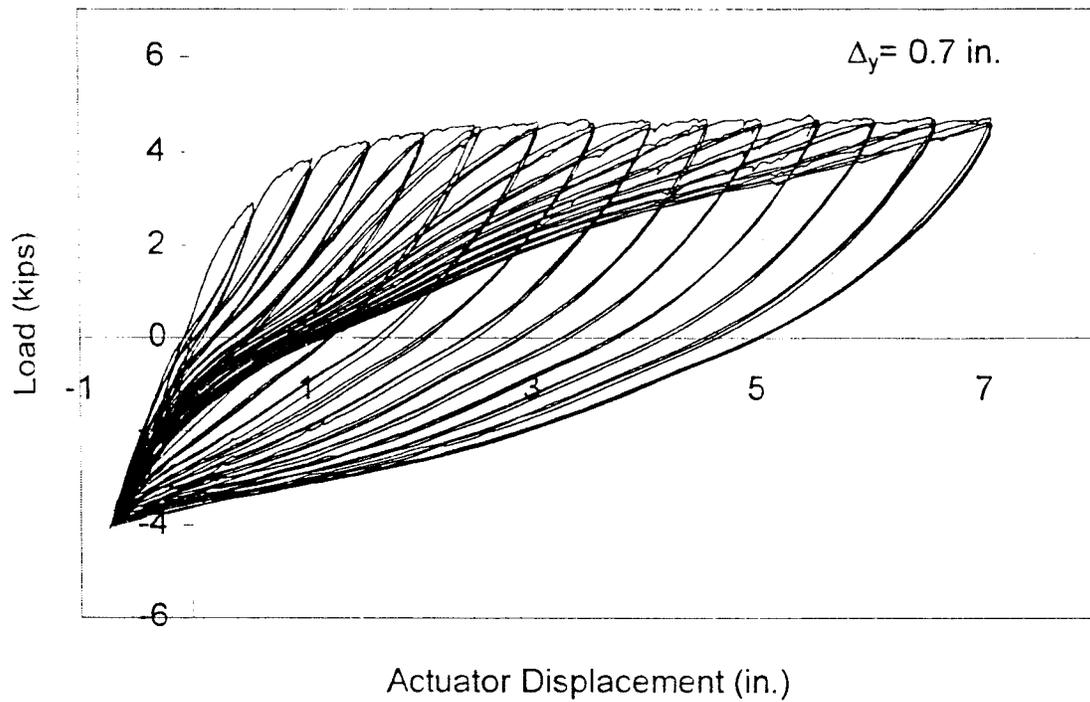
Figure 39 Load Displacement Curves for Specimen SJ2

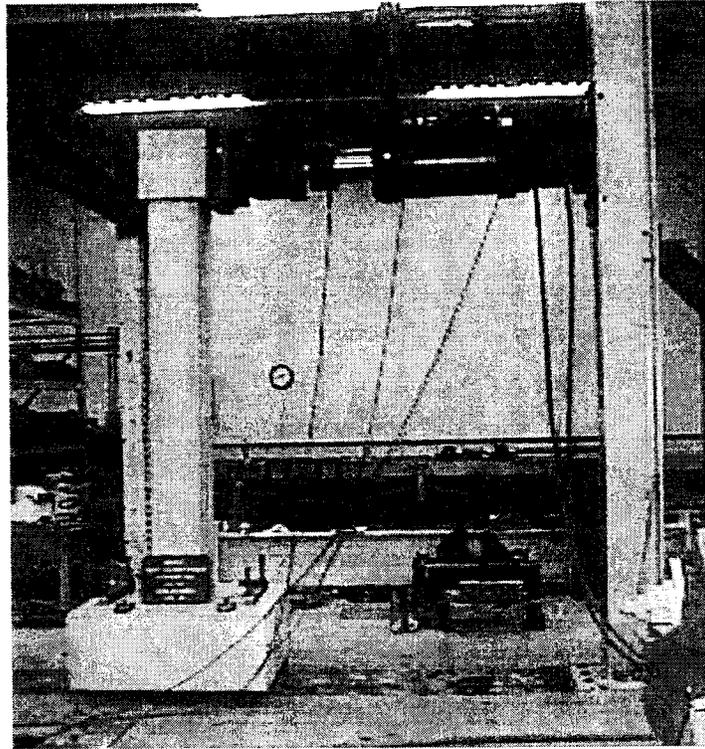
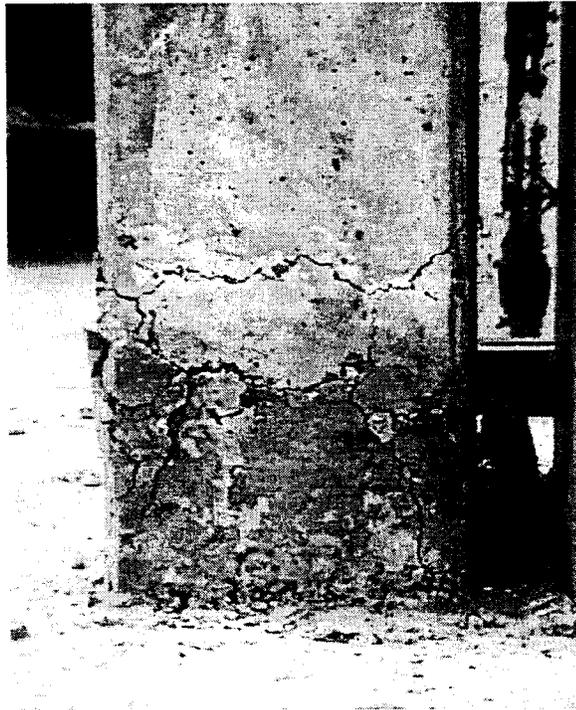
(a) Testing of Specimen AB2

(b) Lap Splice Degradation Cracking

Figure 41 Specimen AB2 Testing Photographs

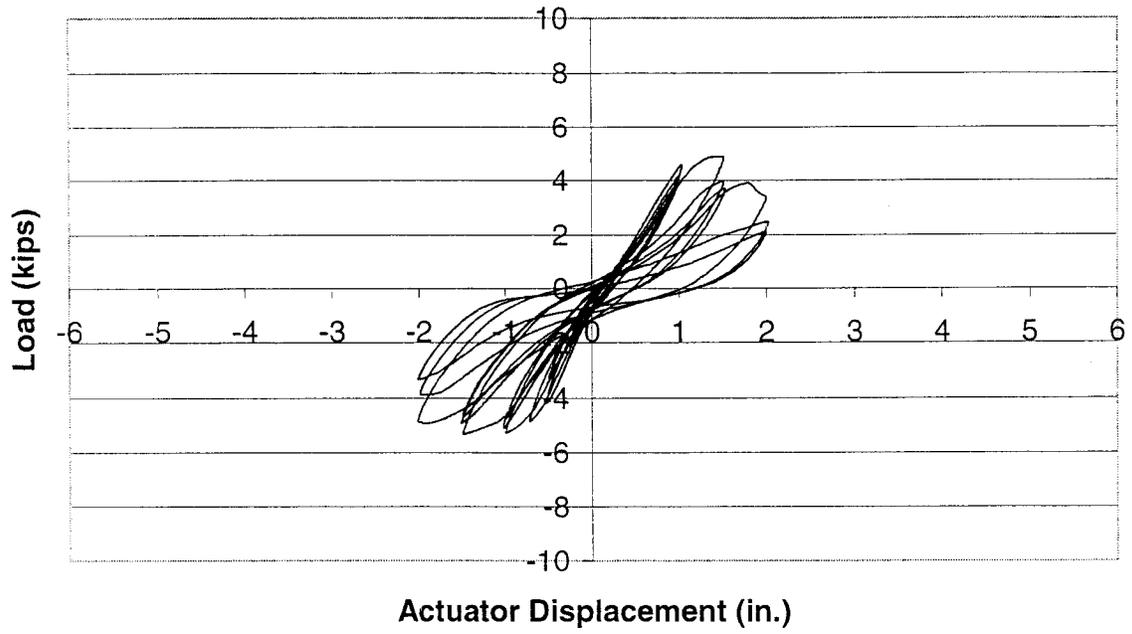
Figure 42 Load-Displacement Curves of Specimen AB2

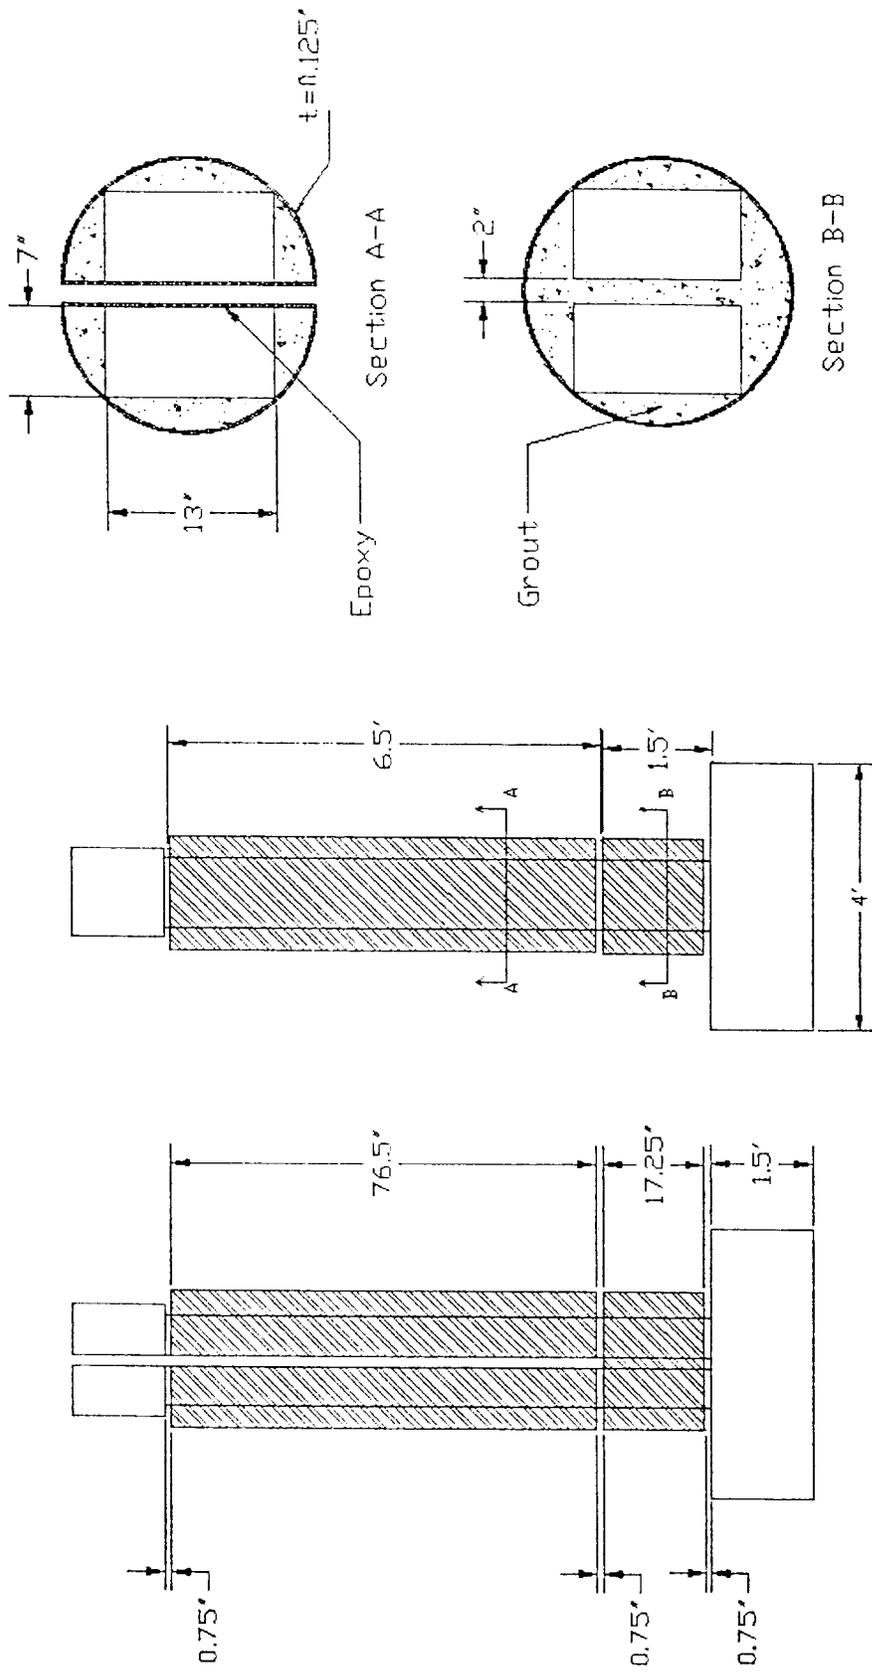
Figure 43 Retrofit Details for Specimen S14

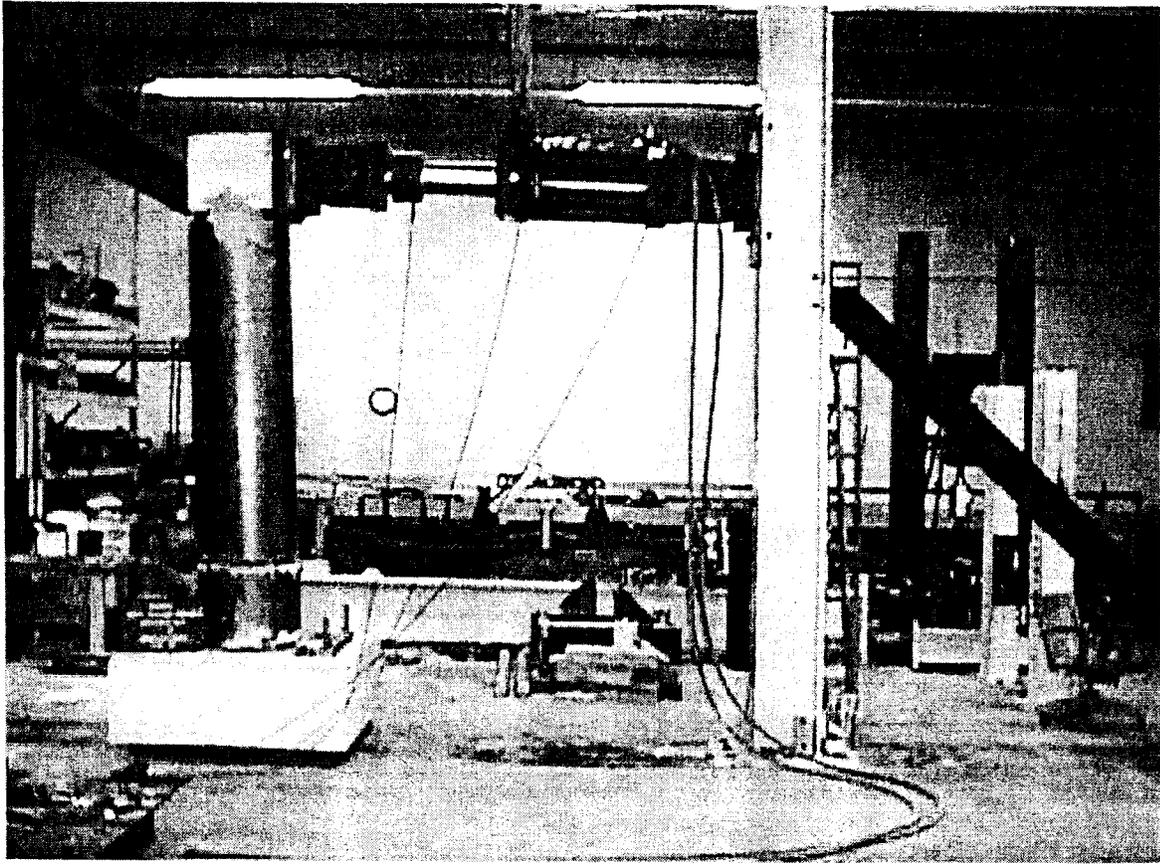
Figure 44 Specimen SJ4 Test Photograph

A photograph of Specimen SJ4 during testing is given in Figure 44. Load-displacement curves are presented in Figure 45. A peak applied load of 35 kN (7.9 kips) was reached at a displacement of 10.2 cm (4 in.). The specimen continued to resist this peak load until approximately 13 cm (5 in.) of displacement, at which time the load dropped. This corresponds to a displacement ductility capacity of approximately 7. Prior to the load dropping, a series of "popping" sounds were heard and "kinks" in the hysteresis curves were observed. The likely cause of these phenomena is reinforcement slippage in the lap splice region. By

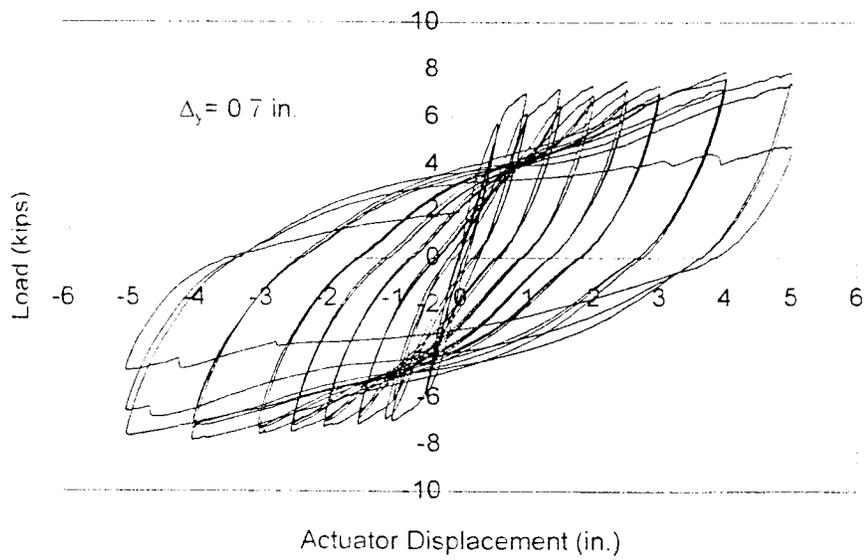
Figure 45 Load-Displacement Curves for Specimen SJ4

comparing the behavior of the steel jacketed specimen with that for the as-built specimen, significant improvement in ductility and energy dissipation is evident with the retrofitted specimen.

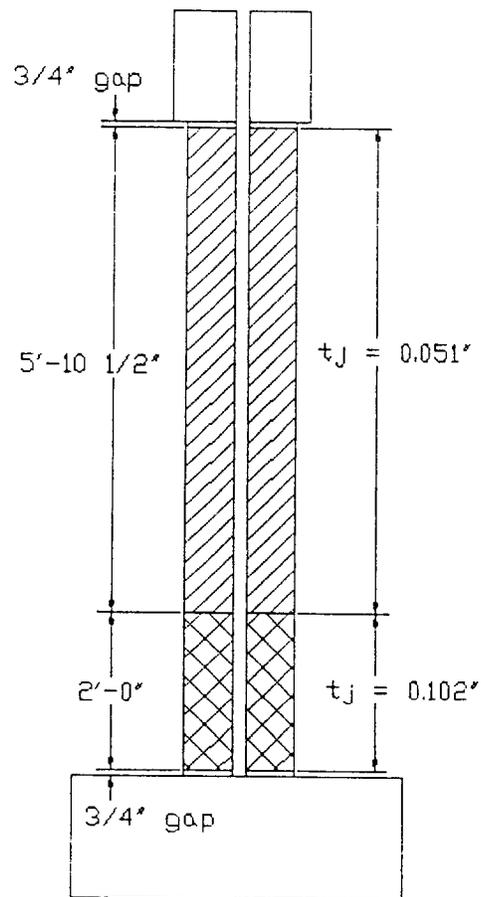
Figure 46 Retrofit Details for Specimen FW4

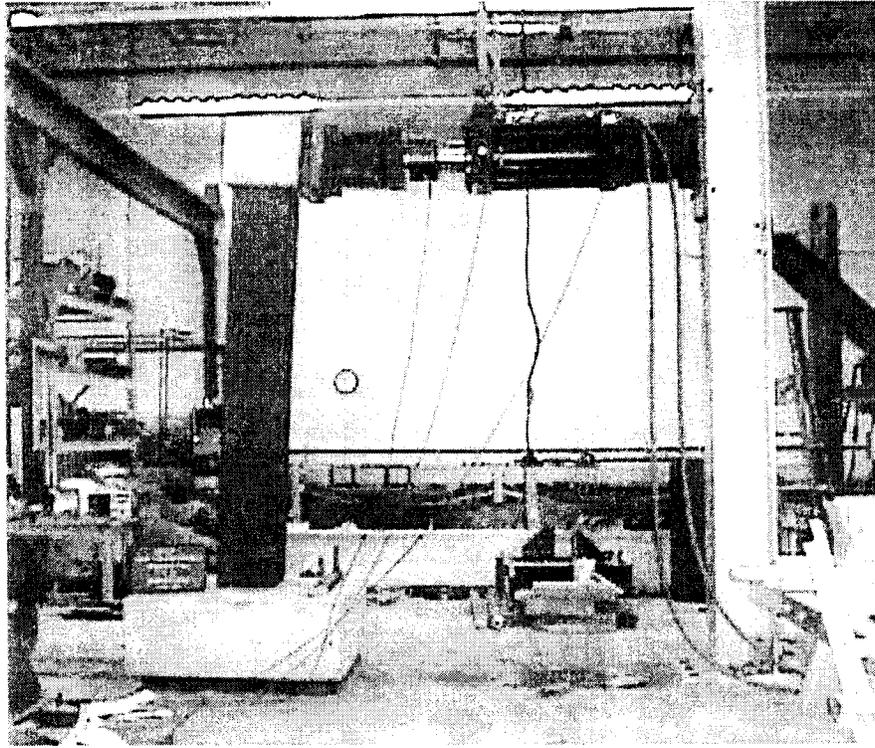
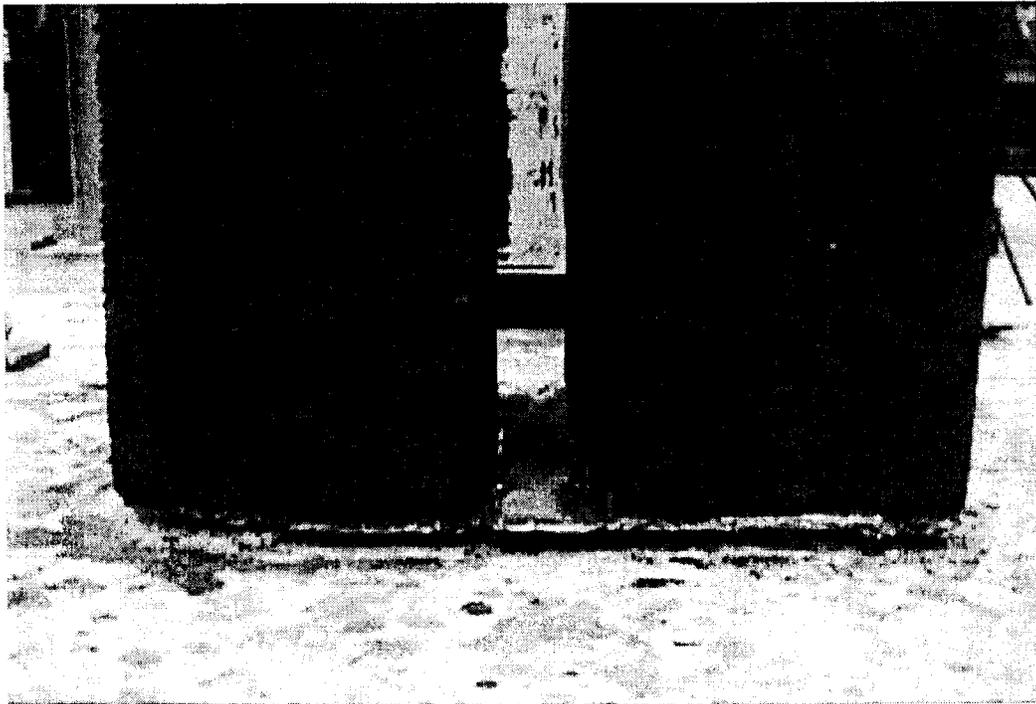
(a) Testing of Specimen FW4

(a) Opening at Base of Columns

Figure 47 Specimen FW4 Testing Photographs

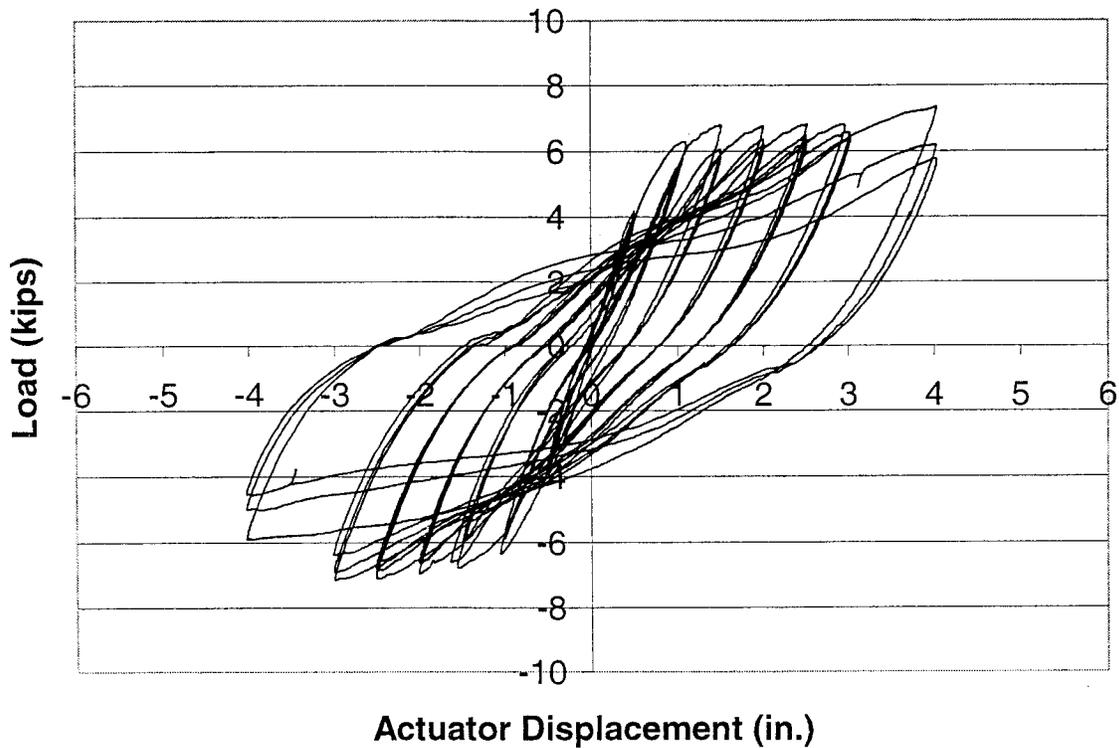
Figure 48 Load-Displacement Curves of Specimen FW4
