1. REPORT NO. <b>WA-RD 482.1</b>	2. GOVERNMENT ACCESSION NO.	3. RECIPIENT'S CATALOG NO.	
4. TITLE AND SUBTITLE <b>Retrofit of Split Bridge Columns</b>	5. REPORT DATE <b>February 11, 2000</b>

Research Project 9902-26  
Split Columns

**RETROFIT OF SPLIT BRIDGE COLUMNS**

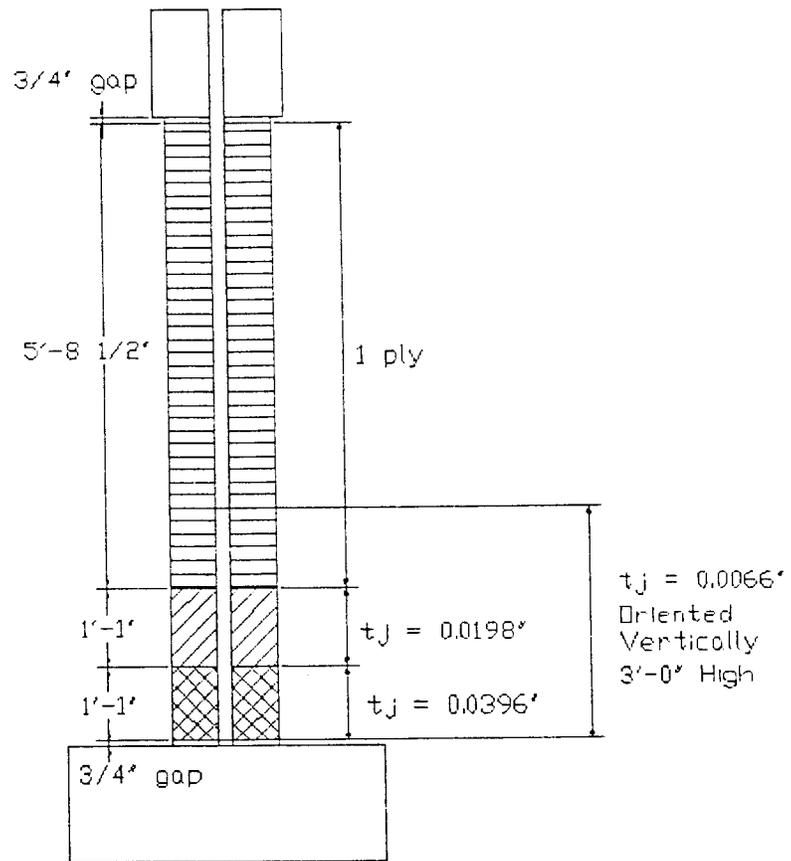
Figure 49 Retrofit Details for Specimen FW5

using the Sumitomo retrofit system. The plastic hinge confinement design for the split sections was performed using both the ACTT-95/08 Provisions (Seible, et al, 1995) and the provisions proposed by Priestley, et al (1996). The controlling jacket thickness came from the Priestley, et al (1996) provisions. The jacket thickness was not doubled as recommended for a rectangular cross-section and jacket strains were limited to 0.004. The controlling jacket thickness was due to a required ultimate compression strain in the concrete of 0.00575. For Specimen FW5, a 33-cm (13-in.) strip of 0.00396-in. thick material was installed in the primary plastic hinge region, and a 33-cm (13-in.) strip of 0.00198-in. thick material was installed in the secondary plastic hinge region. Sumitomo installed one ply ( $t_j=0.0066$  in.) of vertically oriented material on all sides of the bottom 0.9 m (3 ft) of the column to help distribute stresses. Lap splice confinement calculations, per the ACTT-95/08

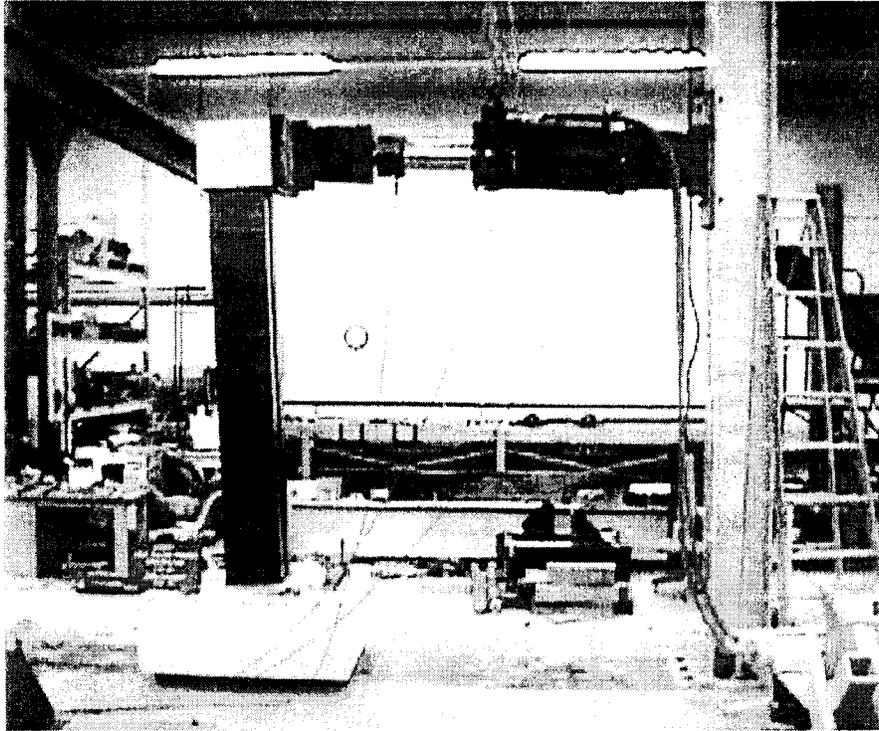
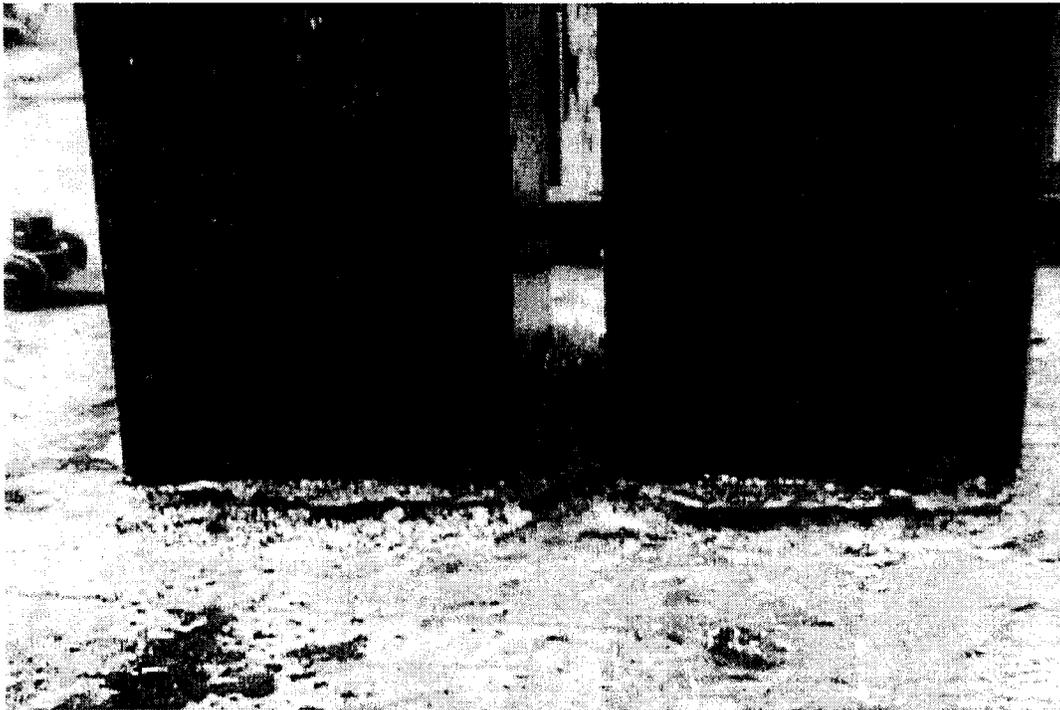
(a) Testing of Specimen FW5

(a) Opening at the Base of the Columns

Figure 50 Specimen FW5 Testing Photographs

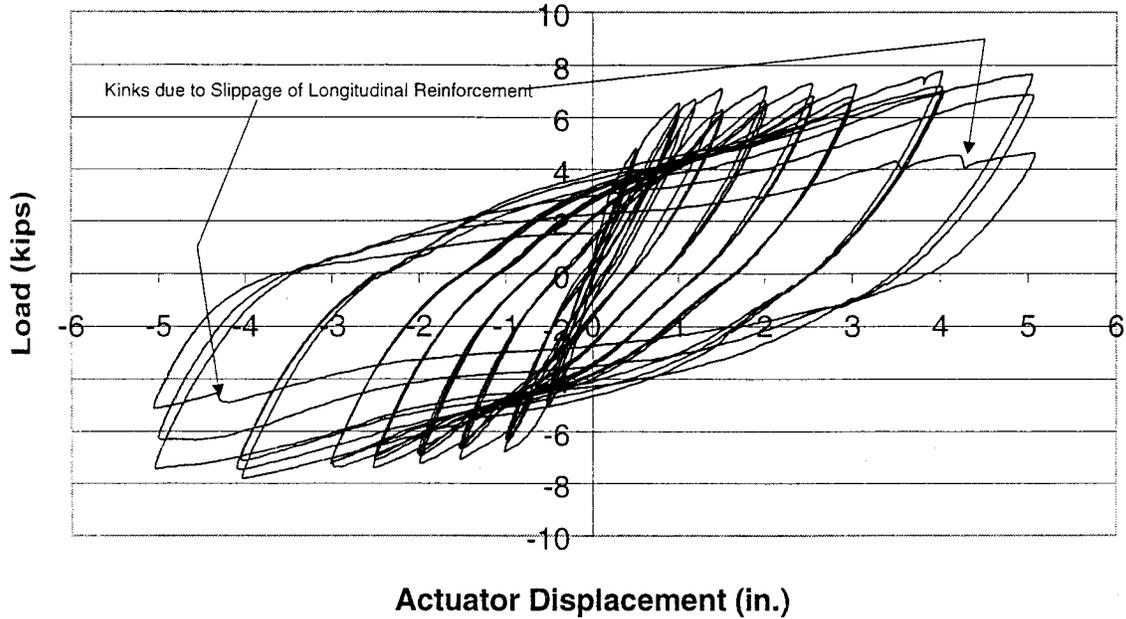
Figure 51 Load-Displacement Curves of Specimen FW5

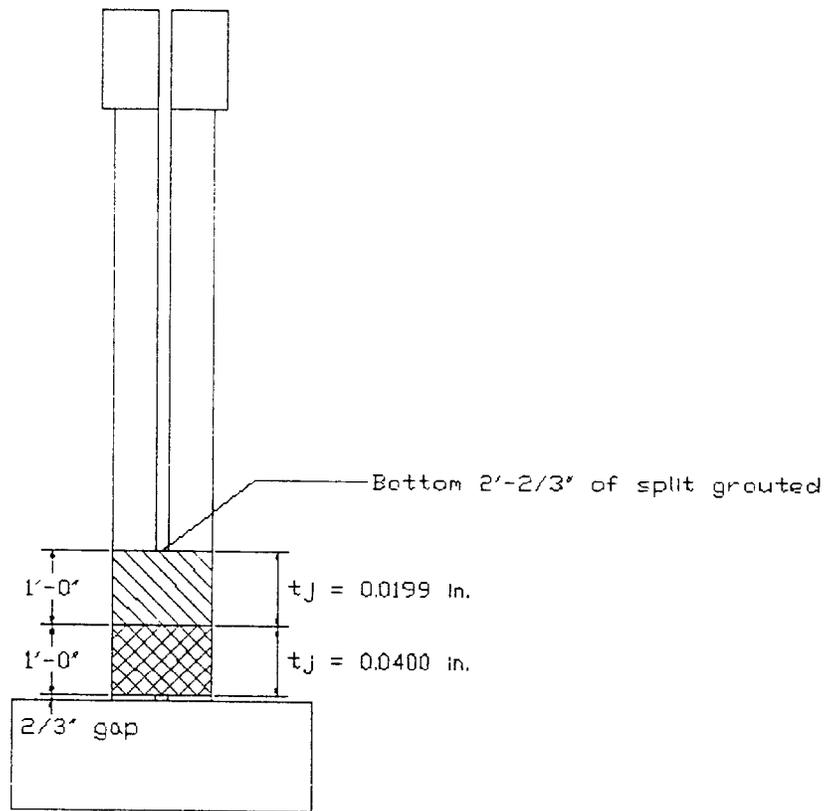
Figure 52 Retrofit Details for Specimen FW6

Specimen FW6 was constructed similarly to the as-built specimen AB2, except that it was retrofitted with the XXSys retrofit system. The split in the plastic hinge region was filled with grout prior to retrofit installation to provide confinement on the inside faces of the split. The plastic hinge confinement design was again based on the ACTT-95/08 Provisions (Seible, et al, 1995). The controlling jacket thickness was due to a required ultimate compression strain in the concrete of 0.0053. A 30-cm (12-in.) strip of 0.0400-in. thick material was installed in the primary plastic hinge region, and a 30-cm (12-in.) strip of 0.0199-in. thick material was installed in the secondary plastic hinge region. Lap splice confinement calculations for the transverse specimen were done in accordance with the ACTT-95/08 Provisions, yielding a required jacket thickness of

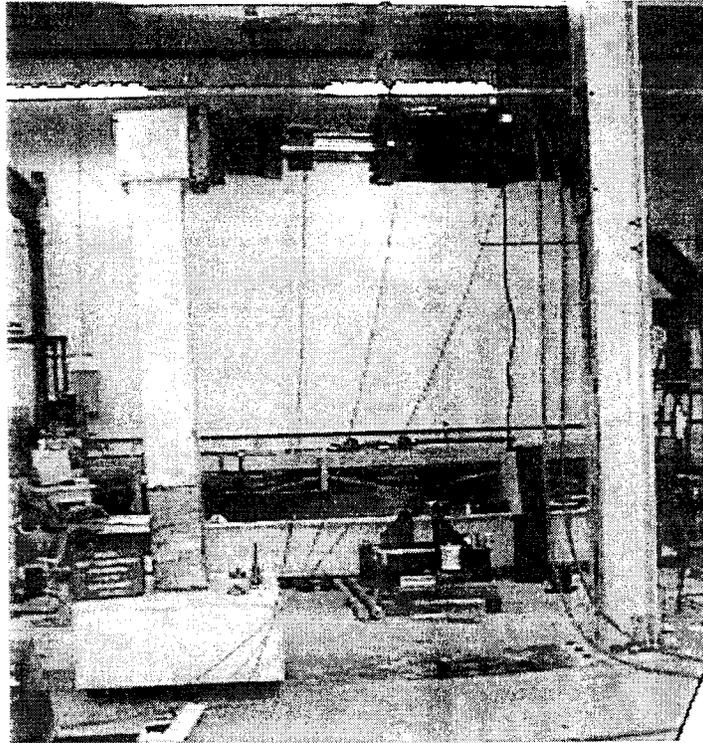
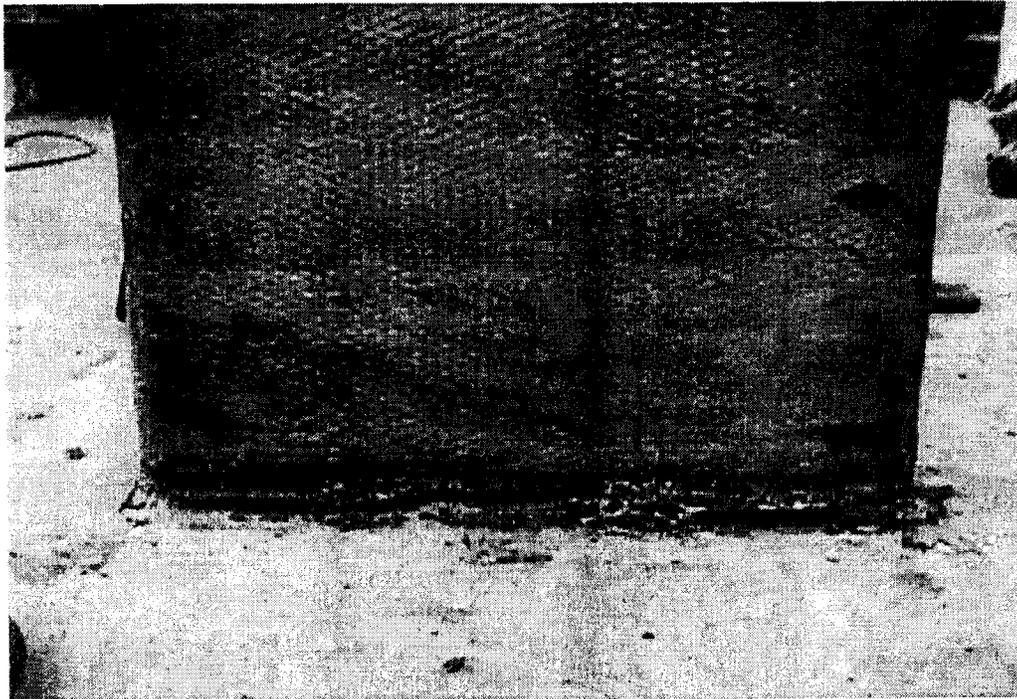
(a) Testing of Specimen FW6

(b) Crack Opening at Base of Columns

Figure 53 Specimen FW6 Test Photographs

Testing photographs of Specimen FW6 are shown in Figure 53. The load-displacement hysteresis curves for Specimen FW6 are given in Figure 54. The specimen experienced a peak load of 30.9 kN (6.94 kips) during the first loading cycle at a displacement of 10.2 cm (4 in.). During the following two loading cycles at a 10.2-cm (4-in.) displacement, the specimen experienced a 65% drop in lateral load capacity. Lap splice degradation at the base of the split section was judged to be the cause of the failure, with a displacement

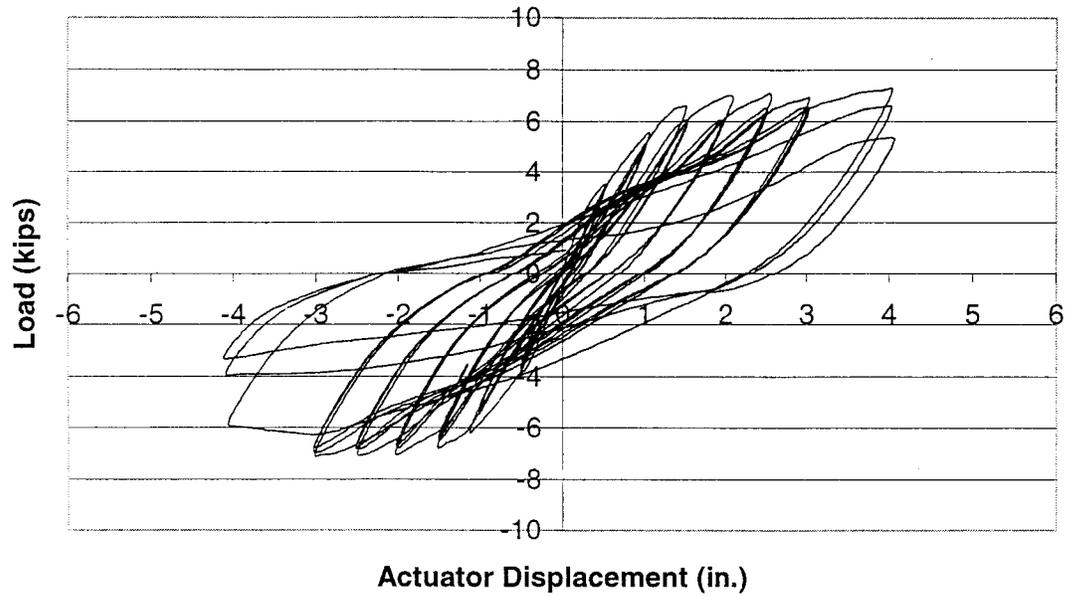
Figure 54 Load-Displacement Curves of Specimen FW6

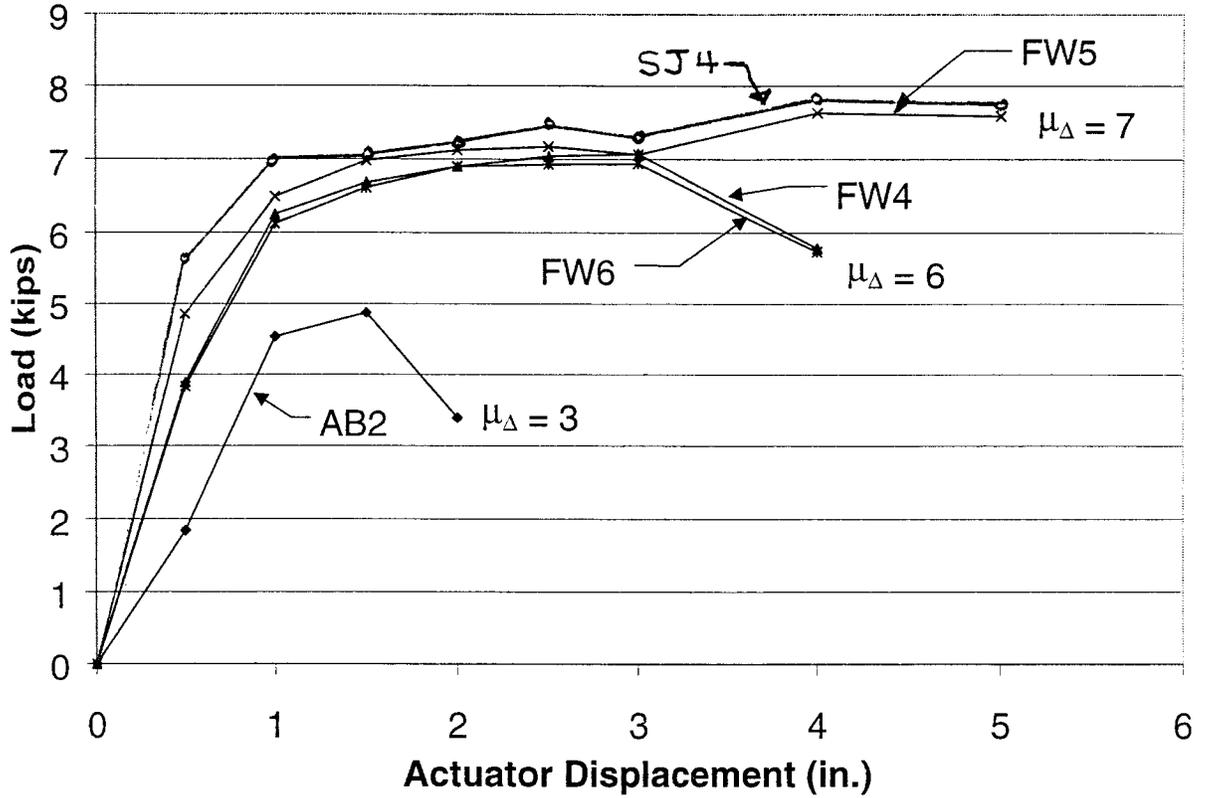
Figure 55 Peak Load-Displacement Envelope of Transverse Specimens
