Final Research Report
Research Project T2695, Task 35
Bucoda Phase III

**LONG-TERM PERFORMANCE OF GEOTEXTILE SEPARATORS
BUCODA TEST SITE—PHASE III**

October 2005

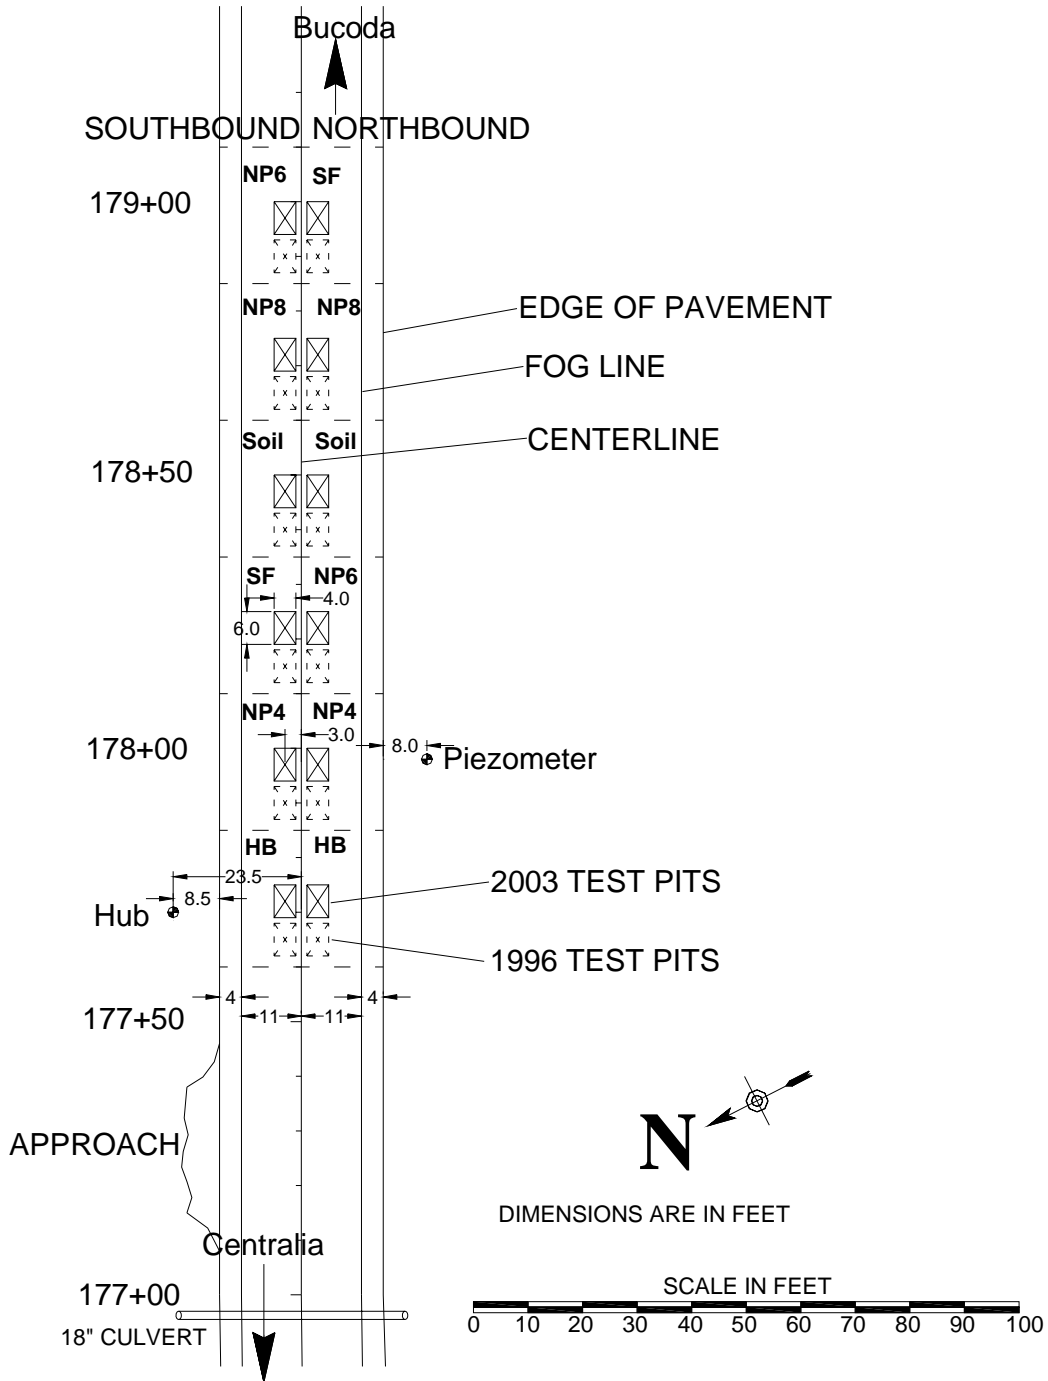
The test section was 150 ft (45.7 m) long and was divided into six 25-ft-long (7.6-m) sections in each travel lane. The project stationing was from 177+60 to 179+10 (ft). Each travel lane contained five different types of geotextile separators and one soil-only control section. The properties of the geotextiles are summarized in Table 1.1.

Figure 1.2. Test section layout.

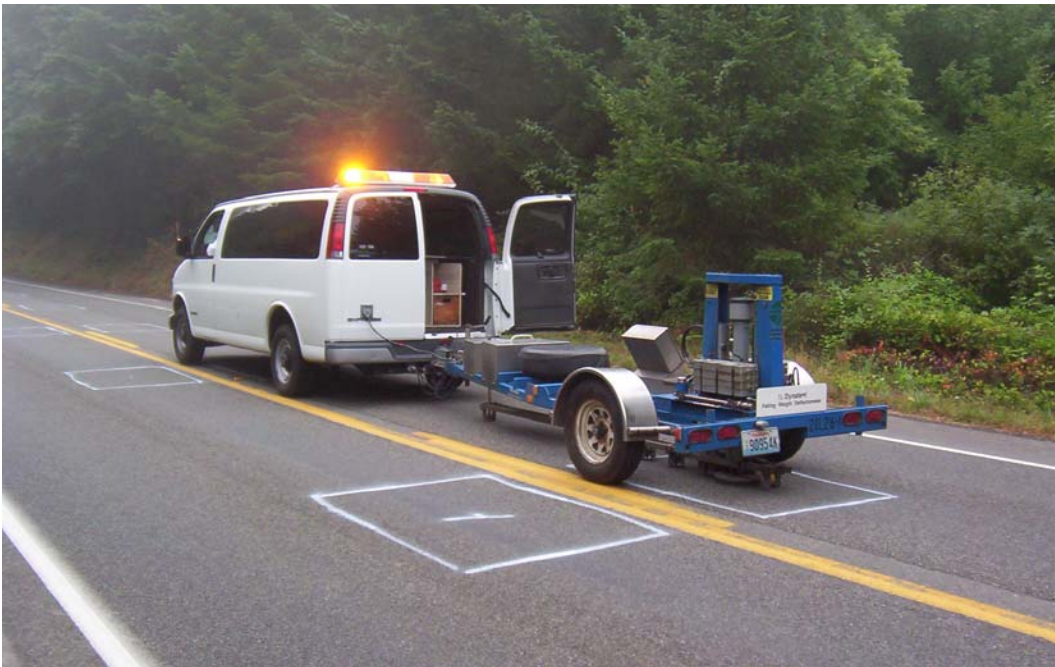
Figure 3.4. Falling weight deflectometer (FWD) trailer and van.

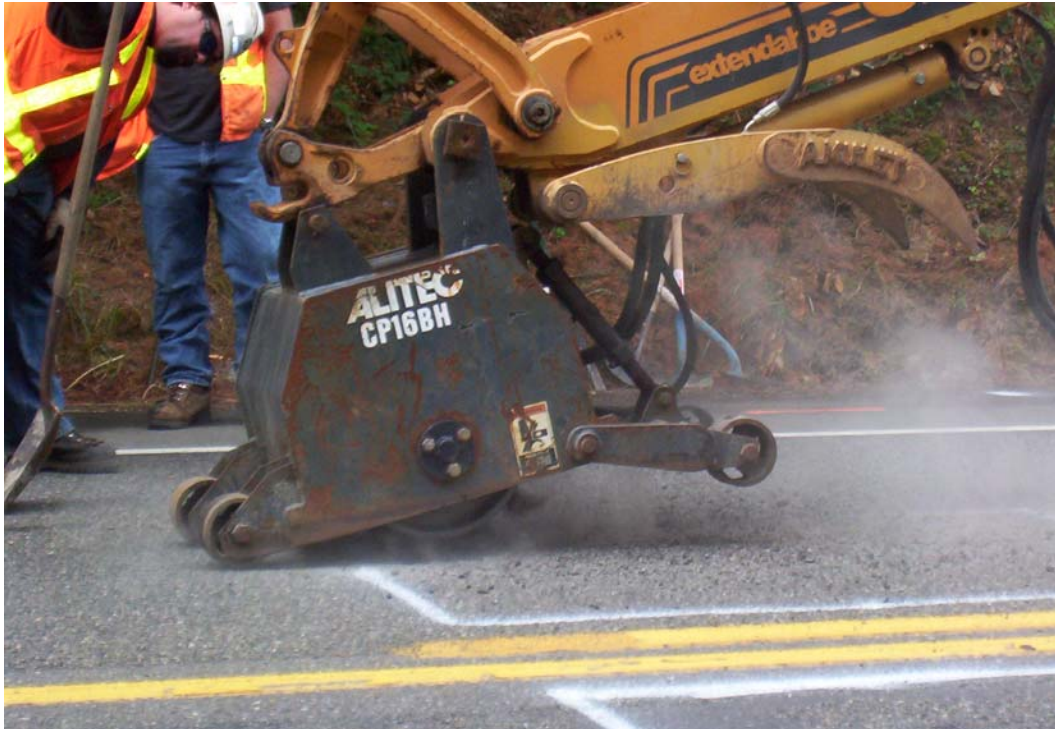
Figure 3.5. Pavement grinding operation.

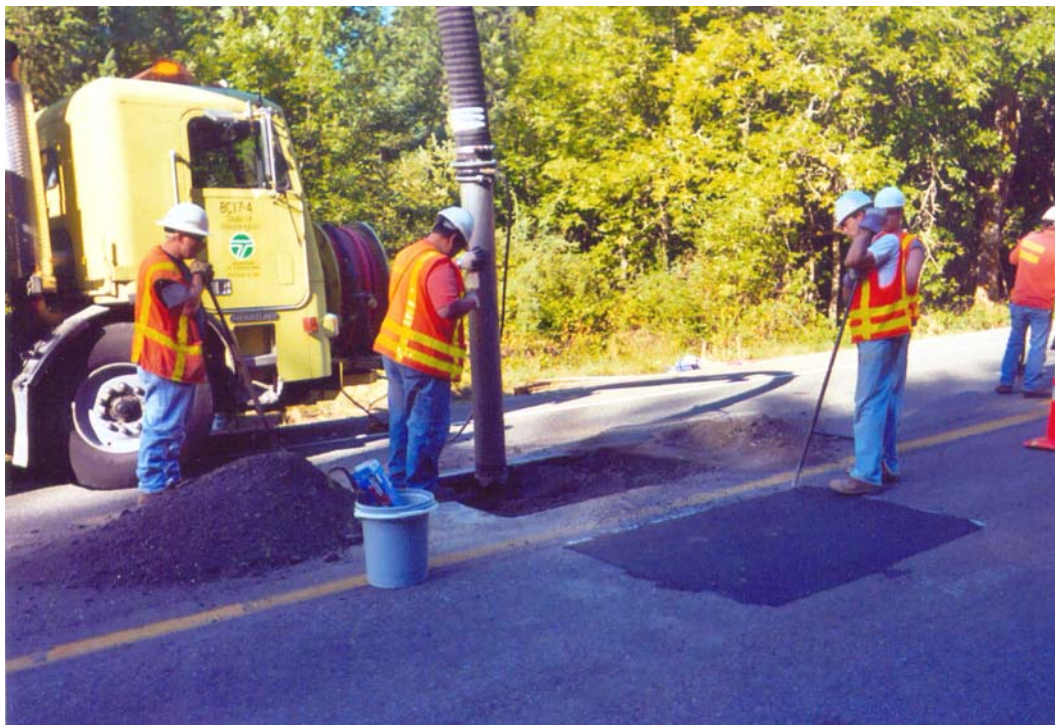
Figure 3.6. Removing the base course with a vacuum truck.

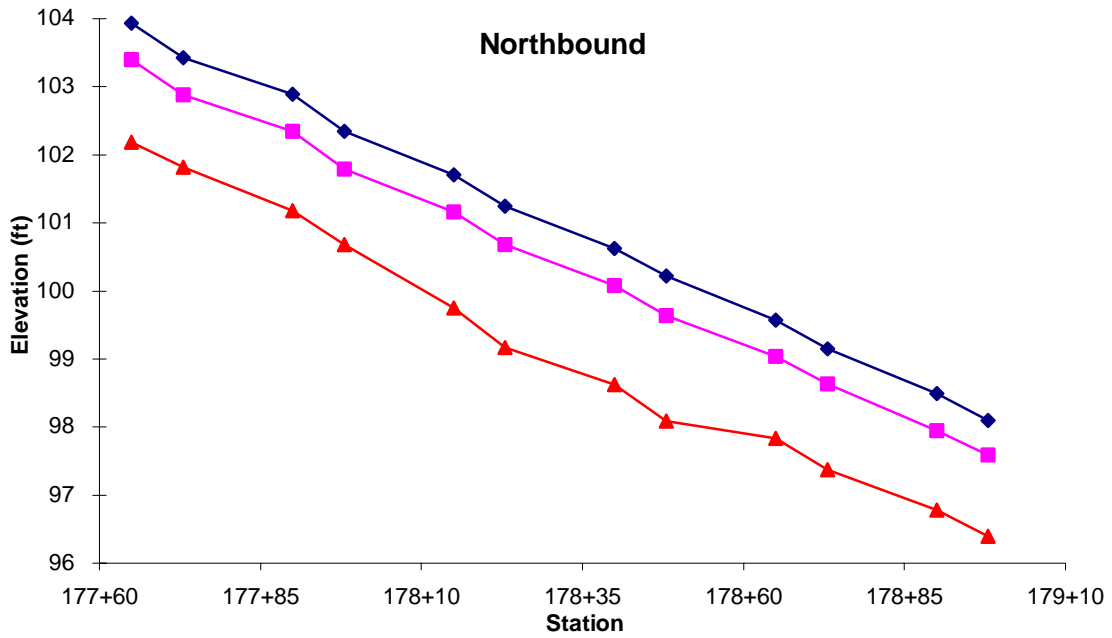
Figure 3.9. Profiles through the center of the test sections, northbound lane.

The base course material consisted of crushed basalt that was specified to meet the requirements for crushed surfacing base course (CSBC). The CSBC material was well-graded, with 100 percent of the material passing the 1 ½-in. sieve and less than 10 percent passing the No. 200 sieve. The base course thickness ranged from 12.7 to 18.6 in. (320 to 470 mm) in the northbound lane and from 20.0 to 26.4 in. (510 to 670 mm) in the southbound lane. The design base course thickness was 12 in. (300 mm) for the northbound lane and 18 in. (460 mm) for the southbound lane. Figures 3.9 and 3.10 show

the profiles through the center of the test section in the northbound and southbound lanes, respectively.

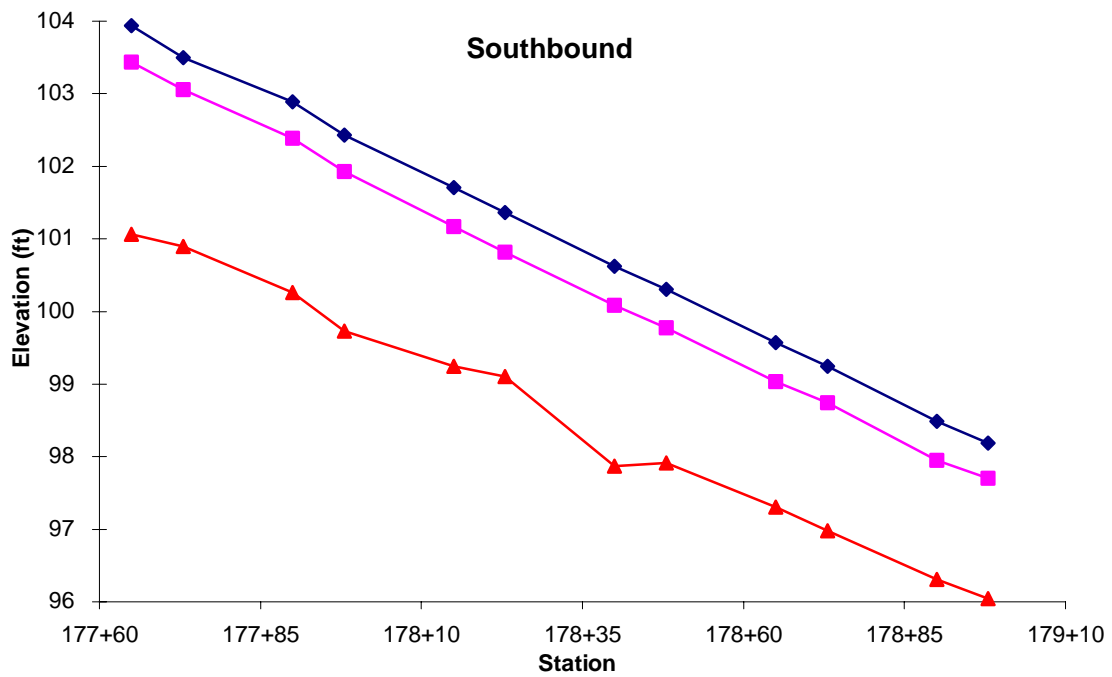
Figure 3.10. Profiles through the center of the test sections, southbound lane.

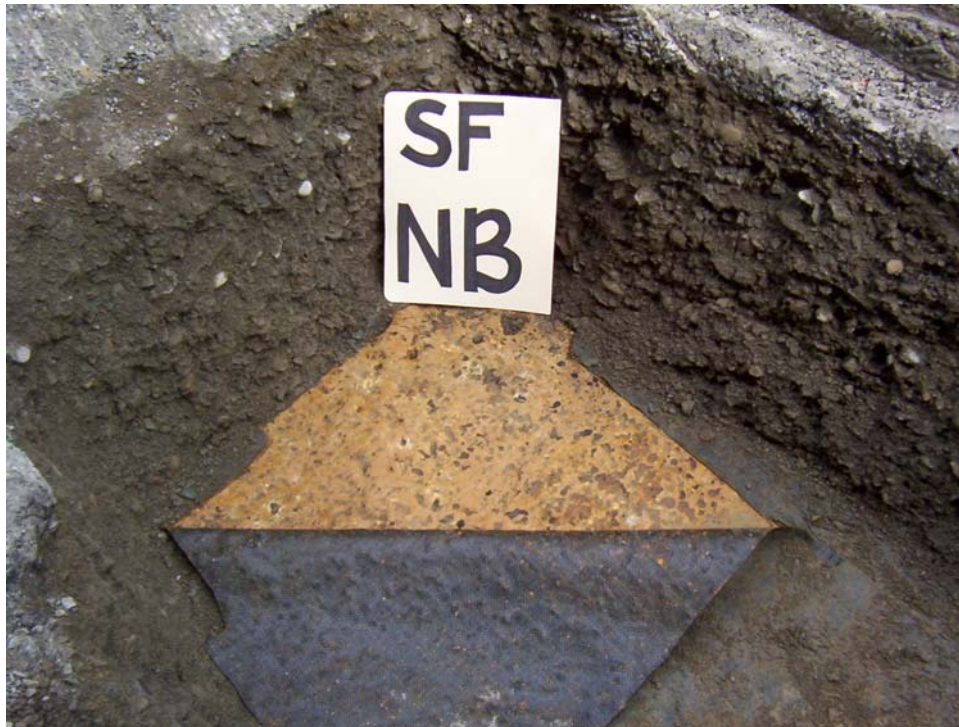
Figure 3.12. SF-NB test pit with geotextile peeled back.

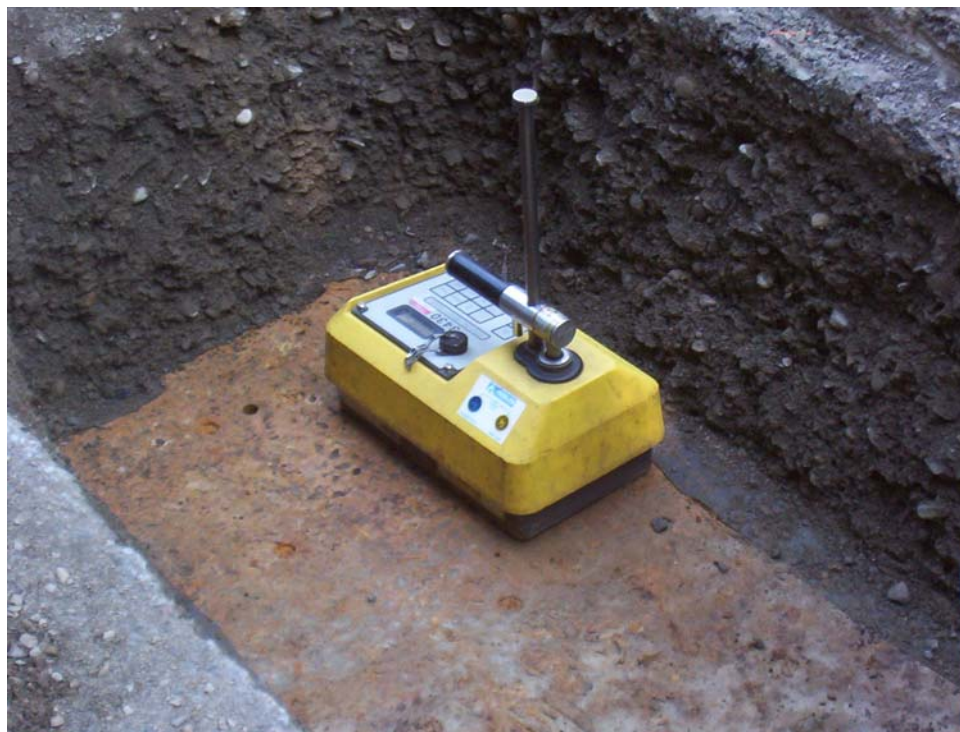
Figure 3.14. Nuclear density test in SF-NB test pit.

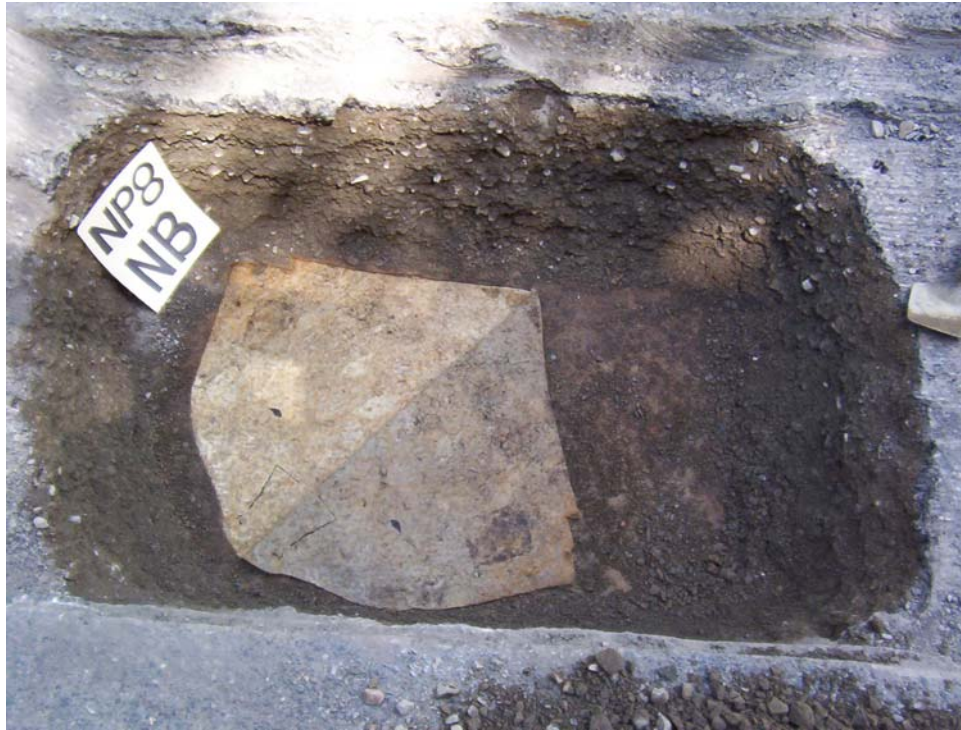
Figure 3.15. NP8-NB test pit with geotextile peeled back.

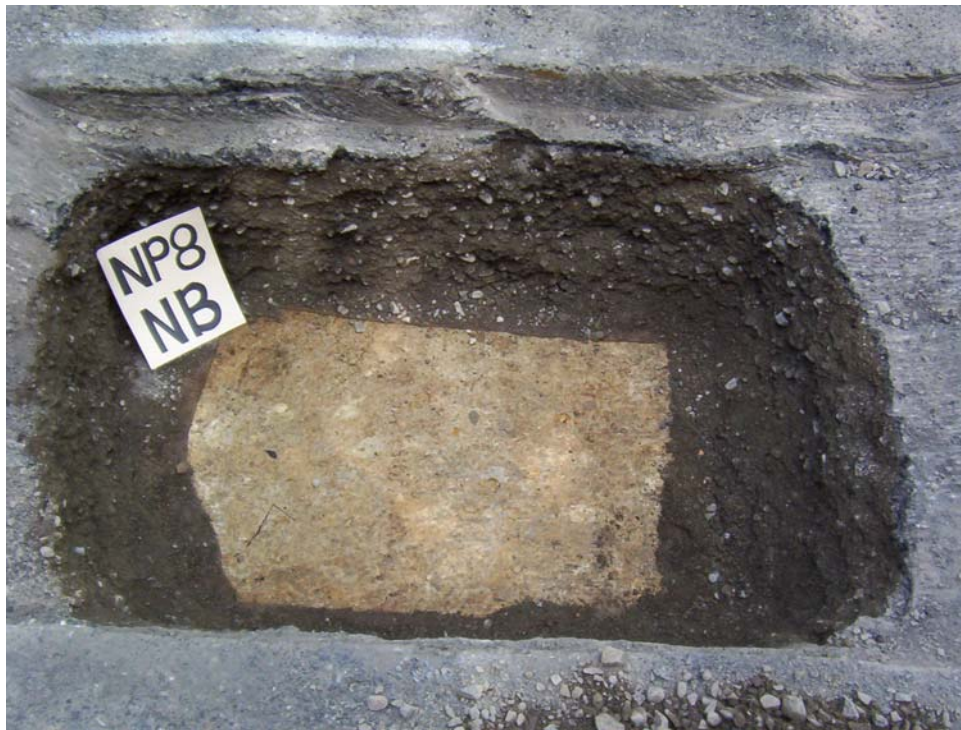
Figure 3.16. NP8-NB test pit after removal of geotextile.

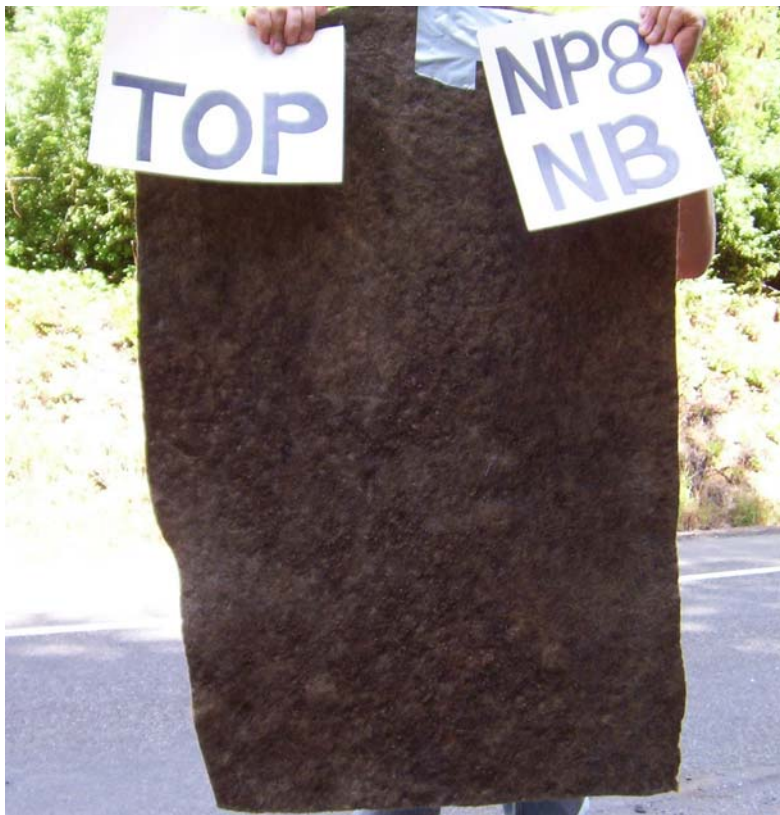
Figure 3.18. Top of NP8-NB geotextile after removal.

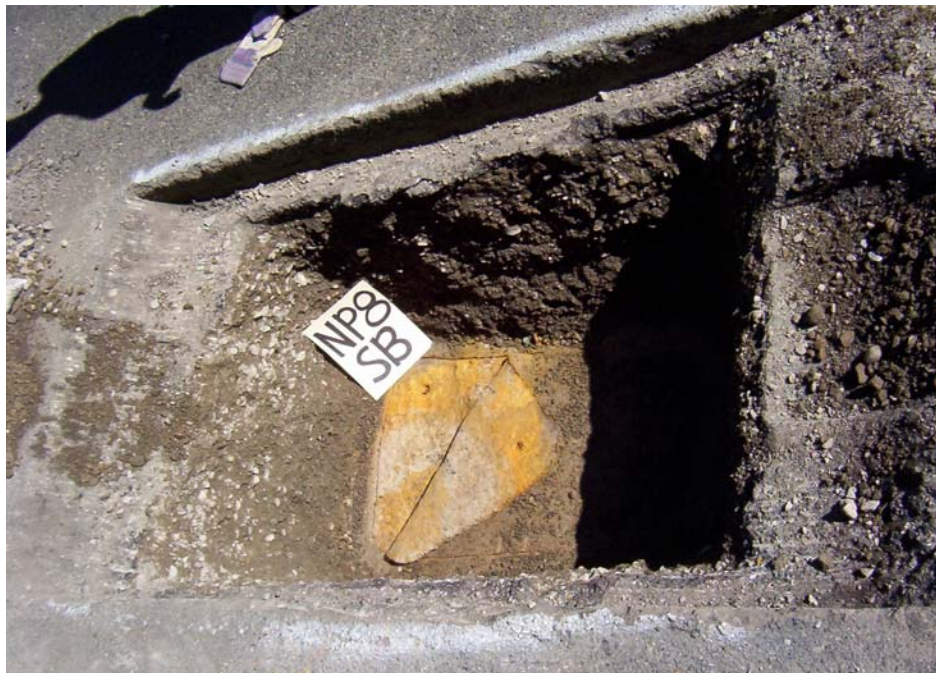
Figure 3.22. NP8-SB test pit with geotextile peeled back.

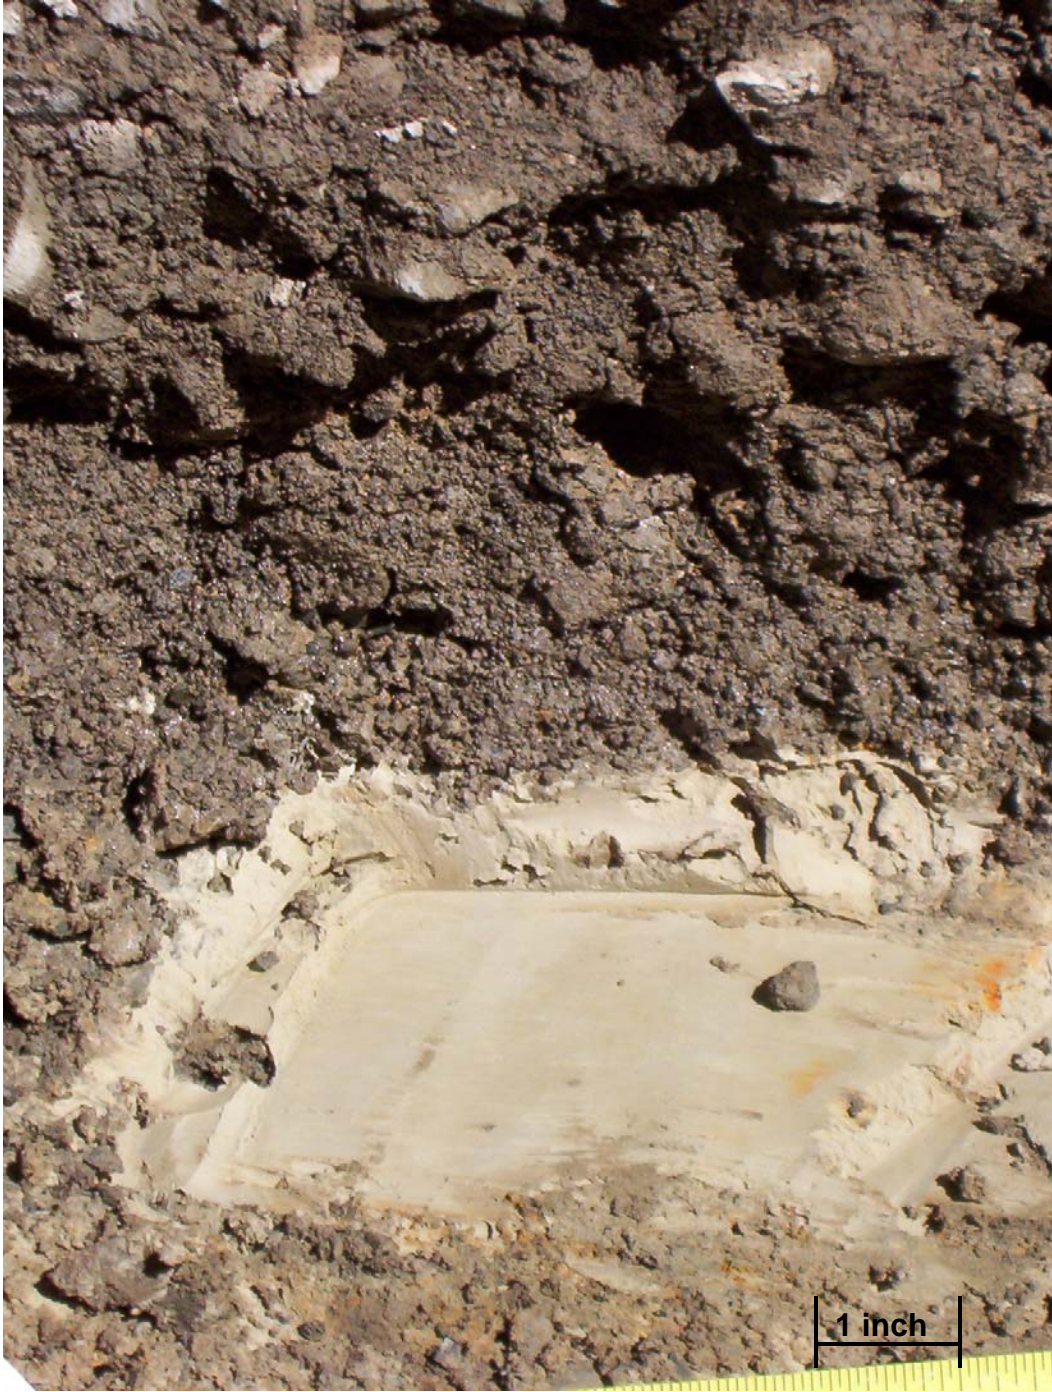
Figure 3.24. Soil-SB test pit after exposure of subgrade.

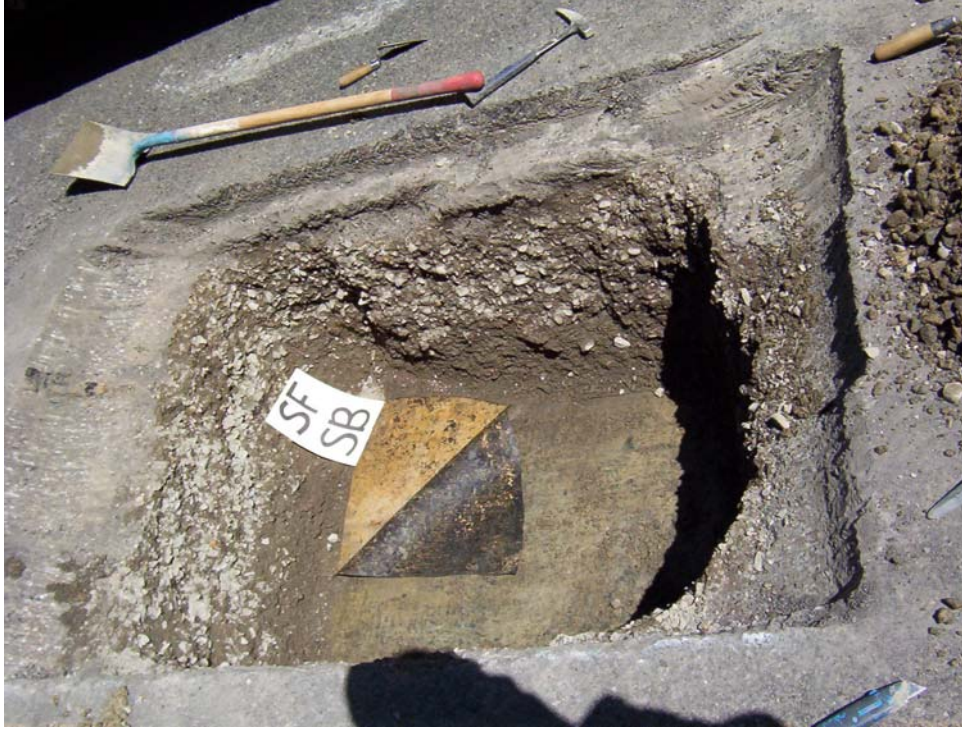
Figure 3.25. Geotextile peeled back in SF-SB test pit.

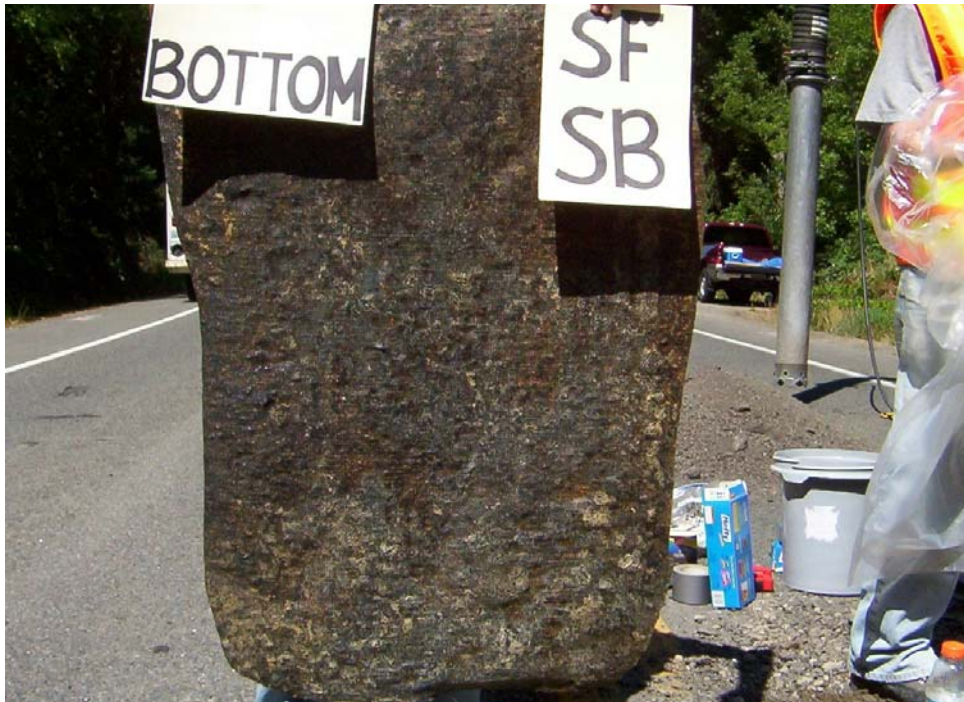
Figure 3.26. Bottom of SF-SB geotextile after removal.

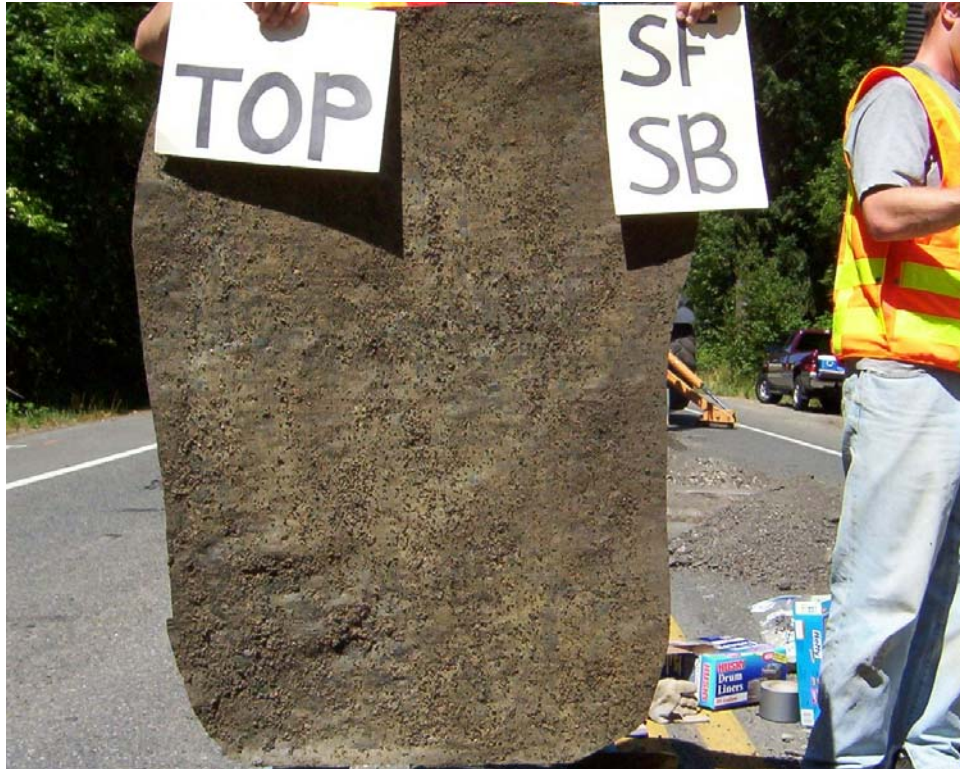
Figure 3.27. Top of SF-SB geotextile after removal.

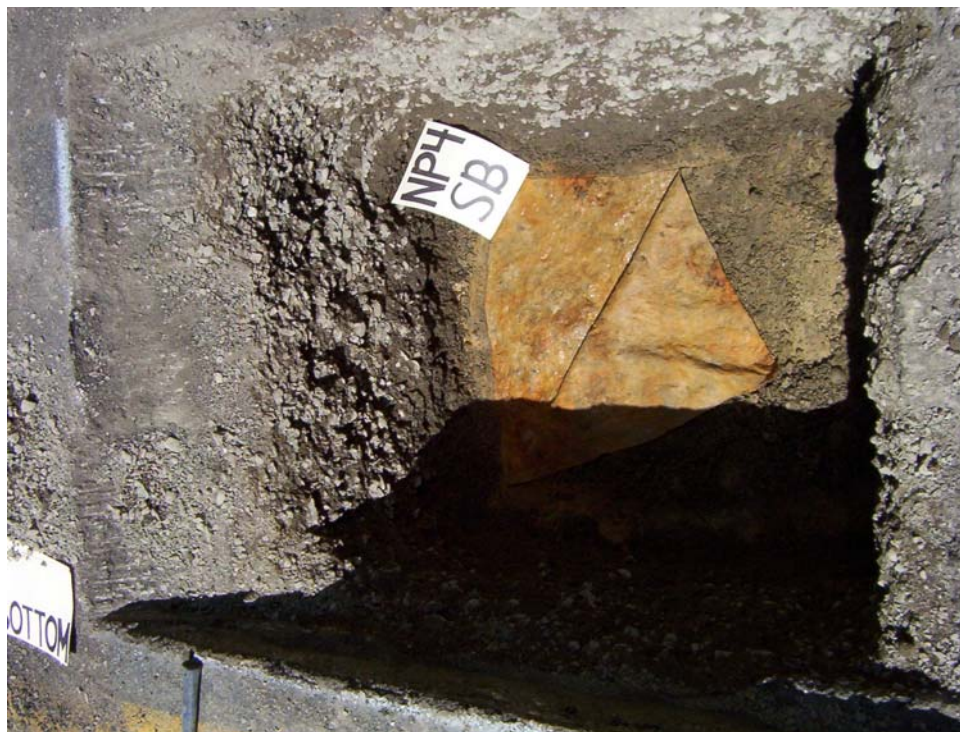
Figure 3.28. NP4-SB test pit with geotextile peeled back.

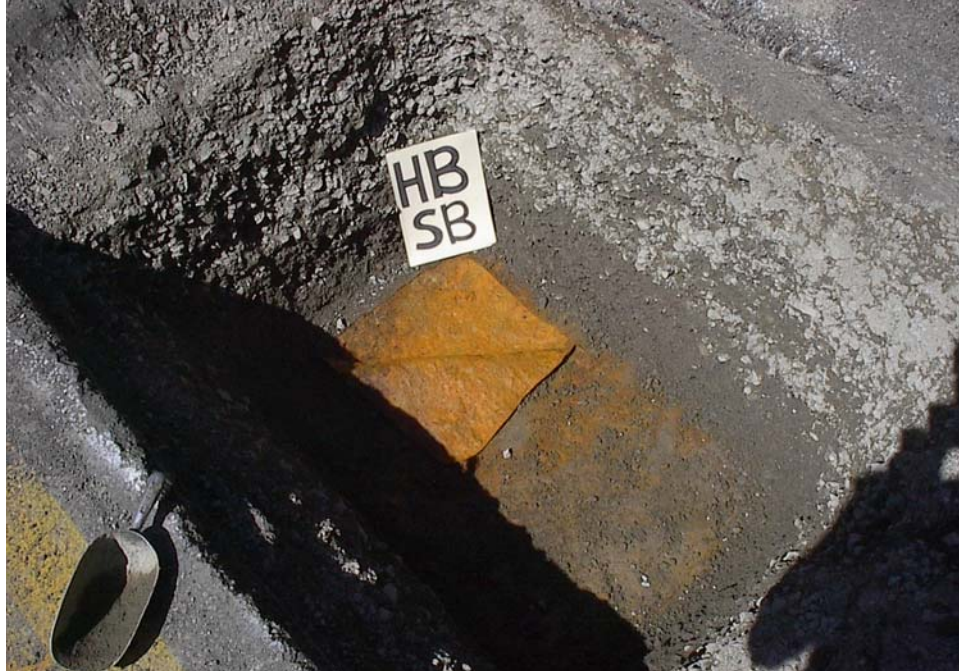
Figure 3.31. HB-SB test pit with geotextile peeled back.

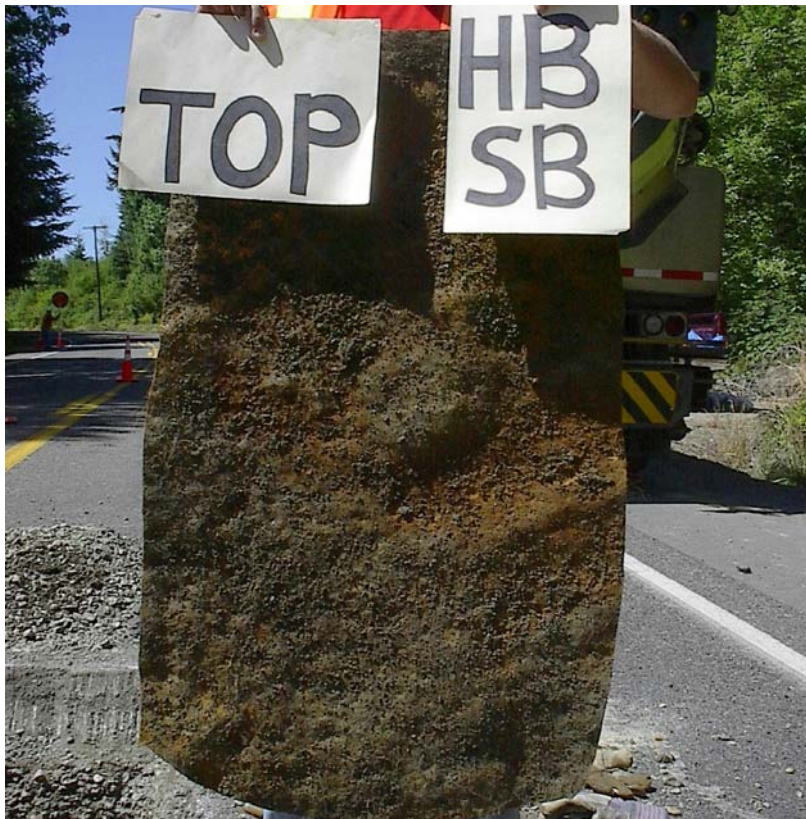
Figure 3.32. Top of HB-SB geotextile.

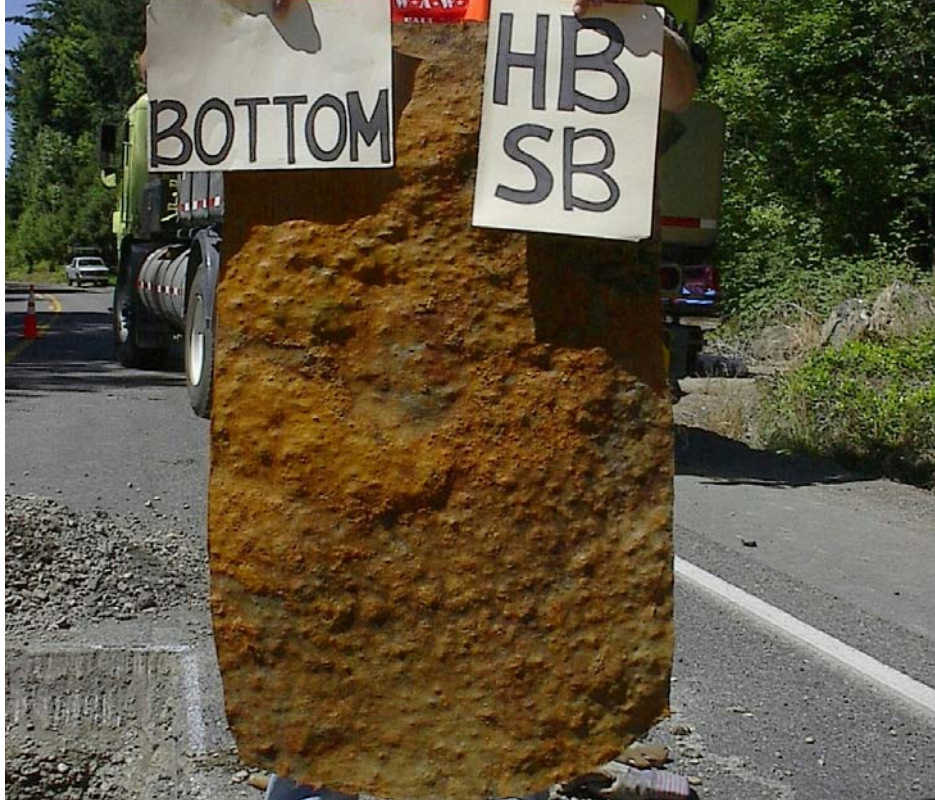
Figure 3.33. Bottom of HB-SB geotextile after removal.

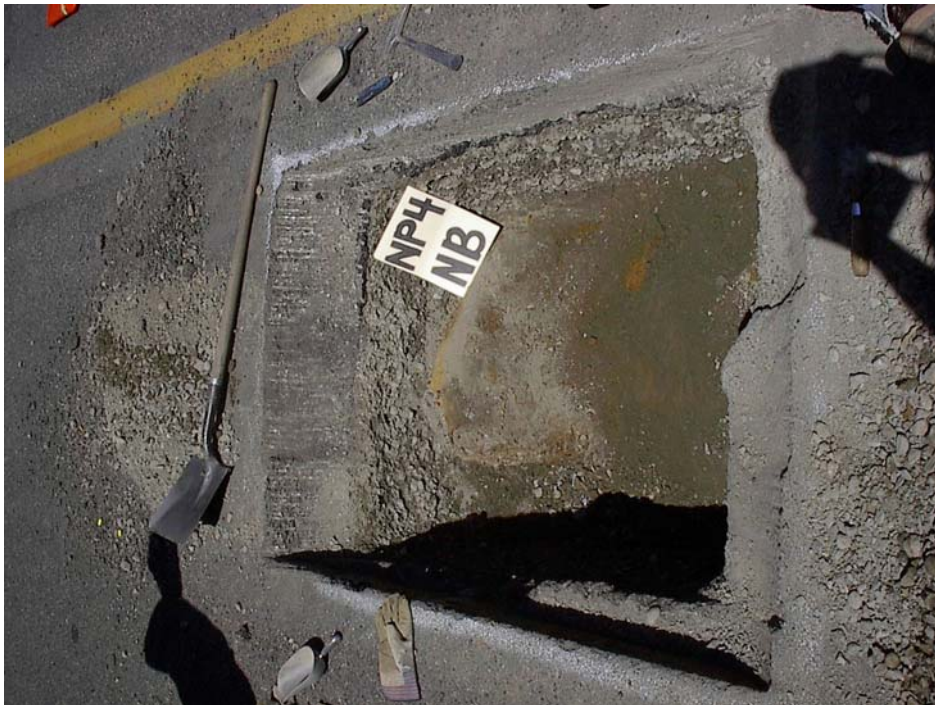
Figure 3.34. NP4-NB test pit prior to geotextile removal.

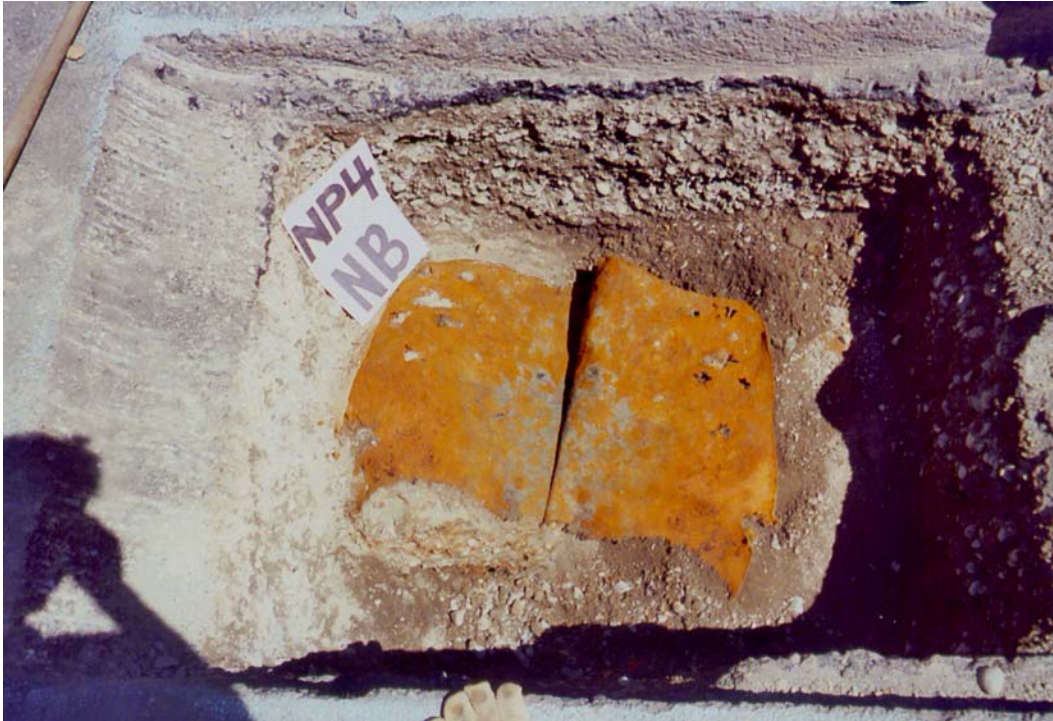
Figure 3.35. NP4-NB test pit with geotextile peeled back.

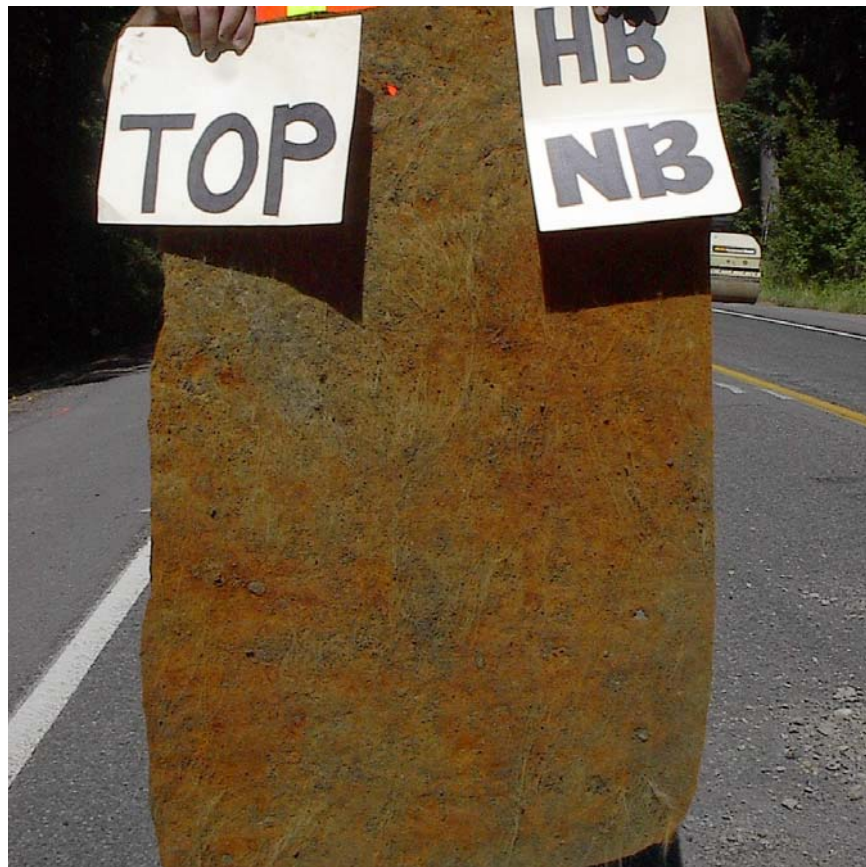
Figure 3.40. Top of HB-NB geotextile after removal.

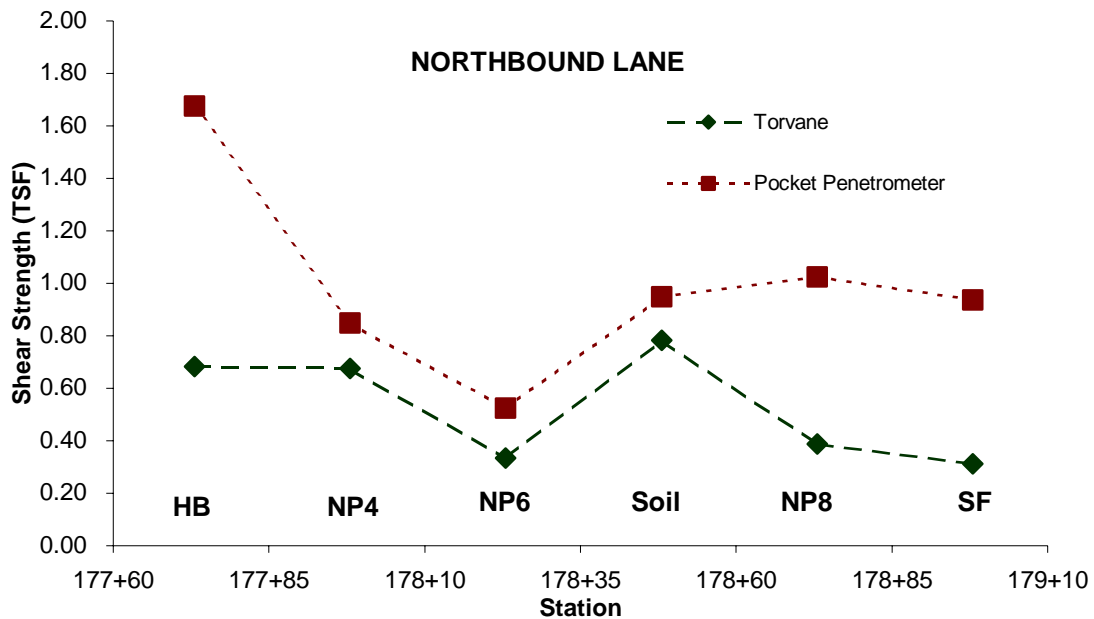
Figure 3.41. Comparison of in situ shear strength tests, northbound lane.

Comparisons of the shear strength determined from the pocket penetrometer tests and torvane tests for the southbound and northbound lanes are shown in figures 3.41 and 3.42, respectively. Comparisons among the NP4-SB, NP4-NB, Soil-SB, NP8-SB, NP6-SB-W, NP4-NB, NP6-NB, and Soil-NB sections were good. The HB-SB, NP6-SB-E, HB-NB, NP8-NB, and SF-NB sections were significantly different. The significant difference was likely due to several factors, but the highly variable subgrade soil conditions that were encountered in the test section probably contributed most to the differences. The pocket penetrometer and torvane test only a very small amount of soil, thus yielding variable results when conditions are not uniform.

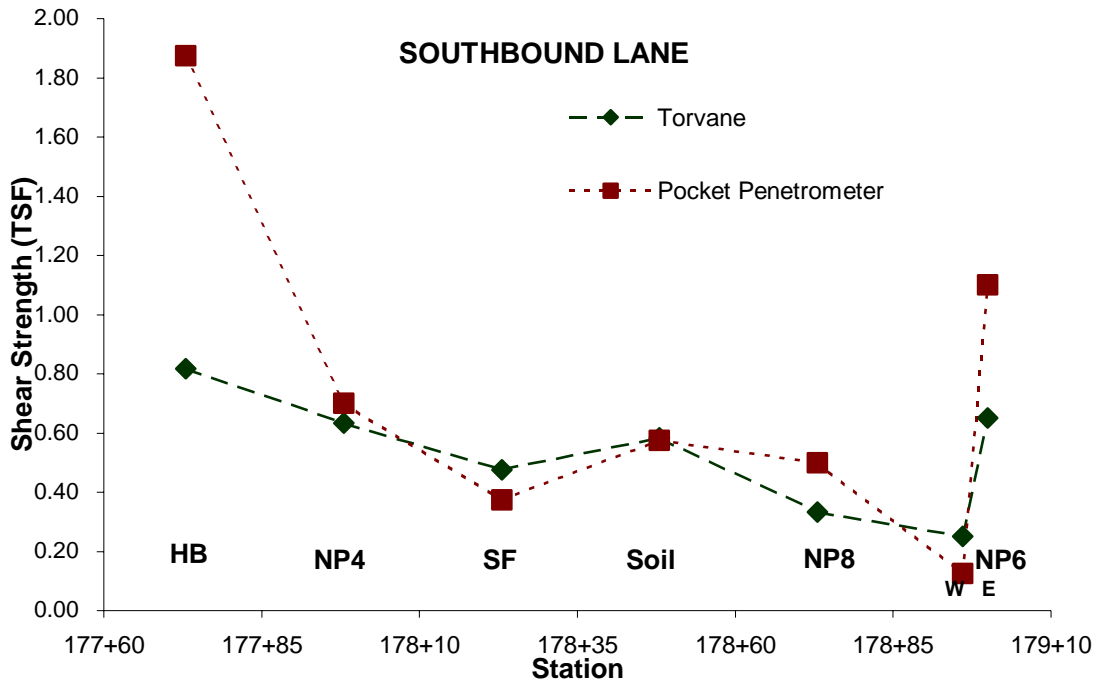
Figure 3.42. Comparison of in situ shear strength tests, southbound lane.

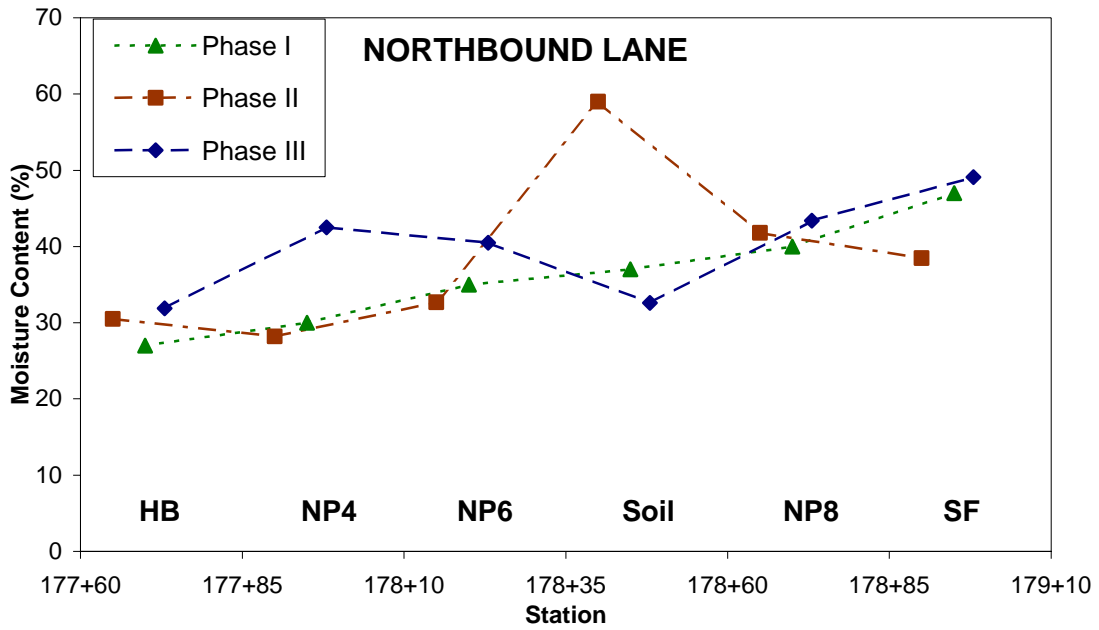
Figure 5.1. Summary of subgrade water content tests, northbound lane.

The figures show that the water contents generally increased with stationing (toward the town of Bucoda), which is downhill. In general, the water contents were lowest during construction (Phase I) and highest during the Phase III investigation. This observation seems counterintuitive, since installation of the geotextiles should improve drainage, thereby lowering the water content. The inconsistency in the water content findings may be attributed to the variability of the soils along the test section and seasonal fluctuations due to changes in weather patterns, temperature, and precipitation.

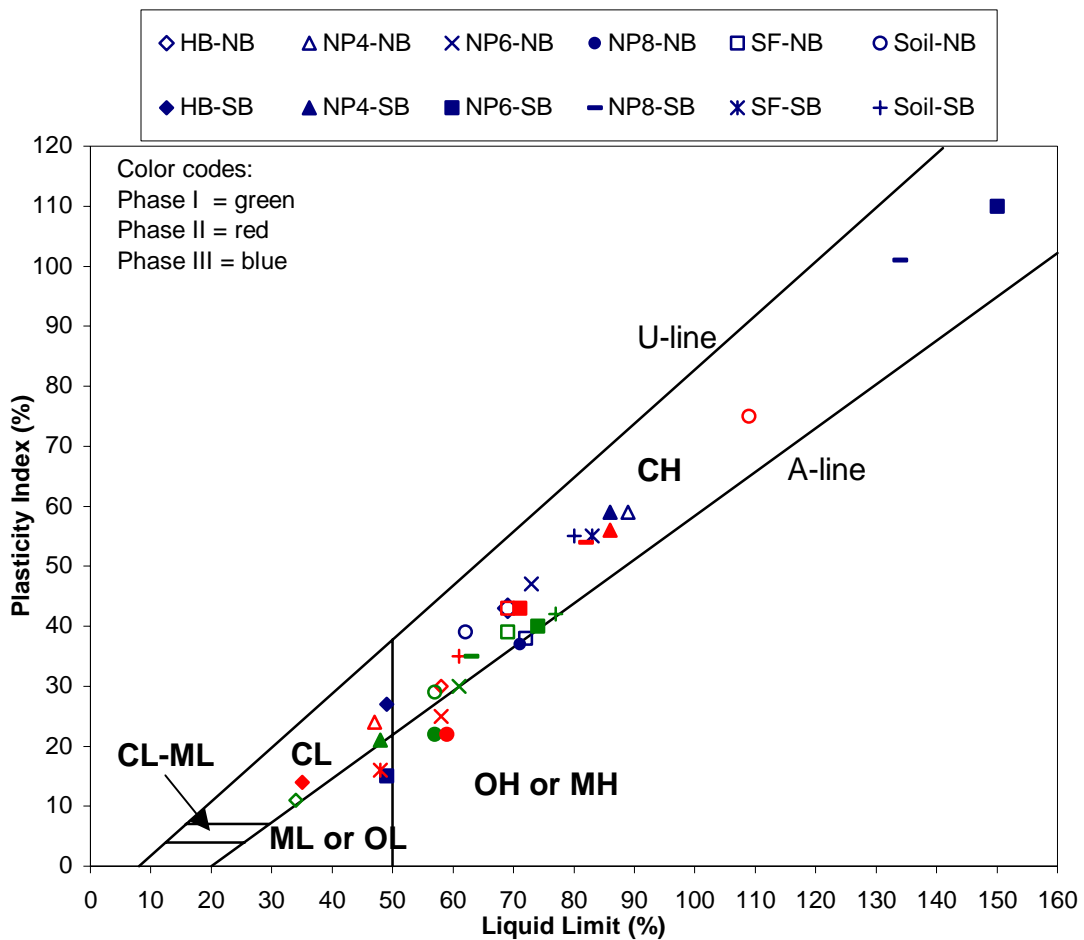
Figure 5.3. Summary of Atterberg limit tests.

Atterberg limit tests were performed on subgrade samples during each phase of investigation. Figure 5.3 shows the variation of the Atterberg limit test results from the test section.

The results of the Atterberg limit tests also illustrate the variability of the soils along the test section. The Phase I Atterberg limit test results generally showed lower

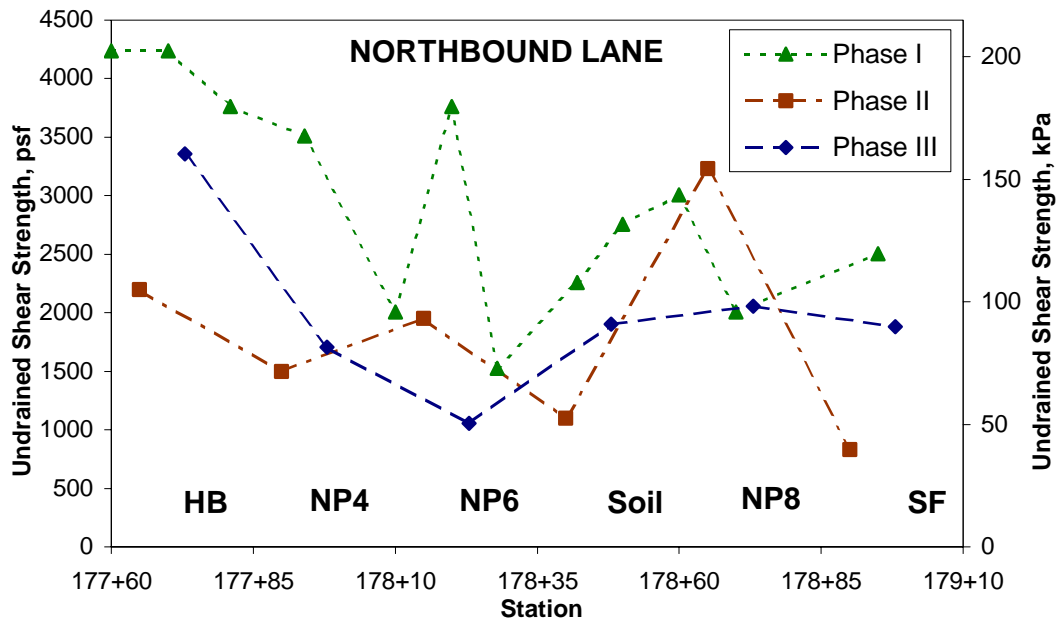
Figure 5.4. Pocket penetrometer results, subgrade soils, northbound lane.

Subgrade shear strengths were determined from pocket penetrometer tests and torvane tests during each phase of site investigation. Figures 5.4 and 5.5 show the results of the pocket penetrometer tests, and figures 5.6 and 5.7 show the results of the torvane tests.
