Final Research Report
Research Project T2695, Task 35
Bucoda Phase III

**LONG-TERM PERFORMANCE OF GEOTEXTILE SEPARATORS
BUCODA TEST SITE—PHASE III**

October 2005

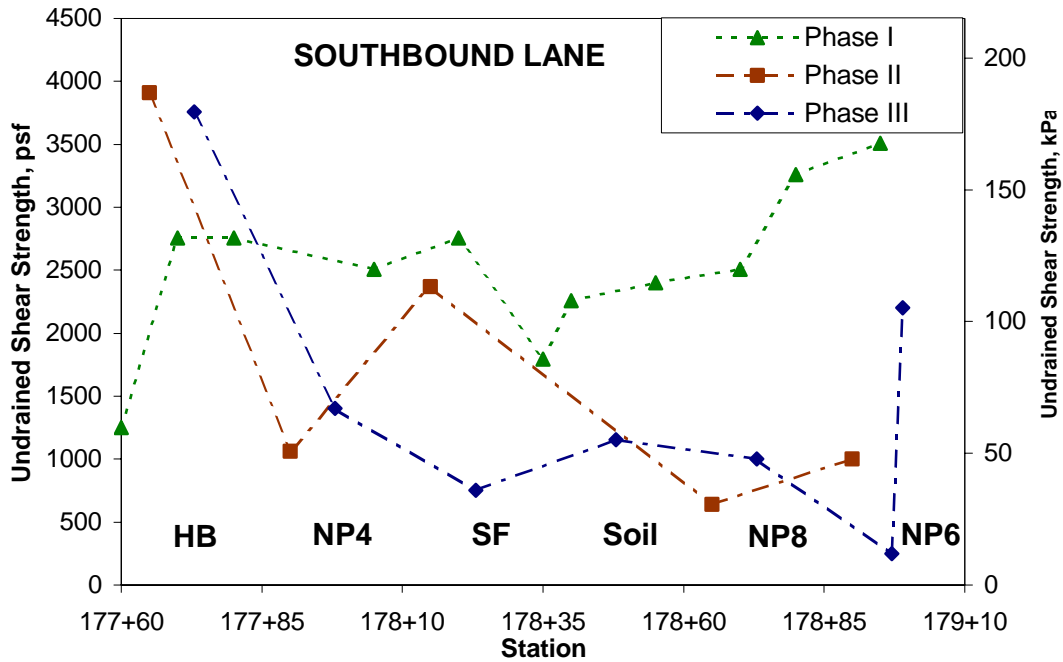
Figure 5.5. Pocket penetrometer results, subgrade soils, southbound lane.

Subgrade shear strengths were determined from pocket penetrometer tests and torvane tests during each phase of site investigation. Figures 5.4 and 5.5 show the results of the pocket penetrometer tests, and figures 5.6 and 5.7 show the results of the torvane tests.

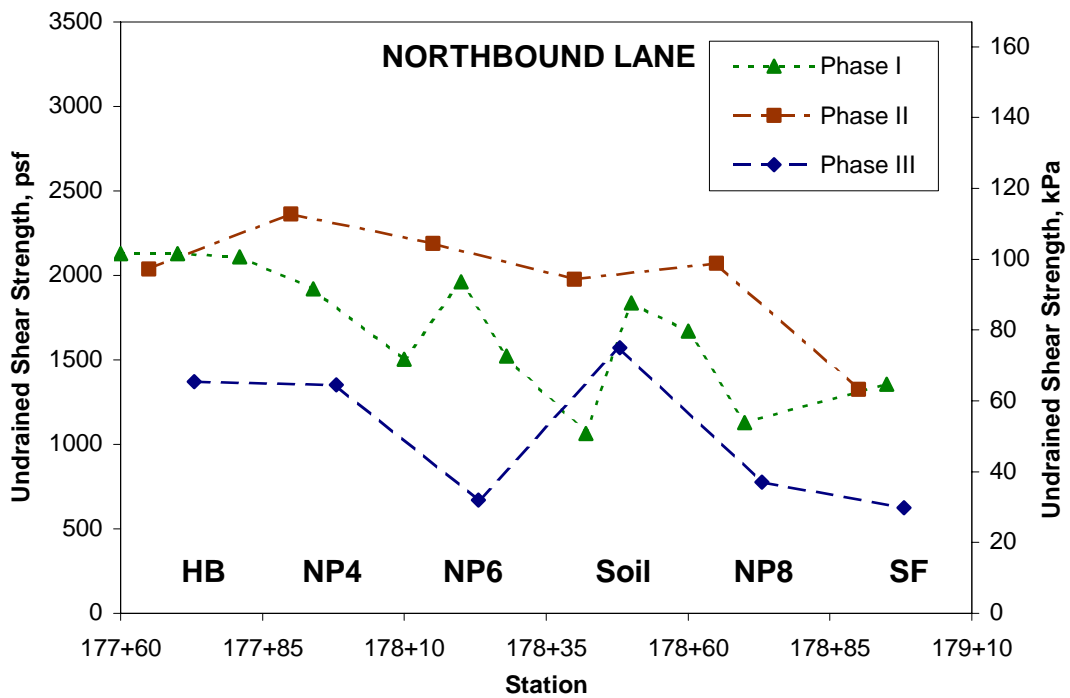
Figure 5.6. Torvane results, subgrade soils, northbound lane.

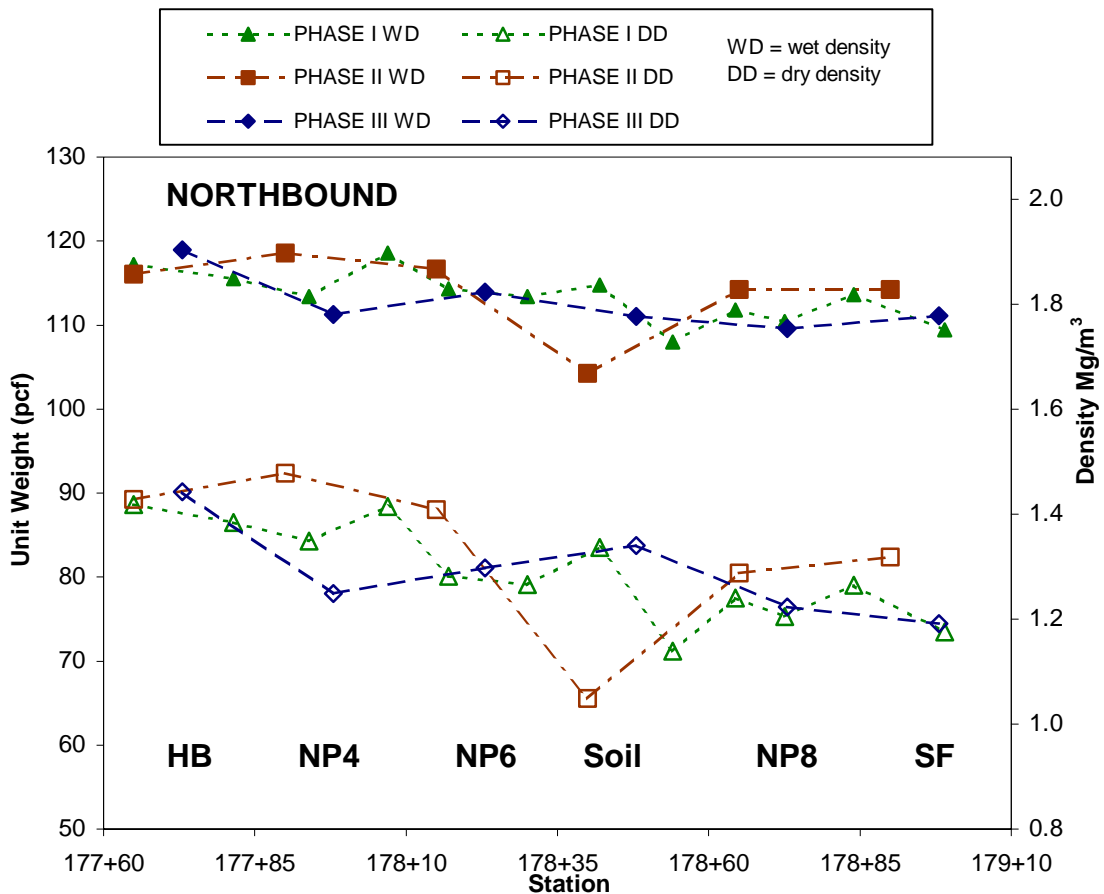
Figure 5.8. Summary of subgrade density tests, northbound lane.

In situ density measurements were taken during the site investigations. All density tests were performed with a Troxler nuclear density gauge. The density test results are summarized in figures 5.8 and 5.9.

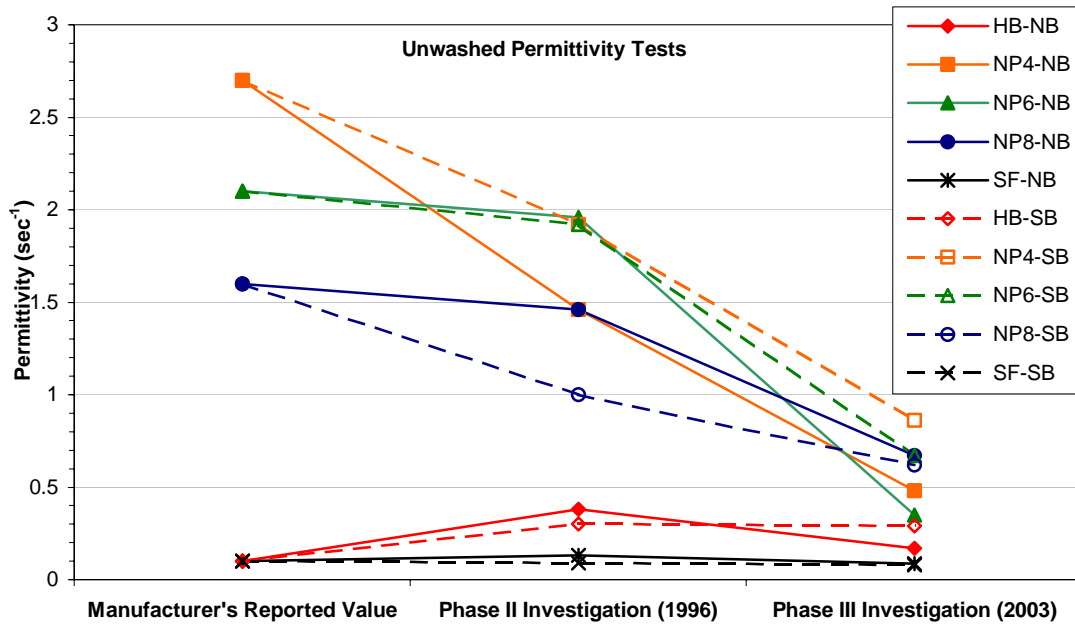
Figure 5.10. Summary of permittivity test results on unwashed exhumed specimens.

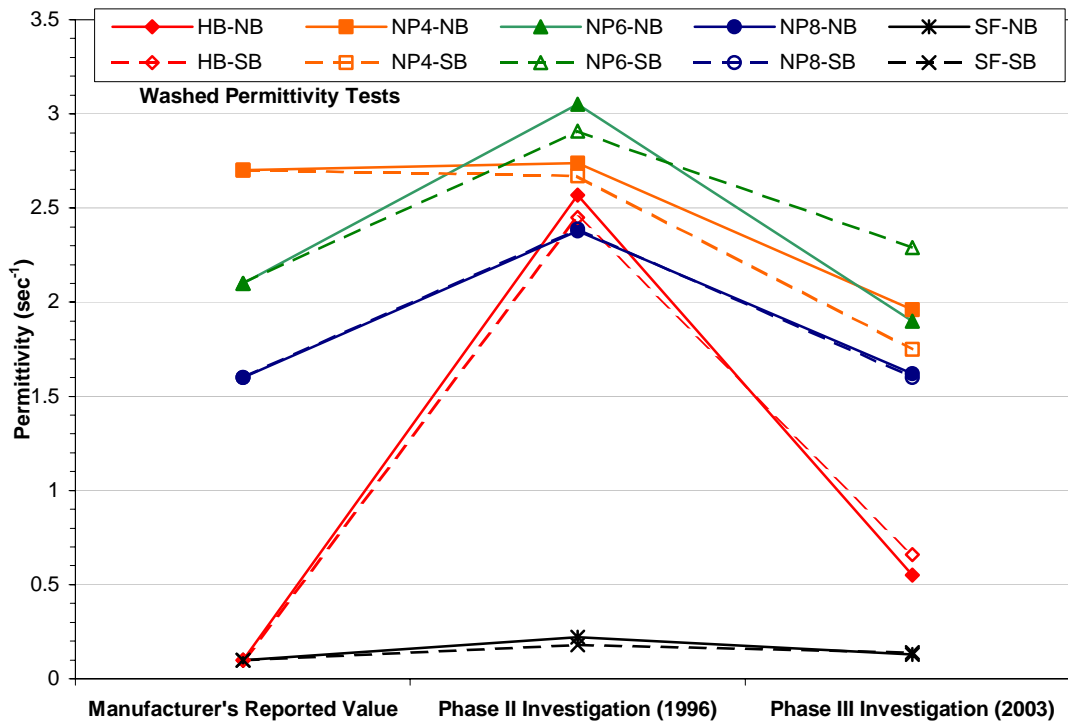
Figure 5.11. Summary of permittivity test results on washed exhumed specimens.

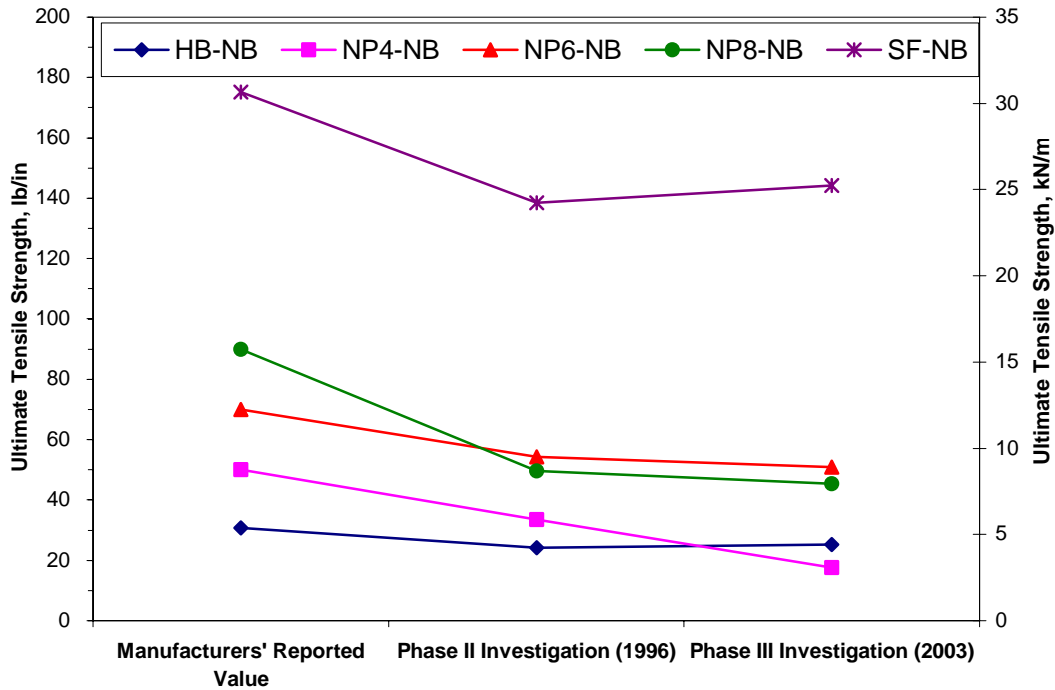
Figure 5.12. Change in ultimate tensile strength over time, 4-in. strip test.

To eliminate some of the above questions, 4-in. (100-mm) strip tensile tests were conducted on archived Phase II specimens and Phase III specimens. The results of the 4-in. strip tests are presented in Chapter 4. In comparison to the manufacturers' reported values, Figure 5.12 shows the Phase II results for ultimate tensile strength, and 5.13 shows the results for percentage of elongation.

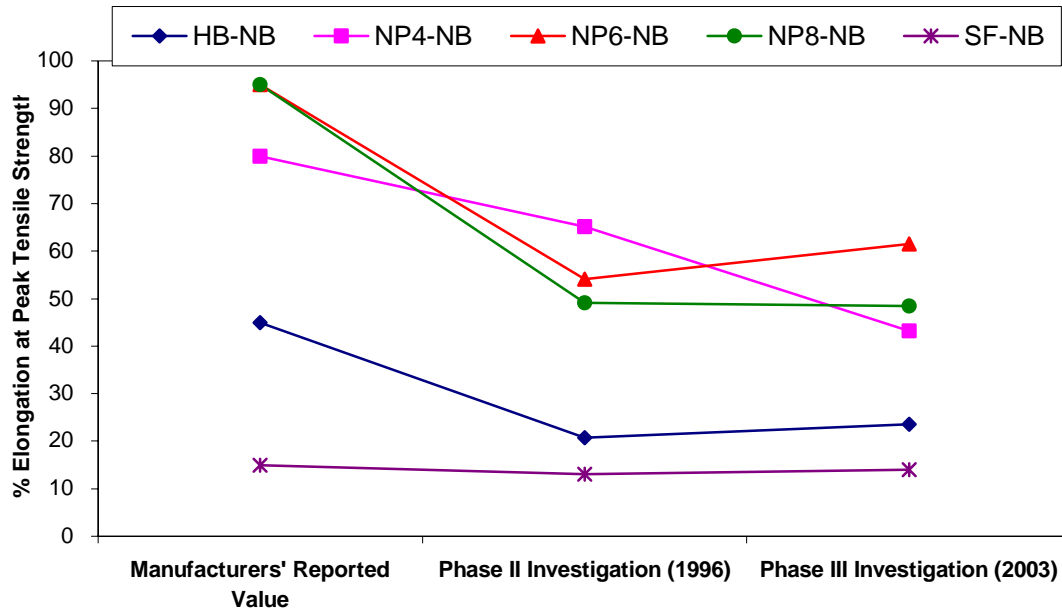
Figure 5.13. Change in percent elongation at failure over time, 4-in. strip test.

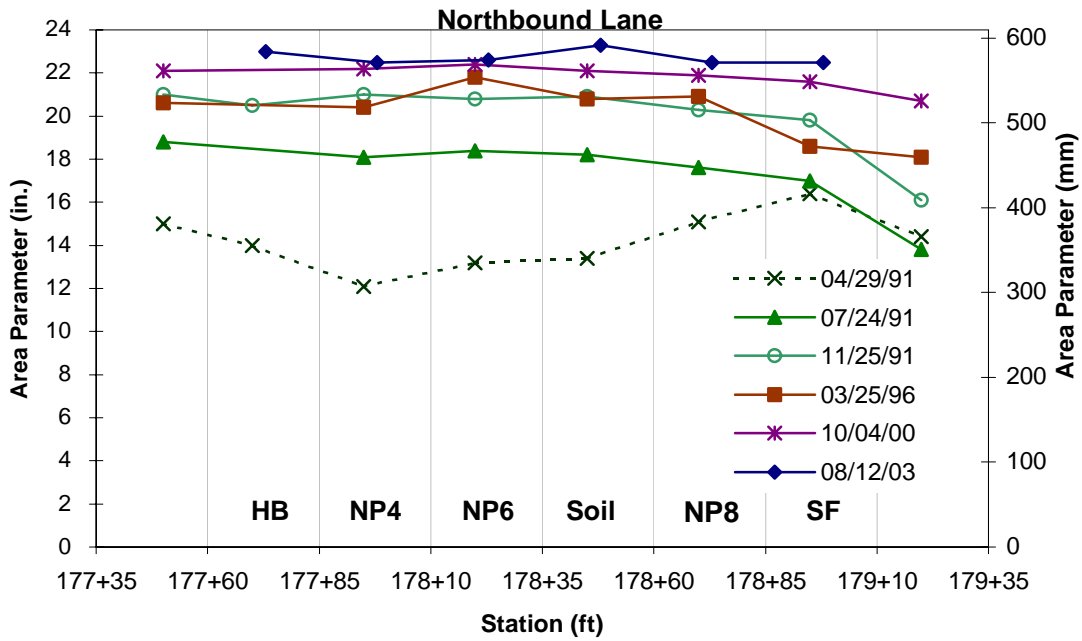
Figure 6.4. FWD area parameter, northbound lane.

Figures 6.4 and 6.5 show the area parameters for the northbound and southbound lanes, respectively. The area parameter generally increased with time over the 12-year period. As was seen with the adjusted deflection values, the largest change in the area parameter occurred in the first few months after construction. In fact, the area parameter increased from about 15 to 24 in. (400 to 600 mm) over the 12-year period—an indication of substantial stiffening of the pavement structure. The trend of decreasing adjusted deflection values and increasing area parameters is an indication that both the pavement structure and subgrade gained strength over time. This is in agreement with the subgrade moduli calculated by the Area Program for the northbound lanes (Figure 6.6) and southbound lanes (Figure 6.7).

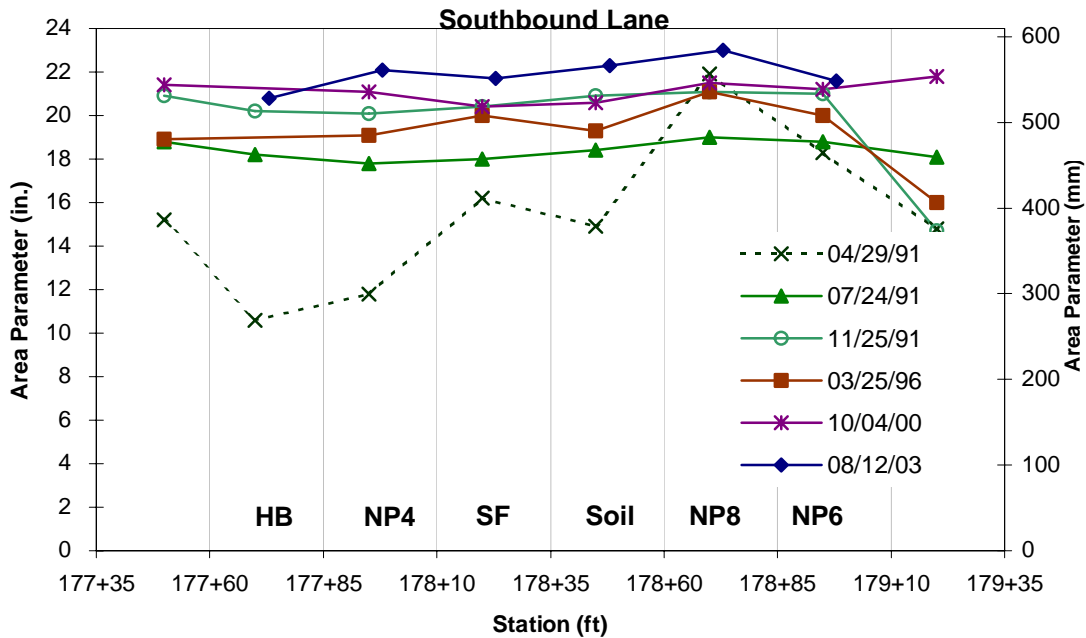
Figure 6.5. FWD area parameter, southbound lane.

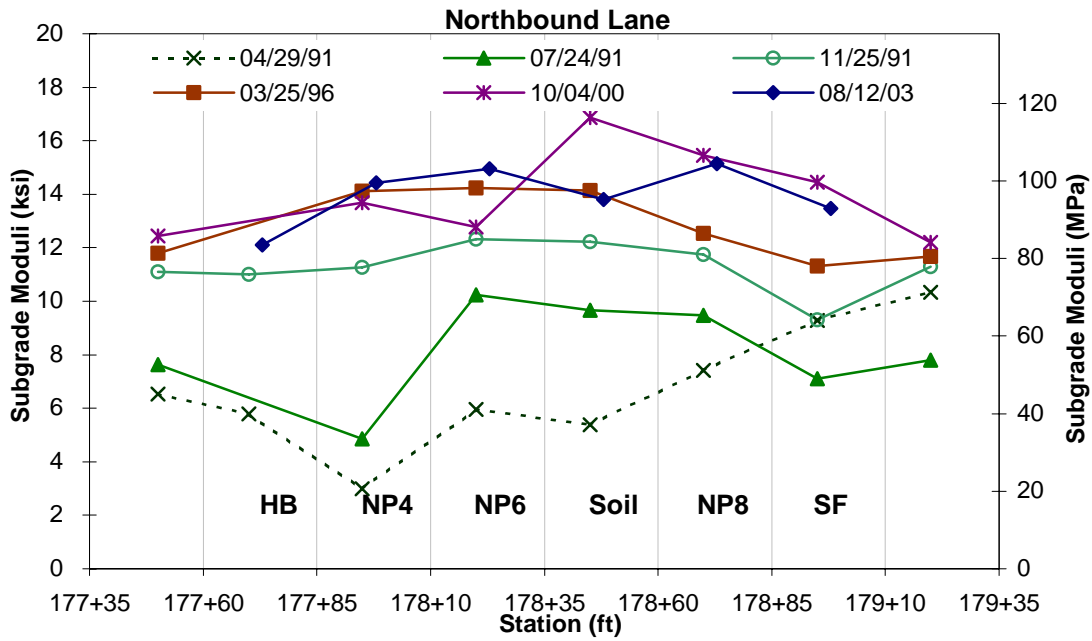
Figure 6.6. Subgrade moduli calculated by Area Program, northbound lane.

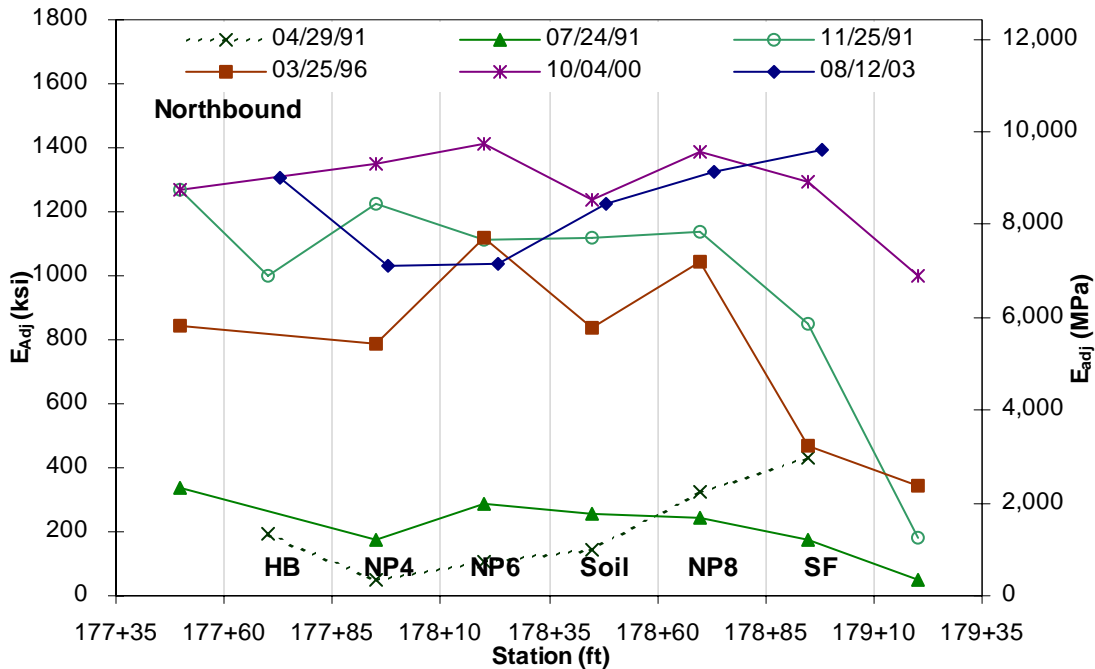
Figure 6.8. Asphalt concrete moduli, northbound lane.

Figures 6.8 and 6.9 are the back-calculated asphalt concrete (AC) moduli adjusted to a temperature of 77°F (25°C) and a 9000-lb (40-kN) load. The significant increase in the moduli in the period after construction may be attributed, in part, to compaction of the AC by traffic and aging of the asphalt binder in the hot mix.

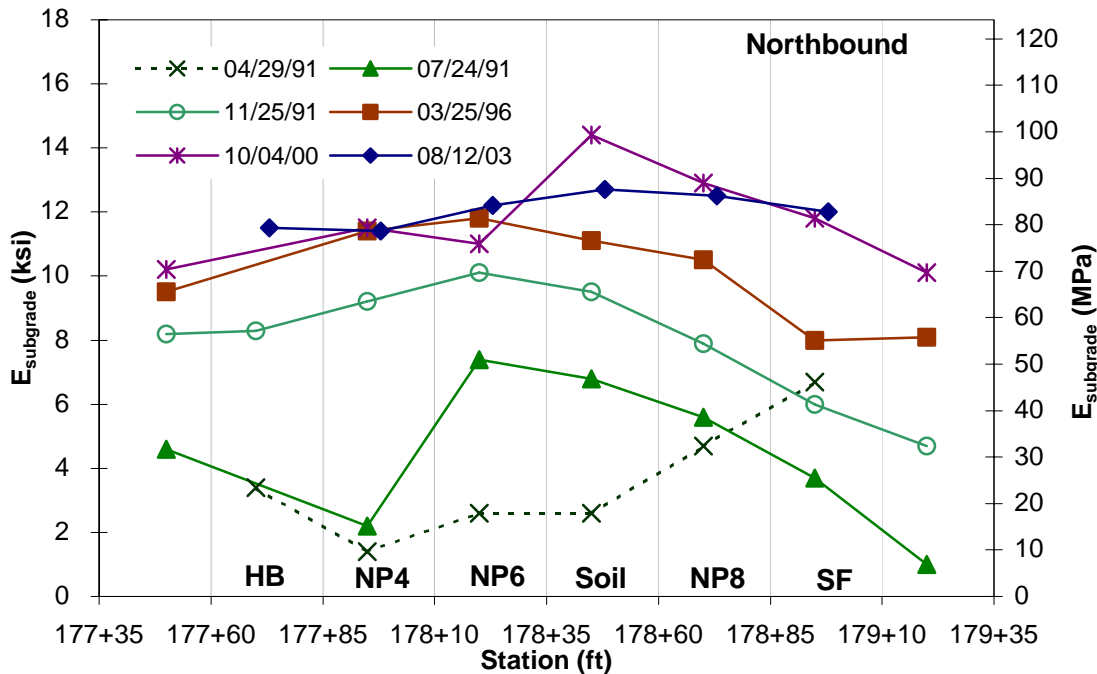
Figure 6.12. Subgrade moduli, northbound lane.

Figures 6.12 and 6.13 show the change in subgrade moduli over the 12-year period. The results are similar to what was found by the Area Program. The Area Program calculated subgrade moduli about 2 to 3 ksi (15 to 20 MPa) higher than Evercalc (about 15 percent), but both programs showed an increase of 5 to 10 ksi (35 to 70 MPa) (about 40 to 80 percent), in the period since just before reconstruction. The subgrade moduli generally increased with time over the 12-year period, and the largest increase was in the first several months after construction. In the figures, the soil-only sections show a similar increase in moduli when compared with the geotextile sections, suggesting that the geotextiles did not make a difference in the performance of the pavement section.

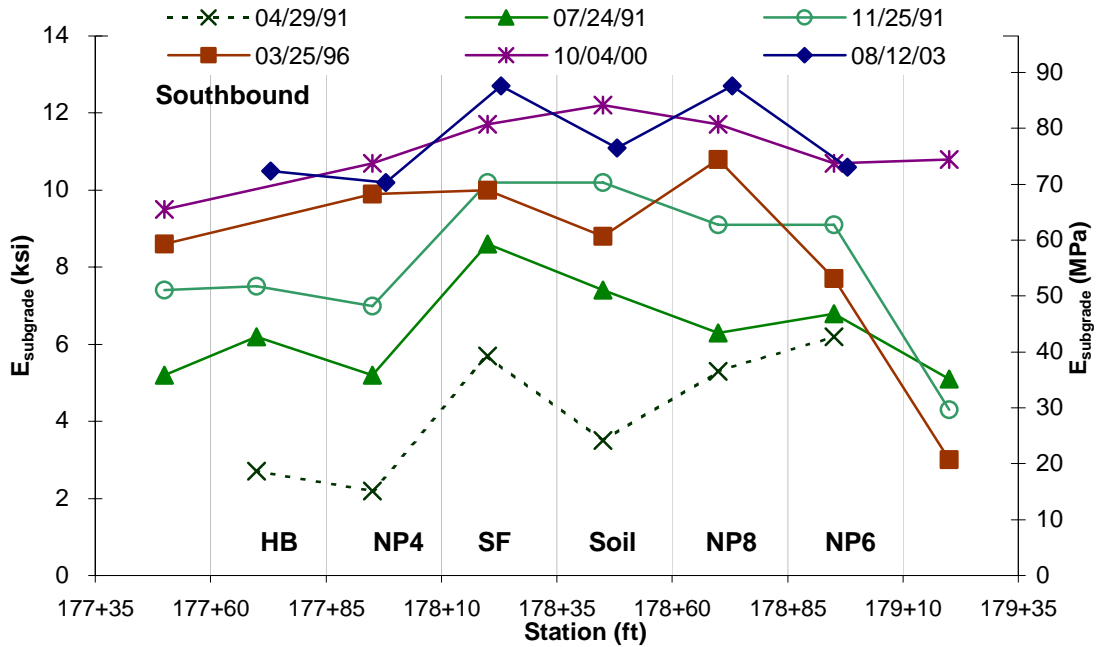
Figure 6.13. Subgrade moduli, southbound lane.

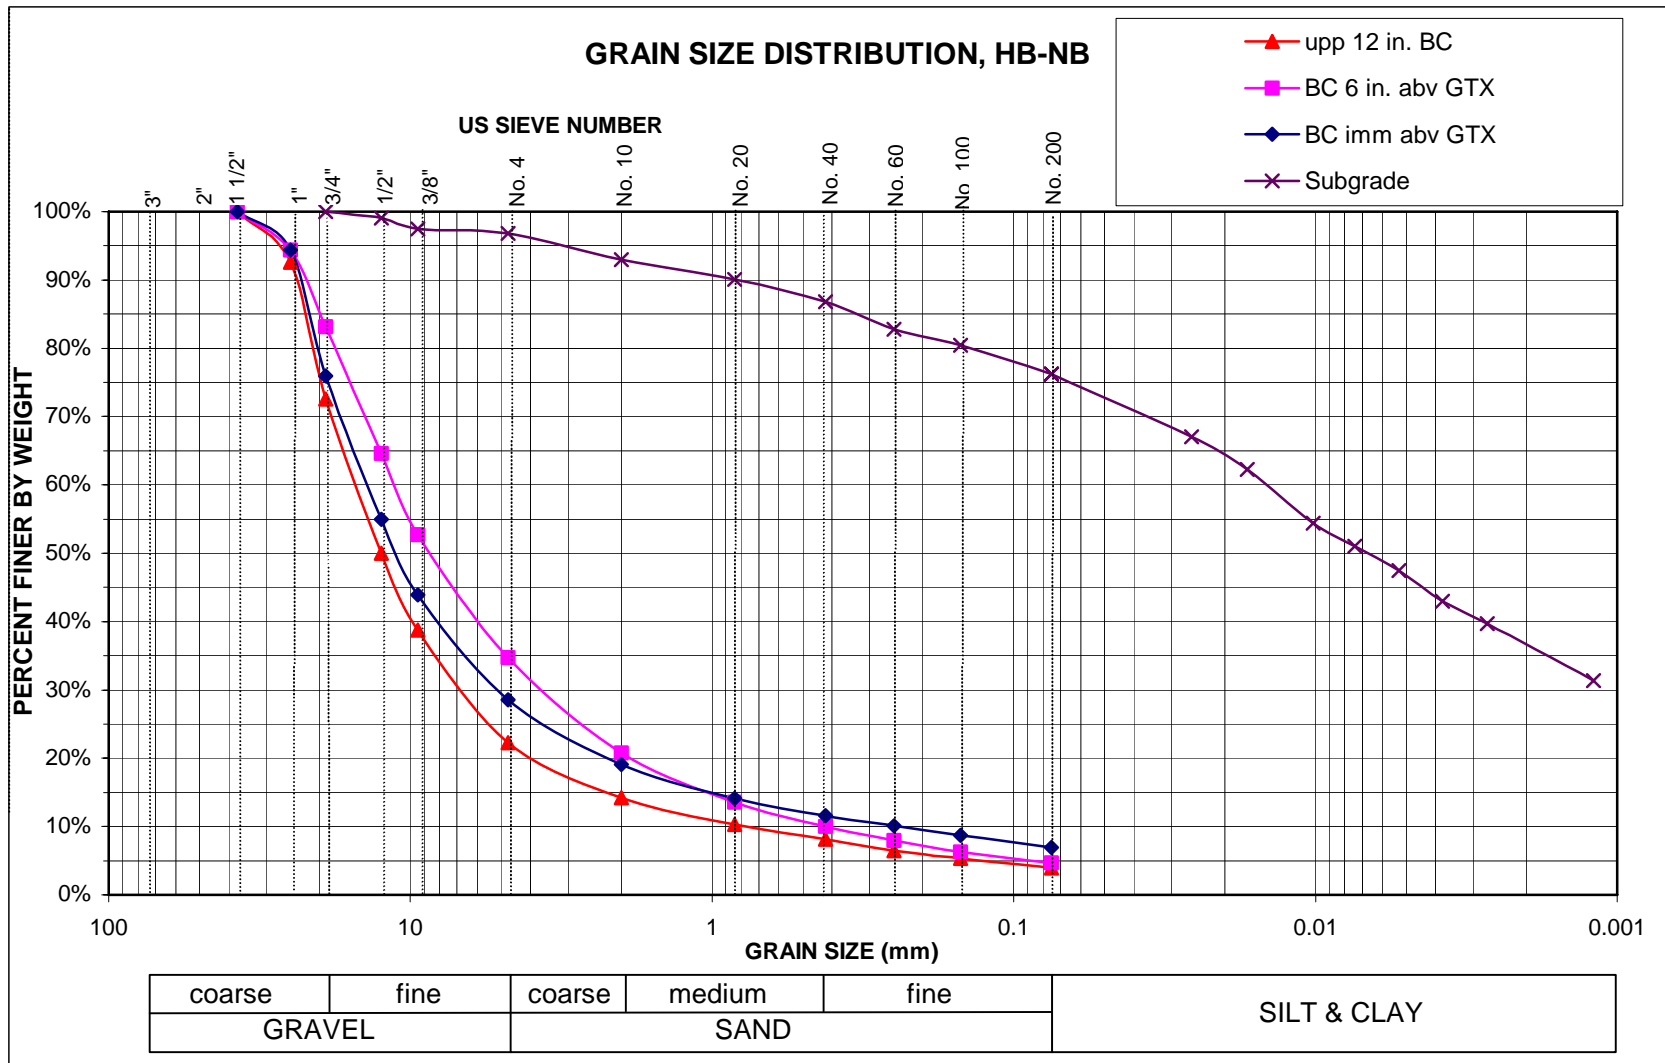
Figure B.1. Grain size distribution curves, HB-NB.
