Research Project T2695, Task No. 8
Behavior and Design of Joints in Bridge Substructures

SEISMIC BEHAVIOR AND RETROFIT OF BRIDGE KNEE JOINT SYSTEMS

1. REPORT NO. WA-RD 601.1		2. GOVERNMENT ACCESSION NO.		3. RECIPIENT'S CATALOG NO.	
4. TITLE AND SUBTITLE SEISMIC BEHAVIOR AND RETROFIT OF BRIDGE KNEE JOINT SYSTEMS				5. REPORT DATE July 2005

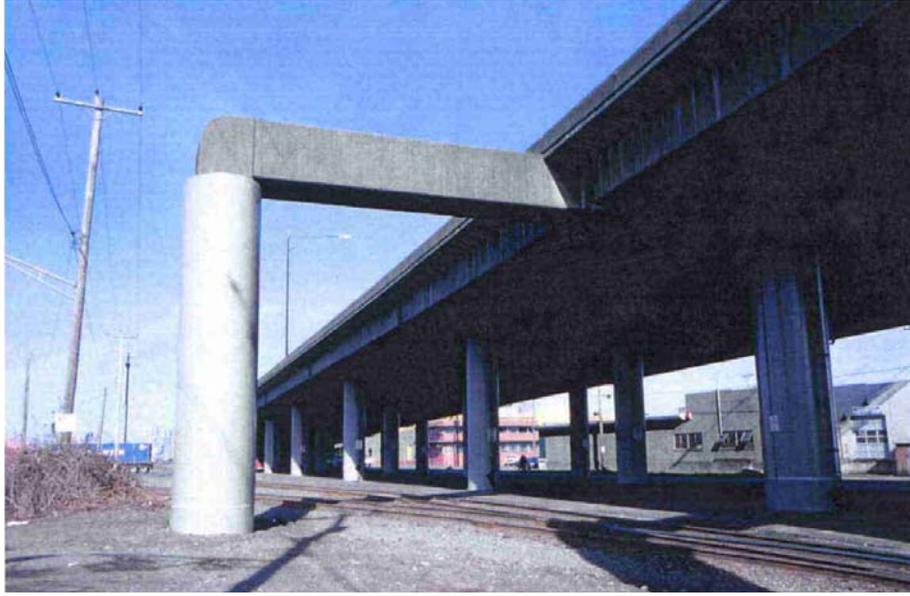
Figure 1 An Outrigger Bent in the SR 99 Spokane Street Overcrossing.

The behavior of the knee joint systems in the SR 99 Spokane Street Overcrossing was selected as the focus of this study. The bridge was designed in 1957 probably based on the 1953 AASHTO Standard Specifications for Highway Bridges, which did not include any provisions for seismic design or detailing (Zhang et al 1996). Part of the structure consists of cast-in-place reinforced concrete box girders supported on forty-three bents, twelve of which have outrigger knee joints. After reviewing several possible candidates, Bent #20 and bent #36 were selected to characterize regular bents with short and long outrigger beams, respectively. Bent # 34 was selected to represent a split outrigger bent with a long outrigger beam. Figure 1 shows an outrigger bent from the SR 99 Spokane Street Overcrossing.

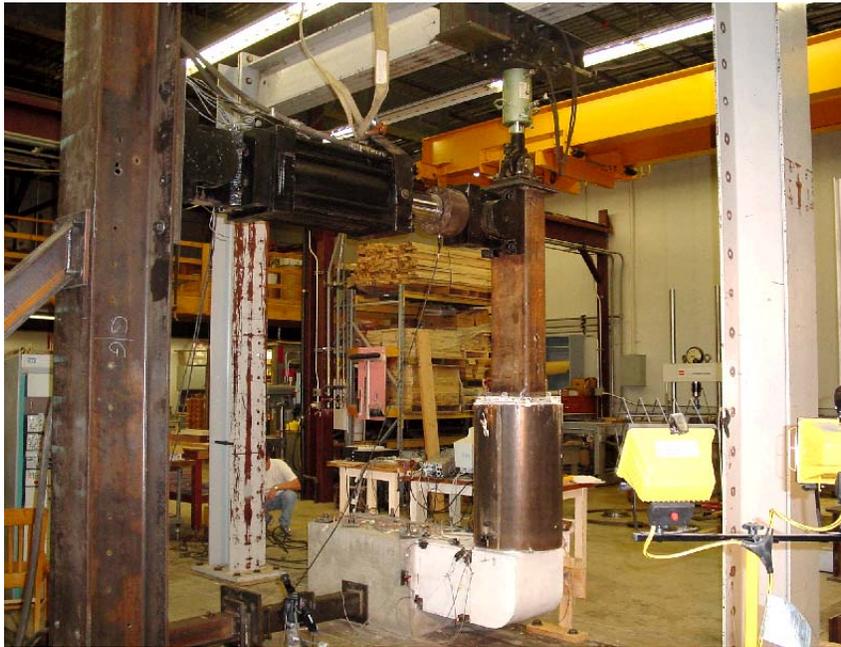
The out-of-plane setup for the test specimens is shown in Figure 6. In general, the specimen location and anchorage to the strong floor were kept the same as for the in-plane case, except for the actuator, which was rotated 90 degrees to apply a horizontal force perpendicular to the plane of the specimen. This configuration results in out-of-plane bending of the knee joint and simultaneous torsion and weak-axis bending of the beam.

Figure 6 Out-of-Plane Testing Setup.

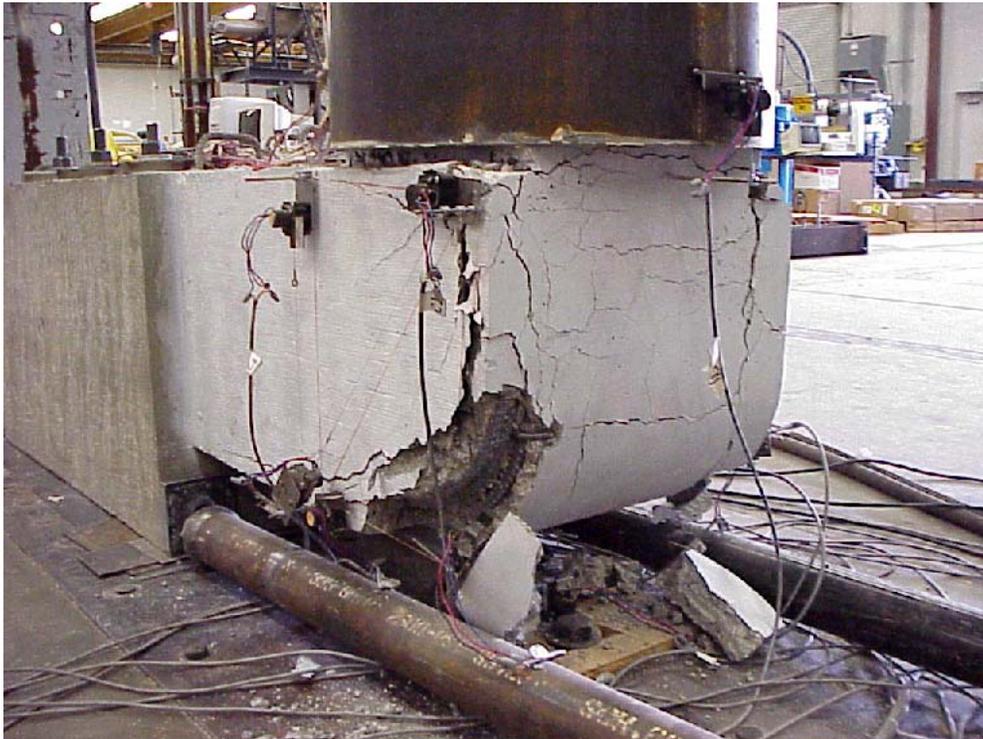
The earliest noticeable shear cracks on both sides of the joint were observed in the first opening cycle to a displacement level of 1.0 in. (25 mm). Bond failure of the embedded column and beam rebar hook extensions occurred when cycling to the third cycle in the closing direction at a displacement level of 2.7 in. (69 mm). The column and the beam hook extensions exposed as concrete along the free perimeter of the joint from both sides spalled off. The test was stopped following the third closing cycle to a displacement level of 3.0 in. (76 mm) with the specimen still being able to support the applied axial load. Figure 9 shows the damage to the test specimen at the end of the test.

Figure 9 Concrete Spalling as a Result of Splitting Bond Failure of the Column Bars Within the Joint Region of Specimen ASI.

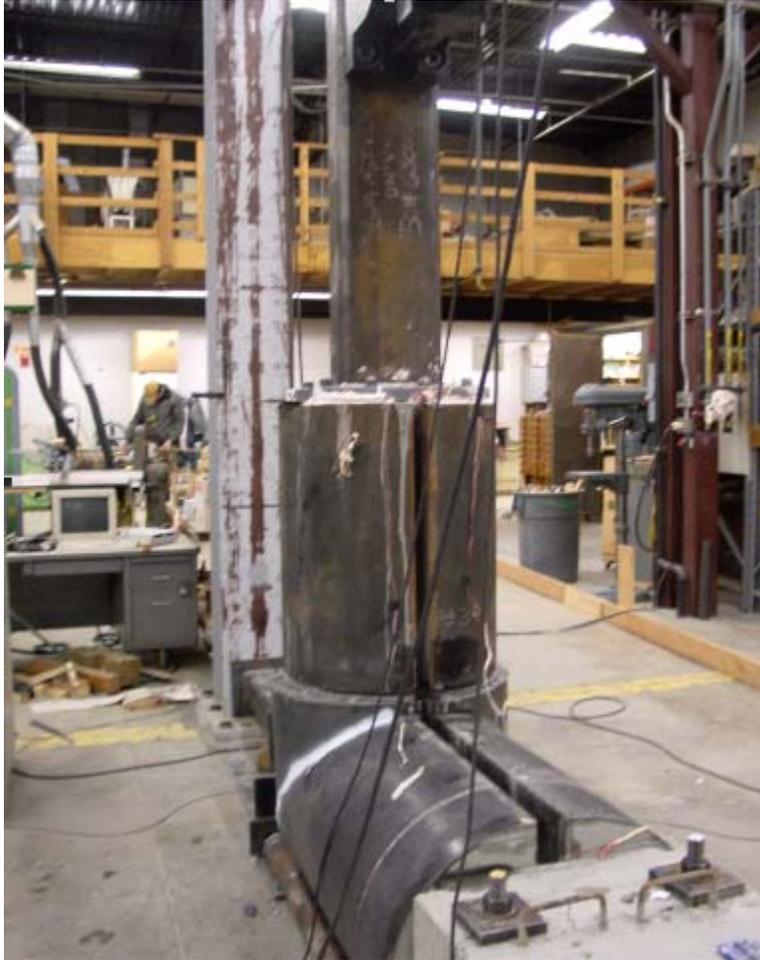
The earliest signs of flexural cracking in the column gap region were observed in the first cycle to 1.5 in. (38 mm) in the closing direction. Upon further loading, and during the third cycle to 2.0 in. (51 mm) displacement level, a flexure crack formed in the gap region as a result of joint closing. The concrete cover on the corners of the column started to crush and spall at a displacement level of 4.0 in. (102 mm) in both directions. The test was concluded at the 5.0 in. (127 mm) displacement level to avoid any damage to the laboratory testing apparatus. Some slippage of the added retrofit jacket over the

Figure 18 Overall View of Specimen RSPLI.

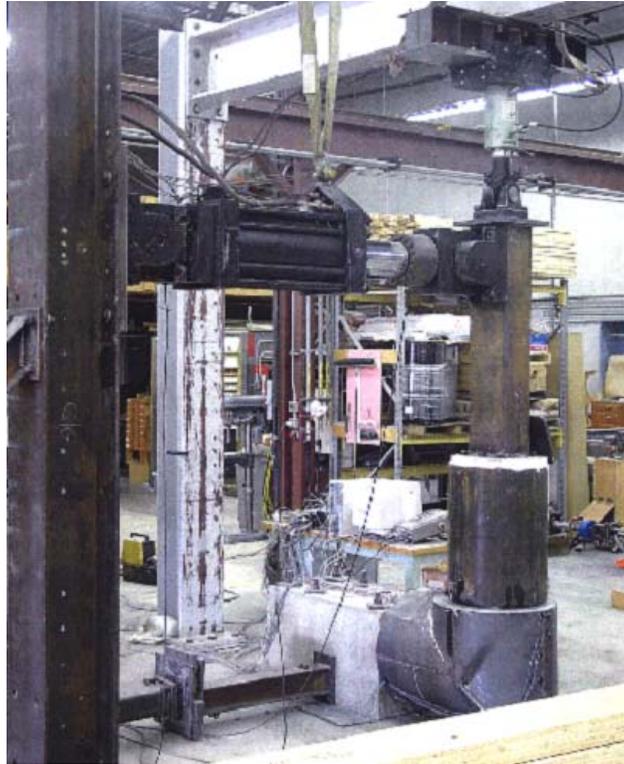
was tested under out-of-plane loading. Figure 20 shows an overall view of Specimen RSO.

Figure 20 Overall View of Specimen RSO.

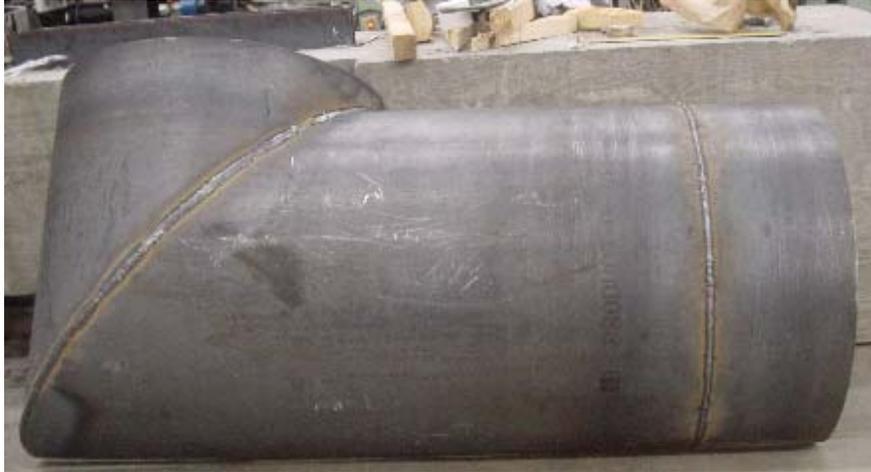
Beam-joint retrofit: The beam-joint jacket is a D-shaped steel jacket consisting of a clamshell- section and a flat plate of the same thickness. The flat plate is adhered to the back face of the beam and the joint, using high-strength epoxy, and then field welded to the clamshell with a full capacity weld. A picture of a clamshell section is shown in Figure 34.

Figure 34 A Picture of the Clamshell Used in the Retrofit of the Beam-Joint.
