**Final Research Report**

**ANALYSIS AND DESIGN OF  
WIRE MESH/CABLE NET SLOPE PROTECTION**

April 2005

1. REPORT NO. <b>WA-RD 612.1</b>	2. GOVERNMENT ACCESSION NO.	3. RECIPIENT'S CATALOG NO.	
4. TITLE AND SUBTITLE <b>ANALYSIS AND DESIGN OF WIRE MESH/CABLE NET SLOPE PROTECTION</b>		5. REPORT DATE <b>April 2005</b>

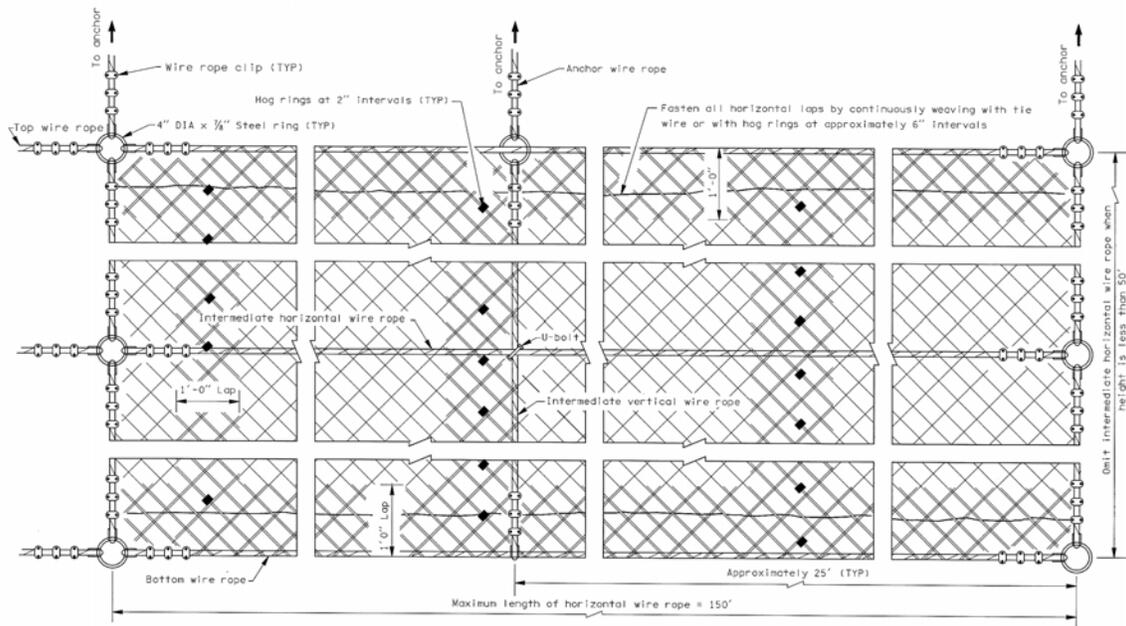
**Figure 1-1. Schematic drawing shows basic elements of a drape mesh system.**

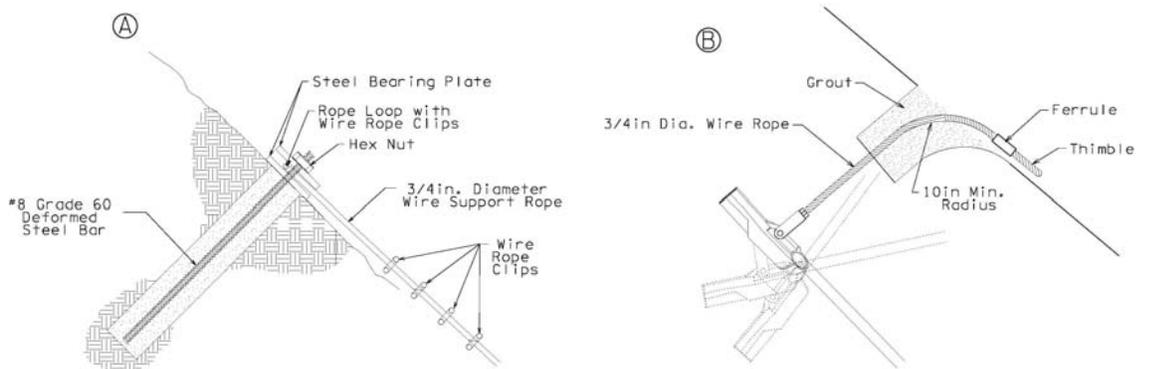
Figure 1-2. Typical rock anchors include (A) deformed steel threaded bar, and (B) a wire rope tendon.

Anchors can be grouped into those for intact rock or soil conditions. Rock anchors most commonly consist of a solid core, deformed steel, continuously threaded bar (Figure 1-2A) or, more recently, a wire rope tendon (Figure 1-2B) placed in a fully grouted hole. Some of the more common soil anchors include deadman-type, wire rope tendons, driven and/or grouted steel bars, hollow core drillable-groutable bars (Figure 1-3A), and MANTA RAY<sup>®</sup> (Figure 1-3B) anchors.

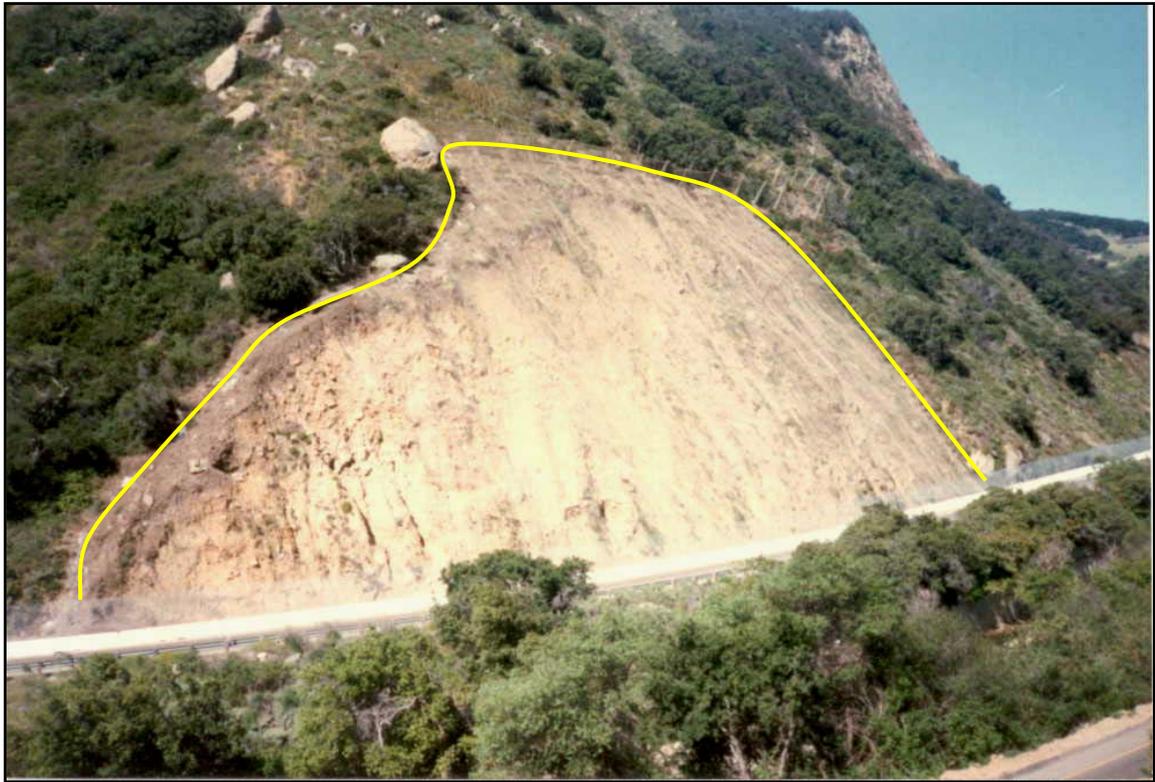
**Figure 2-1. Slope condition before mesh installation; yellow line delineates coverage area**

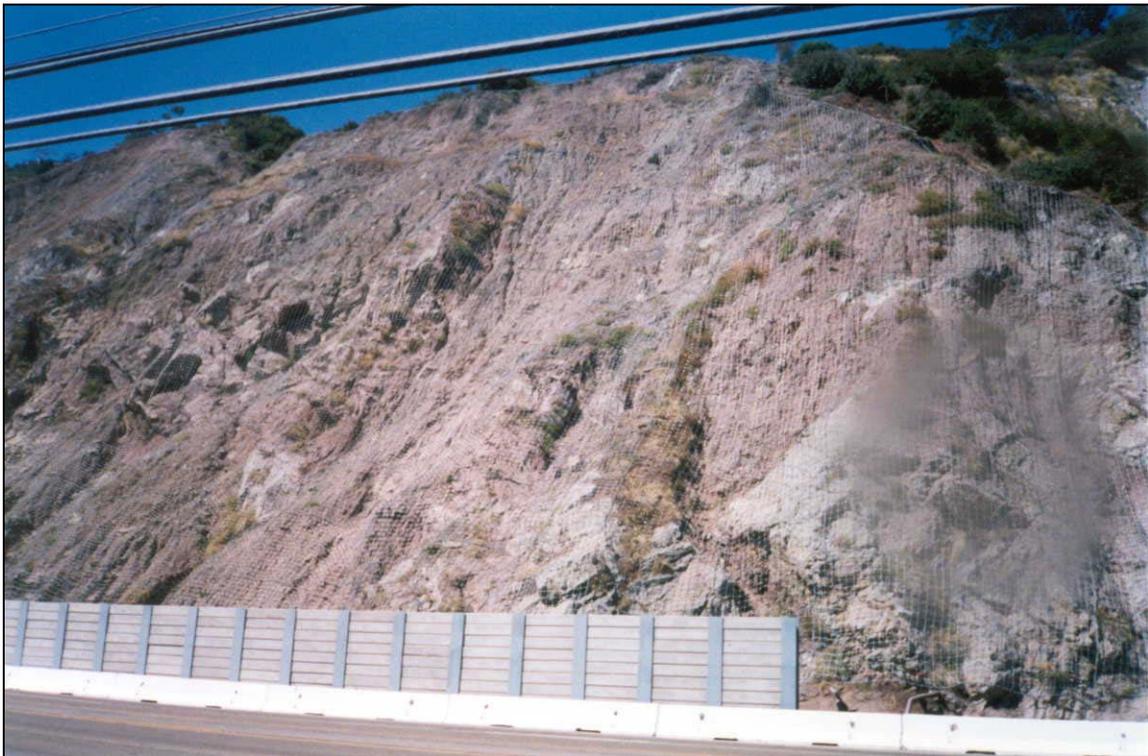
**Figure 2-2. Slope condition after the slope was covered with a cable net.**

small-scale slope instabilities such as rockslides, debris flows, and debris avalanches (Figure 2-2). The material consists of fractured sandstone overlain by Quaternary landslide deposits (angular fragments of sandstone, gravel, and silt). The slide is active and creeps during wet periods. The cut slopes have slope ratios of from near vertical to 1H:1V. Although some catchment area is available, rockfalls 3 to 6 feet in dimension, and small debris flows and rockslides 25 cubic yards in size have reached the roadway.

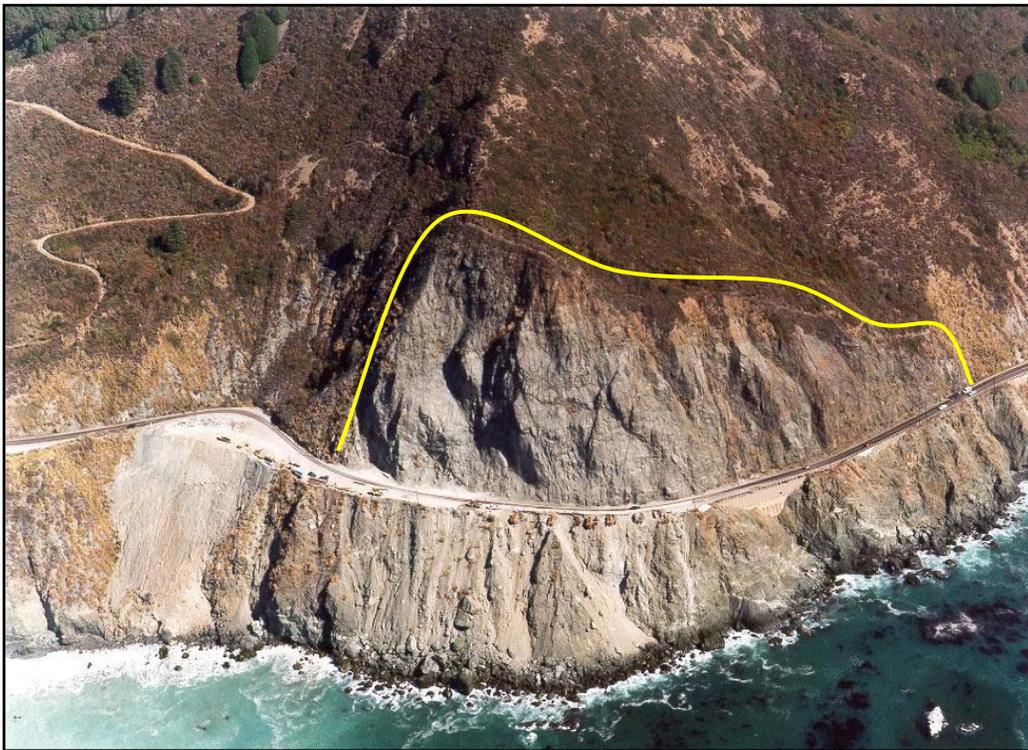
**Figure 2-3. Slope condition after the mesh installation (yellow line) at Rain Rocks site.**

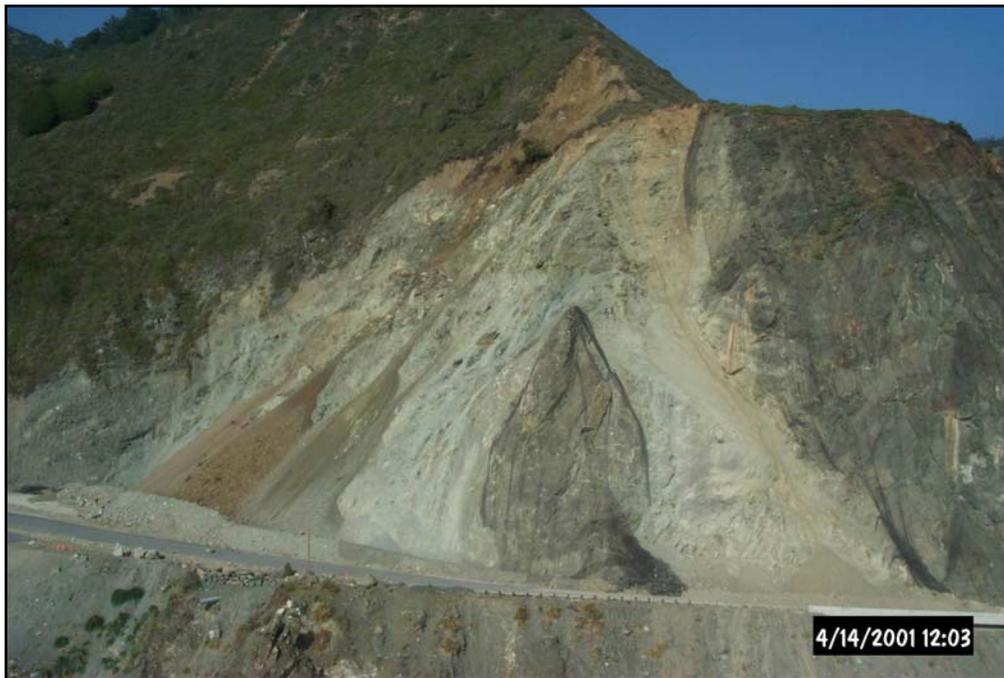
**Figure 2-4. Slope condition after slope instabilities destroyed the hexagonal wire mesh installation at Pitkins Curve adjacent to Rain Rocks chute.**

A small portion of the Pitkins Curve section extended into the original Rain Rocks installation. A small (500-cubic-yard) rockslide tore down the hexagonal wire mesh at the northern end, ripping the mesh from the infrastructure while the infrastructure stayed intact (Figure 2-4). Subsequent instabilities eventually undermined the infrastructure to failure. Again, the anchors and infrastructure were not damaged until the anchors were undermined. Within the slide scarp, a rock chute developed from which 3-foot-diameter rockfalls were regularly affecting the roadway. To mitigate this problem, the chute was covered with 7200 square feet of cable nets.

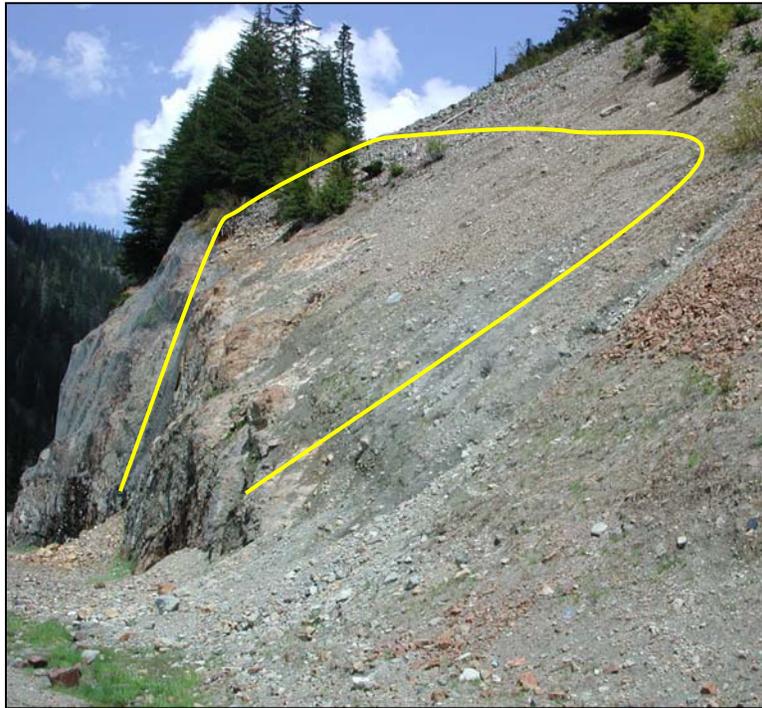
**Figure 2-5. Slope configuration for the western portion of the 1998 cable net installation (yellow line). Extreme snow loads during the winter of 1998/99 caused most of the cable net anchors located along the top of the installation to fail.**

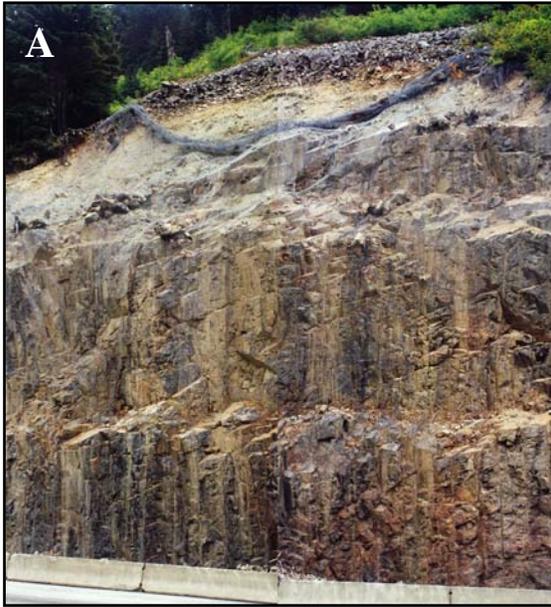
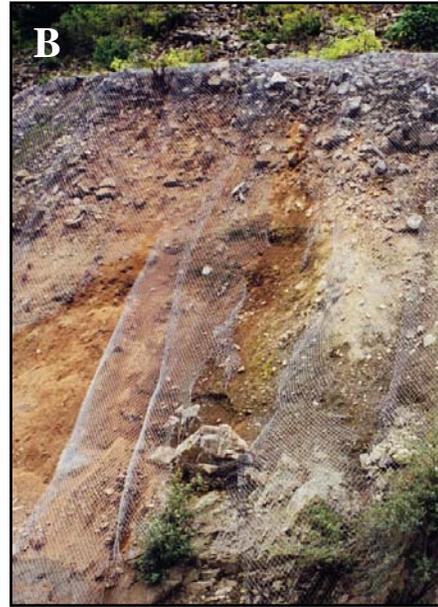
**Figure 2-6A. Failure in the eastern portion of the 1982 chainlink installation. Active erosion undermined the top row of anchors. Pockets of debris accumulated along intermediate support ropes. Figure 2-6B shows localized rupture by a 3- to 4-foot-diameter boulder that initiated from the bouldery talus shown at the top of photograph.**

By the mid-1990s, the eastern portion of the initial chainlink installation was in very poor condition (figures 2-6A and 2-6B). Erosion had exposed many midslope and top anchors. Debris accumulation behind the support ropes and large boulders had caused extensive punctures and ruptures of the system.

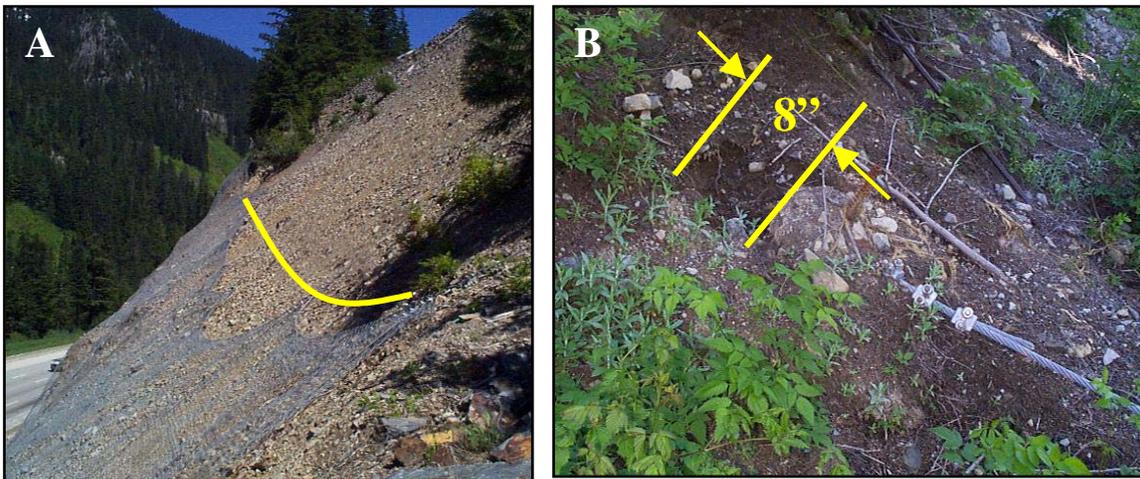
**Figure 2-7A.** Failure of the cable net system in the western portion of the site in July 1999. The yellow line is the approximate location of the top of the cable nets as installed in 1998. **Figure 2-7B** shows deformation of the ground where loads exceeded passive earth pressure, causing 8 inches of anchor deflection.

anchors, causing severe ground deformation (figures 2-7A and 2-7B). The ultimate capacity of the anchors in shear was around 35,000 lbs. Slightly lower-than-design grout strengths and difficulties with grouting in the cobbles and boulders often void of matrix may have contributed to the anchors failing in pullout. Some of the anchors where passive earth pressures were exceeded had been installed vertically, rather than normal to slope, resulting in diminished capacity.

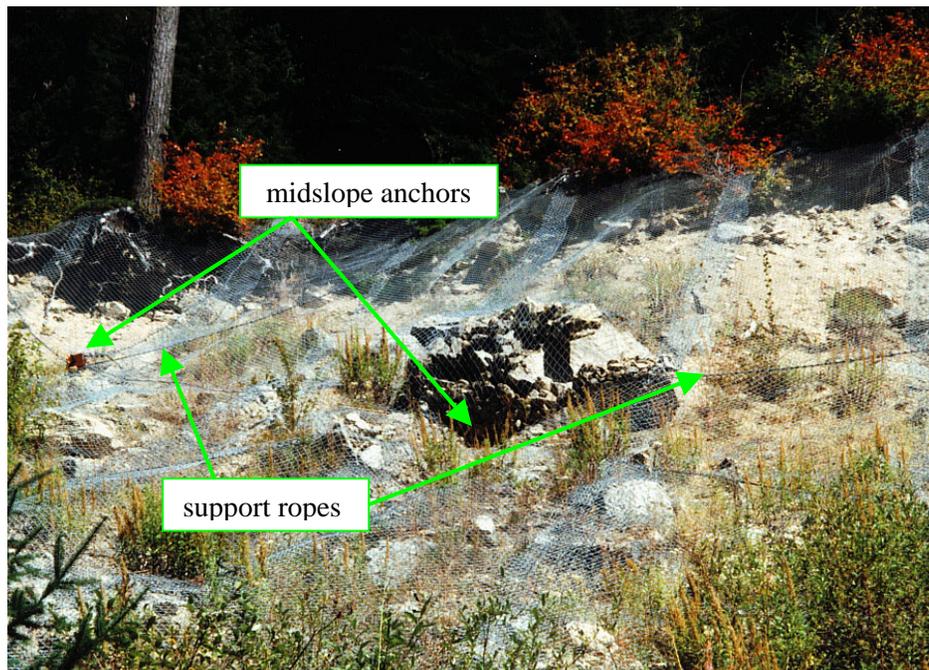
**Figure 2-9. Note the large accumulation of debris at the juncture of the underlying support ropes and the midslope anchor.**

After several decades of severe slope erosion and heavy snow loads, the eastern half of the first installation was badly damaged. Many seams in the chainlink had split, and localized rupture and puncture had occurred in numerous locations near the base of the installation. Support ropes also trapped large quantities of rock debris, imparting significant debris loading on the system (Figure 2-9).

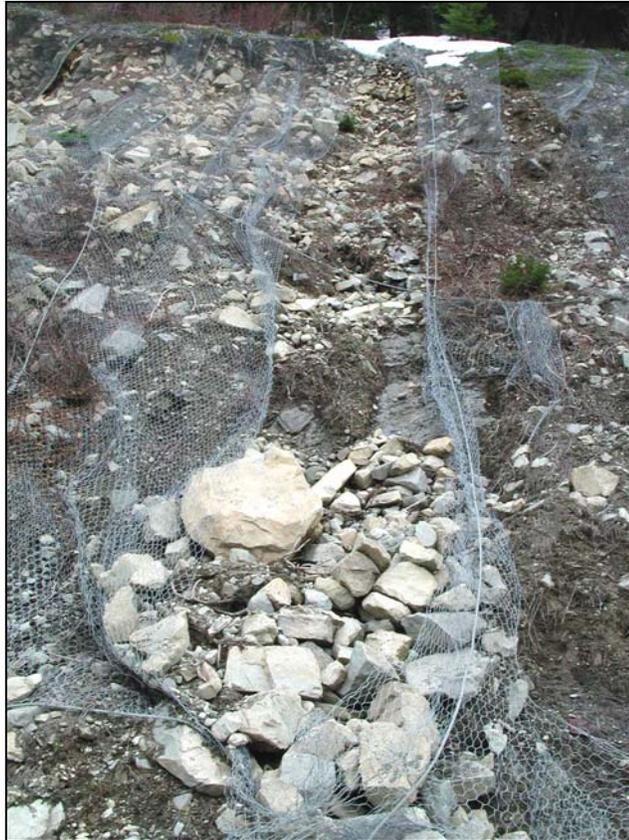
**Figure 2-10. Rupture of the vertical seam and fabric; the midslope horizontal support cable was also damaged. The volume of debris associated with mesh failure is estimated to be 10 cubic yards, with block sizes of up to 3.5 feet in dimension.**

Significant damage has occurred to the section that was replaced in 1998 with hexagonal wire mesh. While a different configuration of support ropes was placed on top of the mesh to better pass debris, a large quantity of debris has still accumulated beneath the lower half of the mesh (Figure 2-10).

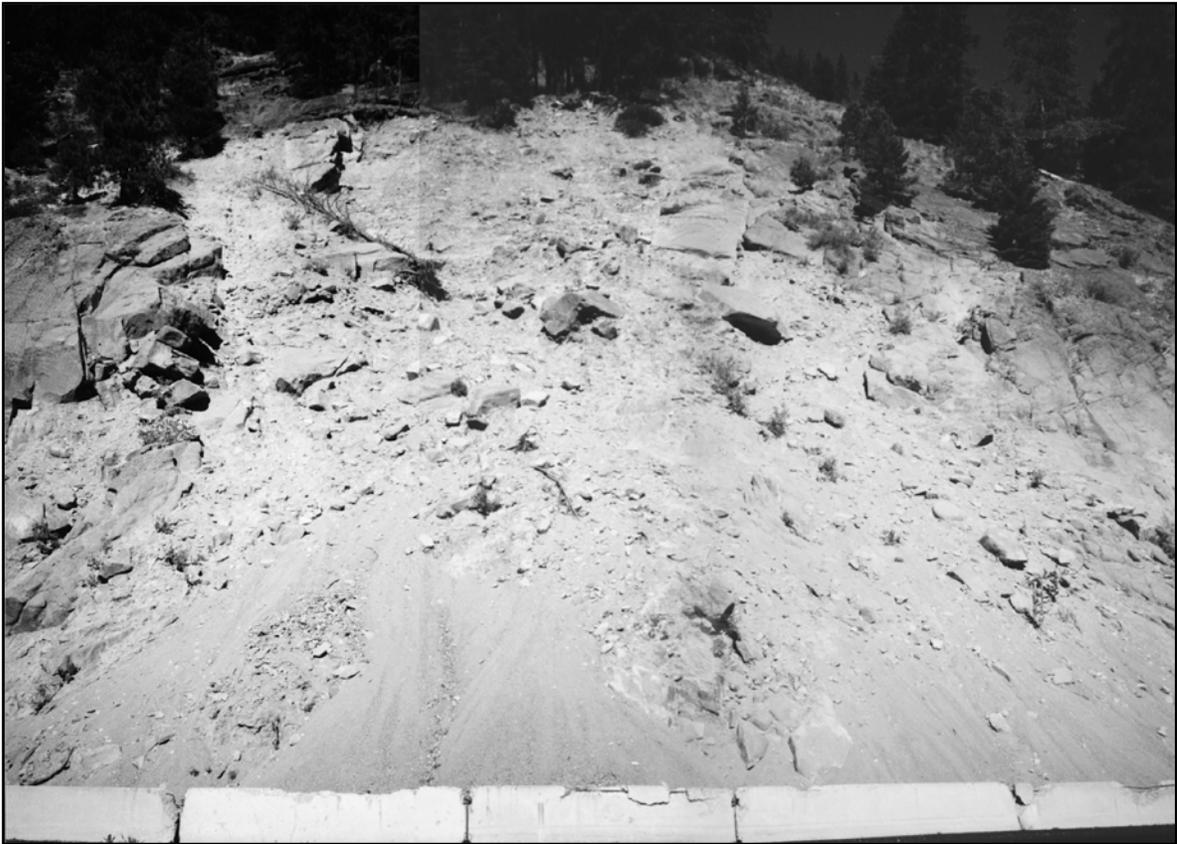
**Figure 2-11. Slope condition before cable net installation; note the rockfall-related damage to the concrete barrier.**

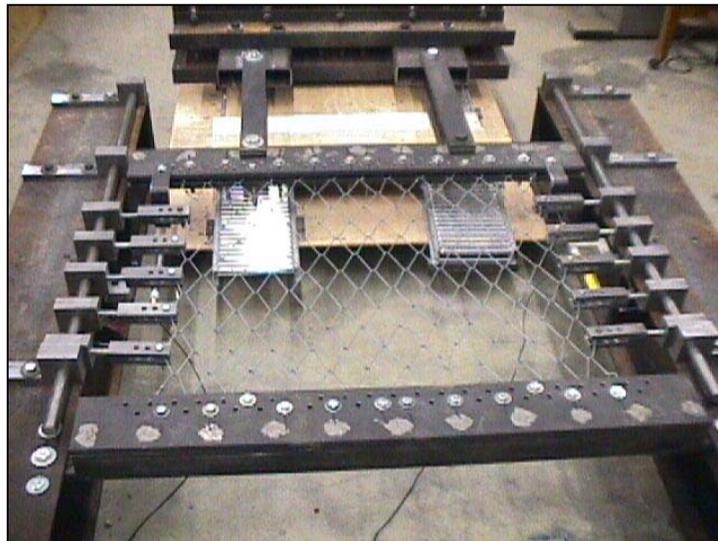
**Figure 3.1. Testing apparatus with TECCO<sup>®</sup> mesh.**

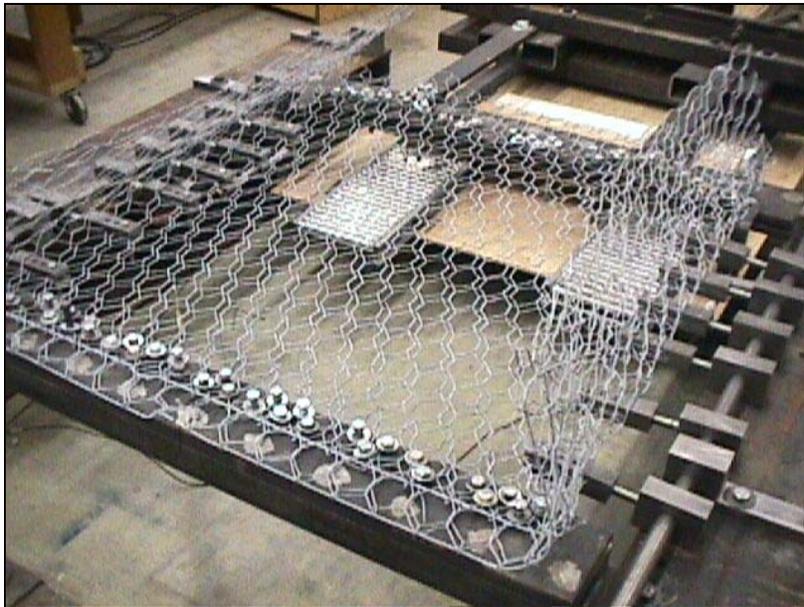
**Figure 3-2. Setup for *Mac Double Galv1* mesh with bolts extended above the loading plates.**

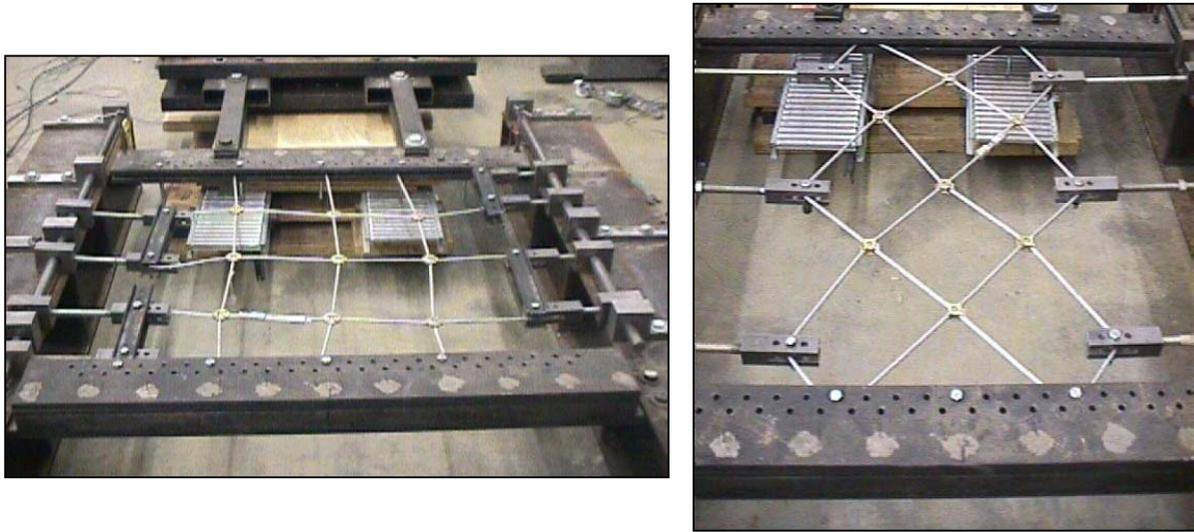
**Figure 3-3. Setup for (A) Geobrug square grid cable net and (B) Geobrug diagonal grid cable net.**

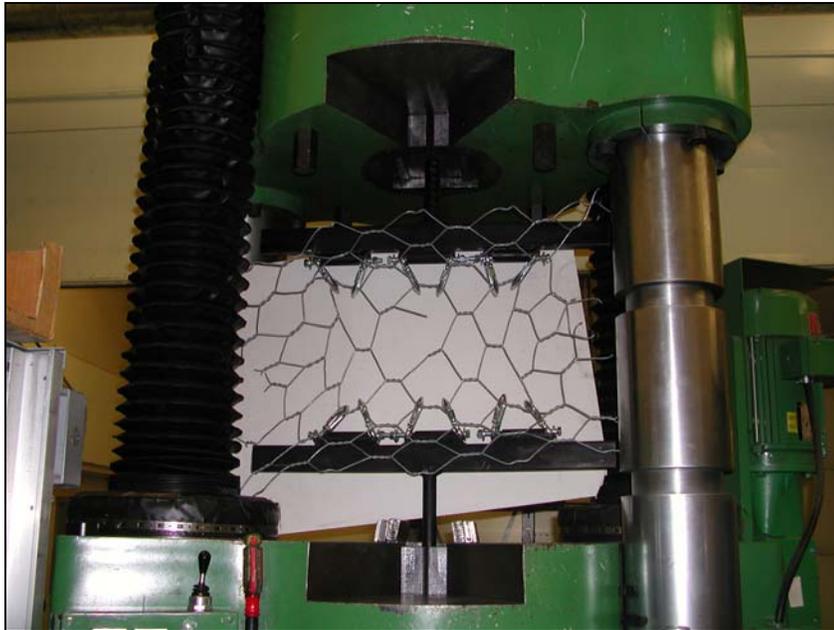
**Figure 3-7. Testing/clamping apparatus and failed specimen of bulk material (no seam).**

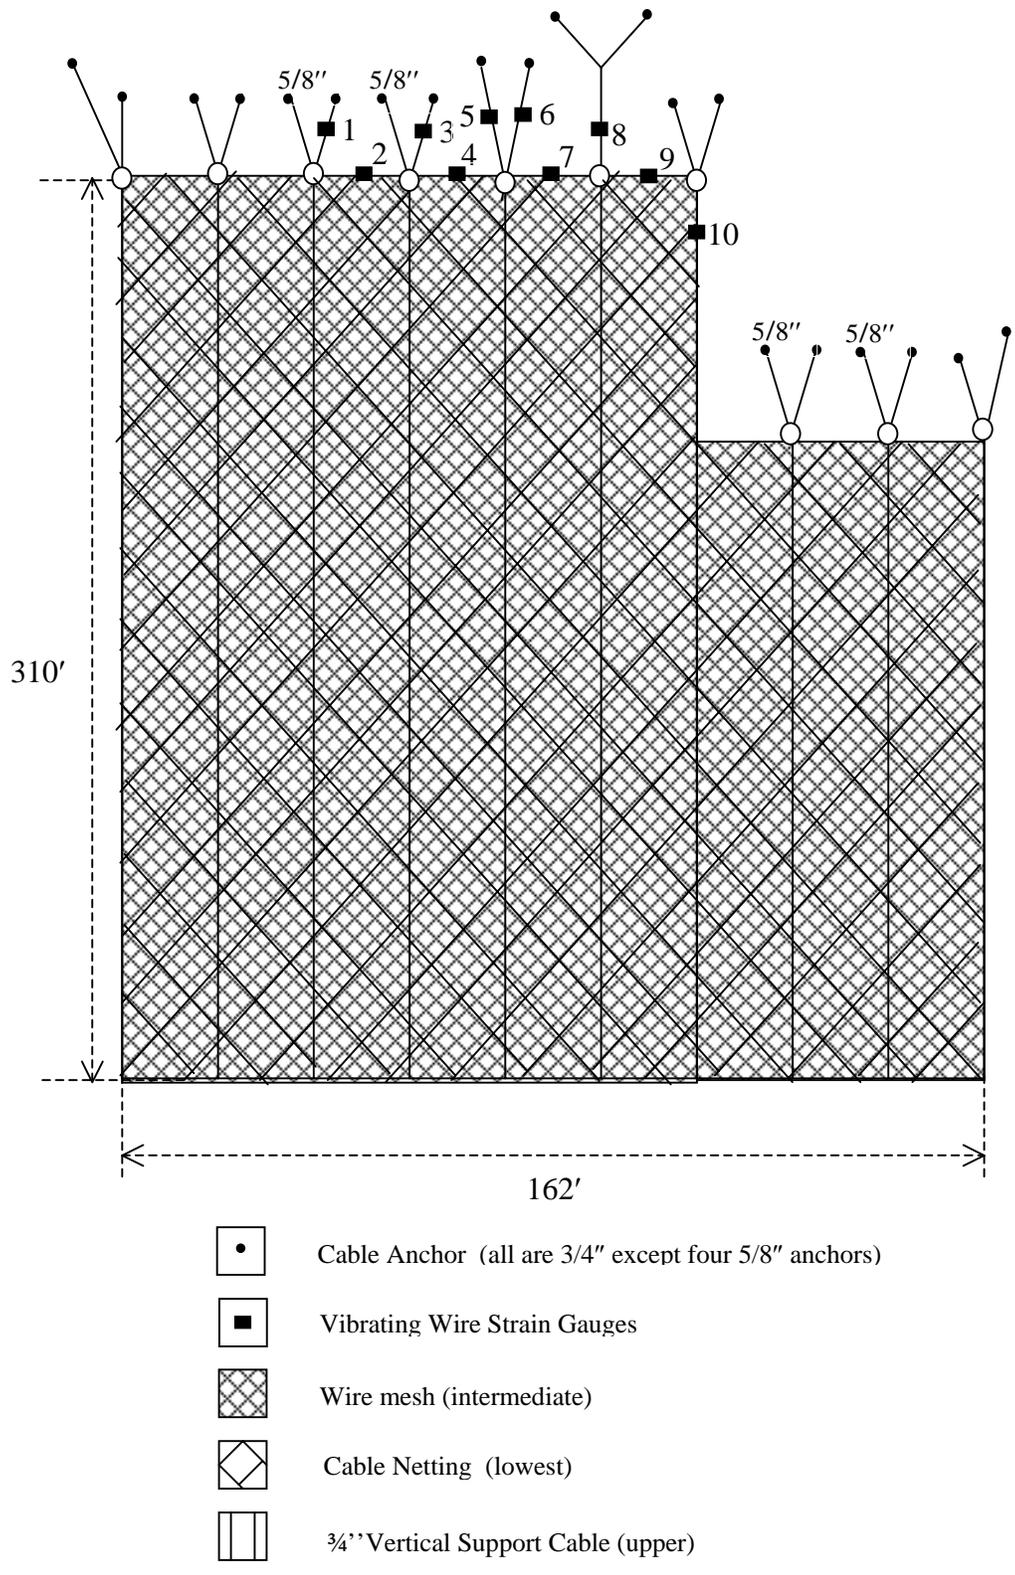
Figure 3-8. Dimensions and configuration of the cable net system and layout of the instrumentation.

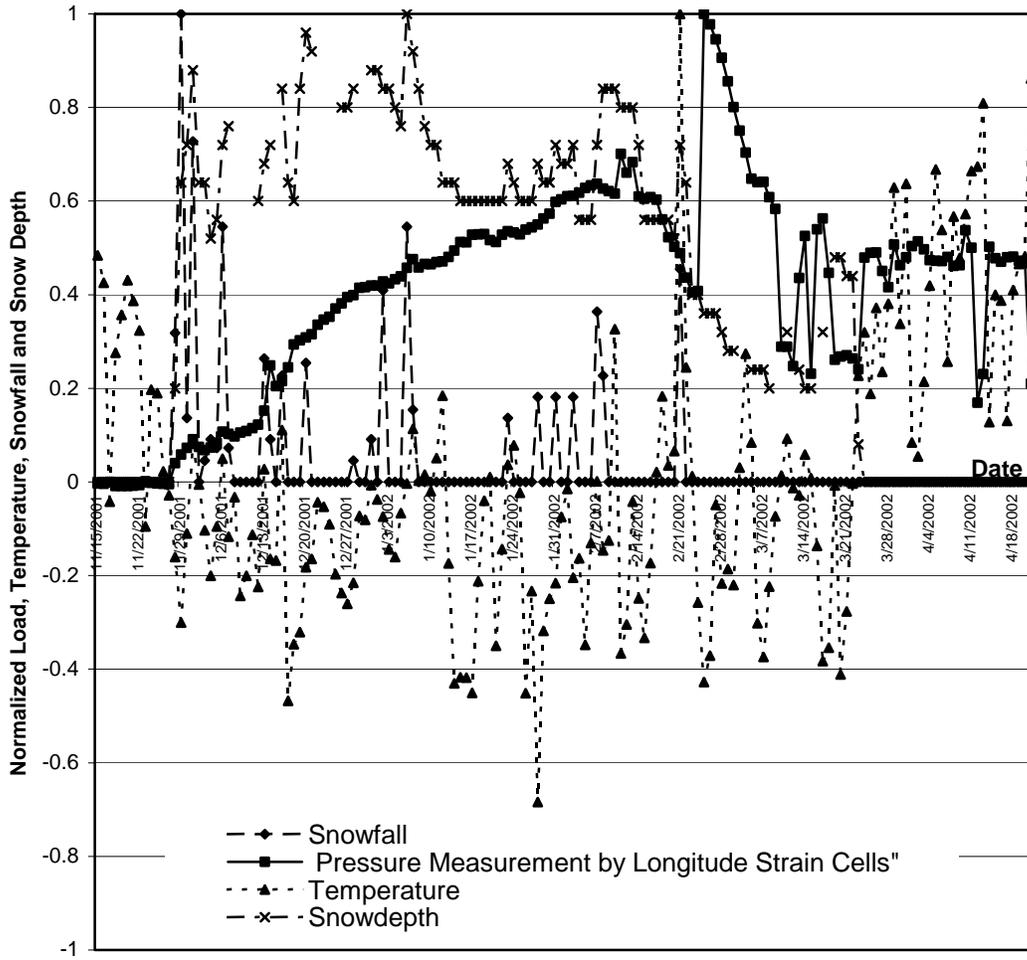
Figure 3-9. Normalized values of load for vertical (longitudinal) strain gauges, temperature, and snow depth.

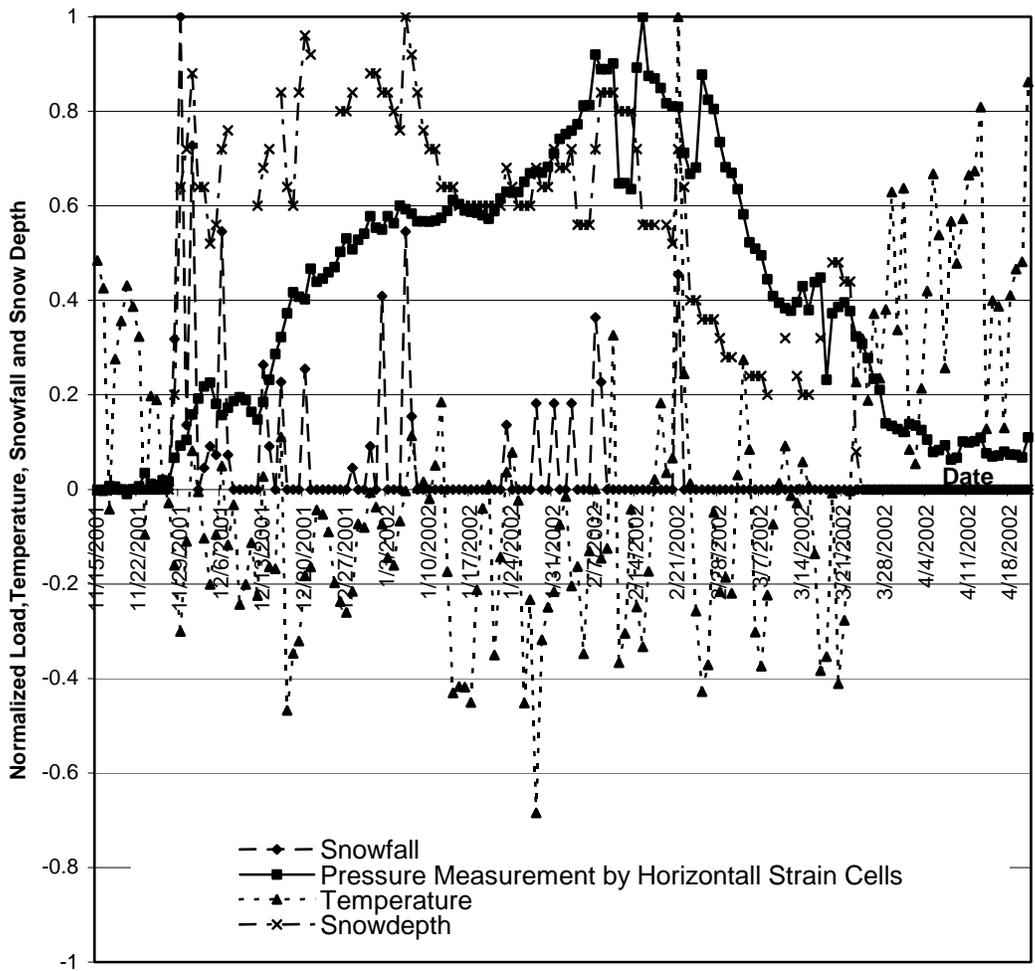
Figure 3-10. Normalized values of load for horizontal (transverse) strain gauges, temperature, and snow depth.

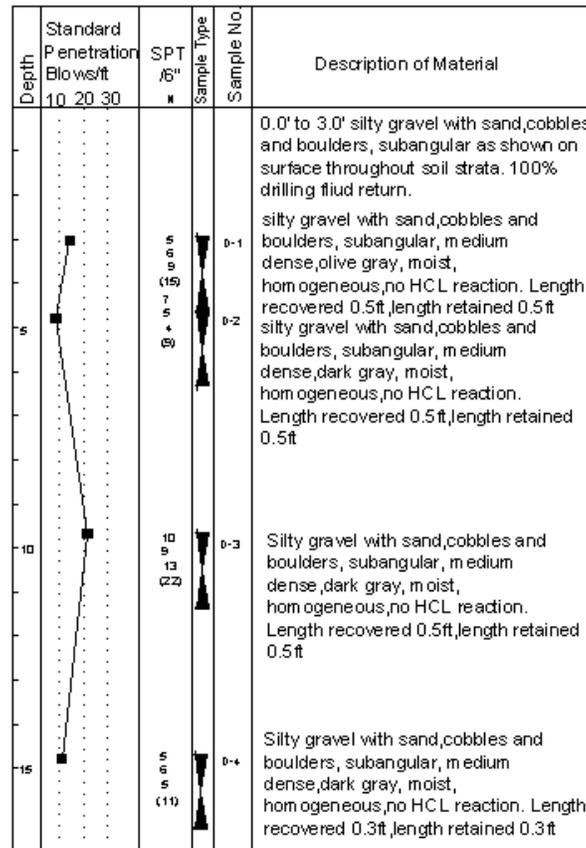
Figure 3-11. A boring log depicts the subsurface conditions in which the anchors were founded. The depths are recorded in feet.

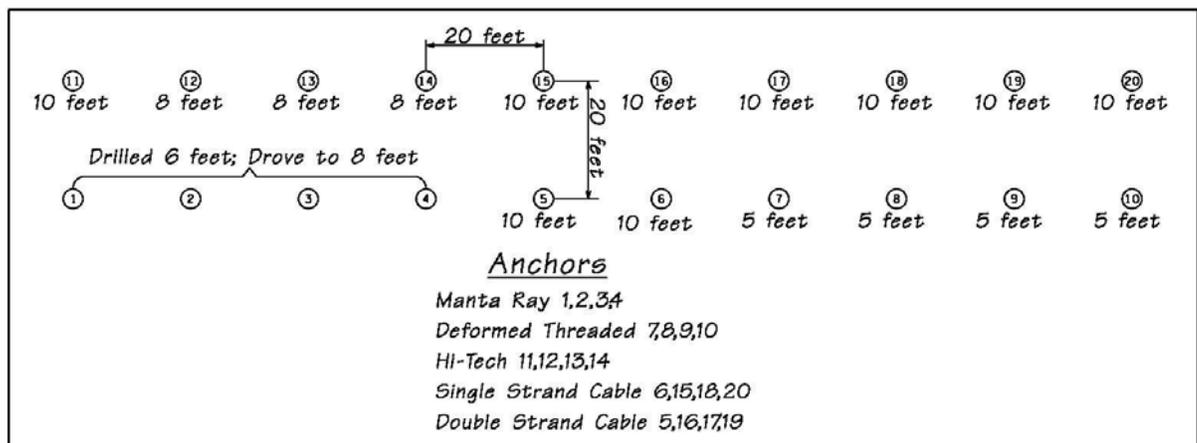
Figure 3-12. Layout of anchors and the depths to which they were installed.

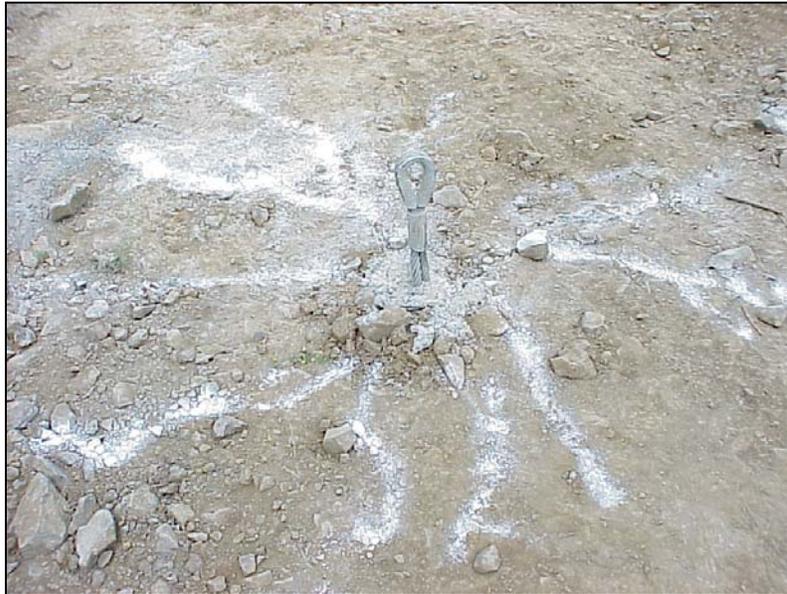
**Figure 3-18. Ground cracking (white painted lines) that developed around Anchor 17 (double cable anchor) during vertical loading.**

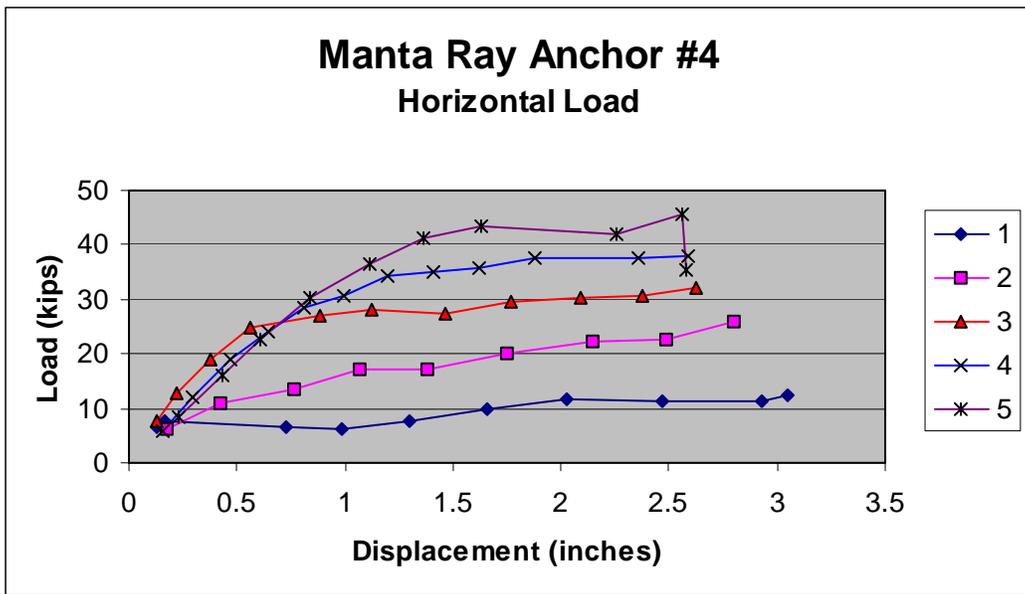
Figure 3-19. Load-displacement plot for horizontal test of a Manta Ray<sup>®</sup> anchor (#4).

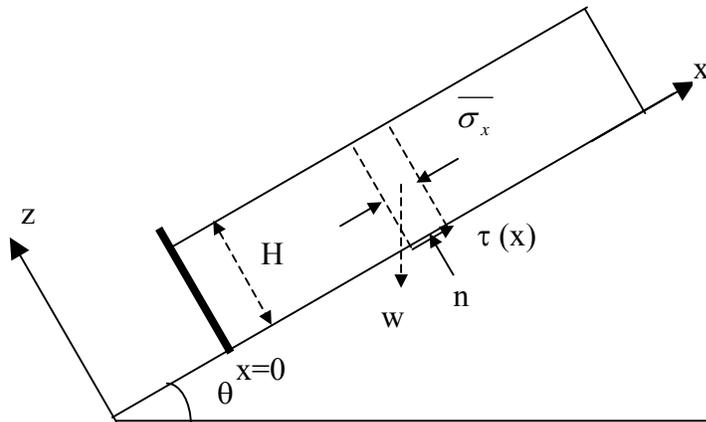
Figure 4-1. Stress components of snowpack upslope of an avalanche structure.

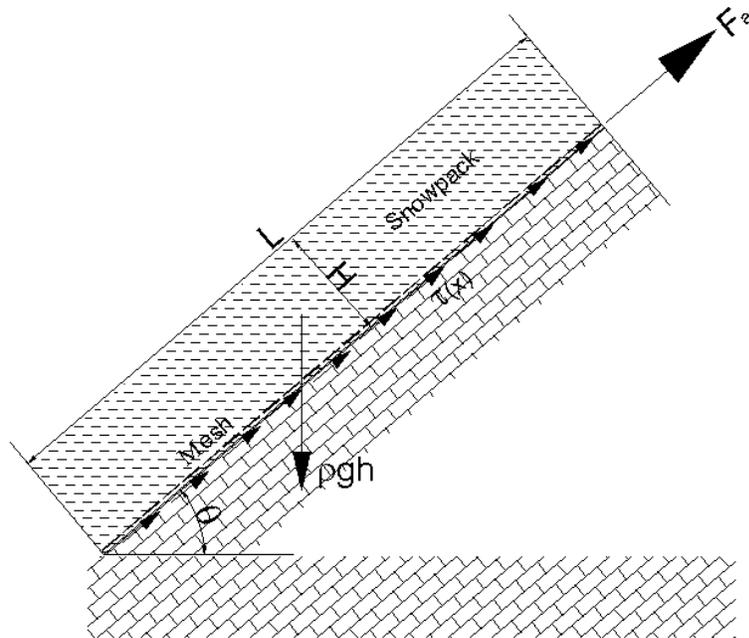
**Figure 4-3: The force components of the mesh and snowpack when the snow is bonded to both to the mesh and ground.  $F_a$  is the drag force on the anchors for a section of mesh  $L$  in length.**

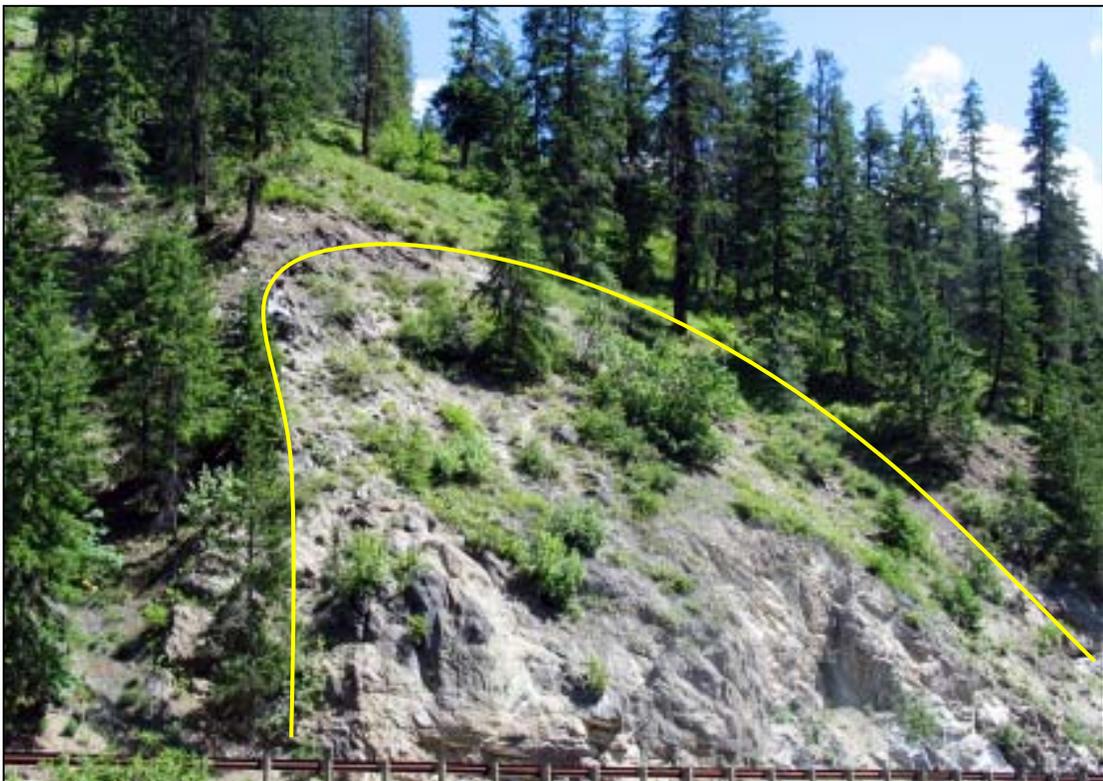
**Figure 4-6: Mesh installation (yellow line) on a planar and relatively smooth slope segment upslope of the steep bedrock exposures at roadway level. Snow accumulates only on the upper slope segment.**

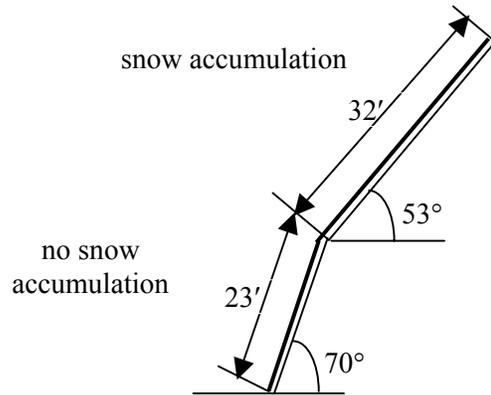
**Figure 4-7: Cross-section of installation with slope configuration and area of snow accumulation.**

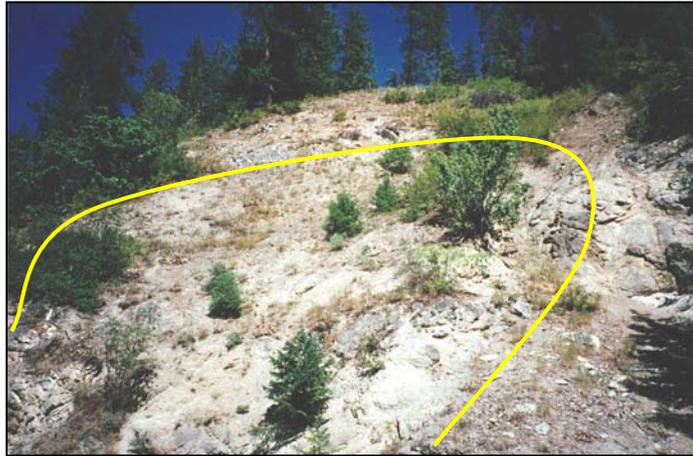
**Figure 4-8. Upper slope area before 1997 installation and the area where snow accumulates. Yellow line delineates approximate coverage area of mesh. Note planar condition and absence of irregularities over much of the upper slope.**

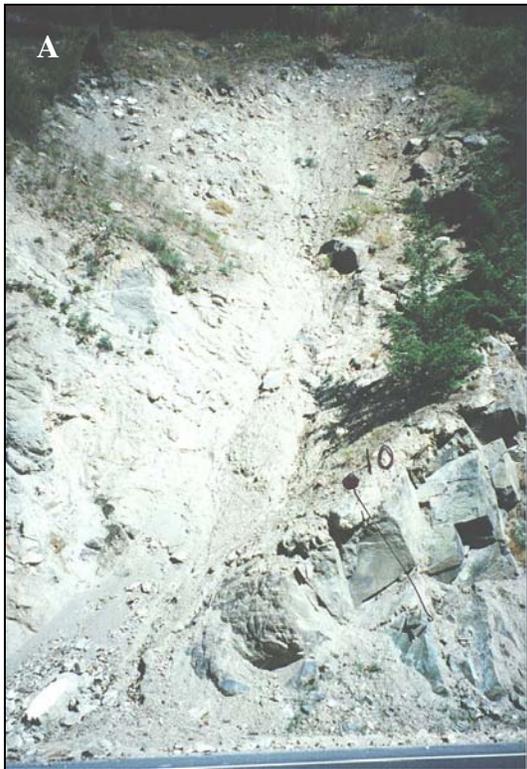
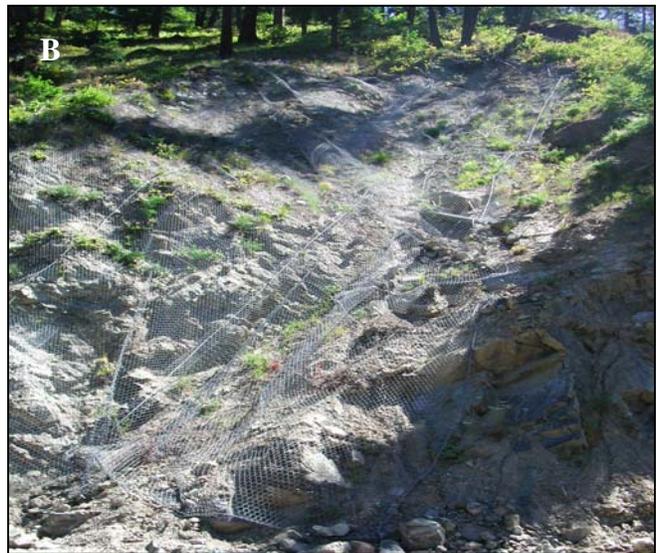
**Figure 4-9. Slope area in (A) 1997 before and (B) 2002 five years after mesh installation and just after repair of the system.**

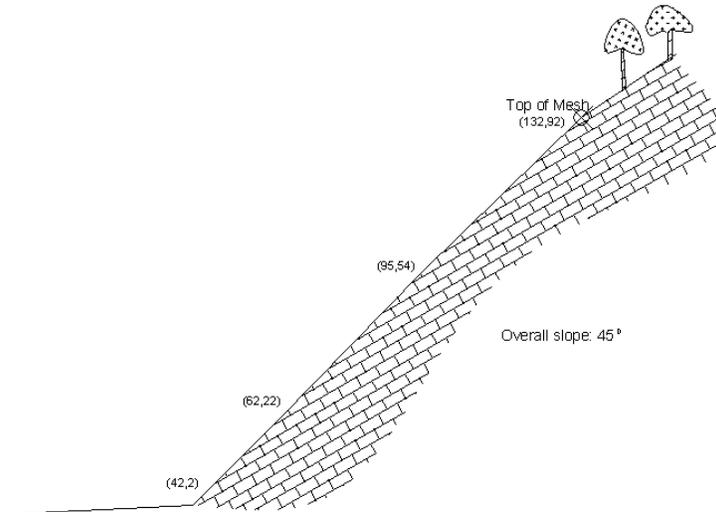
**Figure 4-10. Cross-section of installation shows approximate slope configuration. Snow accumulates on the entire area of the installation.**

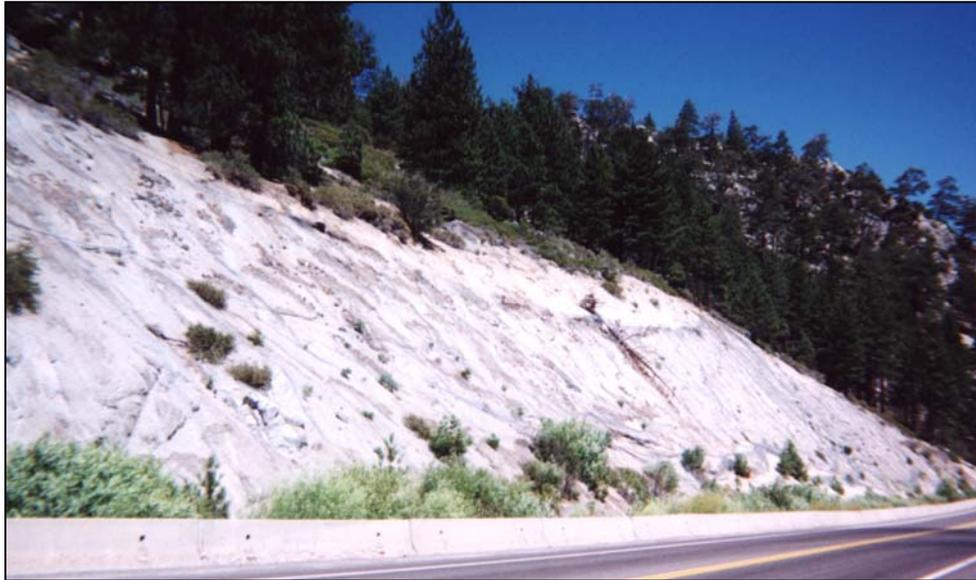
**Figure 4-11. Eastern half of the damaged installation still partially suspended on the slope, held in place mostly through interface friction and the few remaining intact anchors.**

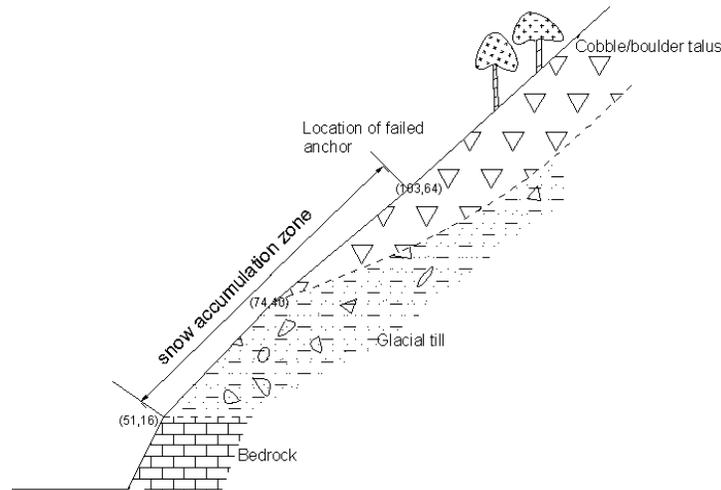
**Figure 4-12. Cross-section through failed cable net shows the portion of the installation that accumulated snow. Snowpack also extended upslope of the installation. The entire slope above the bedrock portion is highly susceptible to snow avalanches.**

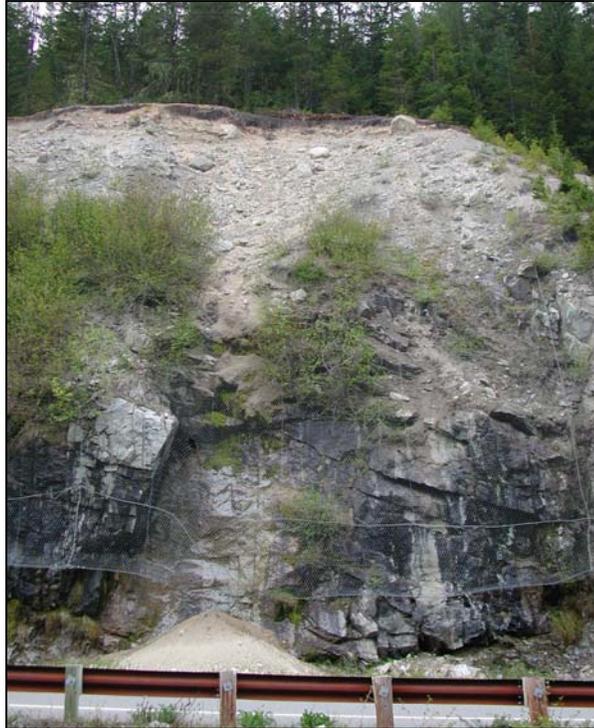
**Figure 4-13. The slope conditions; snow accumulation occurs on the upper portion of the slope.**

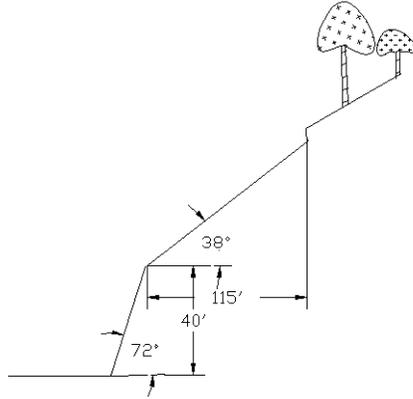
**Figure 4-14. Cross-section shows upper and lower slope segments. The upper segment comprises the zone of snow accumulation on the installation.**
