**Final Research Report**

**ANALYSIS AND DESIGN OF  
WIRE MESH/CABLE NET SLOPE PROTECTION**

April 2005

1. REPORT NO. <b>WA-RD 612.1</b>	2. GOVERNMENT ACCESSION NO.	3. RECIPIENT'S CATALOG NO.	
4. TITLE AND SUBTITLE <b>ANALYSIS AND DESIGN OF WIRE MESH/CABLE NET SLOPE PROTECTION</b>		5. REPORT DATE <b>April 2005</b>

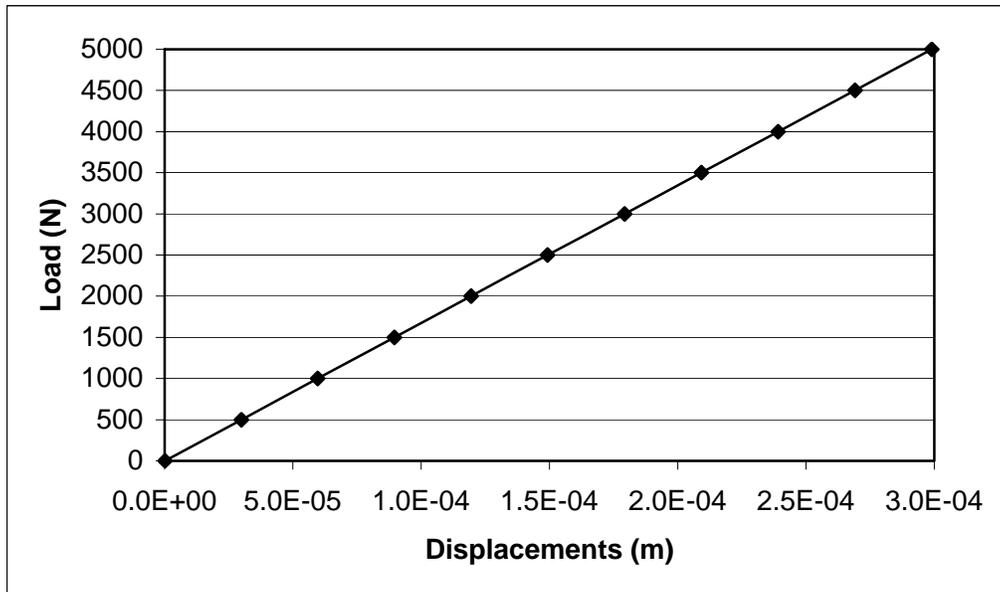
Figure 5-5. Applied load versus displacement of a cell assuming fixed sides.

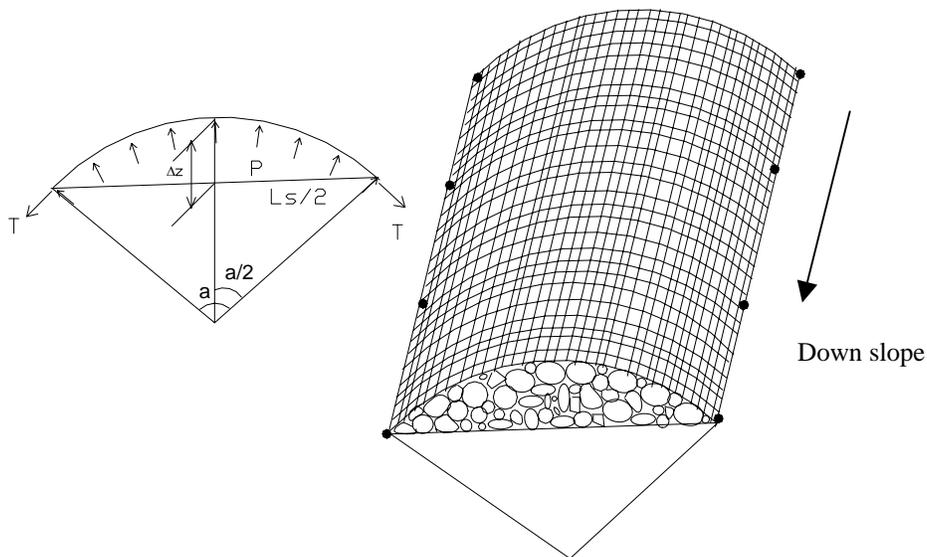
**Figure 5-7. Assumed circular cross-sectional shape of the mesh and the conditions that would result in seam failure.**

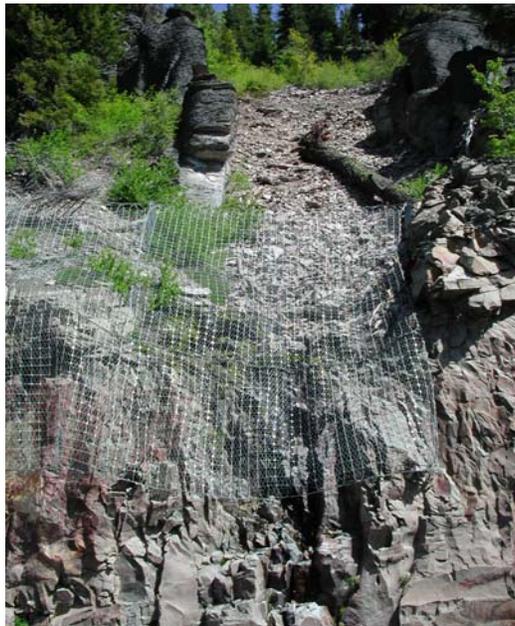
**Figure 5-8. Modified cable net installation, upslope source of rockfall, and typical range of block sizes that impact the installation in a sub-perpendicular orientation.**

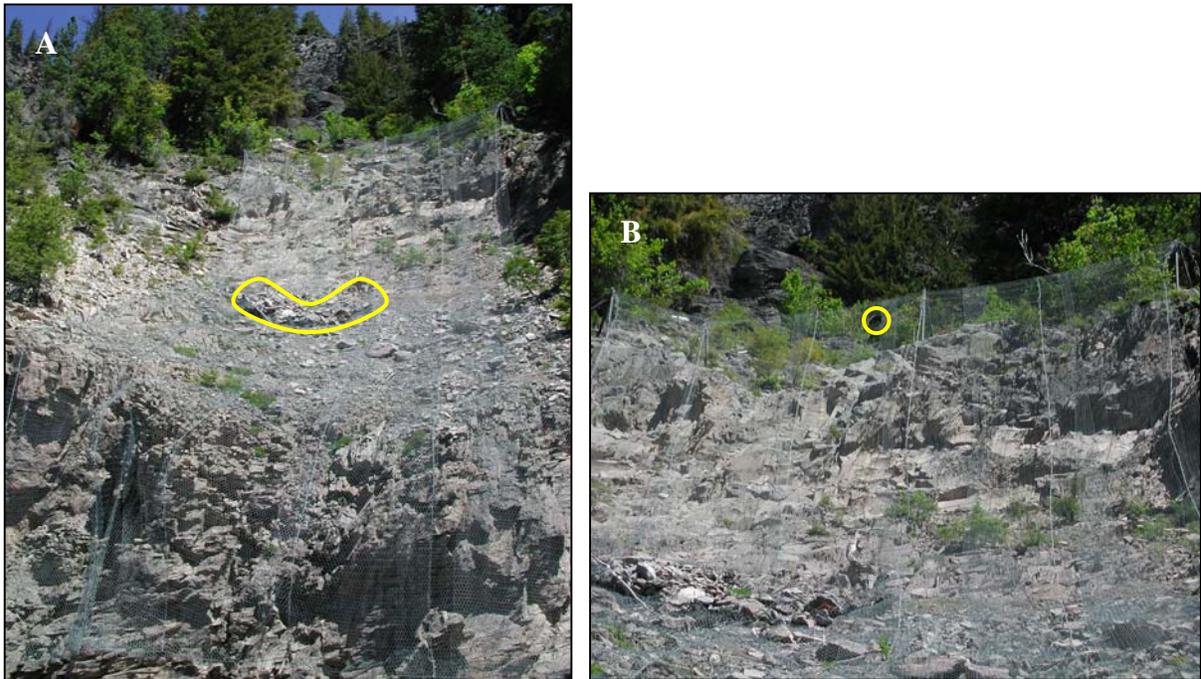
**Figure 5-9. (A) Configuration of slope and installation. Yellow line outlines area of debris accumulation and rupture failure. (B) Enlarged view of top of mesh, downslope of chute. Yellow circle highlights 18-inch (450-mm) puncture of the mesh.**

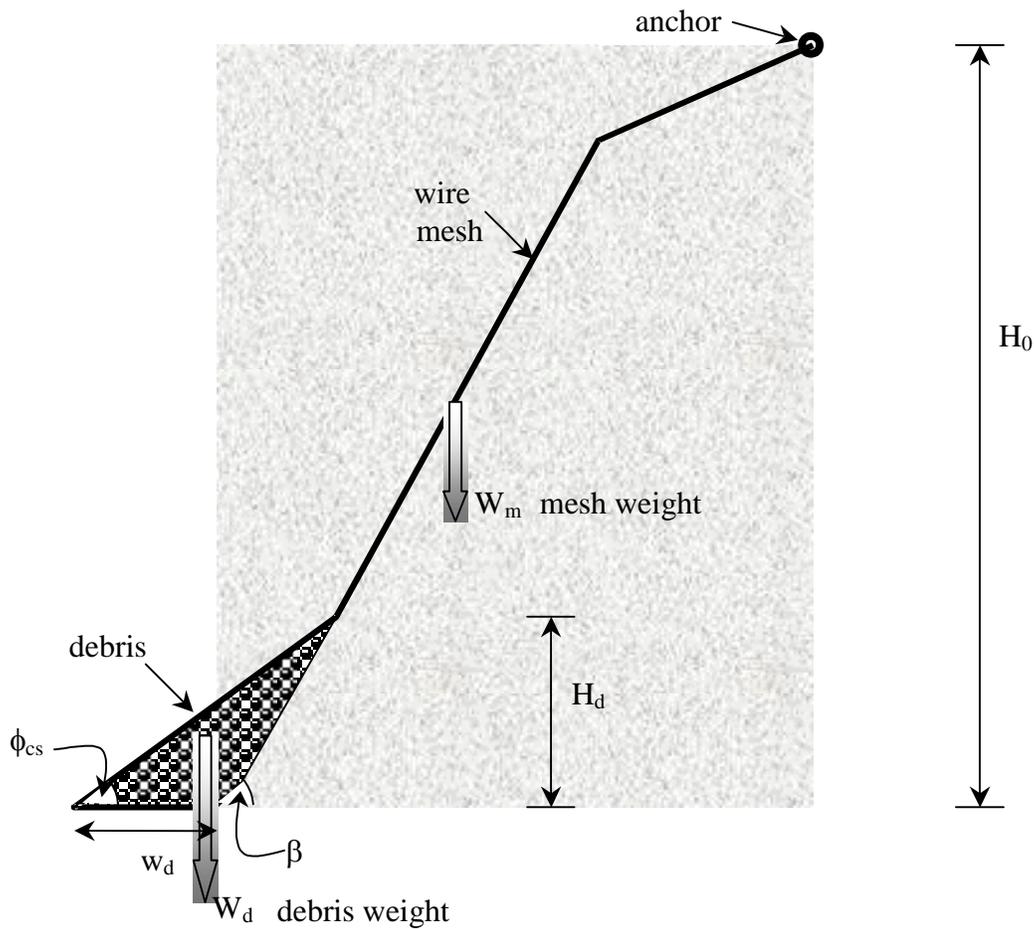
Figure 6-1. Mesh installation and loads that act on the system.

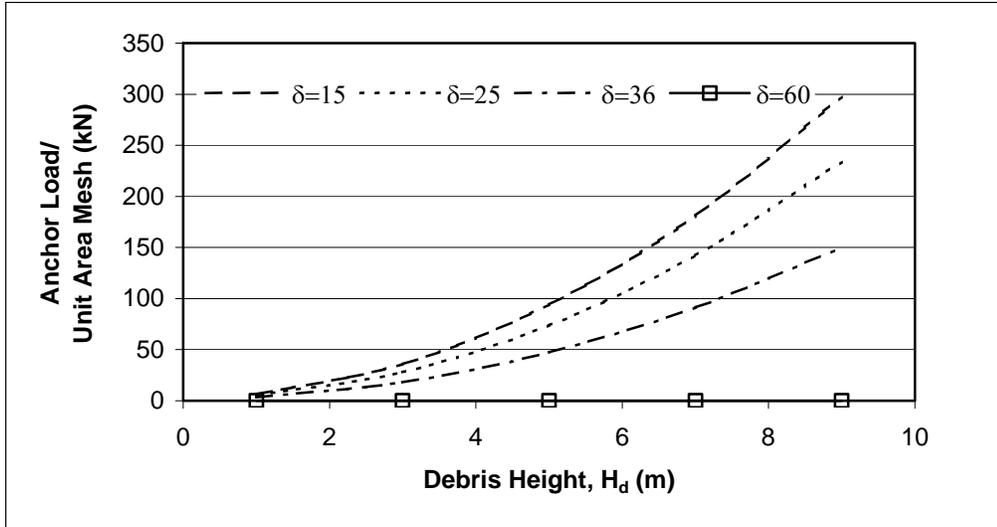
Figure 6-3. The effects of interface friction angle ( $\delta$ ) on anchor load for 30-m (100-ft) slope heights for a range of debris heights on a 50° slope.

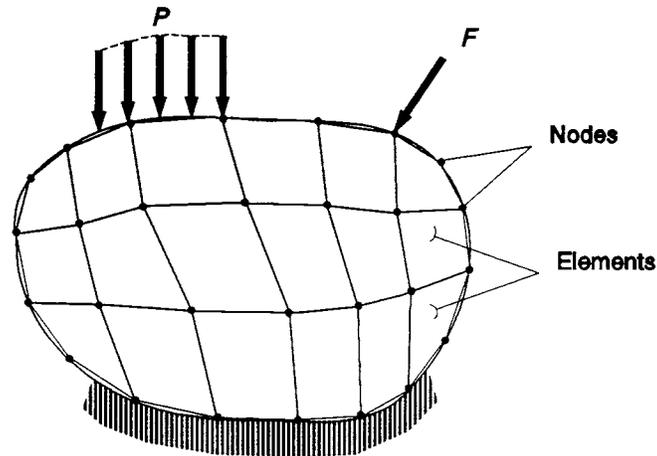
**Figure 6-5. Finite element discretization shows loads (P) and forces (F) acting on mesh (Knight, 1997).**

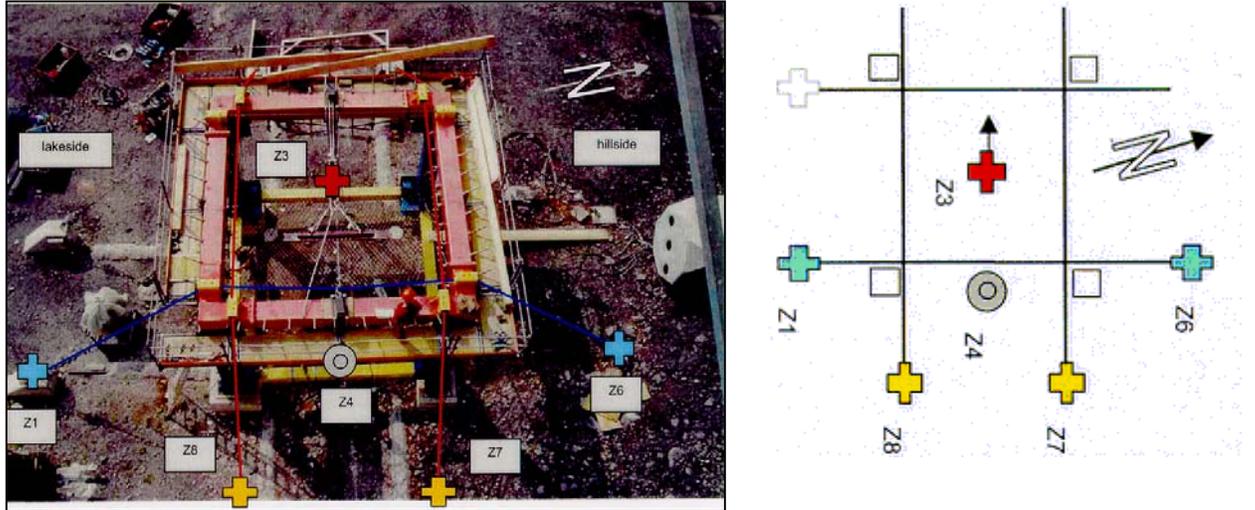
**Figure 6-6. Test setup and locations of load cells. Z4 is the load cell used to measure the force at the stabilizing anchor. Z3 is the load cell used to measure the applied load. Load cells Z1, Z6, Z7, and Z8 measure force at the other supports.**

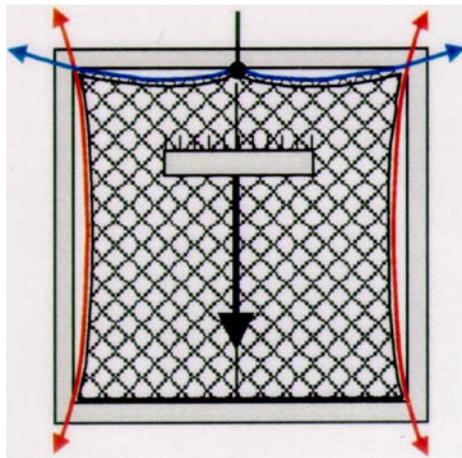
**Figure 6-7. The direction of loading of the TECCO® mesh by the steel beam and the load transfer to perimeters (support ropes and anchors) of the mesh panel. The beam is fixed to a variable number of mesh cells referred to in Table 6-1. The unit of measure for the distance of the beam to the anchor is in the number of mesh cells.**

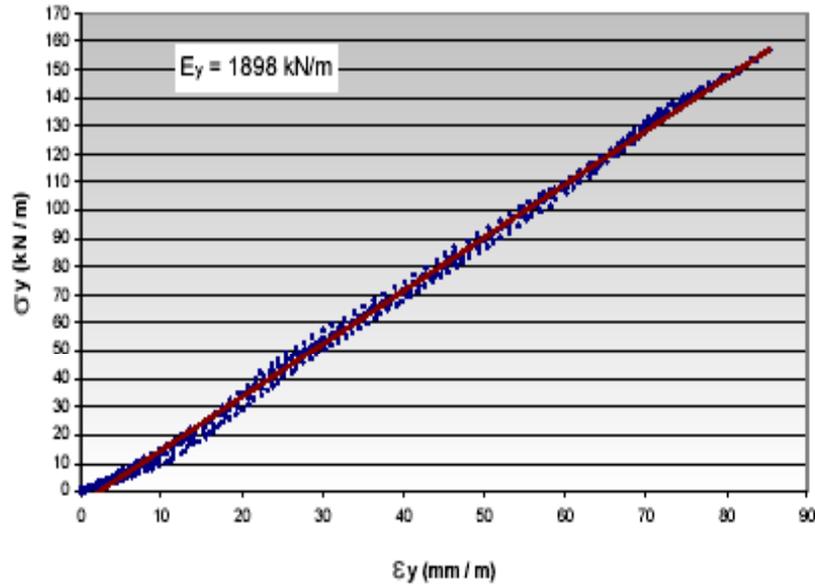
**Figure 6-8. Stress- strain relationship for TECCO® G65 mesh.**

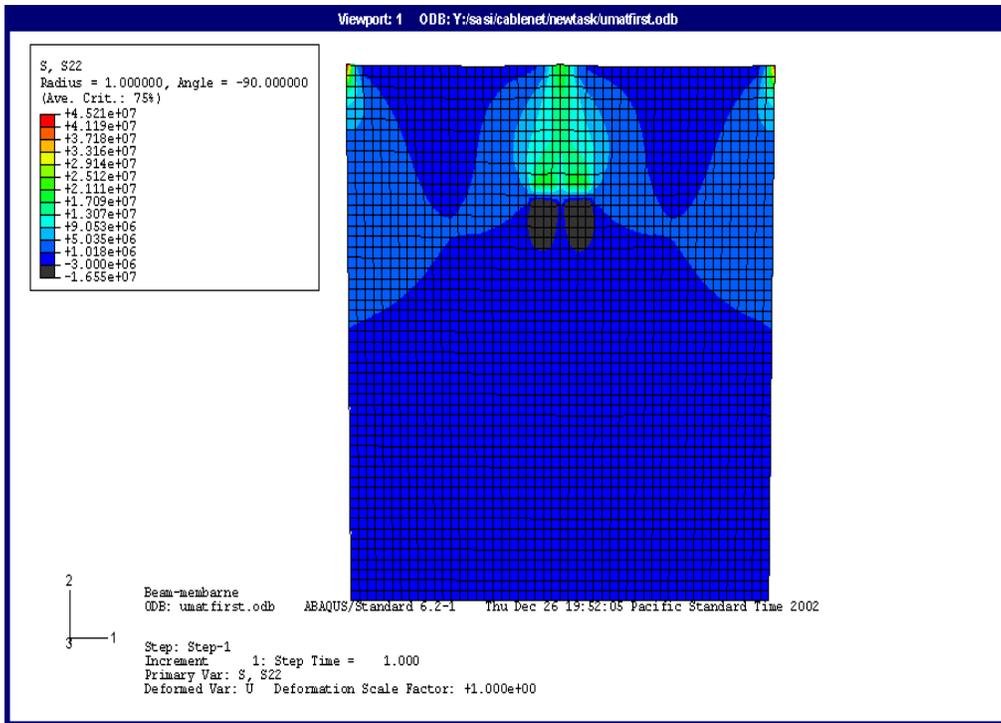
Figure 6-10. Stress contours for Test 1.

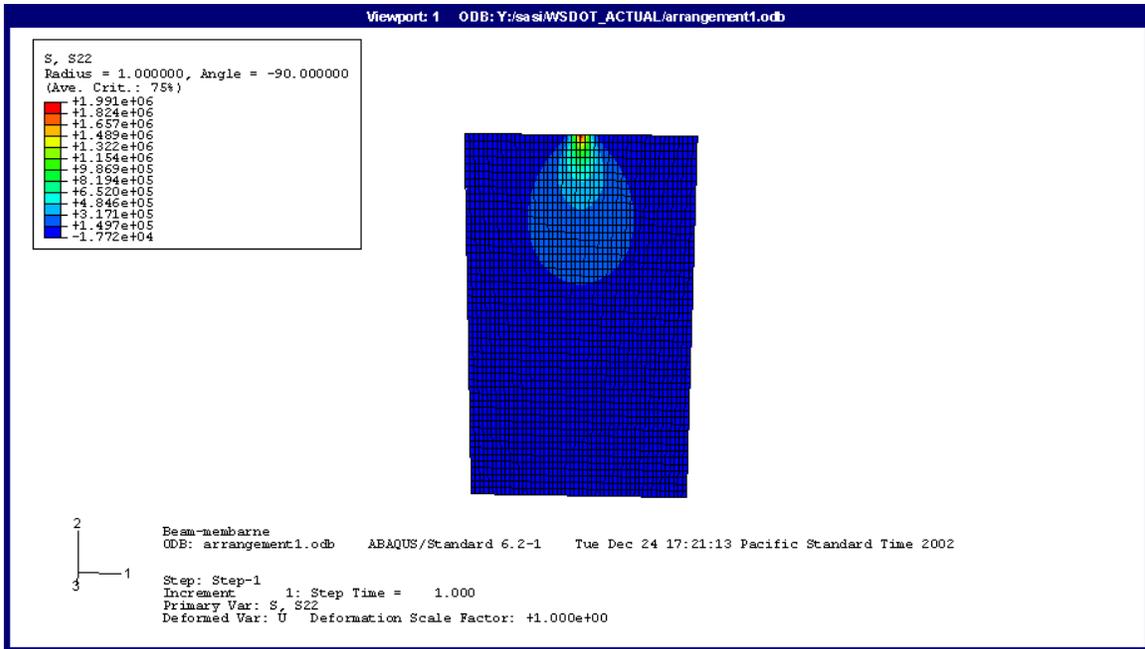
Figure 6-13. Stress contours for arrangement 1.

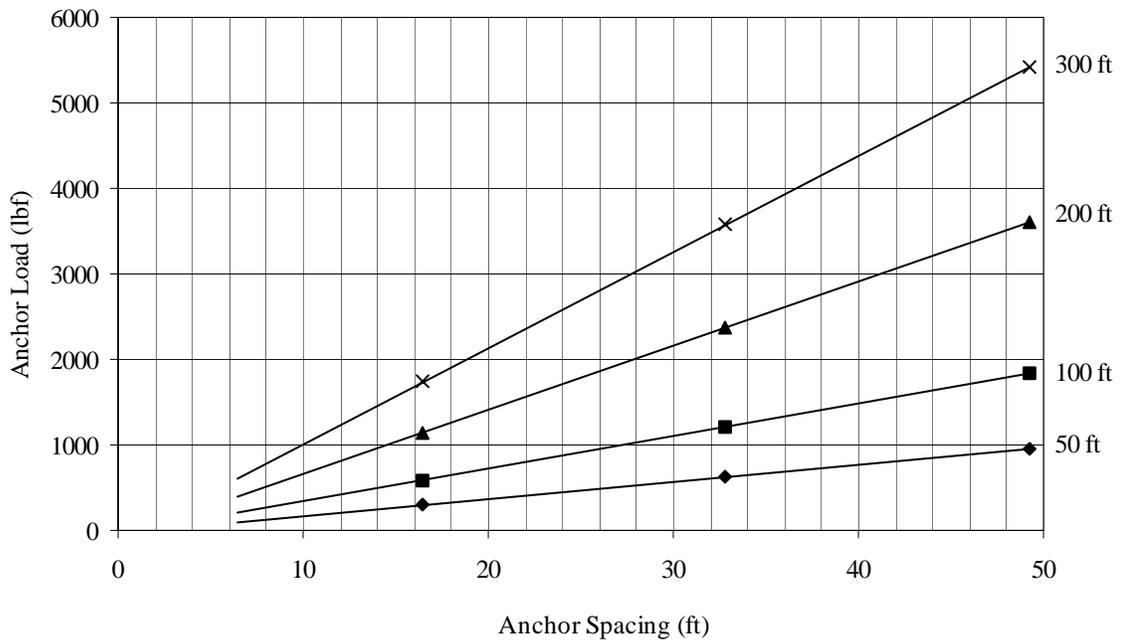
**Figure 6-17. Anchor load v. spacing for double-twisted hexagonal wire mesh for a vertical slope (no interface friction) ranging in height from 50 to 300 ft (15 to 90 m).**

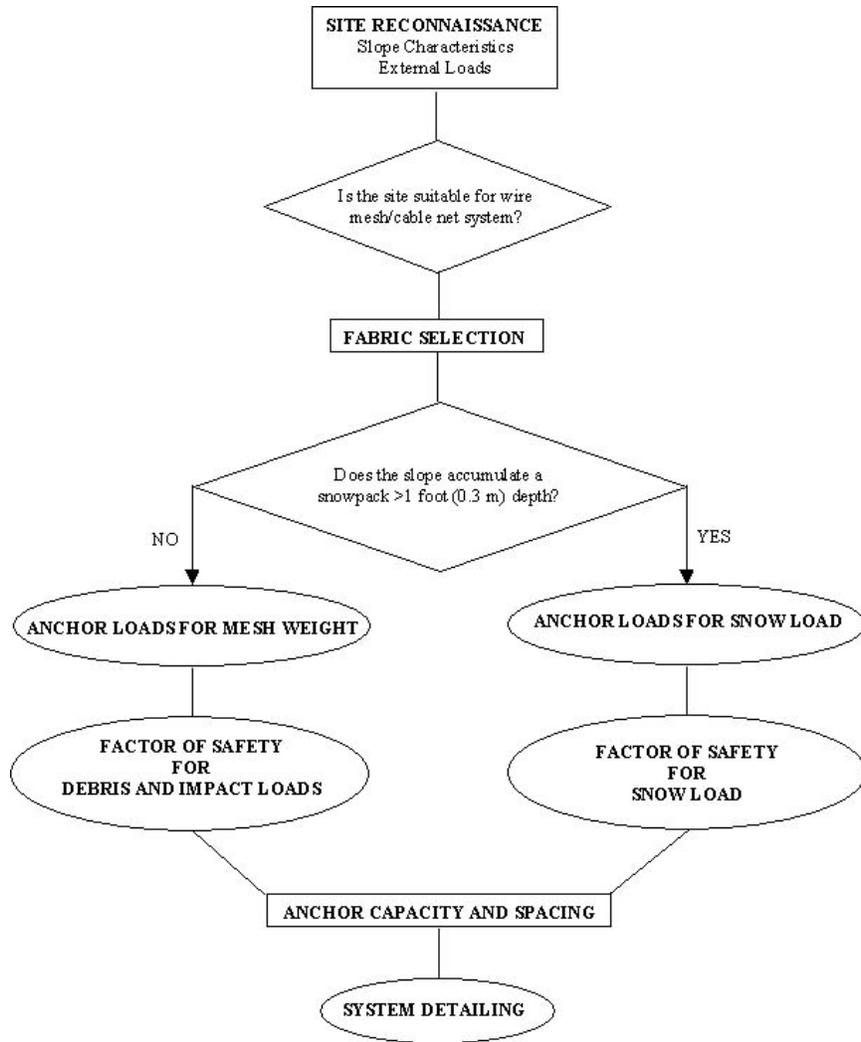
**Figure 7-1. Recommended design approach for wire mesh/cable net systems.**

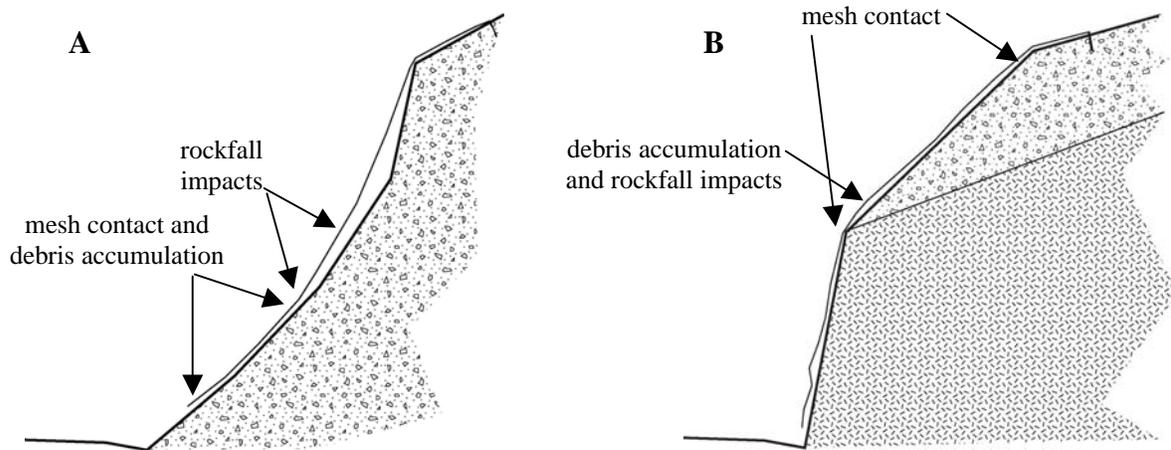
**Figure 7-2. Cross-sections show typical (A) concave and (B) convex slopes and the areas of mesh contact, debris accumulation, and rockfall impacts.**

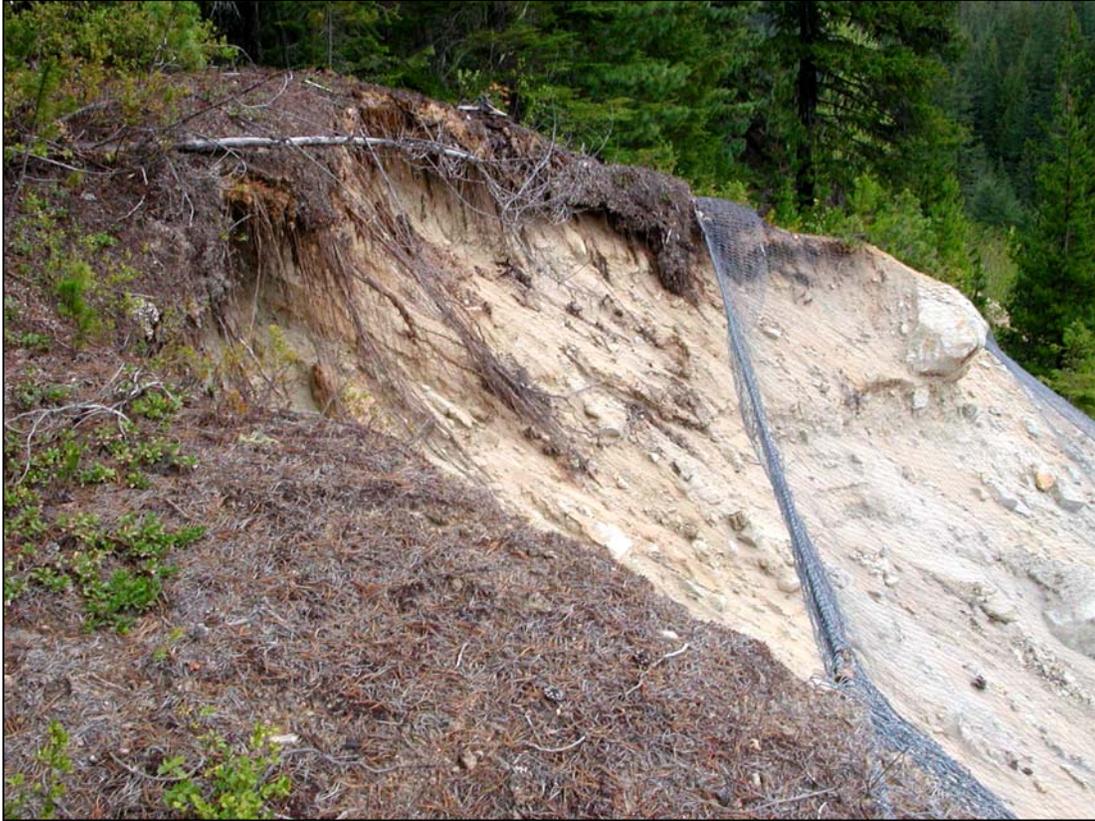
**Figure 7-3. Ongoing erosion threatens a wire mesh system installed in the late 1980s in the North Cascades of Washington.**

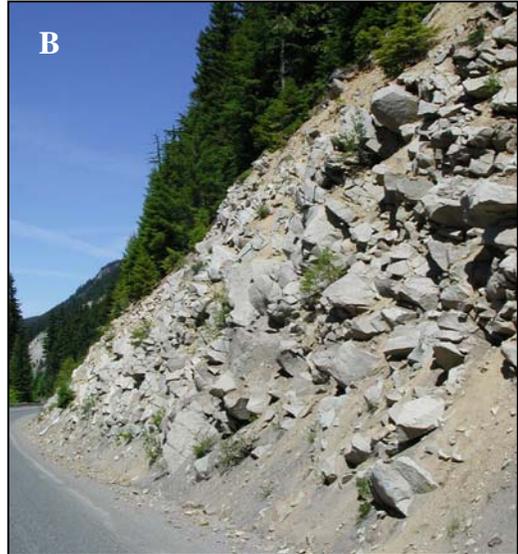
**Figure 7-4. Rough slopes exhibit a high degree of surface roughness with planar, uniform profiles.**

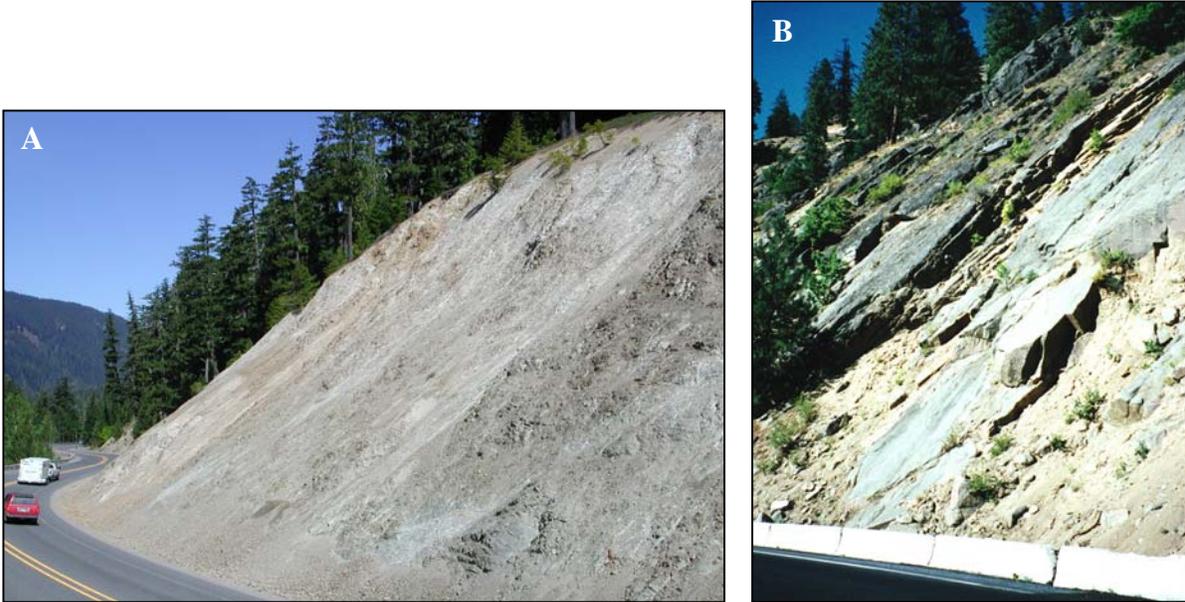
**Figure 7-6. These planar slopes exhibit little surface roughness or slope irregularity. In the case of (A), the slope profile is controlled by the very highly fractured condition of the rockmass. The slope profile in (B) is the result of a highly persistent set of discontinuities that dips coincident with the slope.**

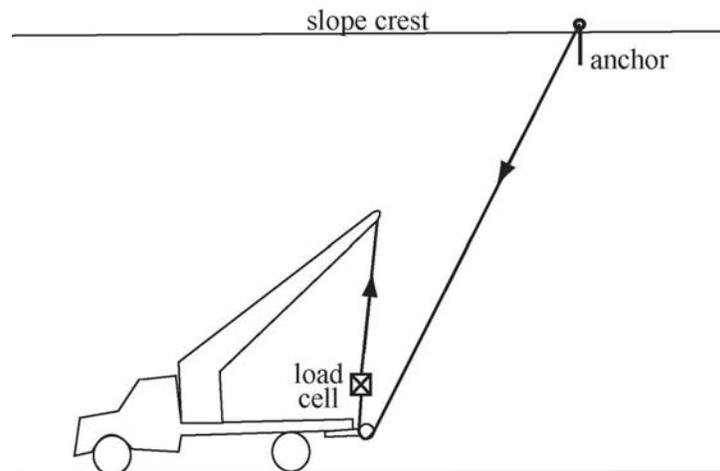
**Figure 7-8. Testing setup of anchors in a sub-horizontal direction.**

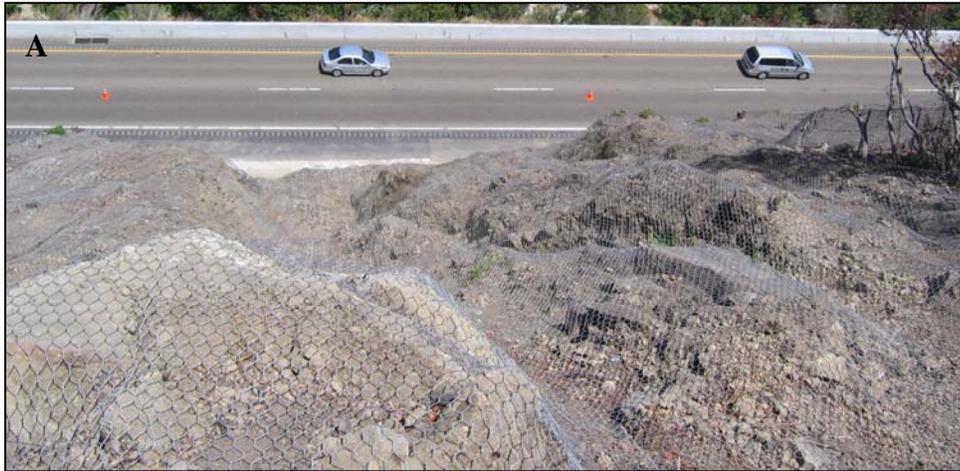
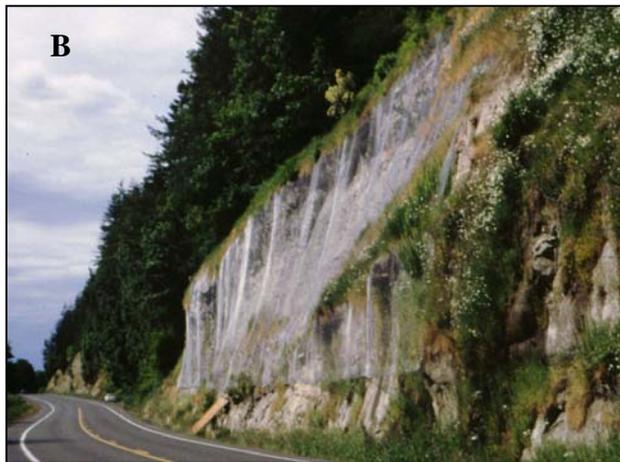
**Figure 7-9. (A) The mesh was carefully installed to closely conform to this moderately inclined slope. (B) On a steep to overhanging slope where mesh conformance is generally more difficult to achieve, the mesh can become more visually apparent.**

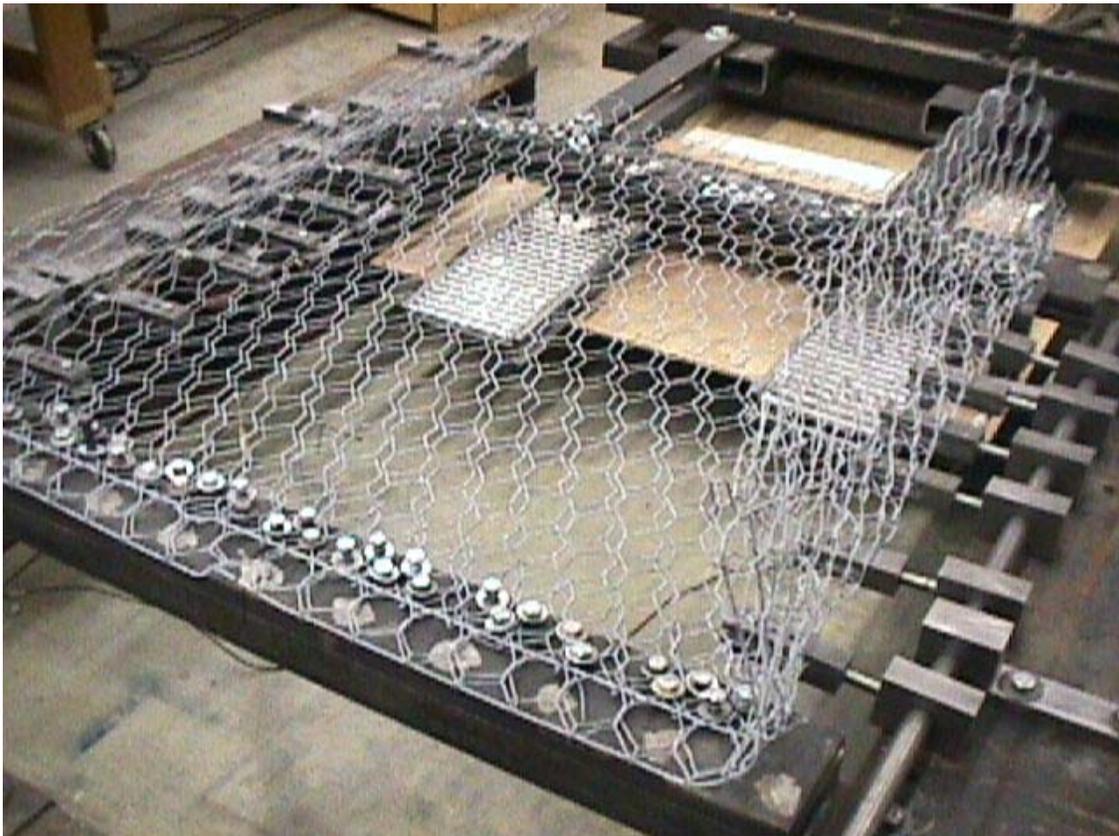
**Figure 2. Testing Setup for Twisted Wire Mesh with Bolts Extended Above the Loading Plates**

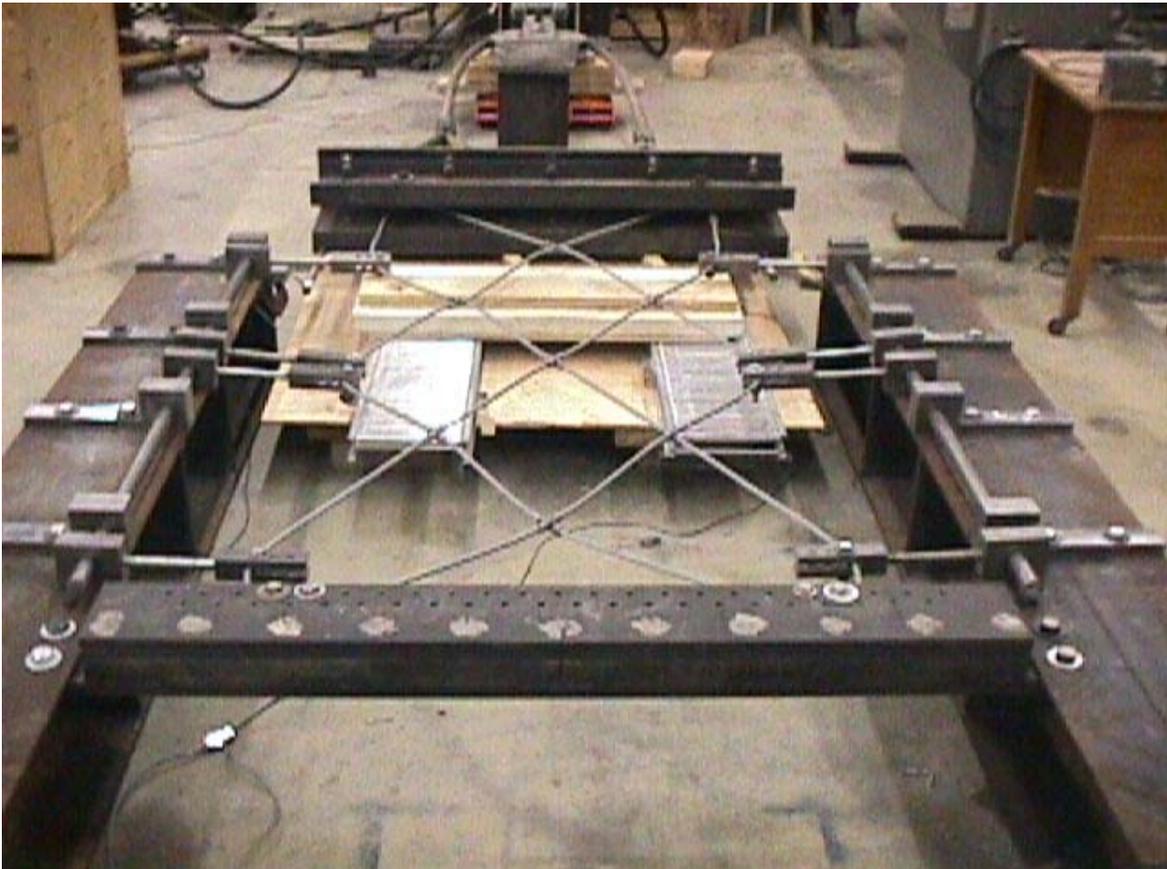
**Figure 4. Testing Setup for Cable Net Mesh from Maccaferri Utilizing Modified Test Apparatus**

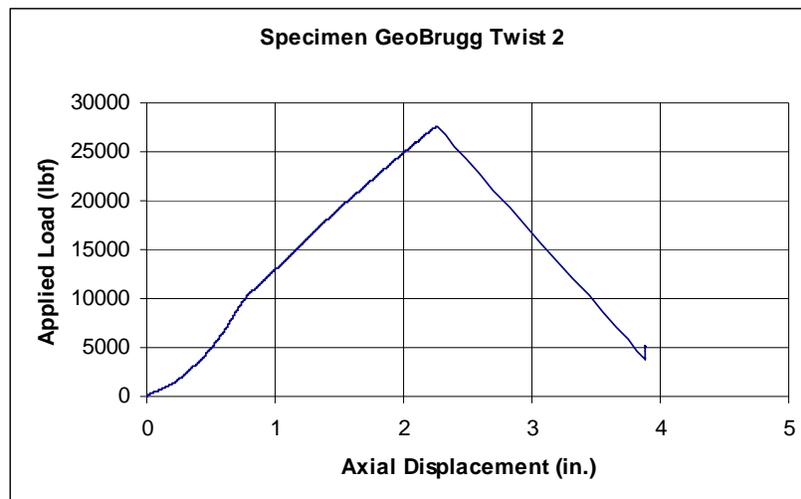
**Figure 5. Testing Typical Load Versus Displacement Plot for Determining Elastic Modulus Values**

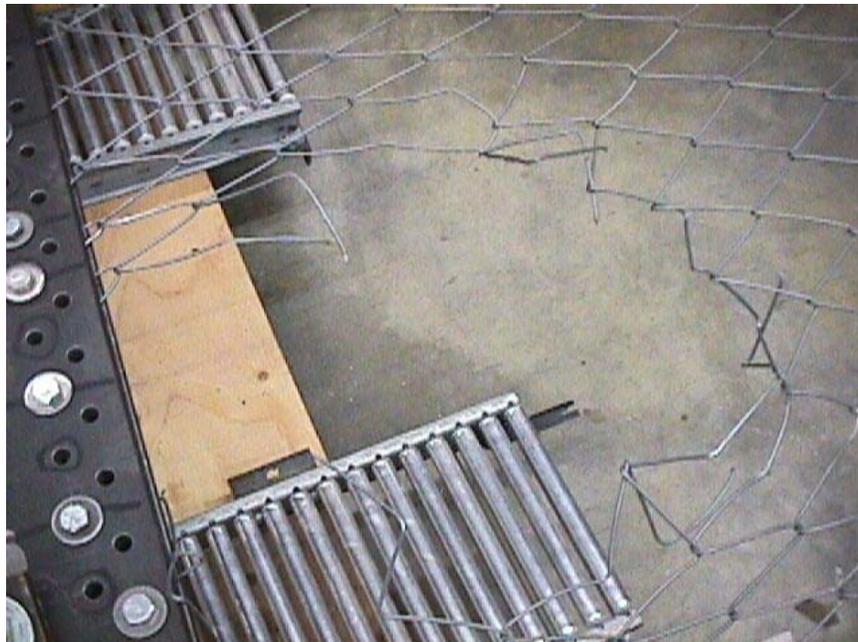
**Figure 6. Typical Failure for GeoBrugg Twist Meshes**

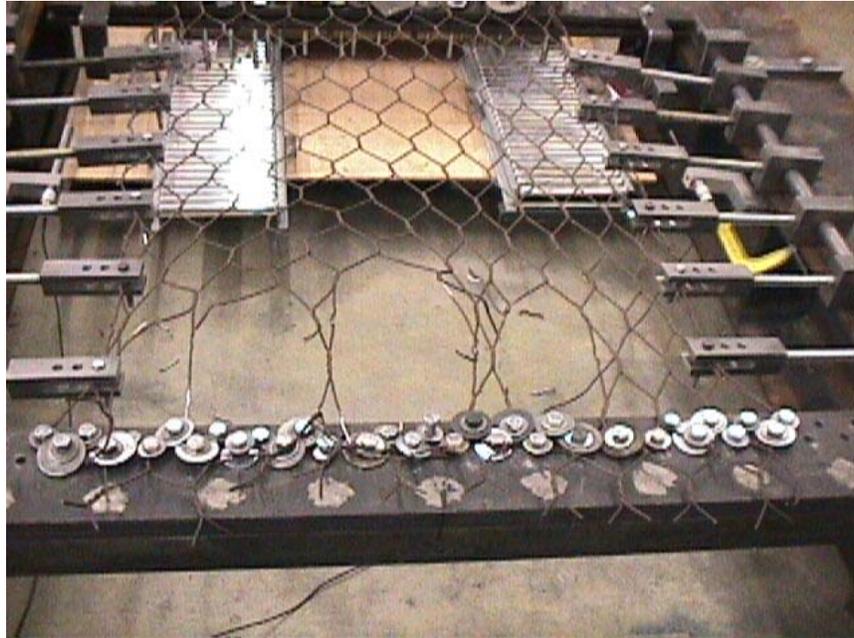
**Figure 7. Typical Failure for Maccaferri Twist Meshes**

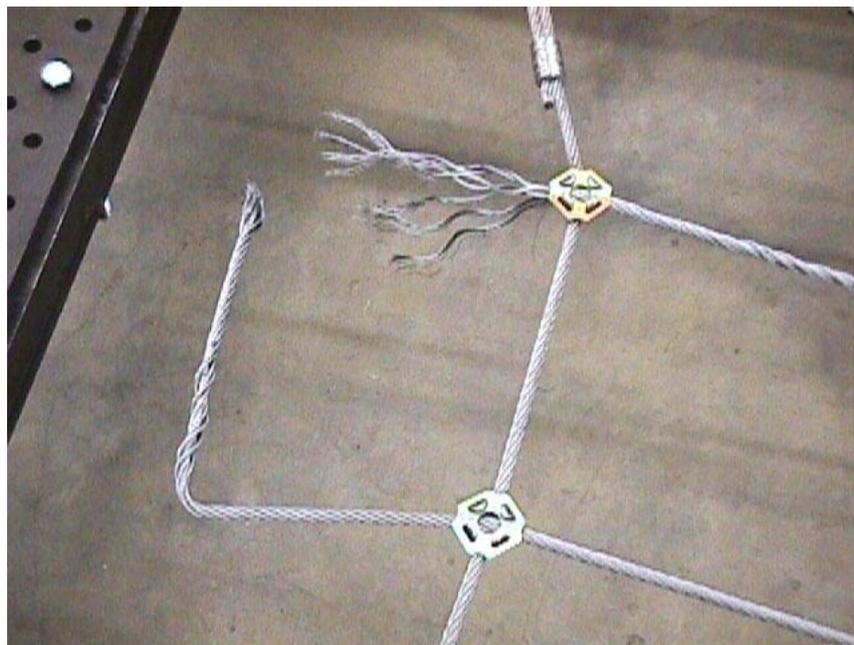
**Figure 8. Cable Breaking Failure of GeoBrugg Cable Specimens**

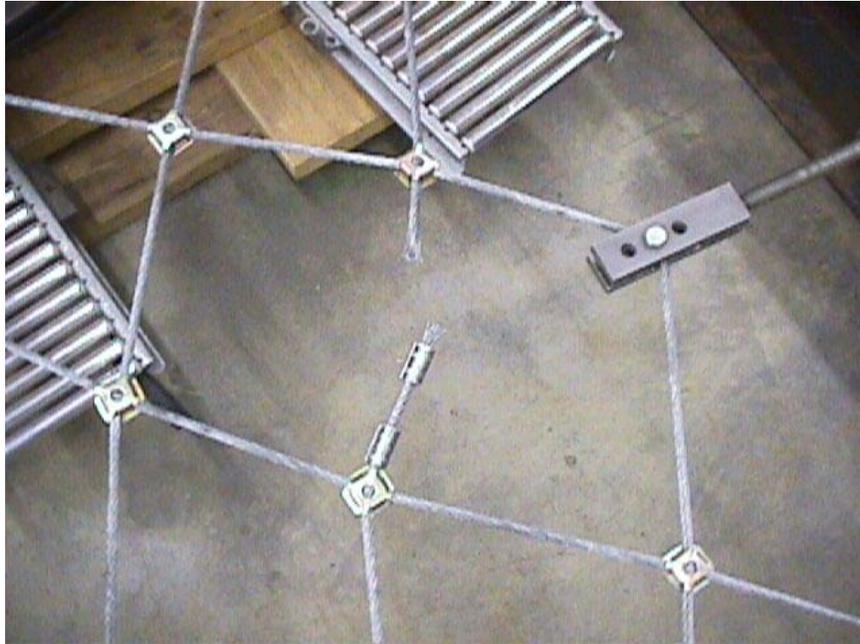
**Figure 9. Cable Slippage Failure of GeoBrugg Cable Specimen**

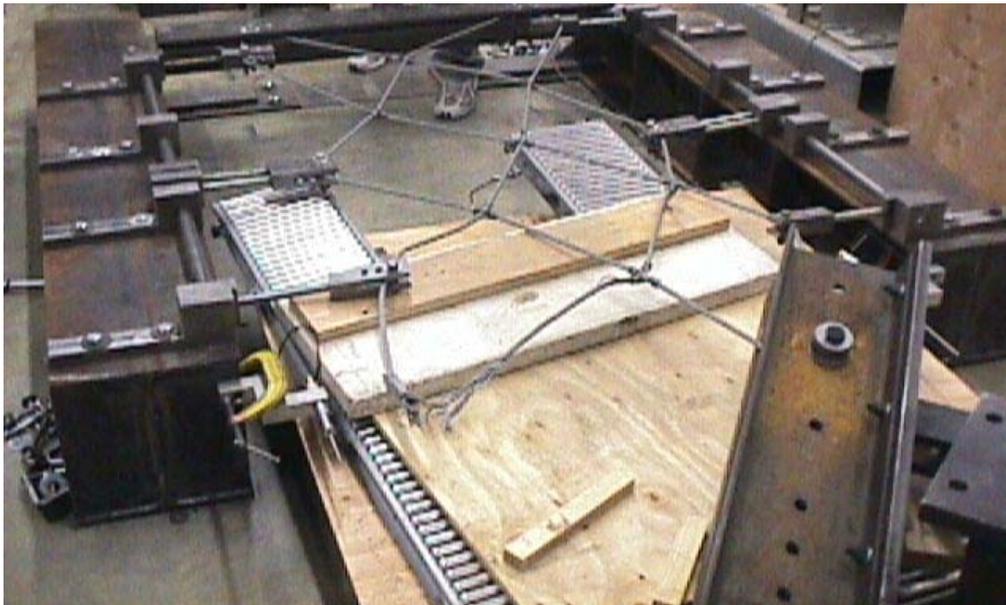
**Figure 10. Typical Cable Failure of Maccaferri Cable Net Specimens**
