Post Construction & Performance Report Experimental Features WA 00-01

URETEK Stitch-In-Time®

I-5 Gravelly Lake to Puyallup River Bridge Milepost 124.19 to Milepost 135.19

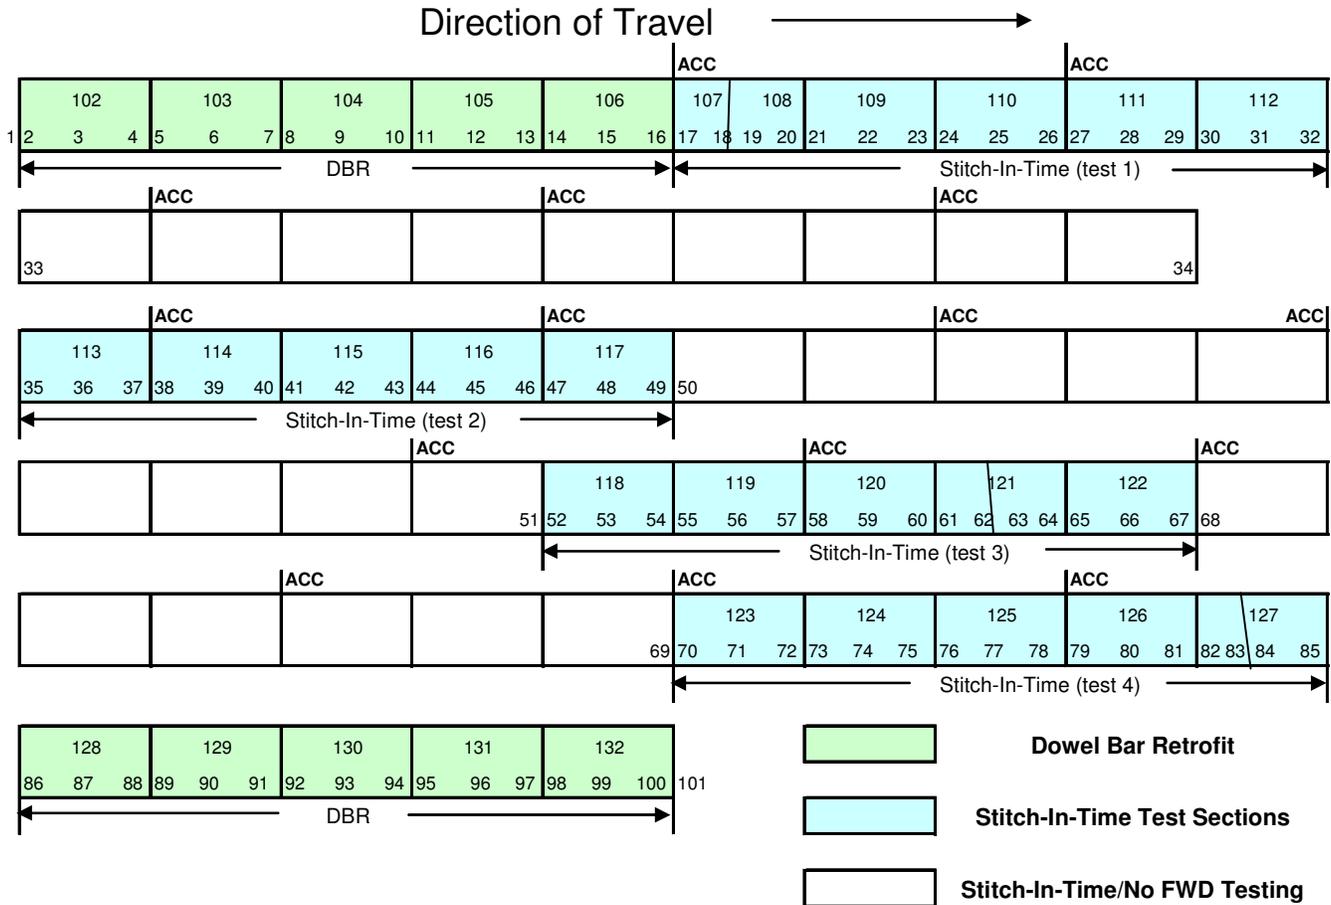
Figure 1. Test section layout with FWD test locations.

Small numbers are falling weight deflectometer test locations. ACC denotes an accumulator joint.

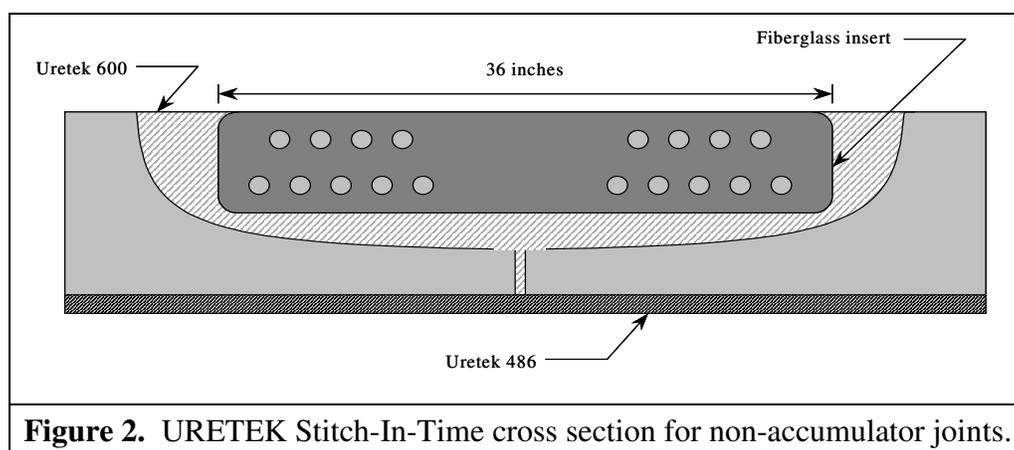
Figure 2. URETEK Stitch-In-Time cross section for non-accumulator joints.

The Stitch-In-Time Process uses a series of thin, saw-cut slots to position six fiberglass inserts, three per wheel path, that tie the individual slabs together. The inserts are five inches wide, 36 inches long and ¼ inch in thickness. The inserts are placed in ½ inch wide sawed slots which are backfilled with a combination of sand and URETEK 600, high-density polymer (Figure 1) to form a monolithic structure. An accumulator joint is installed every 45 feet to allow for the horizontal movement of the concrete slabs. The accumulator joint consists of the same fiberglass insert used in the locked joints, however, it is encased inside a metal box built just slightly larger than the insert. The box is split in the middle with each side straddling the transverse joint. A rubber boot covers the split area to seal out foreign contaminants and seal in the lithium-based grease used for lubrication (see Figure 19 in the section on Construction). The accumulator device is installed in a slot that is cut the full depth of the slab and is cemented in place using the same high-density polymer used for the locked joints.

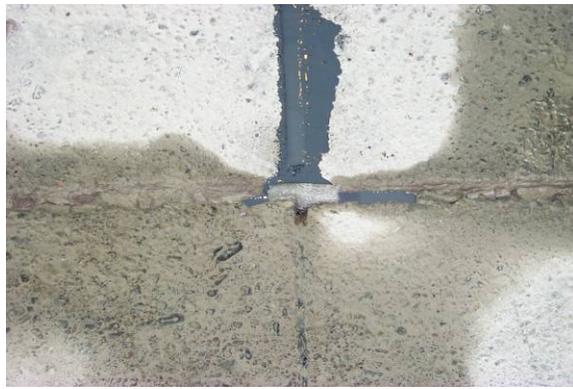
Figure 24. Function of backer rod at joint.

- d. Scrap tire rubber crumbs (1/4 inch) are placed over the backer rod to fill the joint to just below grade.
 - e. Rubber is saturated with URETEK 700 to just below grade.

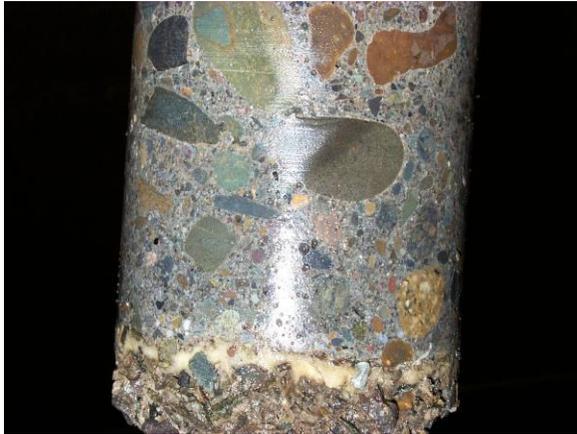
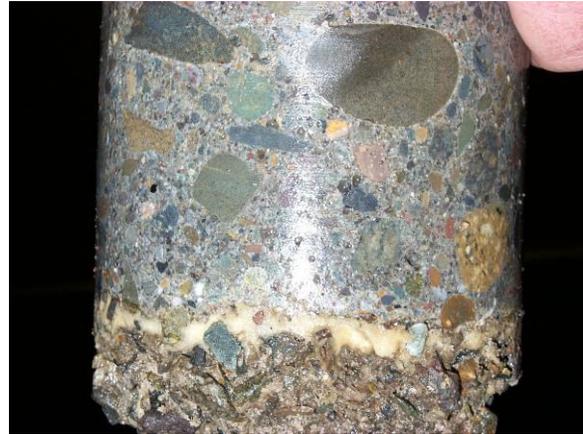
Figures 27 and 28 show an example of the outcome of a URETEK 486 undersealing process. These cores are from a project in the Southwest Region. The URETEK 486 material is the light colored material sandwiched between the aggregate base and PCC pavement.

Figure 27. Core showing URETEK 486 undersealing material.

Figure 28. Close-up of URETEK 486 undersealing material.

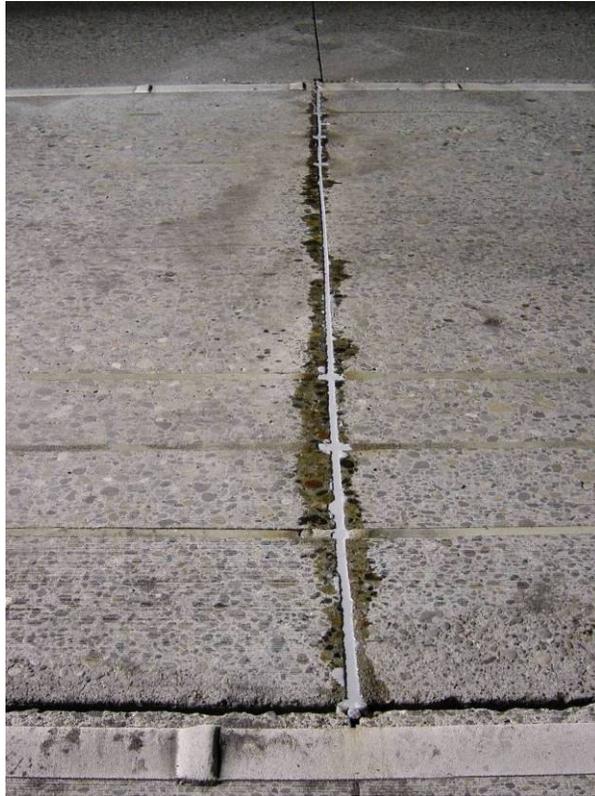
Figure 29. Accumulator joint after resealing.

In July 2001, ten months after installation, the accumulator expansion joints were resealed due to the improper installation of the URETEK 800 joint seal material. Figure 29 shows a completed accumulator joint after resealing.

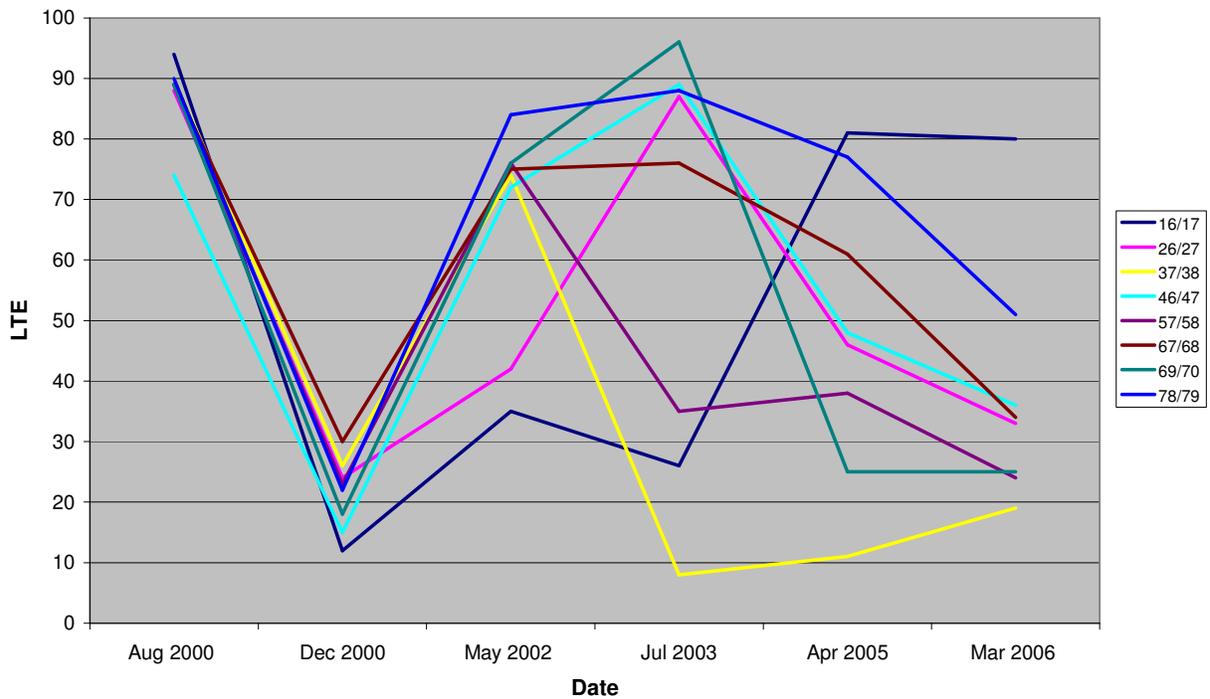
Figure 31. Change in LTE for each accumulator joint over the period of evaluation.

The LTE results for the accumulator joints show a gradual decline from an average of 88 prior to installation to a 38 in March of 2006. A large dip in the values in December of 2000 was undoubtedly due to the extremely low temperatures at the time of testing (see Table 3). The low

temperatures cause the individual slabs to contract and the joints to open. This, in combination with the fact that each joint was saw cut full depth to eliminate any slab to slab contact, would shift all of the load to the fiberglass inserts. The only consistency in response for all of accumulator joints was for the December 2000 measurement. From that point on, the response of each joint was random, four showing high LTE at times of high temperature (July 2003) and three showing very low efficiencies at the same time. With one exception, joint 16/17, the trend is definitely downward since the July 2003 measurement. Joint 16/17 is the joint that is tied into the dowel bar retrofit section at the beginning of the Stitch-In-Time section. The support supplied by the dowel bar section may be influencing the reaction of this particular accumulator joint that actually seems to be getting better with time. The wild variations noted in the LTEs for the individual joints provide another indication that the load transfer readings may be completely dependent on the fiberglass inserts.

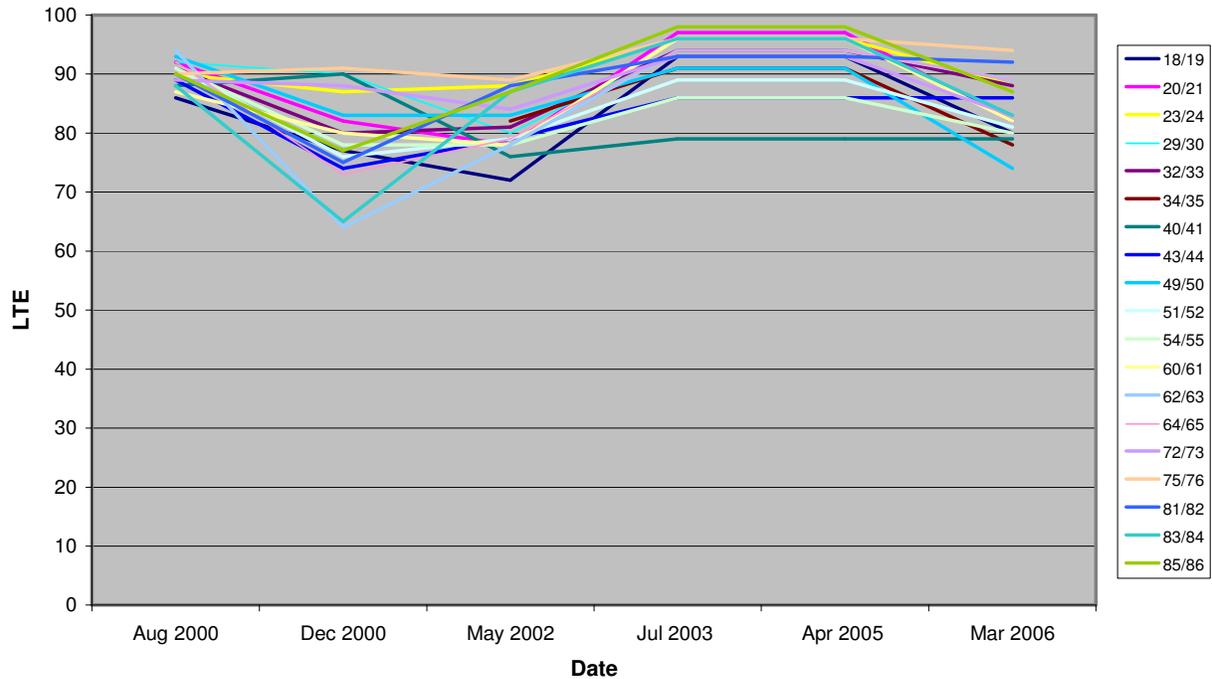
Figure 32. LTE for the Stitch-In-Time locked joints.

The results for the locked joints show better overall LTEs with very little deterioration throughout the evaluation period. The average LTE for all of the joints in the section was 88 prior to construction and ended at 84 at the 2006 measurement. A slight dip in the average is noted for the December 2000 readings taken during the extreme cold temperatures, but nothing of the magnitude noted for the accumulator joints. The consistently high LTEs for the locked joints in spite of the colder temperatures is not unexpected since the joints are held together in a rigid structure by the fiberglass inserts and polymer cement. The overall variation in LTE for the locked joints is minimal throughout the period of evaluation.

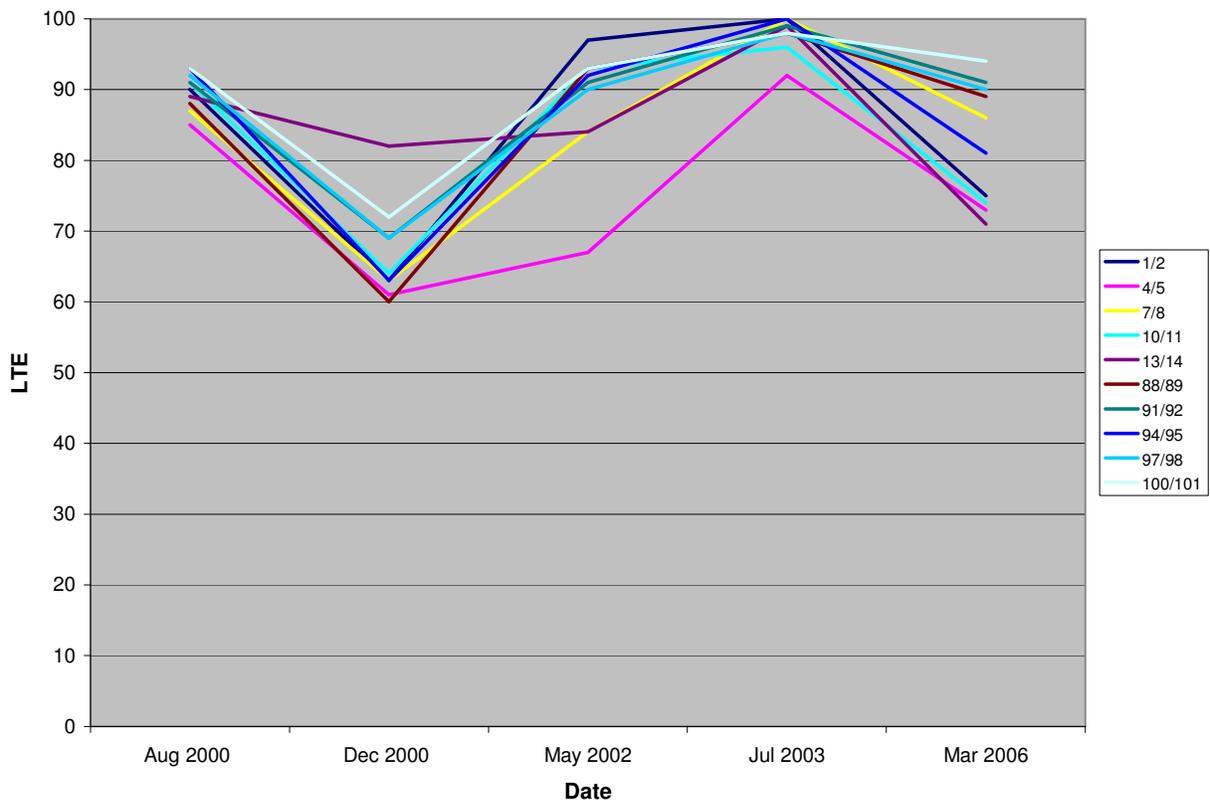
Figure 33. LTE for the dowel bar retrofit joints.

The dowel bar retrofit joint LTEs, listed in Table 7 and shown in Figure 33, fall somewhere between the Stitch-In-Time accumulator and locked joints. They start out at an average LTE of 90 prior to retrofitting and end at 82 in 2006. A more substantial dip in the results can be observed for the December 2000 measurements than that observed for the locked

In summary, a comparison of the average LTEs for each of the three joint groups indicate that the locked joints are performing the best, the dowel bar retrofit joints second best, and the accumulator joints the worst.

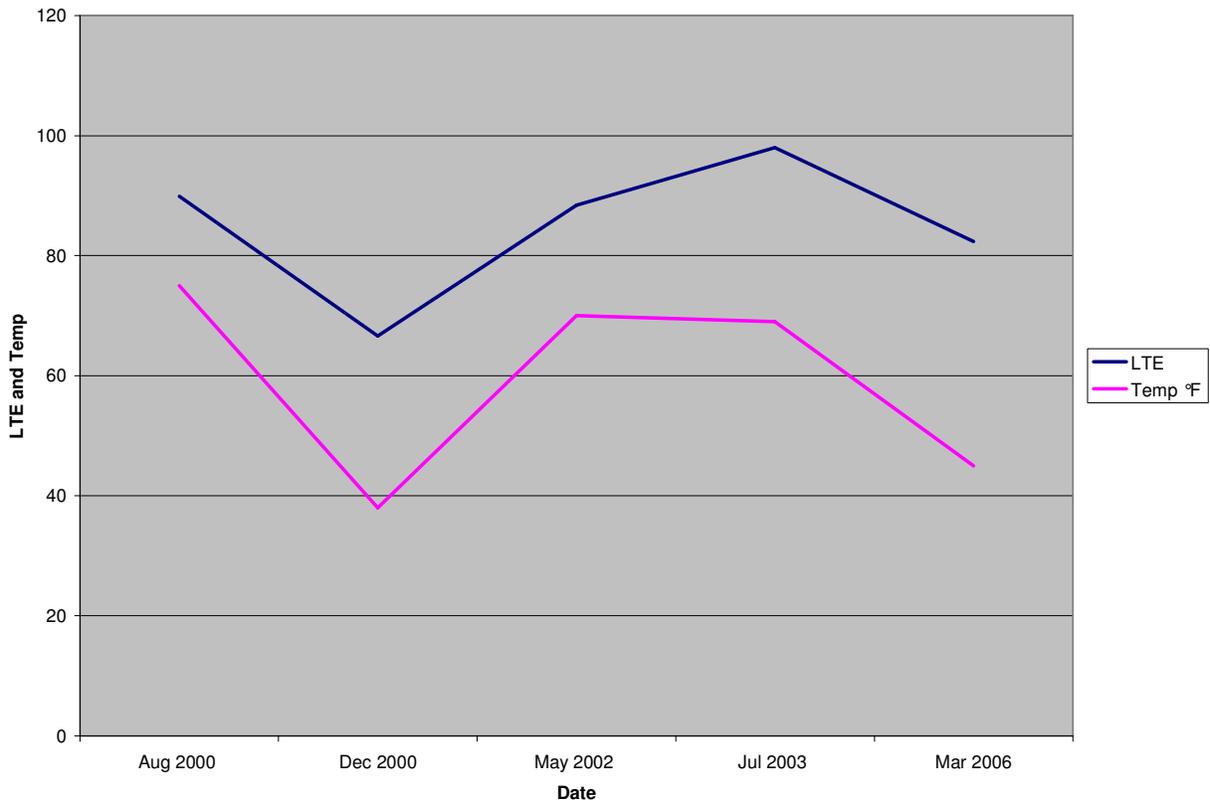
Figure 34. LTE verses temperature for dowel bar retrofit joints.

The change in LTE with temperature is very striking. As the slabs shrink with decreasing temperature, the slab to slab contact lessens resulting in a decrease in LTE. The load transfer increases as the slabs expand due to increasing temperature. What is surprising is that this is observed in both the Stitch-In-Time sections and the dowel bar retrofit sections. Since all of the joints were saw cut full depth in the Stitch-In-Time section, it might not be reasonable to think that temperature would affect LTE. Table 8 shows the pavement temperature at the time of

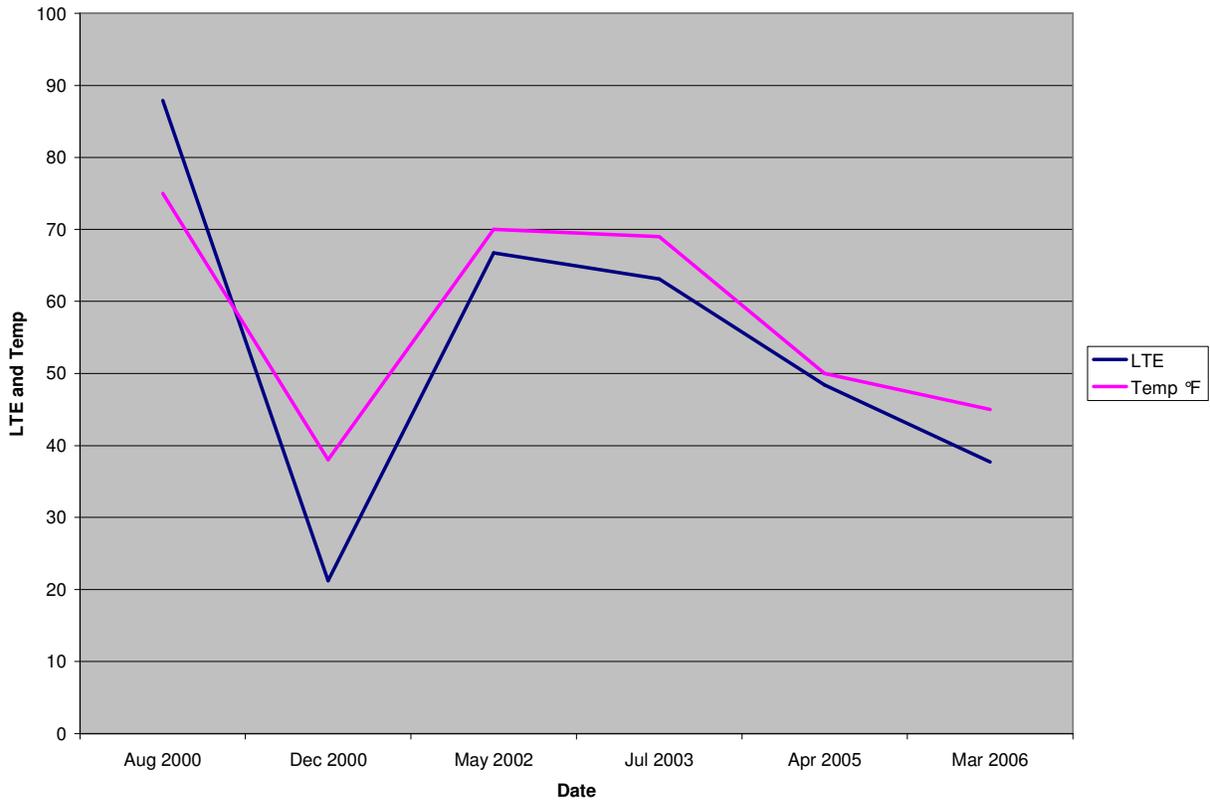
Figure 36. LTE versus temperature for Stitch-In-Time accumulator joints.

The dip in LTE is most noticeable in the accumulator joints, as would be expected. The fiberglass joint inserts are apparently not as effective in carrying the load as is a combination of

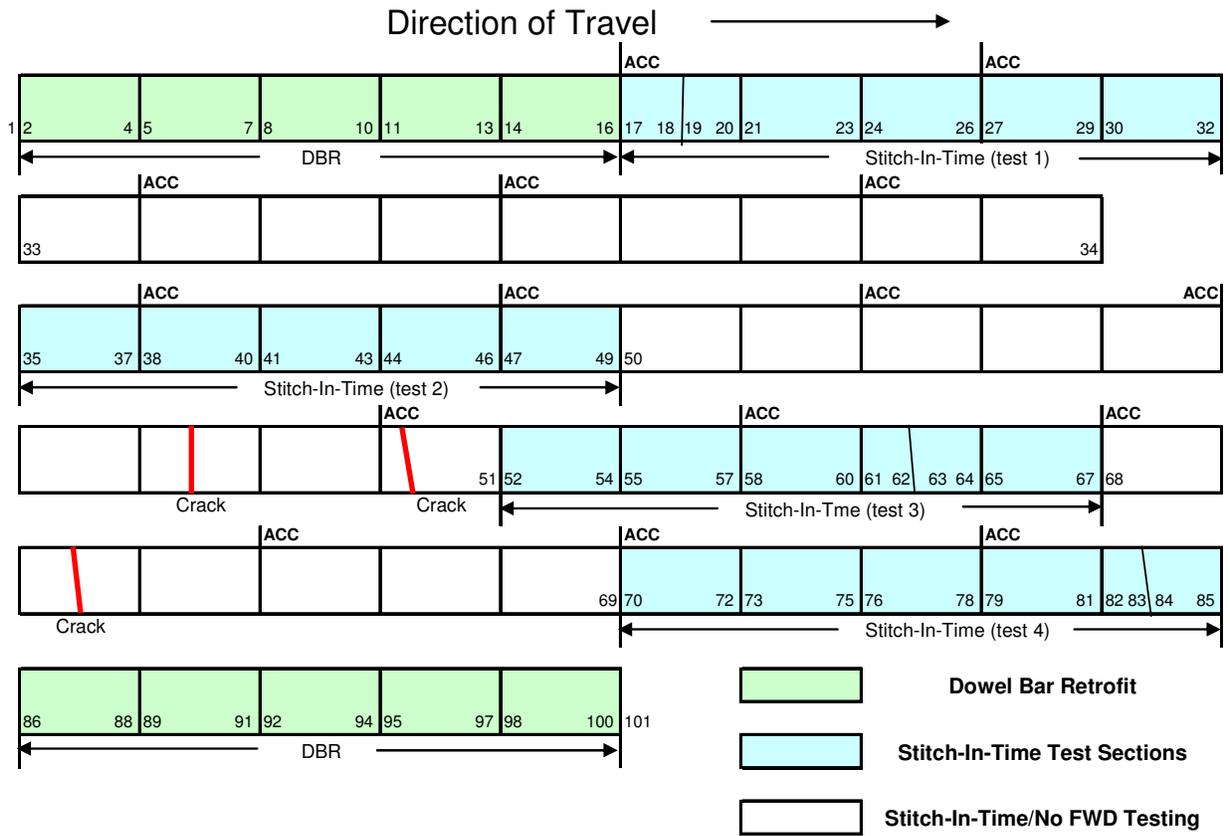
Figure 37. Diagram of numbering and lettering system for each joint or transverse crack.

Three transverse cracks developed in the Stitch-In-Time section during the evaluation period (see Figure 37). There was a concern prior to the installation of the Stitch-In-Time that cracks would develop at the mid-points of the sections of locked panels. Two out of the three new transverse cracks did occur at the mid-points of the section of locked panels, however, none of the other 12 sections of locked panels have exhibited this same type of mid-point crack. Unfortunately, FWD measurements were not taken near any of the new transverse cracks, therefore, the cause of the cracking cannot be determined. Figure 38 shows an example of one of the transverse cracks.

Small numbers are FWD test locations. ACC is an accumulator joint.

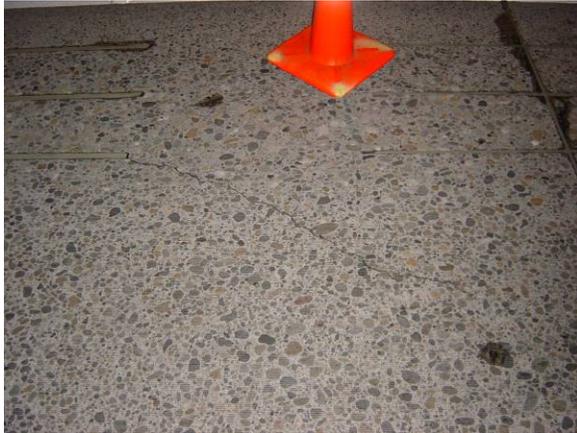
Figure 39. Accumulator joint 16/17. March 2006.

Additional deterioration noted in the Stitch-In-Time section is shown in Figures 39 through 46. This deterioration includes a crack radiating from one of the accumulator joints (Figure 39), low severity spalling and cracking at a locked transverse crack 18/19 (Figure 40), low severity spalling and cracking at the locked joint 20/21 (Figures 41 and 42), low severity spalling at resealed accumulator joint 57/58 (Figure 43), diamond patterned cracking and spalling at the locked joint 81/82 (Figure 44), and diamond patterned cracking and spalling at locked joint 83/84 which was a transverse crack (Figures 45 and 46). The diamond patterned cracking is especially prevalent with the locked joints and in several cases results in medium to severe spalling as noted in the following section where each joint is rated. It appears that considerable stress is being concentrated in the locked joints and this is resulting in either the diamond patterned cracking or a random transverse crack as noted in the previous section.

| Joint | Distress Noted | Rating | | |
|---|--|---|---|---|
| 16/17 | Low severity spalling, sealant loss | | 2 | |

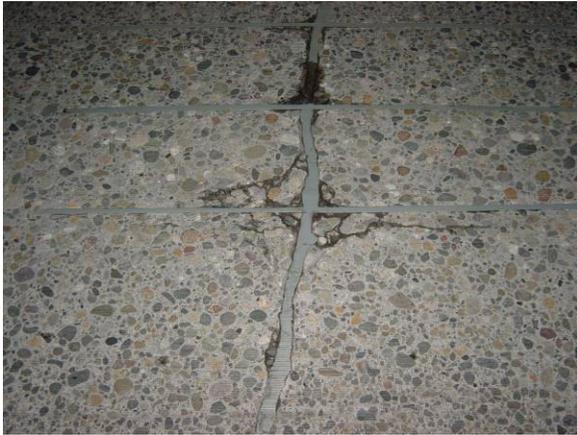
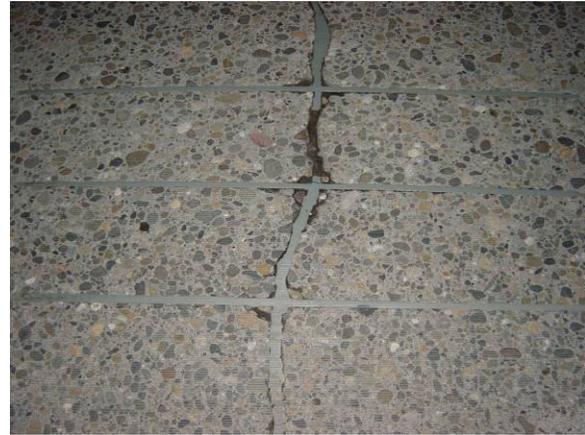
Figure 45. Transverse crack locked joint 83/84. March 2006.

| Joint | Distress Noted | Rating | | |
|---|--|---|---|---|
| 83/84 | High severity spalling, sealant loss | | | 1 |

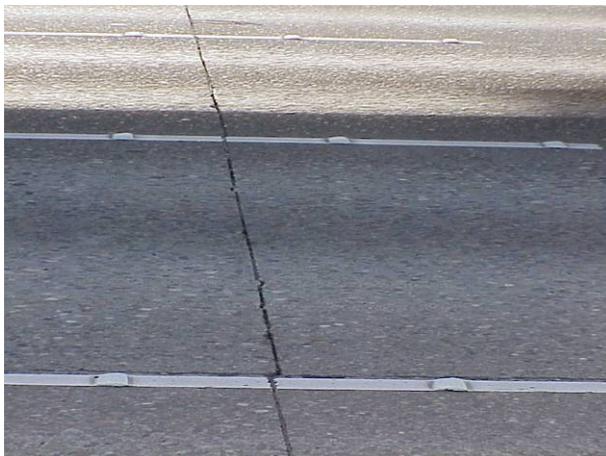
In contrast to the deterioration of the concrete in the Stitch-In-Time section, the dowel bar retrofit section is in very good condition. The two dowel bar retrofit joints shown in Figures 47 and 48 do not display any of the cracking or spalling associated with the Stitch-In-Time joints.

Figure 47. DBR joint 1/2 showing no cracking or spalling of the concrete in the vicinity of the inserted dowel bars.

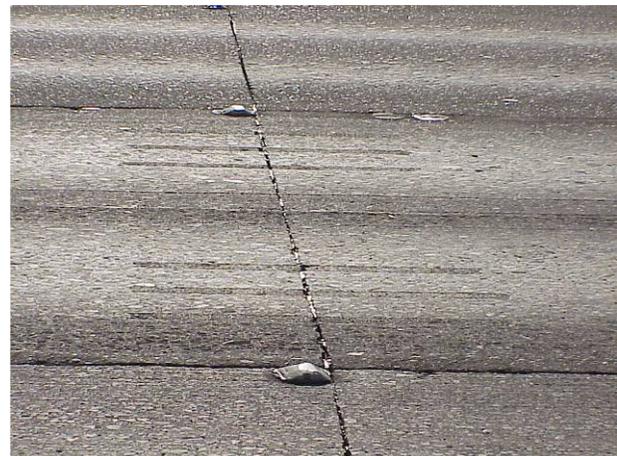
Figure 48. DBR joint 91/92 showing no cracking or spalling of the concrete in the vicinity of the inserted dowel bar.

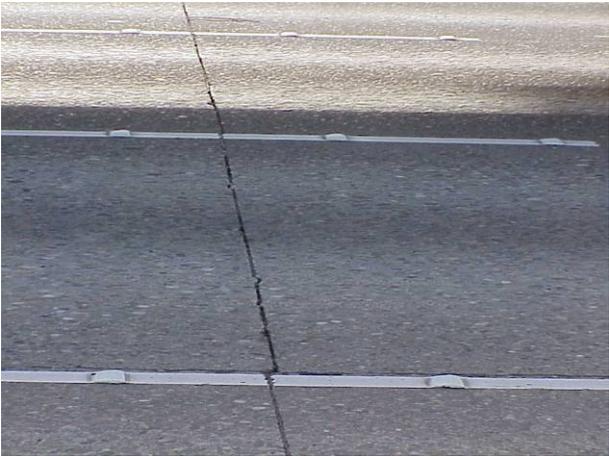
DBR joint 1/2.

| Joint | Distress Noted | Rating | | |
|---|--|---|---|---|
| 1/2 | Low severity spalling | 3 | | |

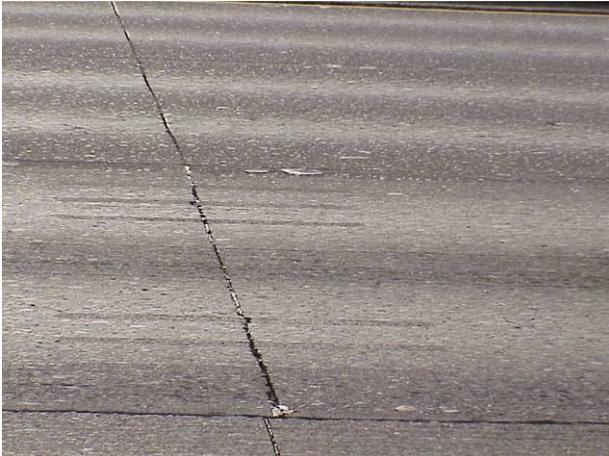
DBR joint 4/5.

| Joint | Distress Noted | Rating | | |
|---|--|---|---|---|
| 4/5 | Medium severity spalling | 2 | | |

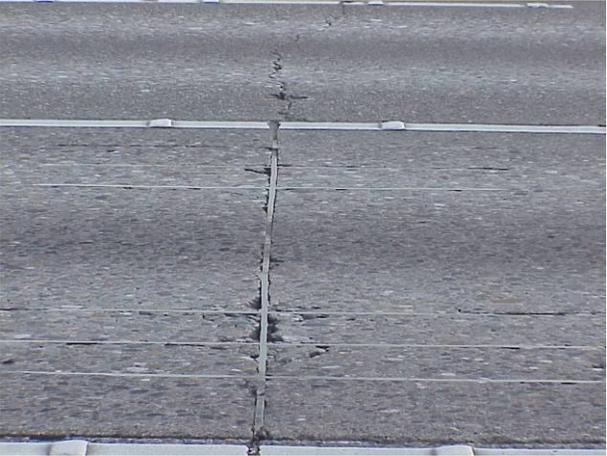
Locked joint 23/24.

| Joint | Distress Noted | Rating | | |
|---|--|---|---|---|
| 23/24 | High severity spalling | | | 1 |

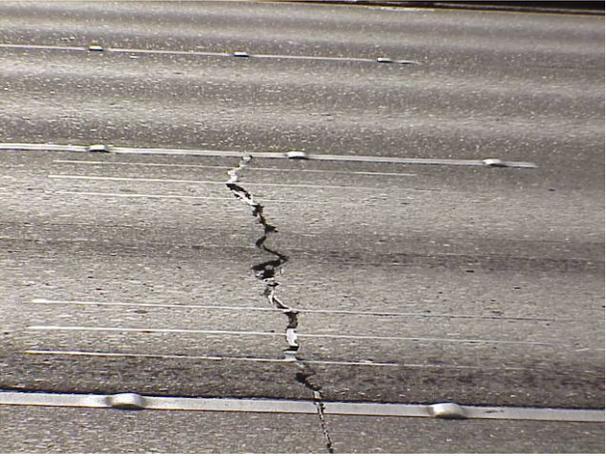
Locked transverse crack 62-63.

| Joint | Distress Noted | Rating | | |
|---|--|---|---|---|
| 62/63 | High severity spalling, sealant loss | | | 1 |

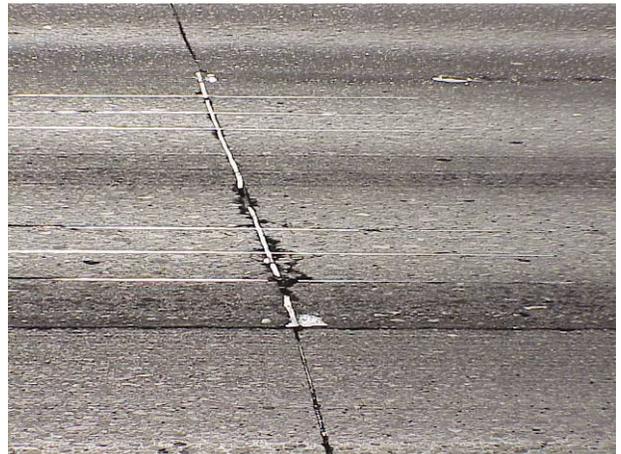
Locked joint 81/82.

| Joint | Distress Noted | Rating | | |
|---|--|---|---|---|
| 81/82 | High severity spalling, sealant loss | | | 1 |

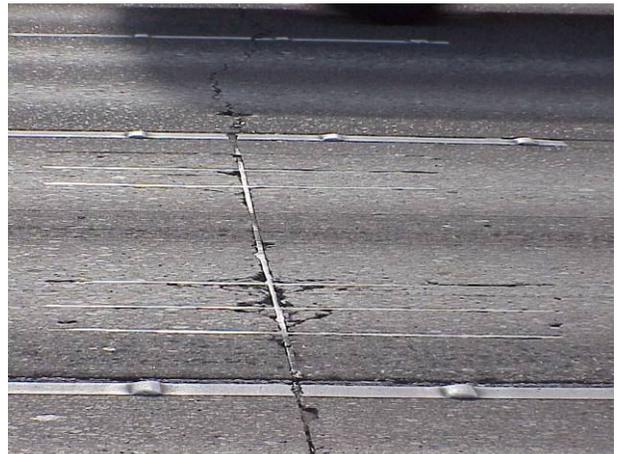
Locked joint F.

| Joint | Distress Noted | Rating | | |
|---|---|---|---|---|
| F | High severity spalling, cracking | | | 1 |

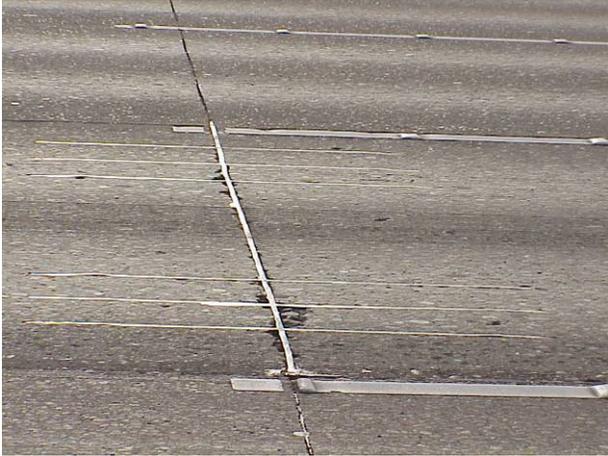
Locked joint H.

| Joint | Distress Noted | Rating | | |
|---|---|---|---|---|
| H | High severity spalling, cracking | | | 1 |

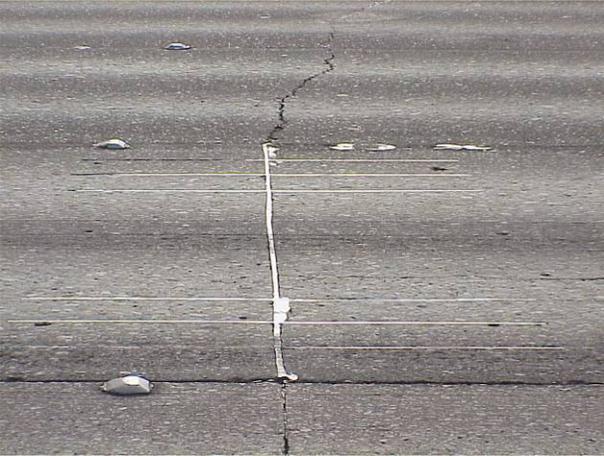
Locked joint R.

| Joint | Distress Noted | Rating | | |
|---|---|---|---|---|
| R | Low severity spalling, cracking | | | 3 |

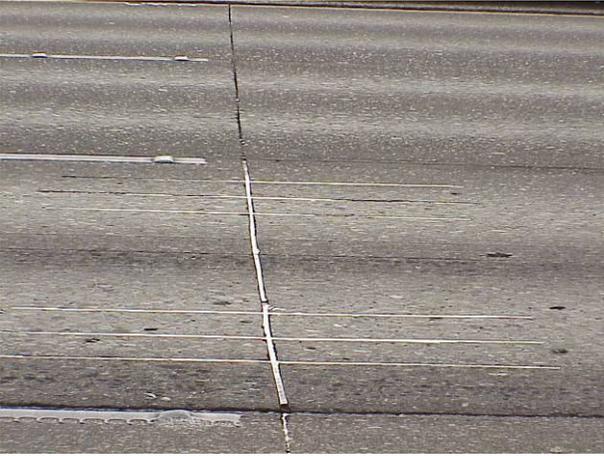
Locked joint T.

| Joint | Distress Noted | Rating | | |
|---|---|---|---|---|
| T | Low severity spalling | | | 3 |

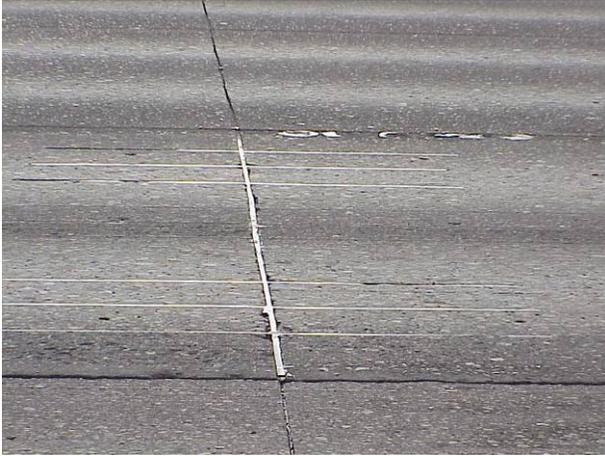
Locked joint U.

| Joint | Distress Noted | Rating | | |
|---|---|---|---|---|
| U | Medium severity spalling | | | 2 |
