Evaluation of Long-Term Pavement Performance and Noise Characteristics of Open-Graded Friction Courses

Project 1: Final Report

WA-RD 683.2

Contract 7134

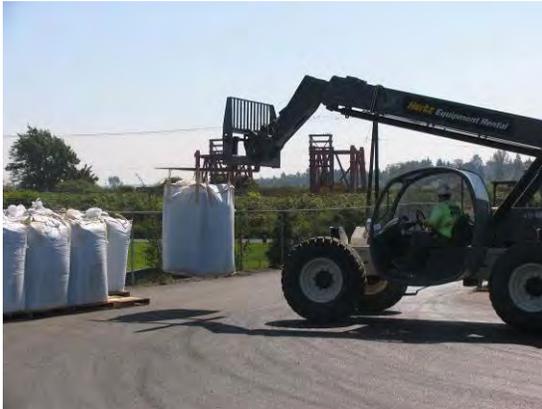
Figure 3. Lifting bags of crumb rubber.

The asphalt plant was a dryer-drum type plant located at Wilder Construction's Smith Island facility. Granite Construction provided the additional equipment for the production of the asphalt-rubber binder. The photos shown in Figures 3 through 6 depict the process used to load the crumb rubber into a shear mixer prior to its storage in heated and agitated tanks. Once the asphalt and rubber mixture was blended the process for producing the HMA was no different than conventional dryer-drum plant production.

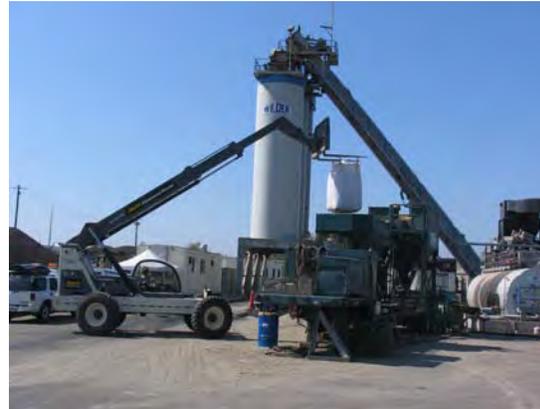
Figure 4. Loading of crumb rubber into double bin supply hopper.

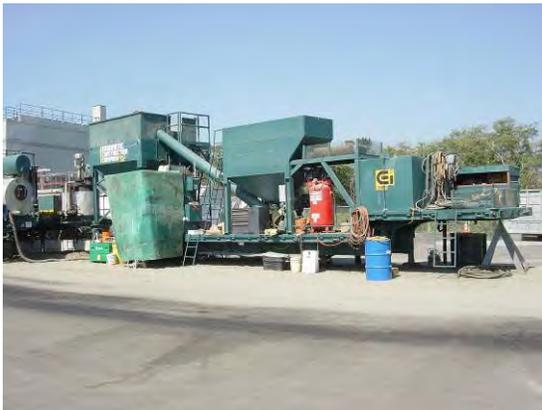
Figure 5. Double bin crumb rubber weigh hopper.

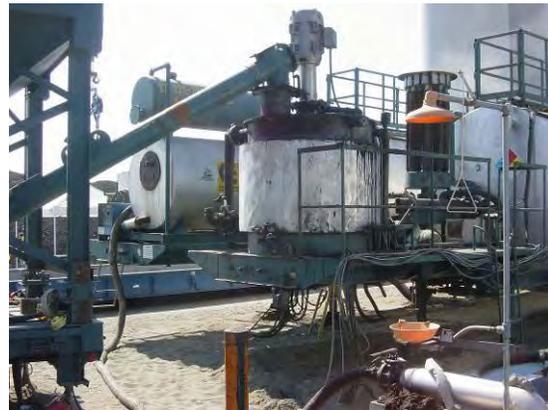
Figure 6. Shear mixer used to combine the crumb rubber with the asphalt binder.

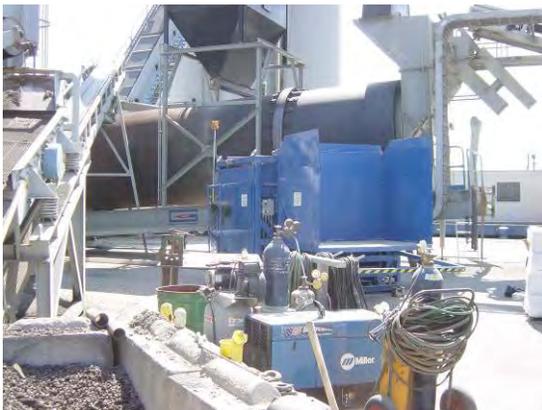
Figure 7. Fiber supply machine.

Modifications to the plant were also necessary for the production of the OGFC-SBS. Figure 7 shows the fiber mixing and distribution machine which introduced a controlled amount of fiber into the dryer drum. Figure 8 shows the supply line hose and hose fitting on the dryer drum.

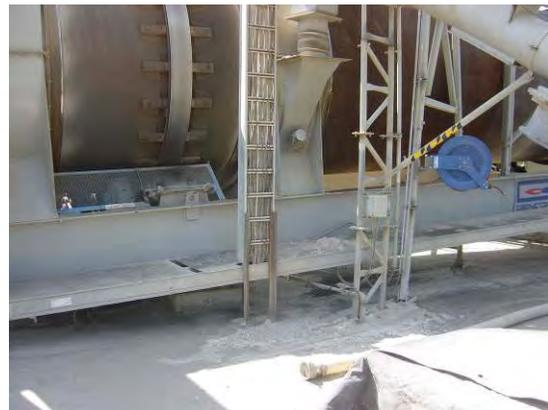
Figure 8. Fiber supply hose and hose fitting in dryer drum plant.

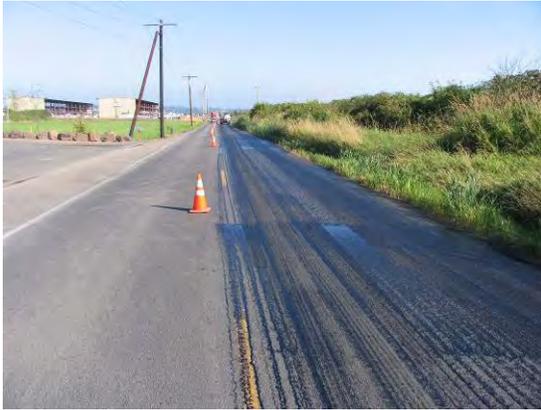
show the streaky application of the CRS-2P tack coat at the beginning of each pass of the distributor truck on the test section paving.

Figure 9. Tack coat application on test section.

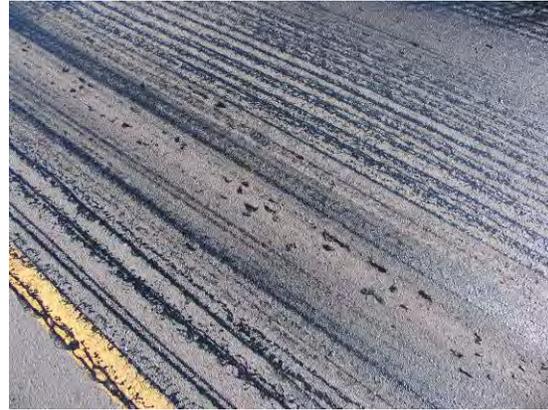
Figure 10. Globs of excess tack on the roadway.

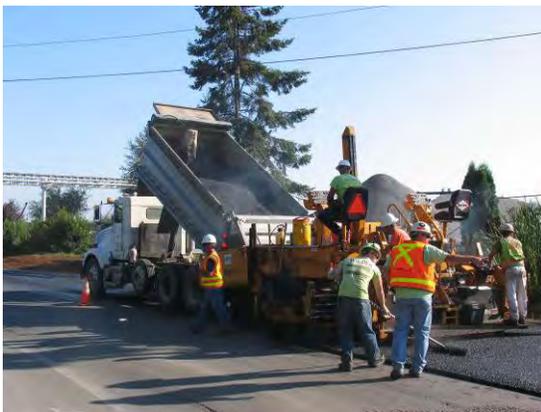
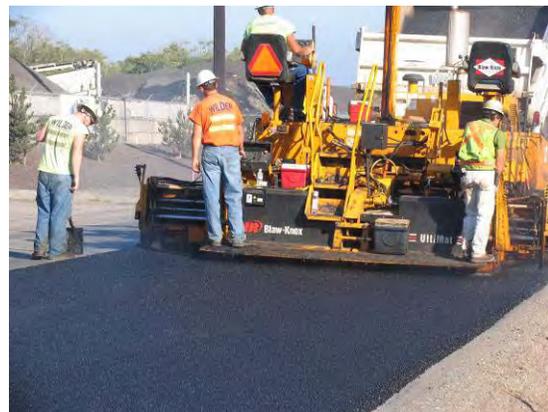
The second set of photos, Figures 11 and 12, show the Ingersoll Rand PF 5510 Blaw-Knox paver laying down the OGFC-AR test section.

Figure 11. Paving the OGFC-AR test section.

Figure 12. Another view of the OGFC-AR test section paving.

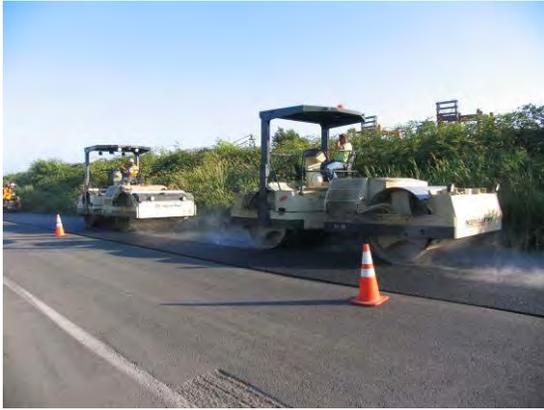
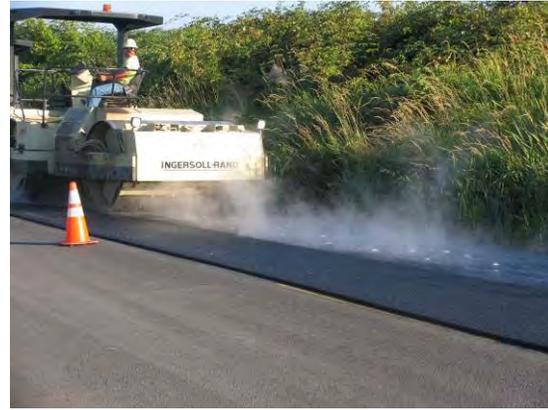
The third set of two photos, Figures 13 and 14, show the Ingersoll Rand DD-130 rollers that were used in the required static mode to compact the open-graded mix. Three rollers were used during the mainline paving with a fourth, an Ingersoll Rand DD-110, added on occasion.

Liquid soap was added to the water in the rollers (1 gallon of dish soap to 300 gallons of water) to prevent the rollers from sticking to the hot-mix.

Figure 13. Rolling of OGFC-AR test section with two rollers.

Figure 14. The soap bubbles on the pavement are from the soap added to the water to prevent sticking.

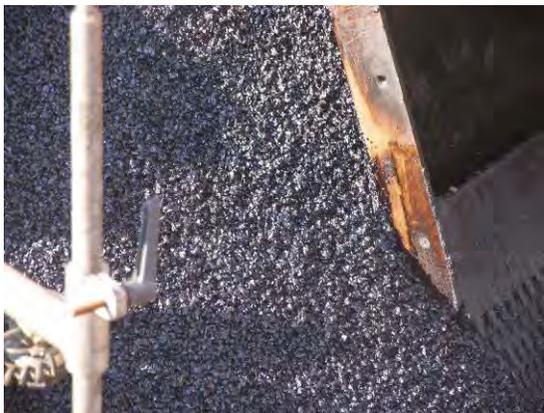
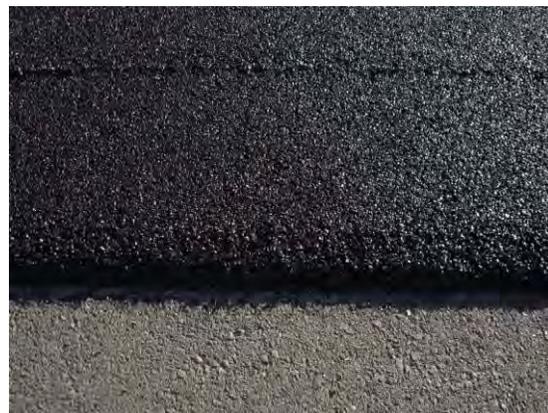
The fourth set of photos, Figures 15 and 16, show the OGFC-AR mix prior to the screed and a close-up of the mix during the compaction process.

Figure 15. OGFC-AR mix behind the material management kit prior to the screed.

Figure 16. Close-up of OGFC-AR mix during the compaction process.

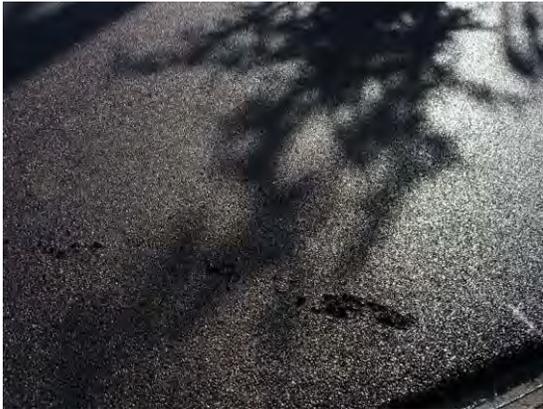
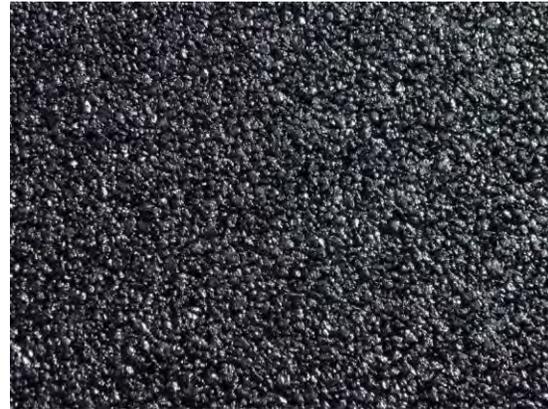
The fifth set of photos, Figures 17 and 18, show the OGFC-SBS mix prior to rolling and after compaction.

Figure 17. OGFC-SBS prior to rolling. Blemishes are footprints.

Figure 18. OGFC-SBS after compaction.

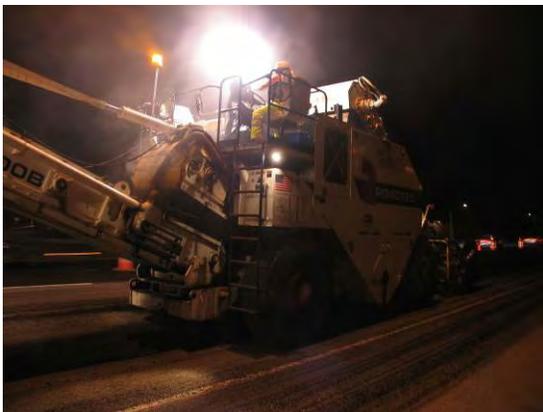
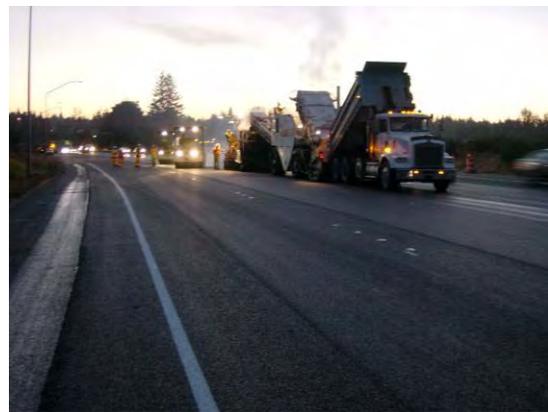
The final two photos, Figures 19 and 20, show the Roadtec Shuttle Buggy material transfer vehicle used to remix the OGFC-AR and OGFC-SBS prior to passing it through the paving machine, and a long-distance view of the paving train. Both photos were taken from the actual mainline paving.

Figure 19. Roadtec Shuttle Buggy material transfer vehicle.

Figure 20. Paving train consisting of dump trucks, Shuttle Buggy, paver and rollers.

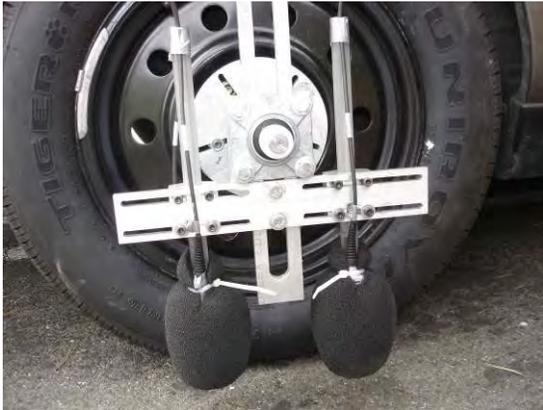
Figure 23. Twin microphones mounted near the rear tire of a vehicle. Note Uniroyal Tiger Paw tire.

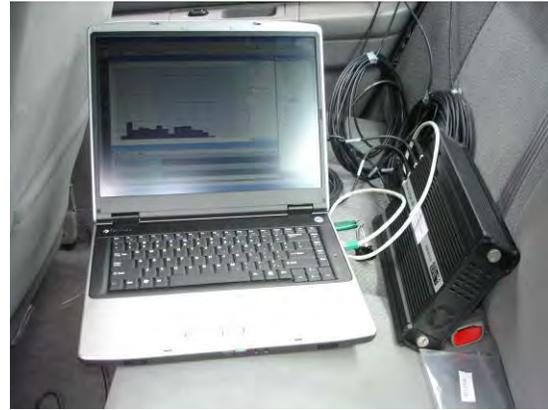
Figure 24. Computer used for data collection.

Measured sound intensity data is analyzed using a PULSE multi-channel data analyzer. The PULSE system was set-up to report overall sound intensity values that are the sum of A-weighted sound intensity within the 1/3 octave frequencies of 500-5000Hz using a multi-channel analyzer (Figure 24). For each 1/3 octave band, the system also measures the coherence of sound pressure between the two microphones and the pressure-intensity index (PI index).

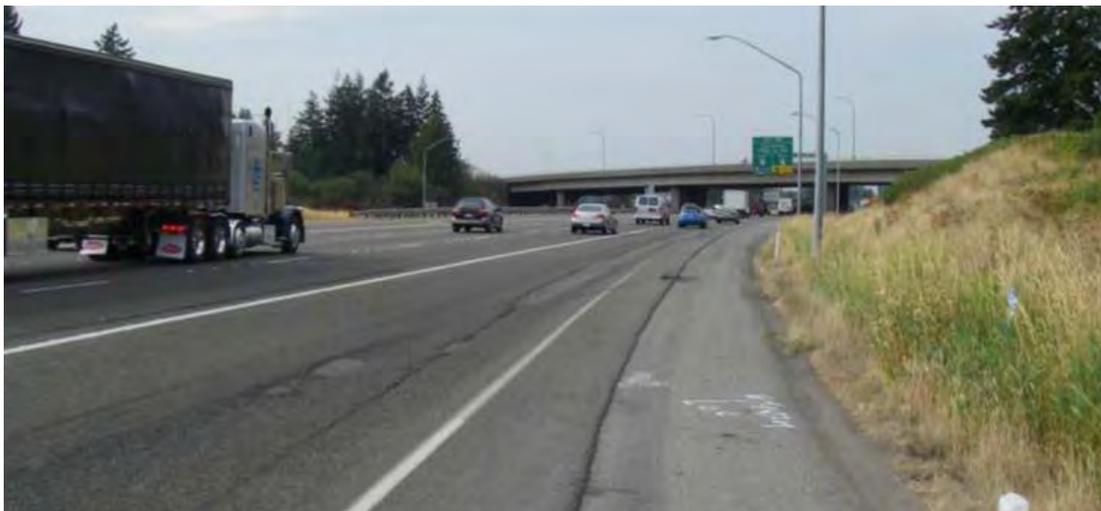
The OGFC-AR test section was removed in the fall of 2010 after only four years of service due to safety concerns with vehicles having to cross the deep ruts during shifts of traffic necessary for the construction of new ramps for the Alderwood Mall interchange. The rutting in the OGFC-AR (Figure 31) was a result of raveling and not the result of deformation of the pavement due to compaction or shoving as evidenced by the accumulation of aggregate on the shoulder (Figure 32).

Figure 31. Rutting in OGFC-AR near Lynnwood. (2010)

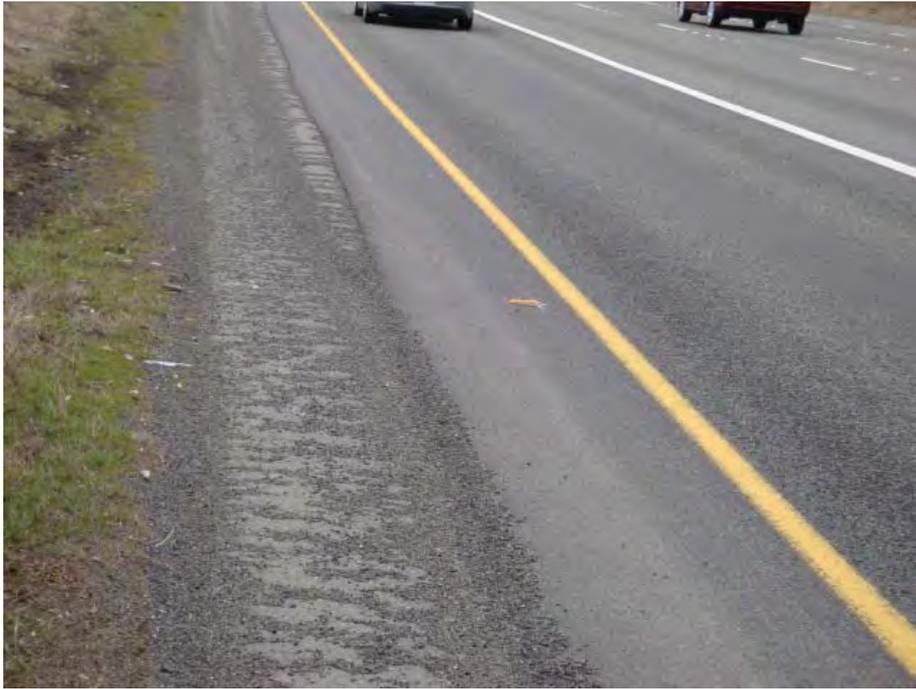
Figure 32. Accumulation of aggregate on the shoulder in the OGFC-AR section. (2010)

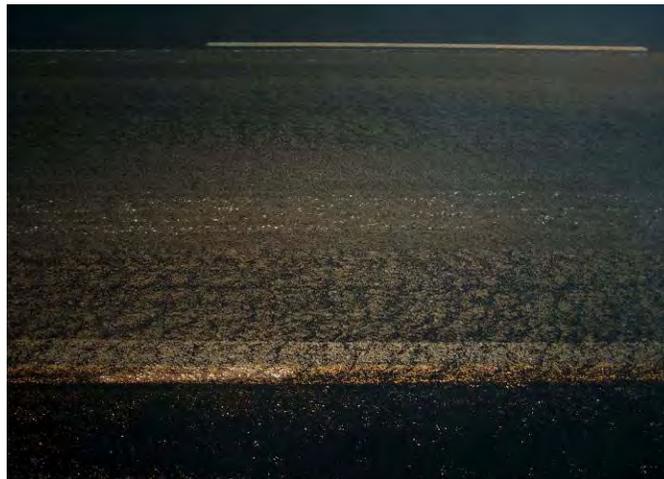
The tack coat for both the OGFC test sections was applied by an Etnyre tack truck. The application of the CRS-2P tack was sporadic at the start of each application but generally very uniform after 500 feet of application (Figure 39). However, there were areas where high application rate caused problems. In these locations, the excess tack coat was picked up by the Shuttle Buggy tires and then deposited on the existing pavement surface as a mound of material. These mounds of cool tack coat would show up in the OGFC-SBS overlay as a cold spot or globule. This did not happen with the OGFC-AR. Tracking of the tack coat by the Shuttle Buggy and delivery trucks was observed in the wheel paths. The amount of tracking was minimal in areas of good coverage but was somewhat substantial in areas that received light coverage (startup locations).

Figure 39. Image of typical tack application with some pickup visible in the wheelpaths.

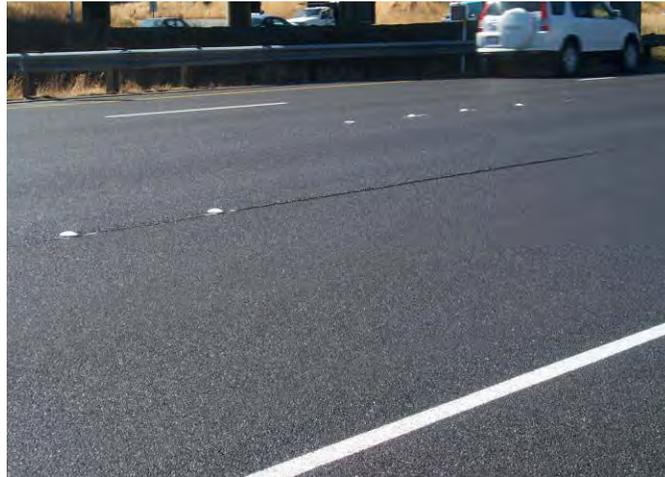
Figure 46. Image of the mismatch at the longitudinal joint.

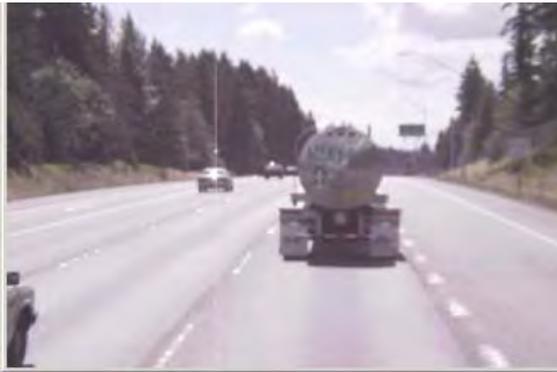
Figure 1. Interstate 5 at MP 188.65

The first test section will begin at MP 188.65 and end at MP 188.15 and the second will begin at MP 188.15 and end at MP 187.65.

This location was selected for ease of construction (occurs at the beginning of the pavement project), relatively similar terrain and the same level of traffic over both test sections.

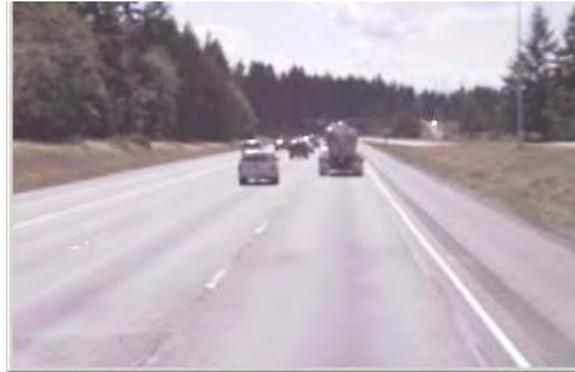
Figure 2. Interstate 5 at MP 188.15
