Evaluation of Long-Term Pavement Performance and Noise Characteristics of Open-Graded Friction Courses – Project 2: Final Report

WA-RD 691.2

Evaluation of Long-Term Pavement Performance and Noise Characteristics of Open-Graded Friction Courses – Project 2

Contract 7353
SR-520
Eastside Quieter Pavement Evaluation Project
MP 4.24 to MP 5.82

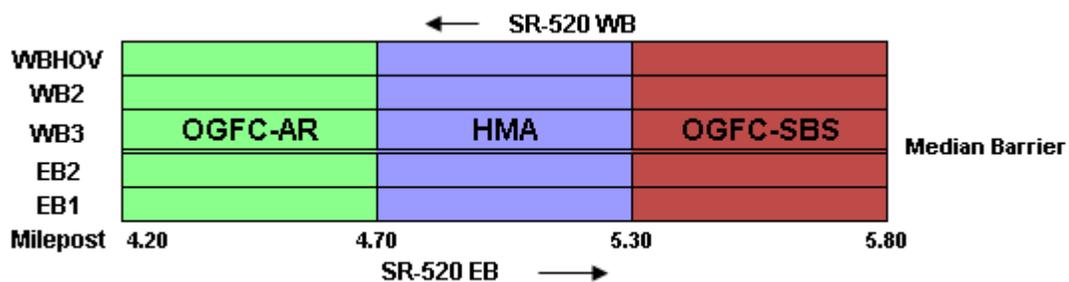
Figure 2. Plan map of section layout.

The open graded sections were placed 0.06 feet thick (3/4 inches) on the two general purpose lanes in each direction and on the HOV lane in the westbound direction. The HOV lane on SR-520 is the outside lane instead of the normal location on the inside. The Class 1/2 inch Hot Mix Asphalt (HMA) was placed 0.15 feet thick on all lanes including the HOV with an 18 foot taper section at each end to transition to the thinner open-graded sections. The paving limits for three different pavement types are shown in Figure 2. This was a simple overlay process with no pre-leveling required.

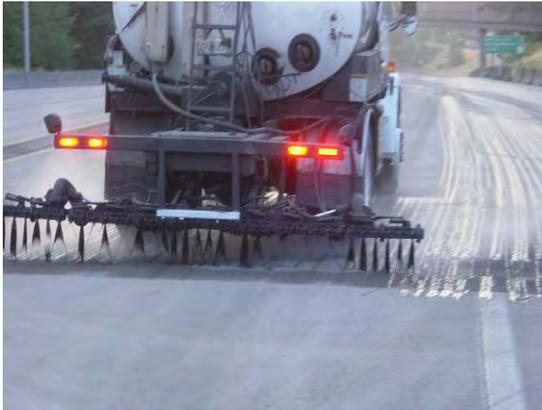
Figure 3. Distributor applying tack coat.

Elements of the paving operation are shown in Figures 3 through 14. There were minor problems that included occasional spills of materials in front of the paver, stoppage of the paver waiting for mix, less than full coverage of the tack coat application, and minor problems at the plant. The inspectors' daily reports indicate that the roller operators were rolling the pavement well beyond the cessation temperature (the point at which no further compaction can occur) and this caused some aggregate breakage as can be seen in Figure 13. Temperature differentials were not a problem on this project due to the use of the Shuttle Buggy material transfer vehicle (MTV) that was specified in the Special Provisions (Appendix B). A detailed construction report on the project with images of the mix and pavement is included as Appendix C.

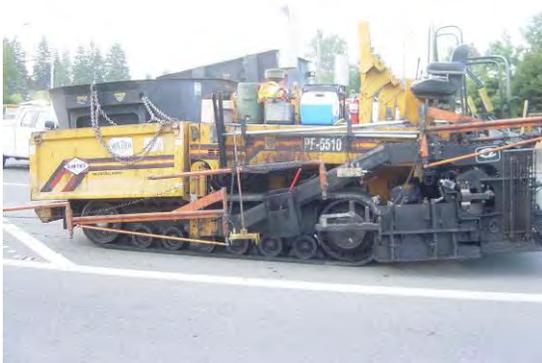
Figure 5. Blaw-Knox PF5510 paver.

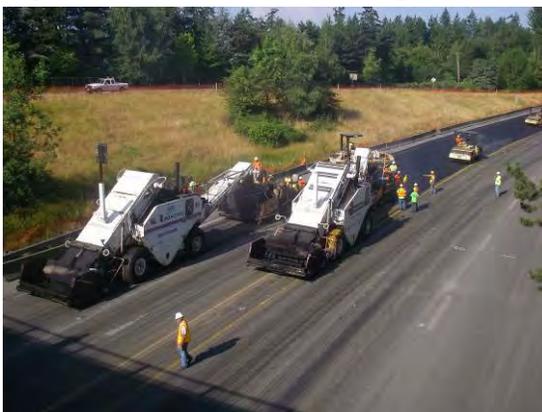
Figure 7. Paving operation with two pavers and two Shuttle Buggies.

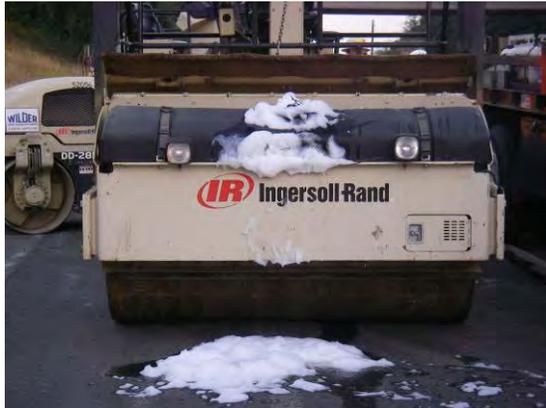
Figure 9. Excess suds from soap added to water used to keep OGFC-AR from sticking to rollers.

The wheels of the rollers used for OGFC or OGFC-AR shall be wetted with water, or if necessary soapy water, or a product approved by the Engineer to prevent sticking to the steel wheels during rolling. The soap shall not contain phosphates. The soap shall be biodegradable.

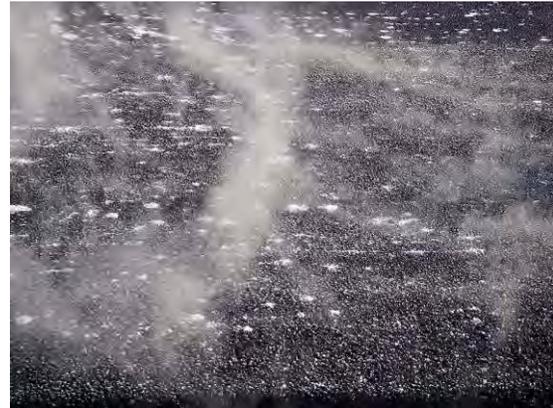
Figure 10. OGFC-AR with excess suds after rolling.

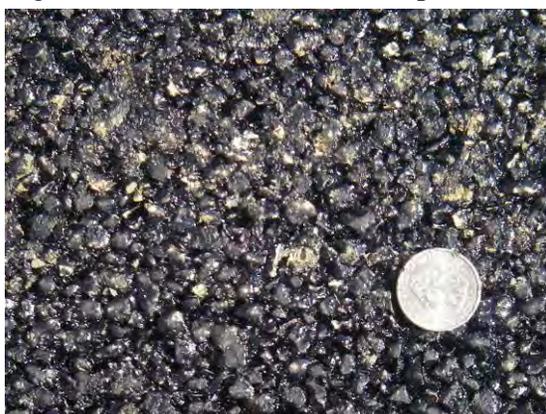
Figure 13. Close-up of OGFC-AR showing aggregate breakage.

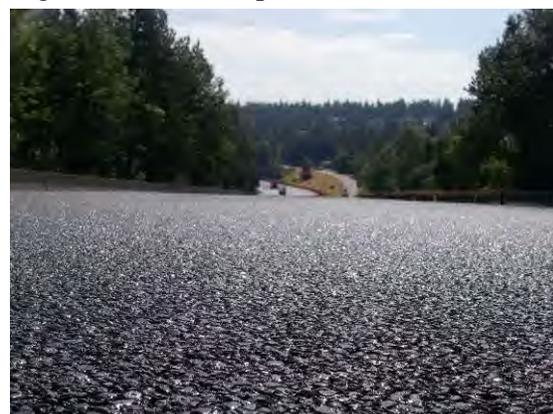
Figure 14. Texture of OGFC-SBS.

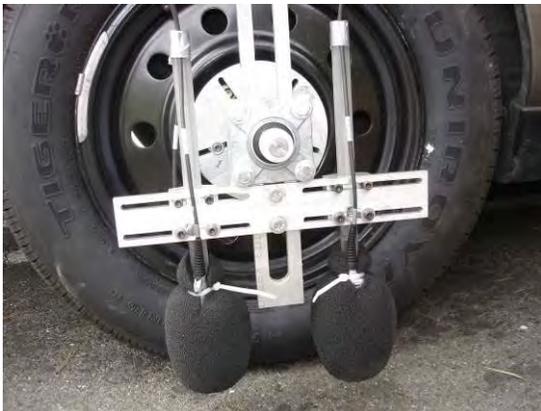
Figure 15. Twin microphones mounted near the rear tire of a vehicle. Note Uniroyal Tiger Paw tire.

The Uniroyal Tiger Paw AWP (P225/60R16) mounted on the dedicated WSDOT Ford Taurus sedan used for all OBSI measurements is equivalent to the Standard Reference Test Tire (SRTT) (P225/60R16) defined in ASTM 2493.

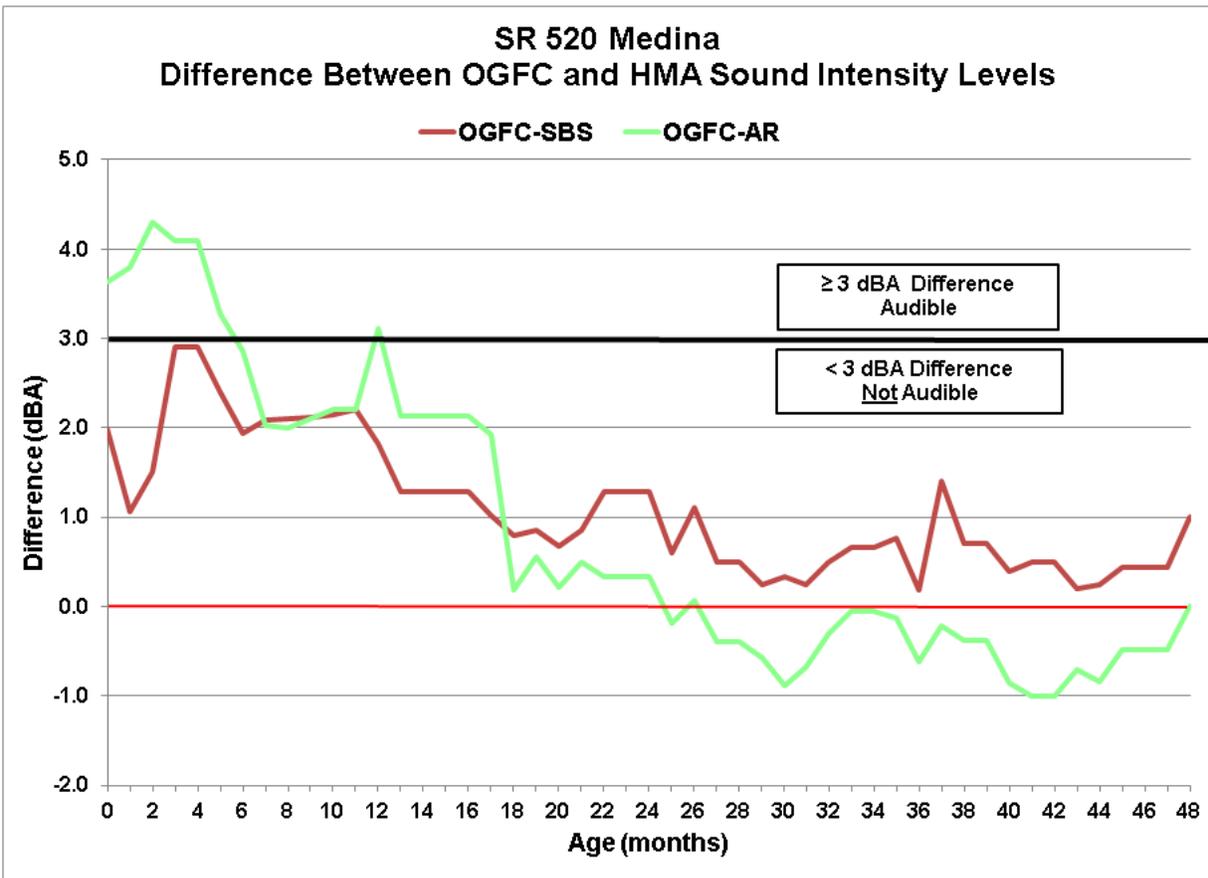
Figure 17. Difference in average sound intensity between the HMA control section and the OGFC-AR and OGFC-SBS quieter pavements.

Figure 17 shows that the OGFC-AR section (green line) was audibly quieter than the HMA for five months before it dropped below the black line and never returned except for one anomalous reading at 12 months (July 2008). The OGFC-AR sound intensity level followed a downward trend that indicates increasing noise levels over time. In August 2009, it drops below the zero level (red line) which means that it is noisier than the HMA. It was noisier for the remainder of the evaluation period.

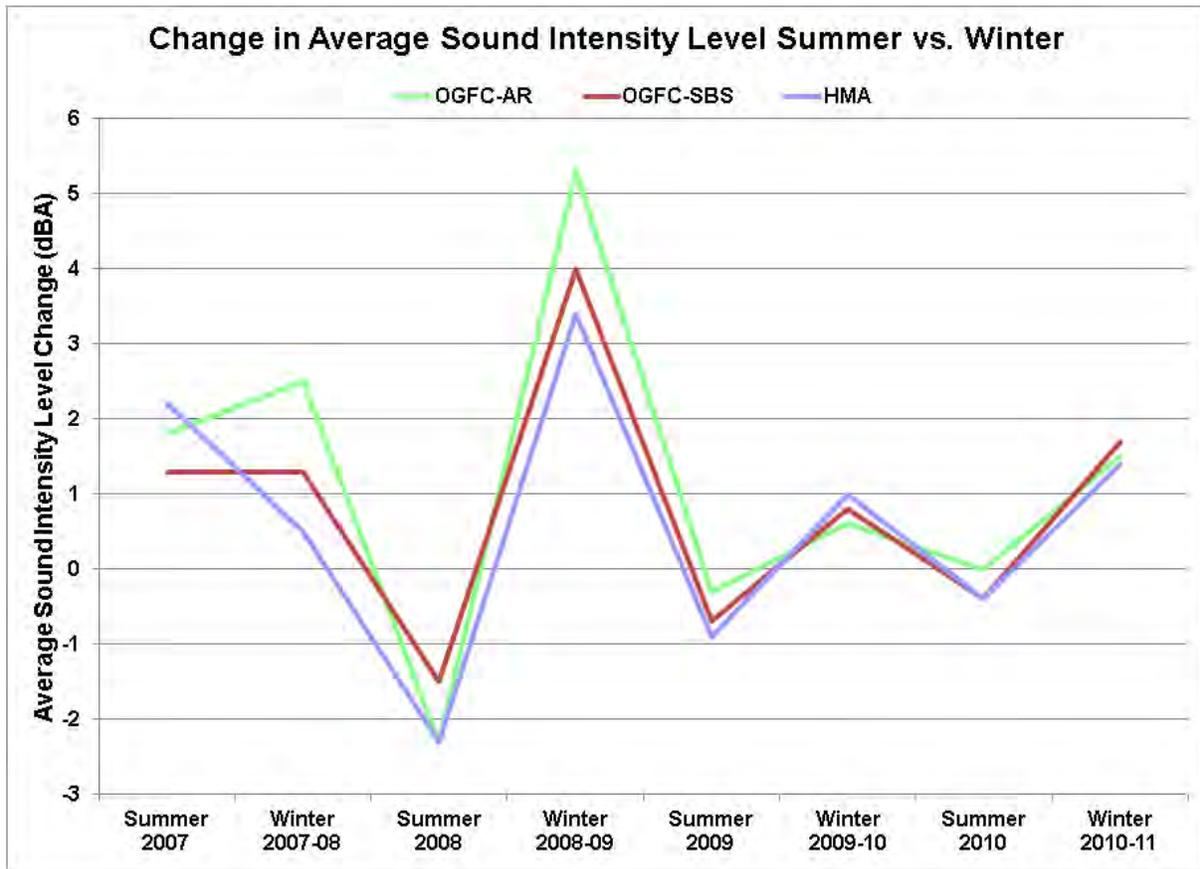
Figure 18. Change in average sound intensity level during the winter and summer.

The average sound intensity level trends in the OGFC-AR and OGFC-SBS followed the same pattern observed on the I-5 Lynnwood quieter pavement section with the increases in the sound intensity levels occurring mainly during the winter studded tire season. The very large change in sound intensity for all of the sections in the 08-09 studs season corresponded to the severe winter storm in December of 2008. WSDOT Maintenance personnel reported high tire chain usage during this period and noted large amounts of aggregate on the shoulders that were attributed to raveling of the OGFC pavements. As will be shown later, the rutting/wear measurements also show a pattern similar to Figure 18. The larger increase in sound levels for both OGFC sections (green and reddish-brown lines) than the HMA pavement (blue line) suggests that winter conditions (studded tires, tires with chains, or colder temperatures and increased moisture) have a greater negative effect on the acoustic performance of OGFC

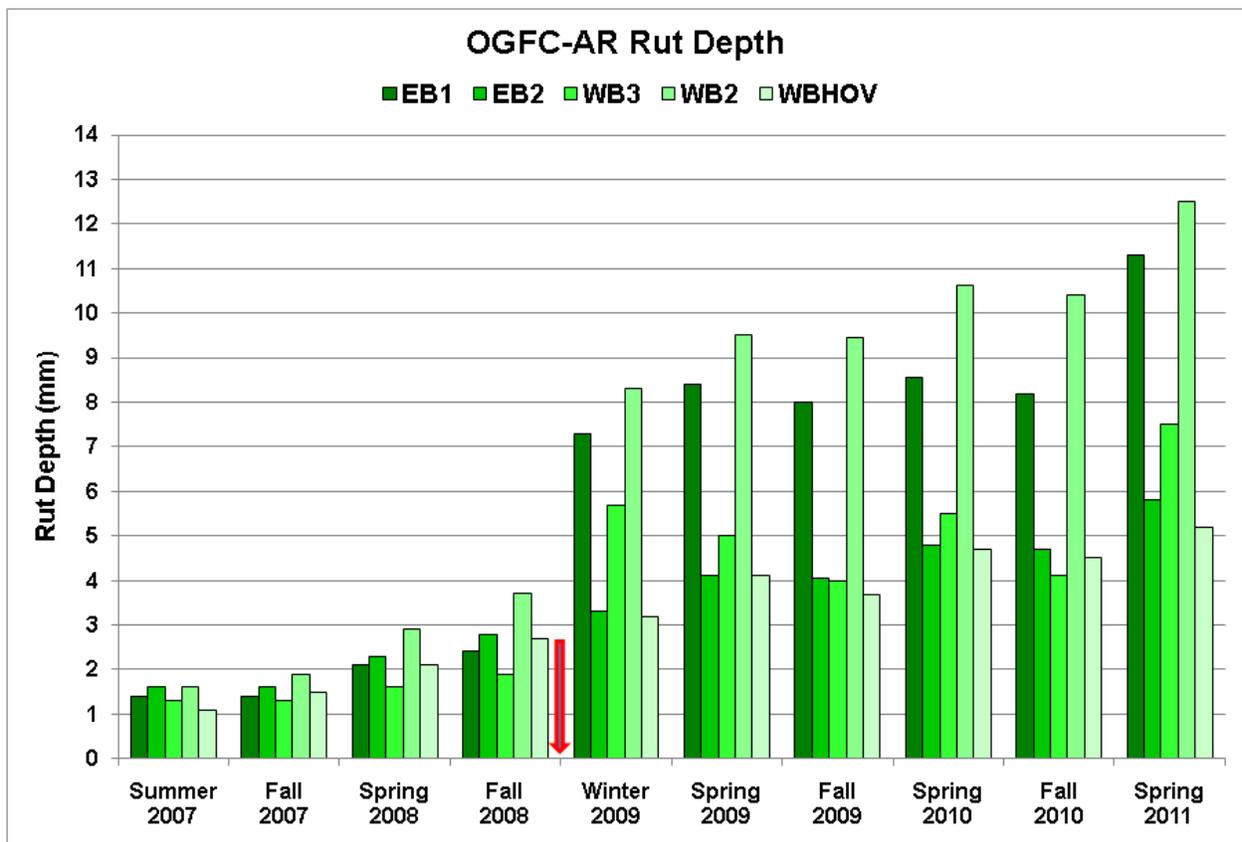
Figure 20. Rut depth for each lane of the OGFC-AR test section. Red arrow marks the severe winter of 2008/2009.

The wear/rutting in the OGFC-AR section showed a gradual increase up to the winter of 2008-09 when a severe winter storm attacked the Puget Sound Region. The average rut depth doubled from the Fall 2008 to the Winter 2009 readings with large jumps in the rutting of the two travel lanes, EB1 and WB2. The rutting continued to increase, especially in these two lanes, all the way to the end of the monitoring period at four years. The maximum rut depths for the EB1 and WB2 lanes were 11.3 and 12.5 mm, respectively.

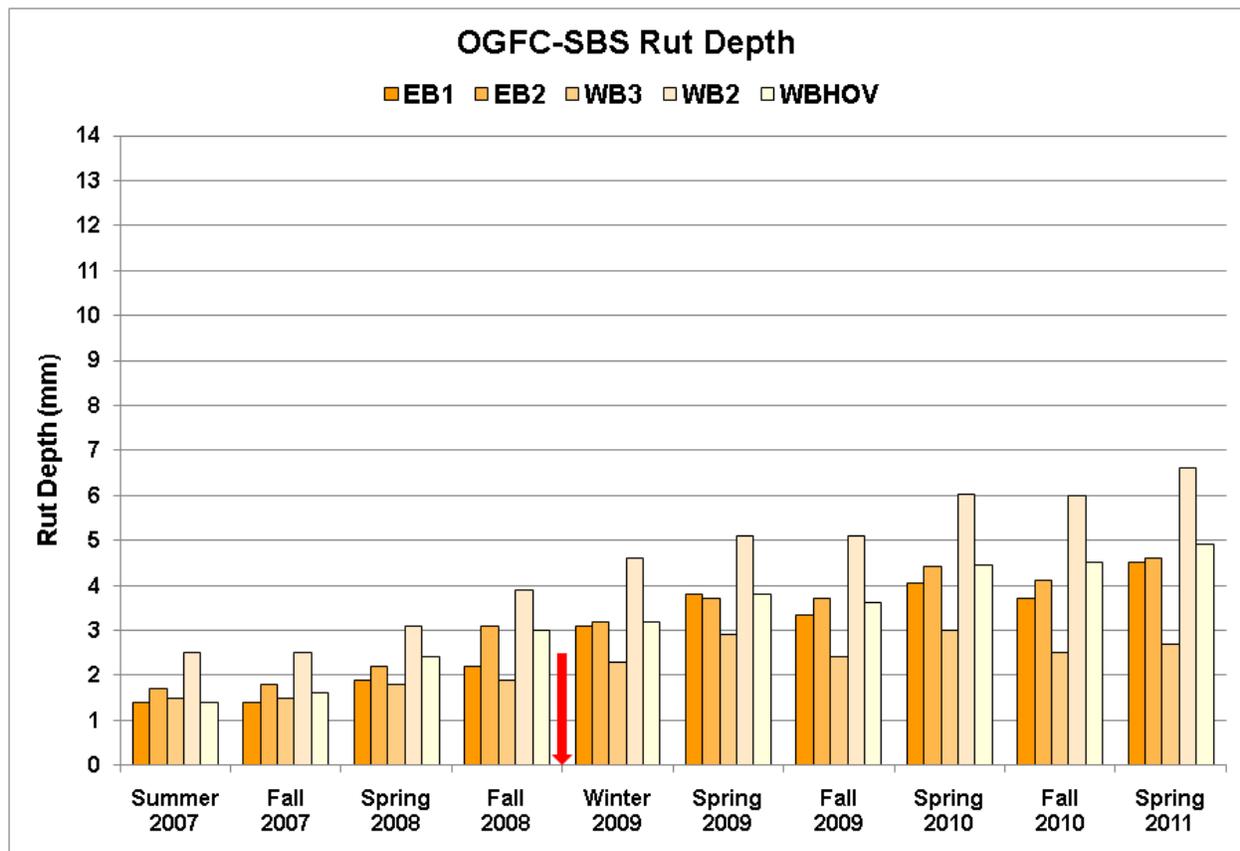
Figure 21. Rut depth for each lane of the OGFC-SBS test section. Red arrow marks the severe winter of 2008/2009.

In contrast to the OGFC-AR, the increase in wear for the OGFC-SBS and HMA test sections is relatively linear with no big increases noted during the winter of 2008-2009 (Figures 21 and 22). The maximum rut depths for the OGFC-SBS and HMA were 6.6 and 8.4, respectively, each recorded in the WB2 lane in April of 2011. Of interest is that EB1 in the OGFC-SBS and HMA is not showing the high wear/rutting as was true for the OGFC-AR. Also of note is that the HMA is showing more wear than the OGFC-SBS in all of the WB lanes, but especially WB2 and WBHOV.

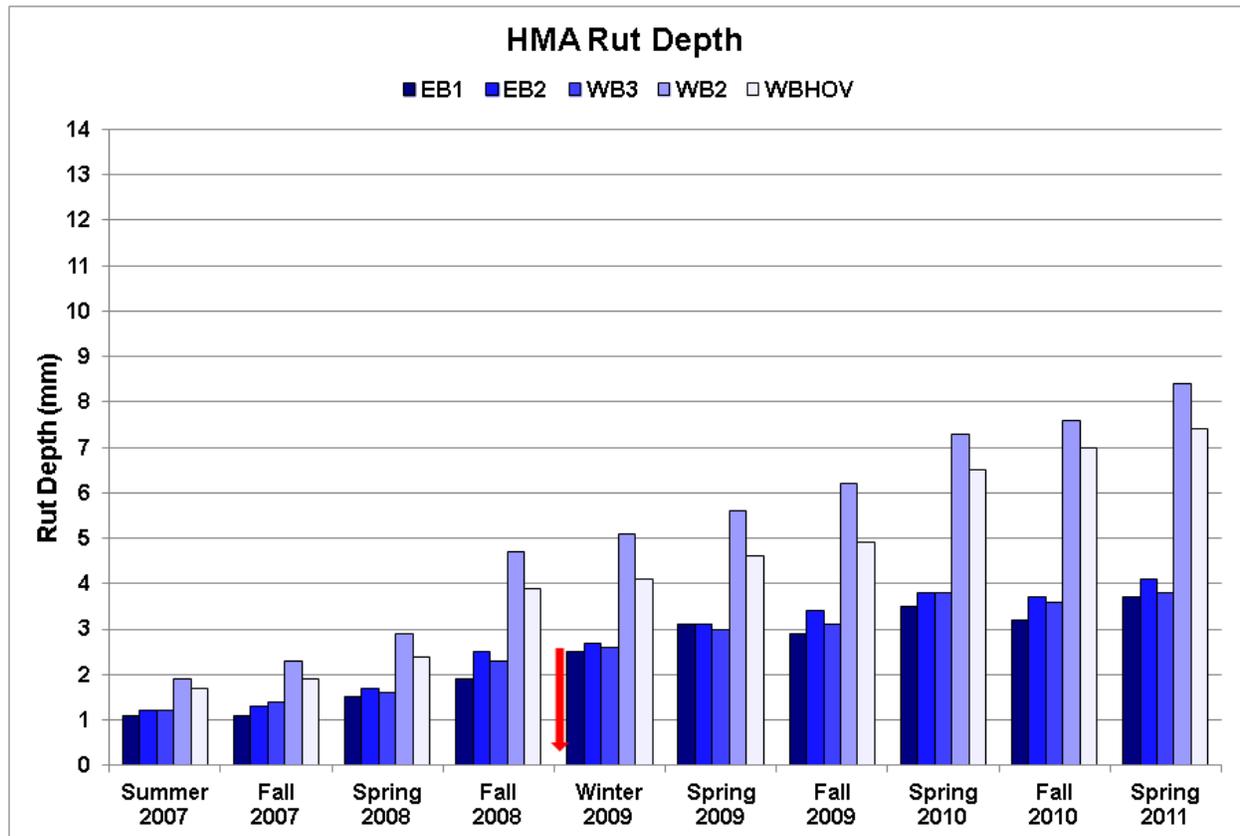
Figure 22. Rut depth for each lane of the HMA test section. Red arrow marks the severe winter of 2008/09.

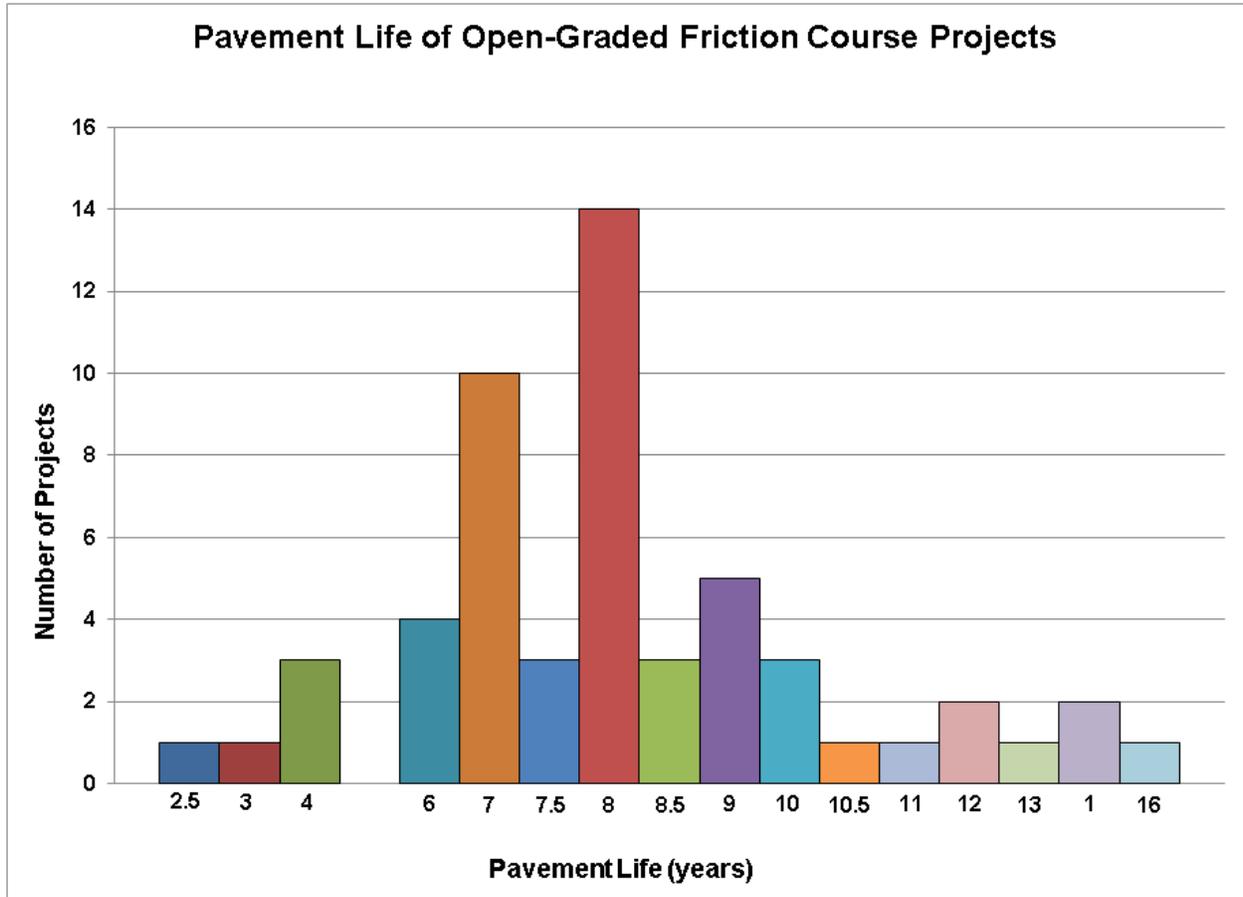
Figure 23. Pavement life of open graded friction course pavement built between 1980 and 1997.

The rapid wear/rutting of the quieter pavement sections on this project is consistent with our past experience with open graded friction courses and the first quieter pavement test section built on I-5 in Lynnwood. WSDOT built 56 open graded friction course projects between 1980 and 1997. A moratorium on the use of open graded friction courses followed the poor performance of these pavements due to rapid wear/rutting from studded tires. The bar chart in Figure 23 shows that the majority of the projects had a pavement life of between six and ten years with 8.2 years as the average for all projects. The current statewide HMA average pavement life is 15 years with the west side of the state averaging 17 years and the east side 11 years. The failure of the OGFC-AR sections due to raveling and rutting at four years is on the lower end of the performance scale as compared to past history with open graded friction course

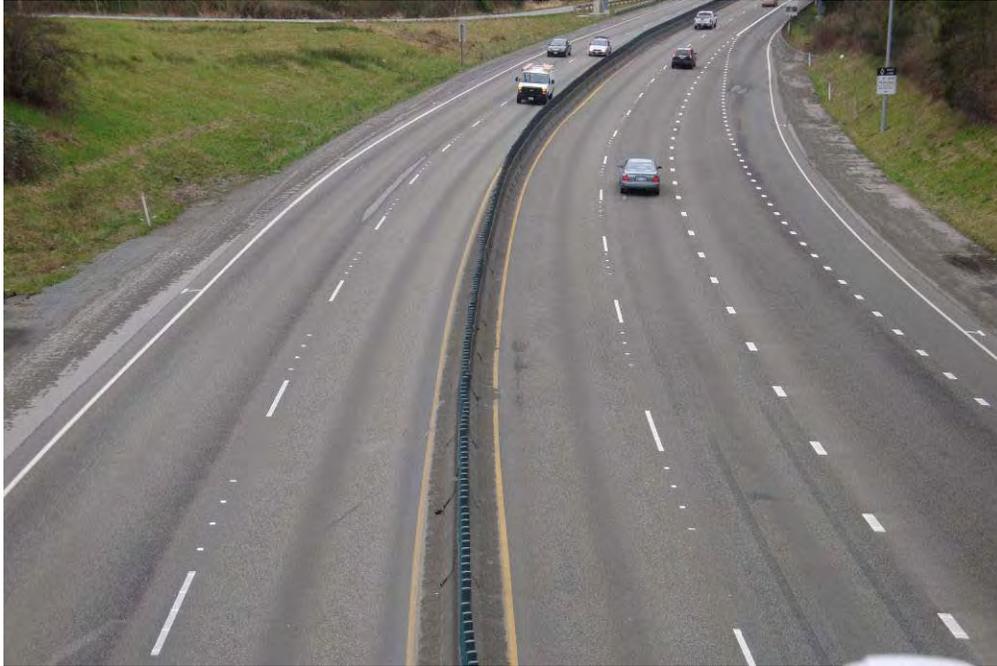
Figure 24. Rutting in EB Lane 1 (far left lane in photo) of OGFC-AR test section on SR 520. (February 2011)

pavements. Photos of the wear/rutting in the OGFC-AR section is shown in Figures 24 and 25. Additional information on the pass performance of the open graded friction course projects can be found in the I-5 Lynnwood Quiet Pavements Final Report (see References).

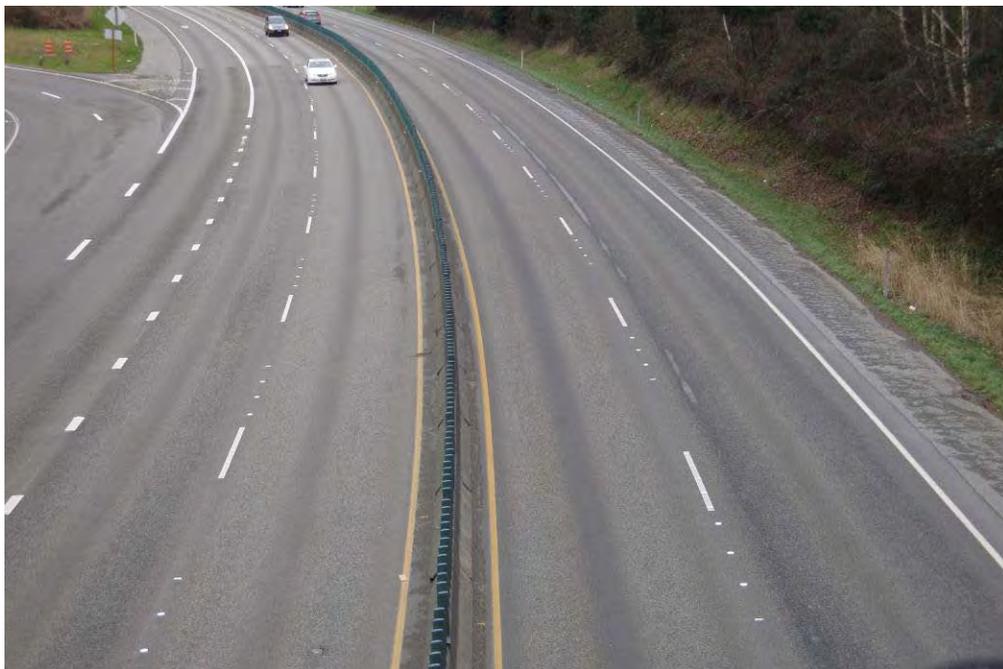
Figure 25. Wear/rutting in EB Lane 1 (far right lane in photo) of the OGFC-AR test section on SR 520. (February 2011)

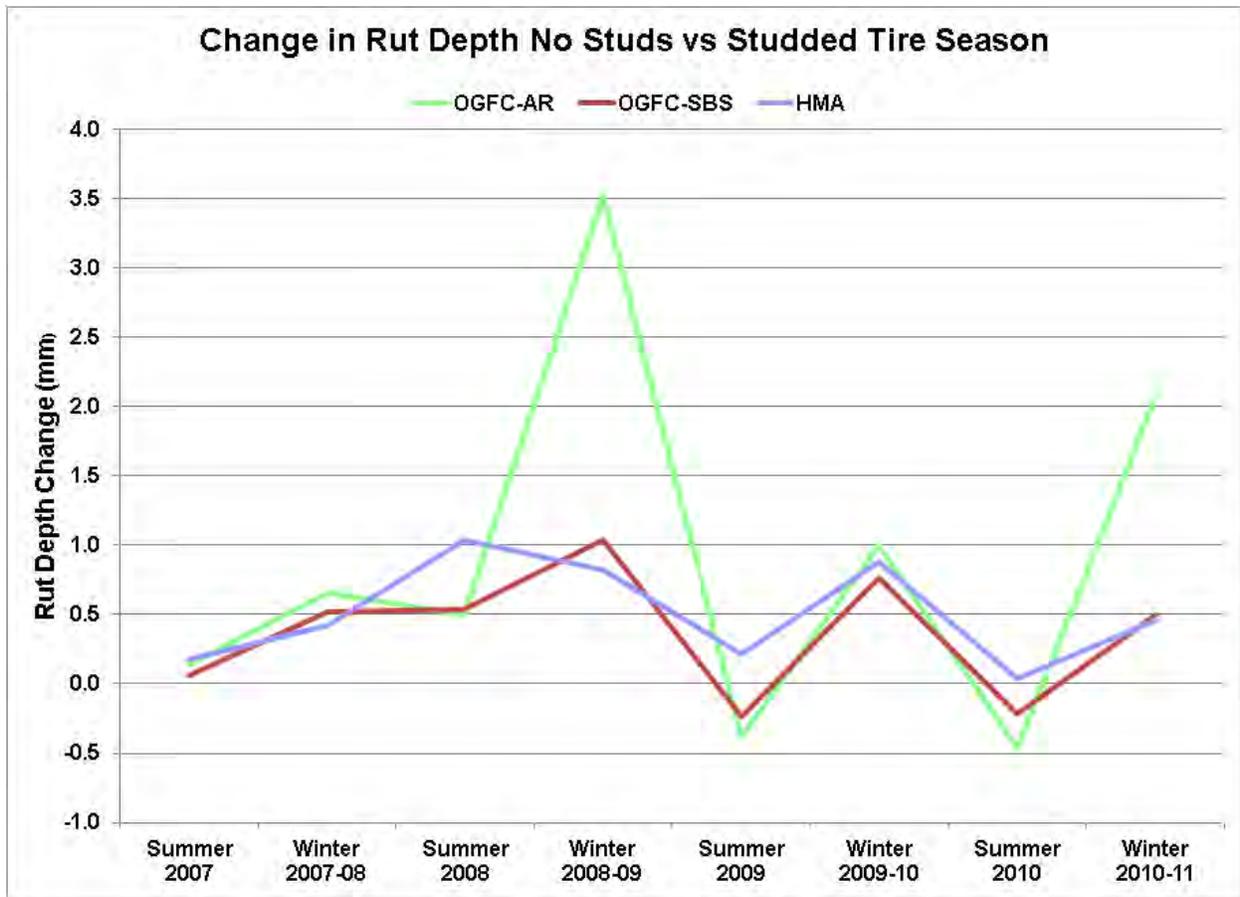
Figure 26. Change in the depth of the ruts in the wheel paths during the period when studded tires are legal versus the change during the remainder of the year.

The winter versus summer change in the depth of the rutting in the wheel paths shows a pattern similar to what was observed in the sound intensity readings with greater amounts of rutting occurring during the time when studded tire use is allowed (winter). Table 13 shows the average change in the depth of the wheel path ruts for all the lanes for each of the fall and spring readings and the calculated difference. The change in rut depth is calculated by subtracting the previous reading from the current reading. For example, the OGFC-AR difference of 3.5 mm for the Spring of 2009 is calculated by subtracting the Fall 2008 previous reading from the Spring 2009 current reading ($6.2 - 2.7 = 3.5$). The change in rutting for each season is shown graphically in Figure 26. The majority of the wear and rutting is occurring during the winter studded tire season. The large change in the OGFC-AR (green line) in the middle of the line graph marks the severe winter storm event in December of 2008. It is apparent that the OGFC-AR section was more susceptible to studded tire wear than either the OGFC-SBS or the HMA section.

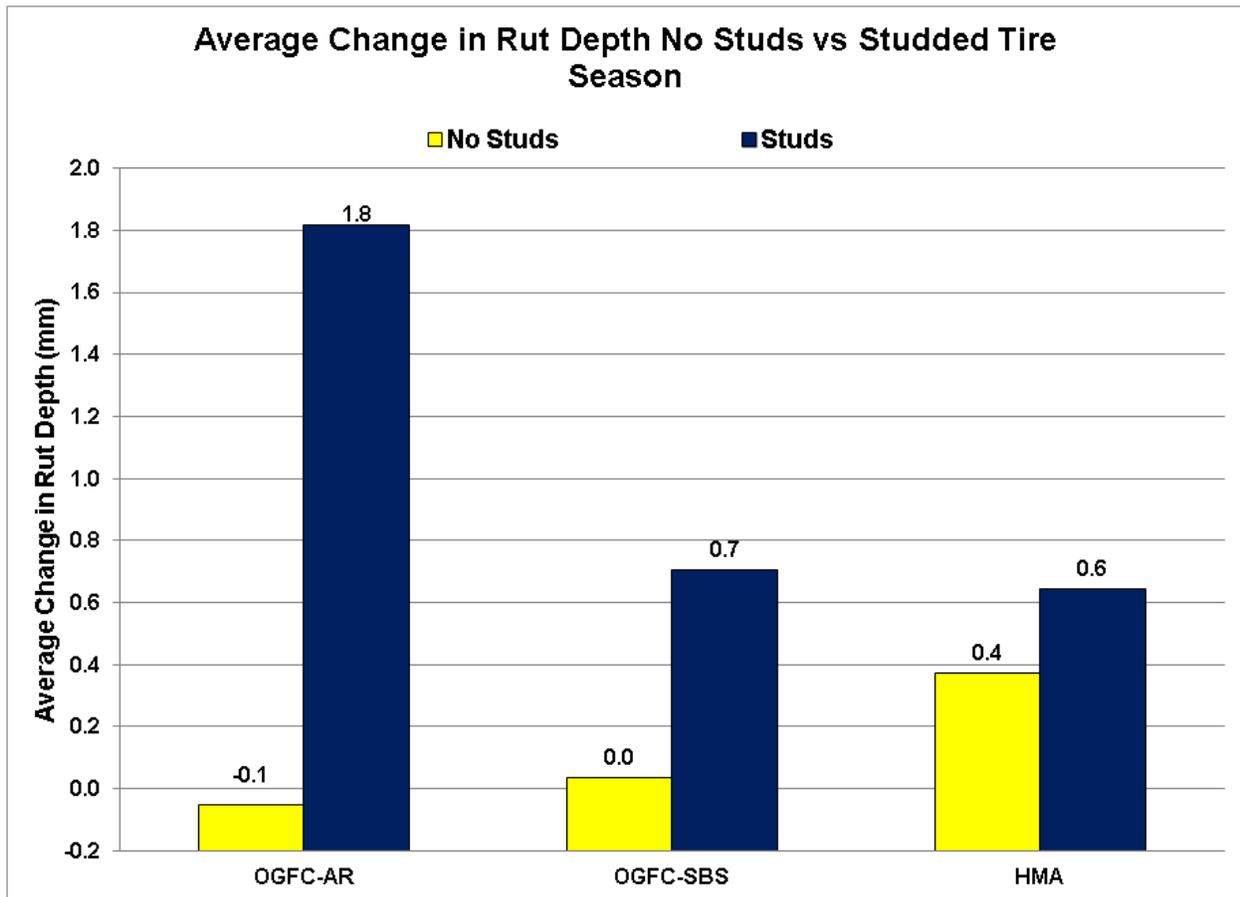
Figure 27. Average change in the depth of the rut during the legal studded tire season as compared to the rest of the year.

The average change in rut depth for all lanes of each section is listed in Table 14 and shown graphically in Figure 27 for the four winter and summer time periods. The OGFC-AR had an average increase in rutting of 1.8 mm during each winter period as contrasted with the OGFC-SBS and HMA sections which showed smaller increases, 0.7 and 0.6 mm, respectively. The average increase for all of the sections during the summer period was between a negative 0.1 mm and 0.4 mm, therefore, the raveling and rutting on all of the sections is occurring primarily during the winter months. A negative rutting value can happen when there is wear across the entire lane which would decrease the rut depth as compared to the previous measurement.

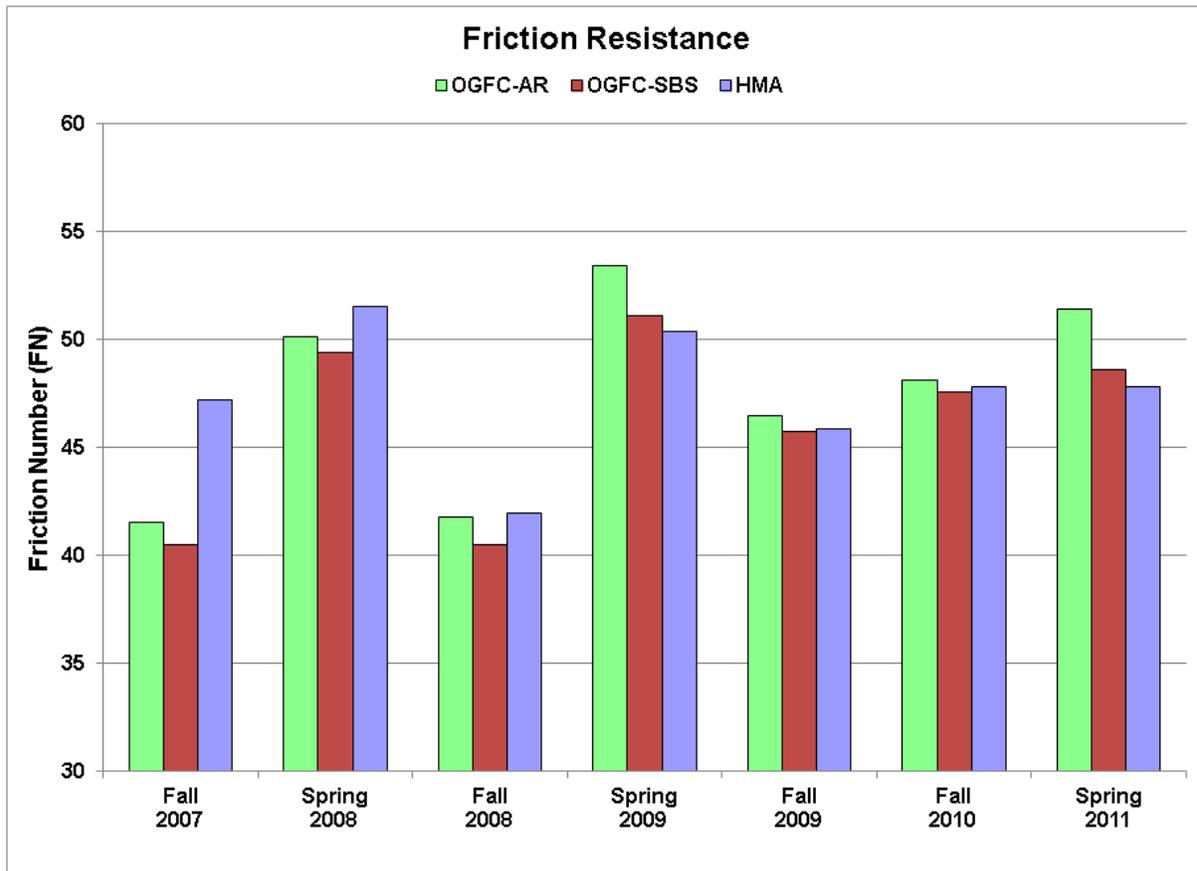
Figure 28. Average friction resistance for each pavement type.

*PC = post-construction measurements taken in September after the July paving. F = Fall, S = Spring. Row colors in the table match the bars in Figure 28. No measurements were made in the Spring of 2010.

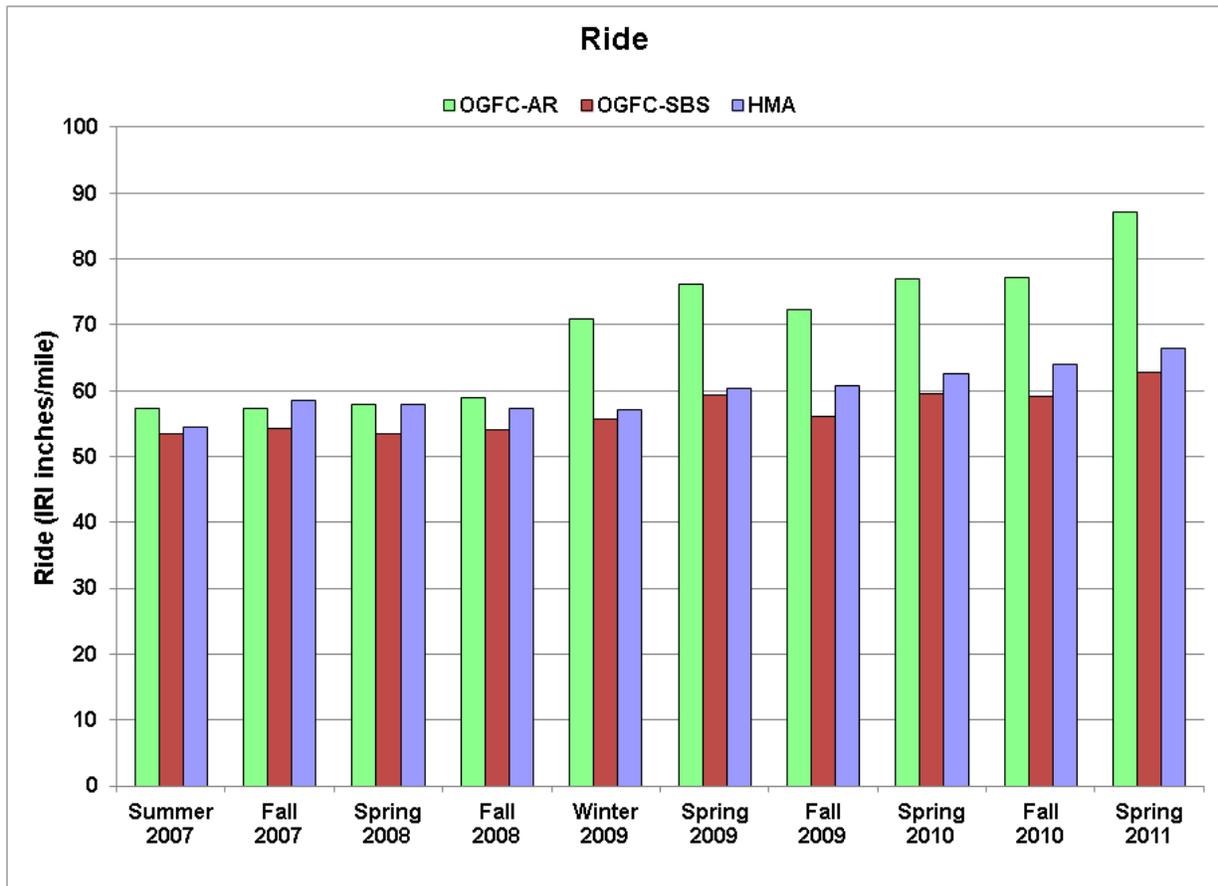
Figure 29. Average ride for each pavement.

Row colors in the table match the bars in Figure 29. F = Fall, S = Spring

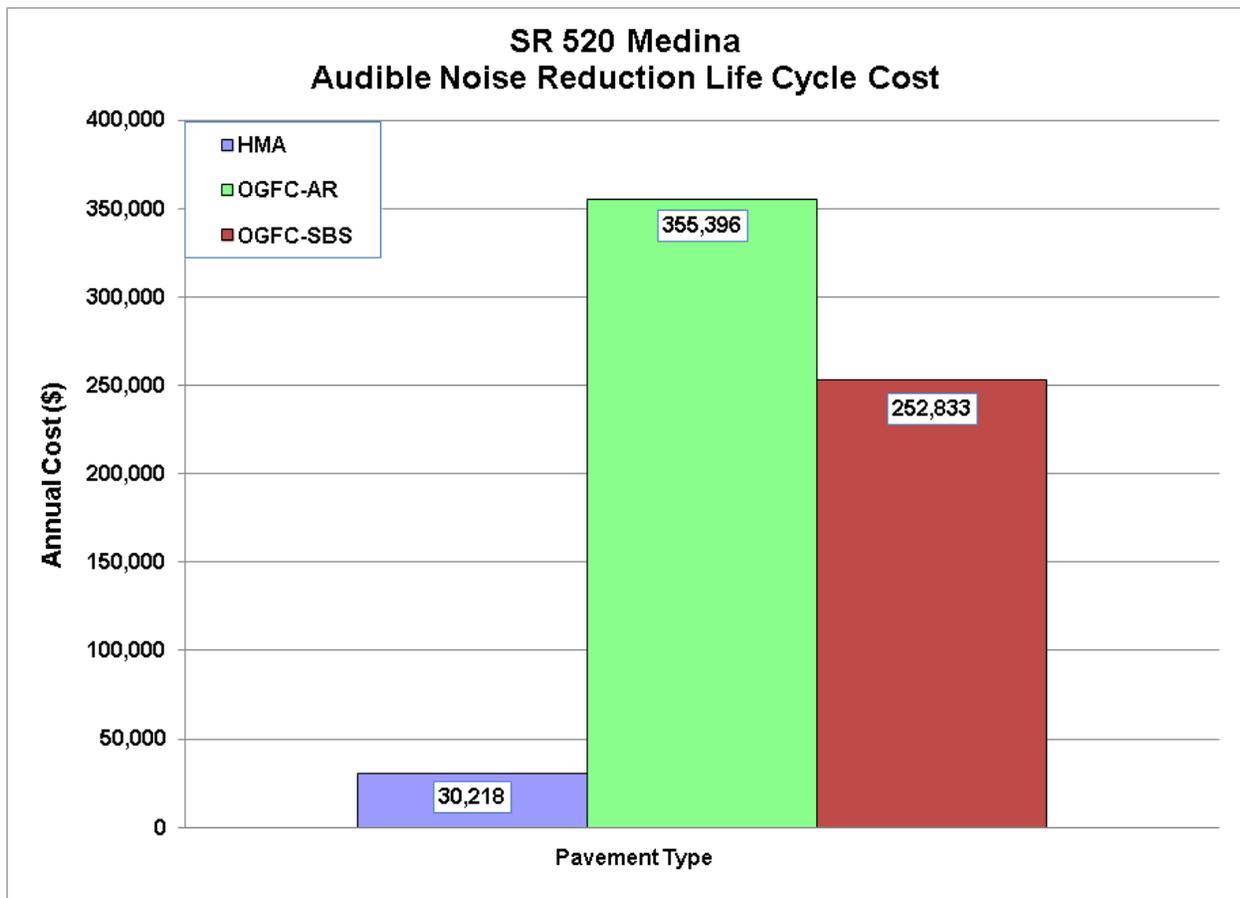
Figure 30. Life cycle cost based on audible noise reduction.

The bar chart below (Figure 30) compares the OGFC-AR and OGFC-SBS if they were replaced as soon as they were no longer audibly quieter than the HMA control section. Cost has been converted to uniform annual cost in order to directly compare the different pavement types. Although the audible noise reduction capability of the OGFC's were less than six months, for simplicity, one year was used in the calculation as the OGFC's pavement life with respect to audible noise reduction. The LCCA for the HMA control section based on performance data is also included for comparison.

The short duration of audible noise reduction for the OGFC's leads to a high life cycle cost. Current performance data for the HMA control section indicates that it will need to be replaced at an age of about 11 years. The OGFC-AR life cycle cost is more than eleven times and the OGFC-SBS eight times the life cycle cost of the longer lasting HMA.

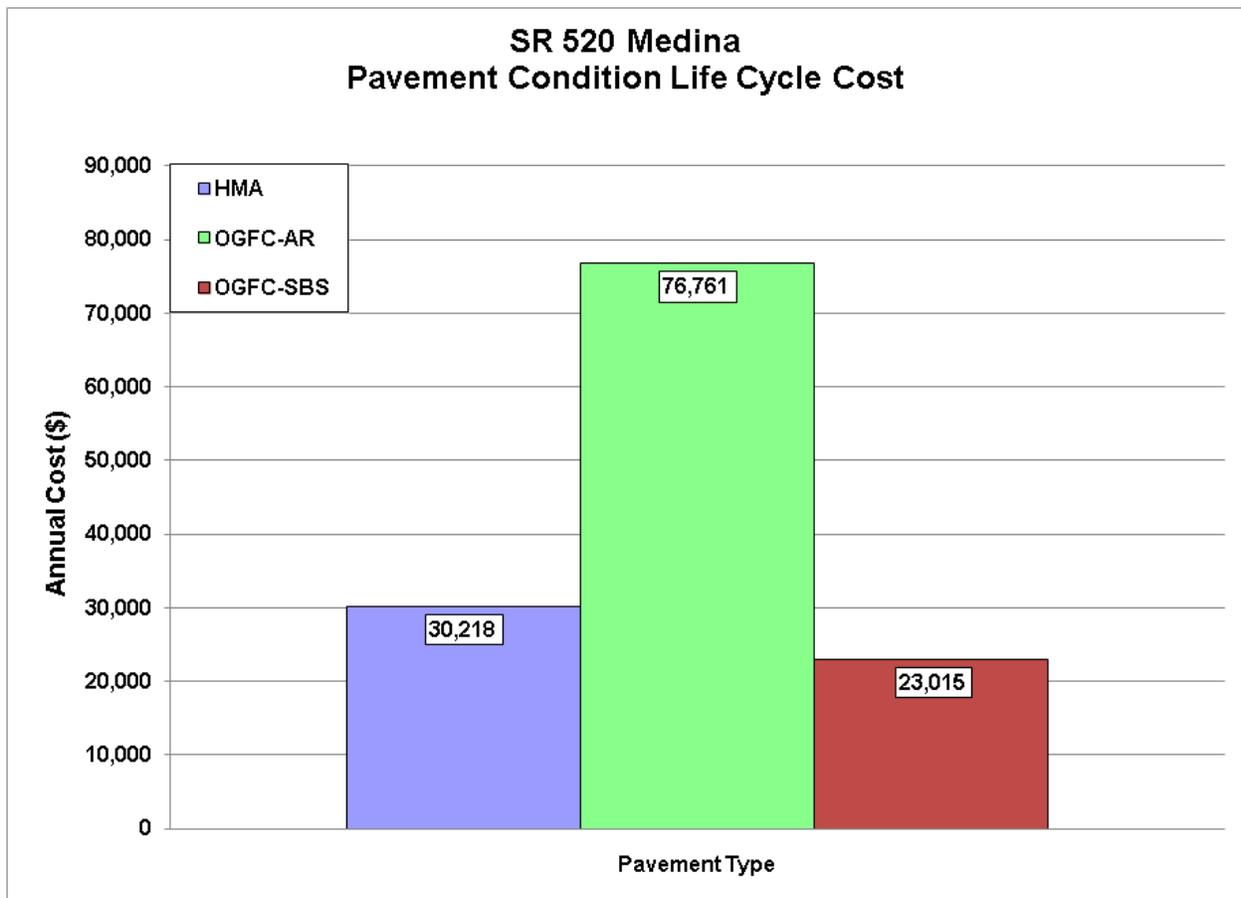
Figure 31. Life cycle cost passed on WSPMS performance data.

An LCCA analysis based on strictly pavement performance was also performed. Data from the Washington State Pavement Management System (WSPMS) indicates that the OGFC-AR would have needed replacement at five years due to rutting from studded tires. The OGFC-SBS would have lasted fourteen years with rutting also dragging down its performance. The bar chart below (Figure 31) shows the LCCA comparison of the OGFC sections and HMA control section.

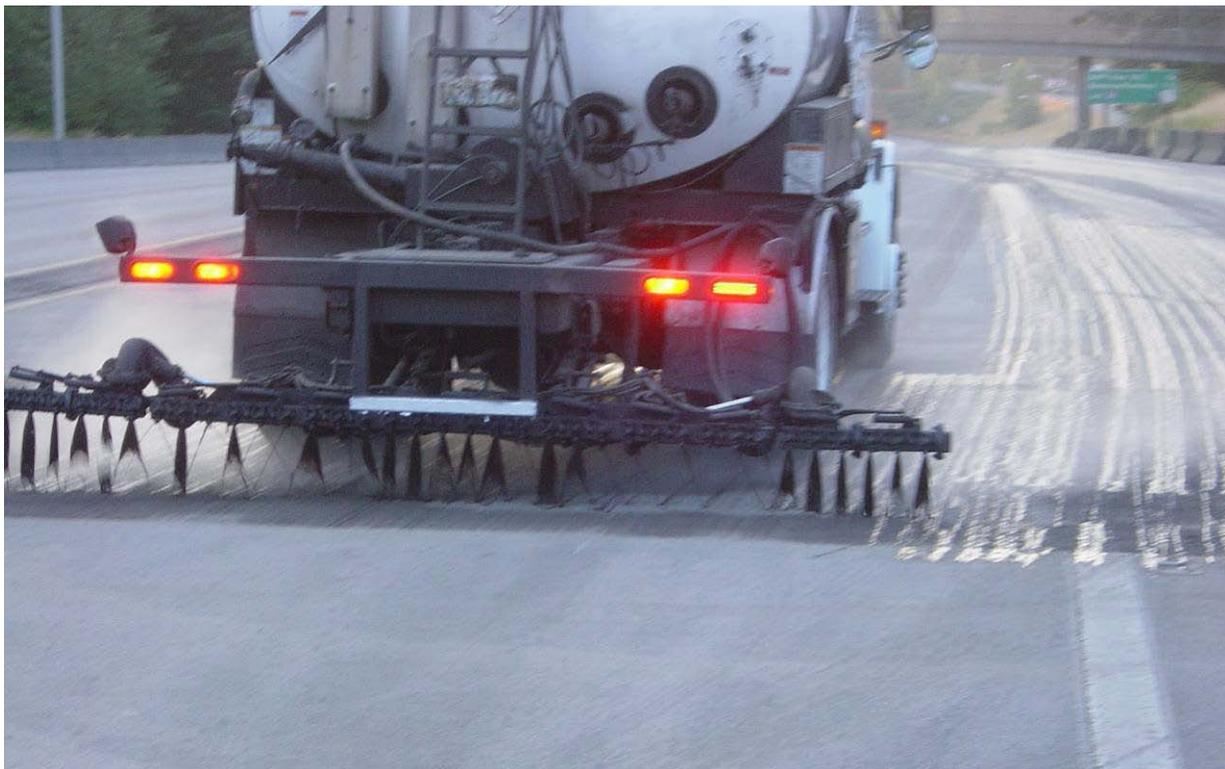
Figure 32. Image of typical tack application with some pickup visible in the wheel paths.

Tack coat for both the OGFC test sections was applied by an Etnyre distributor. The application of the CRS-2P tack was the item of concern because the snivies would plug quickly due to the tack material itself. The tack application was sporadic with streaking in the eastbound lanes of the OGFC-AR but the application was fairly uniform on the westbound lanes. The tack applied on the OGFC-Polymer was also erratic with streaking. Some tracking of the tack coat by the Shuttle Buggy and delivery trucks was observed in the wheelpaths but it was not as substantial as that which occurred on the OGFC project on I-5 near Lynnwood.

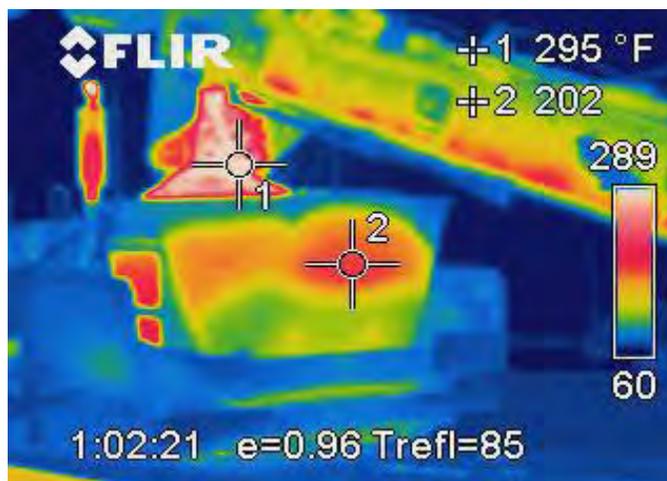
Figure 33. Thermal image of the mix as it leaves the SB and enters the paver hopper at 295°F.

The use of tarps on the HMA delivery trucks and trailers was seen throughout the paving operations for both the OGFC materials. Two ROADTEC Shuttle Buggy (SB) material transfer vehicles were used throughout the project. The SB has excellent remixing and storage capabilities and specifying it in the contract special provisions was a wise choice. The temperature of the mix as it was transferred from the SB into the paver hopper was typically around 290°F. The insulating and remixing capability of this device resulted in consistent temperatures across the mat and behind the screed. The only exception to this consistent pattern of temperatures occurred because of problems with one of the pavers as detailed later.

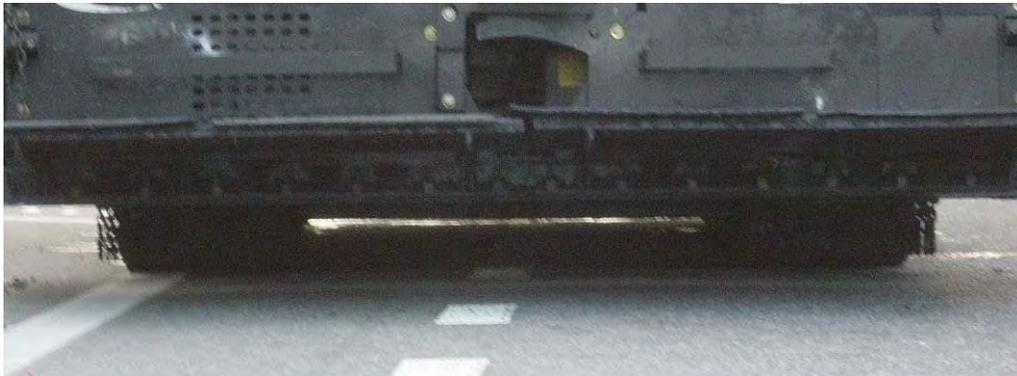
Figure 35. Digital image looking at the paver screed from behind with chain seen near the tracks but not between.

Two Blaw-Knox PF-5510 pavers equipped with paver hopper boxes were used throughout the project. The older was outfitted with a Carlson Easy Screed and the newer was set with a Carlson EZIV. Both pavers were equipped with paver retrofit kits to keep the screed from being starved at the gearbox; however, both were missing chains at the inner portion of the kit. The older paver appeared to leave more longitudinal streaks than the newer but this may have been caused by excessive speed. Streaking was also believed to have been caused by the buildup of cooler material at the front of the screed at the location of the auger extensions. Pieces of mix would dislodge from the paver at this location and travel under the screed and show up as a glob of cooler material in the mat. These globs were removed and replaced using material taken from in front of the screed with the result being that no surface defects were left after compaction.

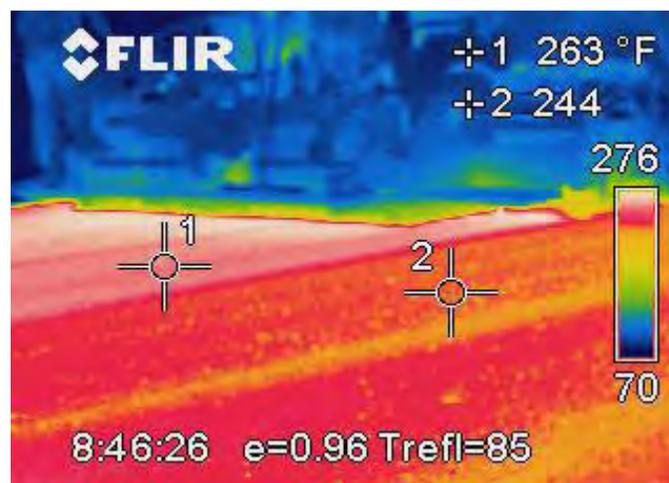
Figure 36. Streaking OGFC of first paver (spot 2) and the consistent mat behind second paver (spot 1).

Most of the problems with streaking and globs of material were eliminated once the speed of the paving operation stabilized. This was also true during the paving of the OGFC-Polymer. Paving was conducted in a side-by-side operation and longitudinal joints were eliminated by hot-lapping of the joint from the simultaneous paving operation.

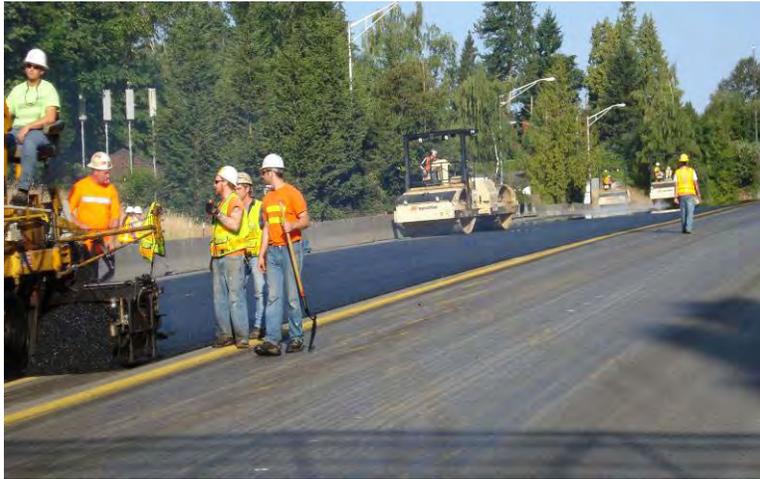
Figure 38. Image of distance between rollers.

Generally, the rollers met the requirement to be within 300 feet of the paver; however, the operators had trouble knowing when to get off the mat after the surface temperature of the pavement reached the Special Provision requirement of 200°F. This was not caused by excessively low temperatures of the OGFC at arrival but seemed to be caused by lack of checking surface temperature while rolling. This caused aggregate breakage to occur during OGFC placement.
