Evaluation of Long-Term Pavement Performance and Noise Characteristics of Open-Graded Friction Courses – Project 2: Final Report

WA-RD 691.2

Evaluation of Long-Term Pavement Performance and Noise Characteristics of Open-Graded Friction Courses – Project 2

Contract 7353
SR-520
Eastside Quieter Pavement Evaluation Project
MP 4.24 to MP 5.82

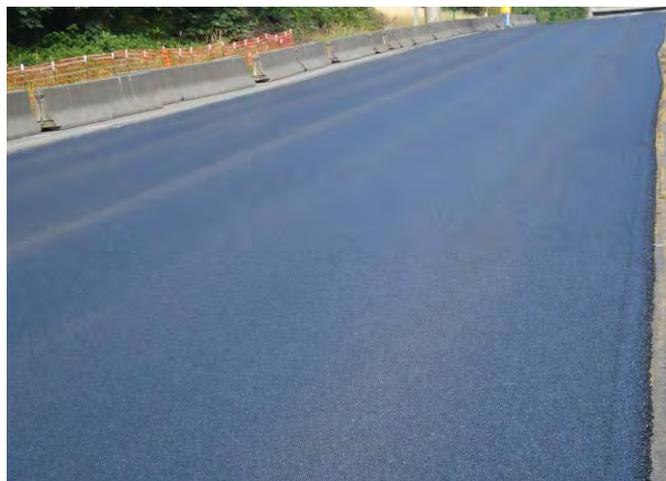
Figure 39. Image of aggregate breakage in paved lanes (brown surface).

Generally, the rollers met the requirement to be within 300 feet of the paver; however, the operators had trouble knowing when to get off the mat after the surface temperature of the pavement reached the Special Provision requirement of 200°F. This was not caused by excessively low temperatures of the OGFC at arrival but seemed to be caused by lack of checking surface temperature while rolling. This caused aggregate breakage to occur during OGFC placement.

The roller operations could have more easily adhered to the 300-foot specification if the paver slowed down at the beginning of each new lane. Additionally, the rollers could have made fewer passes if the temperature of the pavement was being monitored and this would have eliminated

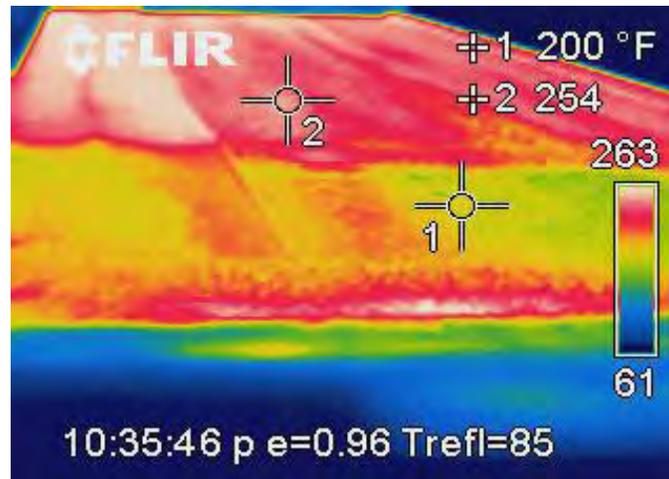
Figure 40. Thermal image of construction joint at startup
