FHWA Contract DTFH61-03-C-00104
Research Task No. 7
Retrofit of Rectangular Bridge Columns

**RETROFIT OF RECTANGULAR BRIDGE COLUMNS USING
CFRP WRAPPING**

December 2008

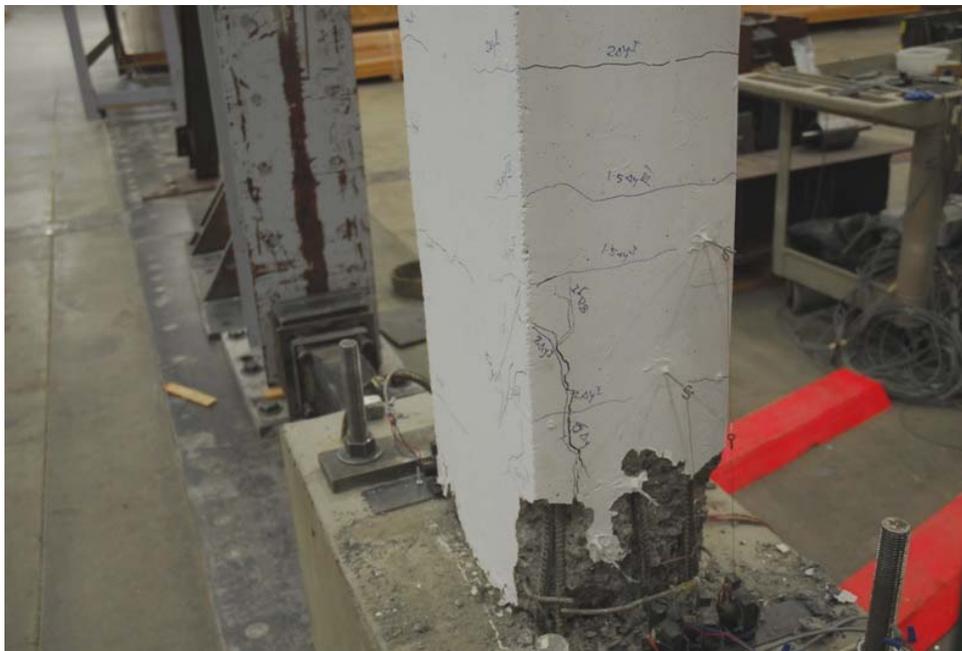
Figure 14 The North Side of Specimen AB-2 Towards the End of Testing.

Horizontal-flexure cracks started to develop at the extreme faces of the column, in the direction of loading, while cycling at a displacement level of 0.6 in. (15 mm). At the end of the test, a number of small flexural cracks covered the bottom half of the column. Vertical cracks associated with lap splice failure began to form at the base of the column while cycling at a displacement level of 1 in. (25 mm). These cracks continued to propagate with increasing levels of lateral displacements. The most notable vertical crack, which occurred on the north face of the column, propagated to the full height of the lap splice during cycling at a displacement level of 2.4 in. (61 mm), as shown Figure 14. At this displacement level, the column reinforcement also became visible due to

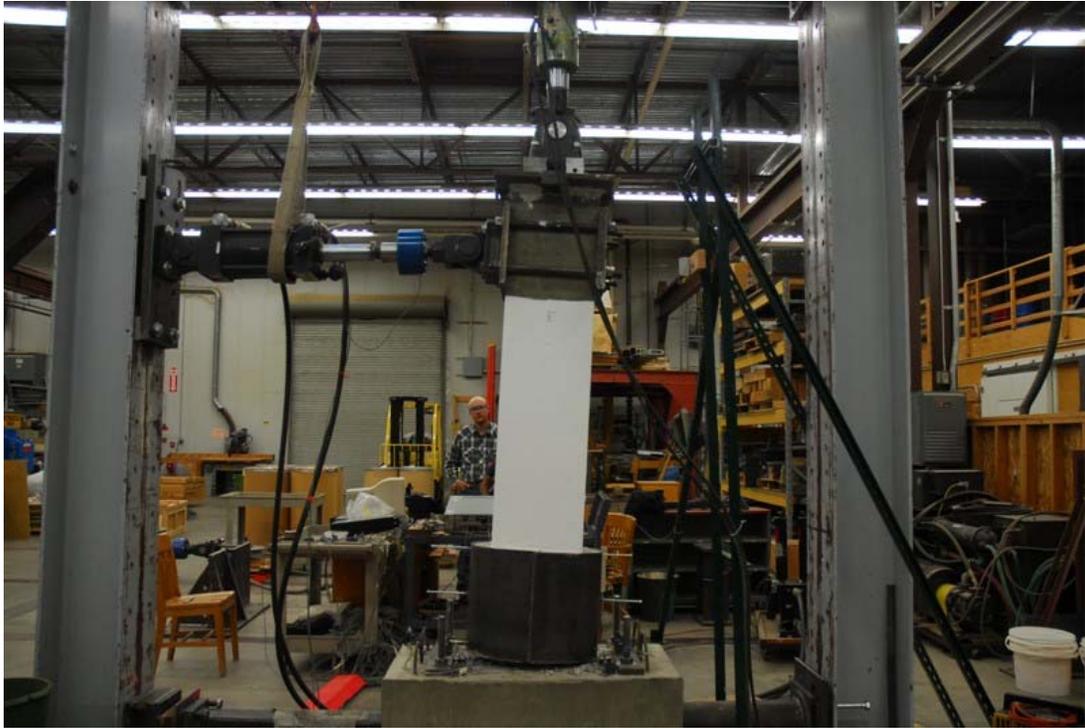
Figure 19 Specimen SJ During Testing

A photograph of Specimen SJ during testing is given in Figure 19. The behavior of Specimen SJ was dominated by hinging at the gap provided between the steel jacket and the footing. The first visible flexure crack in the gap region occurred during the first cycle at the 1.2 in. (30 mm) displacement level. There was no observable flexural cracking above the steel jacket throughout the test. The concrete within the gap region started to crush and spall during the third cycle at the 1.6 in. (41 mm) displacement level, as shown in Figure 20. At a displacement level of 3.2 in. (81 mm), buckling of the longitudinal bars within the gap was observed. During the second cycle at the 3.2 in. (81 mm) displacement level, a series of “popping” sounds accompanied by a “kink” in the lateral load vs. displacement hysteresis curves occurred due to a low-cycle fatigue fracture of the reinforcing bars. Three longitudinal bars ruptured by the end of the test.

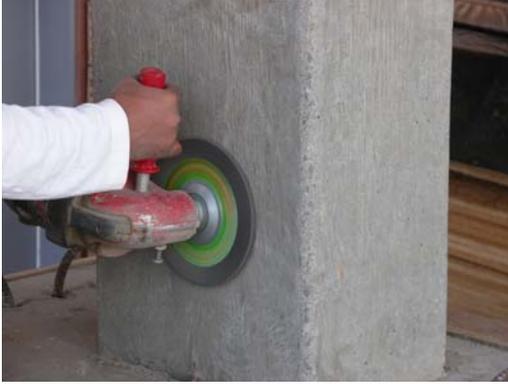
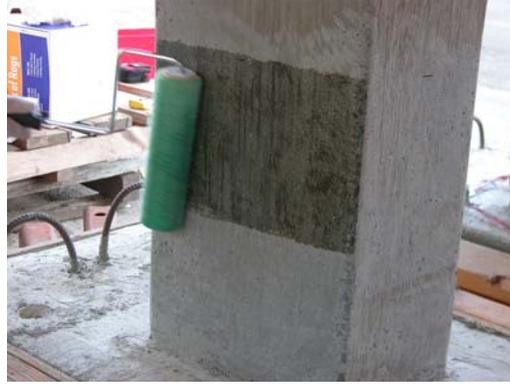
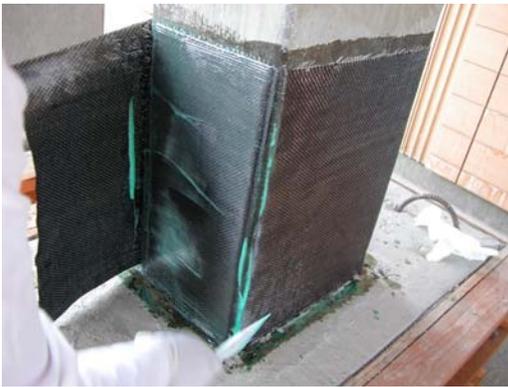
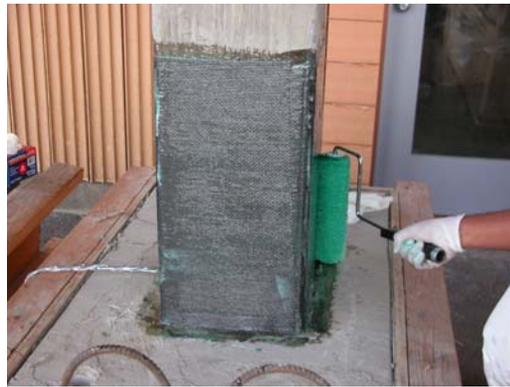
Figure 23 Steps for CFRP Retrofit Installation

a) Smooth Out Irregularities

b) Saturate Column Surface with Epoxy

c) Install CFRP Wrapping

d) Saturate CFRP with Epoxy

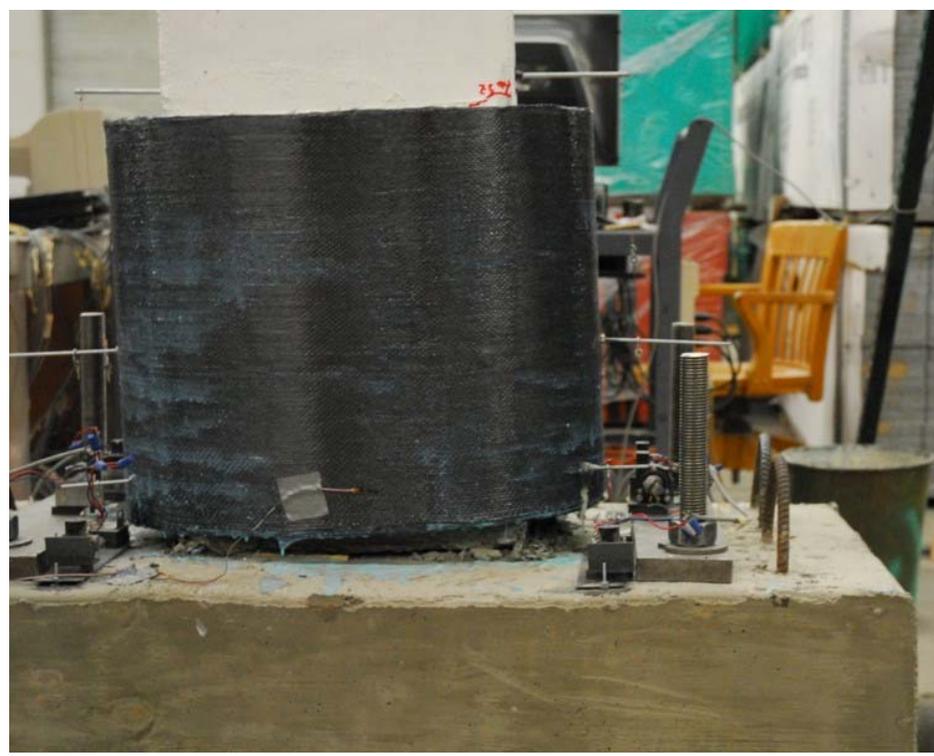
Figure 25 Specimen FRP-MS During Testing

noticeable. The concrete in the gap region began to crush and spall, as shown in Figure 25, at a displacement level of 1.6 in. (30 mm) and exposed the column reinforcement. Buckling of the reinforcement was observed in the gap region during the first cycle at the 2.4 in. (61 mm) displacement level. A “popping” sound was heard during the second cycle at 3.2 in. (81 mm) due to a low-cycle fatigue fracture of a longitudinal bar. After the column’s lateral load resisting capacity dropped below 80% of the peak load, four other longitudinal bars ruptured while loading to a displacement level of 4 in. (102 mm).

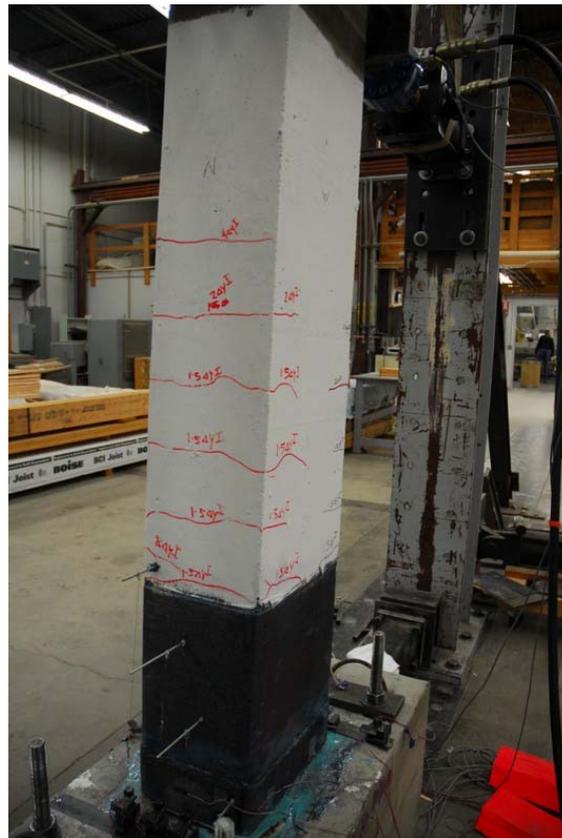
Figure 33 Specimen FRP-8 During Testing

Upon completion of testing, the CFRP jacket showed no sign of rupture, but minor bulging was noticed at the base of the column. The level of bulging in Specimen FRP-8 was comparable to that of Specimen FRP-6. Crack patterns observed in Specimen FRP-8 were essentially the same as for Specimen FRP-6. Figure 33 shows the small

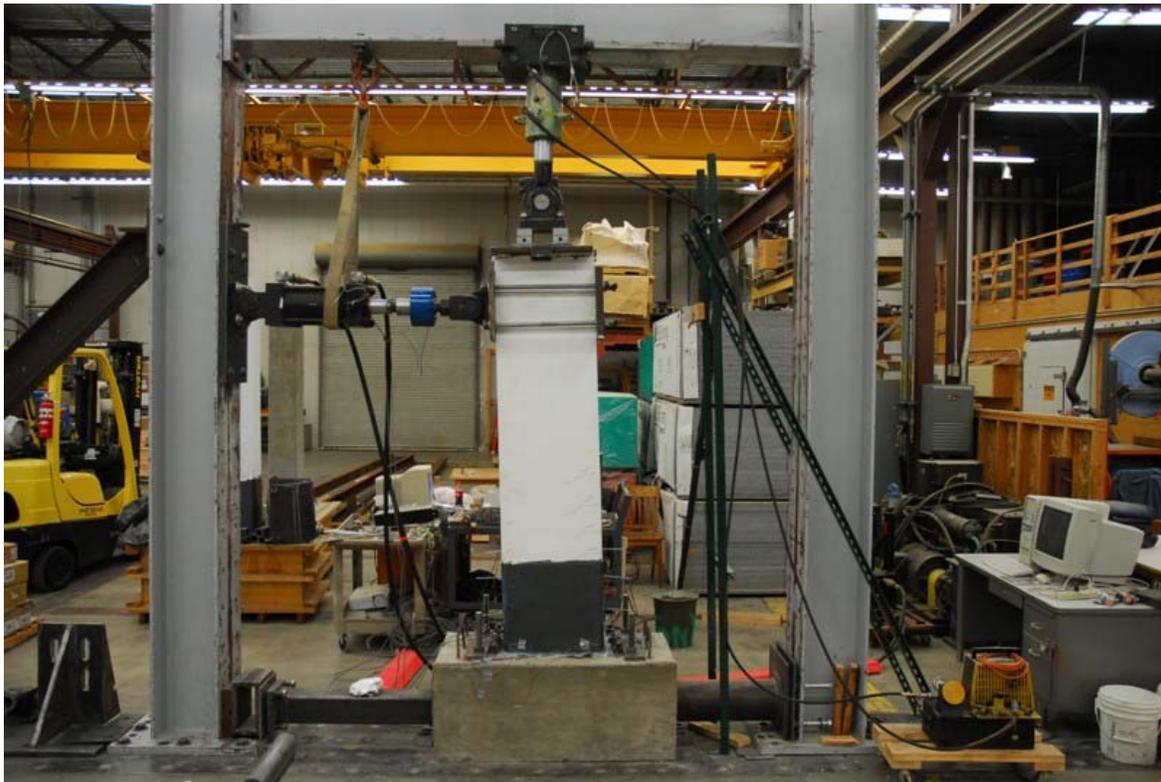
Figure 36 Specimen AR-2 During Testing

A photograph of Specimen AR-2 during testing is shown in Figure 36. The level of damage and the crack patterns for Specimen AR-2 were similar to the other specimens retrofitted with CFRP rectangular jackets. A significant flexural crack developed in the gap region at the base of column. Smaller flexural cracks developed in the column above the CFRP jacket. Bulging of the jacket, shown in Figure 37, occurred in the plastic hinge region toward the end of testing and was similar in extent to that for Specimen FRP-4. In general, the performance of Specimen AR-2 was similar to the retrofitted specimens with
