Seismic Retrofit of Cruciform-Shaped Columns in the Aurora Avenue Bridge Using FRP Wrapping

WA-RD 753.1

WSDOT Research Report

Research Project T4120-15
Aurora Avenue Bridge Retrofit Evaluation

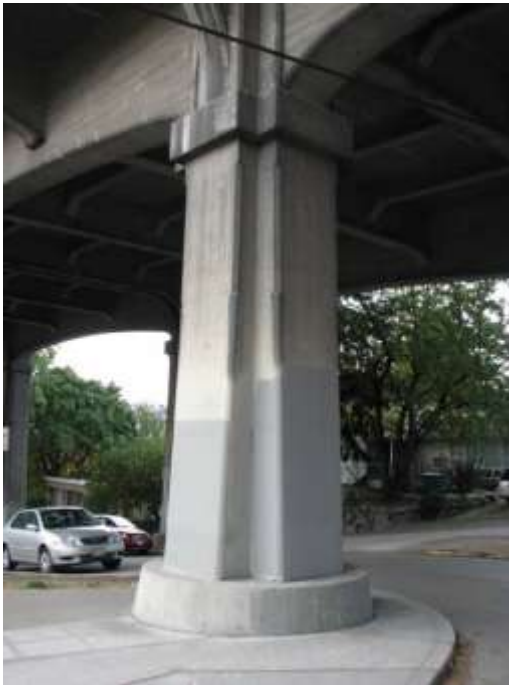
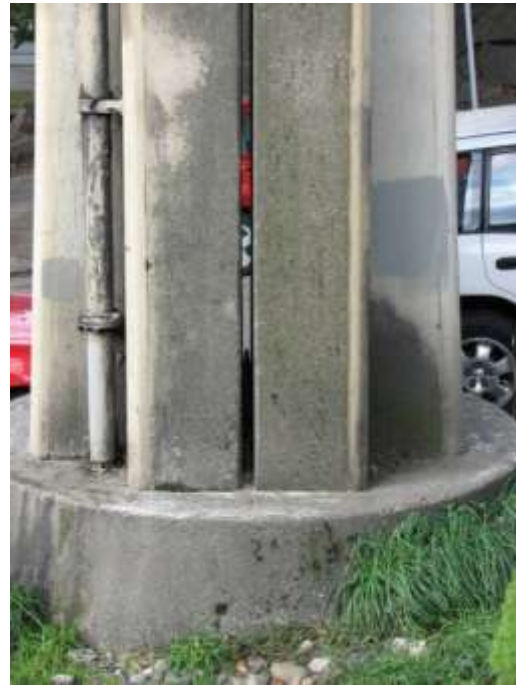
Figure 4 – Typical Solid and Split Columns in the North Approach

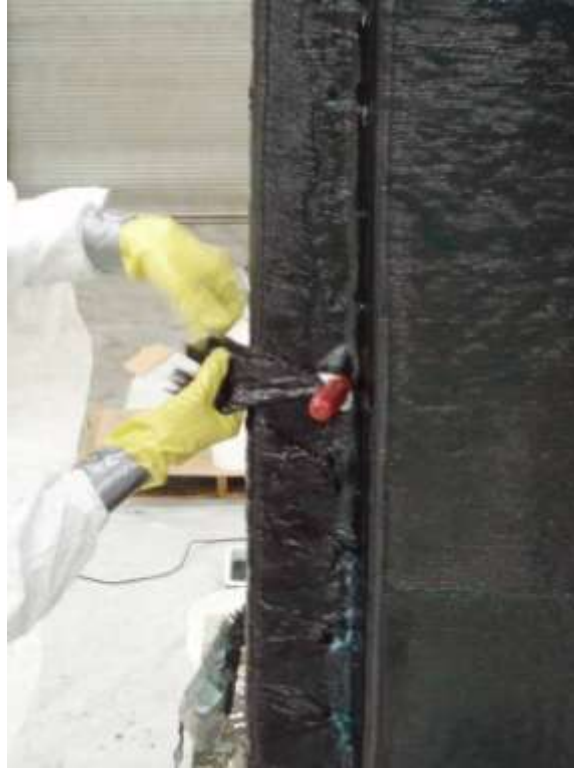
Figure 12 – FRP Anchor Installation

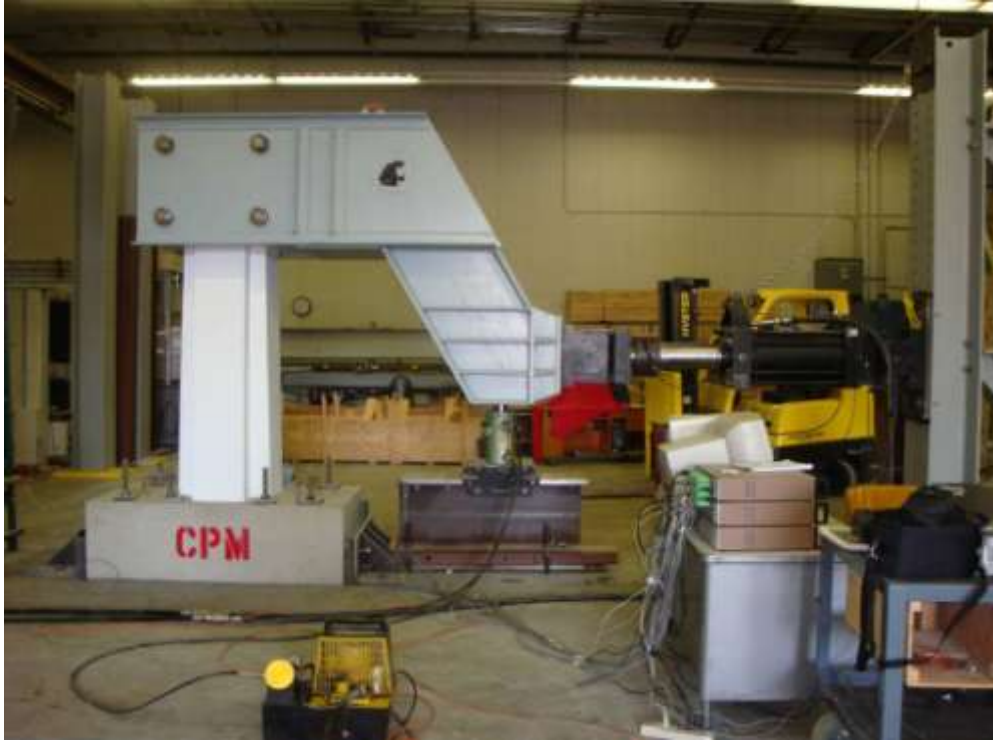
Figure 17 – Column 1 Test Setup

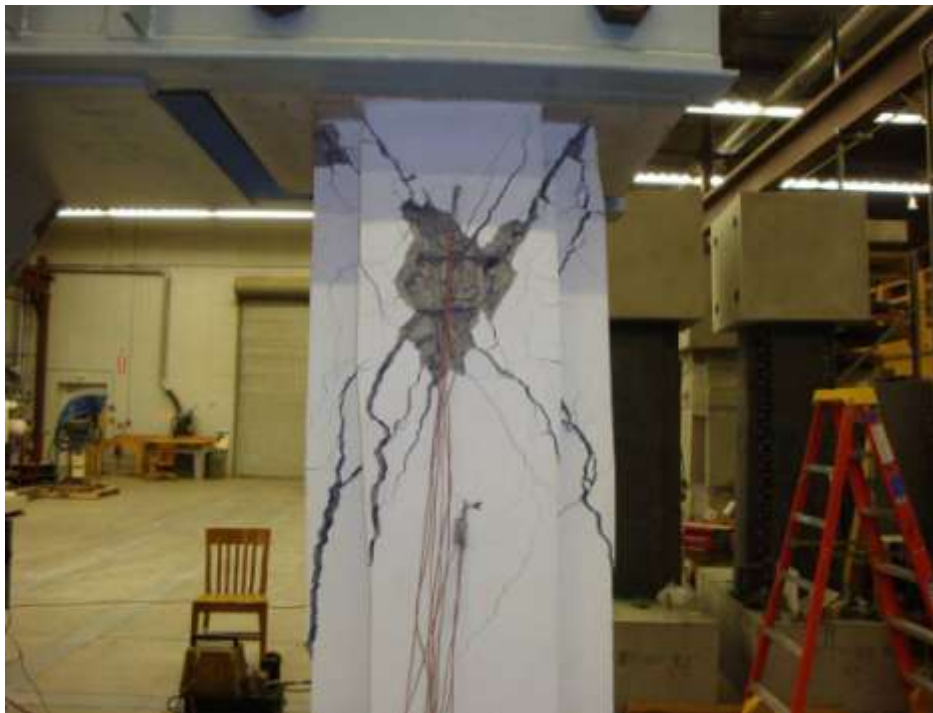
Figure 18 – Column 1 Shear Cracking Near the End of Testing

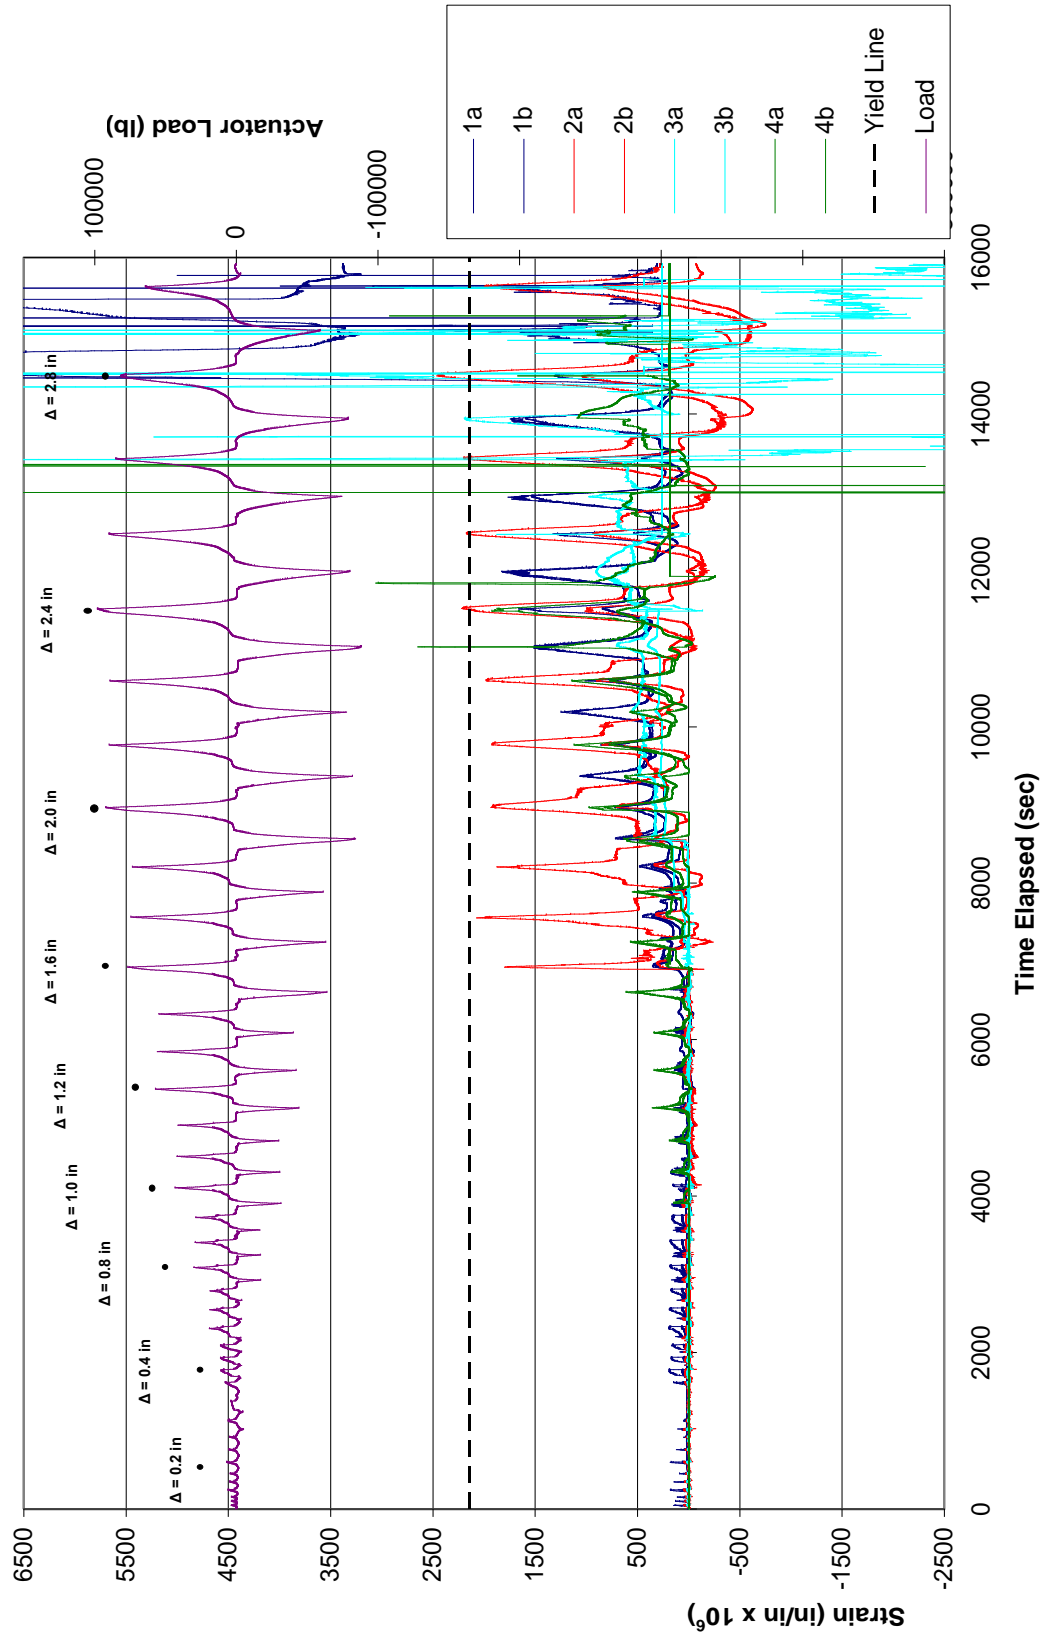
Figure 19 – Column 1 Transverse Strain Gage Data (1 kip = 4.45 kN, 1 in. = 25.4 mm)

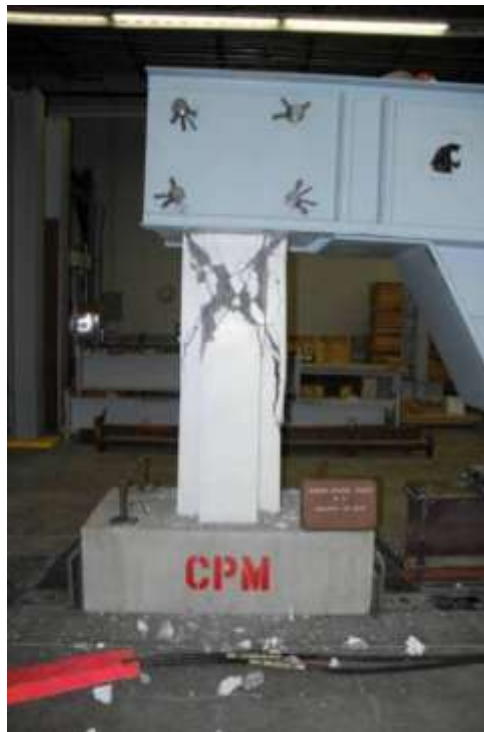
Figure 23 – Column 5 Shear Cracking Near the End of Testing

Yielding of the longitudinal bars in Column 5 first occurred at a lateral force level of 49 kips (218 kN) followed by flexural cracking at the top and bottom of the column. Early shear cracks formed at a lateral force level of about 73 kips (325 kN). Yielding of the transverse reinforcement first occurred at a lateral force level of 93 kips (414 kN) followed by the opening of large shear cracks near the end of the test. The final failure mode for the column was a shear failure. Figure 23 shows the large shear cracks present near the end of testing.

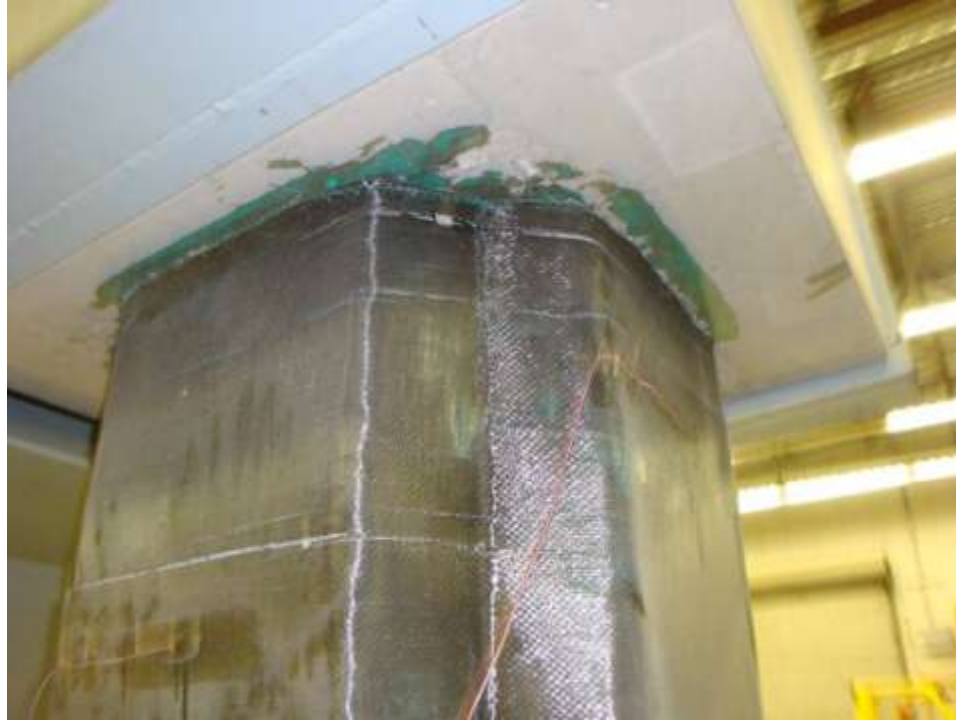
Figure 28 – Column 2 Pullout of FRP Jacket from Reentrant Corners

reentrant corners at the top and bottom of the column, most noticeably at the top. With continued cycling, the pullout of the FRP began to extend down the column, resulting in a significant decrease in the peak lateral load. Figure 28 shows the pullout of the FRP jacket from the reentrant corners. Yielding of the transverse reinforcement first occurred at a lateral force level of 88 kips (390 kN) during the second cycle at a displacement level of 2.0 in. (51 mm). After removing the FRP jacket at the end of testing, it was evident that the final failure mode for the column was a shear failure. Inspection of the specimen after testing showed that the pullout of FRP from the reentrant corners was likely due to spalling of the cover concrete from flexural hinging rather than debonding of the FRP jacket from the concrete.

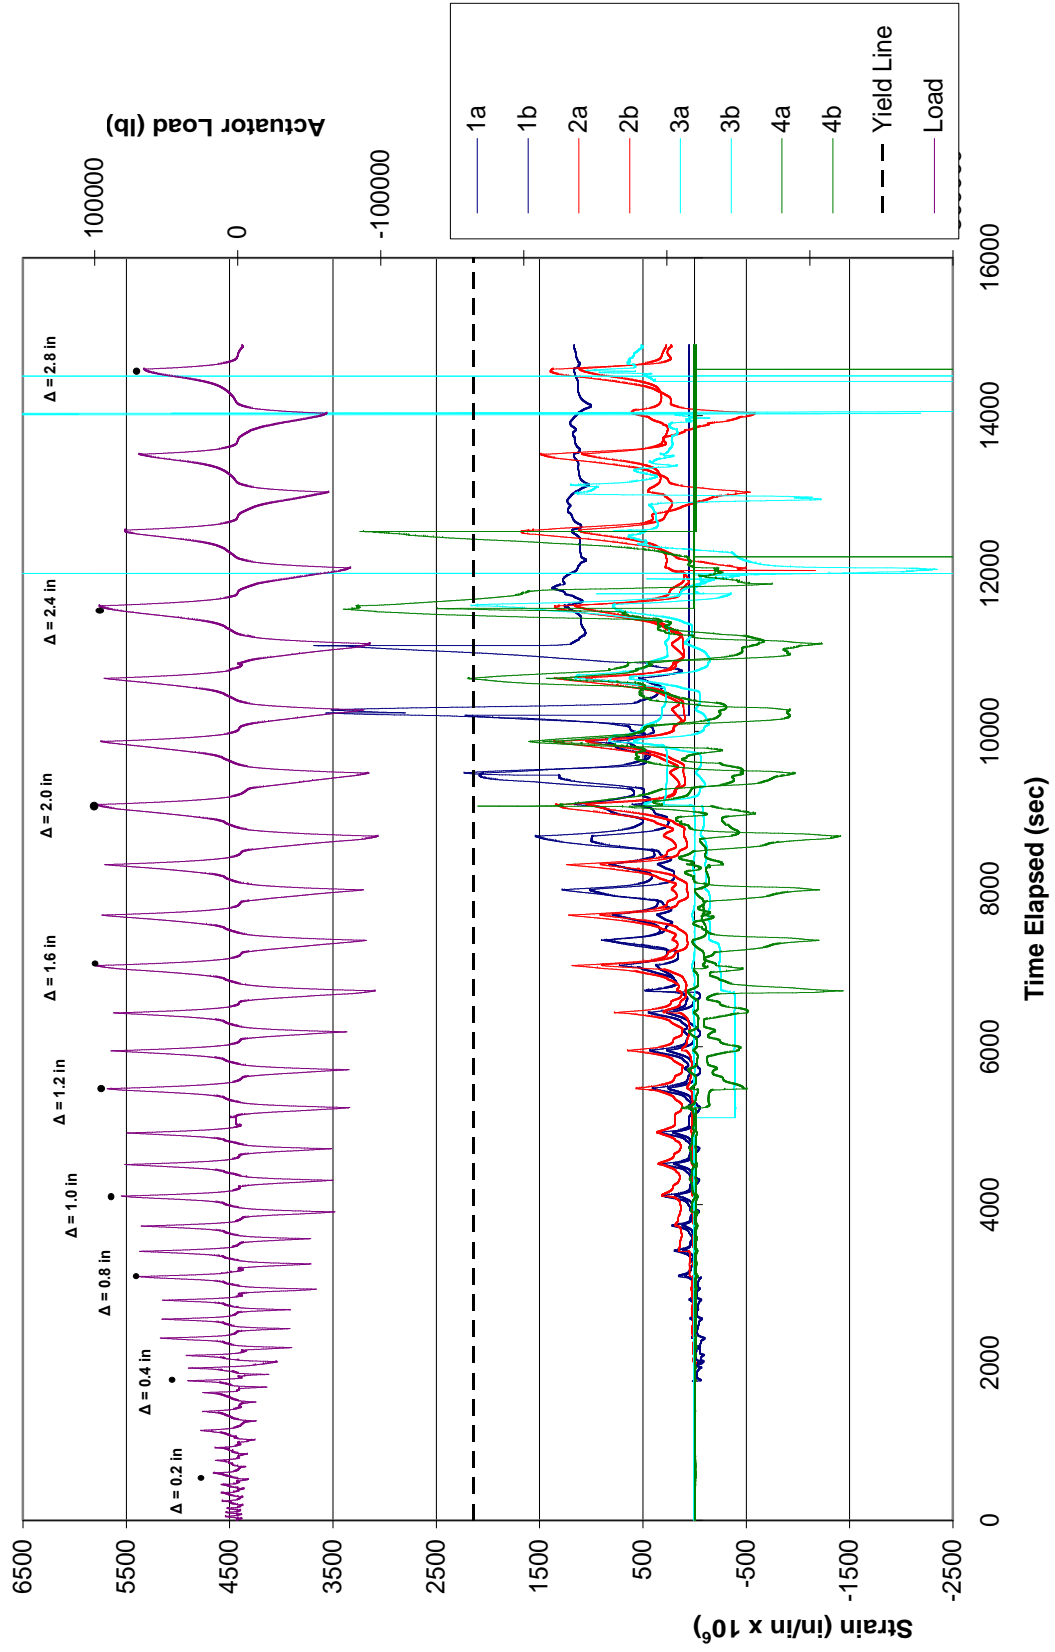
Figure 29 – Column 2 Transverse Strain Gage Data (1 kip = 4.45 kN, 1 in. = 25.4 mm)

Figure 29 shows a plot of the transverse tie strains with time. Almost negligible tie strains were observed up to a displacement level of 0.8 in. (20 mm). A linear strain profile was then observed up to the first yield of the transverse reinforcement during the second cycle at a displacement level of 2.0 in. (51 mm). Very large tie strains were observed during further testing as the FRP jacket pulled away from the reentrant corners.

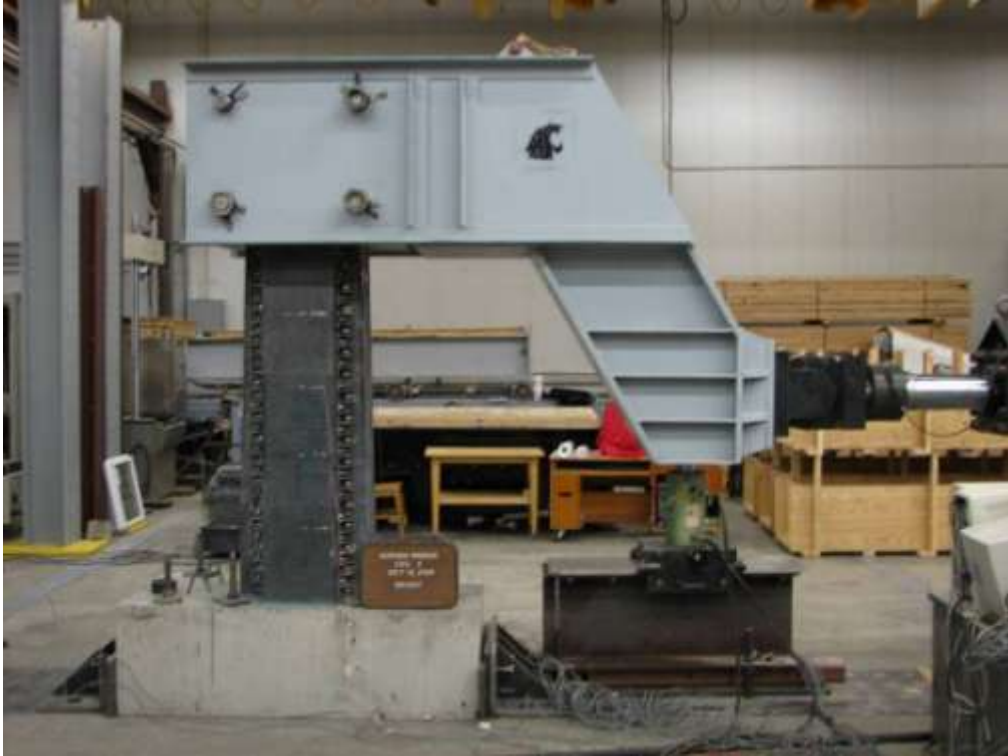
Figure 35 – Column 3 Test Setup

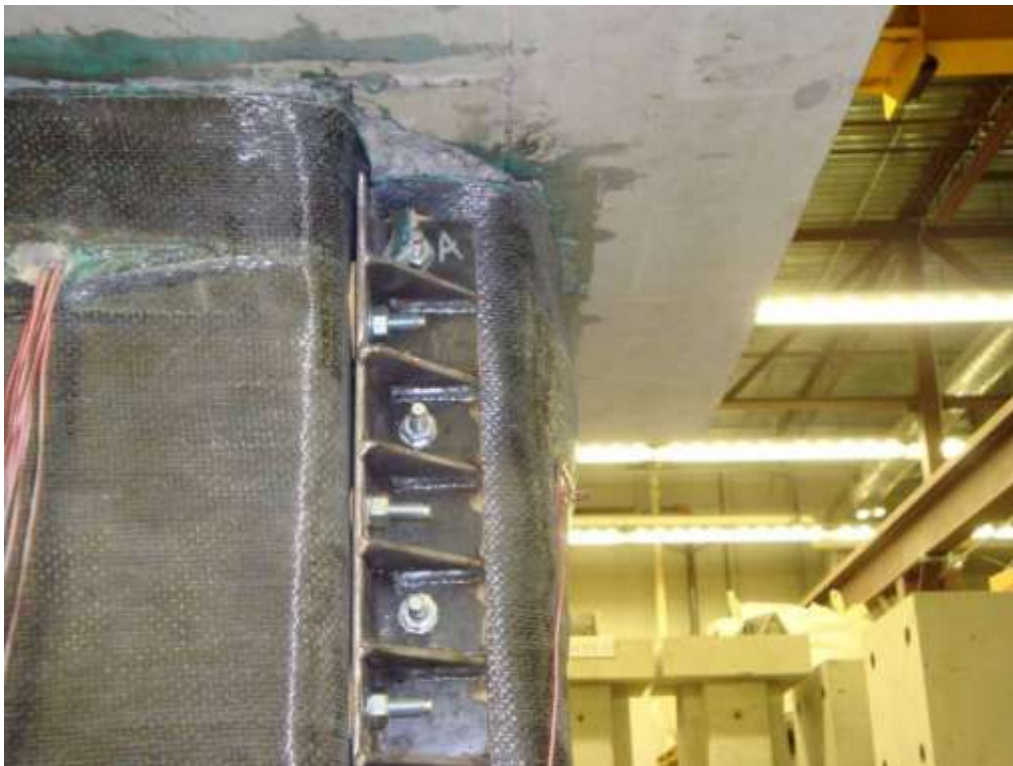
Figure 36 – Column 3 Bulging of FRP Jacket at the Top of the Column

loads. Figure 36 shows the bulging of the FRP jacket at the top of the column. During the first cycle at a displacement level of 3.2 in. (81 mm), the epoxy anchors at the top of the column failed and the load displacement curve peaked before reaching a lateral displacement of 3.2 in. (81 mm), producing failure in the column. No shear distress was observed in the column throughout the test, and the final failure mechanism was development of plastic hinges at the top and bottom of the column. The failure of the epoxy anchors at the top of the column near the end of testing was likely due to crushing and degradation of the concrete under the FRP jacket in the plastic hinge region.

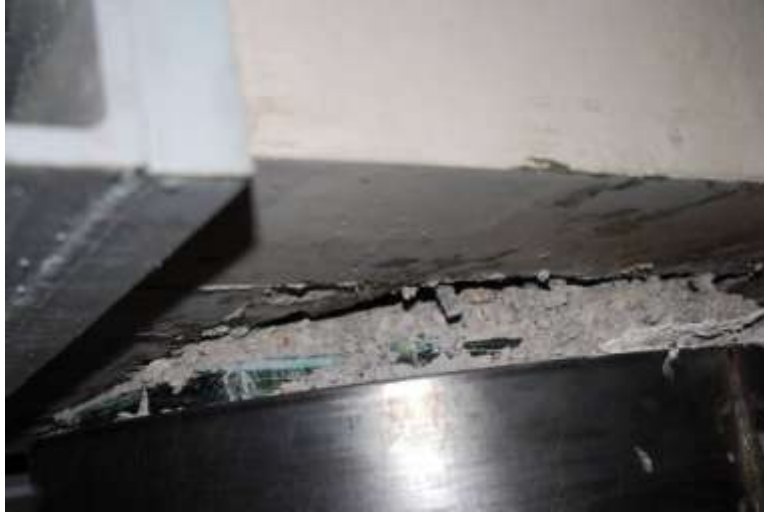
Figure 43 – Column 4 Longitudinal Rebar Fracture

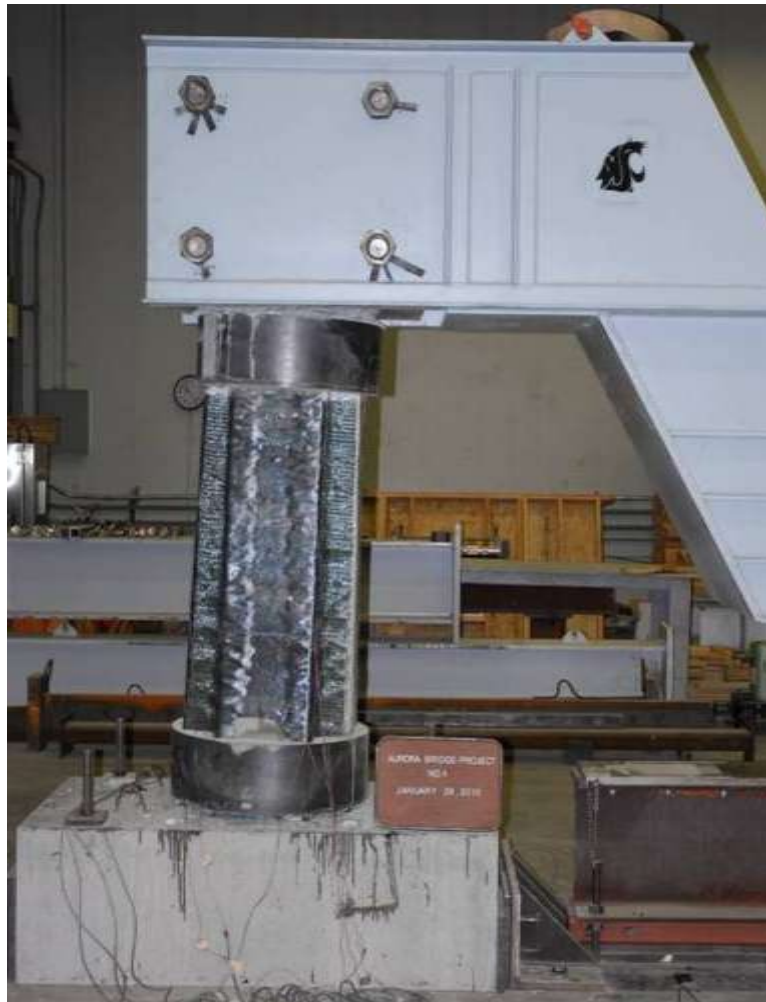
Figure 44 – Column 4 Near the End of Testing

strain. FRP jacket strains were slightly lower than those for Column 3 parallel to the applied load, and strains on the steel collar were almost negligible throughout the test. The applied lateral load remained nearly constant even after development of plastic hinges at the top and bottom of the column up to a displacement level of 3.6 in. (91 mm). While cycling at a displacement level of 3.6 in. (91 mm), several of the vertical reinforcing bars fractured, resulting in significant decrease in the lateral stiffness and strength. Figure 43 shows the fractured longitudinal steel which was caused by low-cycle fatigue due to the stress reversals in the plastic hinge region. The final failure mode for the column was flexural hinging leading to fracture of the longitudinal rebar with no distress observed in the FRP jacket and steel collar at the end of testing. Figure 44 shows the column at the end of testing and illustrates the significant rotation of the plastic hinge regions.

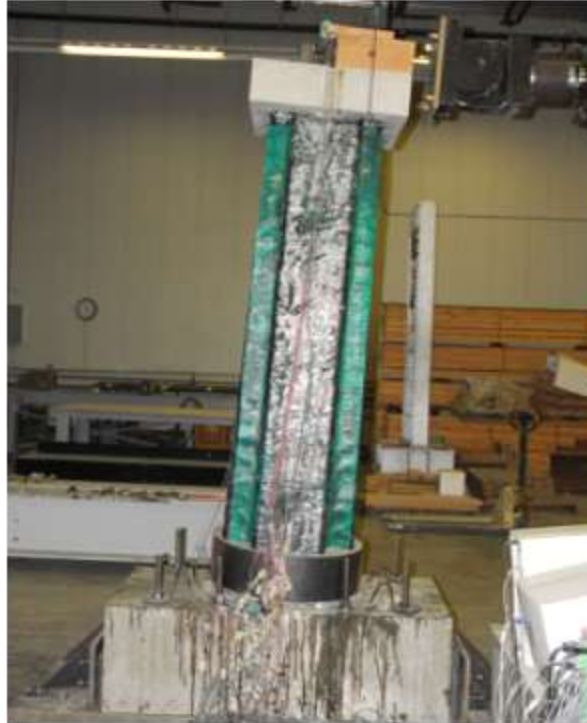
Figure 52 – Column 6 Near the End of Testing
